**Environmental Health and
Safety Department**
Lead Compliance Assurance Report
Field Oversight

June 16, 2022 – December 15, 2022

EH&S Lead Oversight Activity Summary

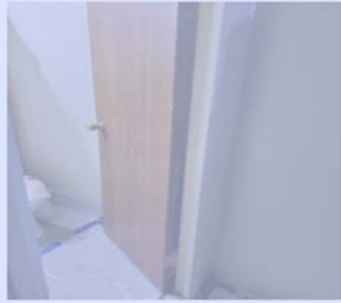
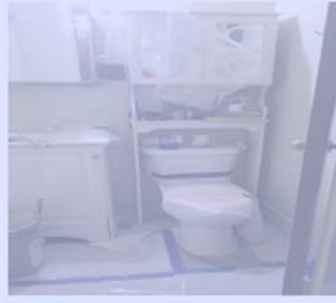
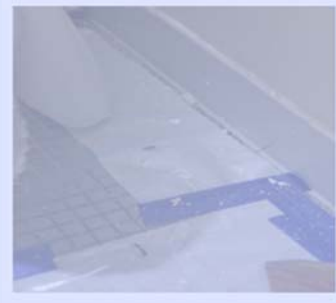
11. PHOTOS:

9. INCIDENT DESCRIPTION: <p>During an oversight inspection of RRP Paint work at Dyckman Houses, EH&S Lead Oversight Team Specialist (LOTS) Chibuzor Nwobodo observed the following on 08/16/2022 at about 3:10 pm:</p> <p>Painters Garces Albeiro and Silverio Grajales were performing RRP paint work with inadequate containment of their work area and not in compliance with the requirements of NYCHA Standard Procedure and EPA regulation. They did not close the door or cover the entrance to the bathroom where they were working with plastic sheeting or any impermeable material. They also did not cover a cabinet inside the bathroom that contained the resident's belongings. At the time of inspection, one of the Painters was just starting to paint the bathroom while the partner was about to start surface preparation of the kitchen.</p> <p>The deficiencies are violations of section(s) of NYCHA Lead Safe Standard Procedure and EPA regulation as follows:</p> <p>40 CFR 745.85.2 - Containing Work Area Before beginning the renovation, the work area must be isolated so that no dust or debris leaves the work area while the renovation is being performed. In addition, the containment integrity must be maintained by ensuring that any plastic or other impermeable materials are not torn or displaced, and taking any other steps necessary to ensure that no dust or debris leaves the work area while the renovation is being performed.</p> <p>SP050201-Lead Safe Standard Procedure Section.V11.I.10(b)(1) - Site Preparation</p> <p>b) Secure the apartment and/or work area against unauthorized entry.</p> <p>d) Cover all items which were not moved from the work area with one layer of disposable polyethylene sheeting. The sheeting must be taped together with duct tape, and taped to the floors or bottom of the walls or baseboards, to form a continuous barrier to the penetration of dust.</p> <p>g) Cover the work area entrance or vertical containment doorway with one layer of sheeting. Tape the sheeting to the top of the door frame or vertical containment high point and weigh down the bottom to create a seal. Create a door flap on the sheeting that allows access into the work area.</p>

10. CORRECTIVE ACTION TAKEN: <small>(Describe what was done after you observed the deficiency, was this reported to the job supervisor, were the corrective actions implemented, did you remain onsite to see completion?)</small> <p>LOTS, Chibuzor Nwobodo asked Painters Garces Albeiro and Silverio Grajales to adequately contain their work area. Painters Supervisor Fernando Do Santos was also contacted and he stated that he constantly reminds his crew to always do proper setup when performing RRP work. The Painters complied with my directive to adequately contain the work area as they created barriers between the work area and the resident by covering the bathroom door and also covered the cabinet inside the bathroom while I was on site.</p>

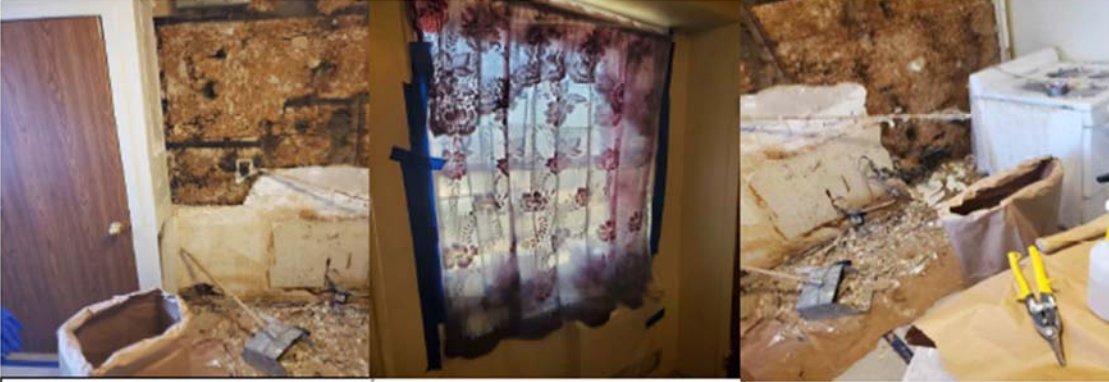
11. PHOTOS:

6. ADMINISTERING DEPARTMENT BROOKLYN BOROUGH	7. DEVELOPMENT: Red Hook West Houses	8. OBSERVATION ADDRESS 135 Richards Street, 7A	
9. INCIDENT DESCRIPTION: During an observation of RRP work performed on 08/24/2022 at about 11:20 am, EH&S Lead Oversight Team Specialist (LOTS), Akinola Idowu observed the following: 1) There was inadequate containment in the kitchen during work activities. Plasterer used 1 mil plastic sheeting to cover the window and failed to properly seal off the kitchen window. Plasterer should have sealed off kitchen window from top to bottom with 6mil plastic sheeting. 2) The work area (Kitchen) was very dusty because plasterer did not adequately wet the disturbed paint surface with water during demolition. These deficiencies violated EPA regulations and NYCHA Lead Safe Standard Procedure as follows: - 40 CRF 745.83 : Work area containment "Containment measures should be designed to prevent the release of lead-containing dust, which can be spread by workers' shoes or by airborne dust, taking any other steps necessary to ensure that no dust or debris leaves the work area while the renovation is being performed" and NYCHA Lead Safe Standard Procedure for containment page 48 "Close windows, and cover the windows with one layer of 6-mil sheeting to prevent dust and debris from settling on windowsills. - NYCHA SP 050.201 Page 93 iv. (l) Close windows, and where applicable, cover the windows with one layer of sheeting to prevent dust and debris from settling on windowsills. - Lead safe work practices guidance at Section II.D of Chapter 11 and 745.80(b): Prohibited activities "Workers must never use prohibited paint-removal practices, should work wet to dampen dust spread (except where this would create an electrical safety hazard), and should clean up thoroughly after the work. During paint-disturbing work, painted surfaces should be wet with a fine mist of water before scraping or sanding to reduce generation of airborne paint dust and RRP works are conducted using lead-safe work practices that do not increase the hazards of lead-based paint to the occupants of the dwelling or child-occupied facility. - NYCHA SP 050.201 Page 95 11 a Using the spray water bottle, spray the surfaces that will be disturbed to limit the creation and dispersal of dust. Periodically re-wet the area while working.

10. CORRECTIVE ACTION TAKEN: <small>(Describe what was done after you observed the deficiency, was this reported to the job supervisor, were the corrective actions implemented, did you remain onsite to see completion?)</small> LOTS Akinola Idowu asked the plasterer to wet the wall and work area with a fine mist of water to bring down the visible dust in the work area but he said "you cannot tell me how to do my job" LOTS insisted that the plasterer needed to spray more water to bring down the dust and he said " fuck out of this place clown". LOTS told the plasterer to lower his voice and be professional but he again said " I am tired, sweating and frustrated by motherfuckers like you". Plasterer failed to comply with the LOTS directive he was given. Plasterer supervisor (Frank Romano) was informed about the behavior of his plasterer. Capital Project Department inspectors training with LOT witnessed this incidence.
