**Environmental Health and
Safety Department**
Lead Compliance Assurance Report
Field Oversight

December 16, 2021 – June 15, 2022

Exhibit B: Renovation, Repair and Painting (RRP) Escalation Reports (December 16th, 2021 – June 15th, 2022)

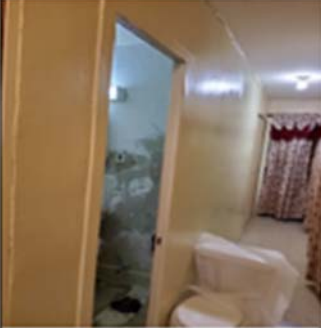
| EHU OVERSIGHT ESCALATION REPORT | | | |
|--|---|---|--|
| <p>9. INCIDENT DESCRIPTION:</p> <p>On 02/08/2022 at about 2:00 pm LOTS Chibuzor Nwobodo observed Plasterer Jomo Longdon performing RRP Plaster work with inadequate containment of the work area. He did not cover the entrance to the bathroom where he was working with plastic sheeting as required. He had completed demolition of bathroom wall #4 and was mixing plaster to start applying white coating at the time of inspection but some debris remained on the floor. He stated that he with his Helper had cleaned up their demolition debris and that whatever debris that was left was created by a maintenance worker that just came to disconnect the toilet.</p> <p>Plasterer Supervisor Jerry Favorito was contacted and he mentioned that plaster work will take too long to dry if the work area is completely covered. I informed him that there is debris on the floor and the prepared surface is bare which means that the work area still has a potential to create lead dust hazard to his staff and the residents. He advised the Plasterer and the Helper to comply with the directive.</p> <p>The failure to cover the entry to the bathroom with plastic sheeting is a violation of the Lead SP 050.201 page 84 (g) which states "Cover the work area entrance or vertical containment doorway with one layer of sheeting. Tape the sheeting to the top of the door frame or vertical containment high point and weigh down the bottom to create a seal. Create a door flap on the sheeting that allows access into the work area".</p> | | | |

| EHU OVERSIGHT ESCALATION REPORT | | | |
|--|---|---|--|
| <p>10. CORRECTIVE ACTION TAKEN: (Describe what was done after you observed the deficiency, was this reported to the job supervisor, were the corrective actions implemented, did you remain onsite to see completion?)</p> <p>LOTS Chibuzor Nwobodo instructed Plasterer Jomo Longdon and his Helper Paul Johnson to adequately contain their work area by covering the bathroom entrance with plastic sheeting. Plasterer Supervisor Jerry Favorito was also contacted and he asked them to comply with the directive. They complied with the directive while I was on site and before continuation of work.</p> | | | |

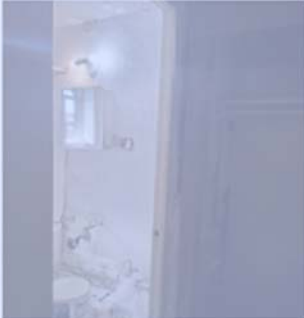
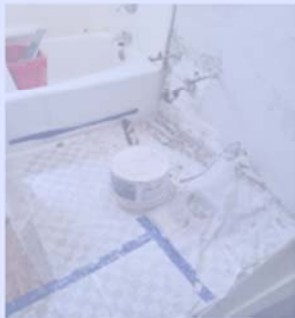
| EHU OVERSIGHT ESCALATION REPORT | | | |
|--|---|---|--|
| 9. INCIDENT DESCRIPTION: During an observation of RRP Plaster Red Hook Houses, there was a violation of NYCHA Lead Safe Standard Procedure and EPA's Lead Safe Work Practices Requirement: SP050201-Lead Safe Standard Procedure Section 7.1.10 - Site Preparation "Cover the work area entrance or vertical containment doorway with one layer of sheeting. Tape the sheeting to the top of the door frame or vertical containment high point and weigh down the bottom to create a seal. Create a door flap on the sheeting that allows access into the work area". 40 CFR 745.85.2 - Containing Work Area Before beginning the renovation, the work area must be isolated so that no dust or debris leaves the work area while the renovation is being performed. In addition, the containment integrity must be maintained by ensuring that any plastic or other impermeable materials are not torn or displaced, and taking any other steps necessary to ensure that no dust or debris leaves the work area while the renovation is being performed. c) Close windows and doors in the work area. Doors must be covered with plastic sheeting or other impermeable material. Doors used as an entrance to the work area must be covered with plastic sheeting or other impermeable material in a manner that allows workers to pass through while confining dust and debris to the work area. EHS Lead Oversight Team Specialists (LOTS) Chibuzor Nwobodo and Samuel Awelewa observed the following on 05/17/2022 at about 11:15 am: Observed and flagged Plasterer Terrell Skinner for not posting warning sign-age outside the work area when performing RRP plaster work; also put in place inadequate containment of his work area as per the NYCHA Standard Procedure and EPA regulation cited above. He did not close or cover the window and the entrance to the bathroom where he was working with plastic sheeting or any impermeable material as required. He had completed demolition of bathroom ceiling and wall #4 including bathroom chair-rail and was plastering the prepared surface at the time of inspection. There were some paint chips, debris and dust accumulated on the floor of the work area. He said that the work was not RRP because the demolished surface was less than two square feet. He did not comply or show any sign that he intends to comply with our directive for him to contain the work area while we were on site. (3) SP050201-Lead Safe Standard Procedure Section V11.1.10.a(1) - Sign-age - Outside the Work Area: a) "Certified renovators post NYCHA Form 088.182, Renovation, Repair, and Painting Safety Sign, before work begins. NYCHA Form 088.182, Lead Safety Sign was not posted at the entrance to the work area. The deficiency was corrected as a sign was posted while we were on site. | | | |

| EHU OVERSIGHT ESCALATION REPORT | | | |
|--|---|---|--|
| 10. CORRECTIVE ACTION TAKEN: (Describe what was done after you observed the deficiency, was this reported to the job supervisor, were the corrective actions implemented, did you remain onsite to see completion?) LOTS, Chibuzor Nwobodo asked the Plasterer, Terrell Skinner to post Paint Safety Sign and to adequately contain the work area by closing the window and covering the bathroom door with 6mil plastic sheeting. He complied with posting the sign but he was not showing any inclination that he wanted to cover the door and the window. Instead he asked us to instruct his Helper to do it when she comes back from the shop. She didn't come back yet by the the time we left; suddenly because of unsafe condition as gun shots were reported within the vicinity. LOT Field Supervisor Samuel Awelewa contacted Plasterer Supervisor Frank and notified him about our observations. | | | |

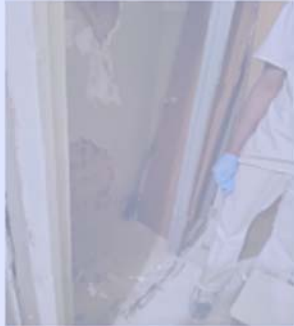
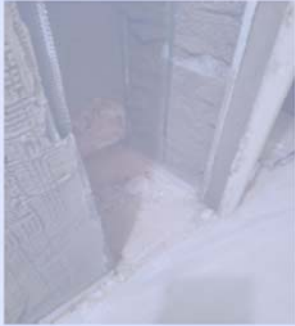
| EHU OVERSIGHT ESCALATION REPORT | | | |
|--|---|---|--|
| <p>9. INCIDENT DESCRIPTION:</p> <p>During an observation of RRP Plaster job at Mill Brook there was a violation of NYCHA Lead Safe Standard Procedure and EPA's Lead Safe Work Practices Requirement:</p> <p>SP050201-Lead Safe Standard Procedure Section 7.1.10 - Site Preparation "Cover the work area entrance or vertical containment doorway with one layer of sheeting. Tape the sheeting to the top of the door frame or vertical containment high point and weigh down the bottom to create a seal. Create a door flap on the sheeting that allows access into the work area".</p> <p>40 CFR 745.85.2 - Containing Work Area Before beginning the renovation, the work area must be isolated so that no dust or debris leaves the work area while the renovation is being performed. In addition, the containment integrity must be maintained by ensuring that any plastic or other impermeable materials are not torn or displaced, and taking any other steps necessary to ensure that no dust or debris leaves the work area while the renovation is being performed.</p> <p>c) Close windows and doors in the work area. Doors must be covered with plastic sheeting or other impermeable material. Doors used as an entrance to the work area must be covered with plastic sheeting or other impermeable material in a manner that allows workers to pass through while confining dust and debris to the work area.</p> <p>EH&S Lead Oversight Team Specialist (LOTS) Chibuzor Nwobodo observed the following on 05/18/2022 at about 11:20 am:</p> <p>Observed and flagged Plasterer Charles Dennis for performing RRP Plaster work with inadequate containment of his work area as per the NYCHA Standard Procedure and EPA regulation cited above. He did not close the door or cover the entrance to the hallway closets where he was working with plastic sheeting or any impermeable material as required. He had completed demolition of surfaces, did partial clean up and was plastering walls at the time of inspection but some debris were on the floor. He told me that the job started the day before, clean up of big demolition debris was done and he thought that containment was no longer necessary. It was pointed out to him that visible dust, paint chips and debris were still on the floor and they still pose potential for Lead dust hazard to him and or the resident.</p> <p>Plasterer complied with my directive to adequately contain the work area, he created barriers between the work area and the resident by covering the hallway closet and part of the hallway while I was on site.</p> | | | |

| EHU OVERSIGHT ESCALATION REPORT | | | |
|--|---|---|--|
| <p>10. CORRECTIVE ACTION TAKEN: (Describe what was done after you observed the deficiency, was this reported to the job supervisor, were the corrective actions implemented, did you remain onsite to see completion?)</p> <p>LOTS, Chibuzor Nwobodo asked the Plasterer, Charles Dennis to adequately contain his work area. Plasterer Supervisor Mitra Gopeesingh was also contacted and he asked the Plasterer to comply with the directive. He complied by properly covering the entrance while I was on site and before continuation of work.</p> | | | |

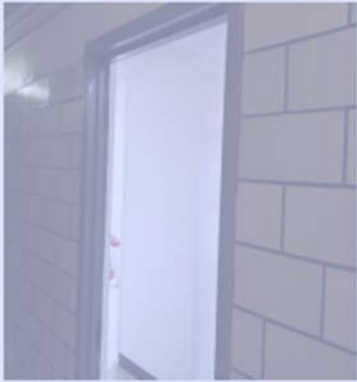
| EHU OVERSIGHT ESCALATION REPORT | | | |
|---|---|---|--|
| <p>9. INCIDENT DESCRIPTION: Lead Oversight Team Specialist (LOTS) John Ospina observed the following deficiencies on June 7th 2022 @ about 10:56 AM:</p> <ol style="list-style-type: none"> 1. Renovation, Repair and Painting Safety Sign (NYCHA 088.182) was not posted at the work area as per NYCHA SP 050.201 page 53 (5)(a)(i) which states "at each entrance to a work area before work begins" 2. EPA cleaning verification card was not available onsite as per NYCHA SP 050.201 page 90 (2)(a) which states "The Certified renovator confirms they have the proper equipment to perform the cleaning verification. The required equipment is: The EPA Post-Renovation Cleaning Verification Card" 3. No barrier between the working area (Bathroom) and the rest of the apartment as per NYCHA SP 050.201 page 84 (g) which states "Cover the work area entrance or vertical containment doorway with one layer of sheeting. Tape the sheeting to the top of the door frame or vertical containment high point and weigh down the bottom to create a seal. Create a door flap on the sheeting that allows access into the work area." 4. The plastic covering the apartment hallway floor was not taped. The plastic was loose and become a potential tripping hazard. As per NYCHA SP 050.201 page 84 (b)(1)(e) which states "Cover the floor of the work area with one layer of six-mil disposable polyethylene sheeting and tape the sheeting down to prevent movement" 5. The RRP certificate for NYCHA plasterer Atilio Cruz was not available on-site. As per NYCHA SP 050.201 I.2(a) which states "Certified Renovator to perform RRP work that might disturb lead-based paint, a NYCHA employee or vendor employee must have current RRP certification." | | | |

| <i>Missing Signage</i> | <i>Improper Containment</i> |

| EHU OVERSIGHT ESCALATION REPORT | | | |
|---|---|---|--|
| <p>10. CORRECTIVE ACTION TAKEN: <small>(Describe what was done after you observed the deficiency, was this reported to the job supervisor, were the corrective actions implemented, did you remain onsite to see completion?)</small></p> <p>LOTS instructed the NYCHA staff that before any RRP job starts, the RRP safety sign must be posted at the work area; the EPA cleaning verification card must be available on-site; The RRP certificate must be carried and available for review at all the times.</p> <p>During the inspection; The RRP safety sign was posted; The EPA cleaning verification card was obtained; The work area was cleaned and verification of cleaning was completed. LOTS contacted the Plasterers' supervisor, Keith Stewart (929-2373291); Who was informed about the deficiencies found during the time of inspection.</p> | | | |

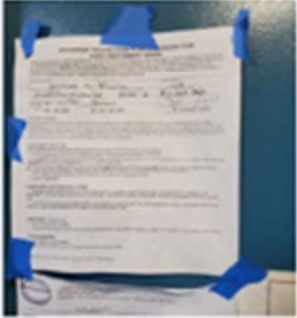
| EHU OVERSIGHT ESCALATION REPORT | | | |
|---|--|--|---|
| <p>9. INCIDENT DESCRIPTION:</p> <p>Lead Oversight Team Specialist (LOTS), Chibuzor Nwobodo observed the following deficiencies on 01/24/2022 at approximately 11:25 am:</p> <p>1) Occupant Protection Plan (OPP) was not properly completed as the occupant location that was checked did not match unit status as vacant.</p> <p>The observed deficiencies were brought to the attention of Abatement Supervisor, Gregory Schadt and he made corrections while I was still on site.</p> <p>SP 050.201-Lead Safe Standard Procedure Section V11.G (d) & (e)</p> <p>e). "Occupant Protection Plan A certified abatement supervisor develops a written occupant protection plan to prevent exposure to any lead-based paint hazards. If a vendor performs the abatement, the vendor develops the plan. See Appendix F, Occupant Protection Plan Template.</p> <p>An occupant protection plan must: 1) Be unique to each apartment".</p> | | | |

| EHU OVERSIGHT ESCALATION REPORT | | | |
|---|--|--|---|
| <p>10. CORRECTIVE ACTION TAKEN: (Describe what was done after you observed the deficiency, was this reported to the job supervisor, were the corrective actions implemented, did you remain onsite to see completion?)</p> <p>NYCHA Lead Abatement Project Inspector Francois Vitalis was present and the Abatement Supervisor was asked to fix the deficiency. Corrections were made while I was still on site.</p> | | | |

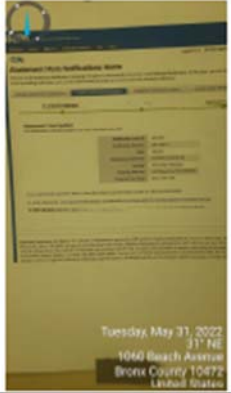
| EHU OVERSIGHT ESCALATION REPORT | | | |
|--|--|--|--|
| 9. INCIDENT DESCRIPTION: <p>On 5/31/22 Compliance Assurance Vendor Jennifer Mith Jean observed a violation of work practice standard for conducting lead-based paint activities. The EPA Notification was not posted as required in by NYCHA's Lead SP 050.021which states:</p> <p>"A copy of the notice of commencement of work must be posted between 24 and 96 hours before work begins. It must be posted at the entrance to the building and at the entrance of the specific apartment where work will take place for the duration of the work."</p> <p>The vendor posted a screen shot of the application, which does not contain the required information such as the name and certification number for the abatement supervisor.</p> | | | |

| EHU OVERSIGHT ESCALATION REPORT | | | |
|--|--|--|--|
| 10. CORRECTIVE ACTION TAKEN: <small>(Describe what was done after you observed the deficiency, was this reported to the job supervisor, were the corrective actions implemented, did you remain onsite to see completion?)</small> <p>After reporting the deficiency to the supervisor, we went to the company vehicle to see if any of the documentation was left behind so that it could be added to the rest of the EPA notification that was posted. There were no additional pages or copies of the EPA notice as what he had was all that was given to him. This violation was not corrected while on-site.</p> <p>LOT was able to verify that a NOC was created and filed with LHC prior to the work.</p> | | | |

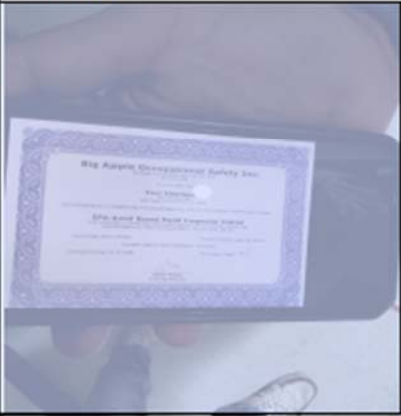
| EHU OVERSIGHT ESCALATION REPORT | | | |
|---|---|--|--|
| <p>9. INCIDENT DESCRIPTION:</p> <p>On 1/14/2022 LOTS Chibuzor Nwobodo observed Yoel Henriquez, dust-wipe technician for Genesis, arrive to perform a dust-wipe clearance sample at Mitchel Houses with an expired Lead Inspector (LII-21-4499) certification, expired on 12/16/2021.</p> <p>Upon inquiry about the status of his Lead Based Paint Inspector certificate, Mr. Yoel Henriquez stated that he knew that his certificate had expired. LOTS informed him that HUD guidelines requires him to have a current certificate to enable him conduct the dust-wipe sampling. He stopped all further setup of sampling templates and left.</p> <p>Painter Supervisor Robert Wacniks arrived to the site and was made aware of the situation.</p> | | | |

| EHU OVERSIGHT ESCALATION REPORT | | | |
|---|---|--|--|
| <p>10. CORRECTIVE ACTION TAKEN: (Describe what was done after you observed the deficiency, was this reported to the job supervisor, were the corrective actions implemented, did you remain onsite to see completion?)</p> <p>Painter Supervisor Robert Wacniks arrived to the site and was informed that the dust-wipe technician had an expired certification and therefore could not proceed with the clearance. He told the resident that he will reschedule the dust-wipe clearance for another day.</p> <p>On 1/18/2022 LOTA contacted Genesis Environmental and obtained Yoel Henriquez's Dust Sampling Technician certification which expires on 01/07/2024. This certificate can only be used for RRP clearance work and not abatement clearance work. Please note that Yoel did not have this certificate with him at the time of the LOT inspection.</p> <p>LOTA informed LHC that they must ensure that Genesis does not assign Yoel to perform sampling for abatement jobs which can only be done by a certified lead inspector or risk assessor, until he renews and provides a valid lead inspector or risk assessor license.</p> <p>LOTA also informed LHC to direct Genesis that all lead personnel must have valid certifications on their person when performing jobs on NYCHA properties.</p> | | | |
