James S. Oddo
Commissioner

Xhevdet Celo, P.E.
Deputy Director
Forensic Engineering Unit

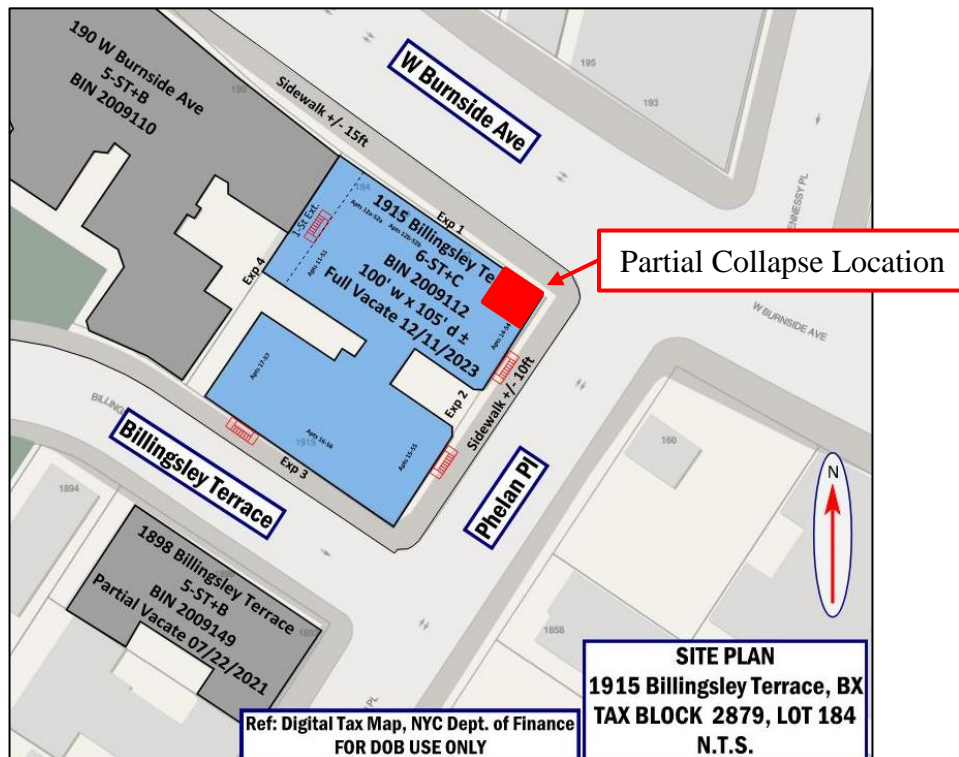
Image #2 – 1915 Billingsley Terrace, Bronx - Site Plan (NYC DOF Tax Map, FEU)

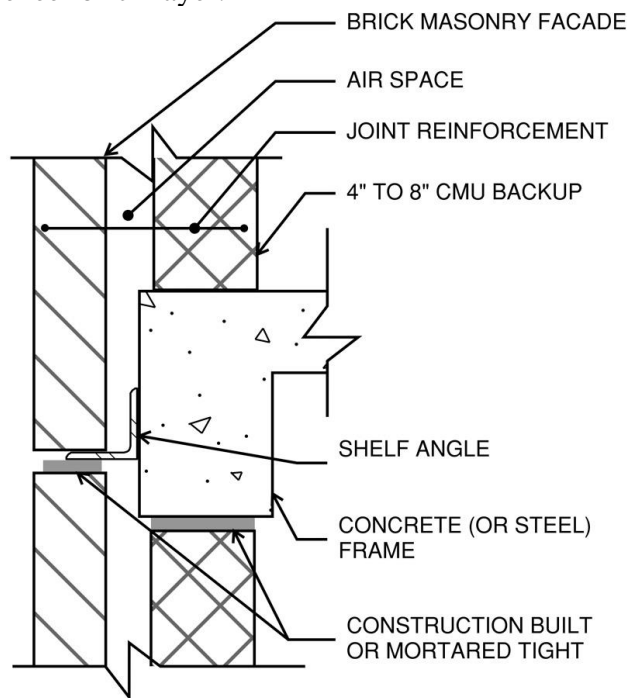
Figure #1 – Typical Cavity Wall System (*STRUCTURE Magazine*)

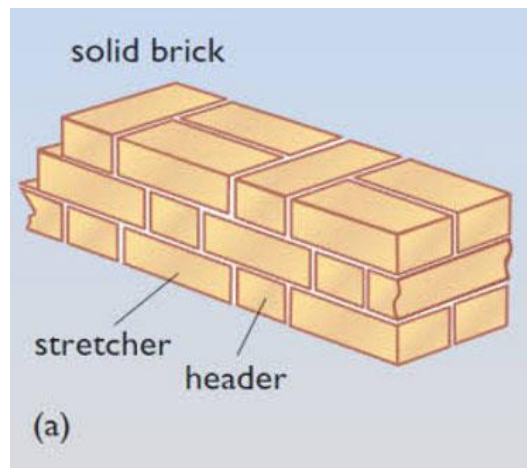
Figure #2 – Typical Solid Masonry Wall System (*Rem-Tie Ltd.*)

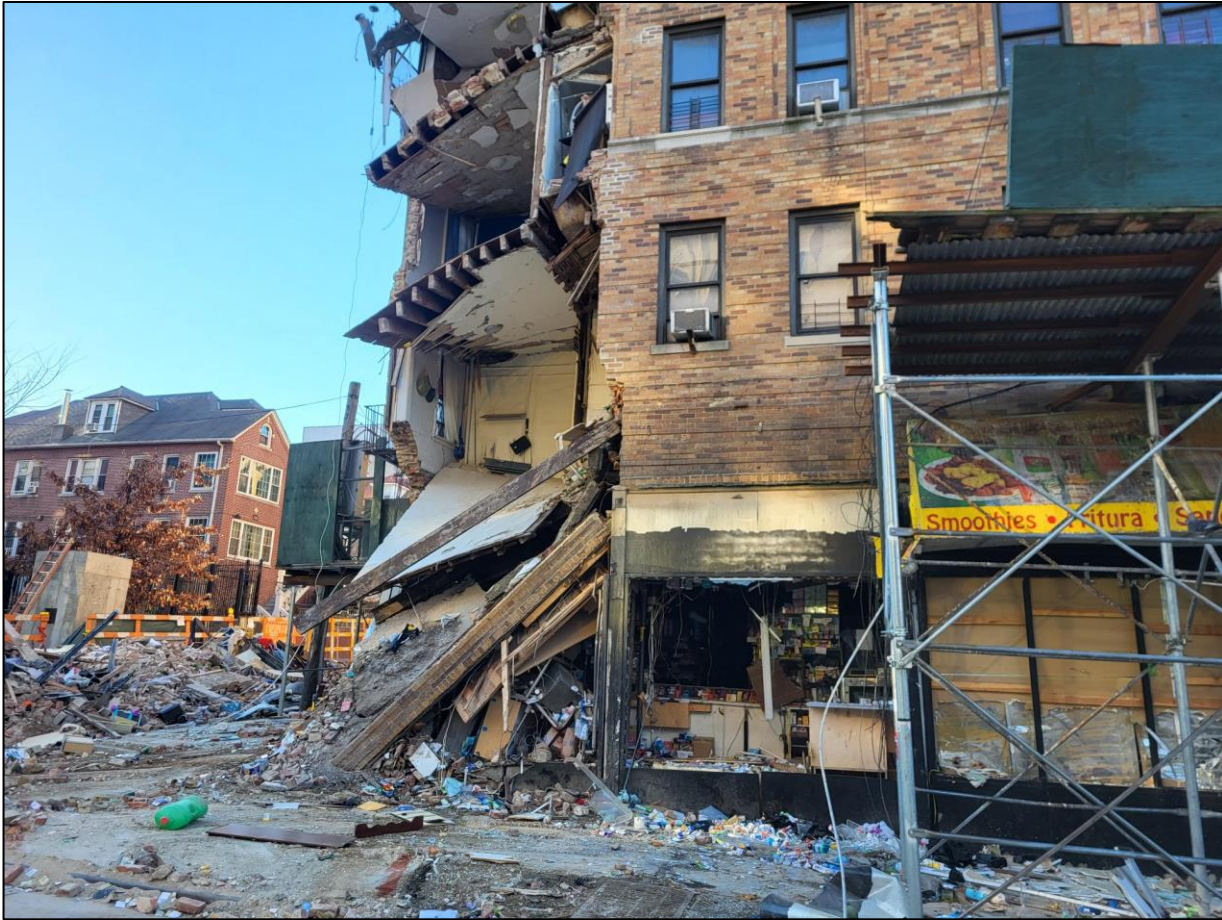
Image #3: Partial collapse at Exposure 1/2 Corner. (2023-12-11, FEU)

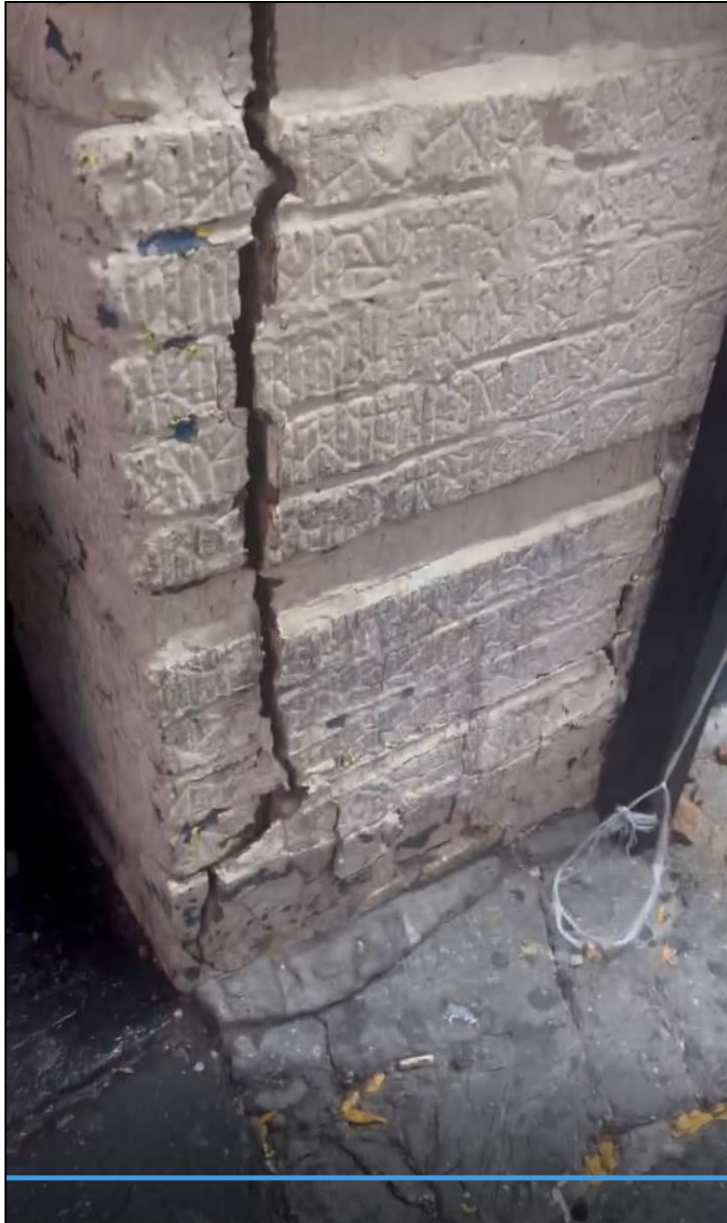
Image #10: Prior to collapse, photos extracted from video taken on October 29, 2023 – Vertical crack from grade at the cellar level load-bearing masonry pier along Phelan Ave. (2023-10-29, Deli owner)

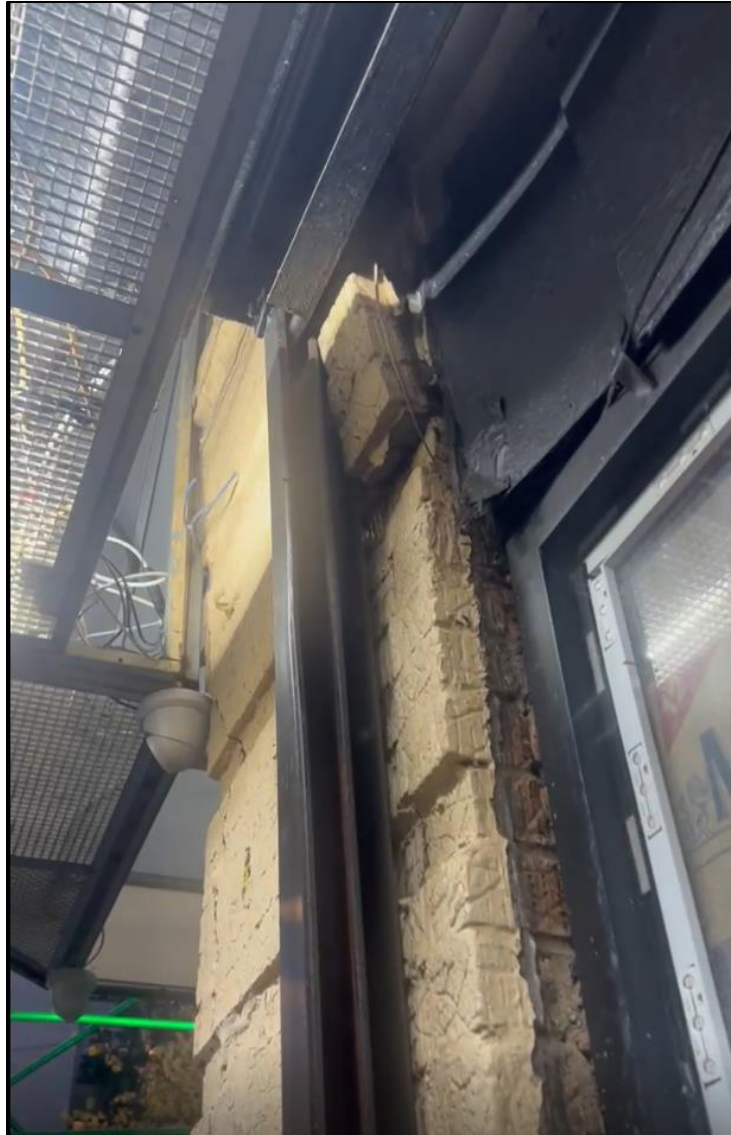
Image #11: Prior to collapse, photos extracted from video taken on October 29, 2023 – Bulging, displaced brick from the top of the cellar level load-bearing masonry pier along Phelan Ave. (2023-10-29, *Deli owner*)

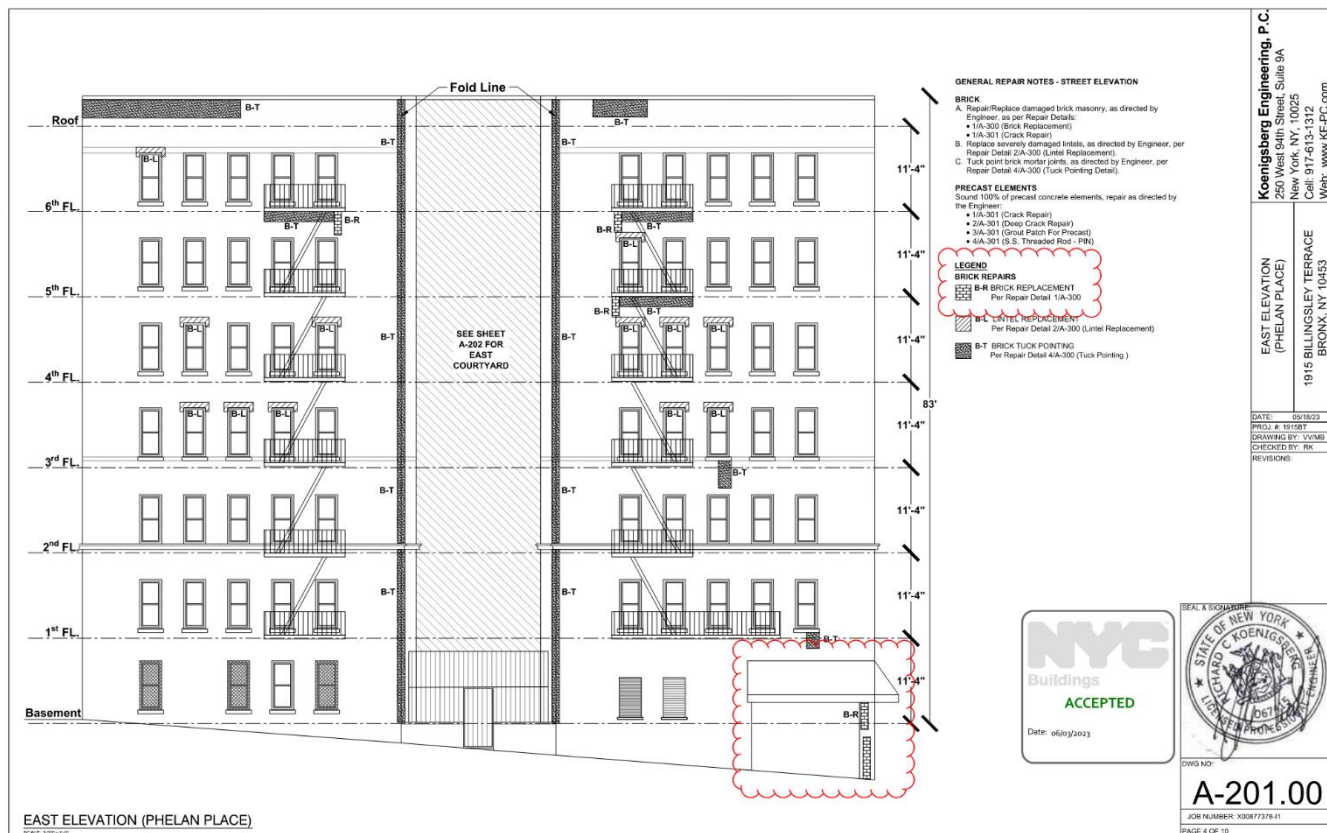
Image #13: Façade repair drawing elevation showing brick replacement at cellar level load-bearing masonry pier (clouded in red) (2023-12-12, DOB NOW filing)

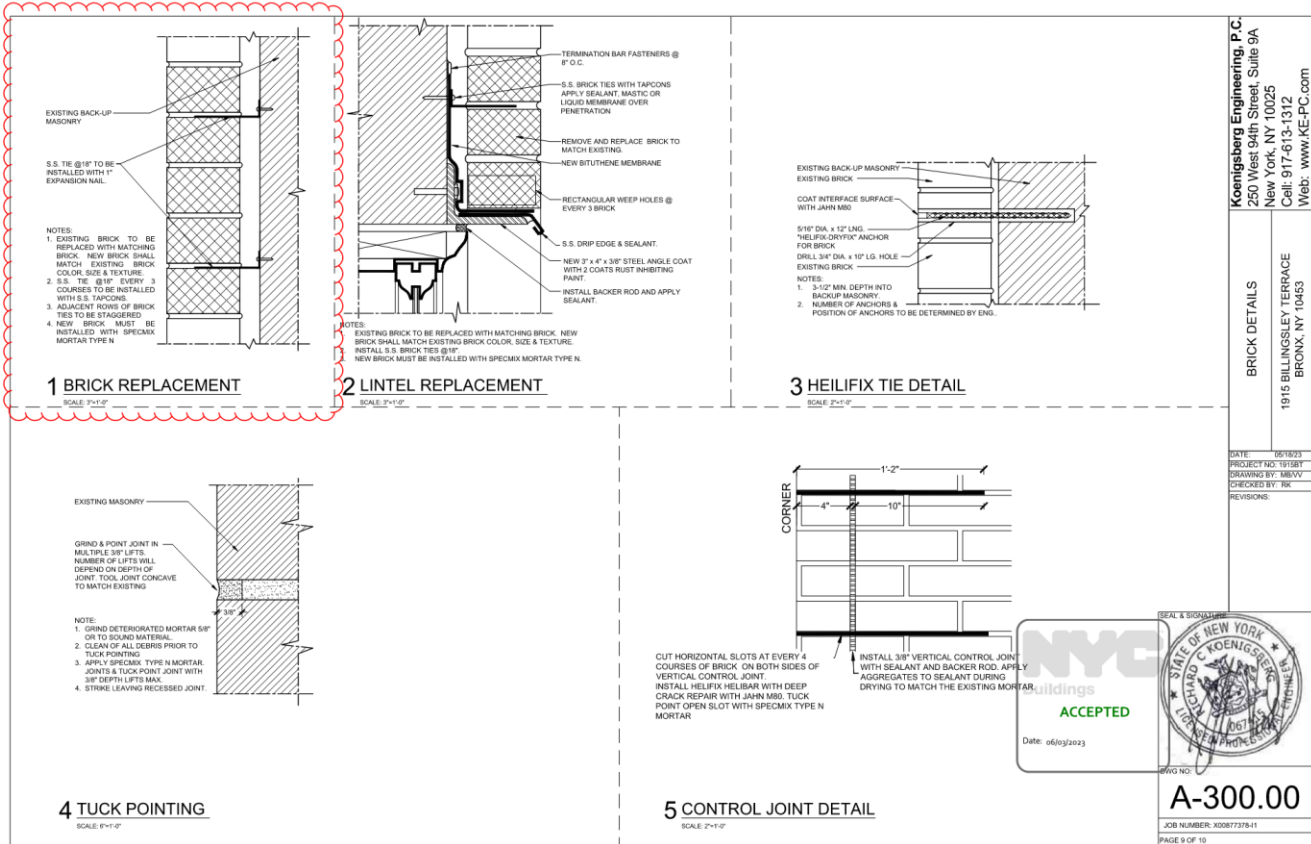
Koenigsberg Engineering, P.C.
250 West 94th Street, Suite 9A
New York, NY 10025
Cell: 917-613-1312
Web: www.KE-PC.com

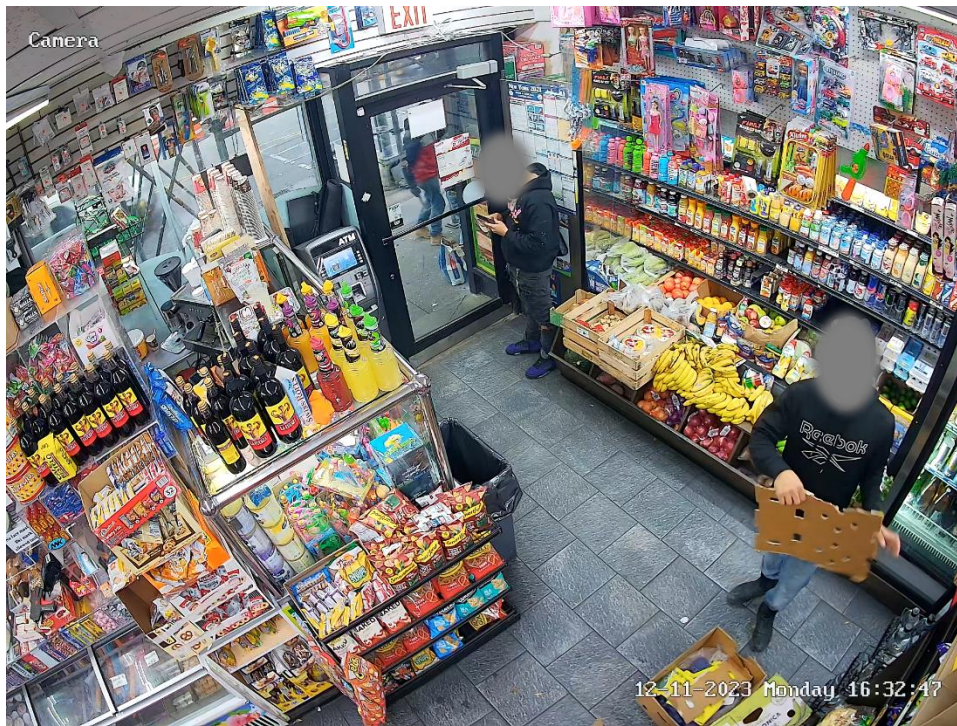
Image #15: D8 Camera Pre-Movement (2023-12-11, 172 W. Burnside Ave. Security Camera)

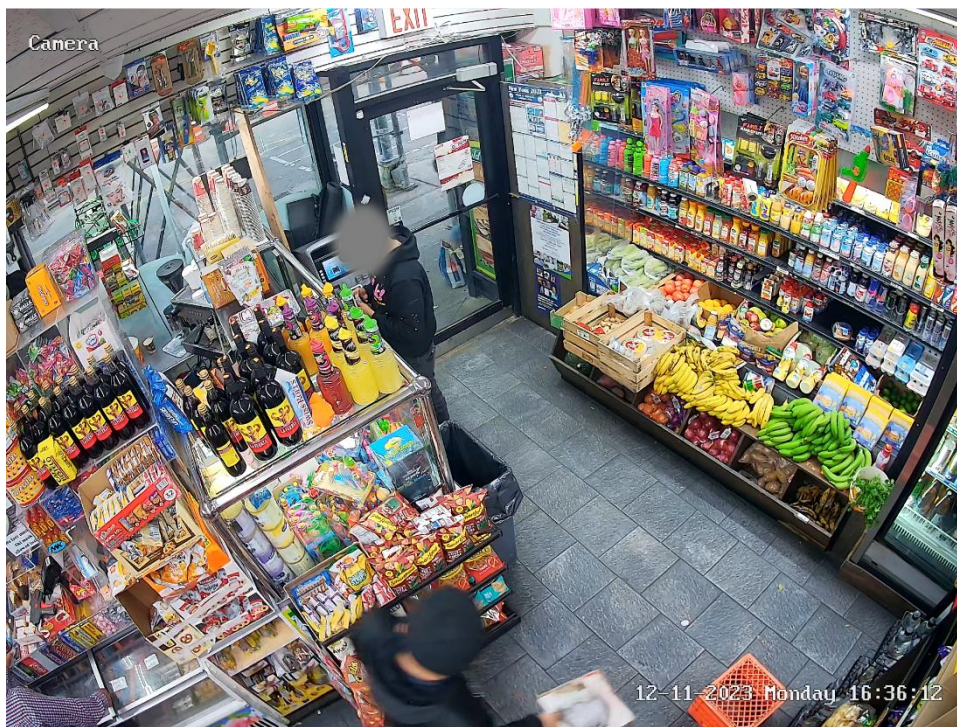
Image #16: D8 Camera Initial Movement (2023-12-11, 172 W. Burnside Ave. Security Camera)

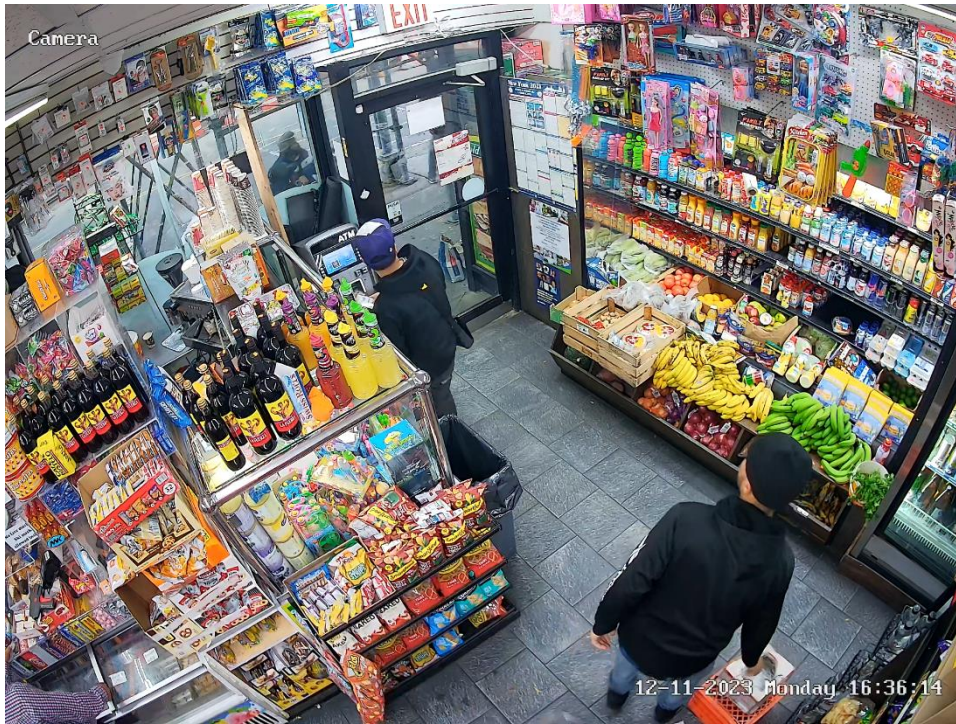
Image #17: D8 Camera Initial Movement with worker reactions (2023-12-11, 172 W. Burnside Ave. Security Camera)

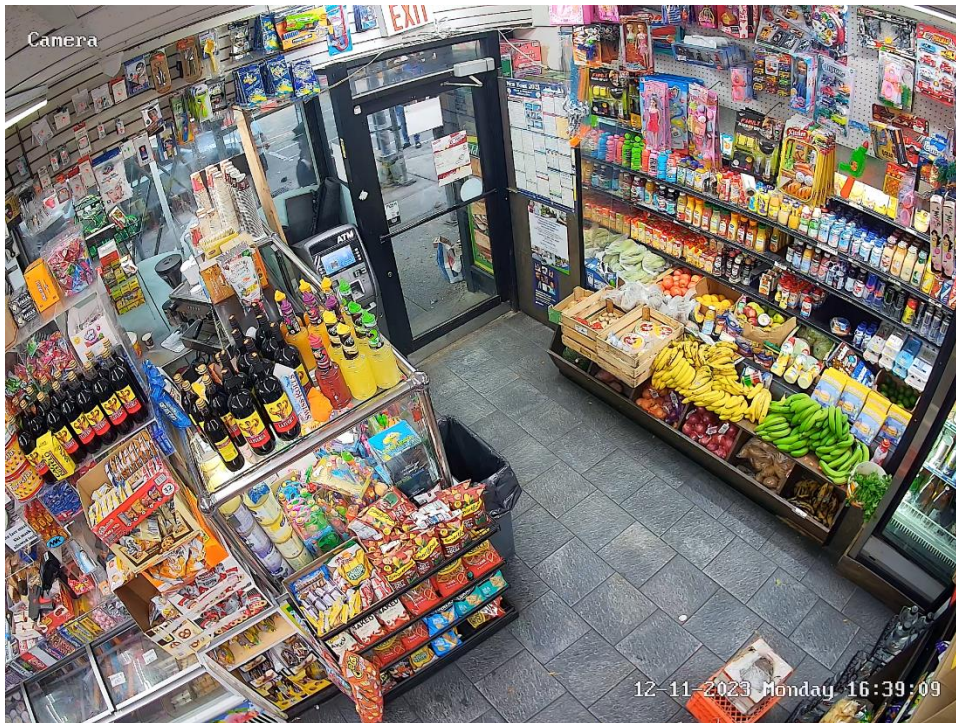
Image #18: D8 Camera Immediately Pre-Collapse (2023-12-11, 172 W. Burnside Ave. Security Camera)

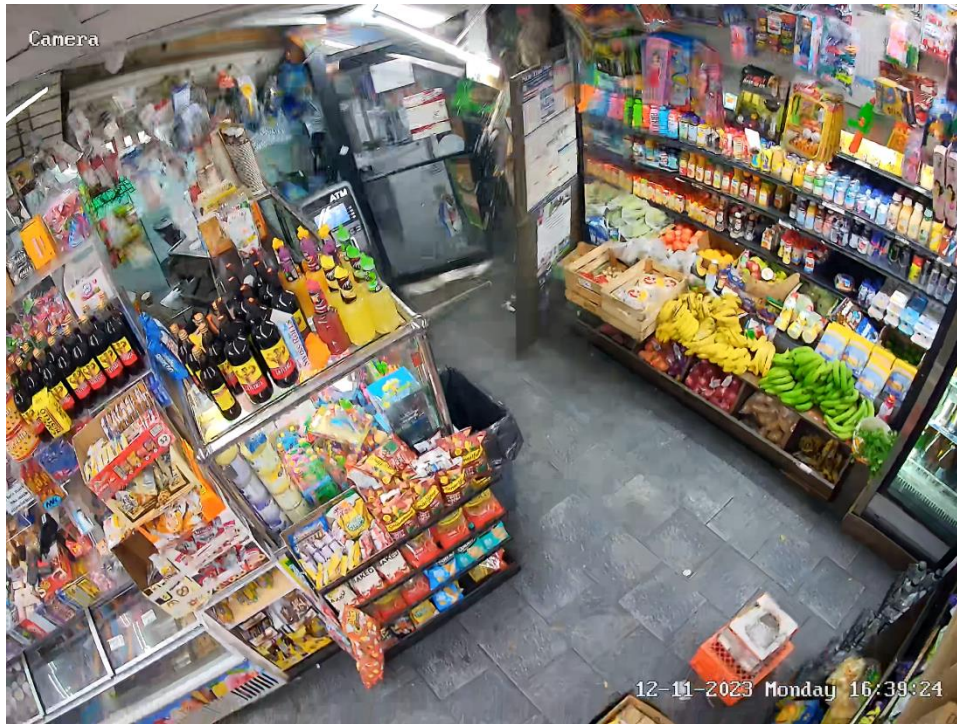
Image #19: D8 Camera Moment of Collapse (2023-12-11, 172 W. Burnside Ave. Security Camera)

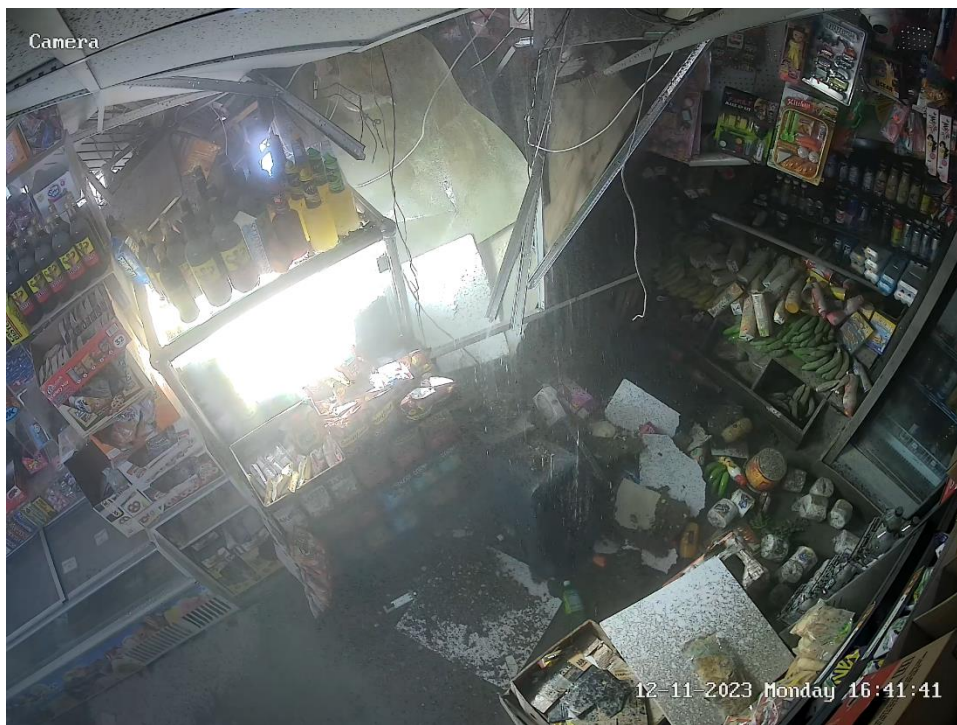
Image #20: D8 Camera Post-Collapse (2023-12-11, 172 W. Burnside Ave. Security Camera)

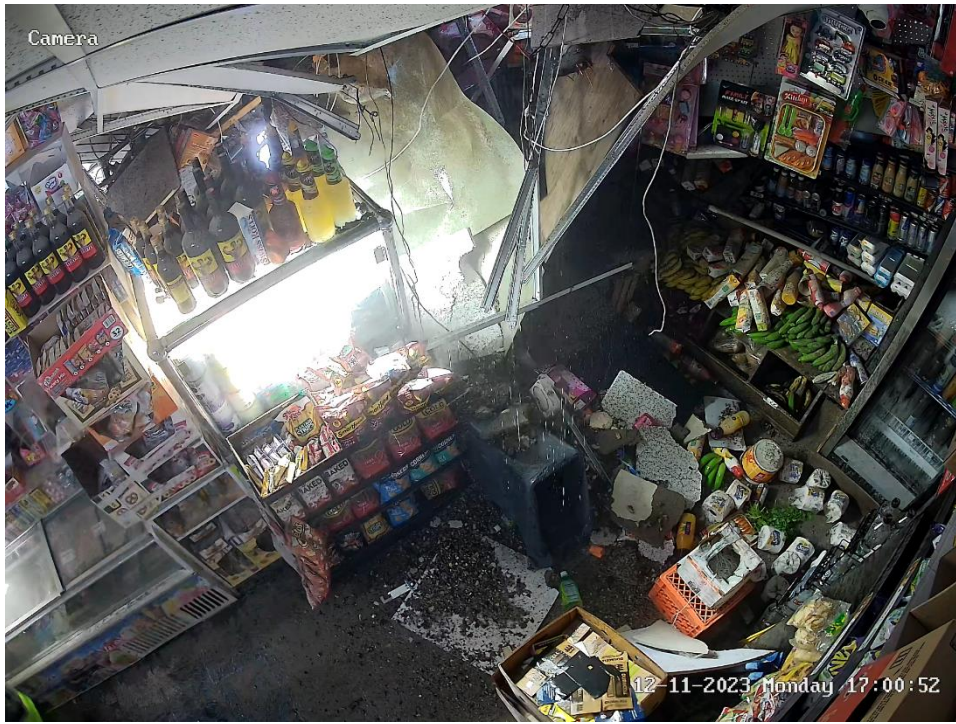
Image #21: D8 Camera FDNY Contact (2023-12-11, 172 W. Burnside Ave. Security Camera)

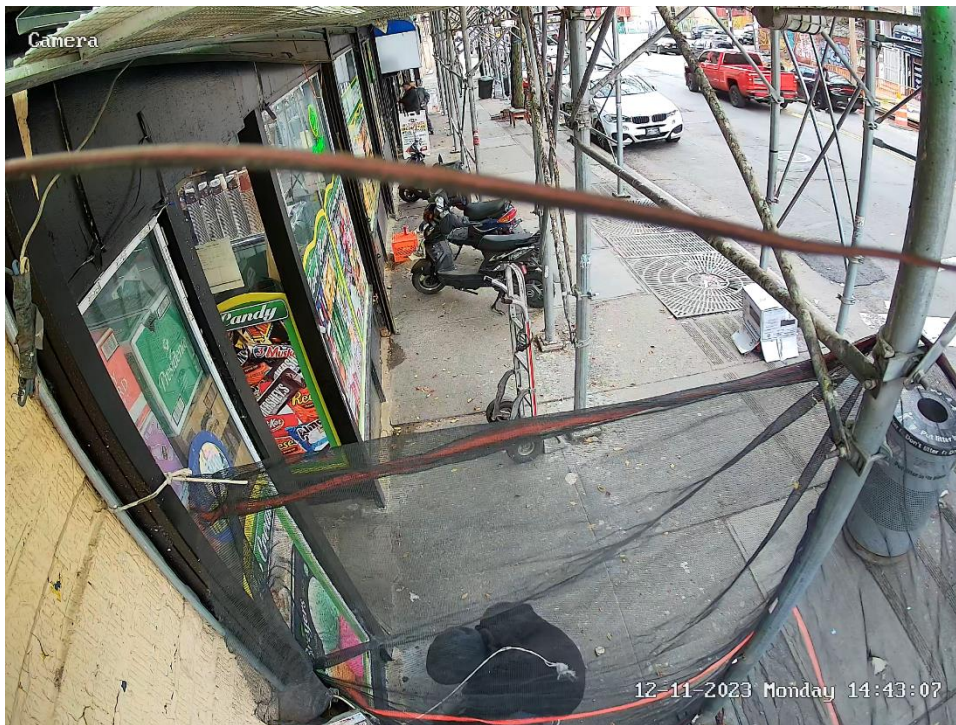
Image #22: D18 Camera worker using chipping gun at bottom of pier (2023-12-11, 172 W. Burnside Ave. Security Camera)

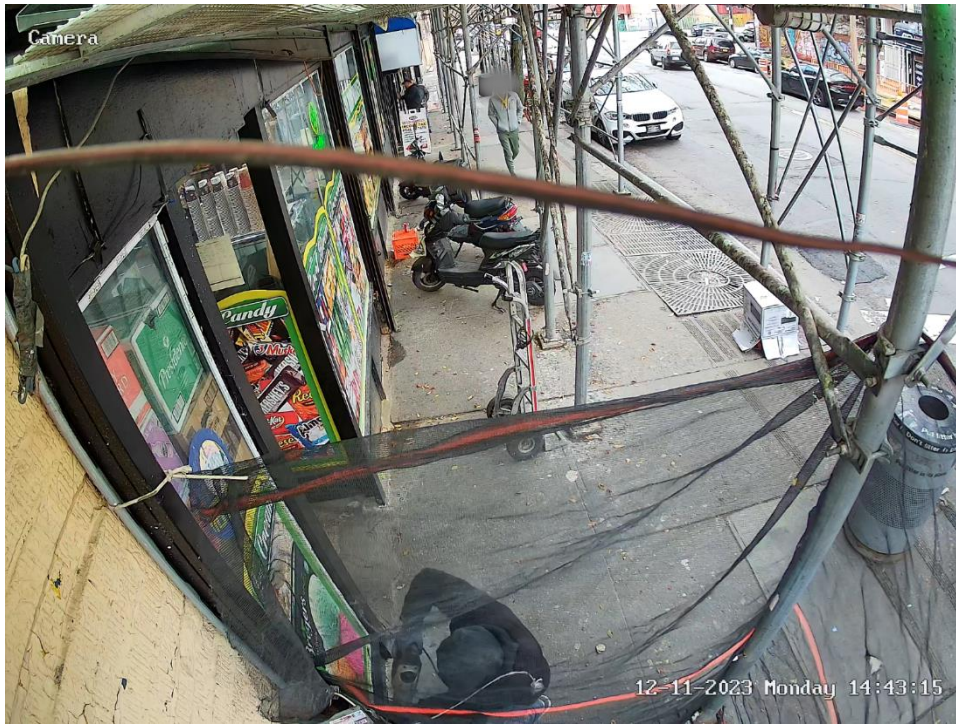
Image #23: D18 Camera worker using chipping gun at bottom of pier (2023-12-11, 172 W. Burnside Ave. Security Camera)

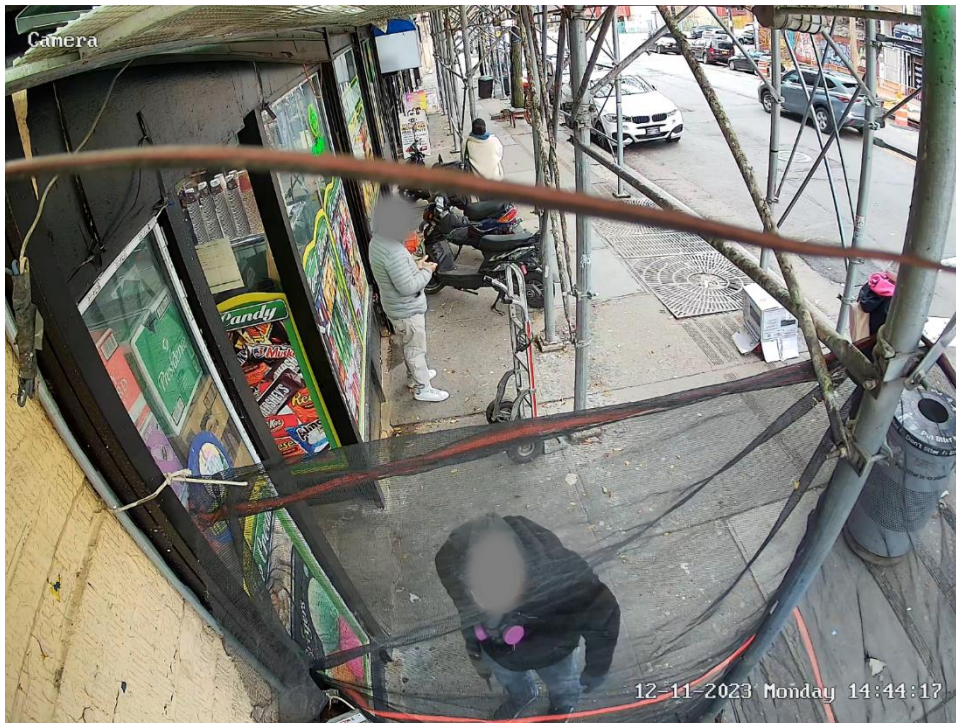
Image #24: D18 Camera worker standing with chipping gun (2023-12-11, 172 W. Burnside Ave. Security Camera)

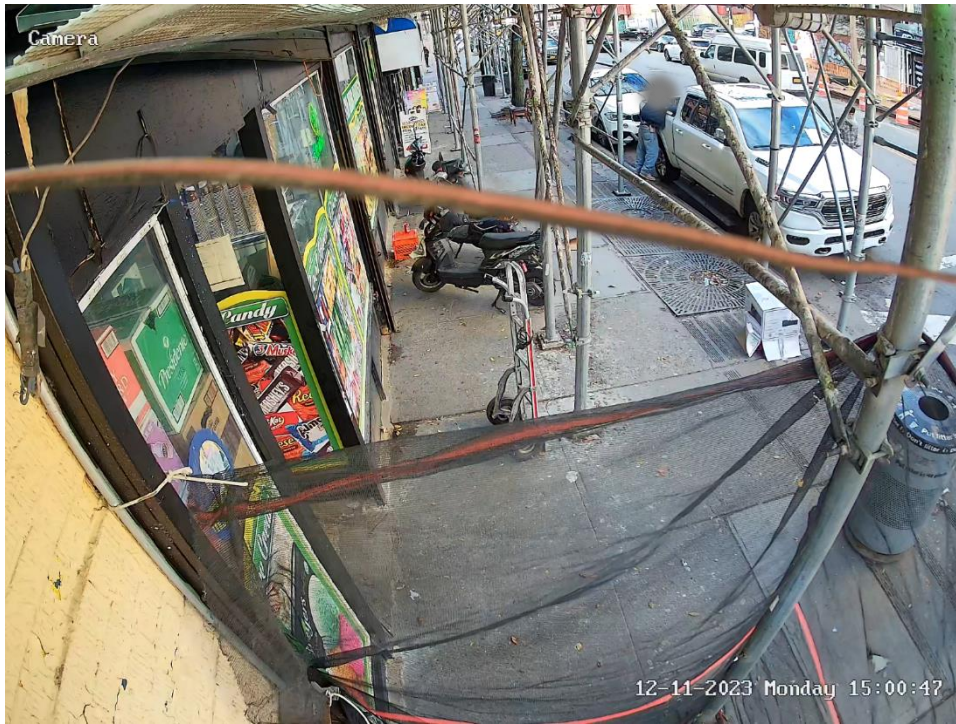
Image #25: Camera D18 Arrival of Permit Holder (2023-12-11, 172 W. Burnside Ave. Security Camera)

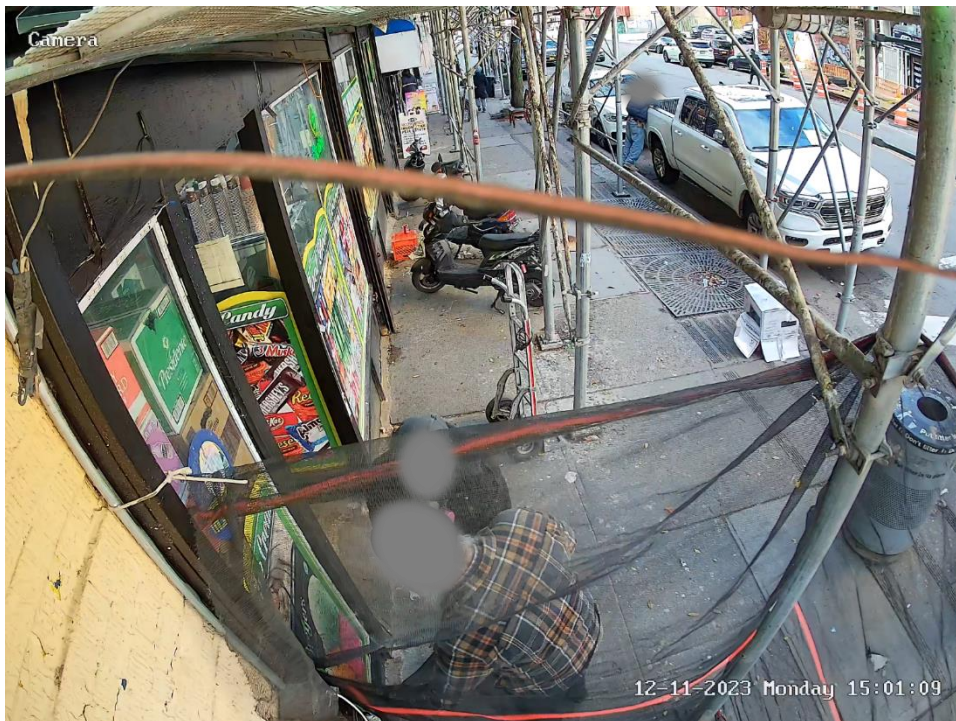
Image #26: D18 Camera Permit Holder giving instructions to worker (2023-12-11, 172 W. Burnside Ave. Security Camera)

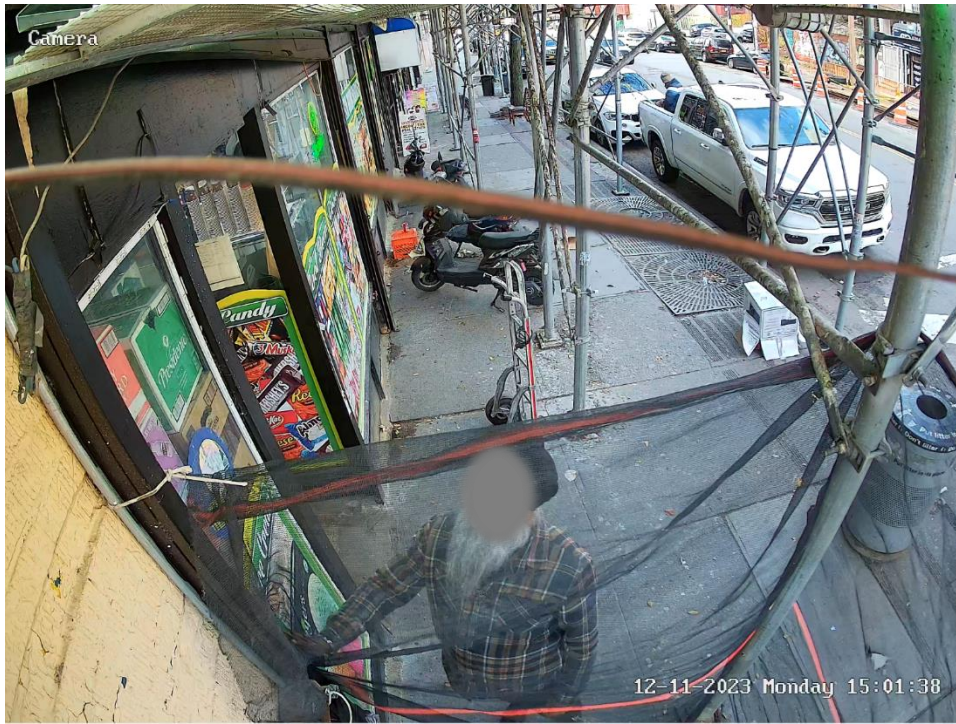
Image #27: D18 Camera Permit Holder inspecting load-bearing masonry pier (2023-12-11, 172 W. Burnside Ave. Security Camera)

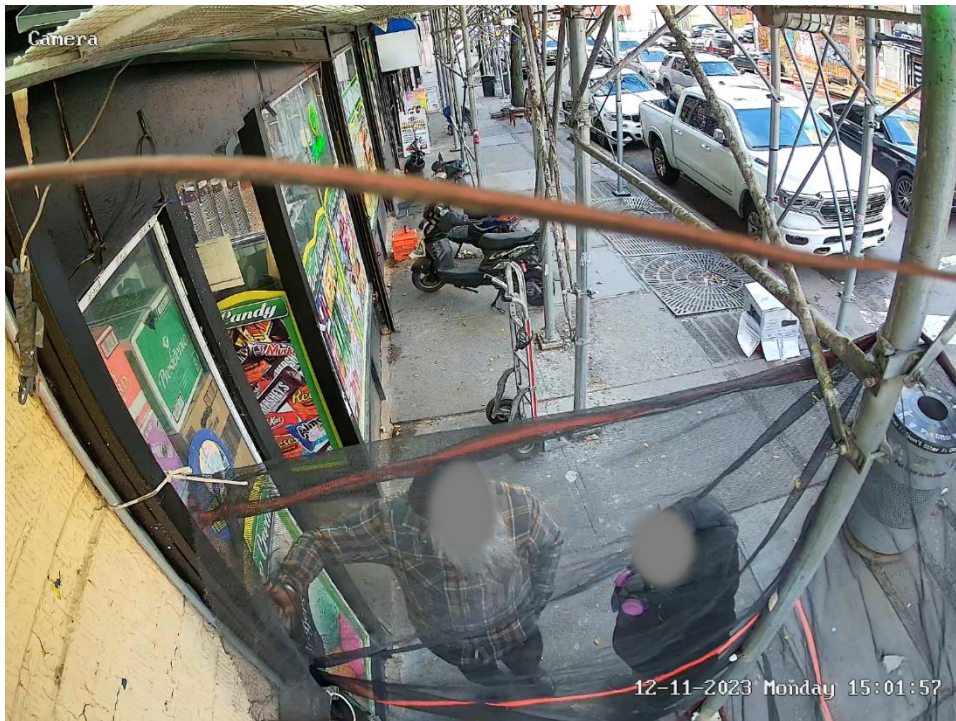
Image #28: D18 Camera Permit Holder giving instructions to worker (2023-12-11, 172 W. Burnside Ave. Security Camera)

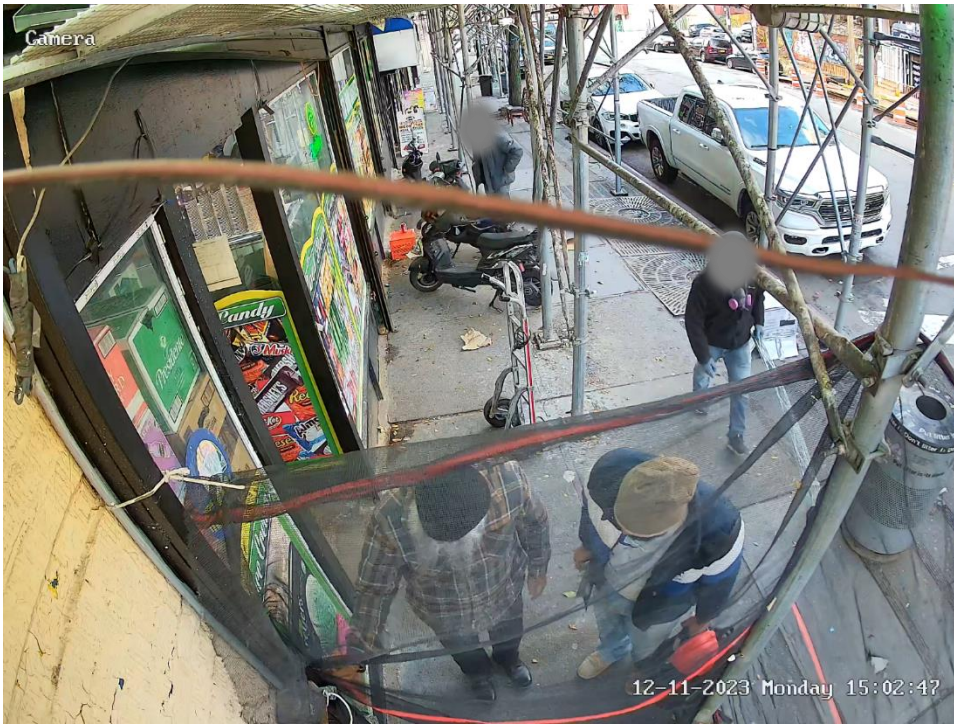
Image #29: D18 Camera Permit Holder giving instructions to other worker (2023-12-11, 172 W. Burnside Ave. Security Camera)

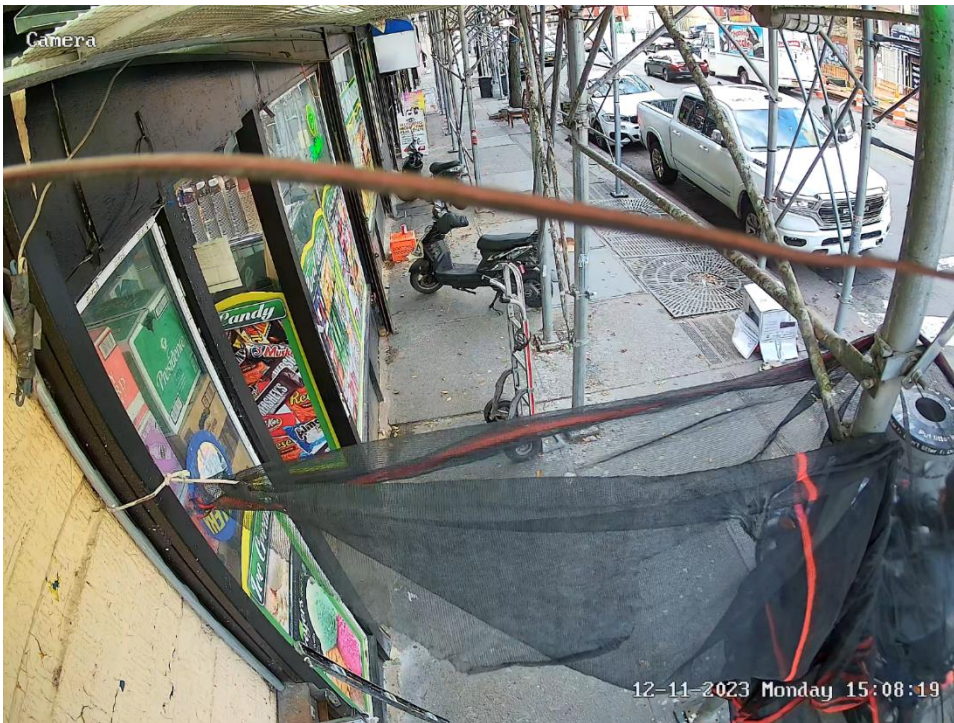
Image #30: D18 Camera Permit Holder leaves site (2023-12-11, 172 W. Burnside Ave. Security Camera)

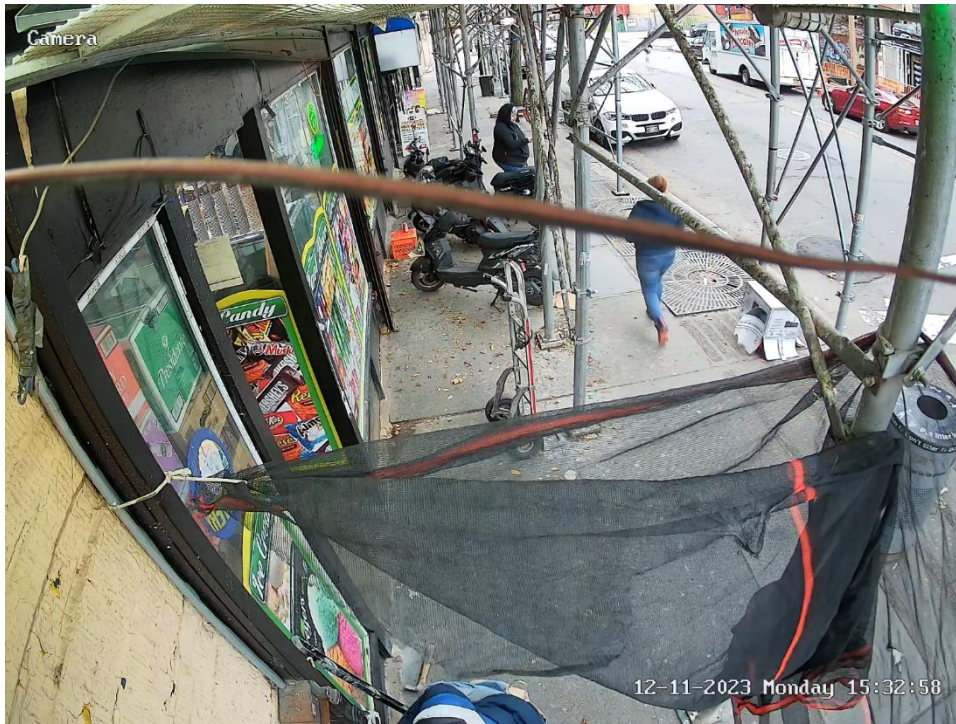
Image #31: D18 Camera Worker with tools (2023-12-11, 172 W. Burnside Ave. Security Camera)

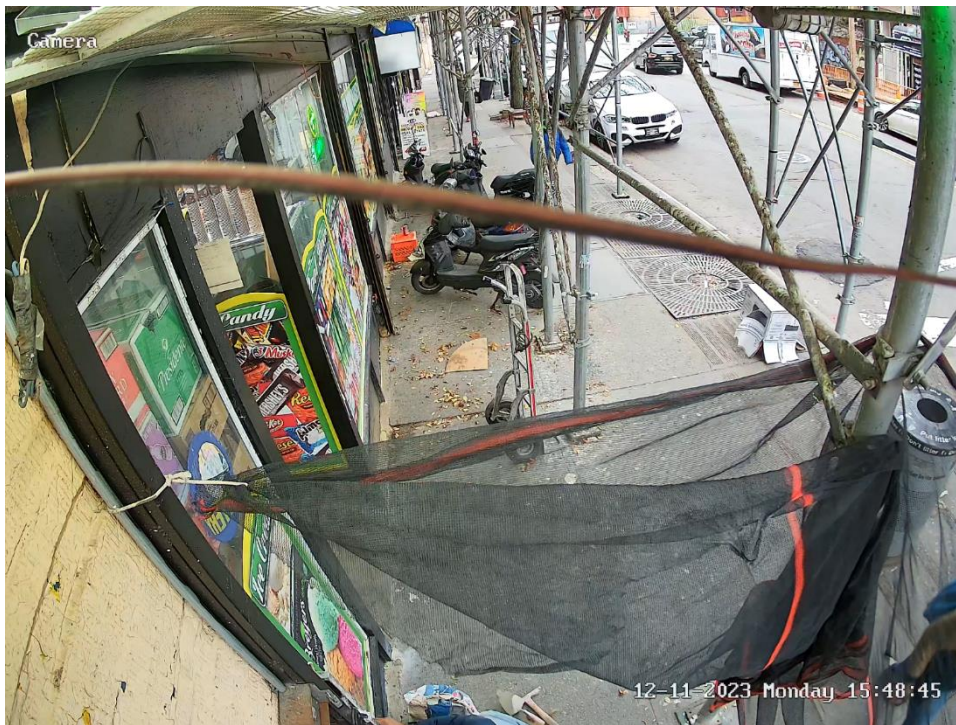
Image #32: D18 Camera Worker with tools (2023-12-11, 172 W. Burnside Ave. Security Camera)

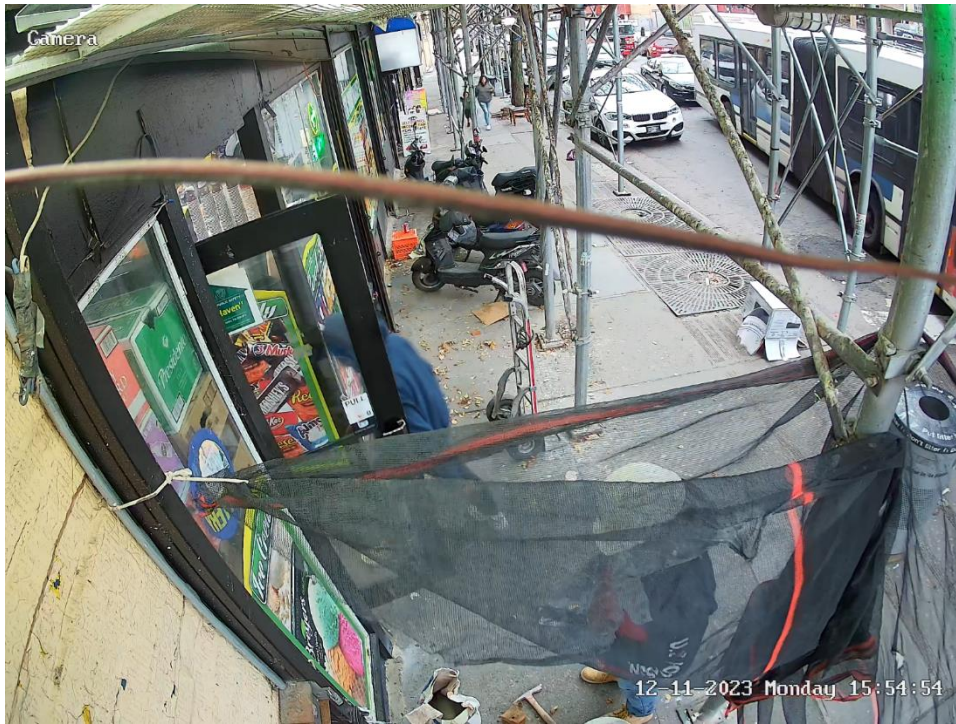
Image #33: D18 Camera Worker with tools and brick (2023-12-11, 172 W. Burnside Ave. Security Camera)

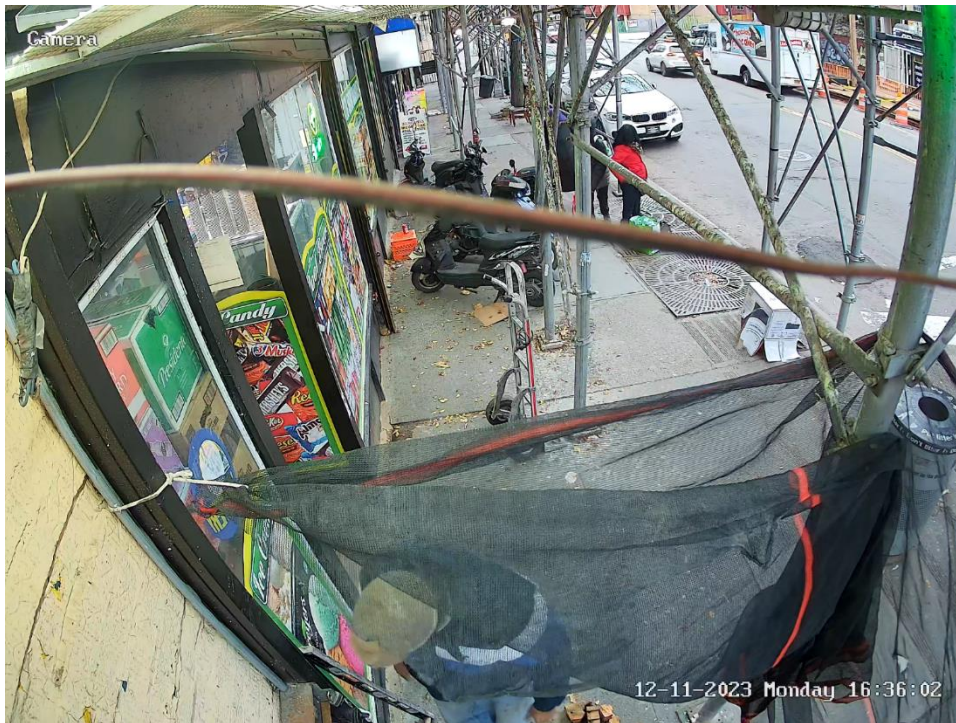
Image #34: D18 Camera Immediately Pre-Movement (2023-12-11, 172 W. Burnside Ave. Security Camera)

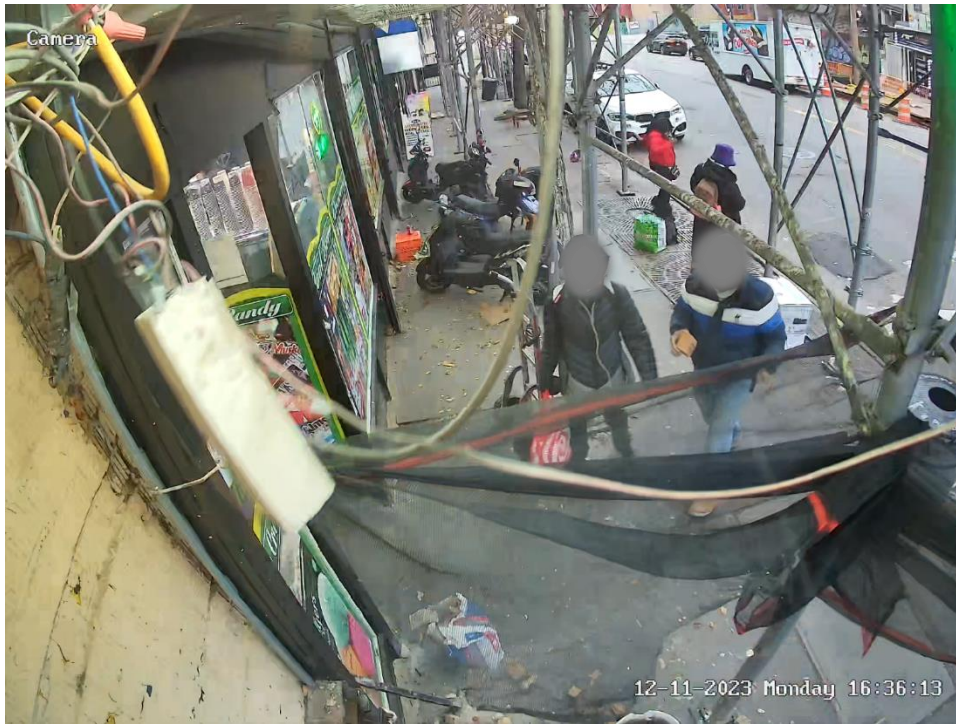
Image #35: D18 Camera Initial Movement (2023-12-11, 172 W. Burnside Ave. Security Camera)

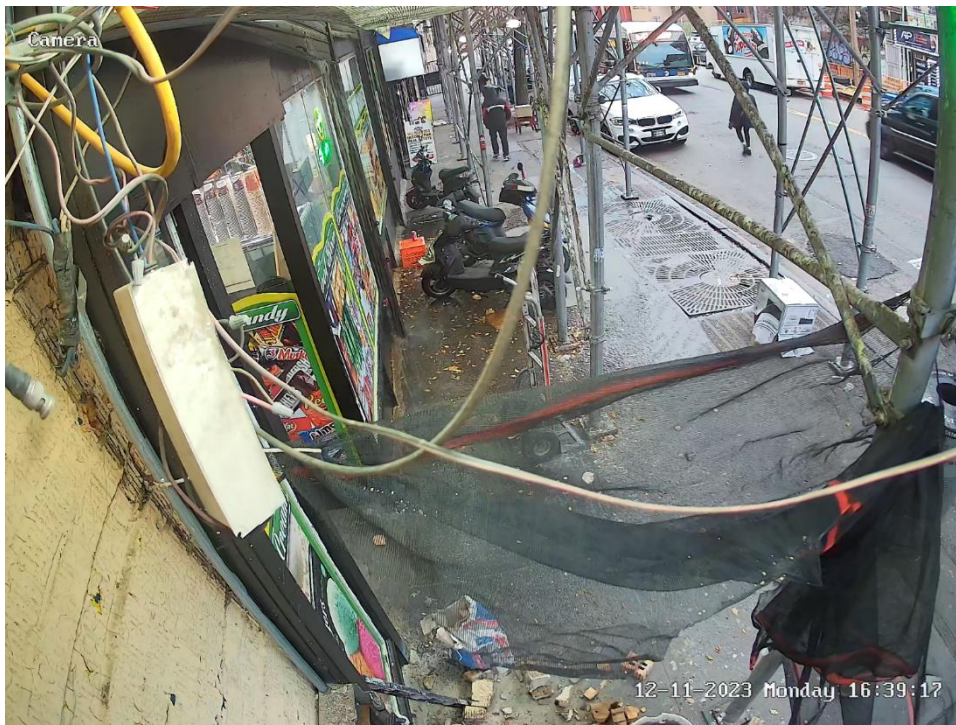
Image #36: D18 Camera Immediately before collapse (2023-12-11, 172 W. Burnside Ave. Security Camera)

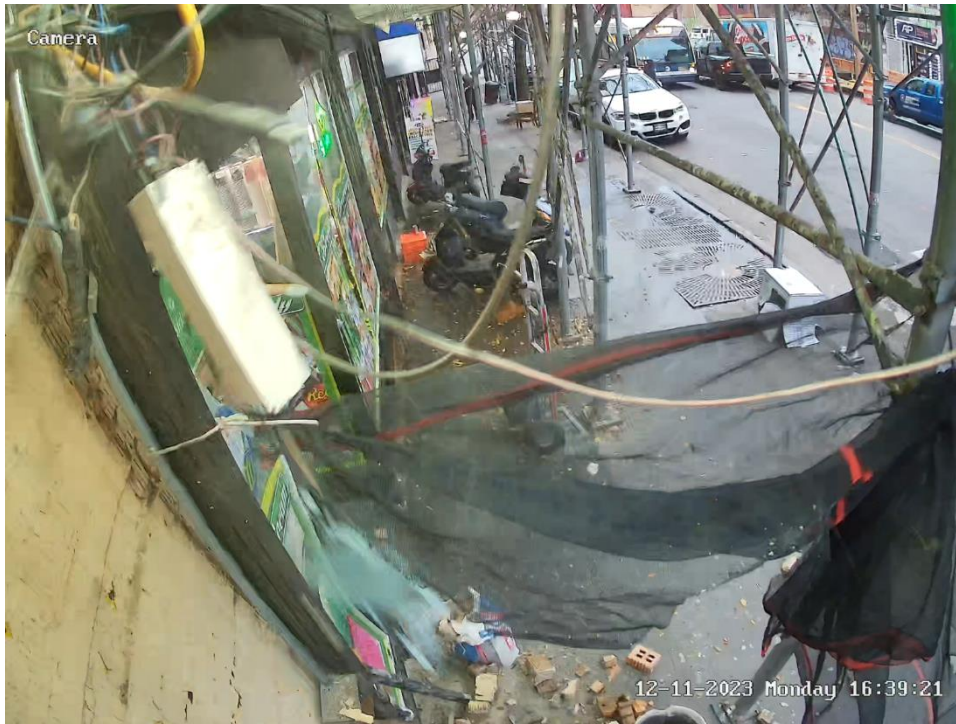
Image #37: D18 Camera Moment of Collapse (2023-12-11, 172 W. Burnside Ave. Security Camera)
