James S. Oddo
Commissioner

Xhevdet Celo, P.E.
Deputy Director
Forensic Engineering Unit

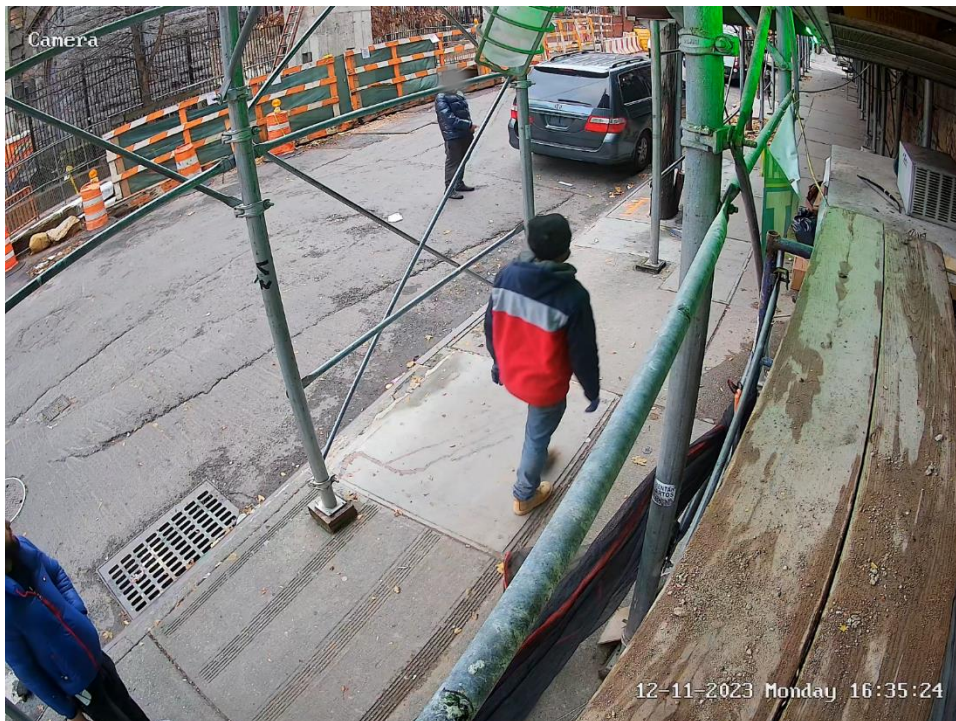
Image #38: D20 Camera Pre-Movement (2023-12-11, 172 W. Burnside Ave. Security Camera)

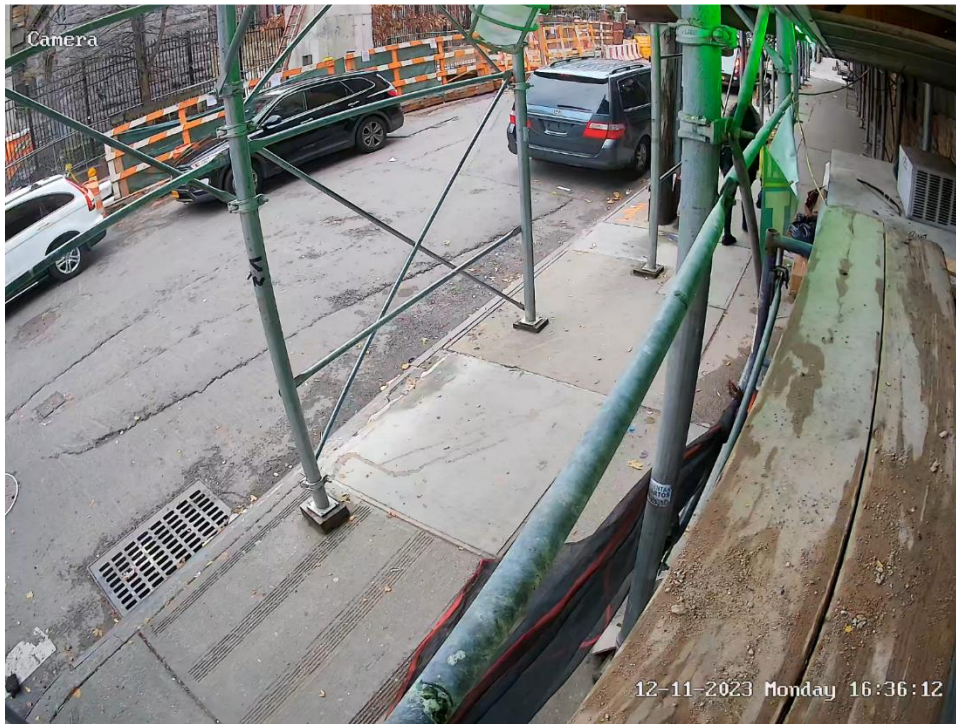
Image #39: D20 Camera Initial Movement (2023-12-11, 172 W. Burnside Ave. Security Camera)

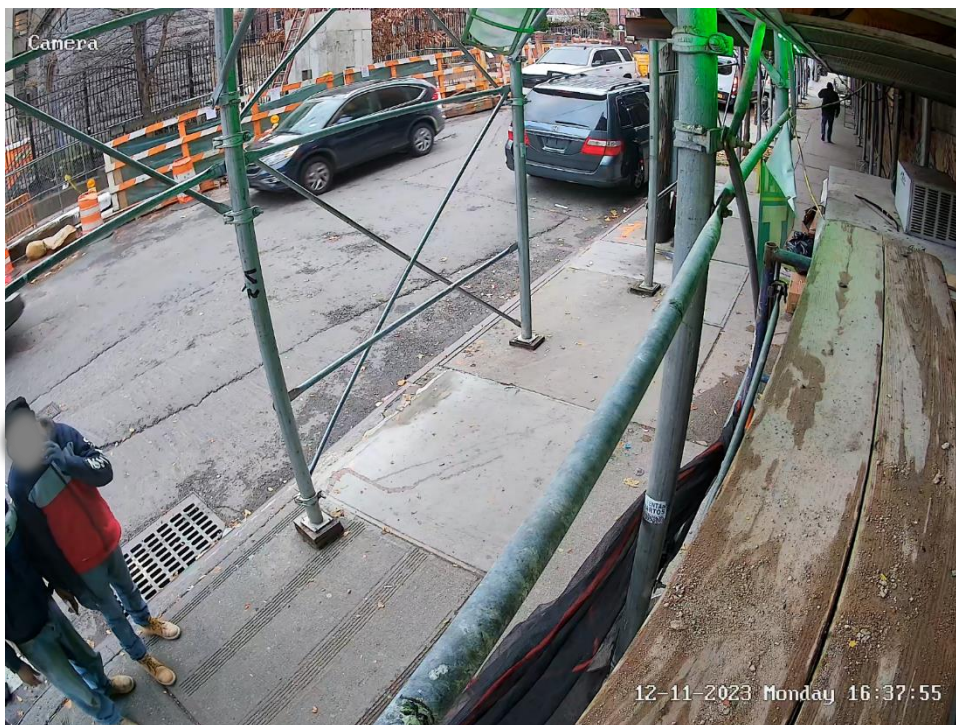
Image #40: D20 Camera Workers on Phone (2023-12-11, 172 W. Burnside Ave. Security Camera)

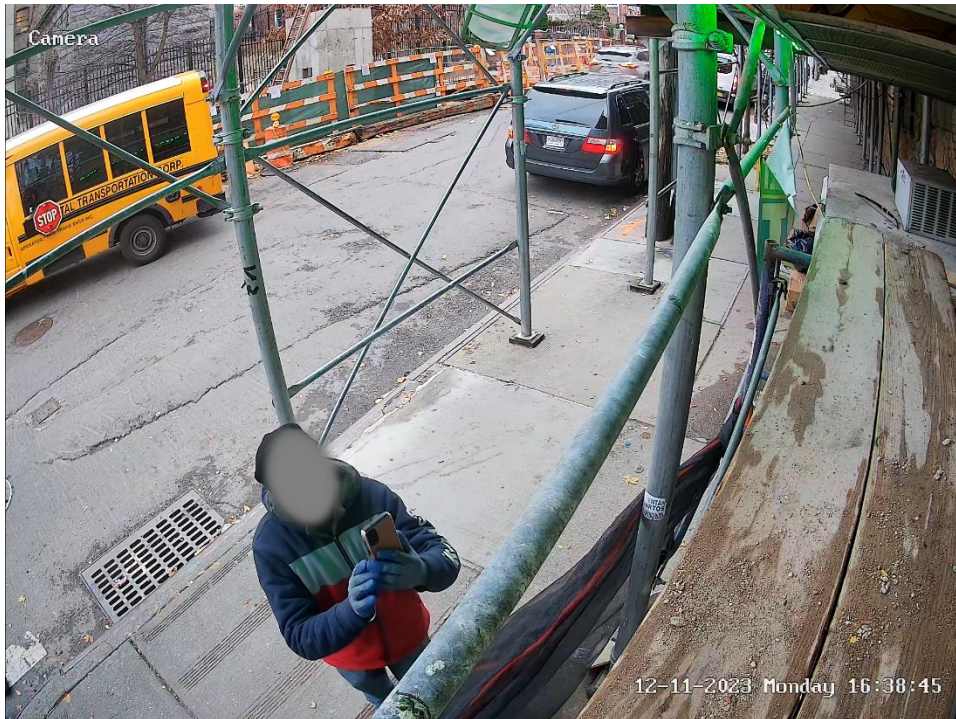
Image #41: D20 Camera Worker taking video of pier (2023-12-11, 172 W. Burnside Ave. Security Camera)

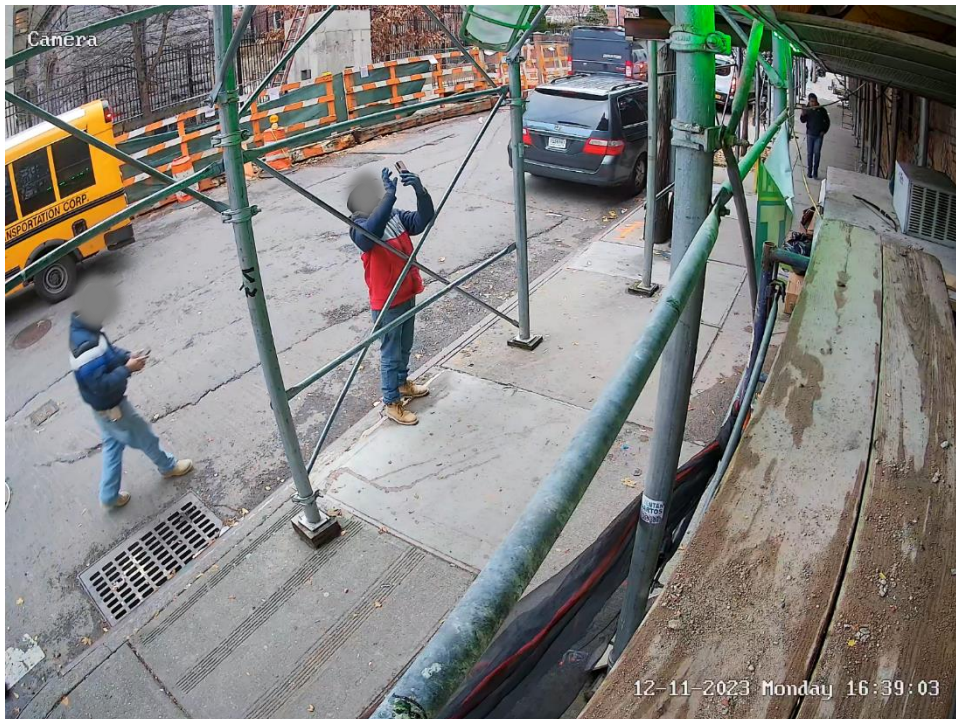
Image #42: D20 Camera Worker filming upper stories of building (2023-12-11, 172 W. Burnside Ave. Security Camera)

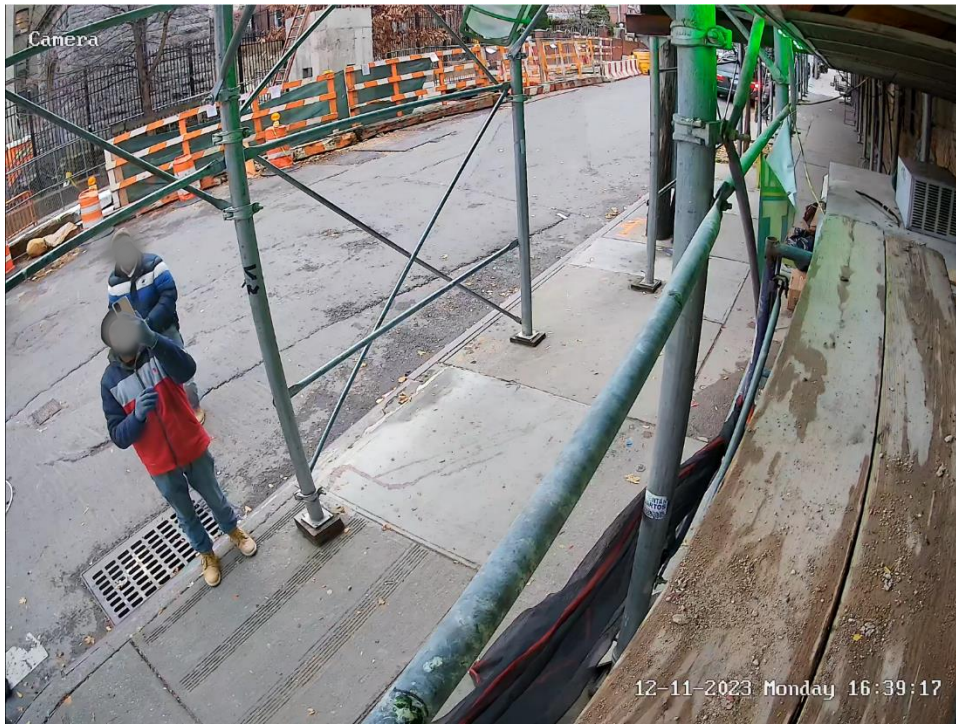
Image #43: D20 Camera Immediately Pre-Collapse (2023-12-11, 172 W. Burnside Ave. Security Camera)
