# SOUTHWEST BROOKLYN MARINE TERMINAL STATION BULKHEAD INVESTIGATION

ANNUAL BULKHEAD INSPECTION

PROJECT NO.	A092286
DOCUMENT NO.	
VERSION	1
DATE OF ISSUE	12/23/2016
PREPARED	DDJS
CHECKED	JOAC
APPROVED	JOAC

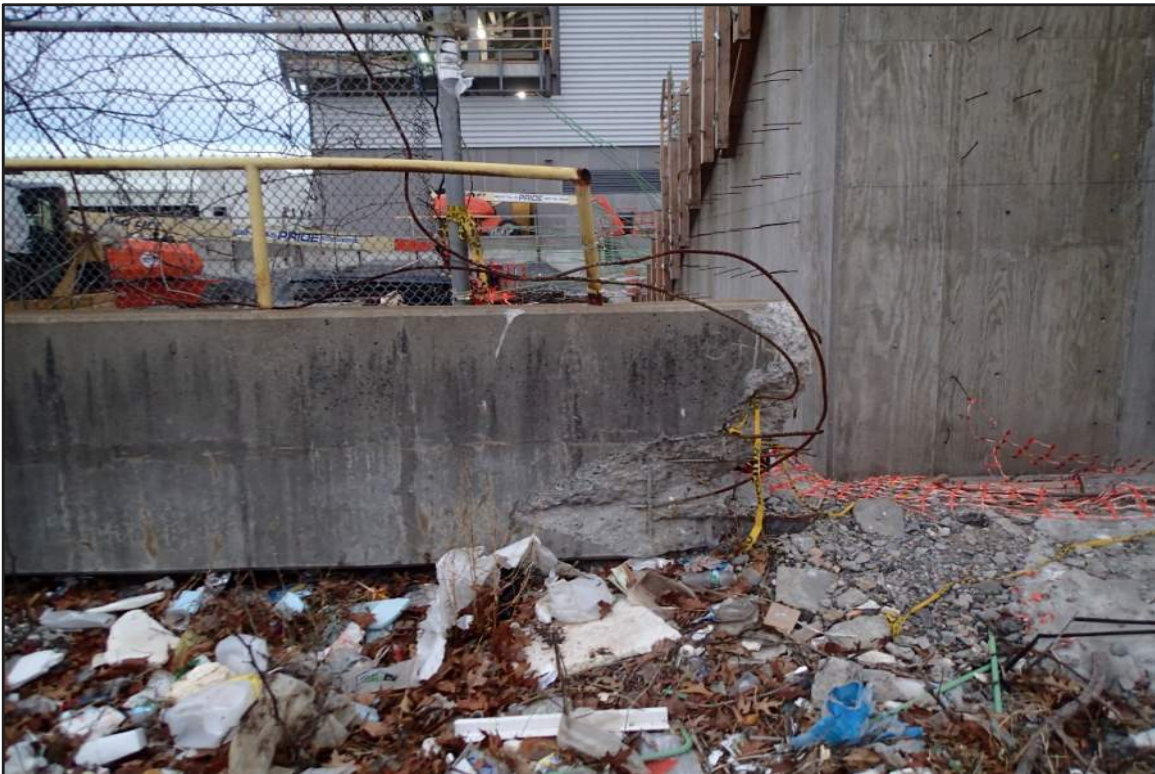
*Photograph 22: East Bulkhead – Demolished concrete curb and deck at Sta. 0+14 (looking north)*

- › Clean and patch the end of the concrete wall at East Bulkhead Station 0+14. It is our understanding that this portion of the East Bulkhead is scheduled to be rehabilitated, pursuant to the U.S. Army Corps of Engineer's permit issued for the construction of the MTS (NAN-2008-0927). That would adequately address this recommendation.

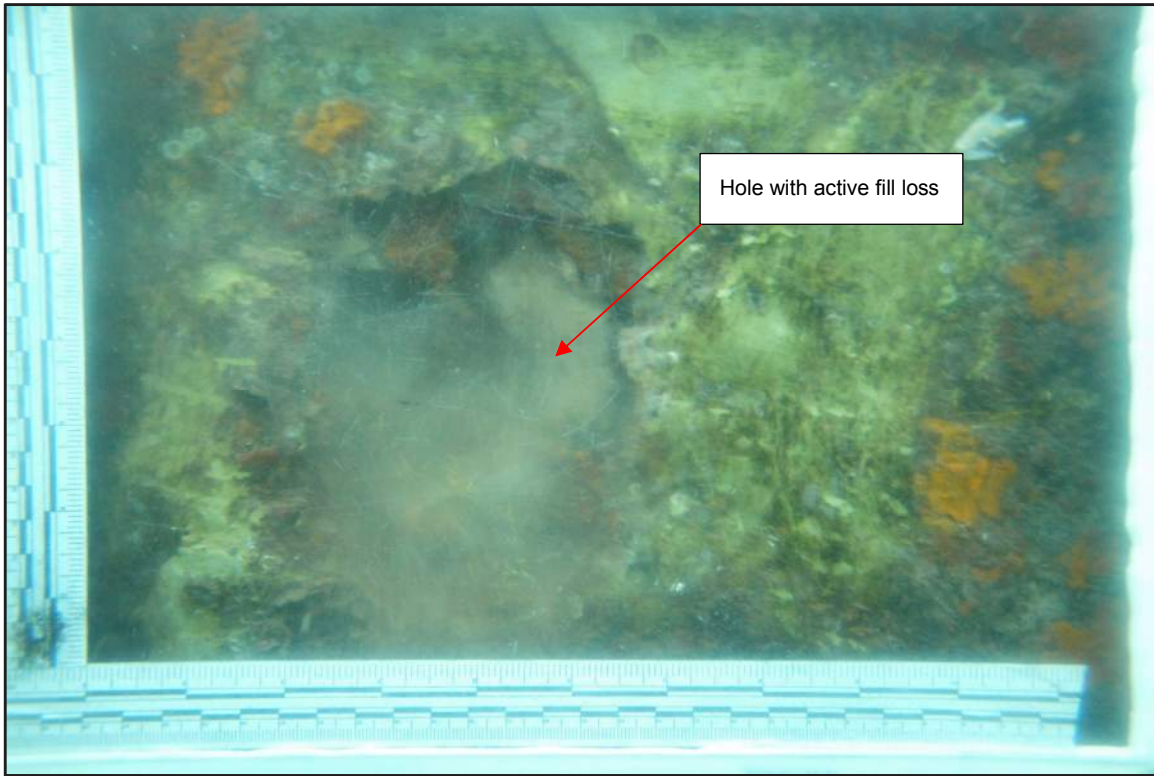
Overall, the West Bulkhead is in Poor condition due to an isolated hole within the intermediate cell adjacent to Cell F-1, a loose bracket at the cell-to-bulkhead intersection, moderate corrosion and coating failure located within the splash and tidal zones of the steel sheet piles and cellular cofferdams (Photograph 25 through Photograph 27). Below mean low water, the steel sheet pile bulkhead is typically in moderate condition with isolated areas of failed coating and surface corrosion (Photograph 28), and isolated coating loss and splash zone failures with surface corrosion on the steel sheet pile cellular cofferdams (Photograph 29). The steel sheet pile cellular cofferdams, located at the western extent of the bulkhead, have been repaired with a splash zone coating along the exposed face of the sheets, extending from the mudline to approximately mean high water. Additionally, the missing steel pile cap section, located at the western edge of the Z-shape steel sheet pile bulkhead, noted during the previous inspection is still missing (Photograph 30).

Photograph 25: West Bulkhead – Hole through splash zone repair and steel sheet pile cell with exposed fill and active fill loss at intermediate cell adjacent to Cell F-1

- › Install and coat a steel patch plate (12 inches by 12 inches) over the approximate 6 inch diameter hole observed at the intermediate cell adjacent to Cell F-1 at the West Bulkhead.

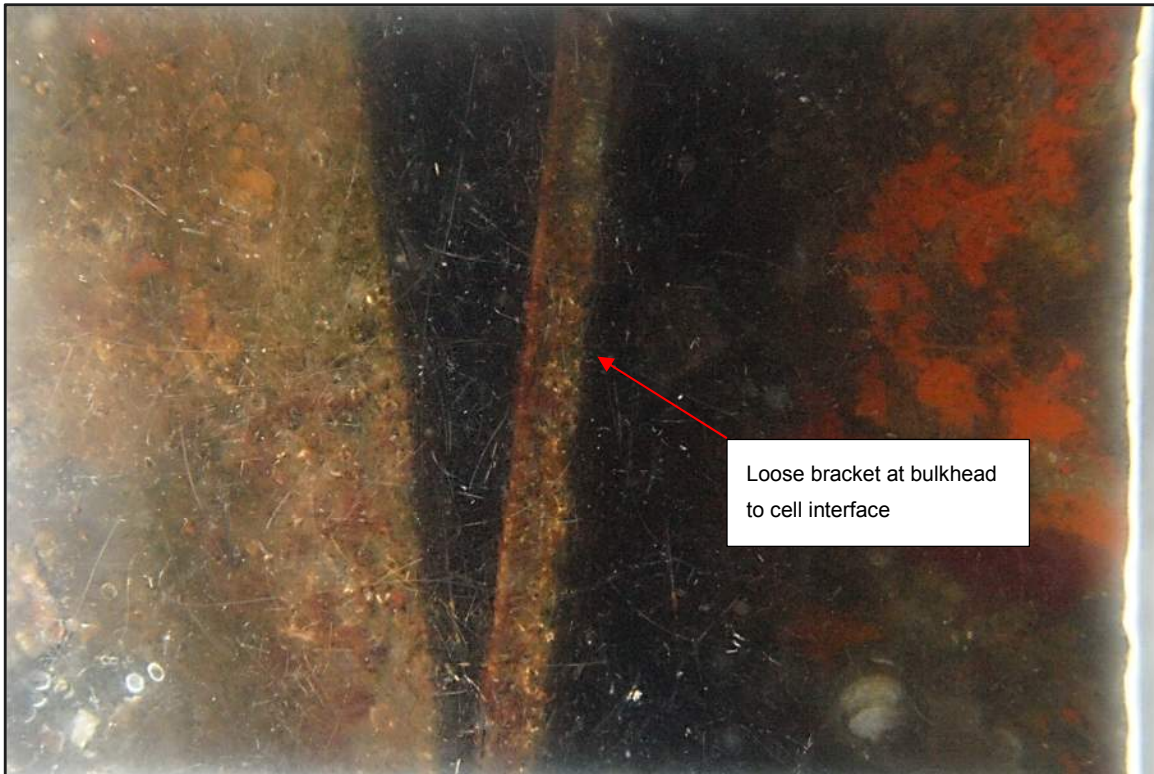
Photograph 26: West Bulkhead – Loose bracket at interface between steel sheet pile bulkhead and steel sheet pile cell

- › Repair the loose transition anchor bracket connection between the West Bulkhead and intermediate cell adjacent to Cell F-1. This repair will require the bearing plate to be realigned, and the nut to be tightened.

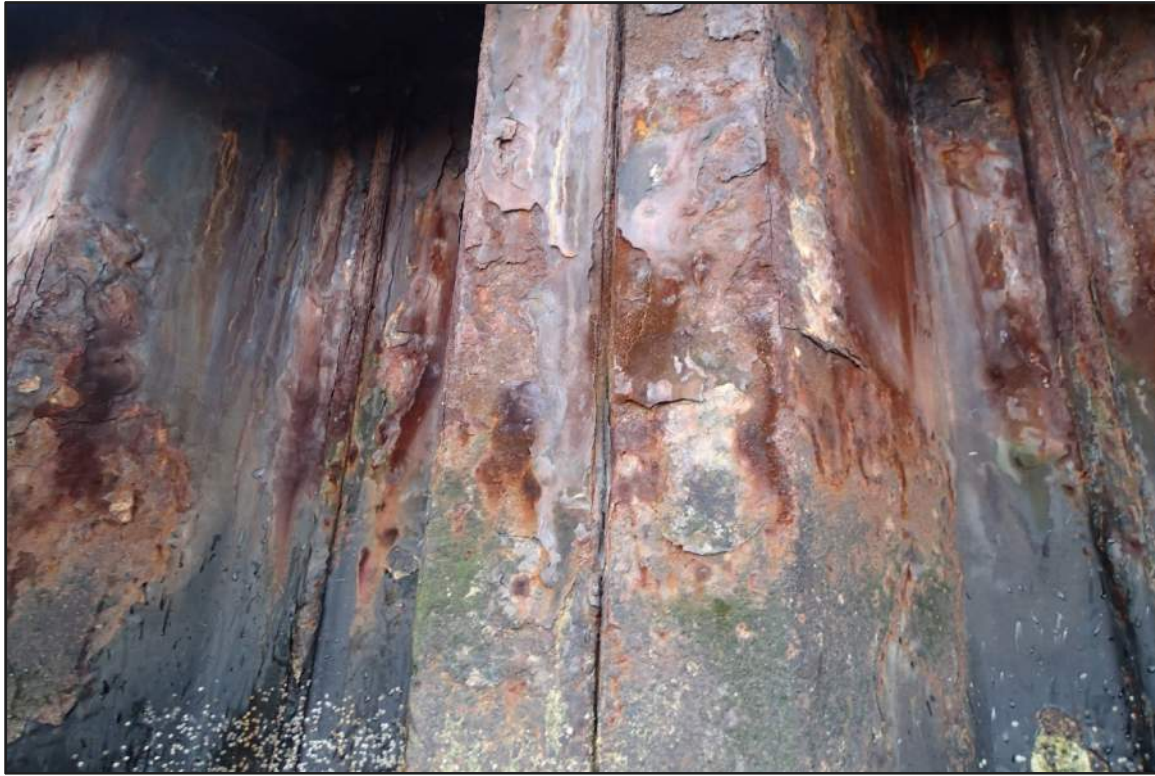
*Photograph 27: West Bulkhead – Typical coating failure with moderate corrosion of steel sheet pile in splash/tidal zone (Looking southeast)*

- › Clean and recoat the steel sheet pile cells from MLW to the top of the element at each cell. Additionally, the splash zone repairs located below MLW should be cleaned and patched, as required. Where splash zone coating failures have occurred, the exposed steel should be assessed by a qualified professional to determine if structural repairs are required.

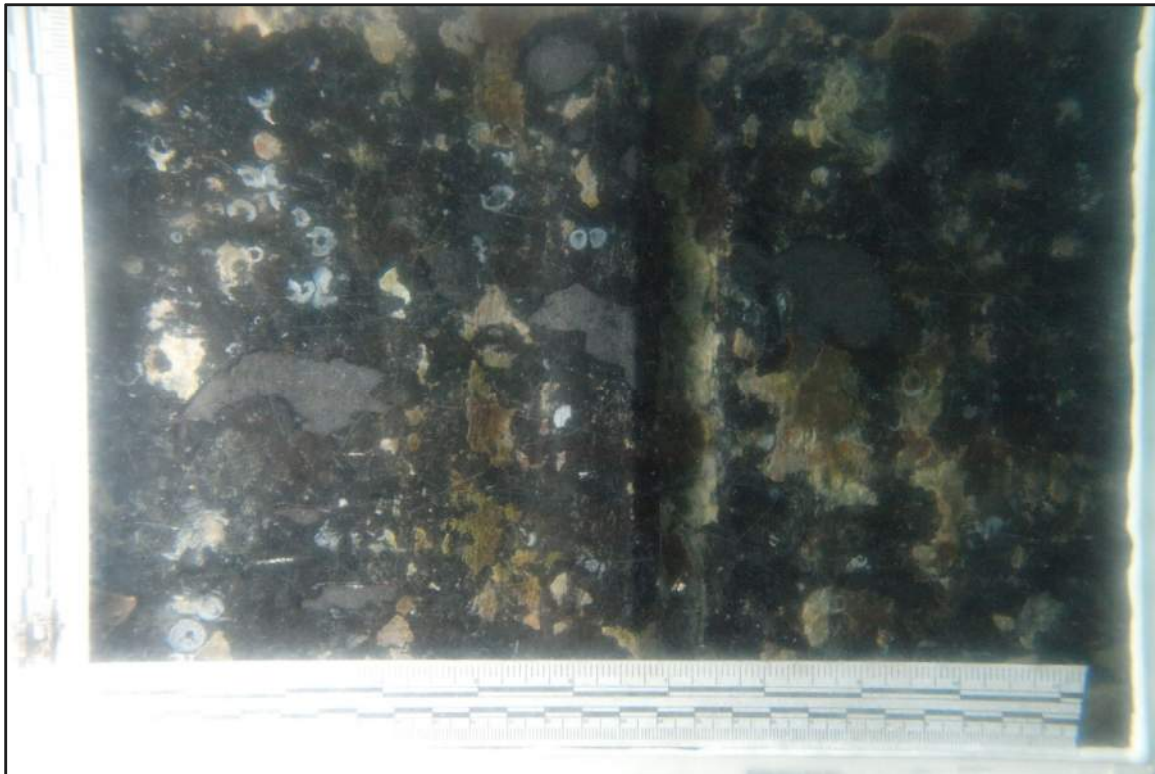
*Photograph 28: West Bulkhead – Typical isolated coating loss on steel sheet pile bulkhead below water*

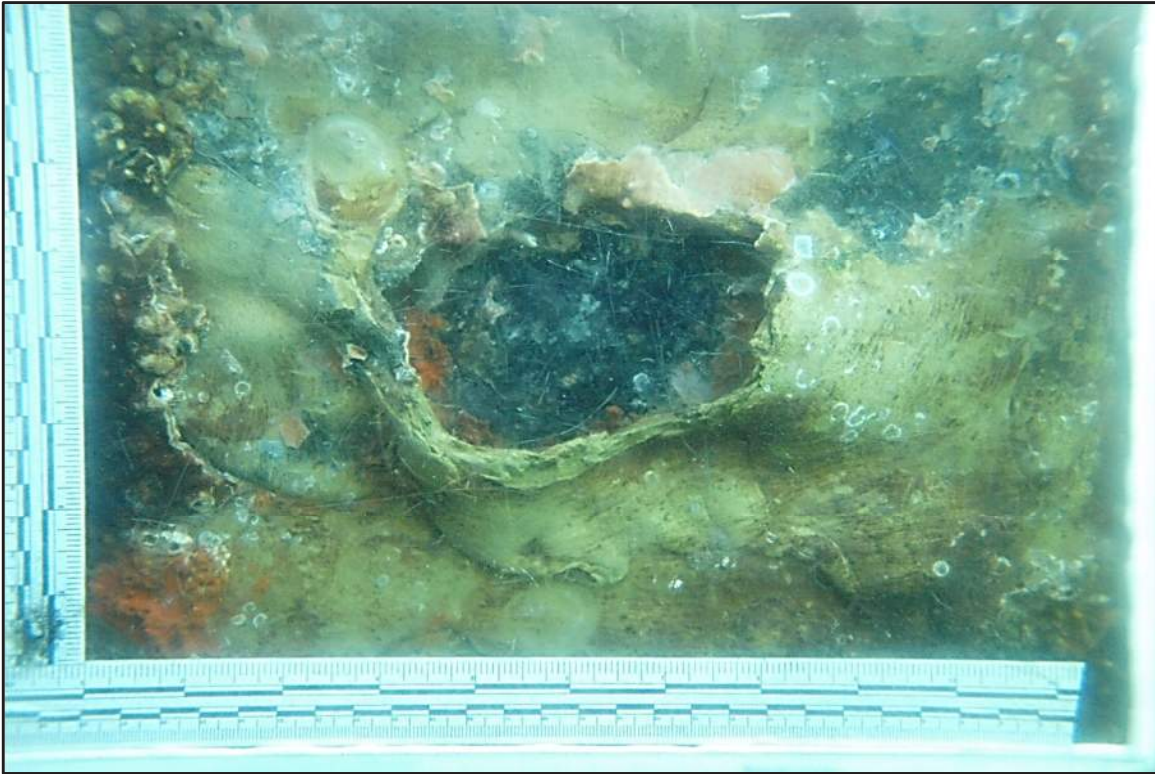
Photograph 29: West Bulkhead – Typical splash zone repair failure with moderate corrosion of exposed steel sheet pile

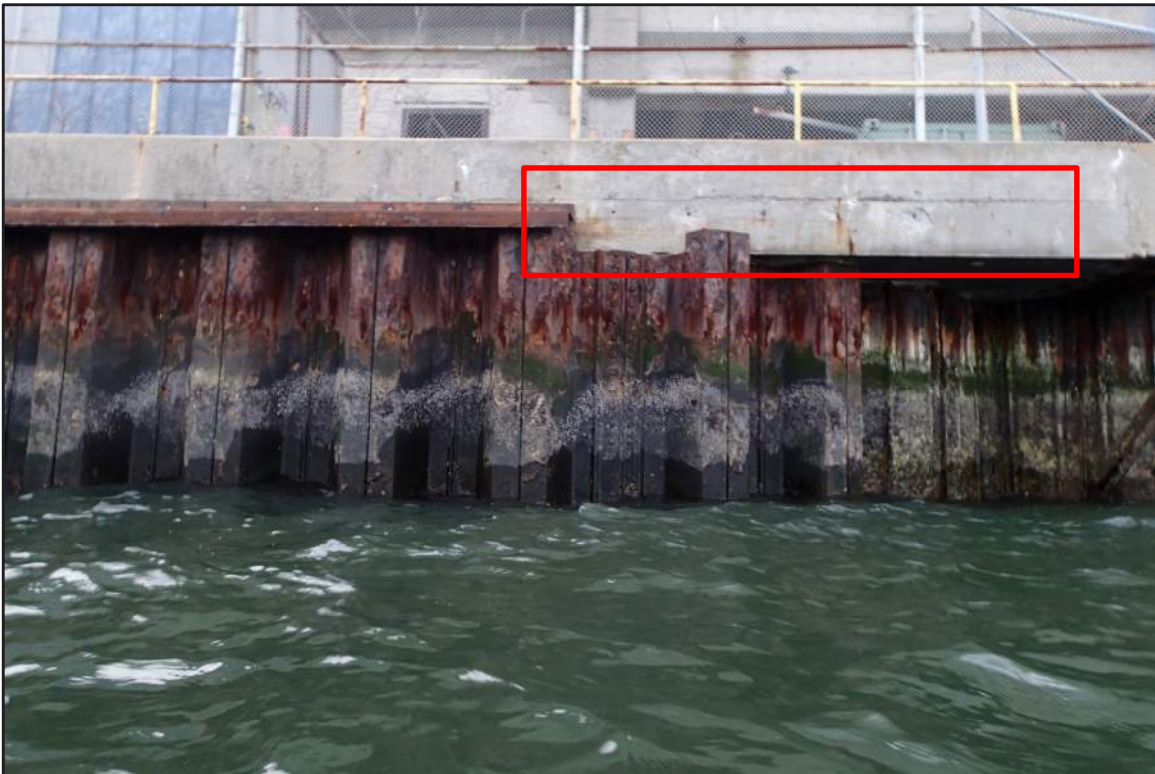
Photograph 30: West Bulkhead - Missing steel pile cap (Looking south)

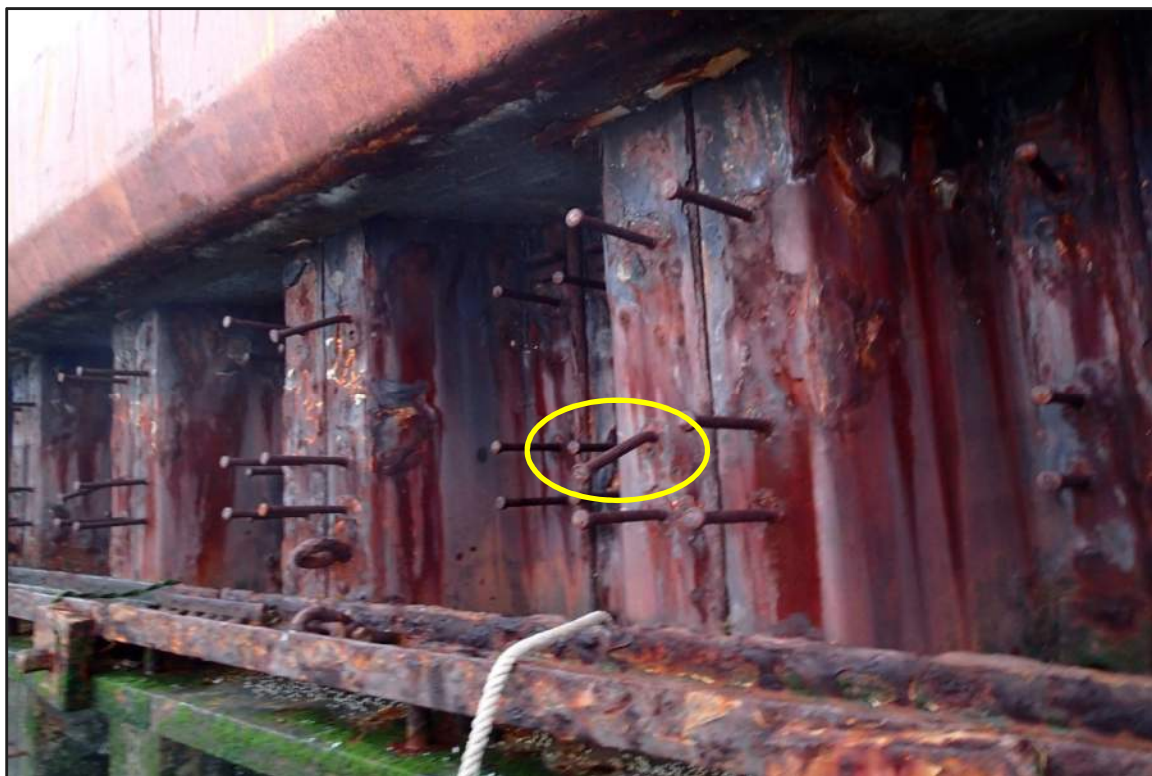
The North Bulkhead is in Fair condition due to moderate to advanced corrosion and coating failure located within the splash and tidal zones of the steel sheet piles, steel cellular cofferdams, and steel anchor tie-backs (Photograph 31 and Photograph 32).

*Photograph 31: North Bulkhead - Typical coating failure with moderate corrosion of steel sheet pile in splash/tidal zone and an isolated damaged shear stud (Looking northeast)*

- › Clean and recoat all steel sheet piles from Mean Low Water (MLW) to top of pile at each of the three bulkheads. It is our understanding that the entire length of the North Bulkhead is scheduled to be encased in concrete, pursuant to the U.S. Army Corps of Engineer's permit issued for the construction of the MTS (NAN-2008-0927). That would adequately address this recommendation for that section of bulkhead.

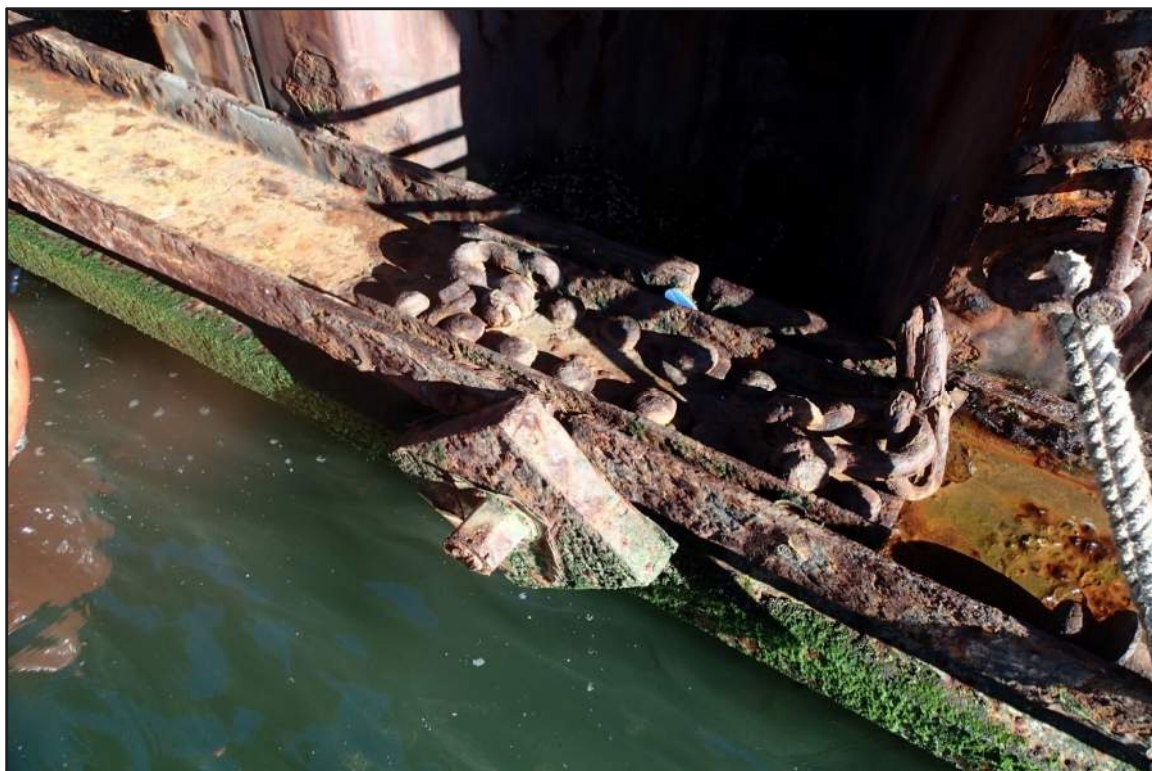
*Photograph 32: North Bulkhead - Typical coating failure with moderate corrosion of steel channel wale, anchor rod, and hardware in splash/tidal zone*

- › Clean and recoat the double channel tie-back wale along the North and East Bulkheads. It is our understanding that the entire length of the North Bulkhead is scheduled to be encased in concrete, pursuant to the U.S. Army Corps of Engineer's permit issued for the construction of the MTS (NAN-2008-0927). That would adequately address this recommendation for that section of bulkhead.

- › Clean and recoat the exposed portions of the steel anchor tie-backs and associated hardware along the North and East Bulkheads. It is our understanding that the entire length of the North Bulkhead is scheduled to be encased in concrete, pursuant to the U.S. Army Corps of Engineer's permit issued for the construction of the MTS (NAN-2008-0927). That would adequately address this recommendation for that section of bulkhead.

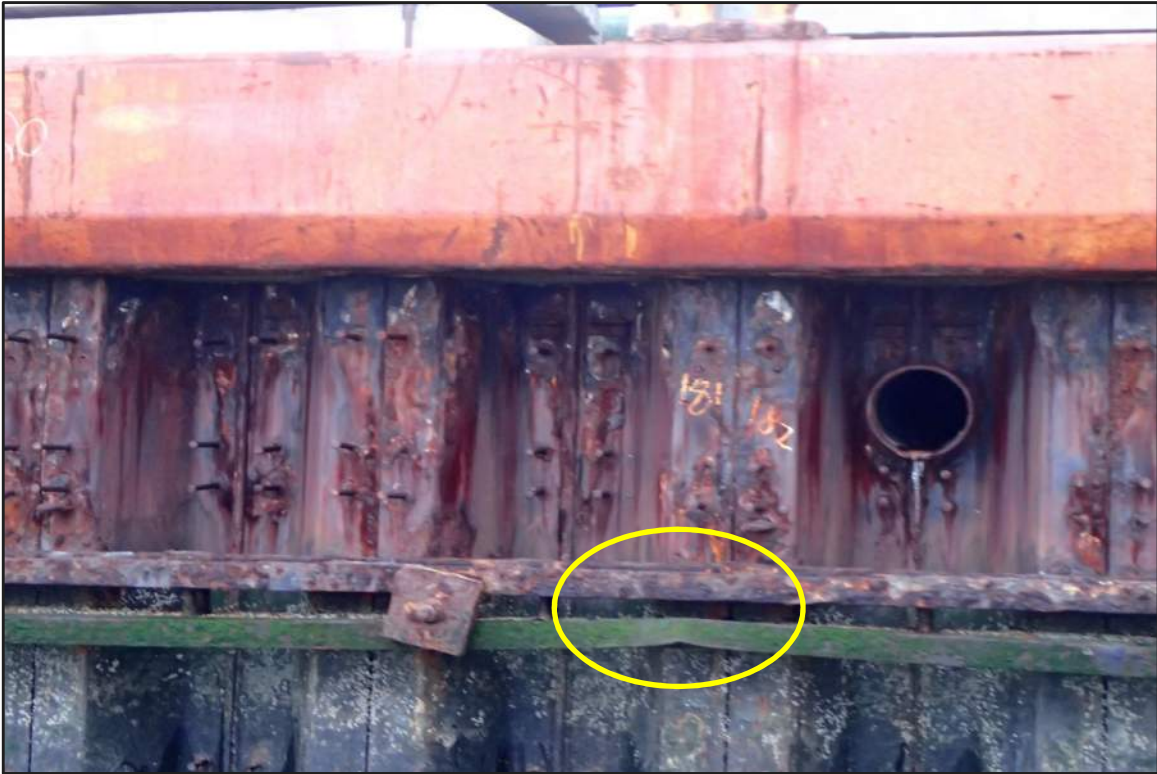
Additional deterioration includes isolated impact damage to the steel wale at Sta. 0+65, isolated deflected and missing shear studs throughout the length of the bulkhead, and isolated disengaged tie-back anchors (Photograph 33 and Photograph 34). Below mean low water, the steel sheet pile bulkhead is typically in moderate condition with isolated areas of failed coating and surface corrosion (Photograph 35), and isolated coating loss and splash zone failures with surface corrosion on the steel sheet pile cellular cofferdams (Photograph 36). The steel sheet pile cellular cofferdams, located at the western extent of the bulkhead, have been repaired with a splash zone coating along the exposed face of the sheets, extending from the mudline to approximately mean high water. Additionally, cut outs through the steel sheet pile bulkhead, noted during the previous inspections, at Sta. 2+80 are still present, but since the steel sheet pile bulkhead at this elevation is no longer retaining fill, due to the inshore concrete bulkhead, these openings are inconsequential. The mooring hardware in place between Sta. 0+96 and 0+00 are in moderate condition with coating loss and corrosion deterioration (Photograph 37). No access hatches for the cellular cofferdams were exposed, so the sand levels could not be observed or measured. The areas where the access hatches would presumably be located appear to have been paved over and are currently staging construction material for the ongoing construction effort (Photograph 38).

Photograph 33: North Bulkhead – Impacted steel wale at approximate Station 0+65 (Looking east)

- › Remove and replace the damaged portion of double channel tie-back wale (approximately 10 LF) at North Bulkhead Station 0+65. It is our understanding that the entire length of the North Bulkhead is scheduled to be encased in concrete, pursuant to the U.S. Army Corps of Engineer's permit issued for the construction of the MTS (NAN-2008-0927). That would adequately address this recommendation.

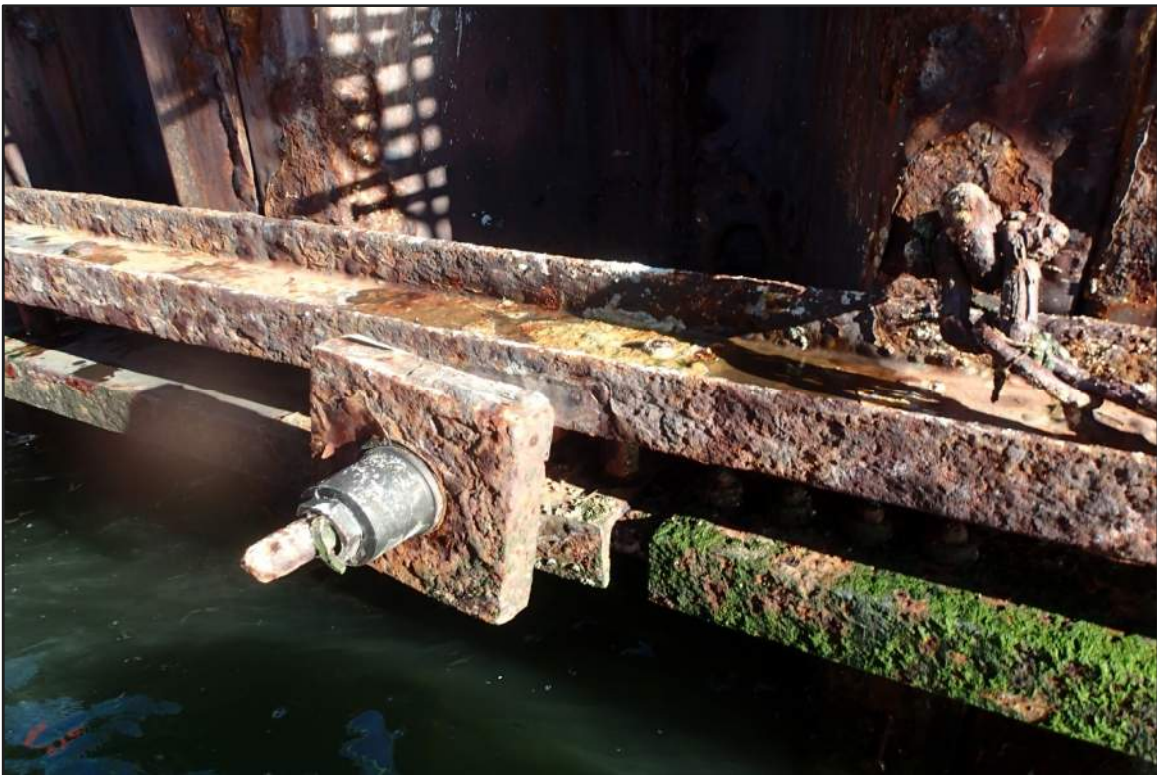
Photograph 34: North Bulkhead – Isolated disengaged tie-back anchor and washer (Looking northeast)

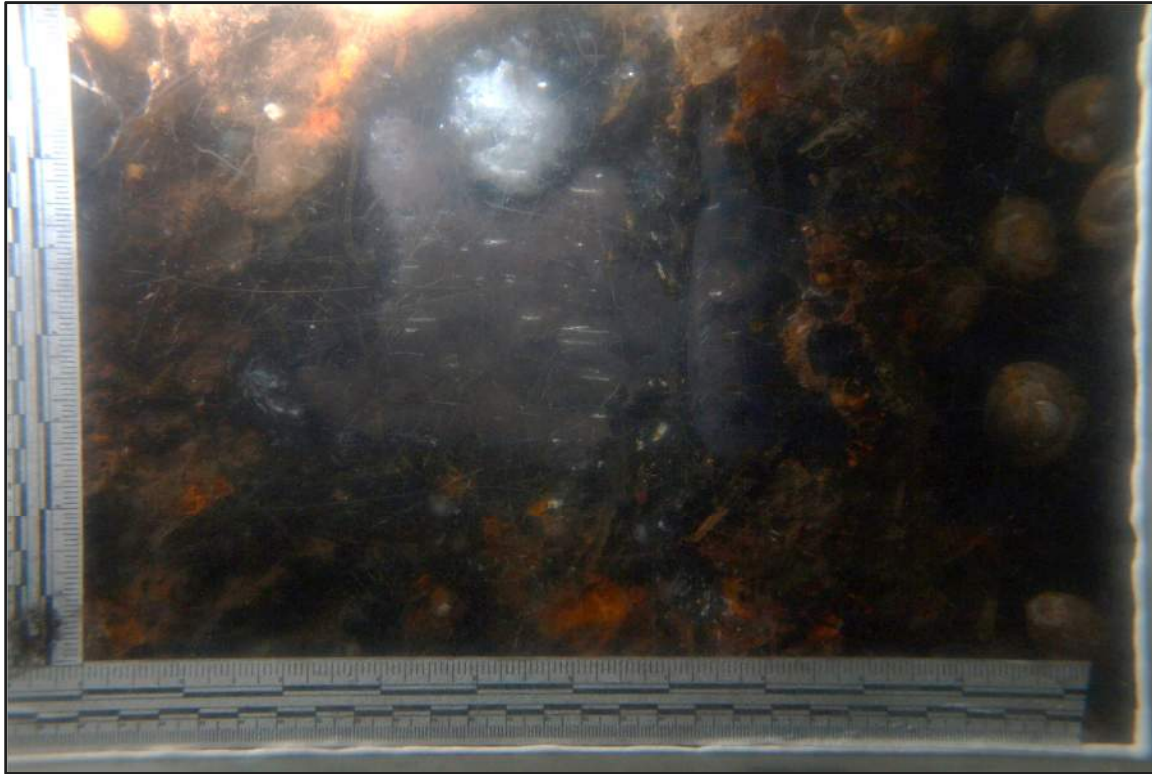
*Photograph 35: North Bulkhead - Isolated coating failure with moderate corrosion of steel sheet pile below water*

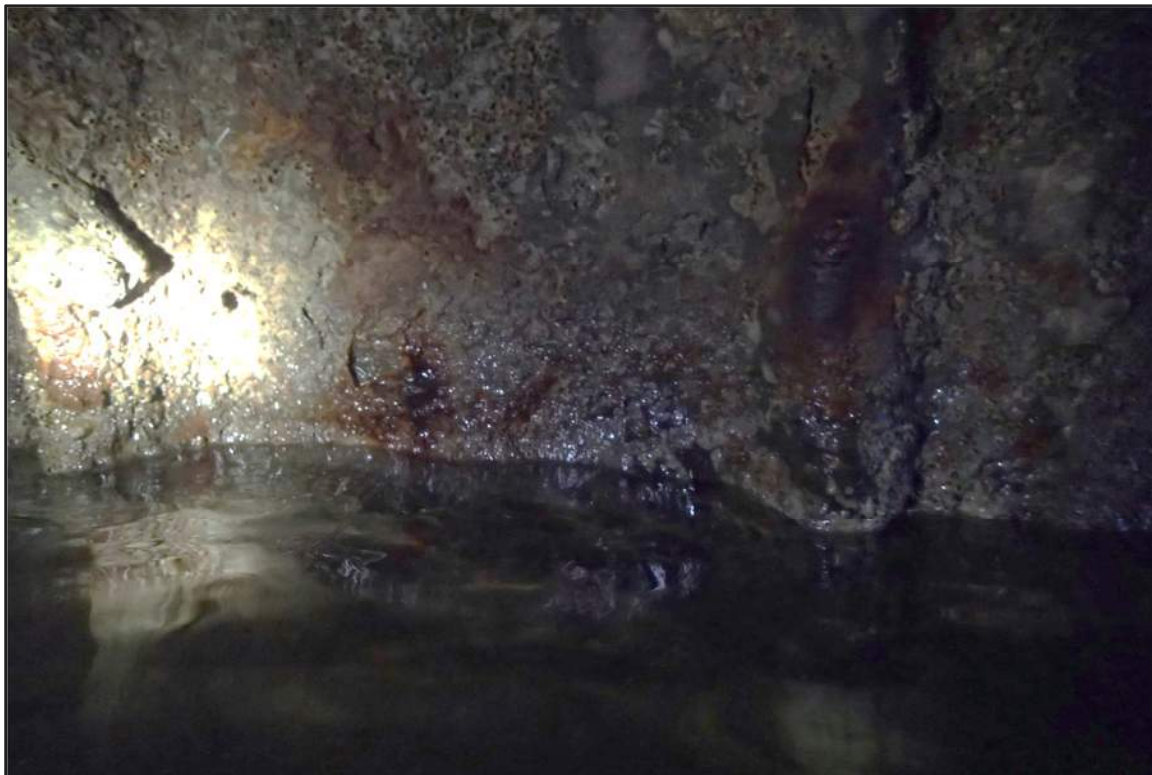
*Photograph 36: North Bulkhead - Typical isolated epoxy failures with corrosion of steel cellular cofferdam in tidal zone (Looking east)*

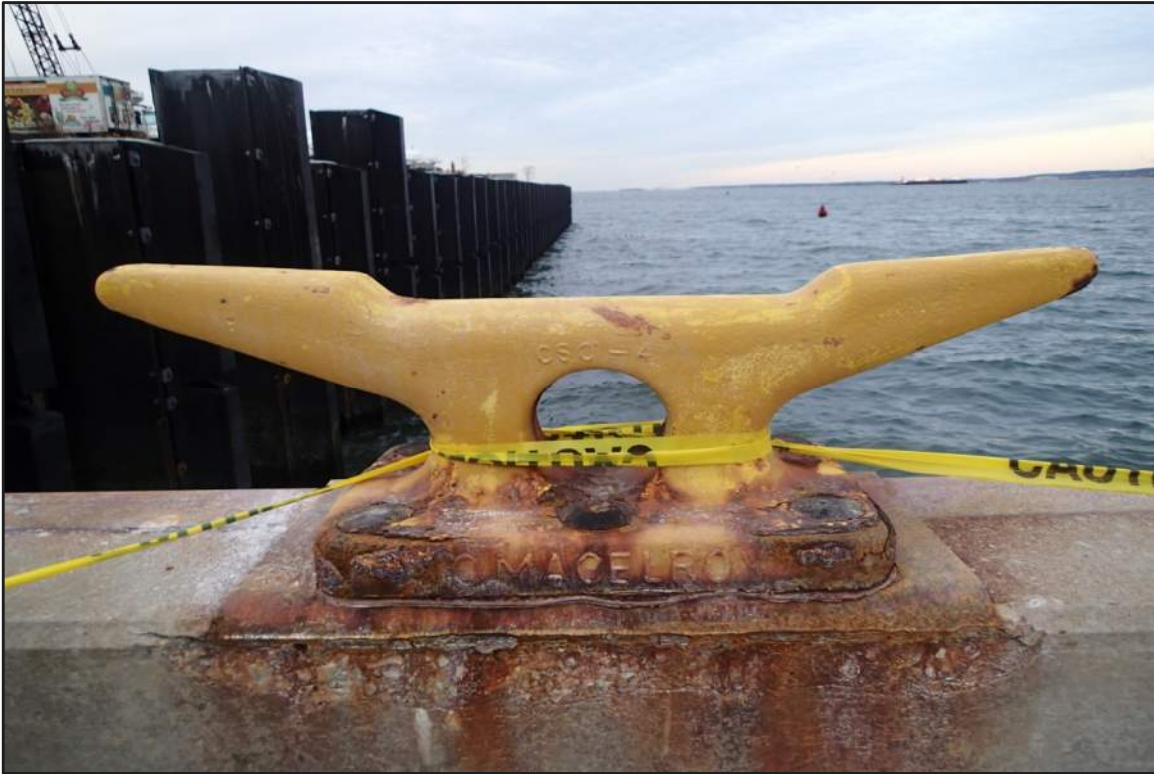
Photograph 37: North Bulkhead - Typical light to moderate corrosion of mooring hardware cleat (Looking west)

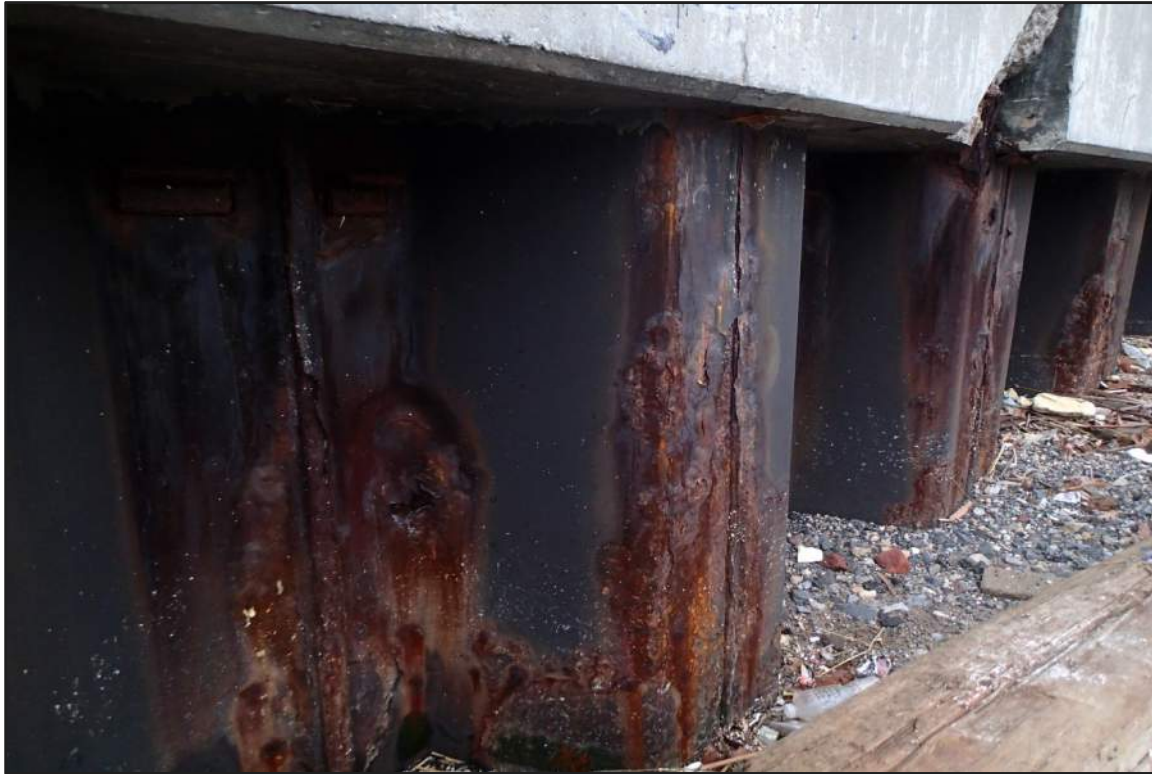
Overall, the East Bulkhead is in Fair condition due to moderate corrosion and coating failure located within the splash and tidal zone of the steel sheet piles and of the steel anchor tie-backs (Photograph 39 and Photograph 40), and isolated spalling of the concrete curb (Photograph 41). Below mean low water, the steel sheet pile bulkhead is typically sound with isolated areas of failed coating and surface corrosion. The external double channel wale has 100 percent coating loss with moderate corrosion (Photograph 42). No access hatches for the cellular cofferdams inshore of the existing bulkhead were exposed, so the sand levels could not be observed or measured. The areas where the access hatches would presumably be located appear to have been paved over and are currently staging construction material for the ongoing construction effort

*Photograph 39: East Bulkhead - Typical coating failure and moderate corrosion in the splash/tidal zone (Looking northeast)*

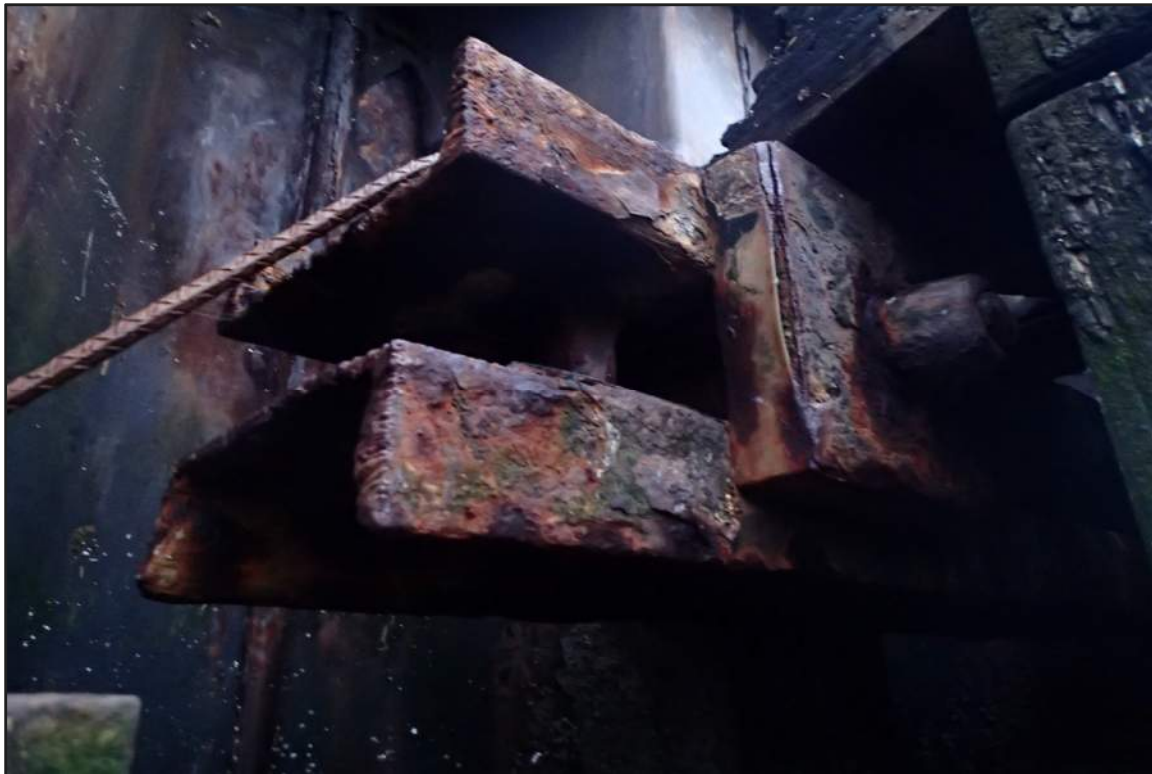
*Photograph 40: East Bulkhead - Typical coating failure with moderate corrosion of steel channel wale, anchor rod, and hardware in splash/tidal zone (Looking northeast)*

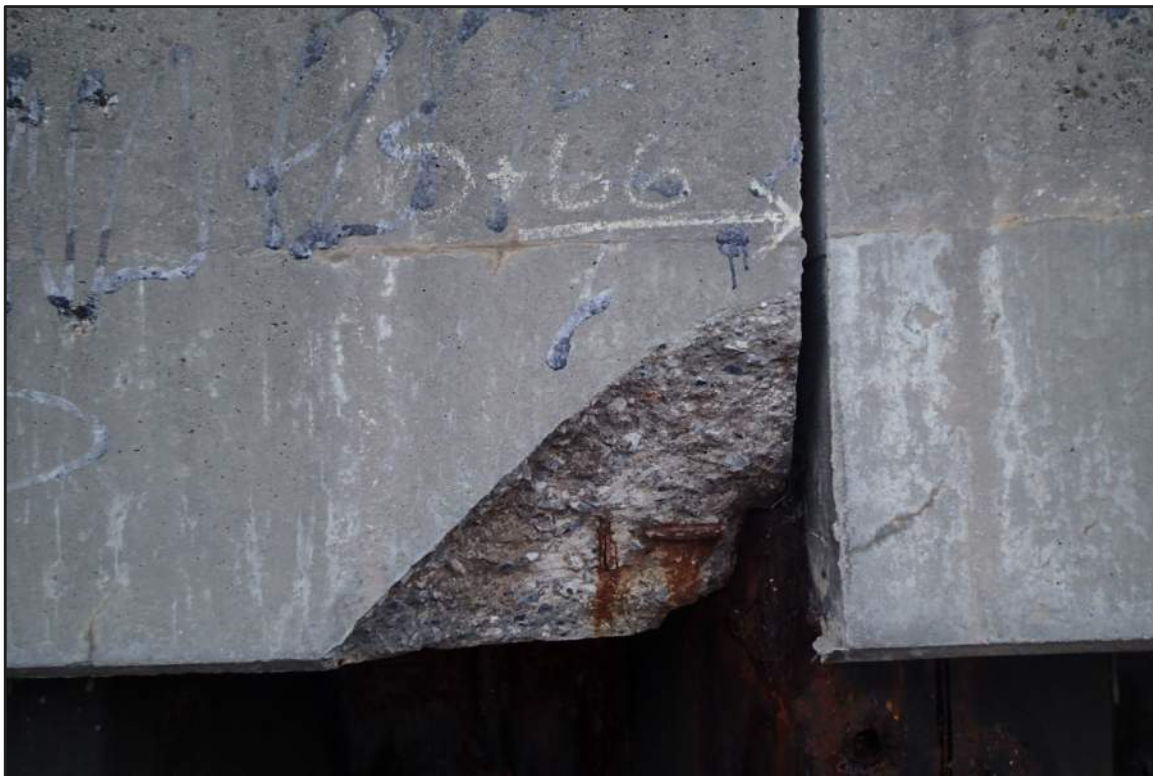
*Photograph 41: East Bulkhead – Open spalling with exposed reinforcement at Sta. 0+66(Looking north)*

- › Clean and patch the observed open spalling located at East Bulkhead Station 0+66. If this segment of bulkhead is schedule to be removed as a part of the ongoing construction efforts, this recommendation is not required.

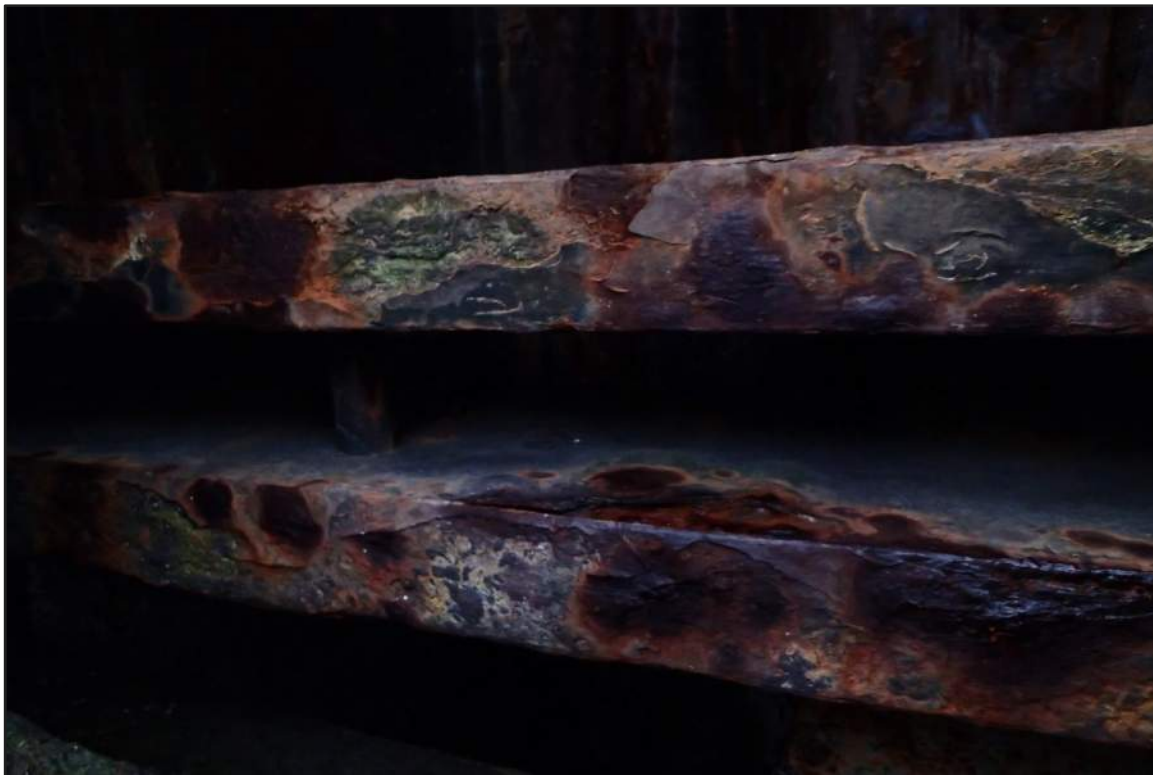
*Photograph 42: East Bulkhead - Typical coating failure with moderate corrosion of steel channel wale inshore of timber fender system in splash/tidal zone (Looking north)*

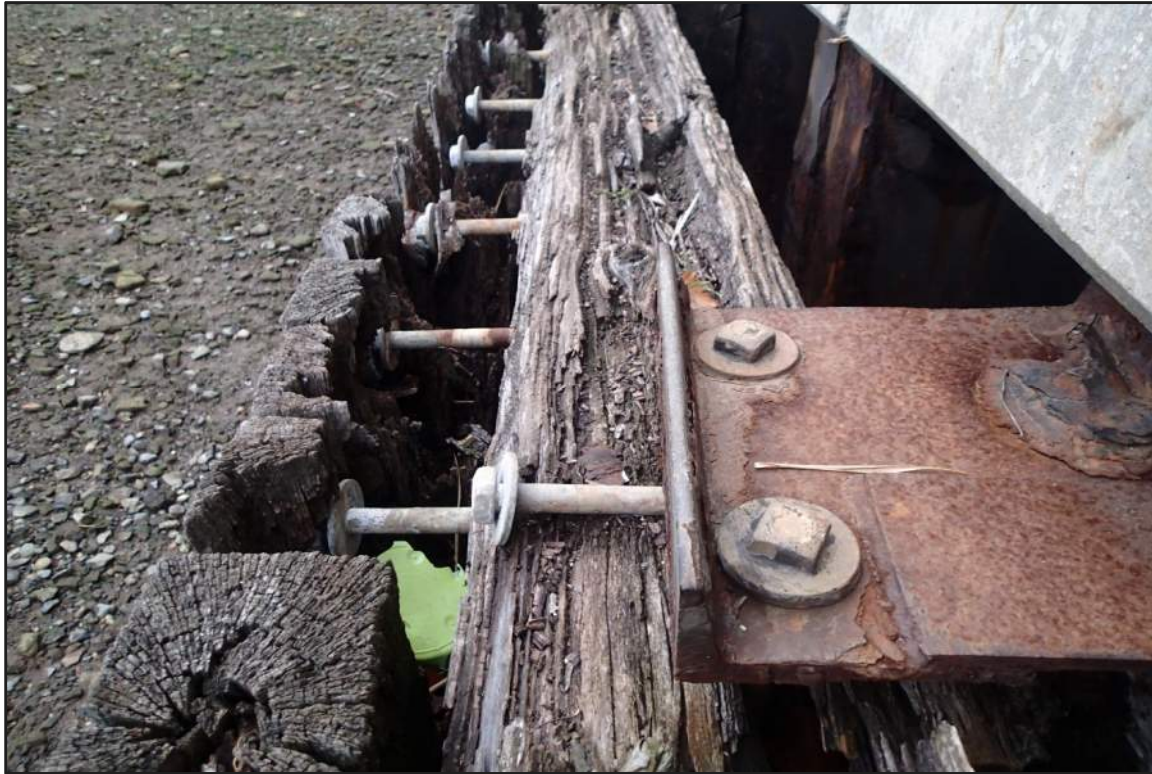
Inspection of the fender system was outside the scope of work for this investigation, but as stated above, the fender system along the North Bulkhead has been removed. It should also be noted that the East Bulkhead fender system is clearly in Serious condition. Observed deterioration includes severe section loss due to rot and weathering at the upper wale and at the top foot of the timber planks (Photograph 43 and Photograph 44).

*Photograph 43: East Bulkhead - Failed timber fender system connections due to rot (Looking west)*

- › Remove the timber fender system located along the East Bulkhead to reduce the dead load on the steel sheet piles, and provide access to the steel sheet pile bulkhead should cleaning and recoating repairs be necessary.

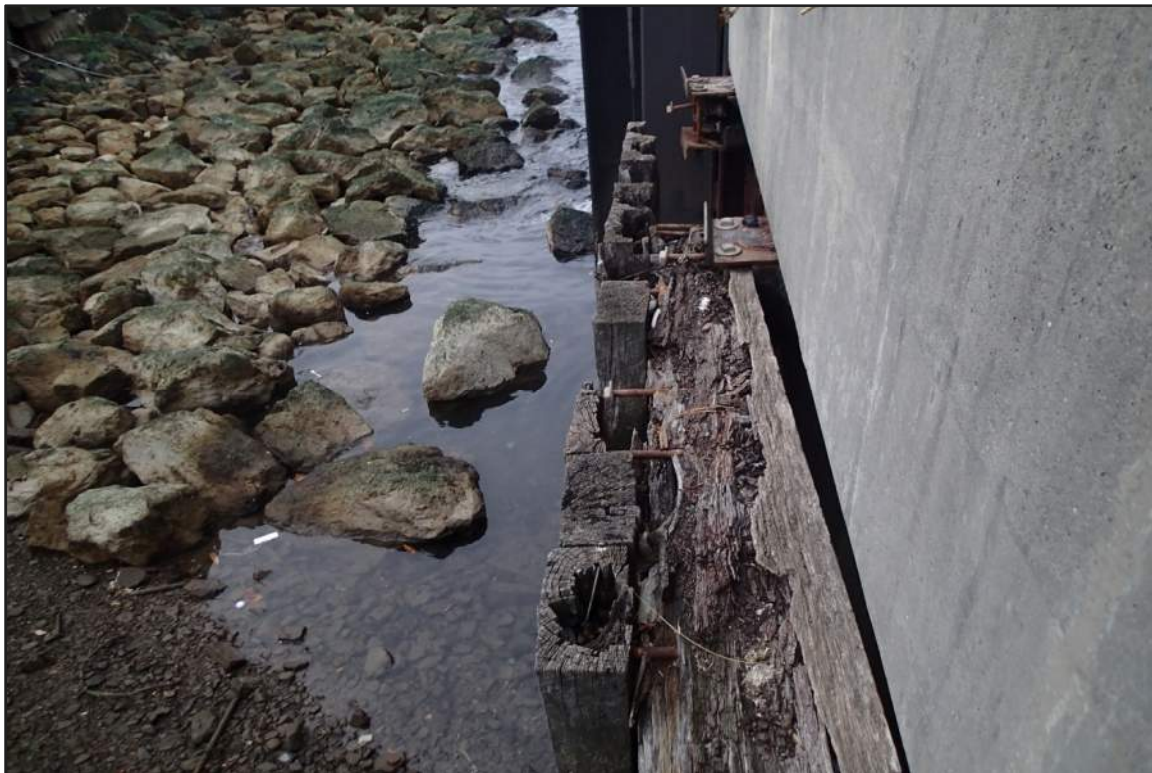
*Photograph 44: East Bulkhead - Heavy rot of the upper timber horizontal wale and panels (Looking west)*
