# SOUTHWEST BROOKLYN MARINE TRANSFER STATION BULKHEAD INVESTIGATION

ANNUAL BULKHEAD INSPECTION

PROJECT NO. A092286  
DOCUMENT NO.  
VERSION 4  
DATE OF ISSUE 12/28/2017 (Rev 1 – 02/26/2018)  
PREPARED SPWN  
CHECKED DDJS  
APPROVED JOAC

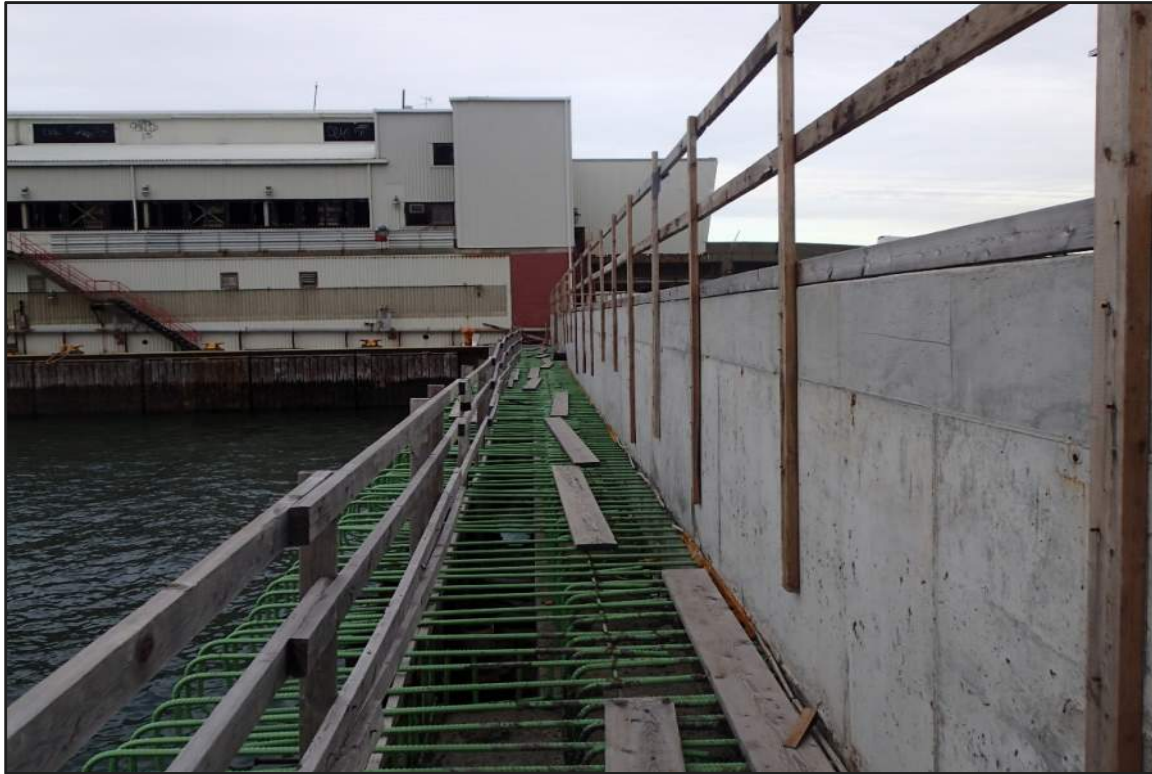
*Photograph 13: North Bulkhead – Partially constructed structure from 2016 inspection with exposed epoxy coated reinforcement (Looking north)*

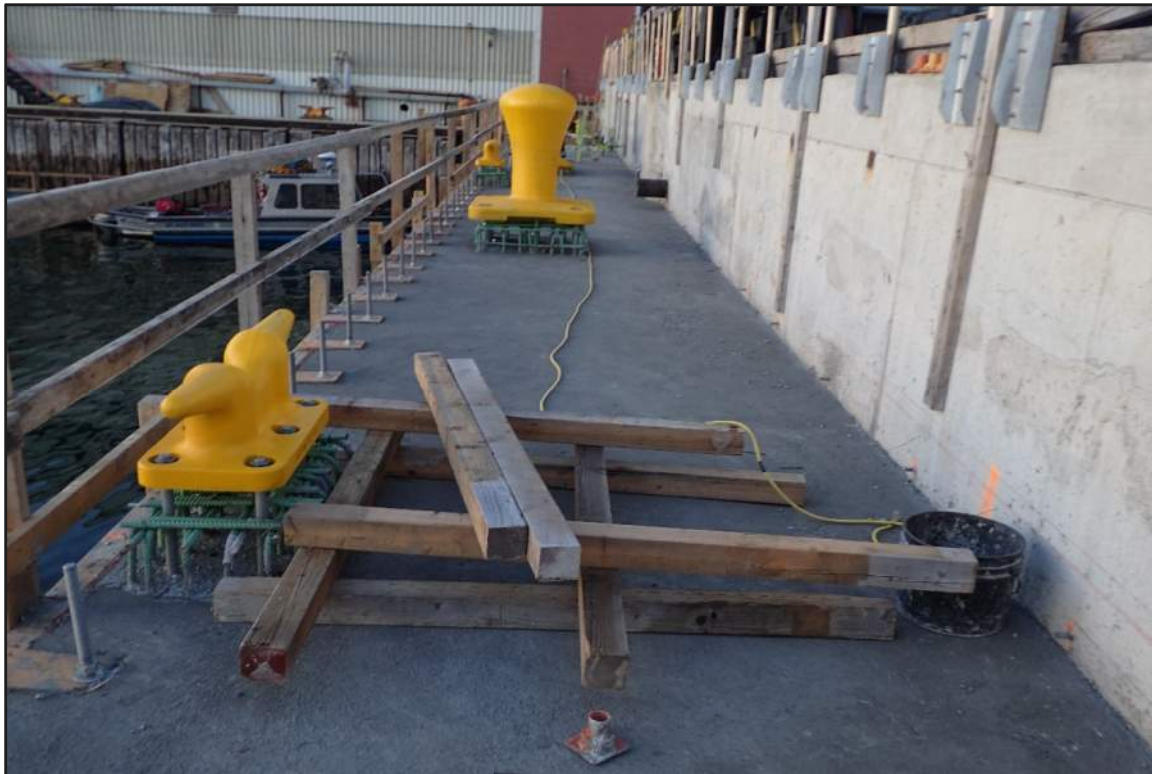
*Photograph 14: North Bulkhead – Nearly fully constructed deck structure with exposed epoxy coated reinforcement at the base of the new mooring hardware installations (Looking north)*

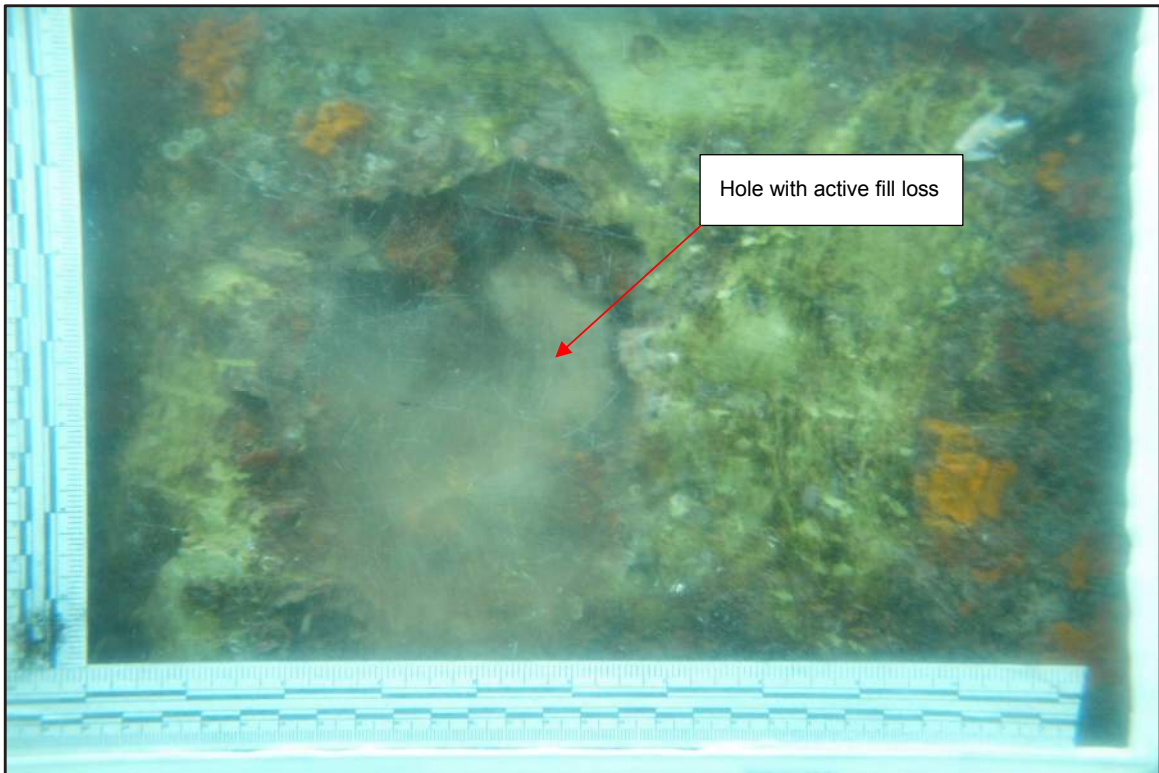
Overall, the West Bulkhead is in Poor condition due to an isolated hole within the intermediate cell adjacent to Cell F-1 noted during the 2016 inspection, a loose bracket at the cell-to-bulkhead intersection, moderate corrosion and coating failure located within the splash and tidal zones of the steel sheet piles and cellular cofferdams (Photograph 28 through Photograph 30). Below MLW, the steel sheet pile bulkhead is typically in moderate condition with isolated areas of failed coating and surface corrosion (Photograph 31), and isolated coating loss and splash zone failures with surface corrosion on the steel sheet pile cellular cofferdams (Photograph 32). The steel sheet pile cellular cofferdams, located at the western extent of the bulkhead, have been repaired with a splash zone coating along the exposed face of the sheets, extending from the mudline to approximately mean high water. Additionally, the missing steel pile cap section, located at the western edge of the Z-shape steel sheet pile bulkhead, noted during the previous inspection is still missing (Photograph 33).

Photograph 28: West Bulkhead – Hole through splash zone repair and steel sheet pile cell with exposed fill and active fill loss at intermediate cell adjacent to Cell F-1 observed in 2016 inspection

- › Install and coat a steel patch plate (12 inches by 12 inches) over the approximate 6 inch diameter hole observed at the intermediate cell adjacent to Cell F-1 at the West Bulkhead.

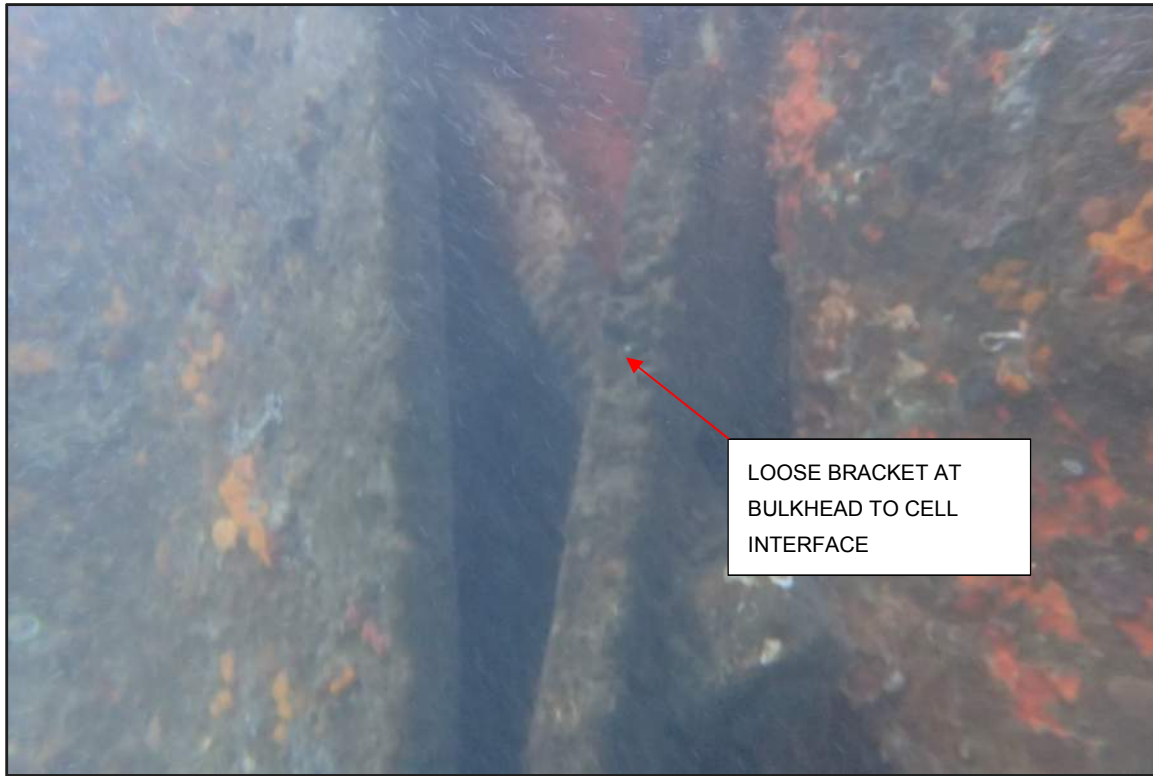
*Photograph 29: West Bulkhead – Loose bracket at interface between steel sheet pile bulkhead and steel sheet pile cell*

- › Repair the loose transition anchor bracket connection between the West Bulkhead and intermediate cell adjacent to Cell F-1. This repair will require the bearing plate to be realigned, and the nut to be tightened.

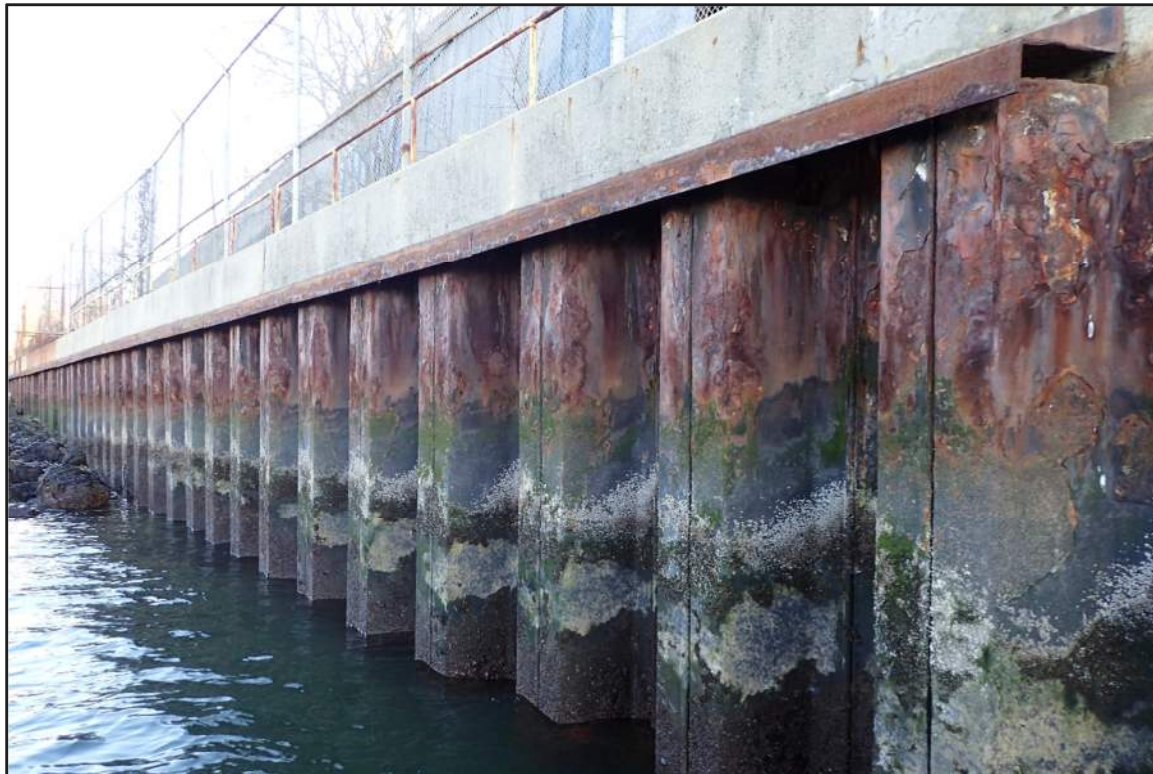
*Photograph 30: West Bulkhead – Typical coating failure with moderate corrosion of steel sheet pile in splash/tidal zone (Looking east)*

- › Clean and recoat all steel sheet piles from MLW to top of pile at each of the West Bulkhead.
- › Clean and recoat the steel sheet pile cells from MLW to the top of the element at each cell. Additionally, the splash zone repairs located below MLW should be cleaned and patched, as required. Where splash zone coating failures have occurred, the exposed steel should be assessed by a qualified professional to determine if structural repairs are required.

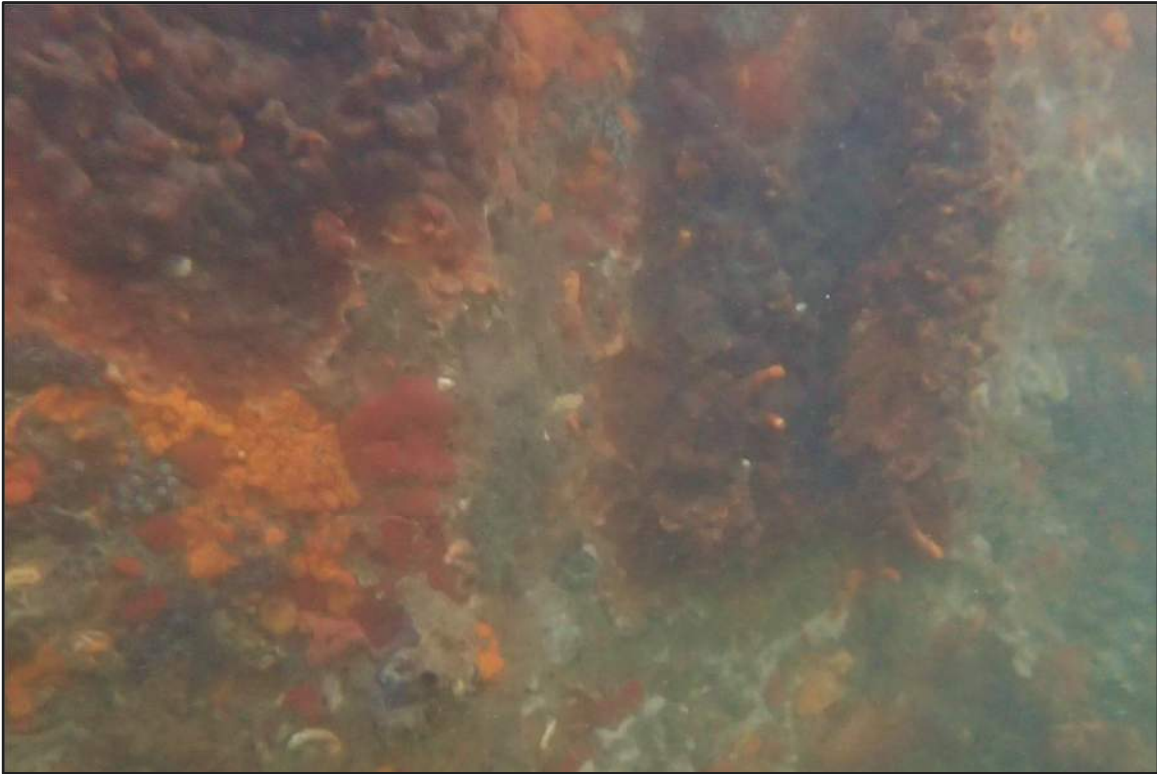
*Photograph 31: West Bulkhead – Typical isolated coating loss on steel sheet pile bulkhead below water*

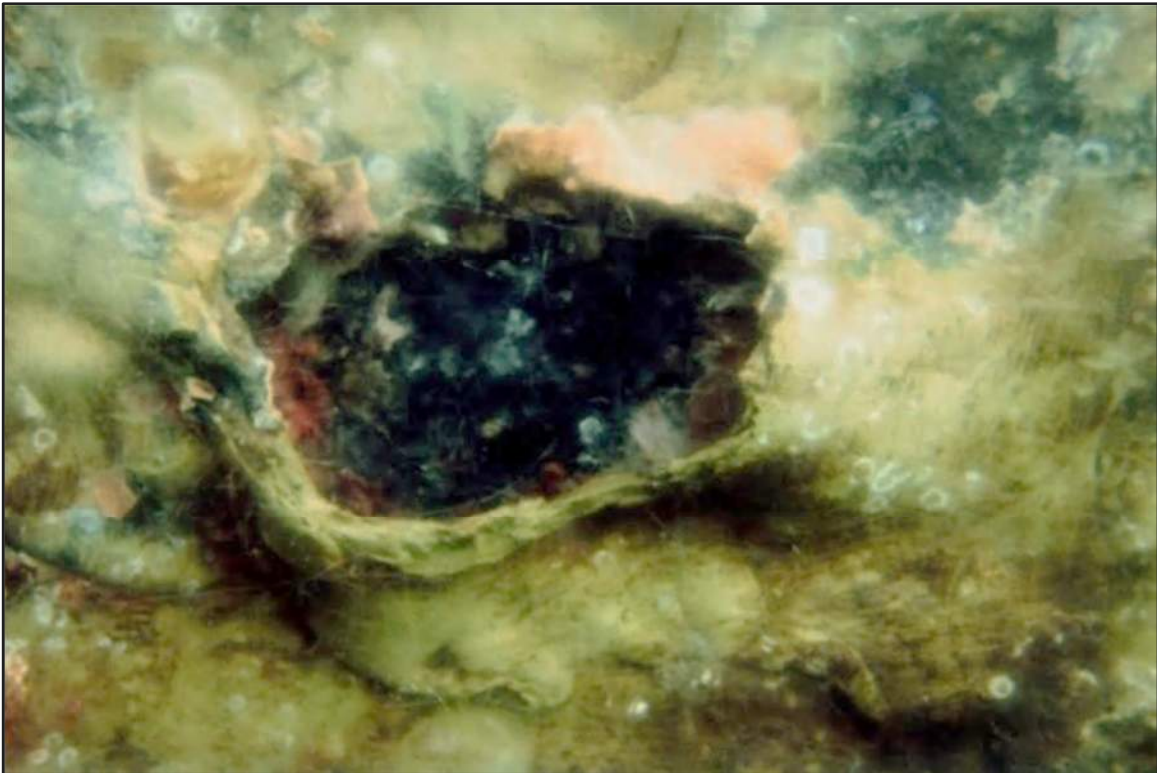
*Photograph 32: West Bulkhead – Typical splash zone repair failure with moderate corrosion of exposed steel sheet pile*

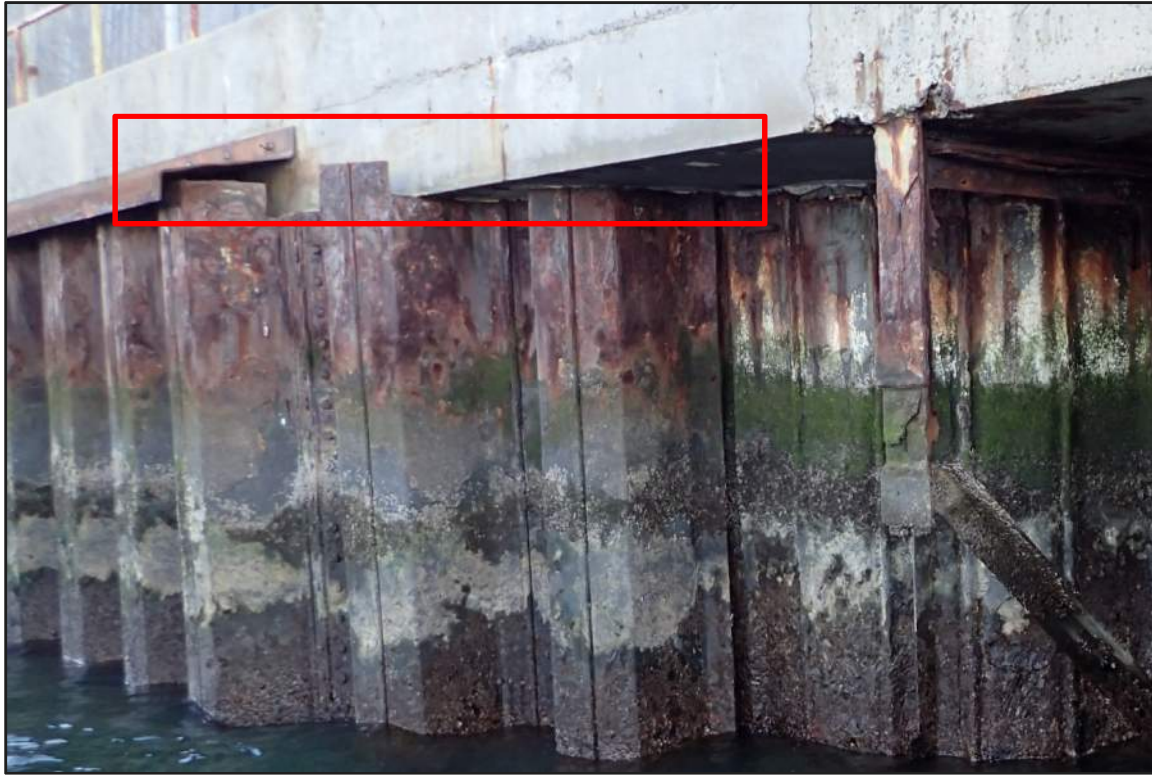
*Photograph 33: West Bulkhead - Missing steel pile cap (Looking southeast)*

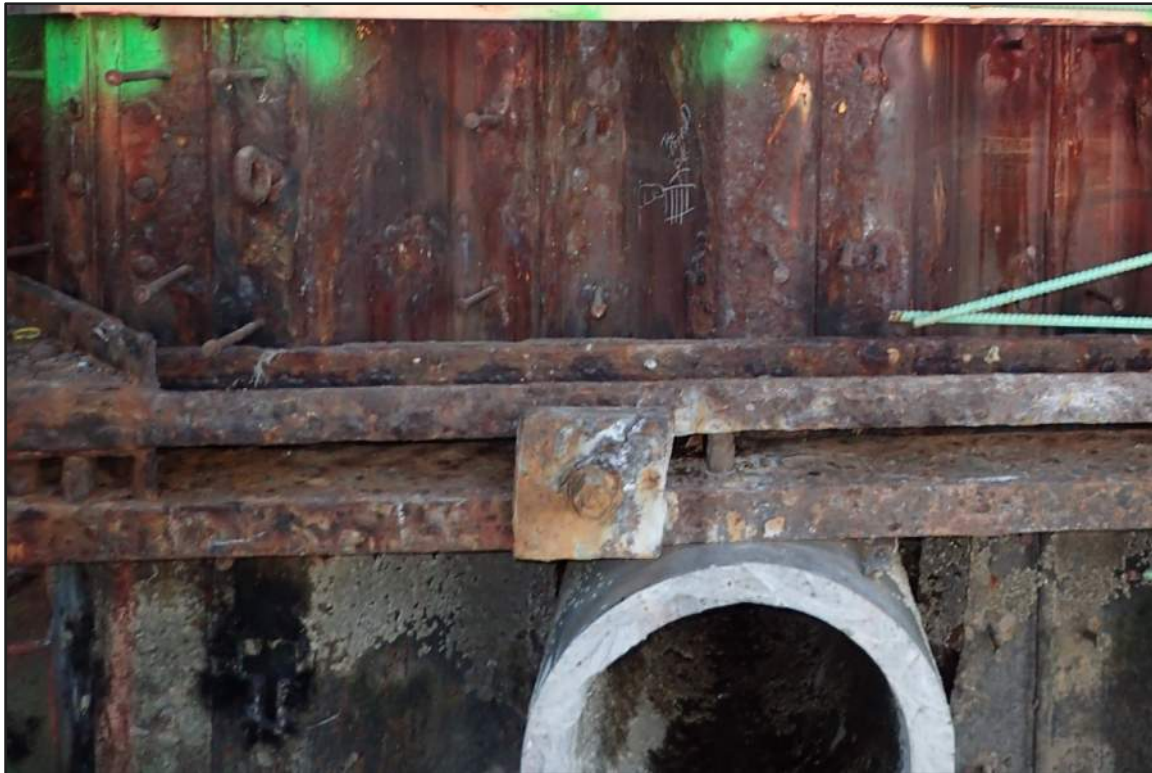
*Photograph 34: North Bulkhead - Typical coating failure with moderate corrosion of steel channel wale, anchor rod, and hardware in splash/tidal zone that is not yet encased in concrete (Looking east)*

- › Clean and recoat the double channel tie-back wale where exposed along the North Bulkhead. It is our understanding that the entire length of the North Bulkhead is scheduled to be encased in concrete, pursuant to the USACE permit NAN-2009-00077. This repair is currently in the process of being installed. Once the installation of the encasement repair is complete, it would adequately address this recommendation for that section of bulkhead.

- › Clean and recoat the exposed portions of the steel anchor tie-backs and associated hardware where exposed along the North Bulkhead. It is our understanding that the entire length of the North Bulkhead is scheduled to be

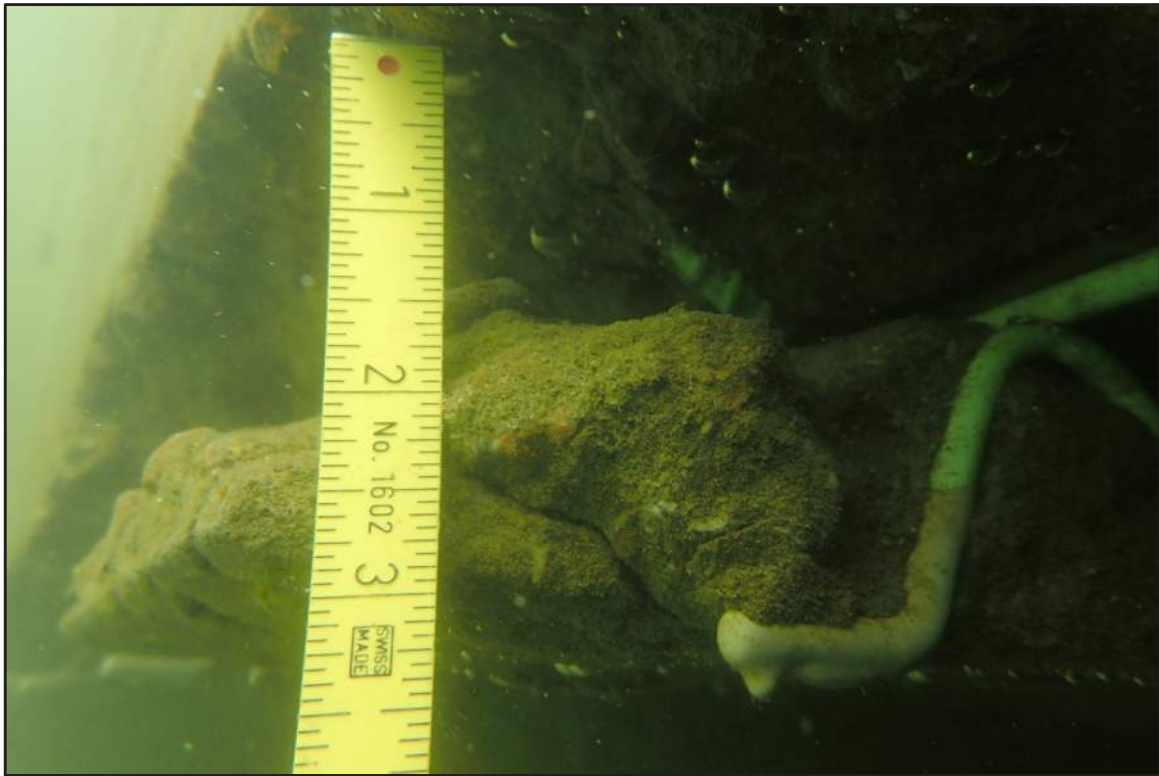
The North Bulkhead is in Fair condition due to moderate to advanced corrosion and coating failure located within the splash and tidal zones of the steel sheet piles in the sections still pending partial concrete encasement, the sections of exposed steel anchor tie-backs, and the steel cellular cofferdams (Photograph 34). Additionally, the partial concrete encasement of the steel sheet piles exhibits intermittent areas of exposed epoxy coated steel reinforcement due to poor consolidation of the concrete during the pouring process. The observed deteriorated is located along the bottom of the partial concrete encasement, and along the full length of the vertical cold joints (Photograph 35 through Photograph 37).

*Photograph 35: North Bulkhead – Poor consolidation of the concrete at the bottom of the partial concrete encasement (Looking northeast)*

- › Re-form and pour, or patch, the areas of exposed epoxy coated steel reinforcement and/or poorly consolidated concrete in the new partial concrete encasement repair of the North Bulkhead steel sheet piles. Additionally, all existing and future hardware penetrations into the reinforced concrete matrix should be sealed watertight via non-shrink grout or splash zone epoxy patches. It is COWI's understanding that the onsite contractor is in the process of repairing the observed defects.

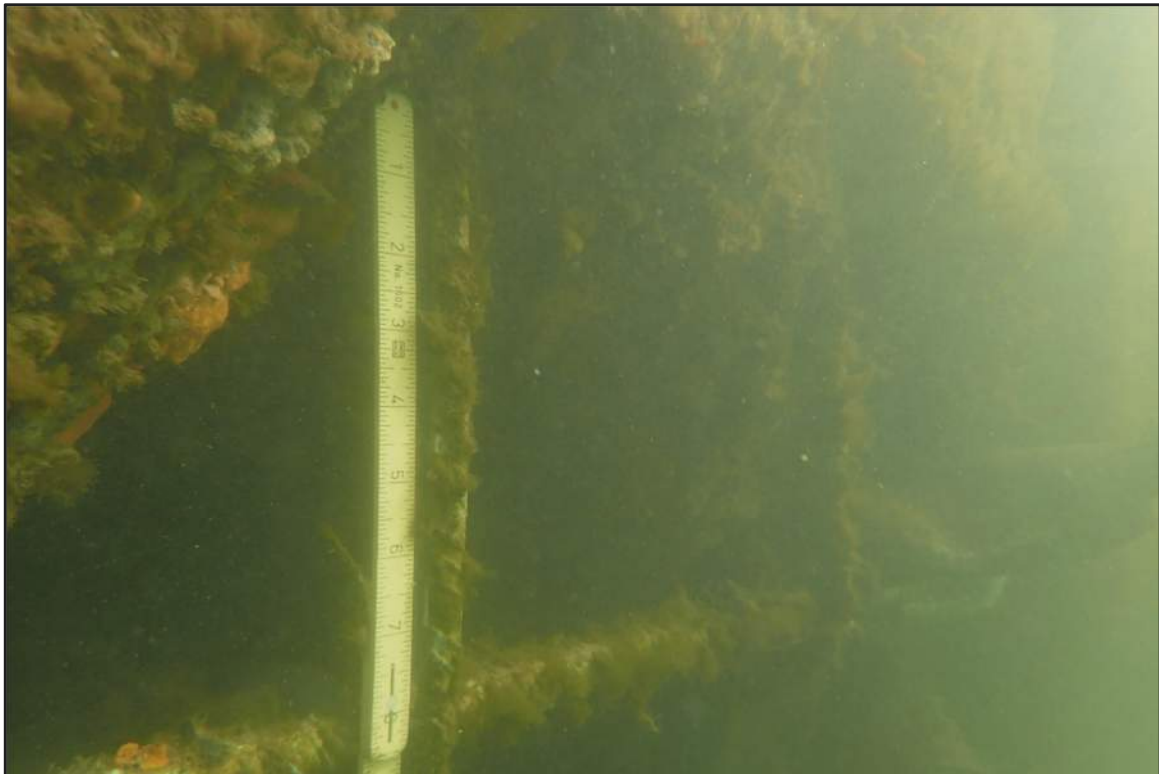
*Photograph 36: North Bulkhead – Poor consolidation of the concrete at the bottom of the partial concrete encasement (Looking northeast)*

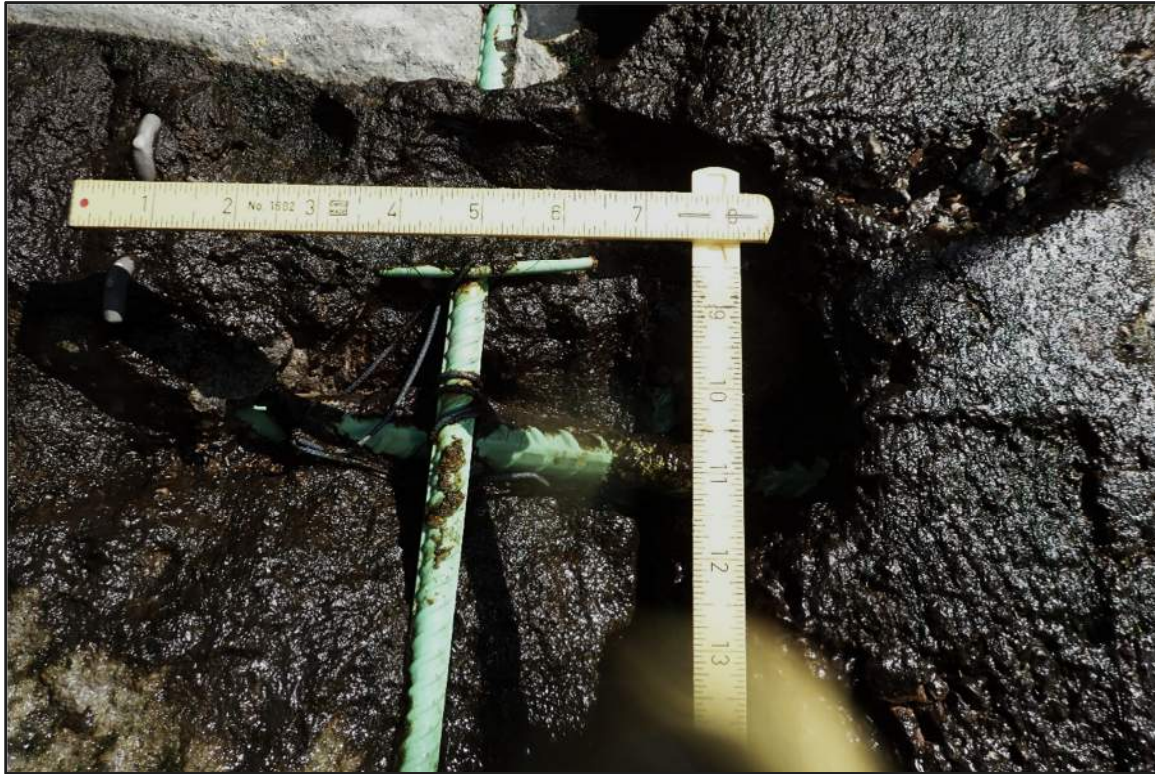
*Photograph 37: North Bulkhead – Poor consolidation of the concrete at the vertical cold joints of the partial concrete encasement (Looking east)*

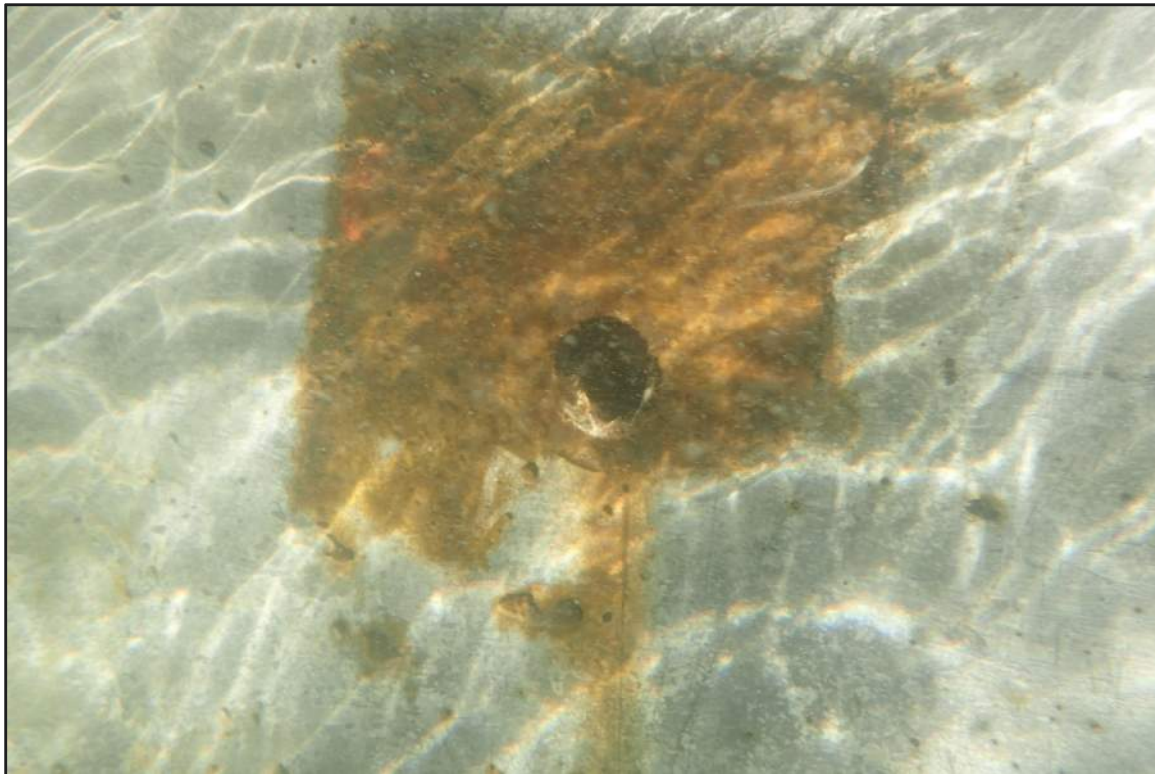
The formwork for this partial encasement was held in place by threaded rods anchored to the steel sheet piles that penetrated through, terminating with backing plates and compression nuts. The penetrations through the concrete encasement were not sealed after the forms were removed, which could result in accelerated deterioration of the concrete and any exposed steel reinforcement due to saltwater intrusion (Photograph 38).

*Photograph 38: North Bulkhead – Typical exposed formwork hardware penetration in the face of the partial concrete encasement (Looking east)*

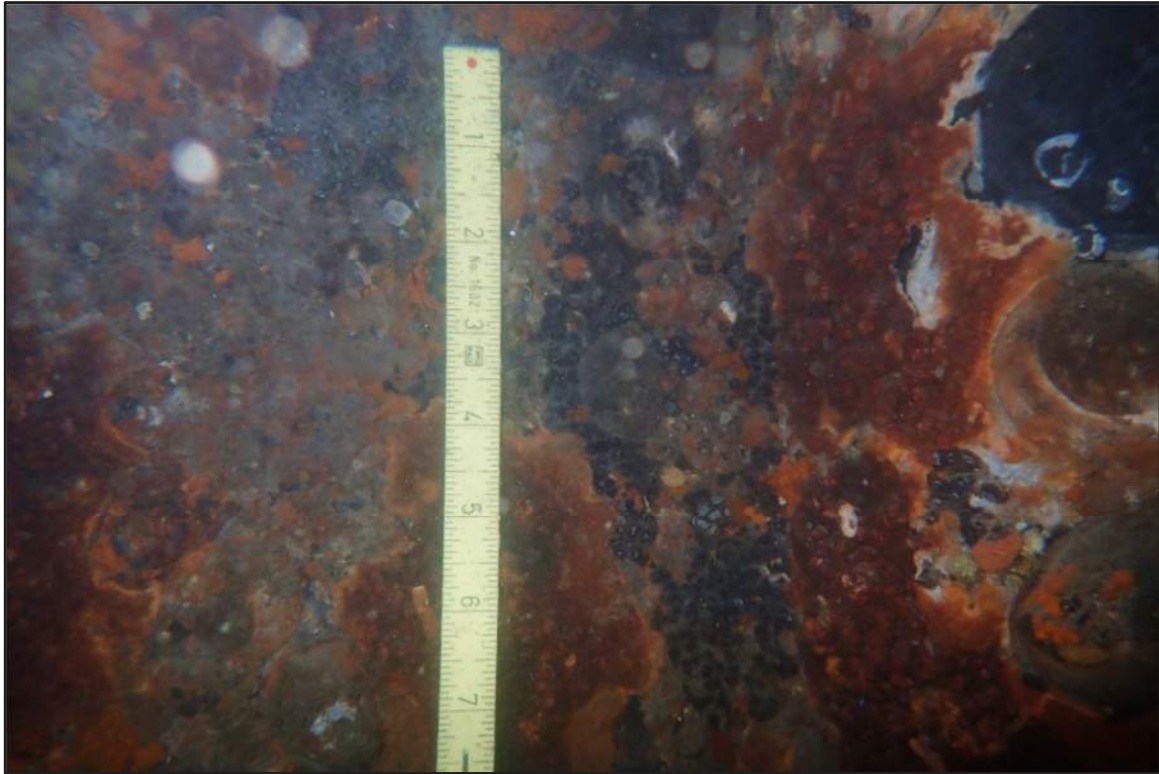
*Photograph 39: North Bulkhead - Isolated coating failure with moderate corrosion of steel sheet pile below the partial concrete encasement (Looking east)*

- › Clean and patch exposed steel sheet pile bulkhead below concrete encasement with splash zone epoxy during a future bulkhead maintenance project, after this scope of work is completed.

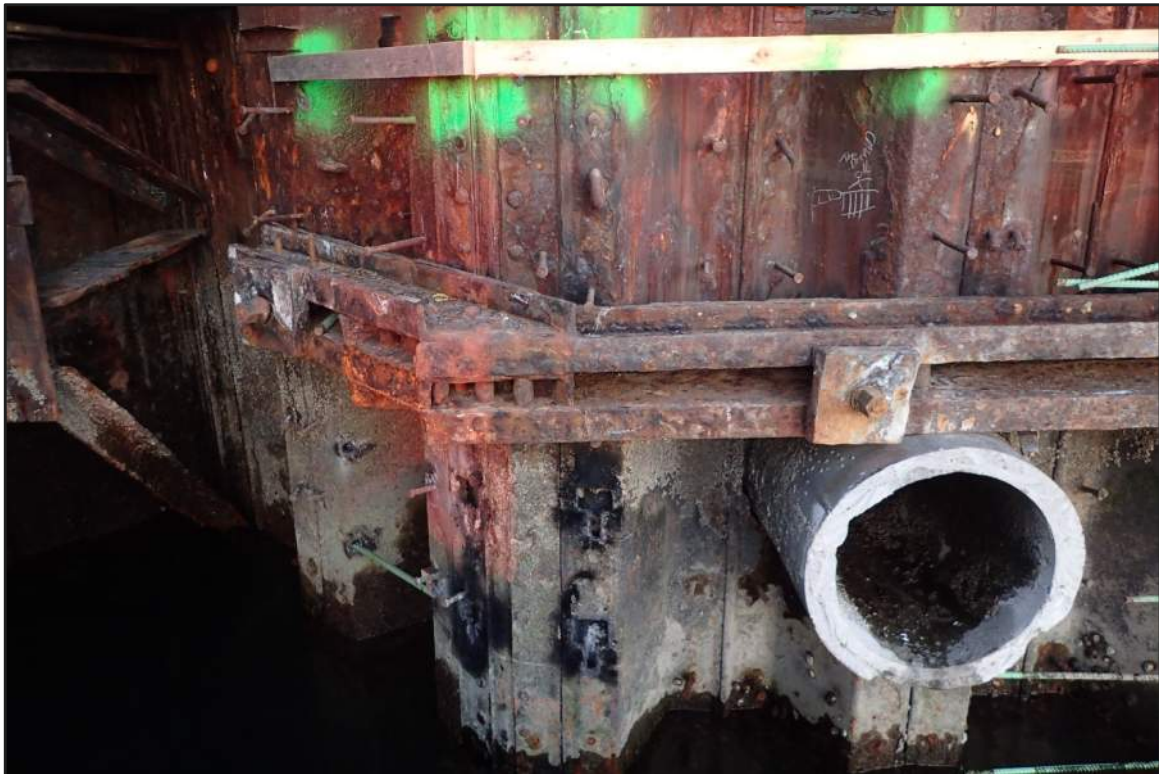
*Photograph 40: North Bulkhead - Moderate to advanced corrosion of steel sheet in the splash zone and tidal zone in the areas still pending concrete encasement (Looking east)*

- › Clean and recoat all steel sheet piles from MLW to top of pile at each of the North Bulkhead. It is our understanding that the entire length of the North Bulkhead is scheduled to be encased in concrete, pursuant to the USACE permit NAN-2009-00077. This repair is currently in the process of being installed. Once the installation of the encasement repair is complete, it would adequately address this recommendation for that section of bulkhead.

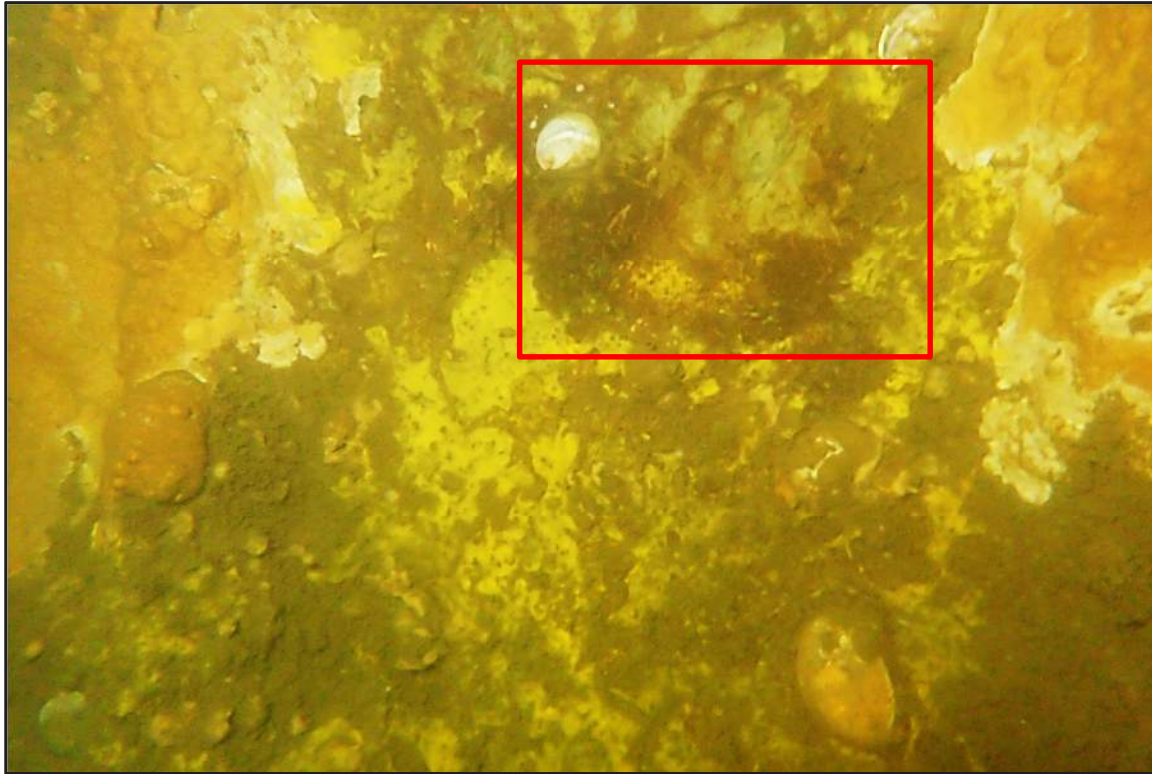
*Photograph 41: North Bulkhead - Typical isolated epoxy failures with corrosion of steel cellular cofferdam in tidal zone (Looking east)*

- › Clean and recoat the steel sheet pile cells from MLW to the top of the element at each cell. Additionally, the splash zone repairs located below MLW should be cleaned and patched, as required. Where splash zone coating failures have occurred, the exposed steel should be assessed by a qualified professional to determine if structural repairs are required.
- › Install a bulk anode cathodic protection system along each of the North Bulkhead. It is our understanding that an impressed current cathodic protection system is scheduled to be installed along the North Bulkhead, pursuant to the USACE permit NAN-2009-00077. That would adequately address this recommendation for those sections of bulkhead.

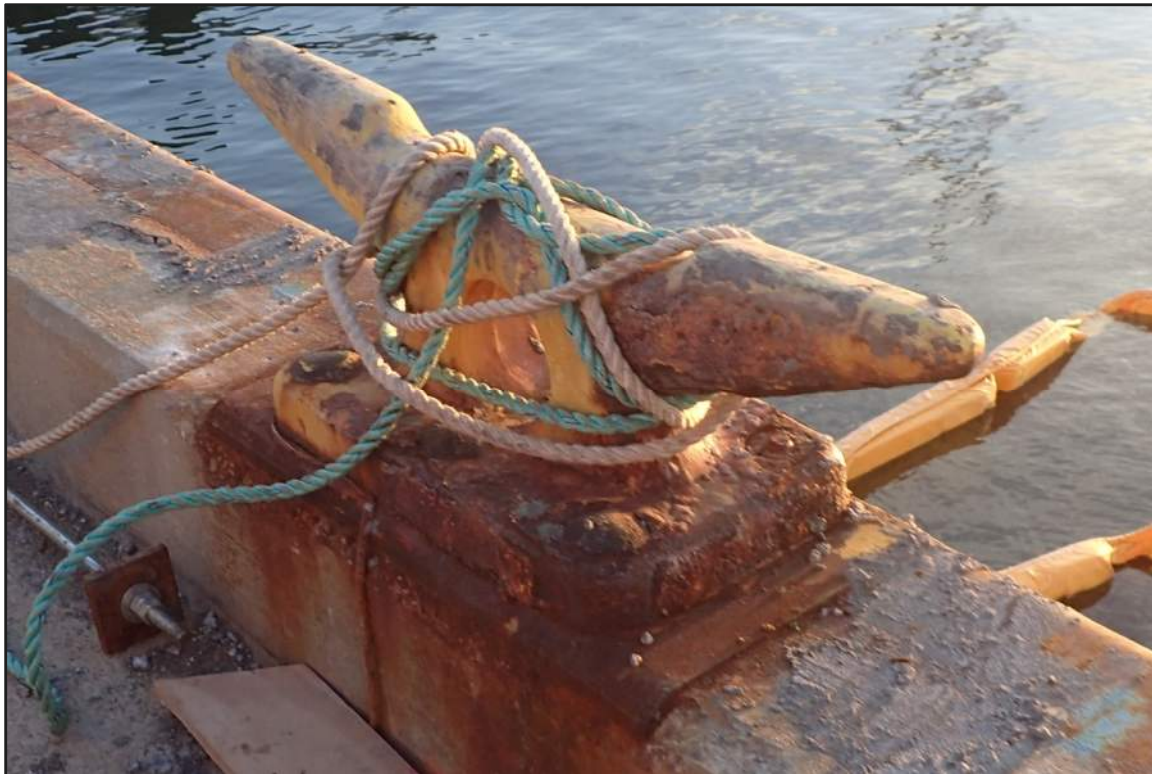
*Photograph 42: North Bulkhead – Typical moderate corrosion of original vintage mooring hardware cleat (Looking south)*

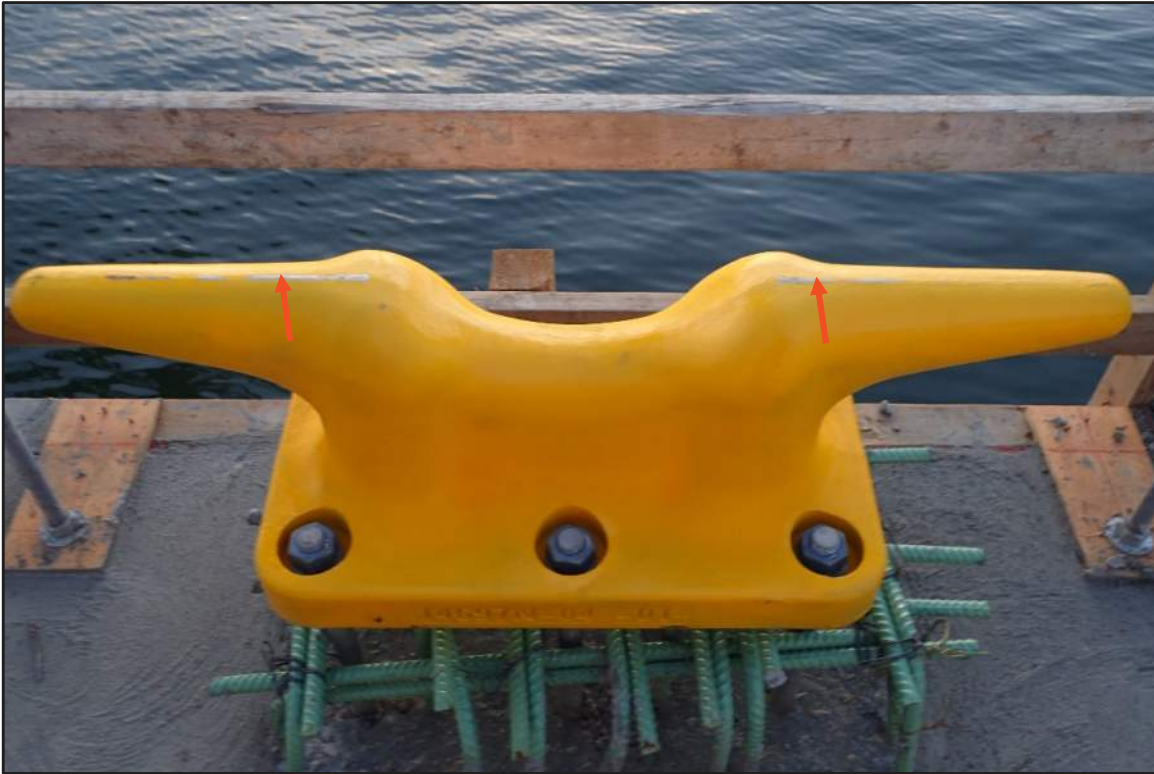
Photograph 43: North Bulkhead - Typical minor coating loss of new mooring hardware cleat due to abrasion during installation process (Looking west)

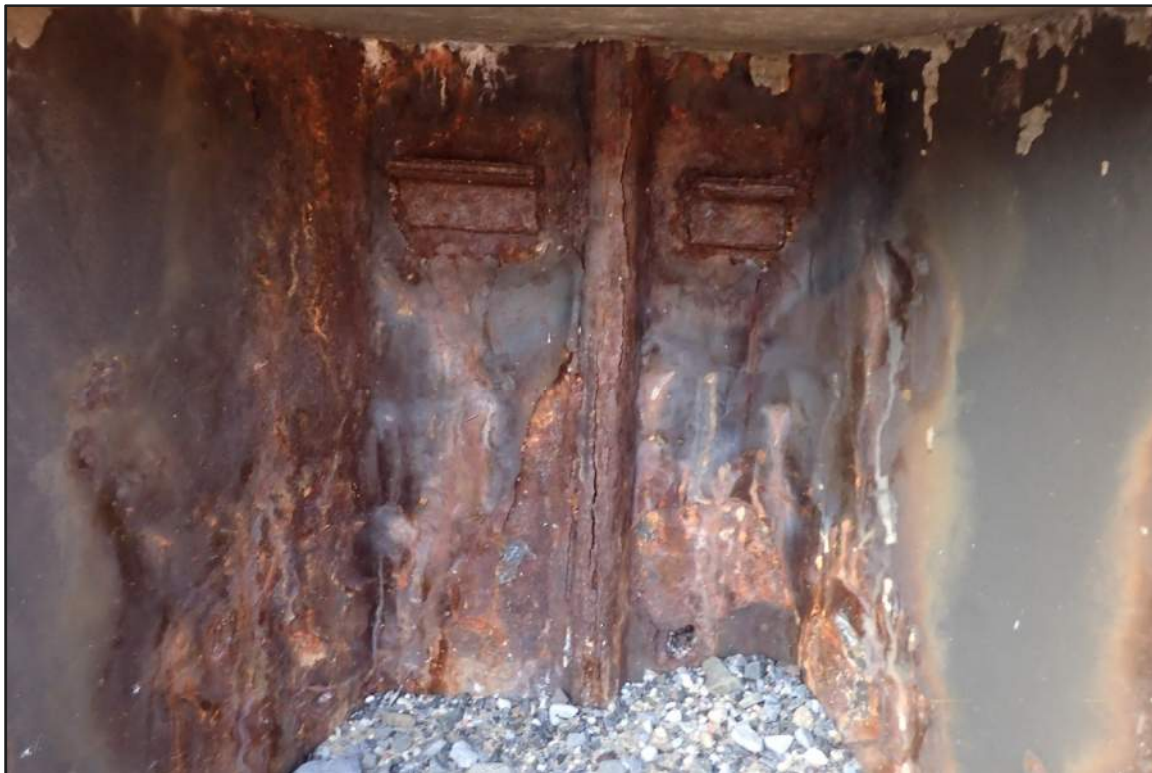
*Photograph 46: East Bulkhead - Typical coating failure and moderate corrosion in the splash/tidal zone (Looking northwest)*

- › Clean and recoat all steel sheet piles from MLW to top of pile at each of the East Bulkhead.
- › Clean and recoat the double channel tie-back wale where exposed along the East Bulkhead.

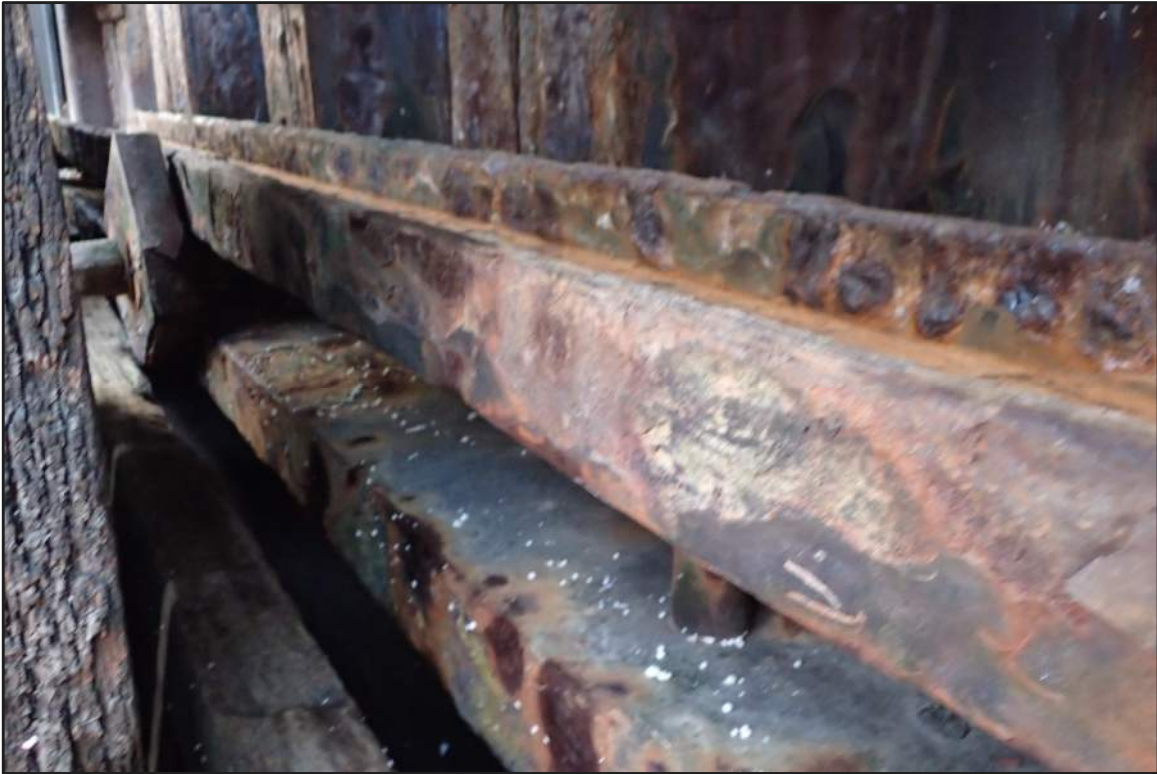
*Photograph 47: East Bulkhead - Typical coating failure with moderate corrosion of steel channel wale, anchor rod, and hardware in splash/tidal zone (Looking southwest)*

- › Clean and recoat the exposed portions of the steel anchor tie-backs and associated hardware where exposed along the East Bulkhead.
- › Remove the timber fender system located along the East Bulkhead to reduce the dead load on the steel sheet piles, and provide access to the steel sheet pile bulkhead should cleaning and recoating repairs be necessary.

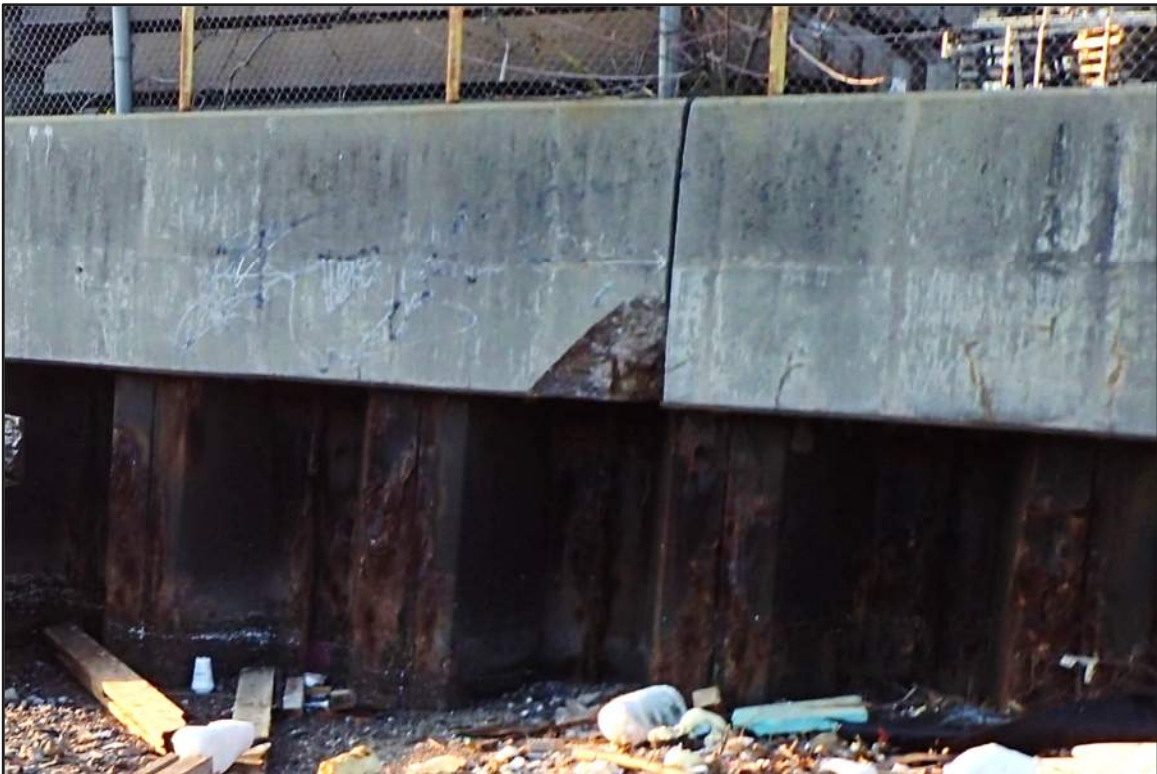
*Photograph 48: East Bulkhead – Open spalling with exposed reinforcement at Sta. 0+66 (Looking northwest)*

- › Clean and patch the end of the concrete wall at East Bulkhead Station 0+14.
- › Clean and patch the observed open spalling located at East Bulkhead Station 0+66. If this segment of bulkhead is scheduled to be removed as a part of the ongoing construction efforts, this recommendation is not required.

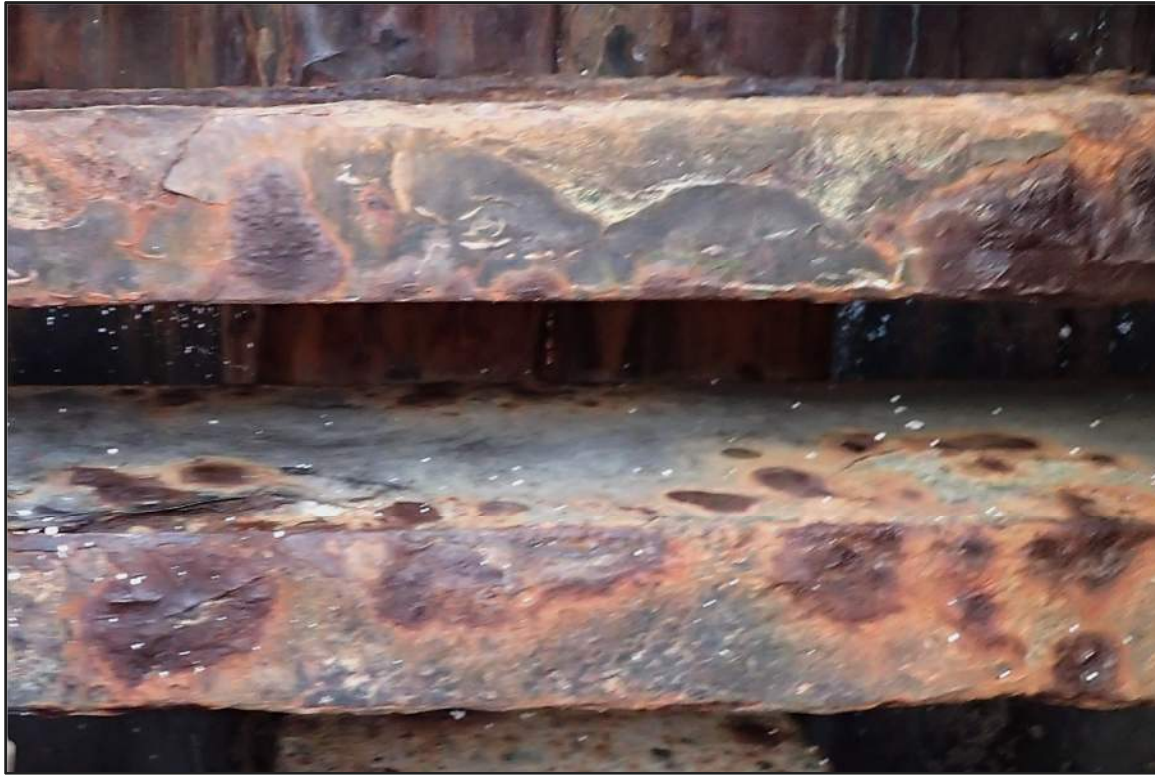
Overall, the East Bulkhead is in Fair condition due to moderate corrosion and coating failure located within the splash and tidal zone of the steel sheet piles and of the steel anchor tie-backs (Photograph 46 and Photograph 47), and isolated spalling of the concrete cap (Photograph 48). Below MLW, the steel sheet pile bulkhead is typically sound with isolated areas of failed coating and surface corrosion. The external double channel wale has 100 percent coating loss with moderate corrosion (Photograph 49).

*Photograph 49: East Bulkhead - Typical coating failure with moderate corrosion of steel channel wale inshore of timber fender system in splash/tidal zone (Looking north)*
