# SOUTHWEST BROOKLYN MARINE TRANSFER STATION BULKHEAD INVESTIGATION

ANNUAL BULKHEAD INSPECTION

PROJECT NO. A092286  
DOCUMENT NO.  
VERSION 4  
DATE OF ISSUE 12/28/2017 (Rev 1 – 02/26/2018)  
PREPARED SPWN  
CHECKED DDJS  
APPROVED JOAC

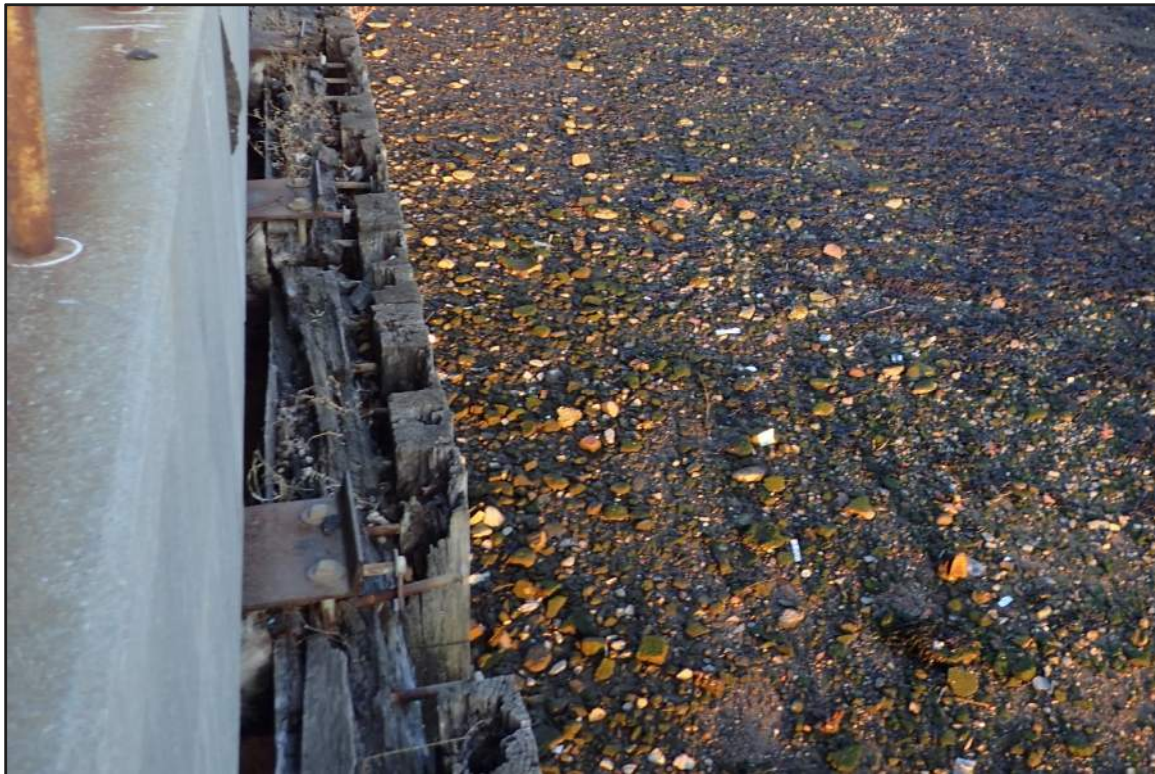
The fender system along the North Bulkhead has been removed, and is scheduled to be replaced. The East Bulkhead fender system is in Serious condition due to rot and weathering at the upper wale and at the top foot of the timber planks (Photograph 50).

*Photograph 50: East Bulkhead - Failed timber fender system connections, upper timber horizontal wale, and panels due to heavy rot (Looking east)*

- › Clean and recoat the exposed portions of the steel anchor tie-backs and associated hardware where exposed along the East Bulkhead.
- › Remove the timber fender system located along the East Bulkhead to reduce the dead load on the steel sheet piles, and provide access to the steel sheet pile bulkhead should cleaning and recoating repairs be necessary.
