**RE: NYC Department of Sanitation
Southwest Brooklyn Marine Transfer Station (MTS)
NYSDEC ID No.: 2-6106-00002/00022: 2018 Bulkhead Inspection Report (Permit)**

**SOUTHWEST BROOKLYN
MARINE TRANSFER STATION (MTS)
BROOKLYN, NEW YORK**

ROUTINE INSPECTION

MARCH 2019

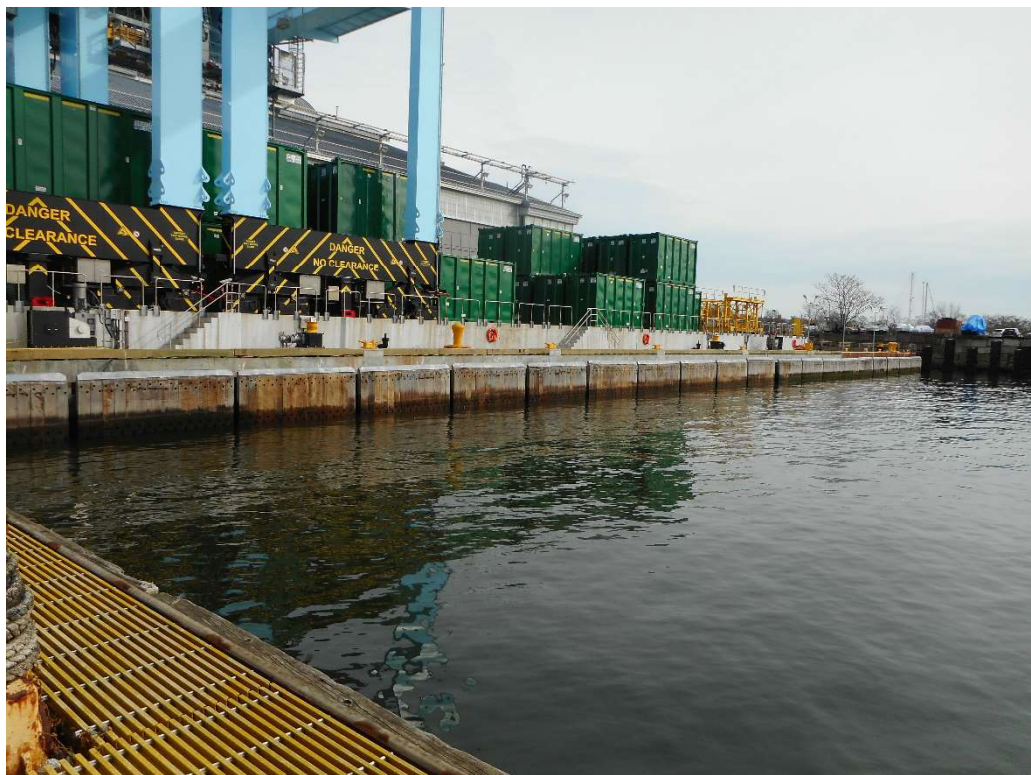
The Western Bulkhead was assessed to be in **satisfactory** condition due to the recent rehabilitation of the west face of the bulkhead. Based on the current condition (with the recent rehabilitation) of the critical structures and components that support this system, the overall structural capacity of the Western Bulkhead appear to be consistent with the design intent of the rehabilitation. As a result, no load restrictions or structural repairs are recommended at this time. A follow-up inspection should be scheduled for this system within 5 years.

Photo 2-8. Western Bulkhead and Fender at New SW Brooklyn MTS

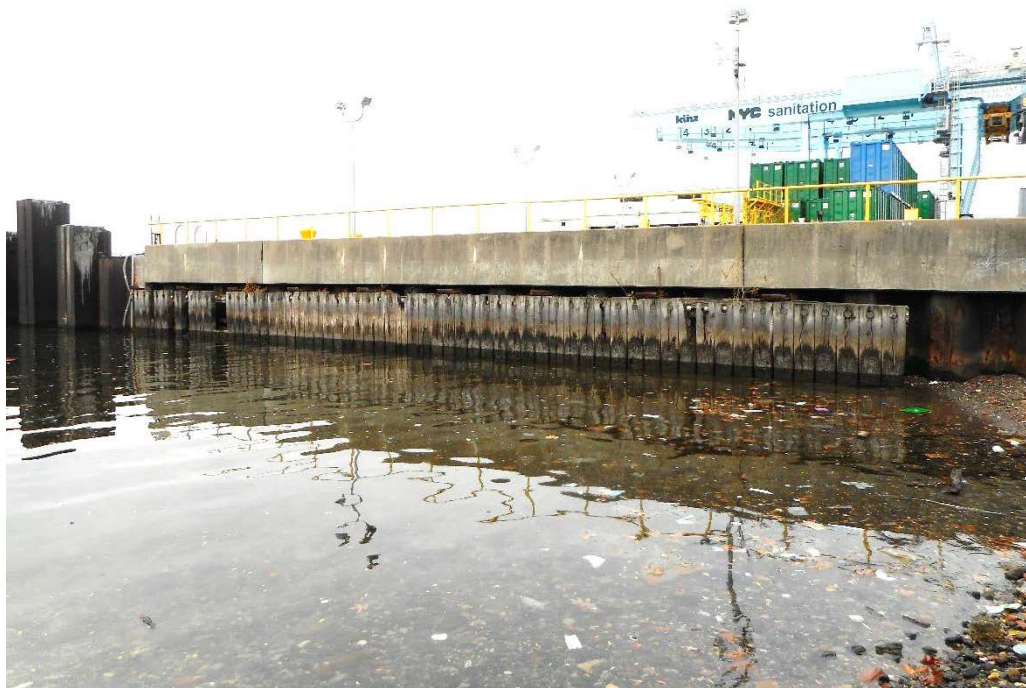
The new Western Fender was assessed to be in **fair** condition due to the Advanced and Severe defects that are mostly attributed to poor and incomplete installation of the Fender Systems. In addition, some of the connections providing critical support to the Fender System do not match the drawings due to changes in the bolt configuration (from 6 bolts to 4 bolts). Thus, the structural capacity of the Fender Rack does not meet the design intent. As a result, Maser recommends taking cautionary measures during berthing operations to reduce impact on the Fender System until the installation is complete; replacing all missing connection hardware and verifying that all connections at the Western Fenders are complete and properly installed with properly tightened connections and the correct hardware. If the installation defects are corrected in accordance with design drawings, the overall conditions rating is likely to improve from fair to good. A follow-up inspection should be scheduled for the structure after installation repairs/corrections are complete and in 5 years.

Photo 2-9. Western Bulkhead and Fender at New SW Brooklyn MTS

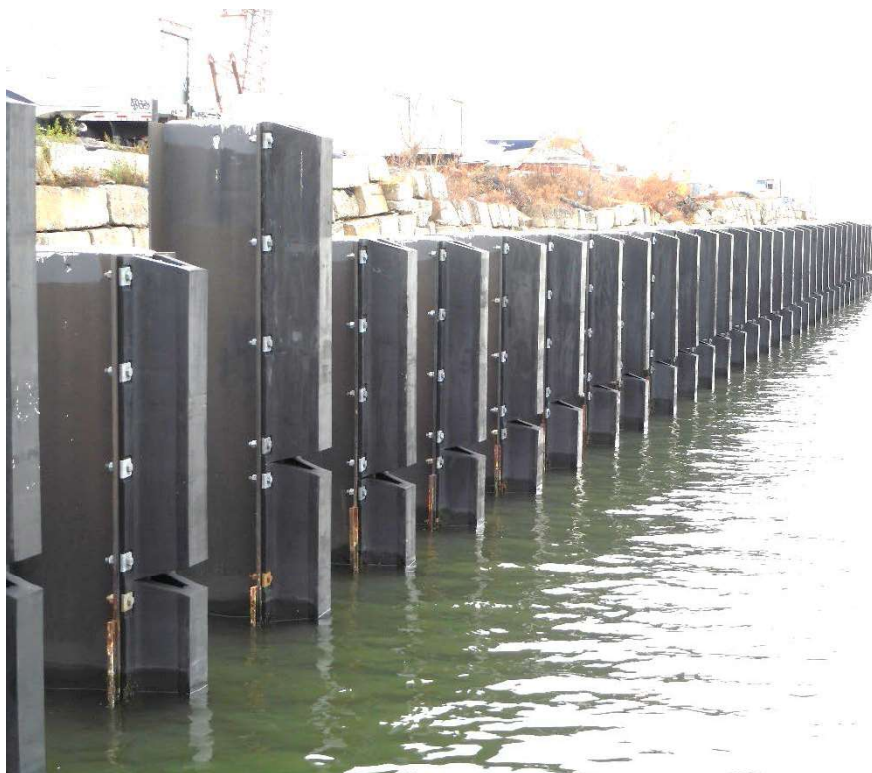
The Southwest Bulkhead was assessed to be in **good** condition as no specific structural defects were observed during the cursory inspection. There is no indication that the structural capacity of the Southwest Bulkhead has diminished from the initial design. As a result, no load restrictions or structural repairs are recommended at this time. A follow-up inspection should be scheduled for this system within 5 years.

Photo 2-10. Southwest Bulkhead and Fender at New SW Brooklyn MTS

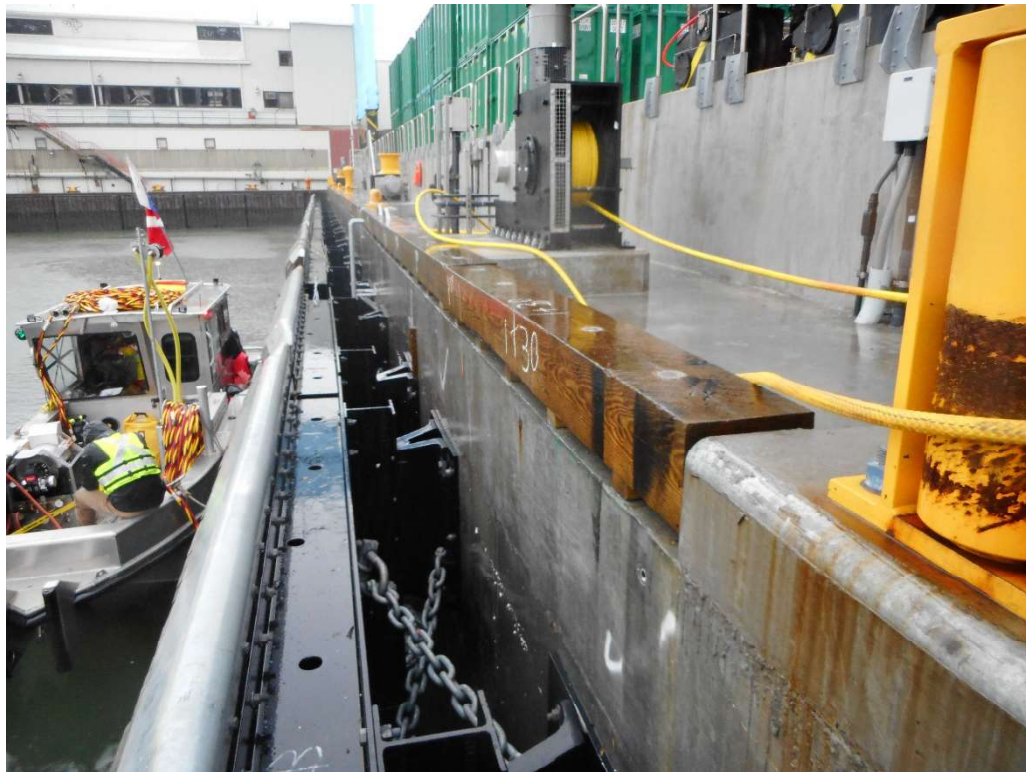
Minor deterioration typically observed in the West Face of the Western Bulkhead were mostly observed in the concrete encasements at the steel sheet piles. Minor deterioration observed in the concrete encasements generally includes: general and random cracks up to 1/16"; occasional corrosion stains or small pop-out corrosion spalls; and structural cracks up to 1/16" wide.

Photo 3-108. West Face of Western Bulkhead

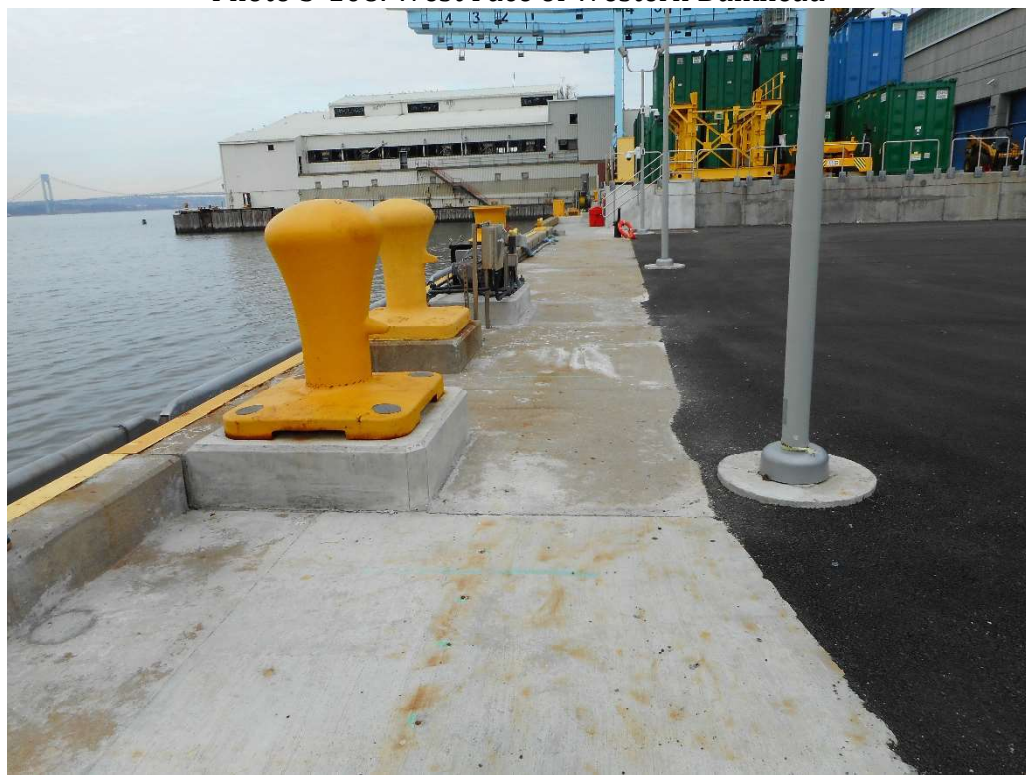
Photo 3-109. Pile Cap and Concrete Deck at Western Bulkhead (West Face)

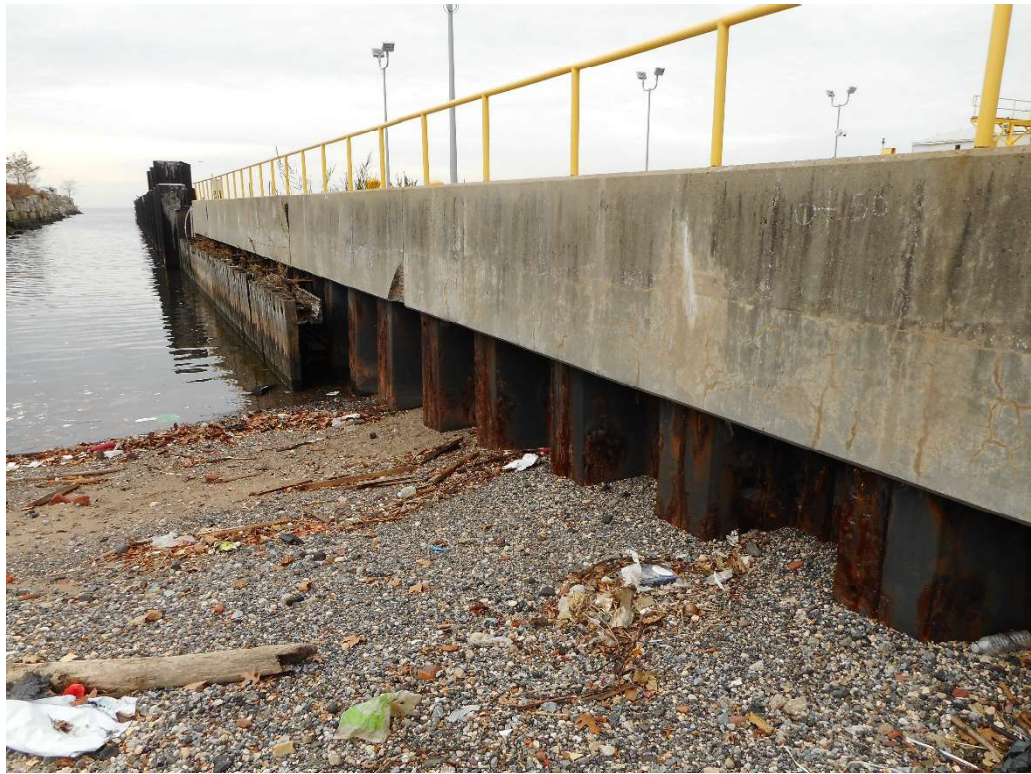
Moderate deteriorations typically observed in the South Face of the Western Bulkhead were observed throughout the steel sheet piles, steel wale and tie rods; while advanced and severe deteriorations were observed in localized areas of the bulkhead. The moderate deteriorations typically observed in the exposed steel

components generally include: protective coating loss (over 50% of surface); moderate surface corrosion; moderate section loss in the steel, estimated to be less than 30% nominal section loss.

Severe deteriorations observed in localized areas generally include perforations or loss of wall thickness exceeding 50% of nominal thickness (hole in steel sheet).

Photo 3-110. South Face of Western Bulkhead

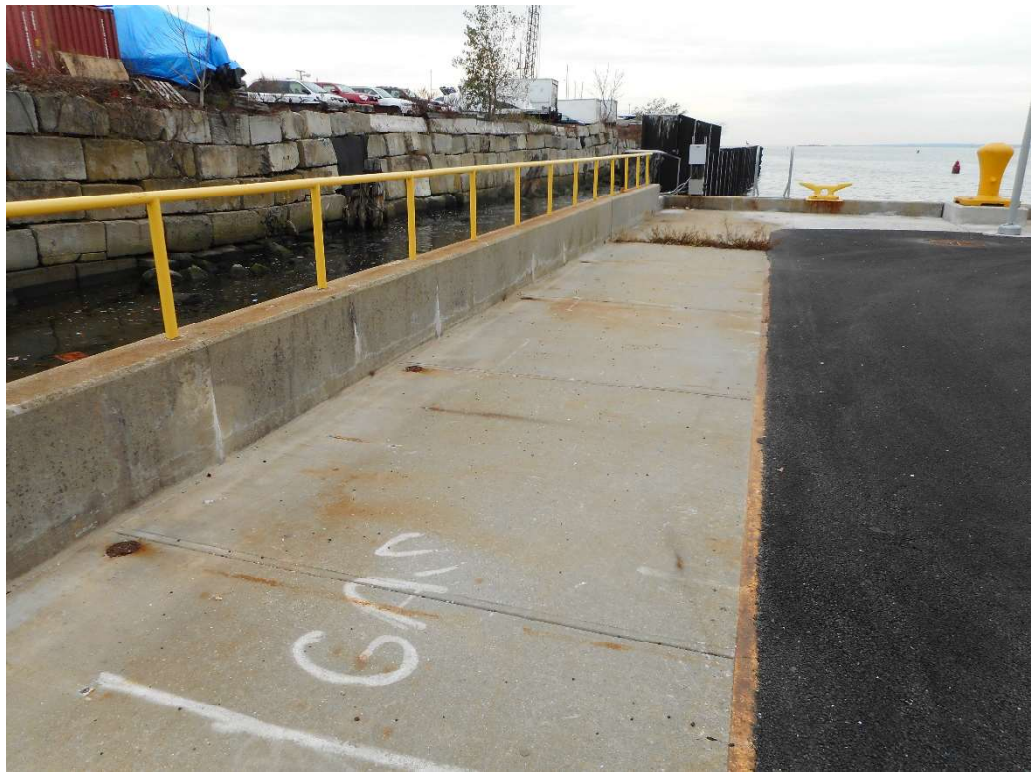
Advanced deteriorations observed were noted in the concrete cap and limited to a large spall observed in one location, at the base of the concrete cap (approximately 14" high and 20" wide).

Photo 3-111. Pile Cap and Concrete Deck at Western Bulkhead (South Face)
