Re: Southwest Brooklyn Marine Transfer Station (MTS)
NYSDEC Permit # 2-6106-00002/00022
2020 Bulkhead Inspection Report

2020 BULKHEAD INSPECTION REPORT

**REPORT OF THE INSPECTION OF THE NORTH BULKHEAD FENDER SYSTEM
at the
SOUTHWEST BROOKLYN MARINE TRANSFER STATION**

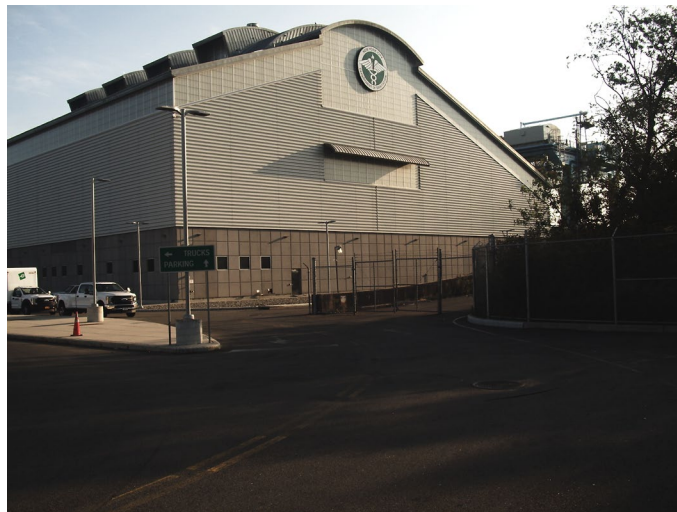
Photo 1

The main building at the Southwest Brooklyn Marine Transfer Station

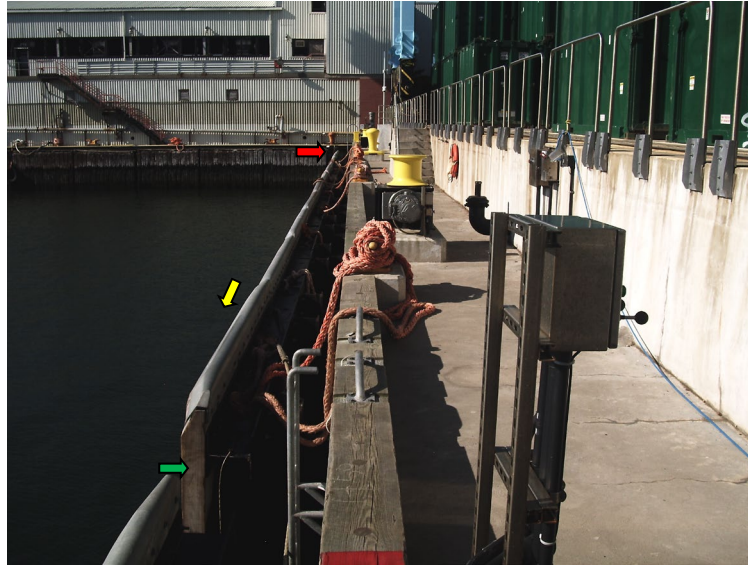
Photo 2

Looking south to north along the timber fender bulkhead. The red arrow is pointing to the north end of the fender where we began the inspection. The yellow arrow points toward the south in the direction in which the inspection progressed. The green arrow is pointing at the end of one of the fender panels.

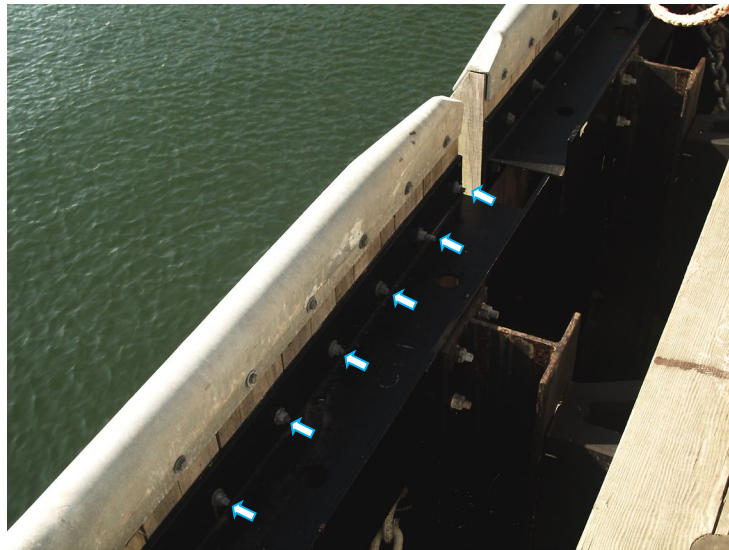
Photo 3

Looking down at the inshore side of the fender shows how each timber is bolted through the flange of the whaler both above the whaler's web (blue & white arrows) and (although not visible in this photo) below the whaler's web.

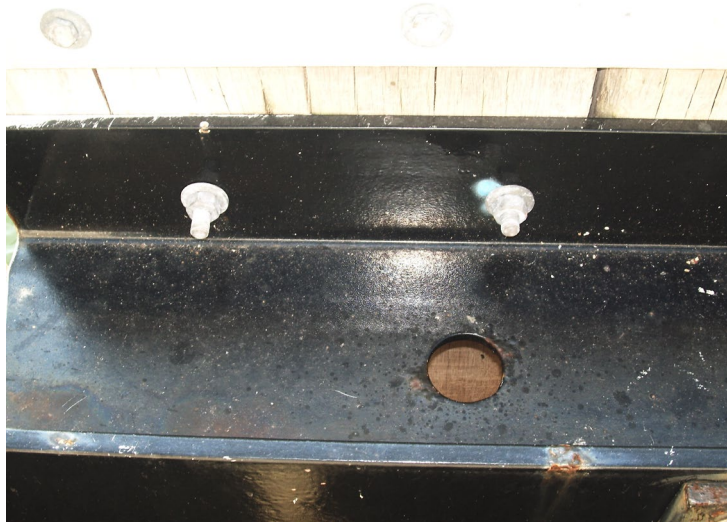
Photo 4

A close-up view of the bolts through the upper flange of the upper whaler holding the fender timbers in place.

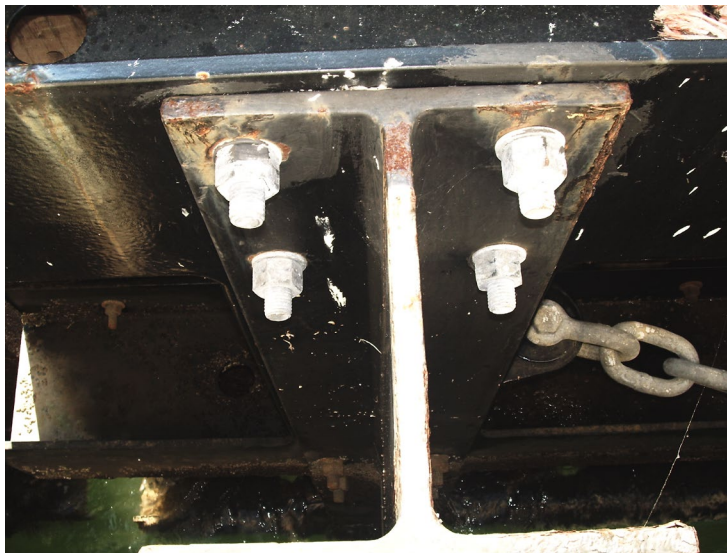
Photo 5

The four bolts seen in this photo show the typical arrangement of the connection between a whaler and a pile.
