Re: NYSDEC Permit 2-6106-00002/00022 Ren 4 (Permit)  
Southwest Brooklyn Marine Transfer Station (MTS)  
New York City Department of Sanitation (DSNY)  
2022 Bulkhead Inspection Report

**To:** Anthony Barna Waste Management  
**From:** Chris Critelli Savin Engineers, P.C.  
**Cc:** Joseph Fiteni, P.E. Savin Engineers, P.C.  
**Date:** October 12, 2022  
**Re:** Southwest Brooklyn Marine Transfer Station - Bulkhead Fender System Inspection

As directed by Waste Management, the existing bulkhead fender system at the Southwest Brooklyn Marine Transfer Station (SWBMTS) was inspected for any deficiencies that may compromise the integrity of the fender system. Transit Corp with Savin oversight performed the visual inspection of the fender system on Sunday, September 25<sup>th</sup>, 2022. This memorandum discusses the findings.

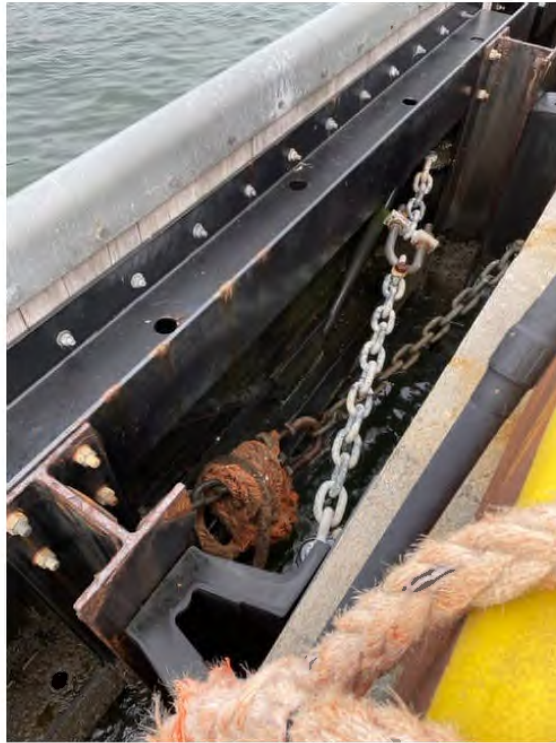
Photo No. 1 – General Conditions of Steel Frame, Piles and Bracing Chains

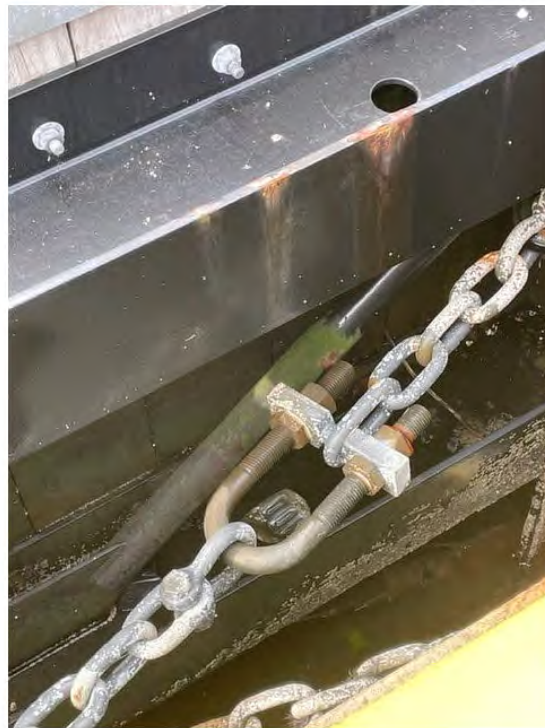
Each of the fenders is structurally strengthened with the use of tie rods arranged in an X pattern and a pair of chains also arranged in an X pattern. The chains and tie rods are above the water and observed by Savin Engineers. Both chains and rods were generally found to be in good condition.

Photo No. 2 – General Conditions of Bracing Chains

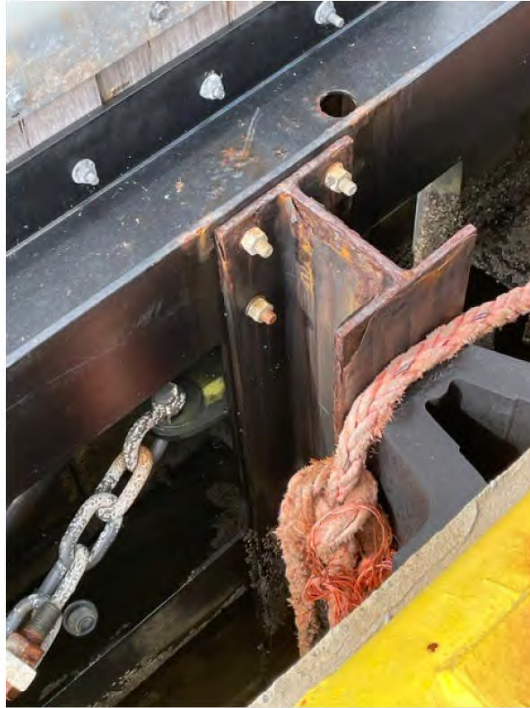
Photo No. 3 – General Conditions of H-Piles; minor corrosion throughout its length on the surface.

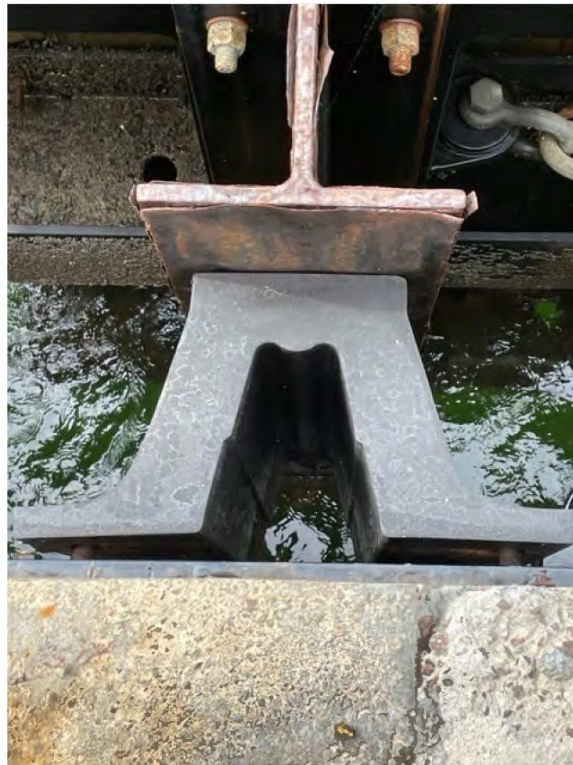
Photo No. 4 – Anchor Bolts from Fender to Base Plate are loose. Rubber Fender no longer flush with concrete wall. Typical from Fenders No. 13-20.

All locations where there are missing or corroded bolts should have new bolts installed; and areas where bolts are loose, bolts should be properly tightened. This includes connections of the fenders to the base plate, timber planks to the steel cap plate and walers to piles. Connection from the fenders and baseplates should be repaired so that they are flush with one another and the bulkhead. Damaged timber planks should be replaced. Missing steel cap plate at Fender No. 3 should be replaced. The concrete spall in the bulkhead at Fender No. 10 and cracking in the bulkhead at Fender No. 12, should be monitored for expansion. The damaged H-Pile at Fender No. 9 and the corresponding fender should be replaced.

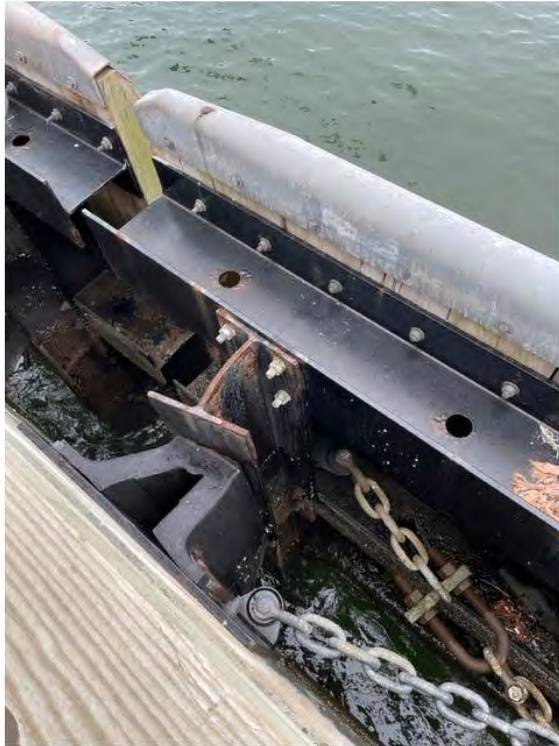
Photo No. 5 – H-Pile, Timbers and Deformed at Fender No. 9 as a result of Impact.

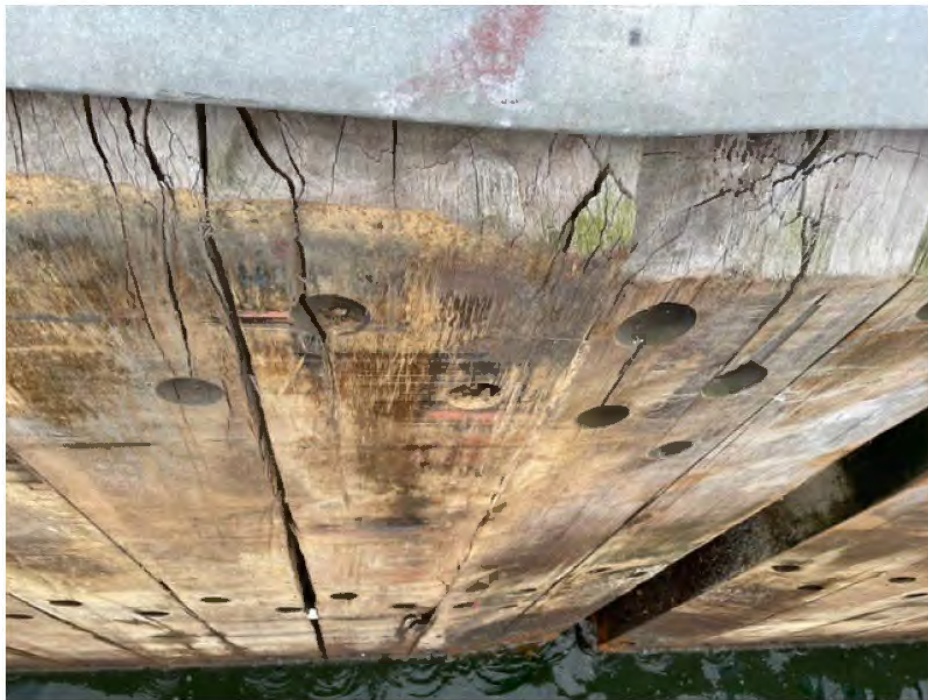
Photo No. 6 – Timber cracked at Fender No. 7 as result of impact.

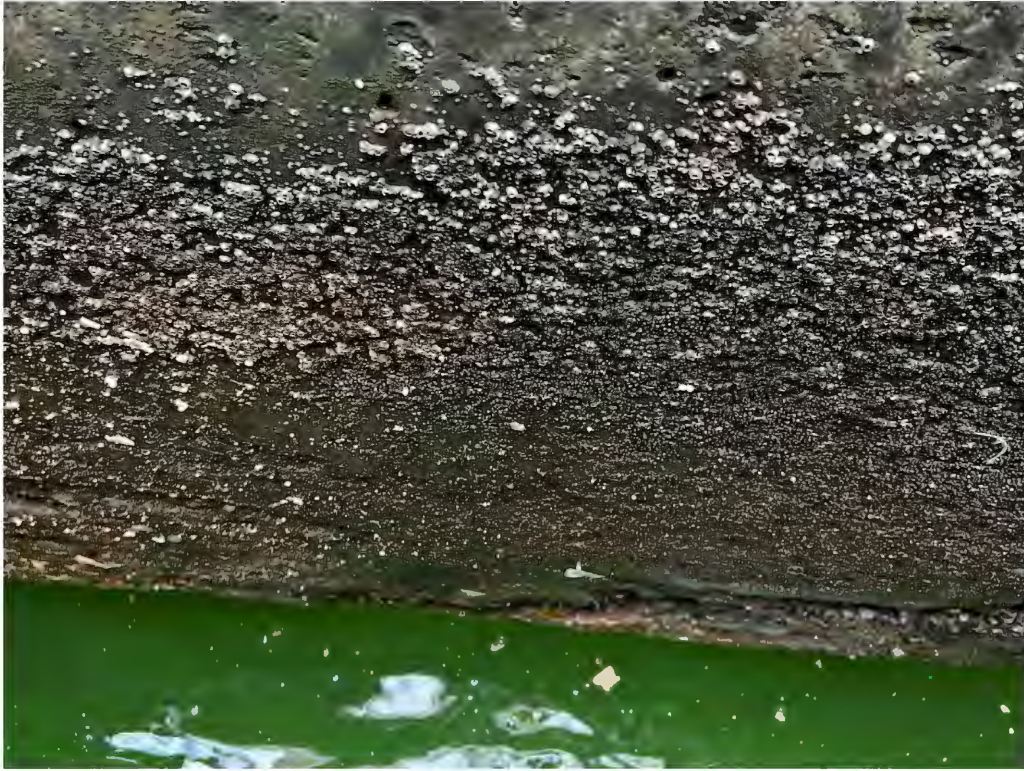
Photo No. 7 – Crack at concrete bulkhead spanning the width of Fender No. 12.

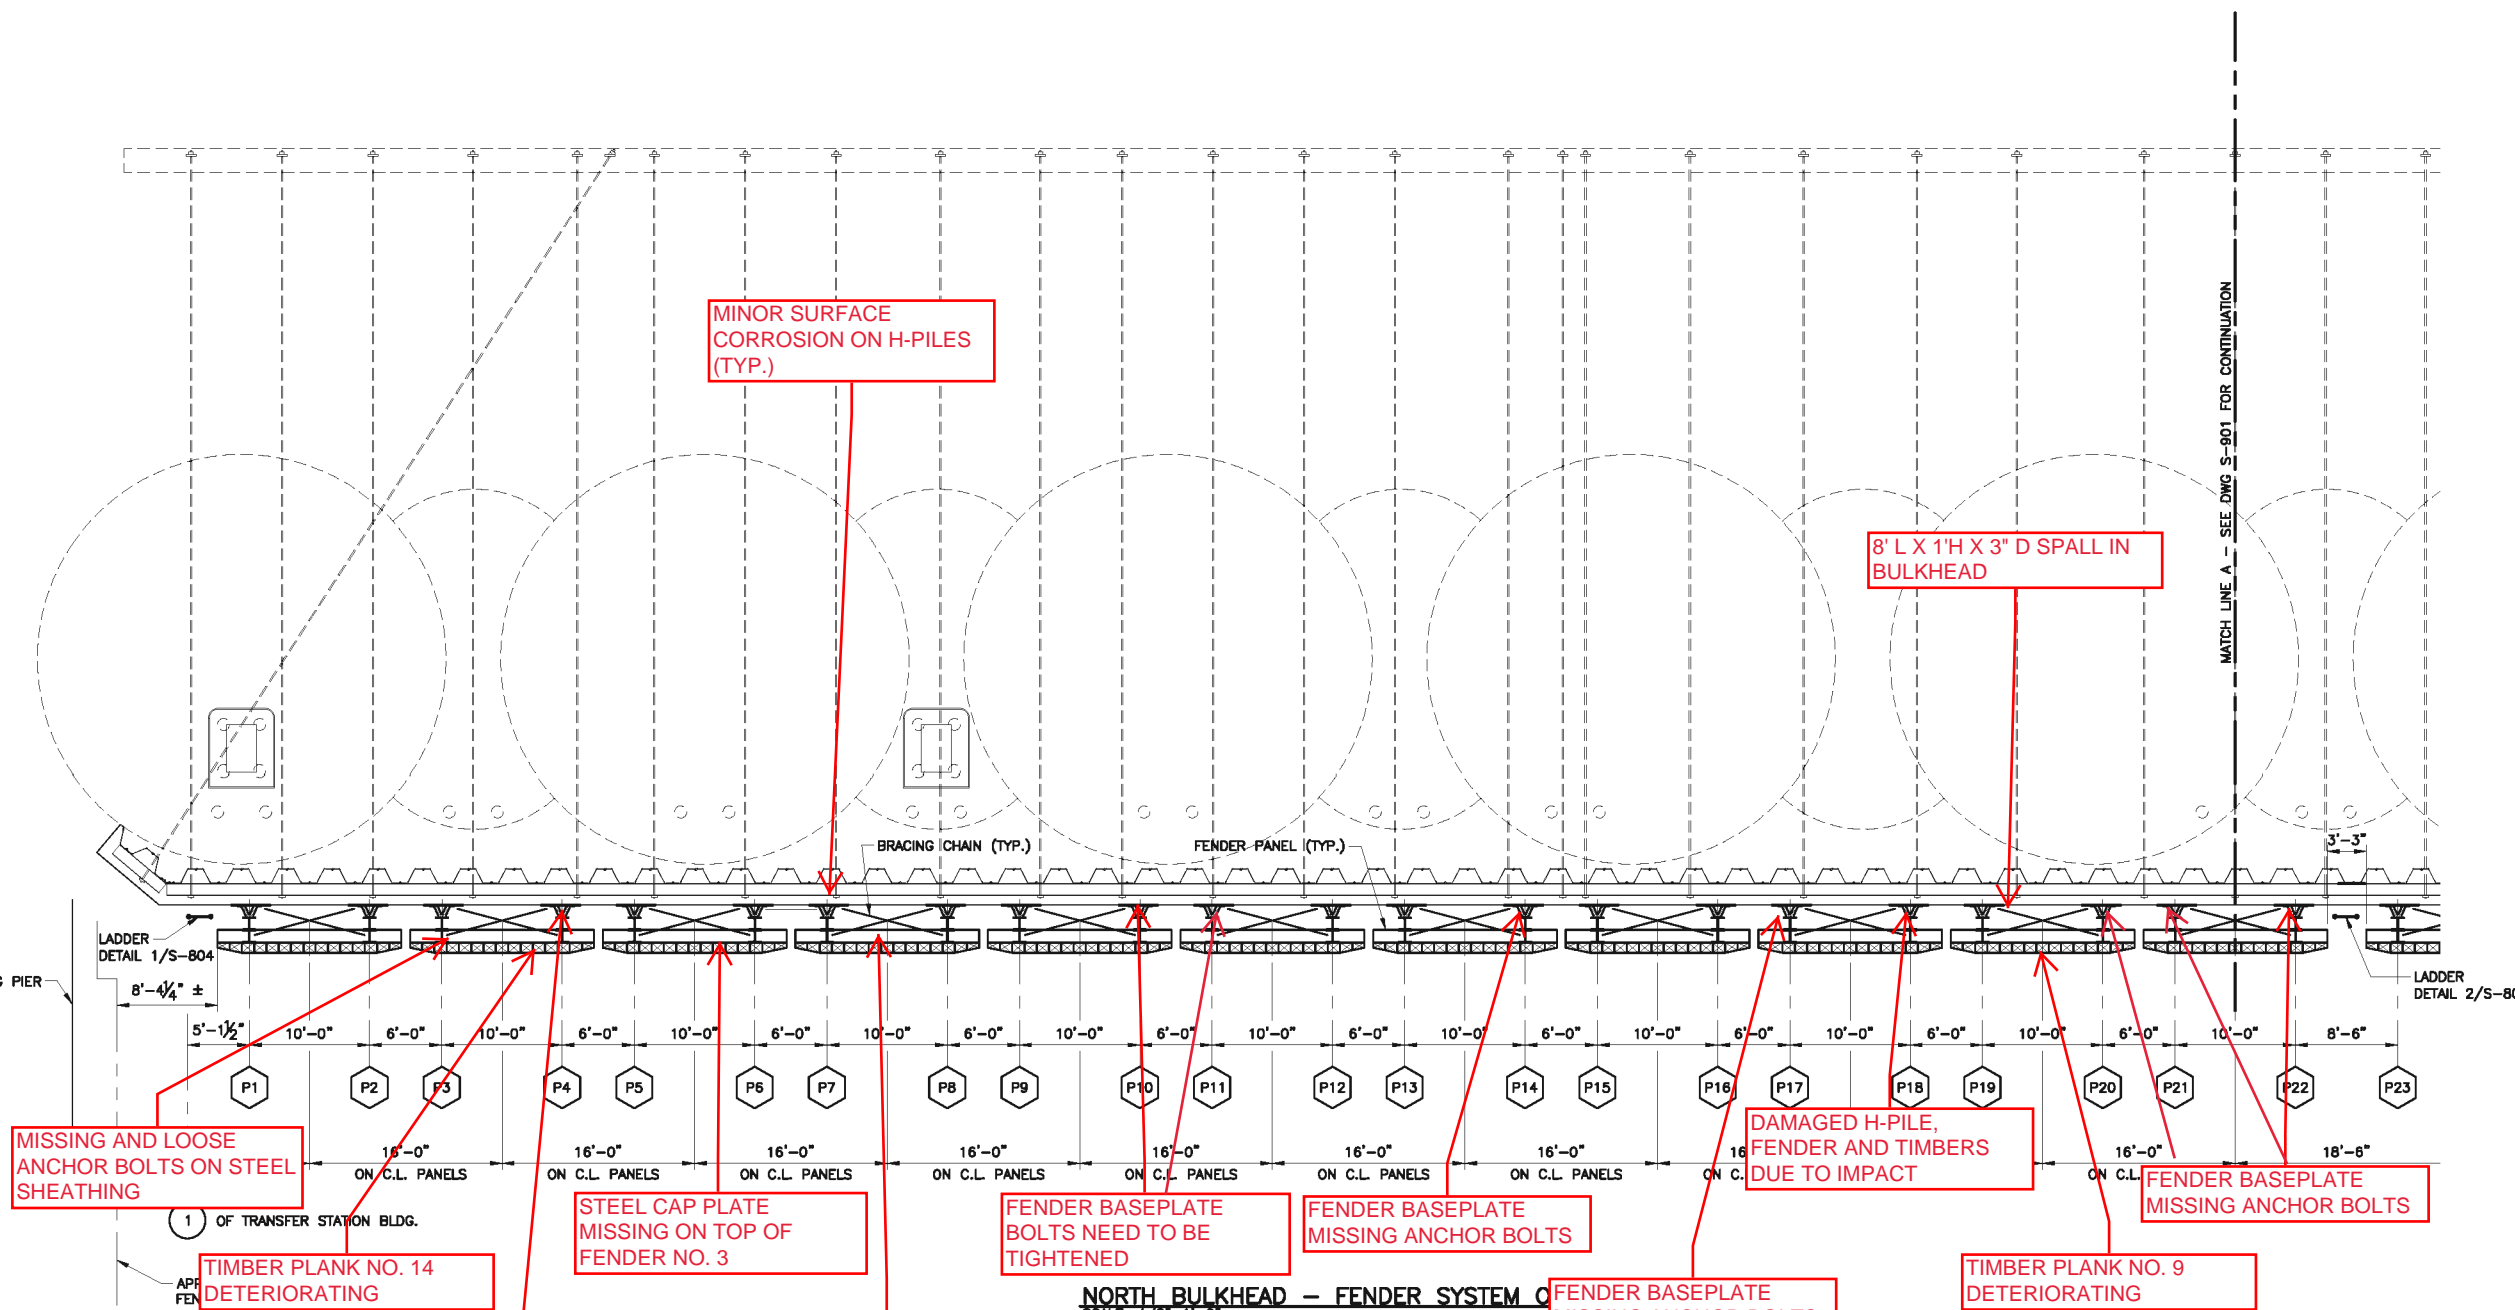
CONTRACT NO. 2  
STRUCTURAL  
FENDER SYSTEM PARTIAL PLAN - SHEET 1

MISSING AND LOOSE ANCHOR BOLTS ON STEEL SHEATHING

TIMBER PLANK NO. 14 DETERIORATING

STEEL CAP PLATE MISSING ON TOP OF FENDER NO. 3

STEEL CAP PLATE IS LOOSE

FENDER BASEPLATE IS LOOSE

FENDER BASEPLATE BOLTS NEED TO BE TIGHTENED

FENDER BASEPLATE MISSING ANCHOR BOLTS

DAMAGED H-PILE, FENDER AND TIMBERS DUE TO IMPACT

TIMBER PLANK NO. 9 DETERIORATING

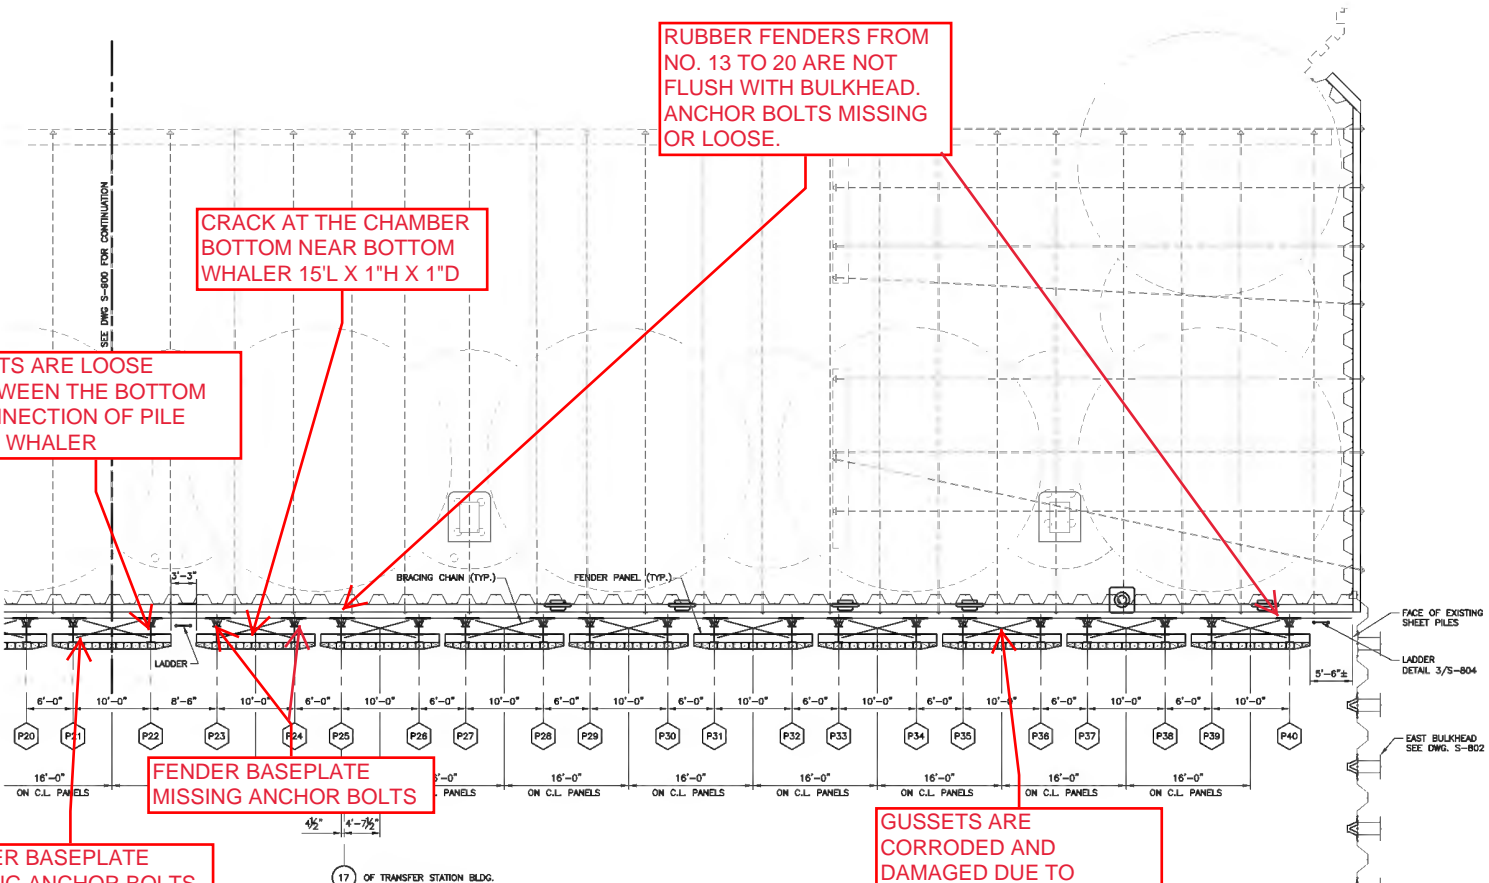
CONTRACT NO. 2  
STRUCTURAL  
FENDER SYSTEM PARTIAL PLAN - SHEET 2

RUBBER FENDERS FROM NO. 13 TO 20 ARE NOT FLUSH WITH BULKHEAD. ANCHOR BOLTS MISSING OR LOOSE.

CRACK AT THE CHAMBER BOTTOM NEAR BOTTOM WHALER 15'L X 1"H X 1"D

BOLTS ARE LOOSE BETWEEN THE BOTTOM CONNECTION OF PILE AND WHALER

FENDER BASEPLATE MISSING ANCHOR BOLTS

GUSSETS ARE CORRODED AND DAMAGED DUE TO CHAINS GRINDING AGAINST THEM
