Re: NYSDEC Permit 2-6106-00002/00022 Ren 4 (Permit)
Southwest Brooklyn Marine Transfer Station (MTS)
New York City Department of Sanitation (DSNY)
2023 Bulkhead Inspection Report

Re: Southwest Brooklyn Marine Transfer Station
2023 Bulkhead Fender System Inspection

SOUTHWEST BROOKLYN MARINE TRANSFER STATION
DECEMBER 2023

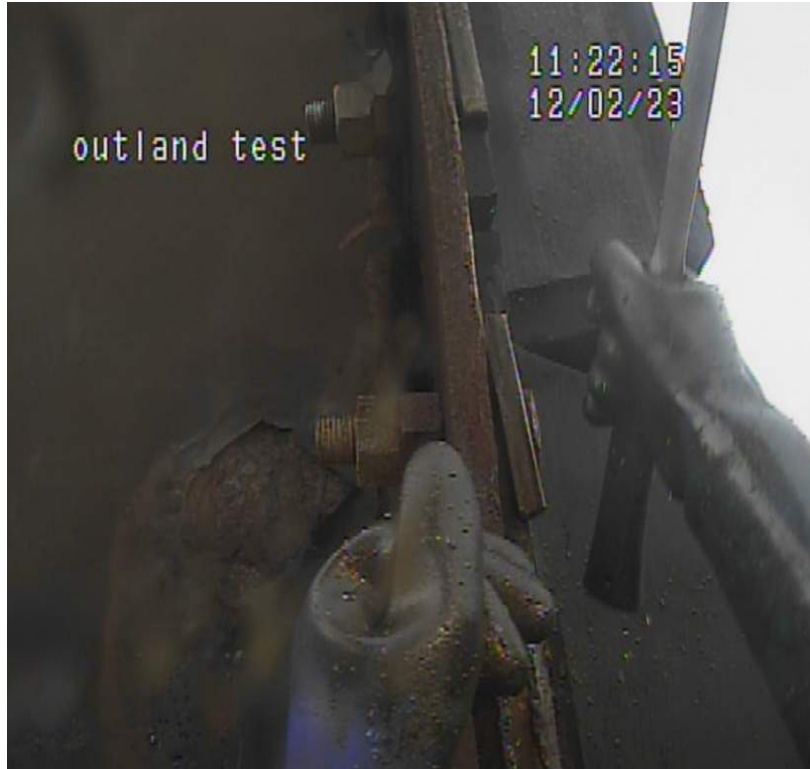
Photo 3. Loose Bolt

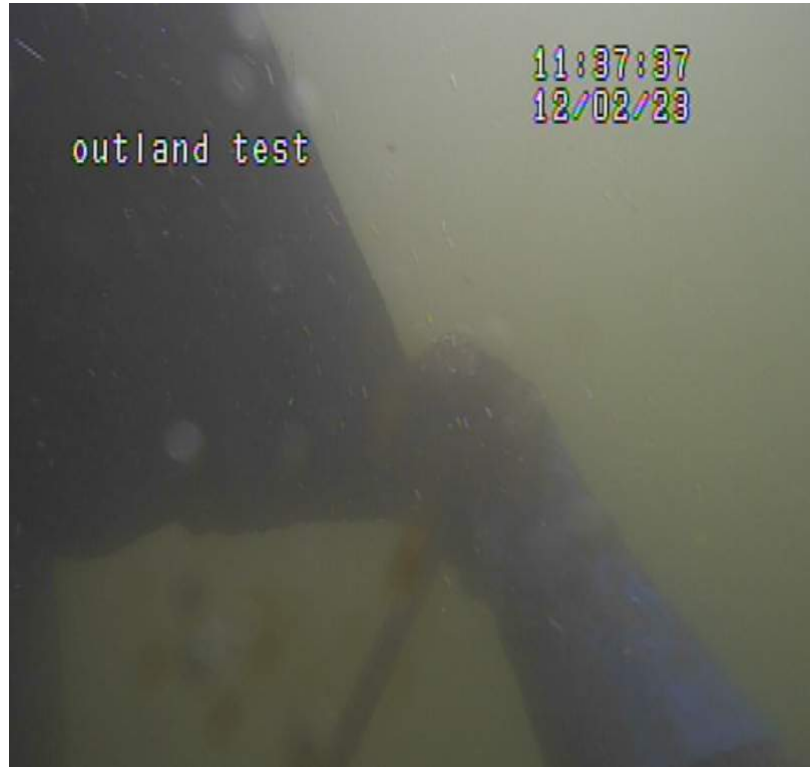
Photo 4. Rubber Fender Peeling Off.

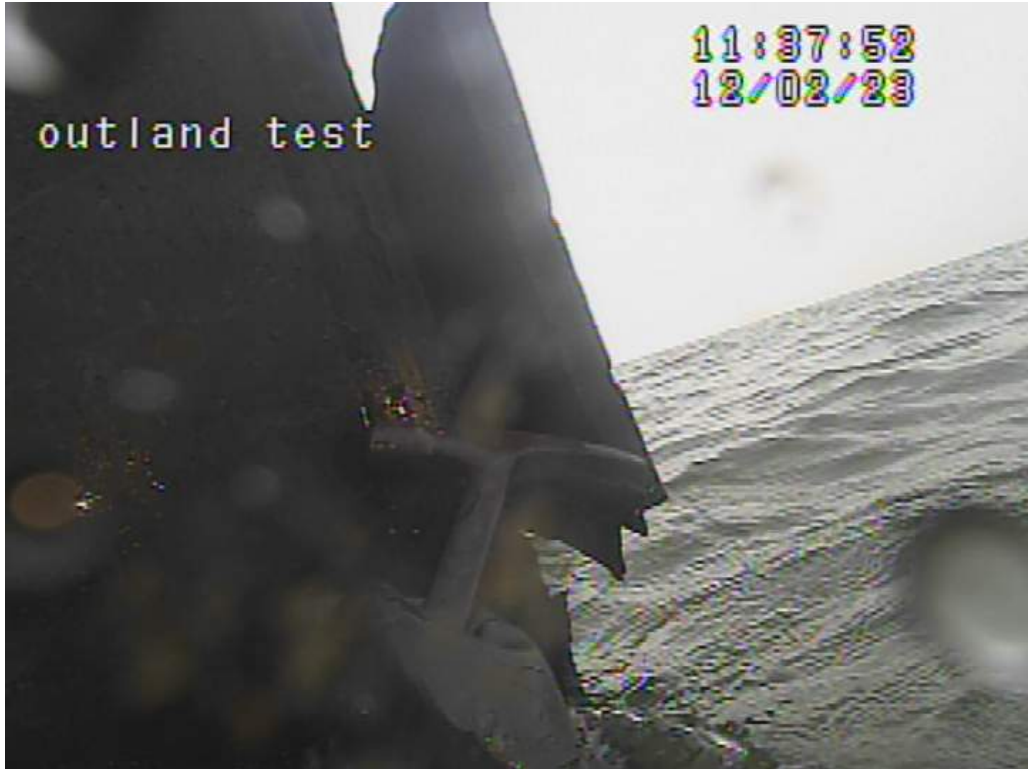
Photo 5. Rubber Fender Peeling Off.

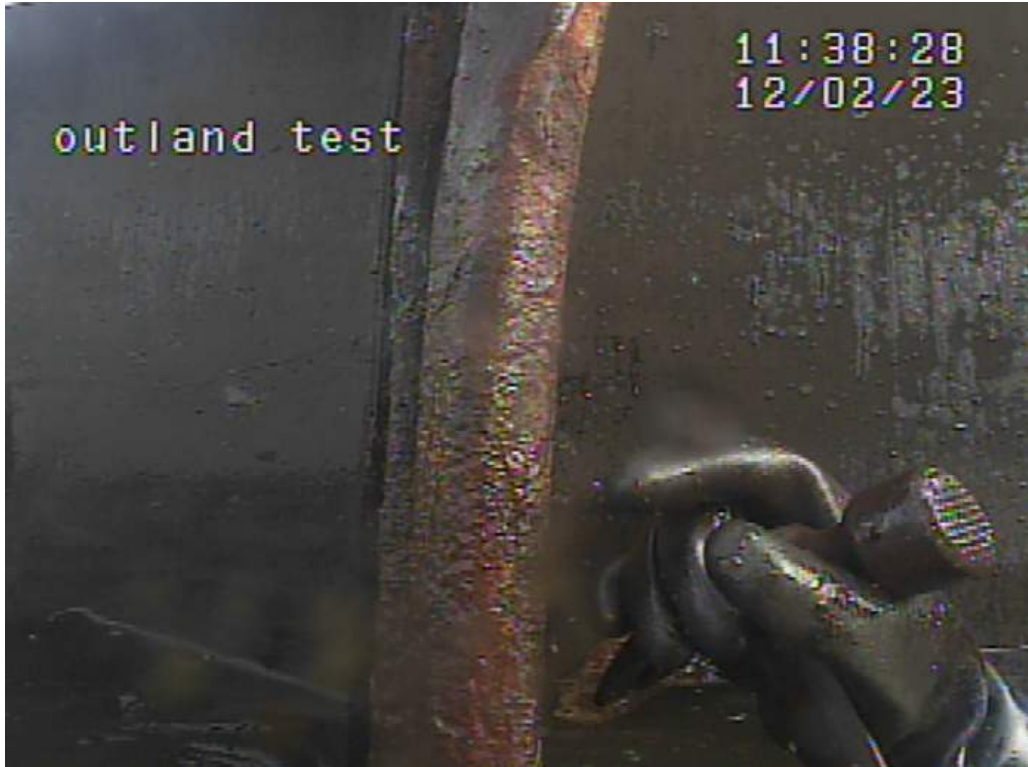
Photo 6. Bent at Steel Sheeting.

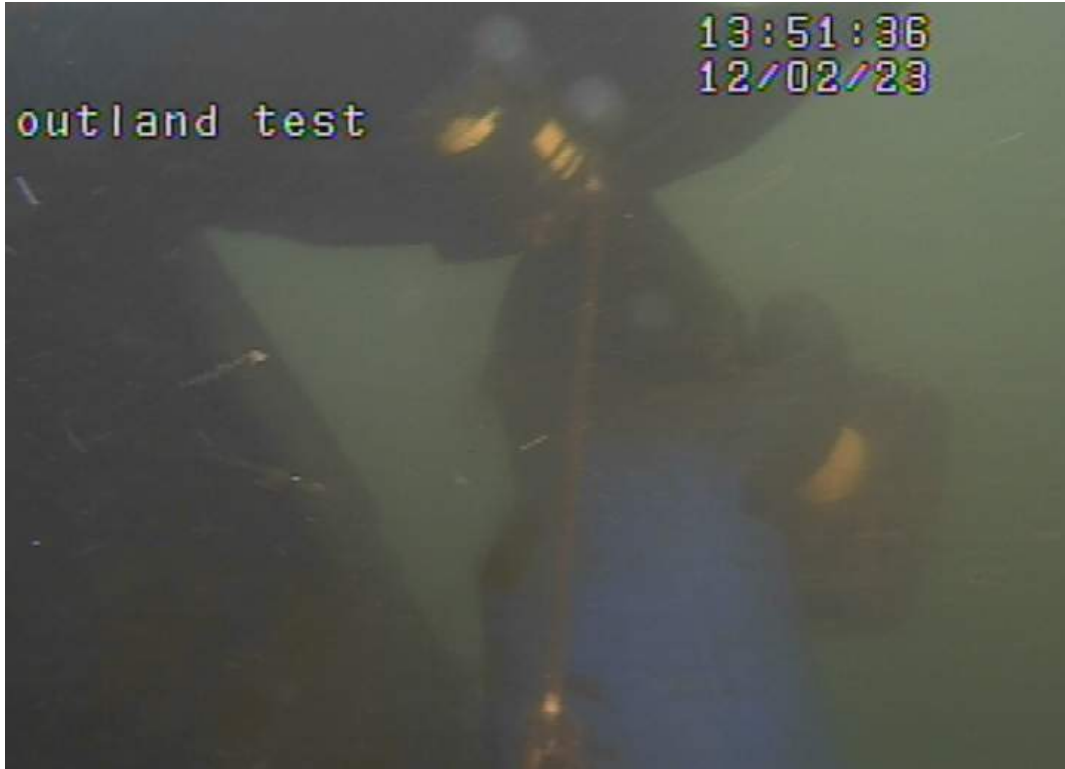
Photo 7. Rubber Fender Peeling Off.

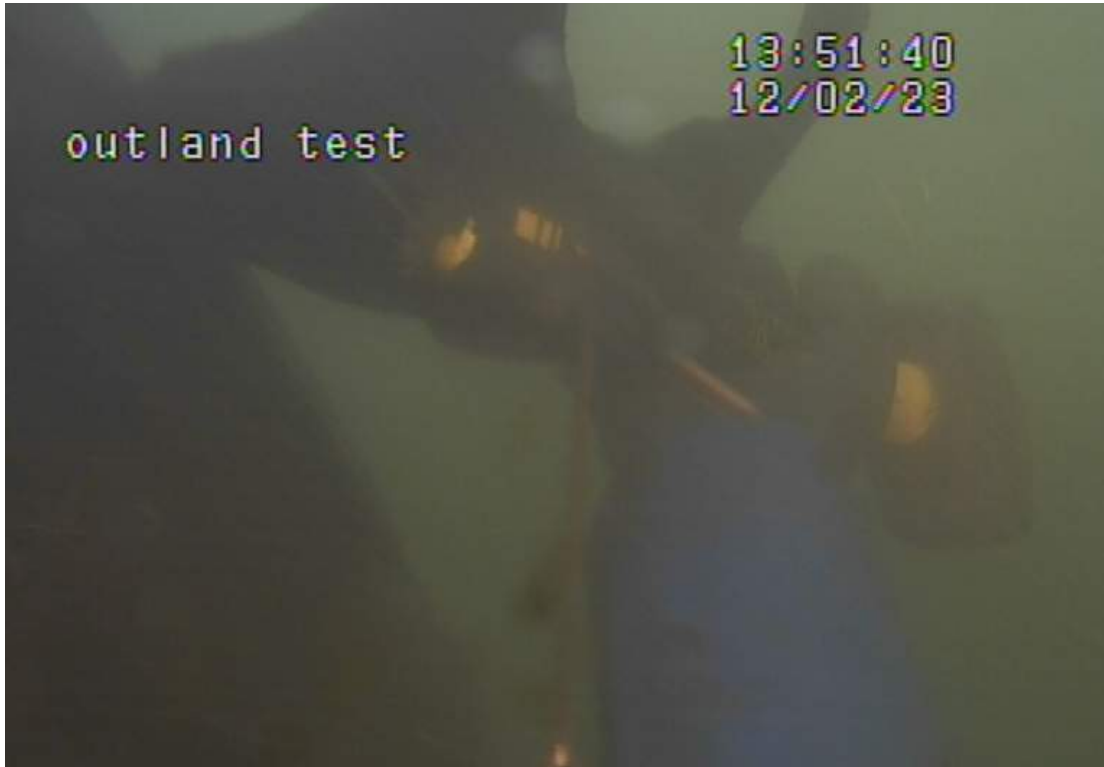
Photo 8. Rubber Fender Peeling Off.

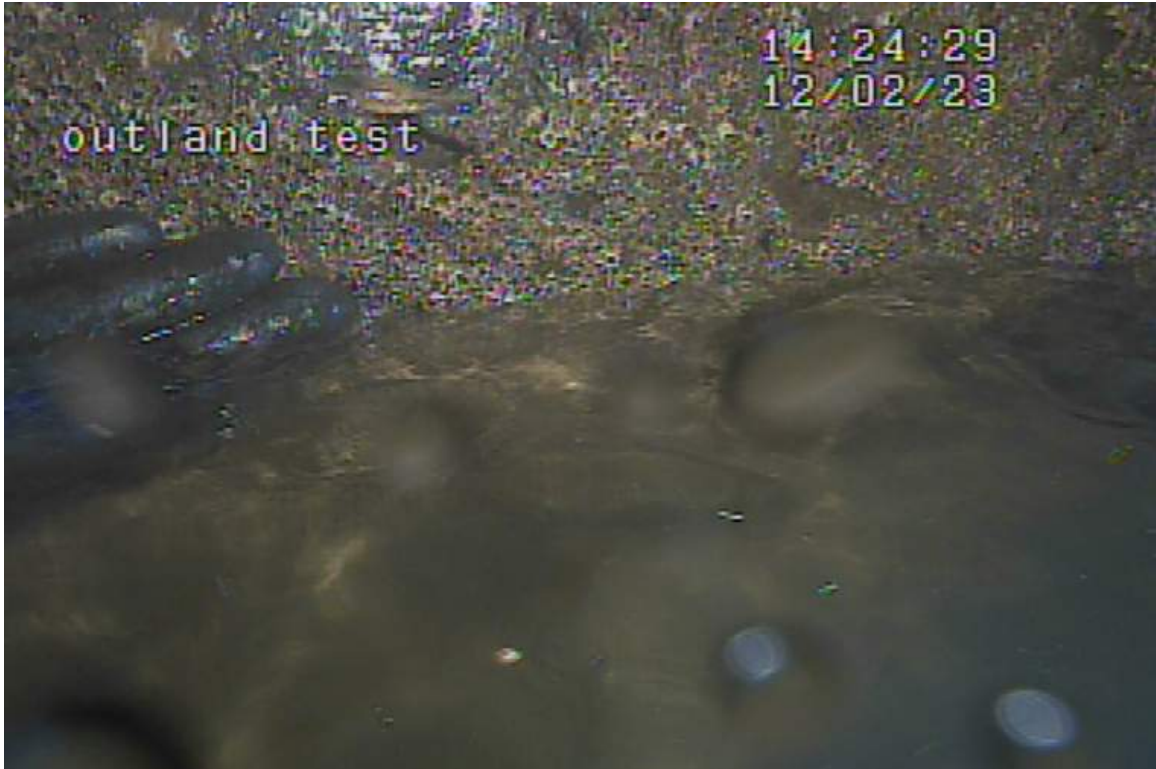
Photo 9. Typical divet at Concrete Bulkhead.

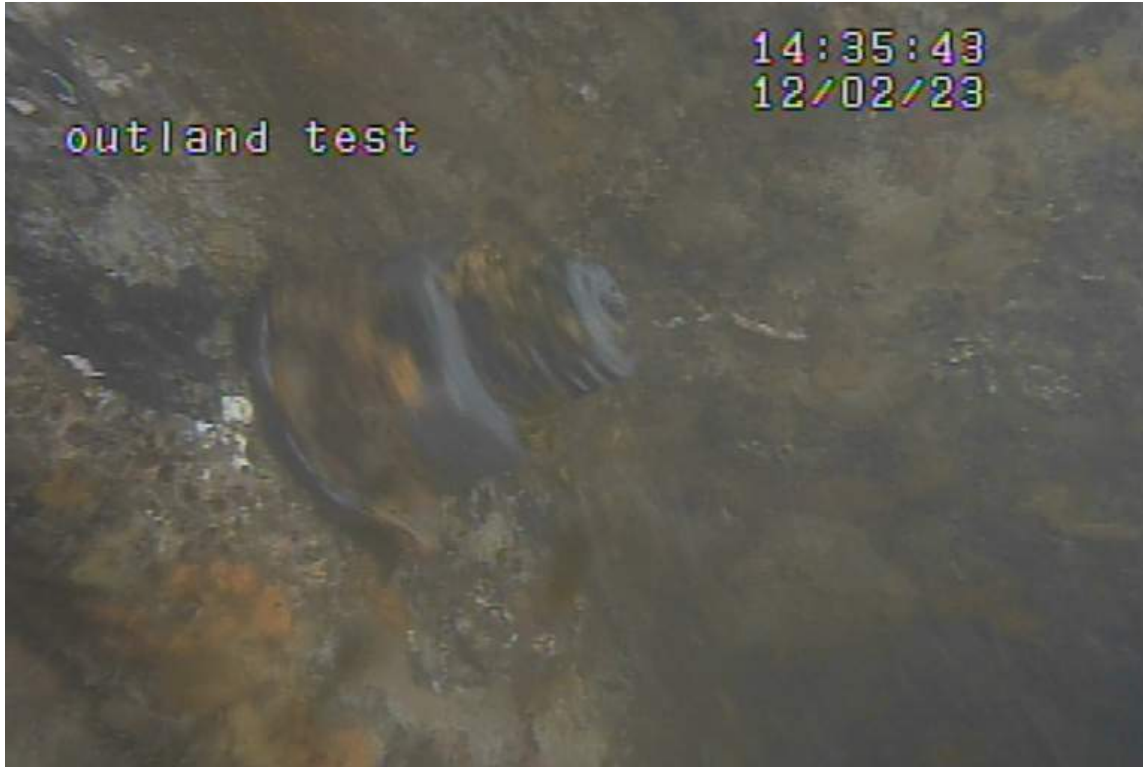
Photo 10. Loose Bolt.

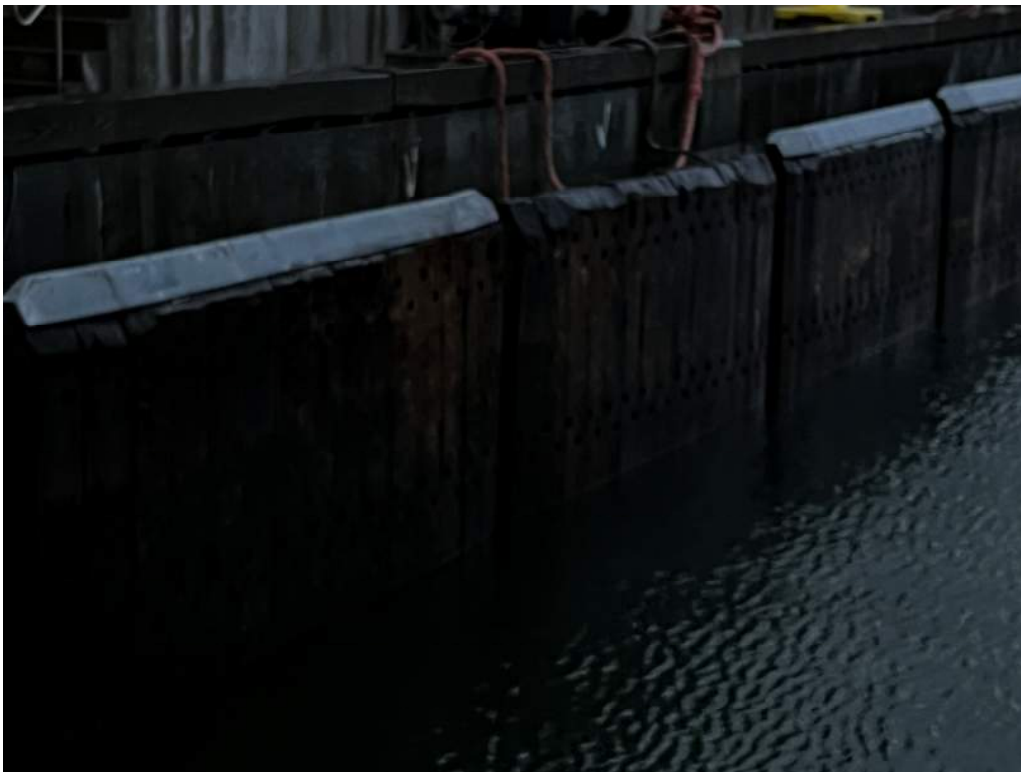
Photo 2. HDG cap plate missing at fender #3

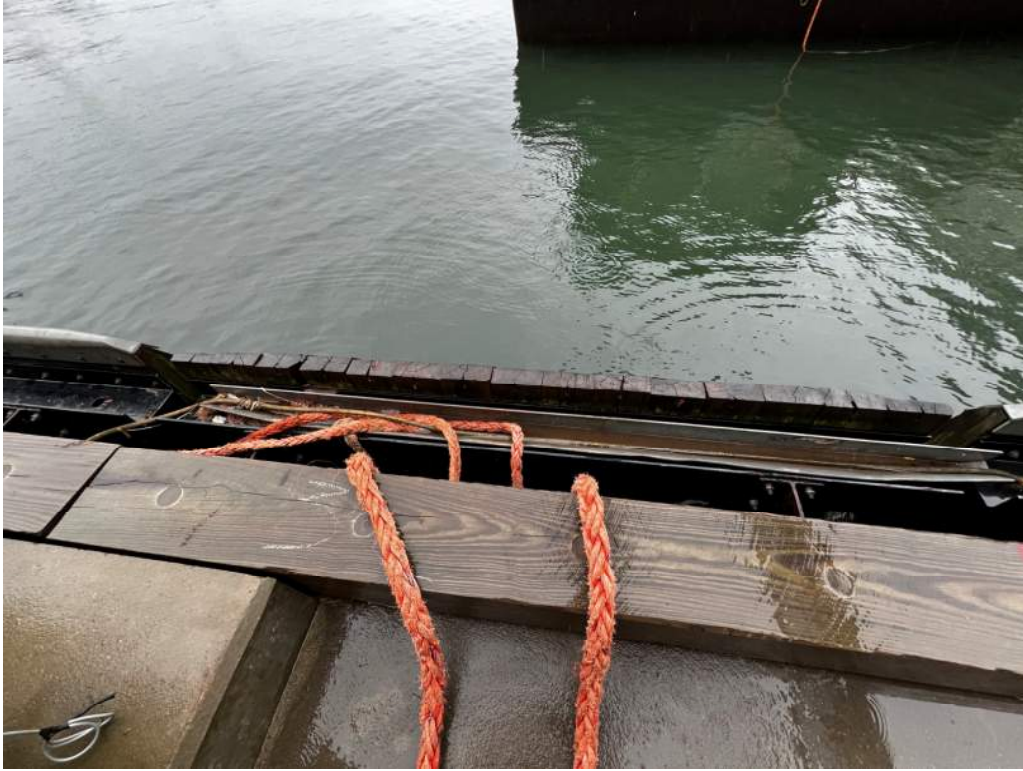
Photo 3. Missing cap plate at fender #3.

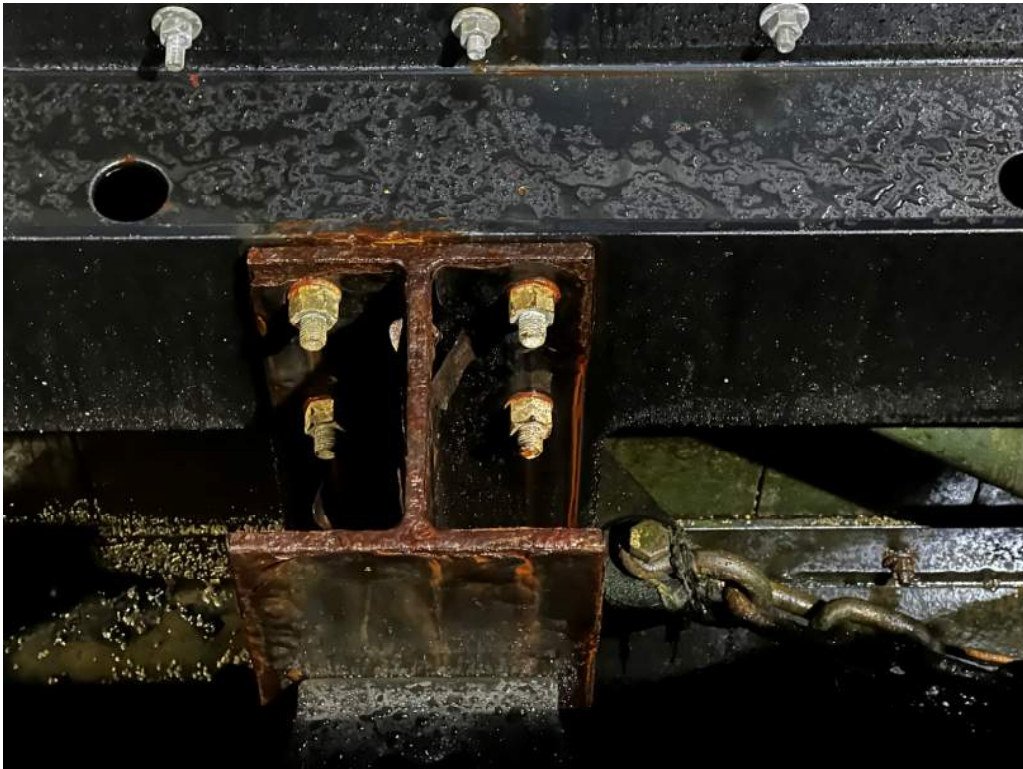
Photo 4. Typical corrosion at top of HP Piles.

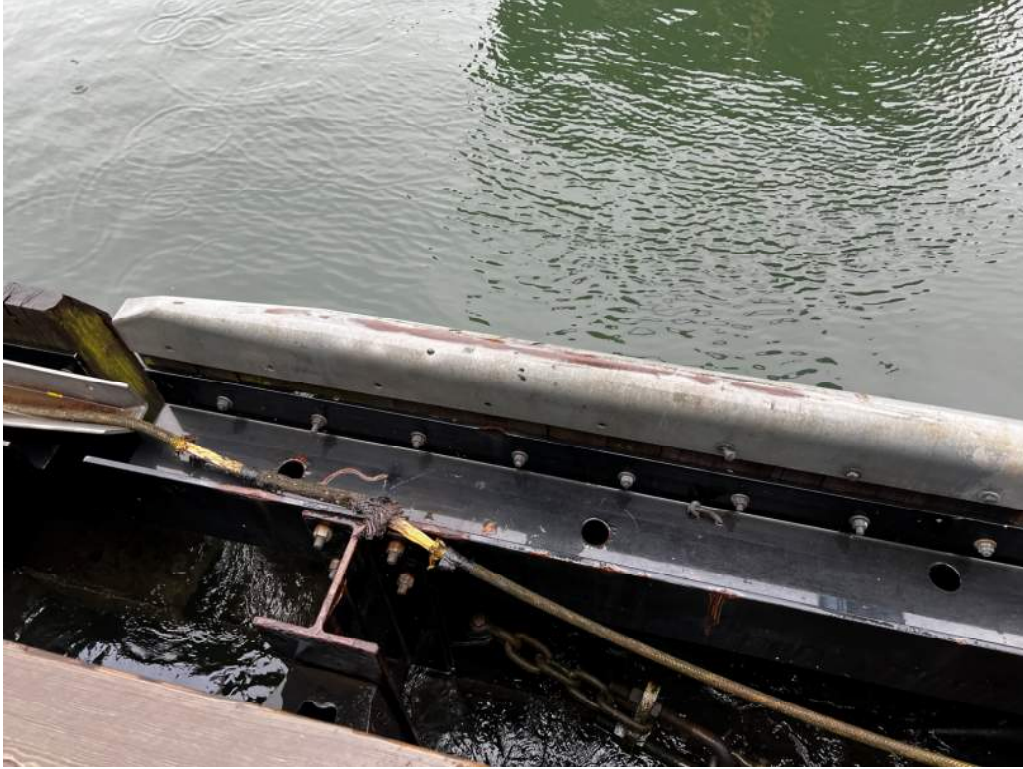
Photo 5. Typical missing bolts for the cap plate.

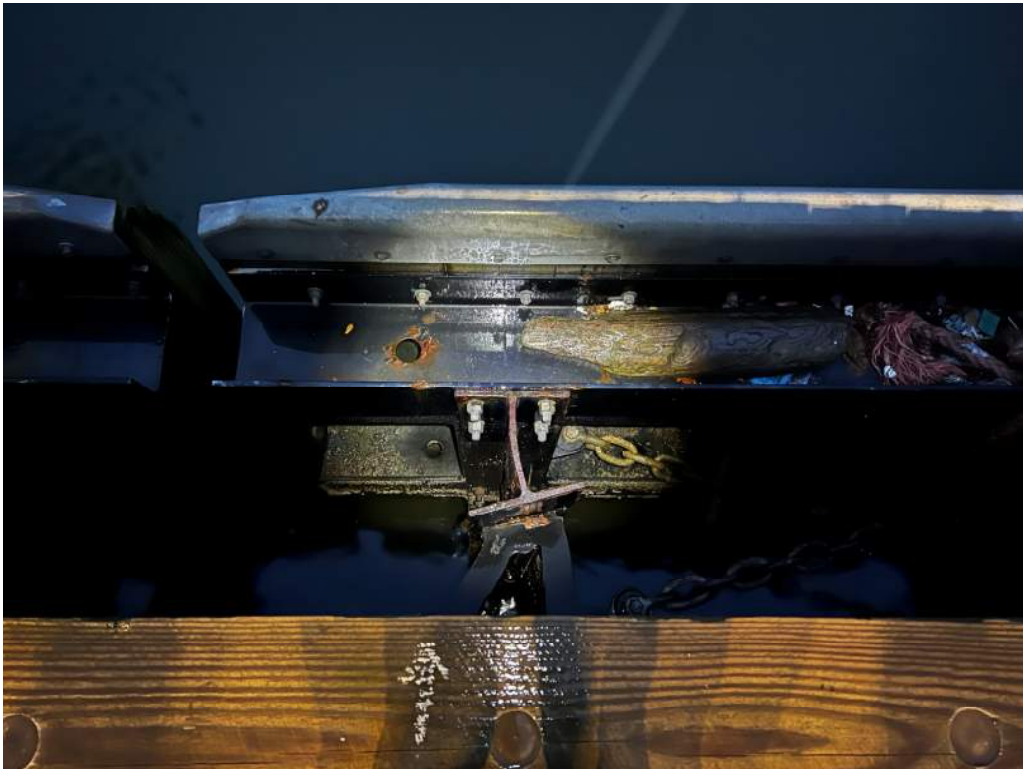
Photo 6. Bent HP Pile and rubber fender at fender #9.

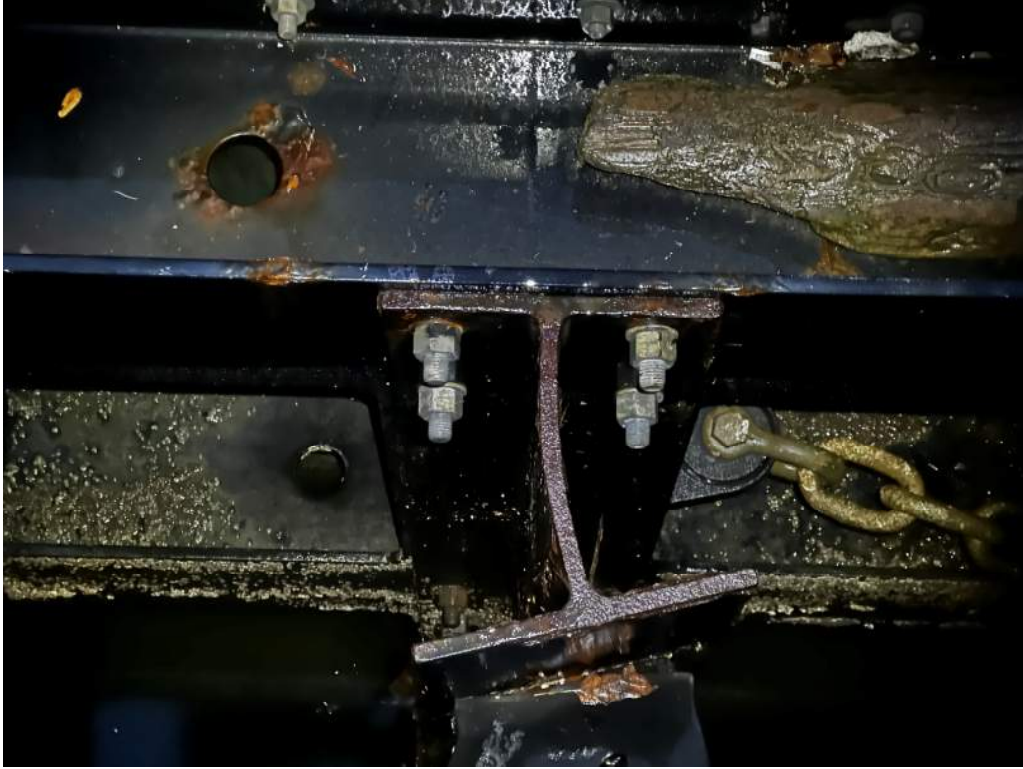
Photo 7. Close view of bent HP Pile and rubber fender at fender #9.

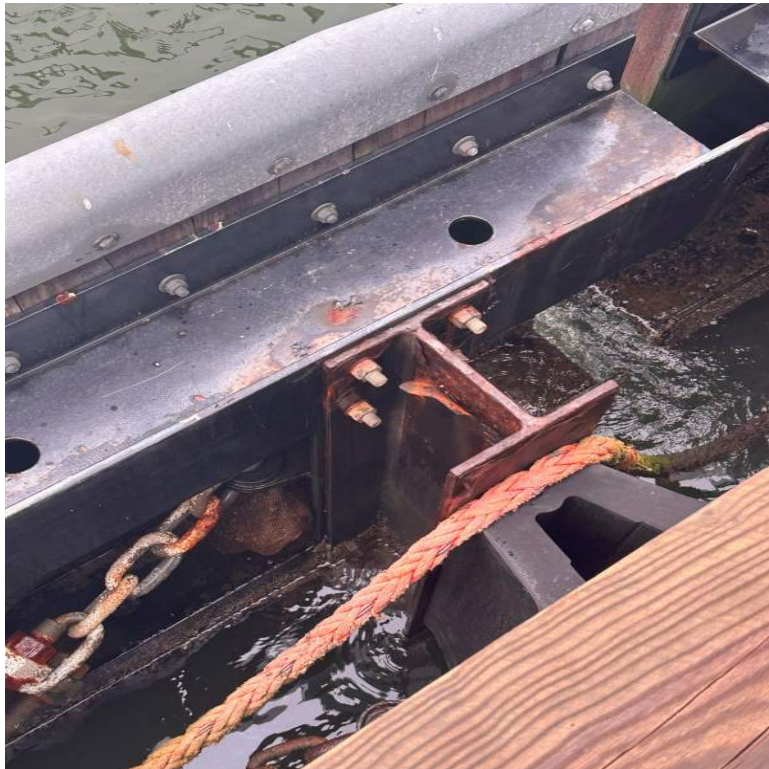
Photo 8. Corrosion at HP Pile.

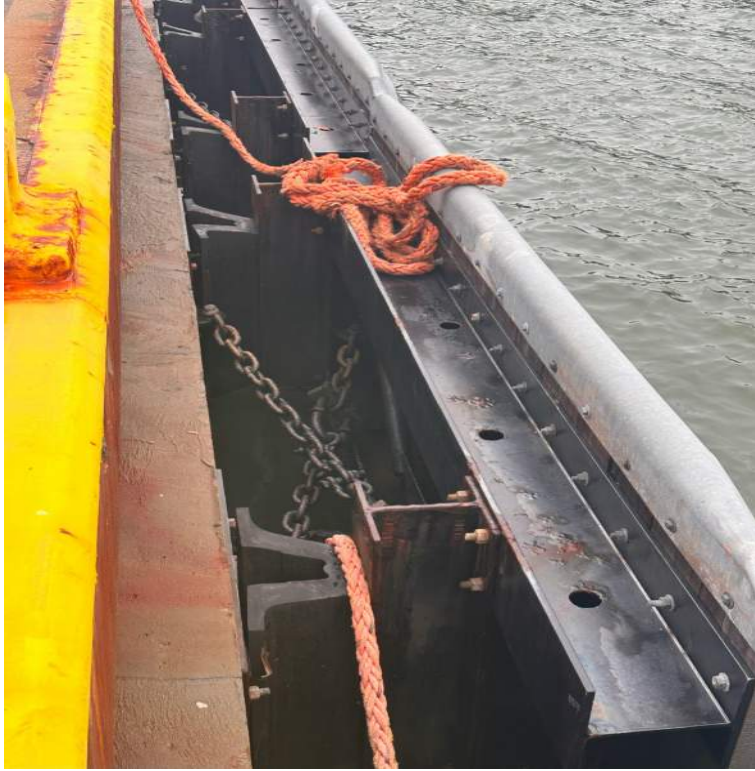
Photo 9. Rubber fender detached from concrete bulkhead at fender #17.

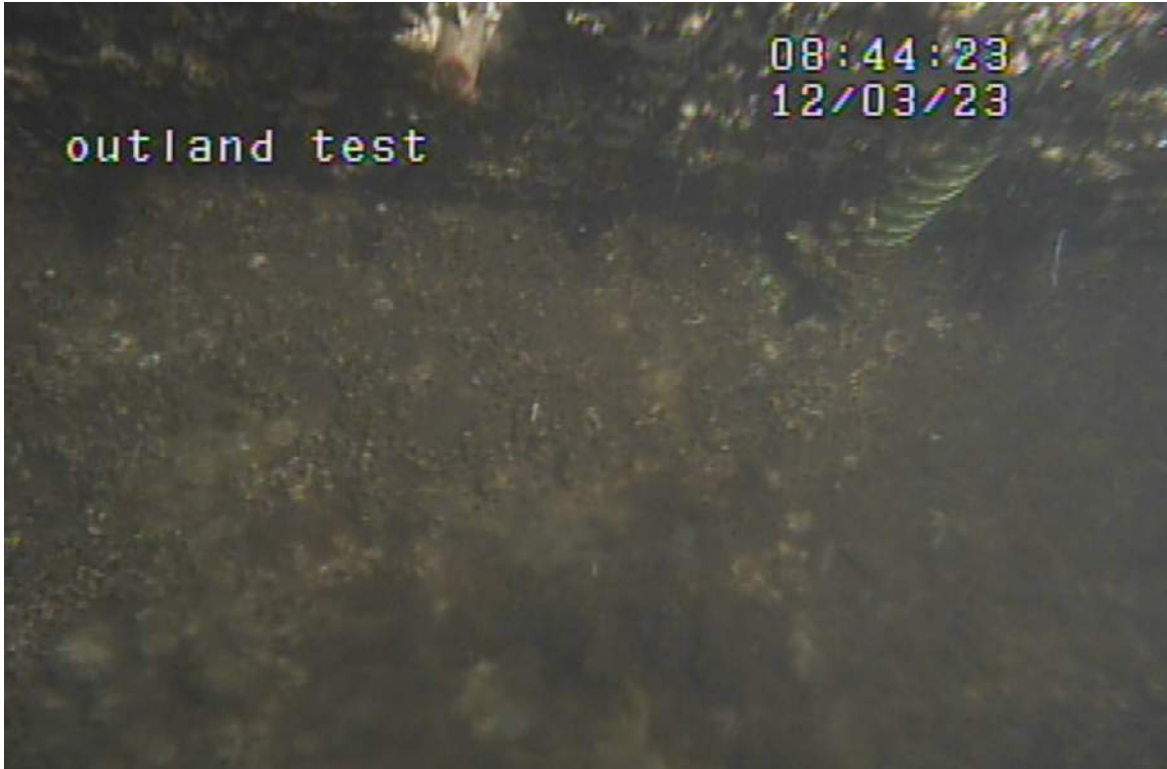
Photo 11. Exposed rebar at concrete bulkhead at fender #1.

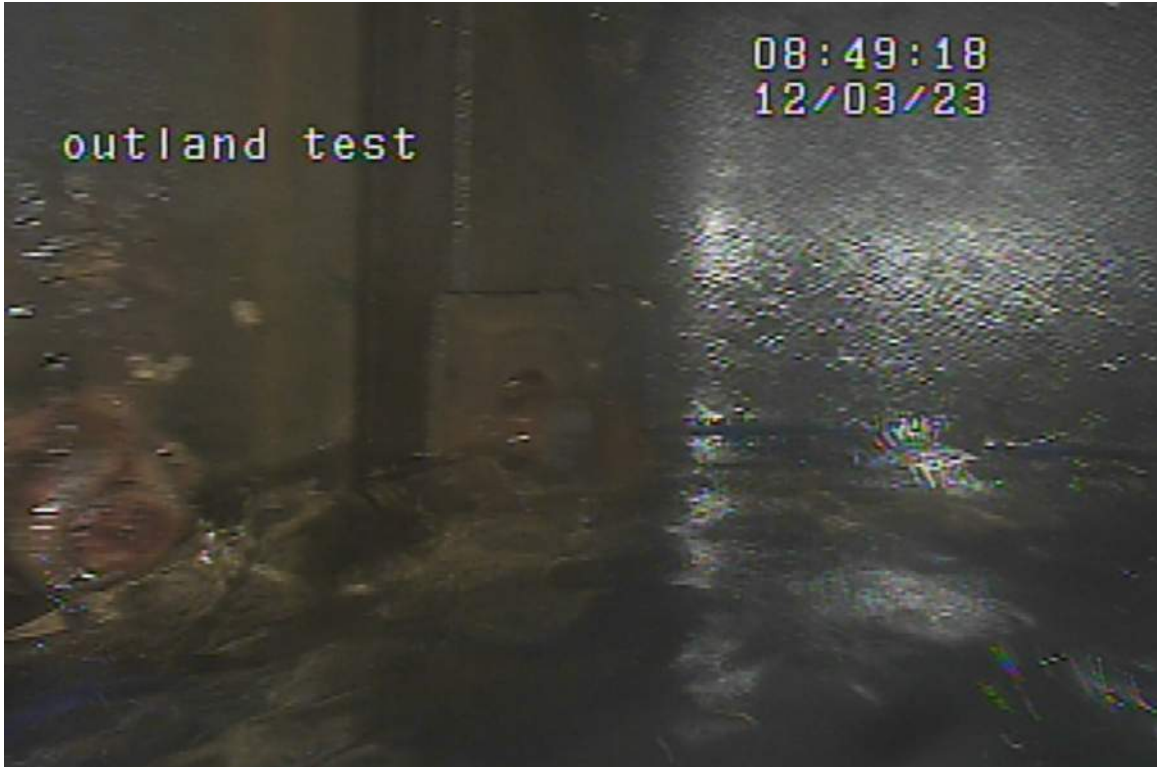
Photo 11. Loose bolt at fender #1.

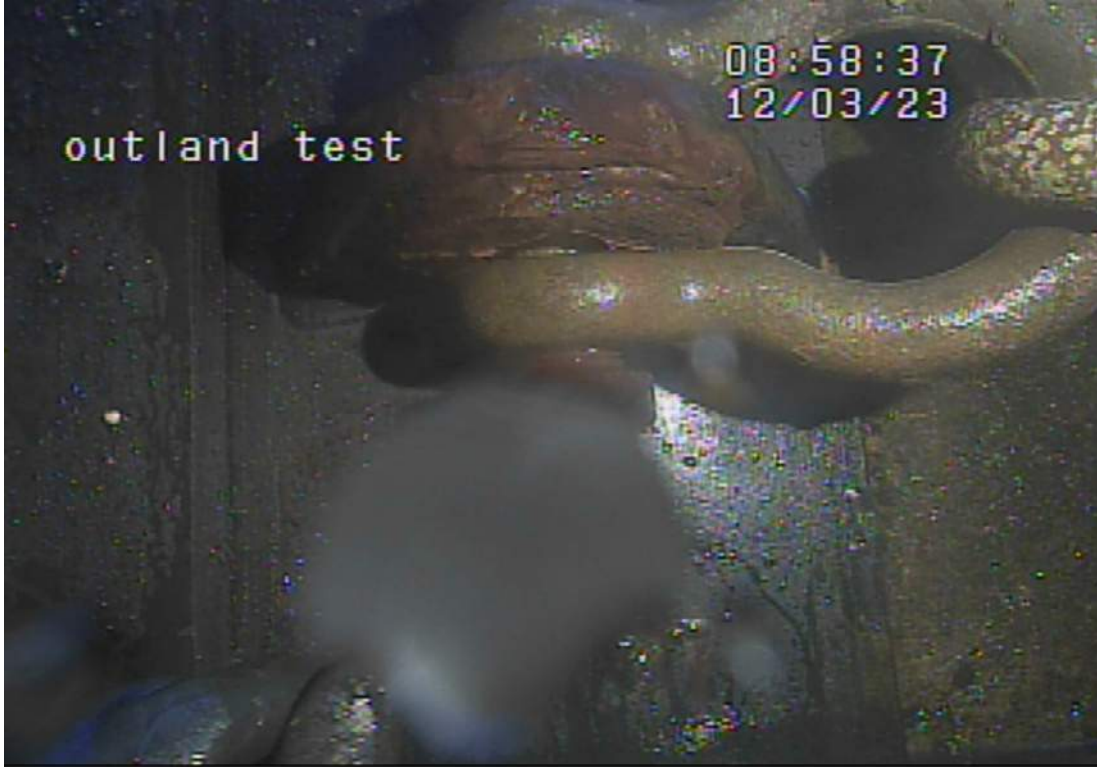
Photo 12. Minor Corrosion at shackle for fender #2.

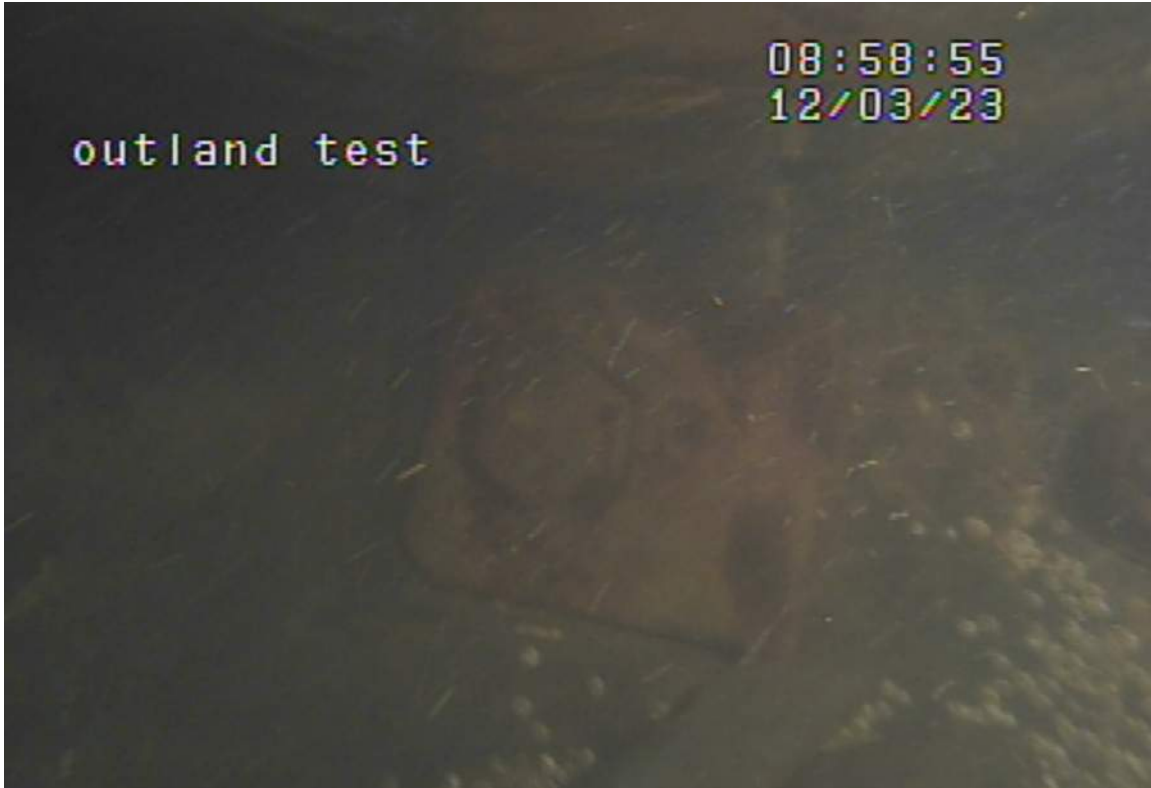
Photo 13. Loose washer at fender #2. (typical)

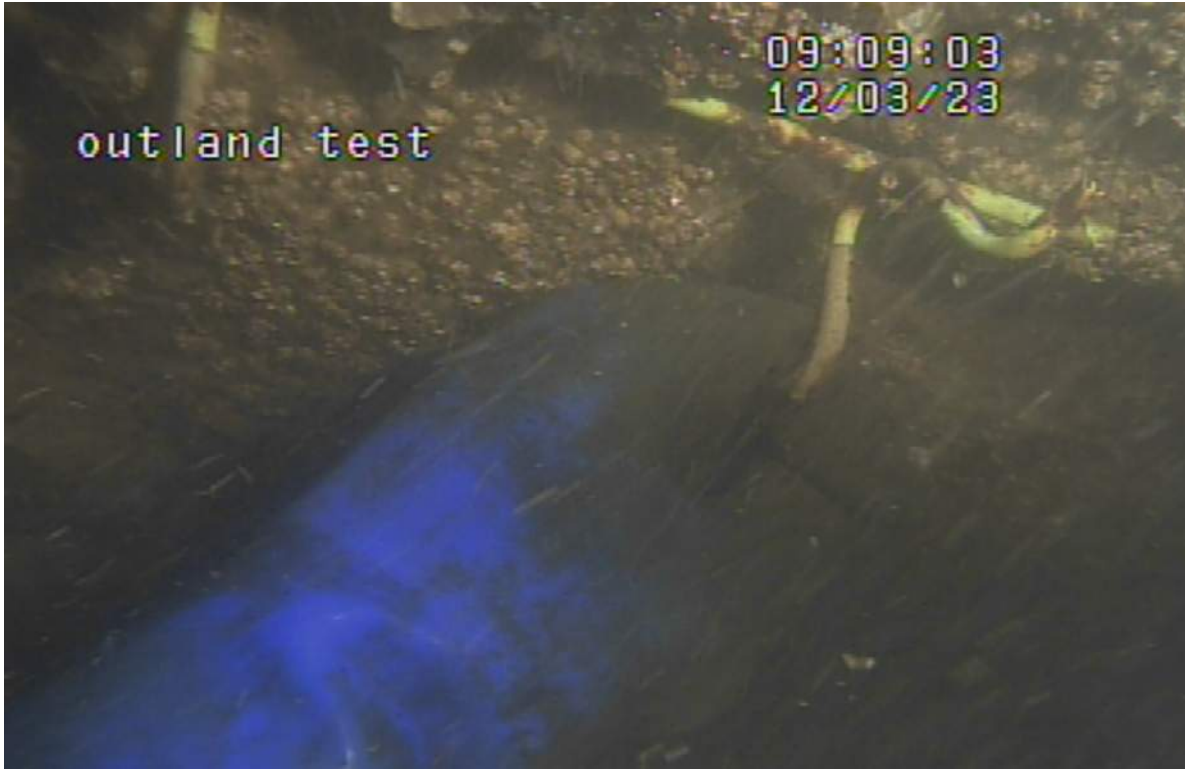
Photo 14. Exposed chair at underside of concrete deck.

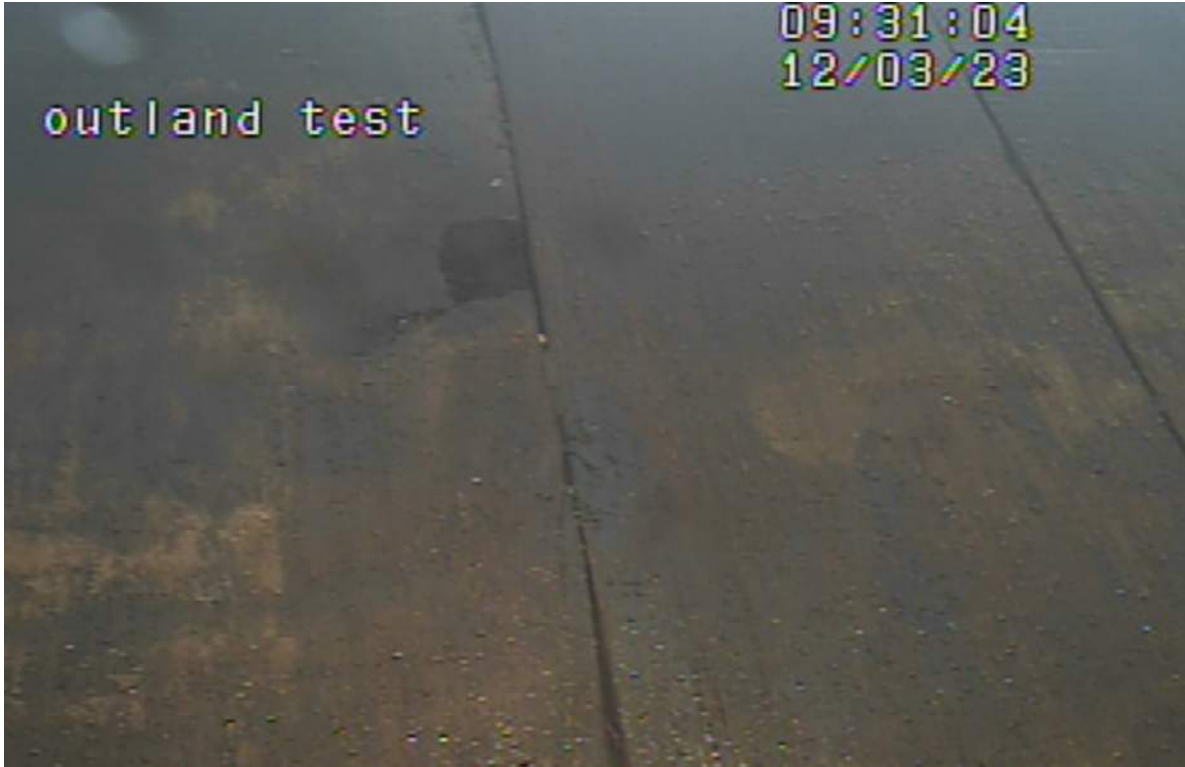
Photo 15. Minor rot at top of fender #5.

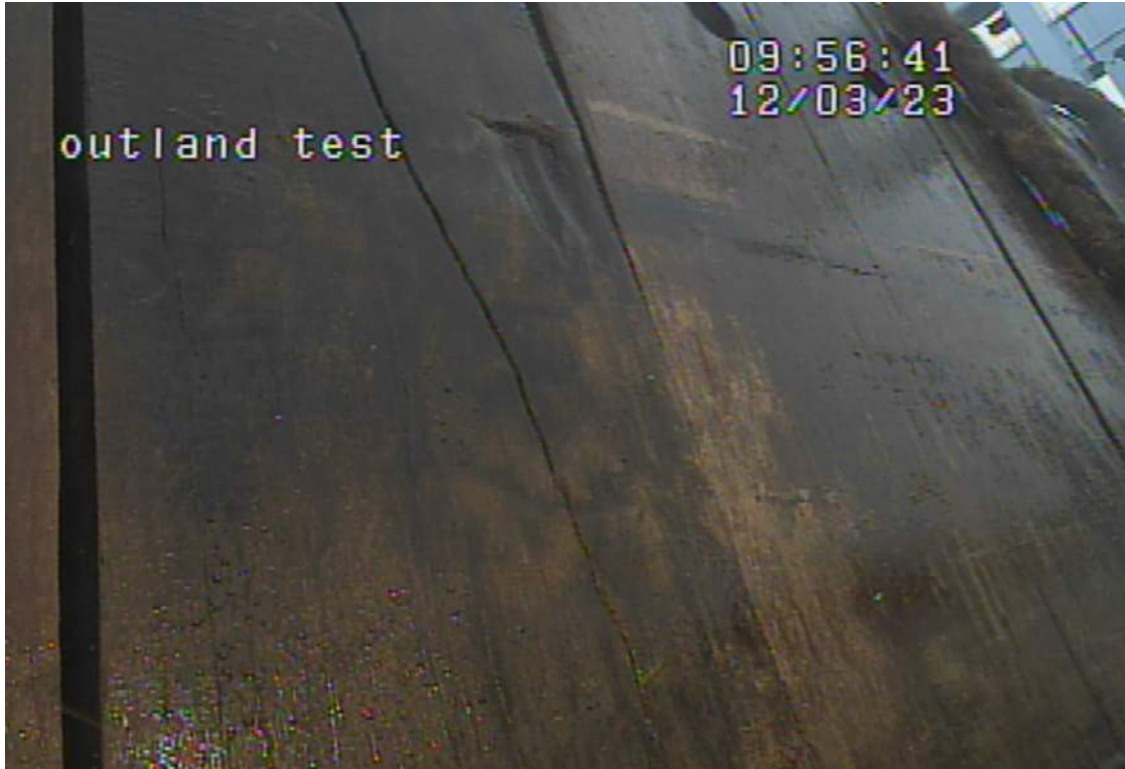
Photo 16. Vertical Split at face board at fender #7.

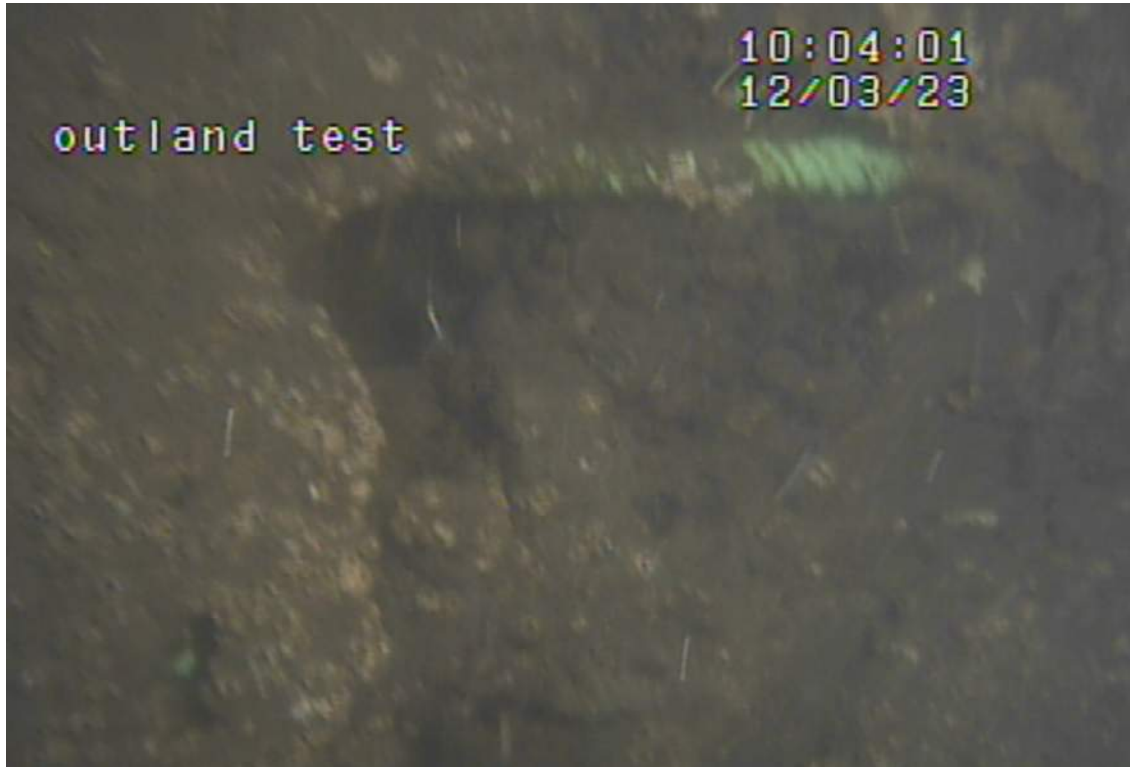
Photo 17. Exposed rebar at fender #7.

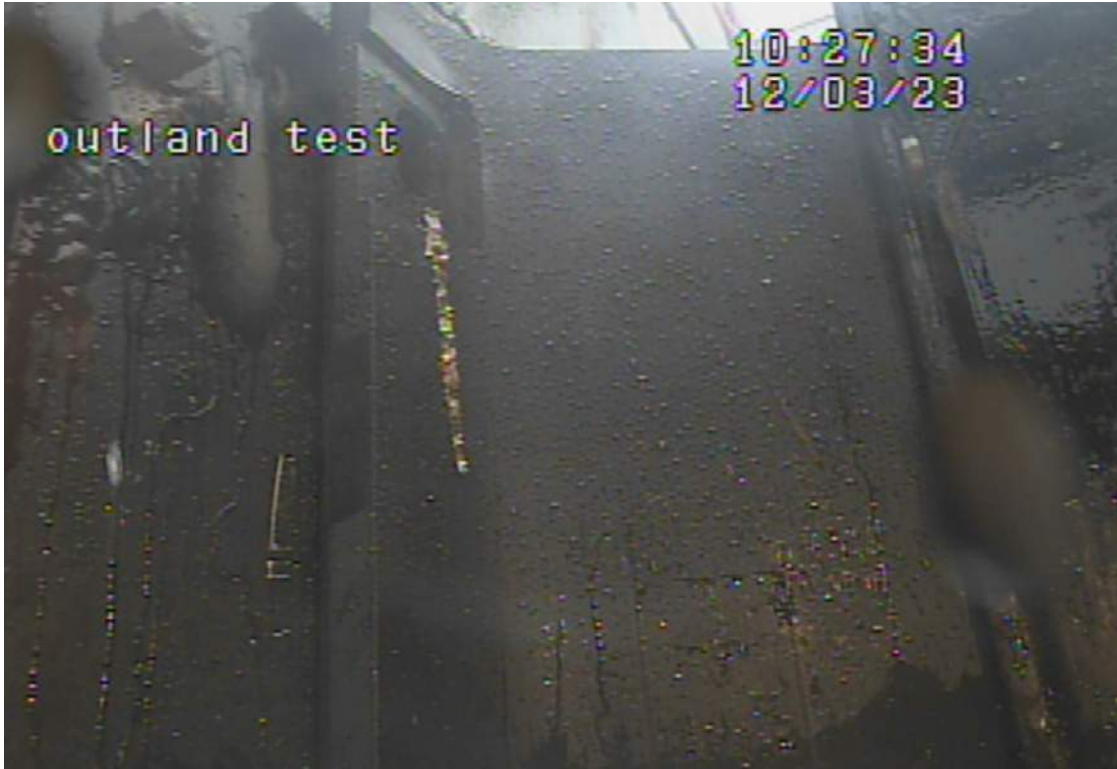
Photo 18. Bolt and washer missing at the connection rubber fender to HP pile at fender #8
