INSPECTION OF THE CELLULAR COFFERDAMS AT THE SOUTHWEST BROOKLYN MARINE TRANSFER STATION

January 2020

New York City Department of Sanitation

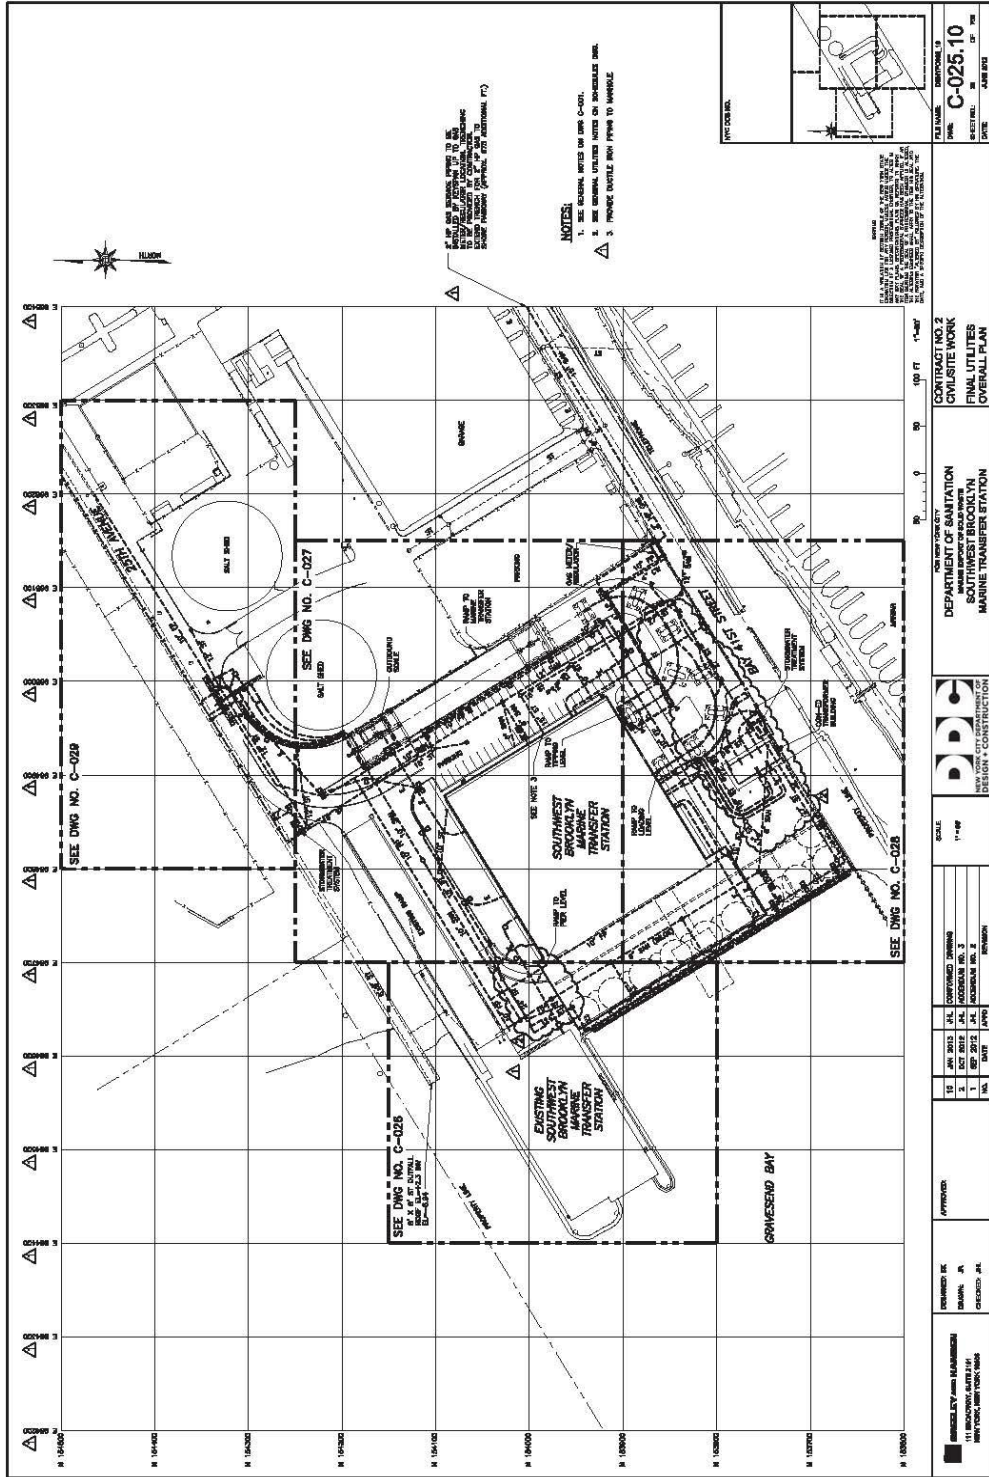
Figure 2

Observed Conditions: After identifying the inspection ports that are located on the pier deck at elevation 11.50' (Figures 2 & 3), each cover was removed and visually inspected. Following that, a tape measure was lowered into each port hole until it hit the sand fill material and the results were recorded. See photos 1 thru 4. The calculated heights of the fill in all the ports ranged from elevations 8.92' to 9.50'. That is 8.50' to 9.08' above mean high water level.

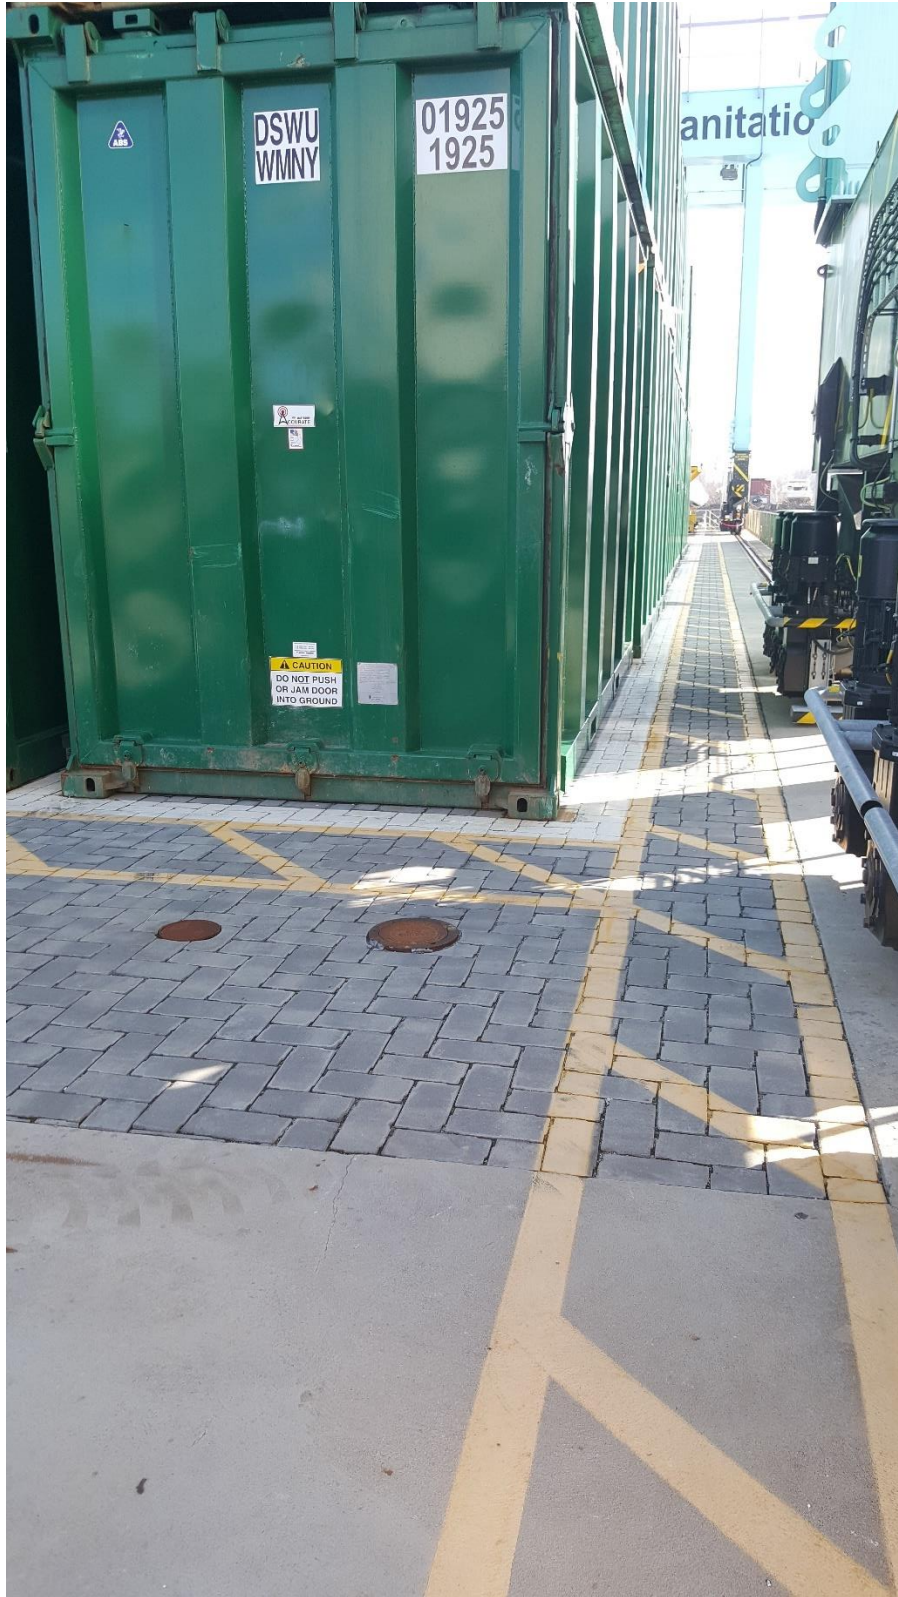
Photo 1 – Inspection Port on the Pier Deck

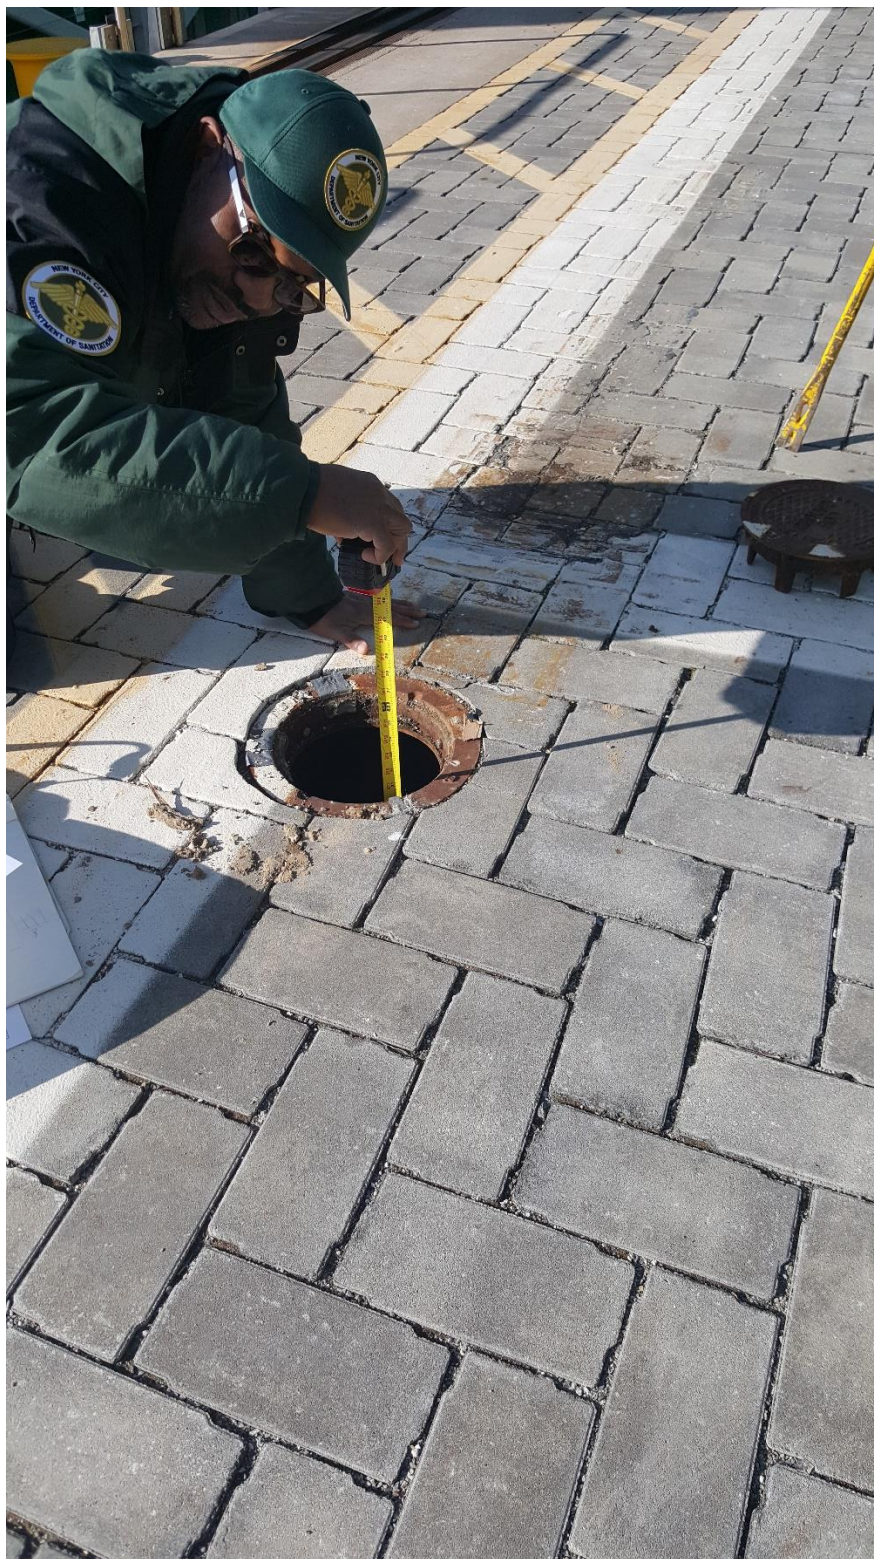
Photo 2 – Measurement Tape Lowered into Inspection Port

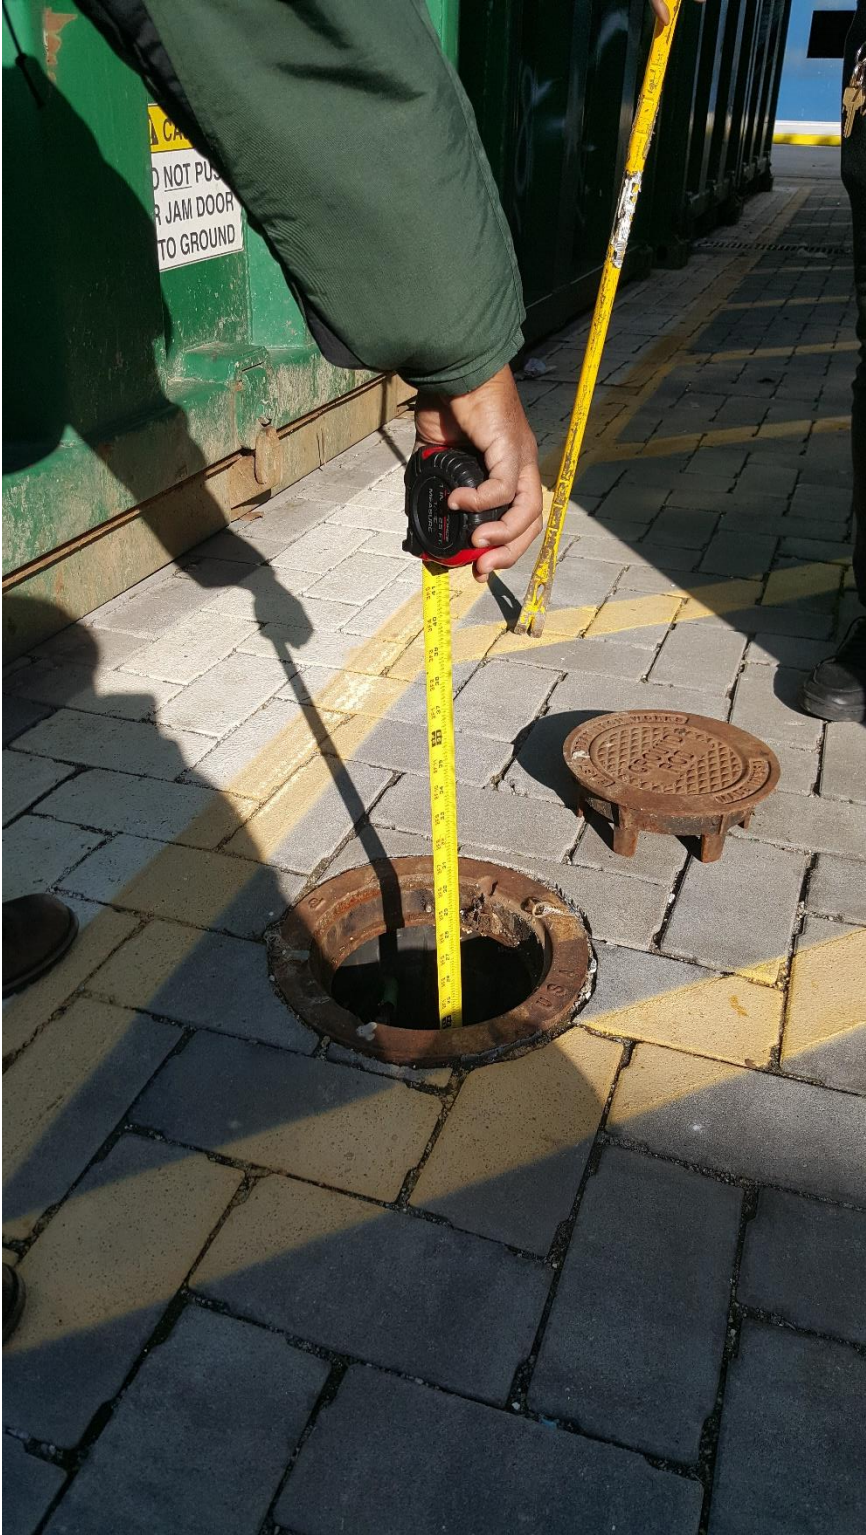
Photo 3 – Inspection Port with Cover Removed

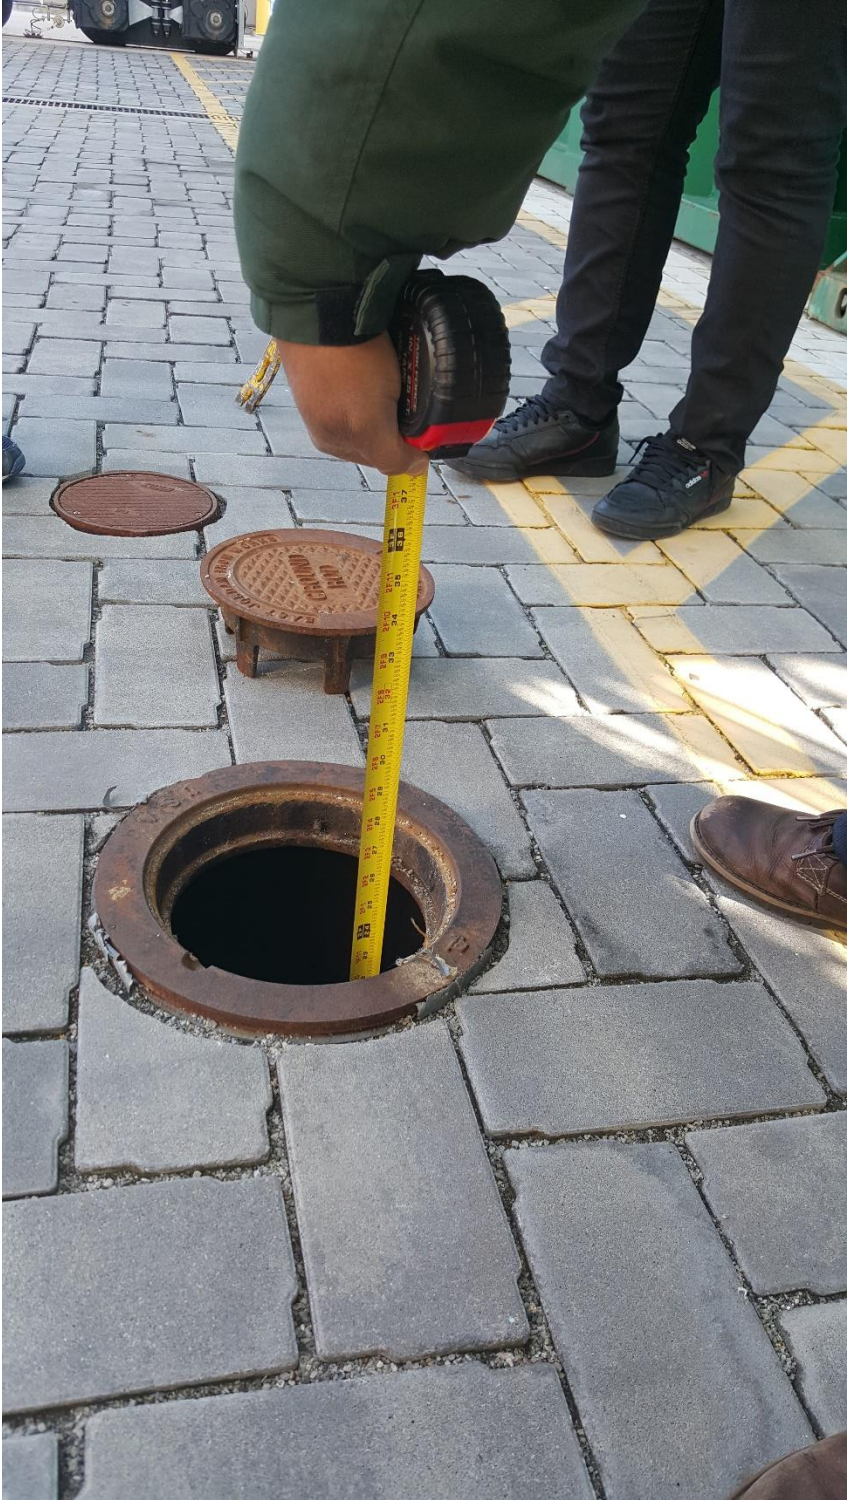
Photo 4 – Inspection Port on Pier Deck
