**177 Montague Street, aka 134-138 Pierrepont Street – Brooklyn  
Trust Company Building – Individual and Interior Landmark  
Borough of Brooklyn**

177 Montague Street  
(aka The Brooklyn Trust  
Company Building)

Arched Window Repair/  
Replacement

LPC Presentation

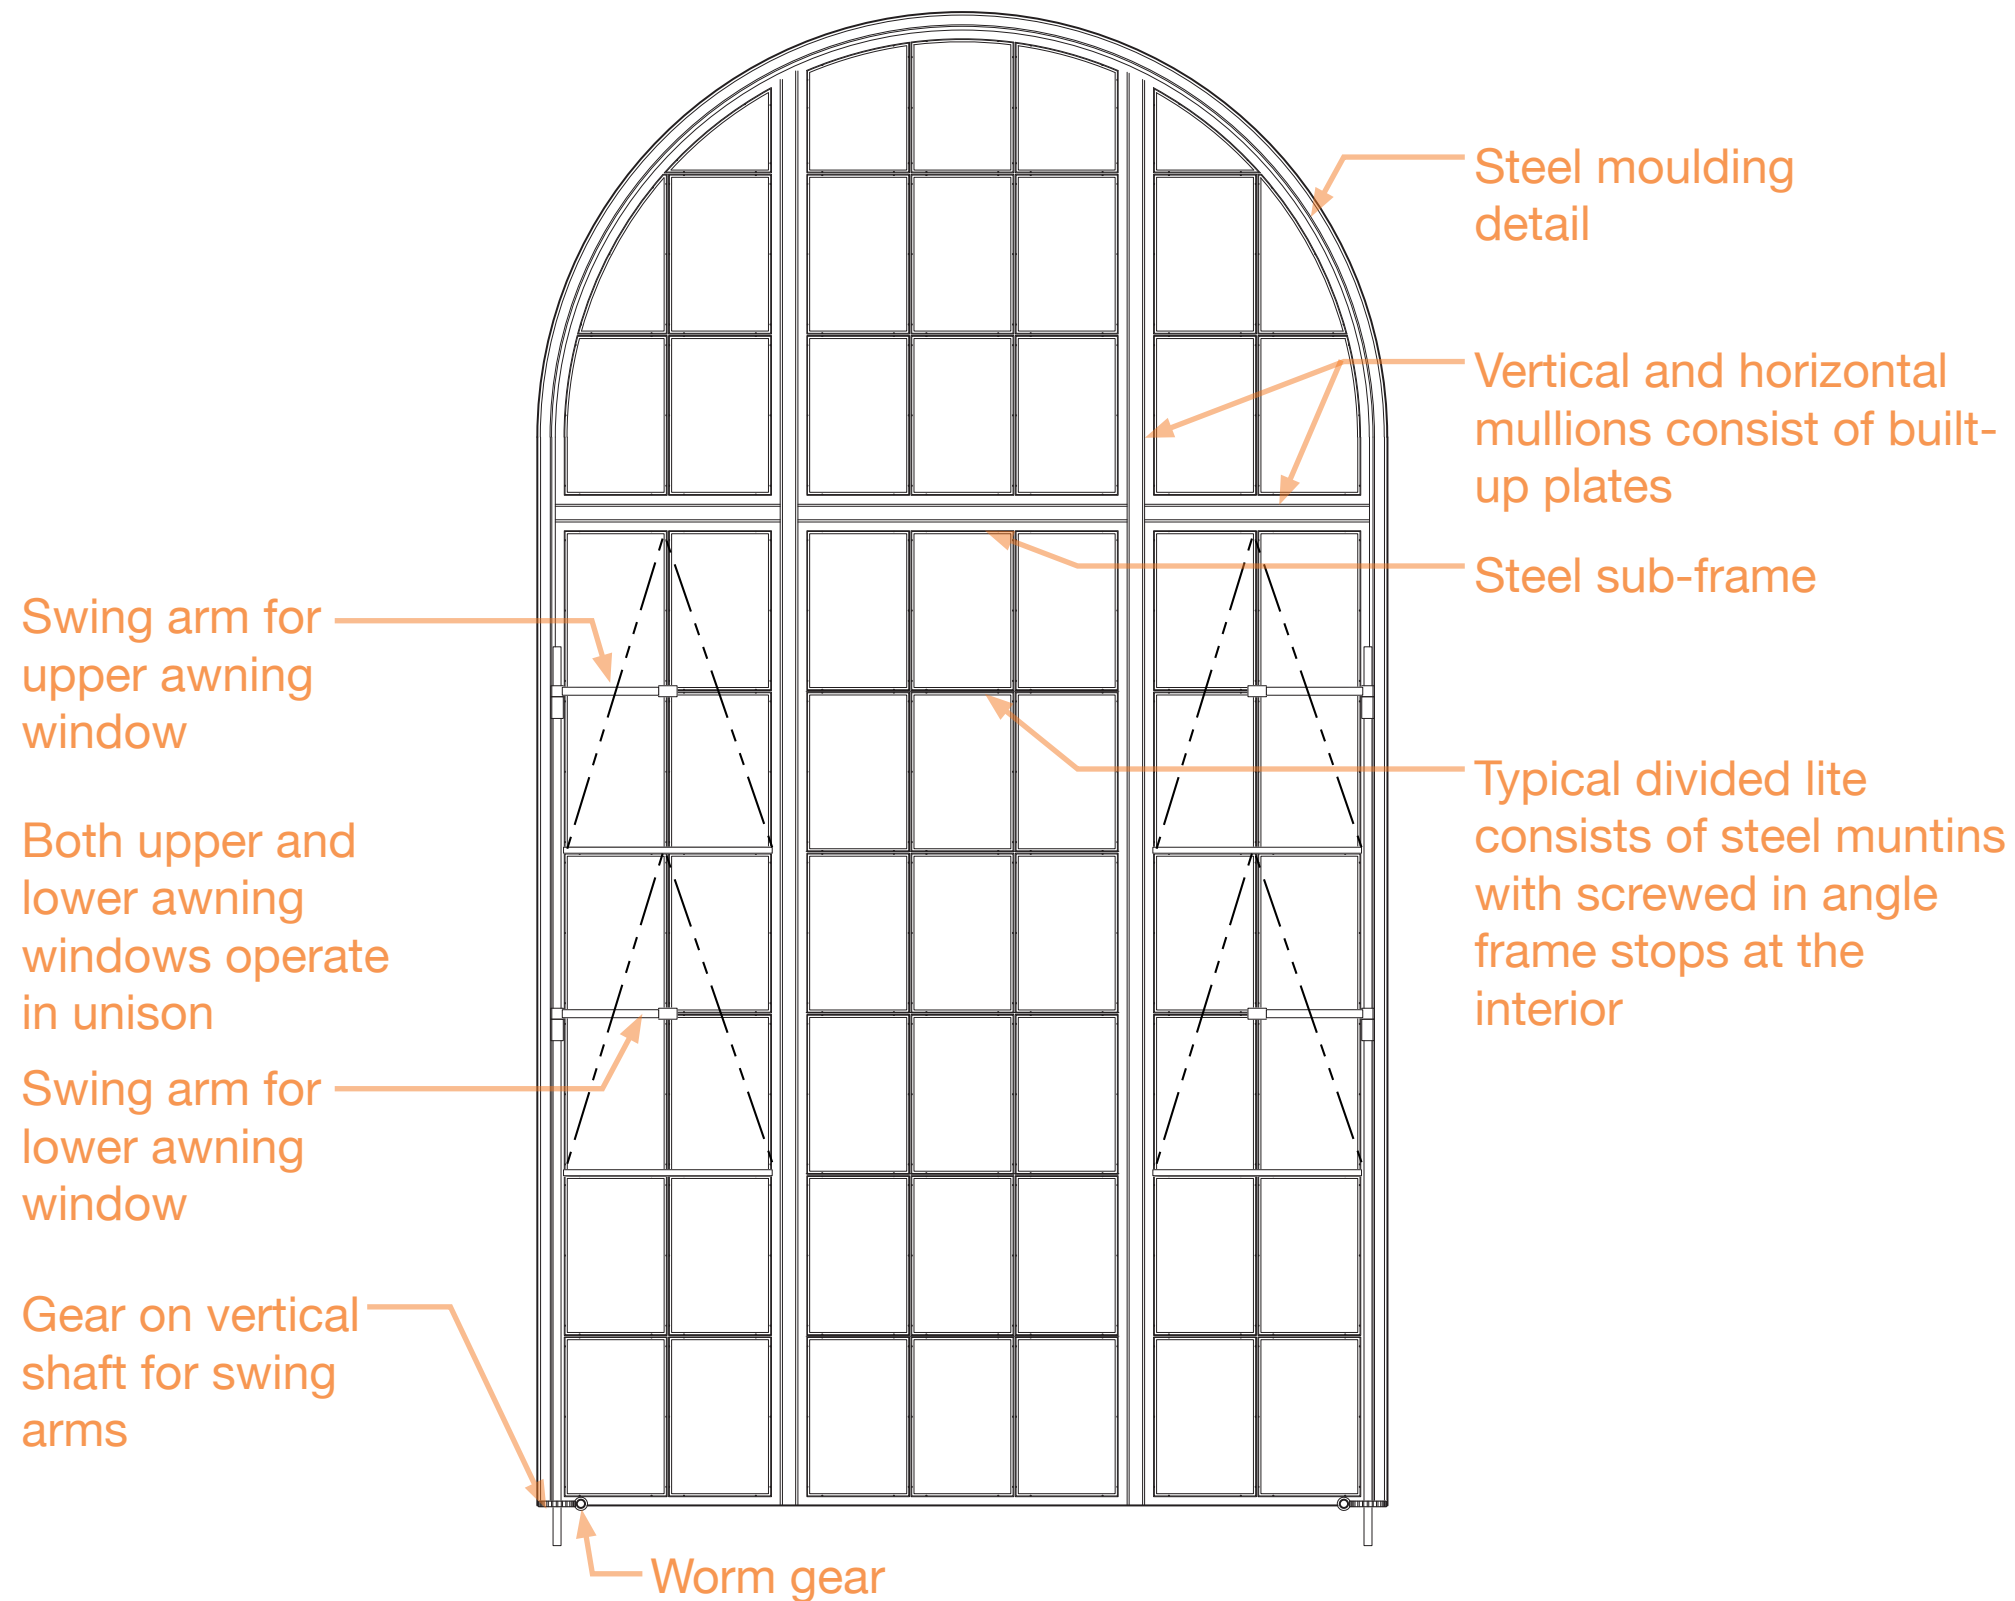
Existing Window Construction (view from interior)

- Evidence of condensation and paint damage along horizontal mullion
- Smaller lites are in poor condition, leaking, and allowing water infiltration. Awning windows are damaged and in non-operable condition.
- Proposed scope is to reattach the original arms to the replacement muntins to mimic the original configuration.
- Crank or mechanism to operate shaft is missing.

- We are proposing to replace all of the infill lites with a similar Hopes Windows steel profile and insulated glass in increase thermal performance.
- Major mullions and frame are to be repaired and are to remain

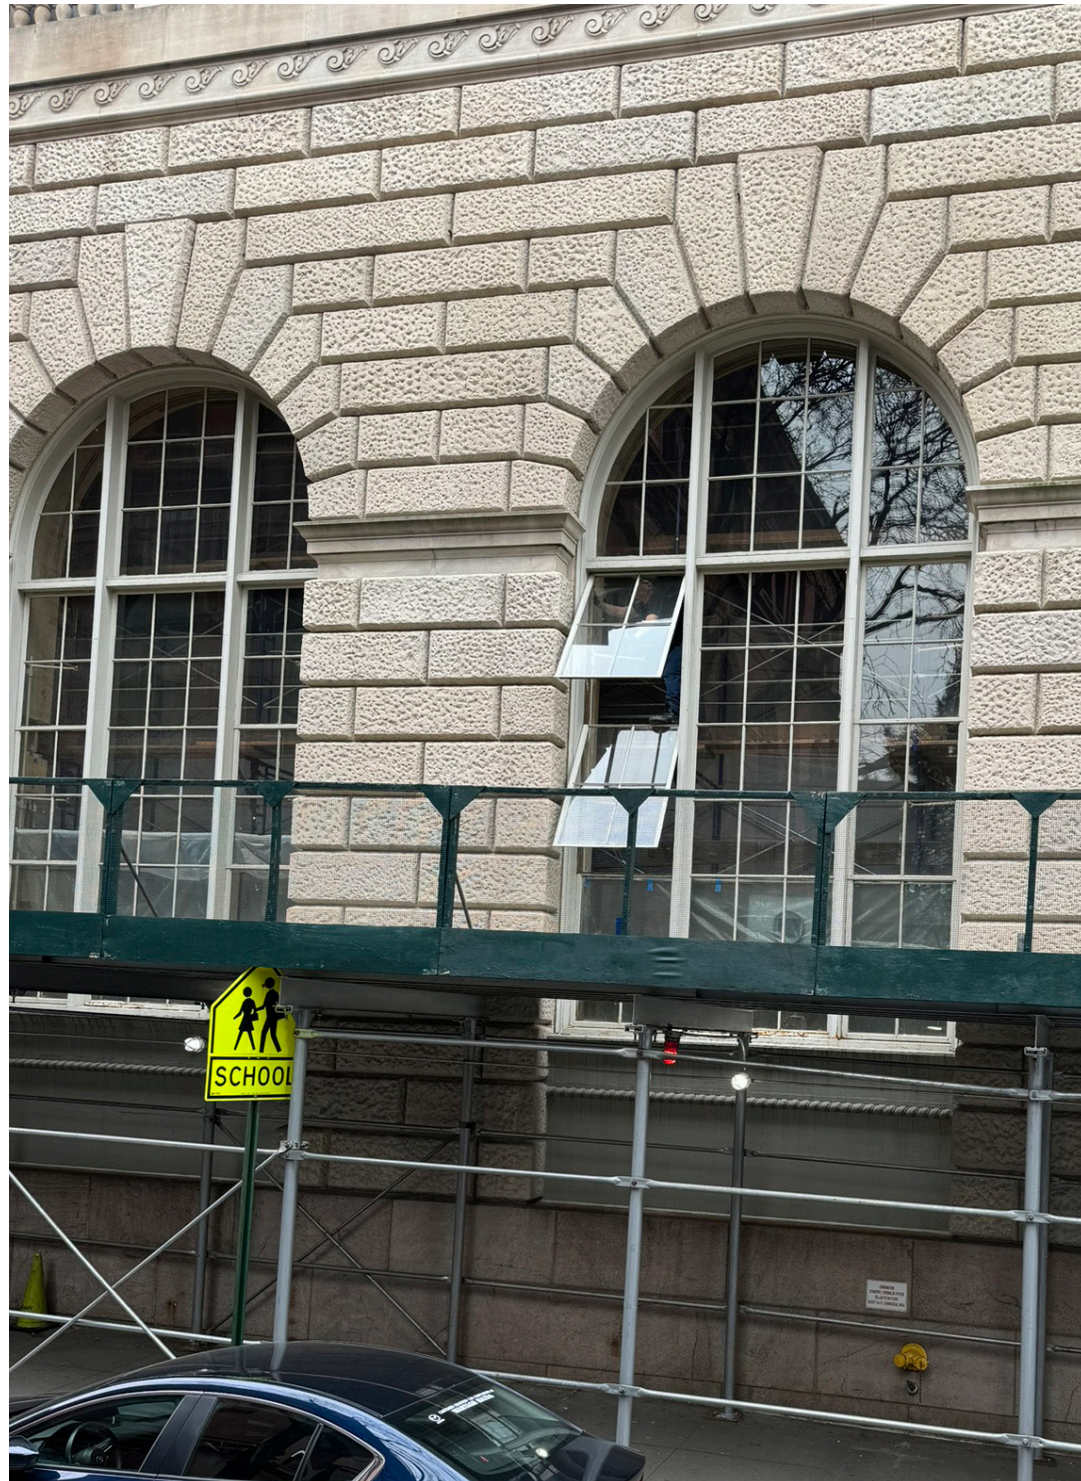
Discovery of operation: Two windows were worked loose. We were expecting casement window swings, but they are awning swings. The window operation is virtually undetectable from the exterior. They appear fixed.

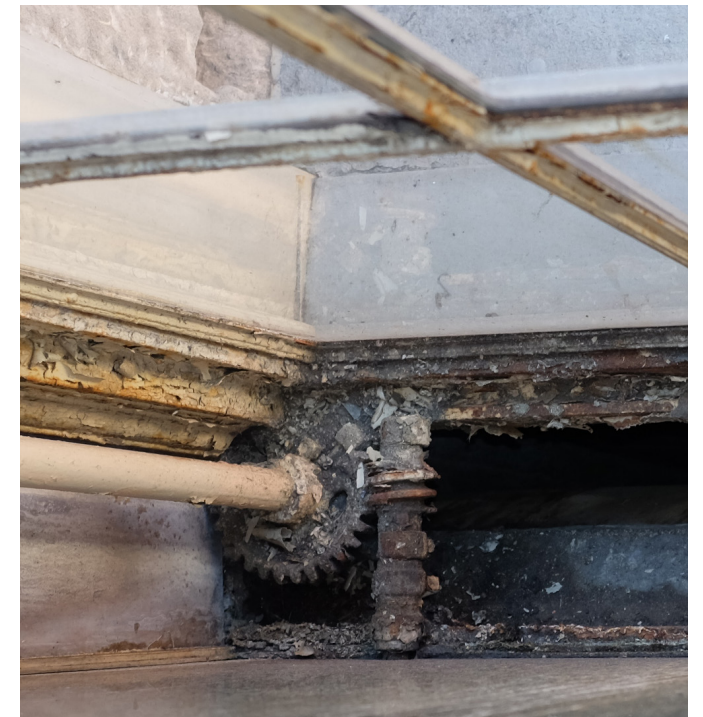
Worm gear and shaft to turn arms (crank is missing)

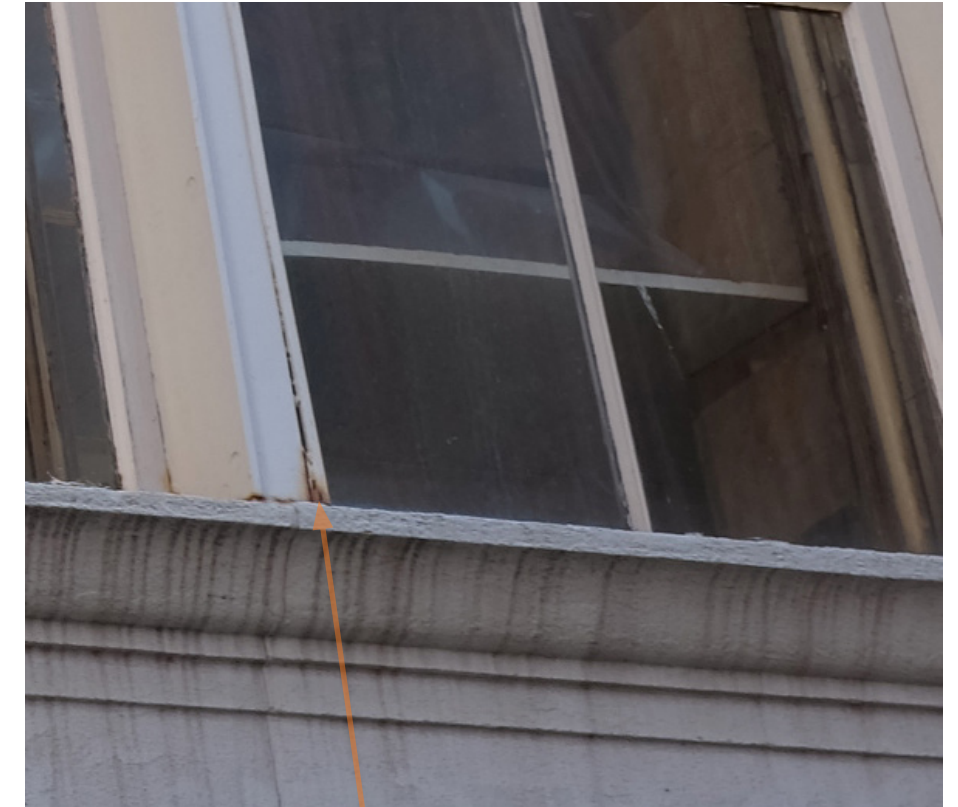
**Bent plate of mullion.  
Rust will be removed and  
plate to be straightened.  
(Mullions are to remain.)**

- Overall, exterior frame and mullions appear to have minor issues and will be repaired

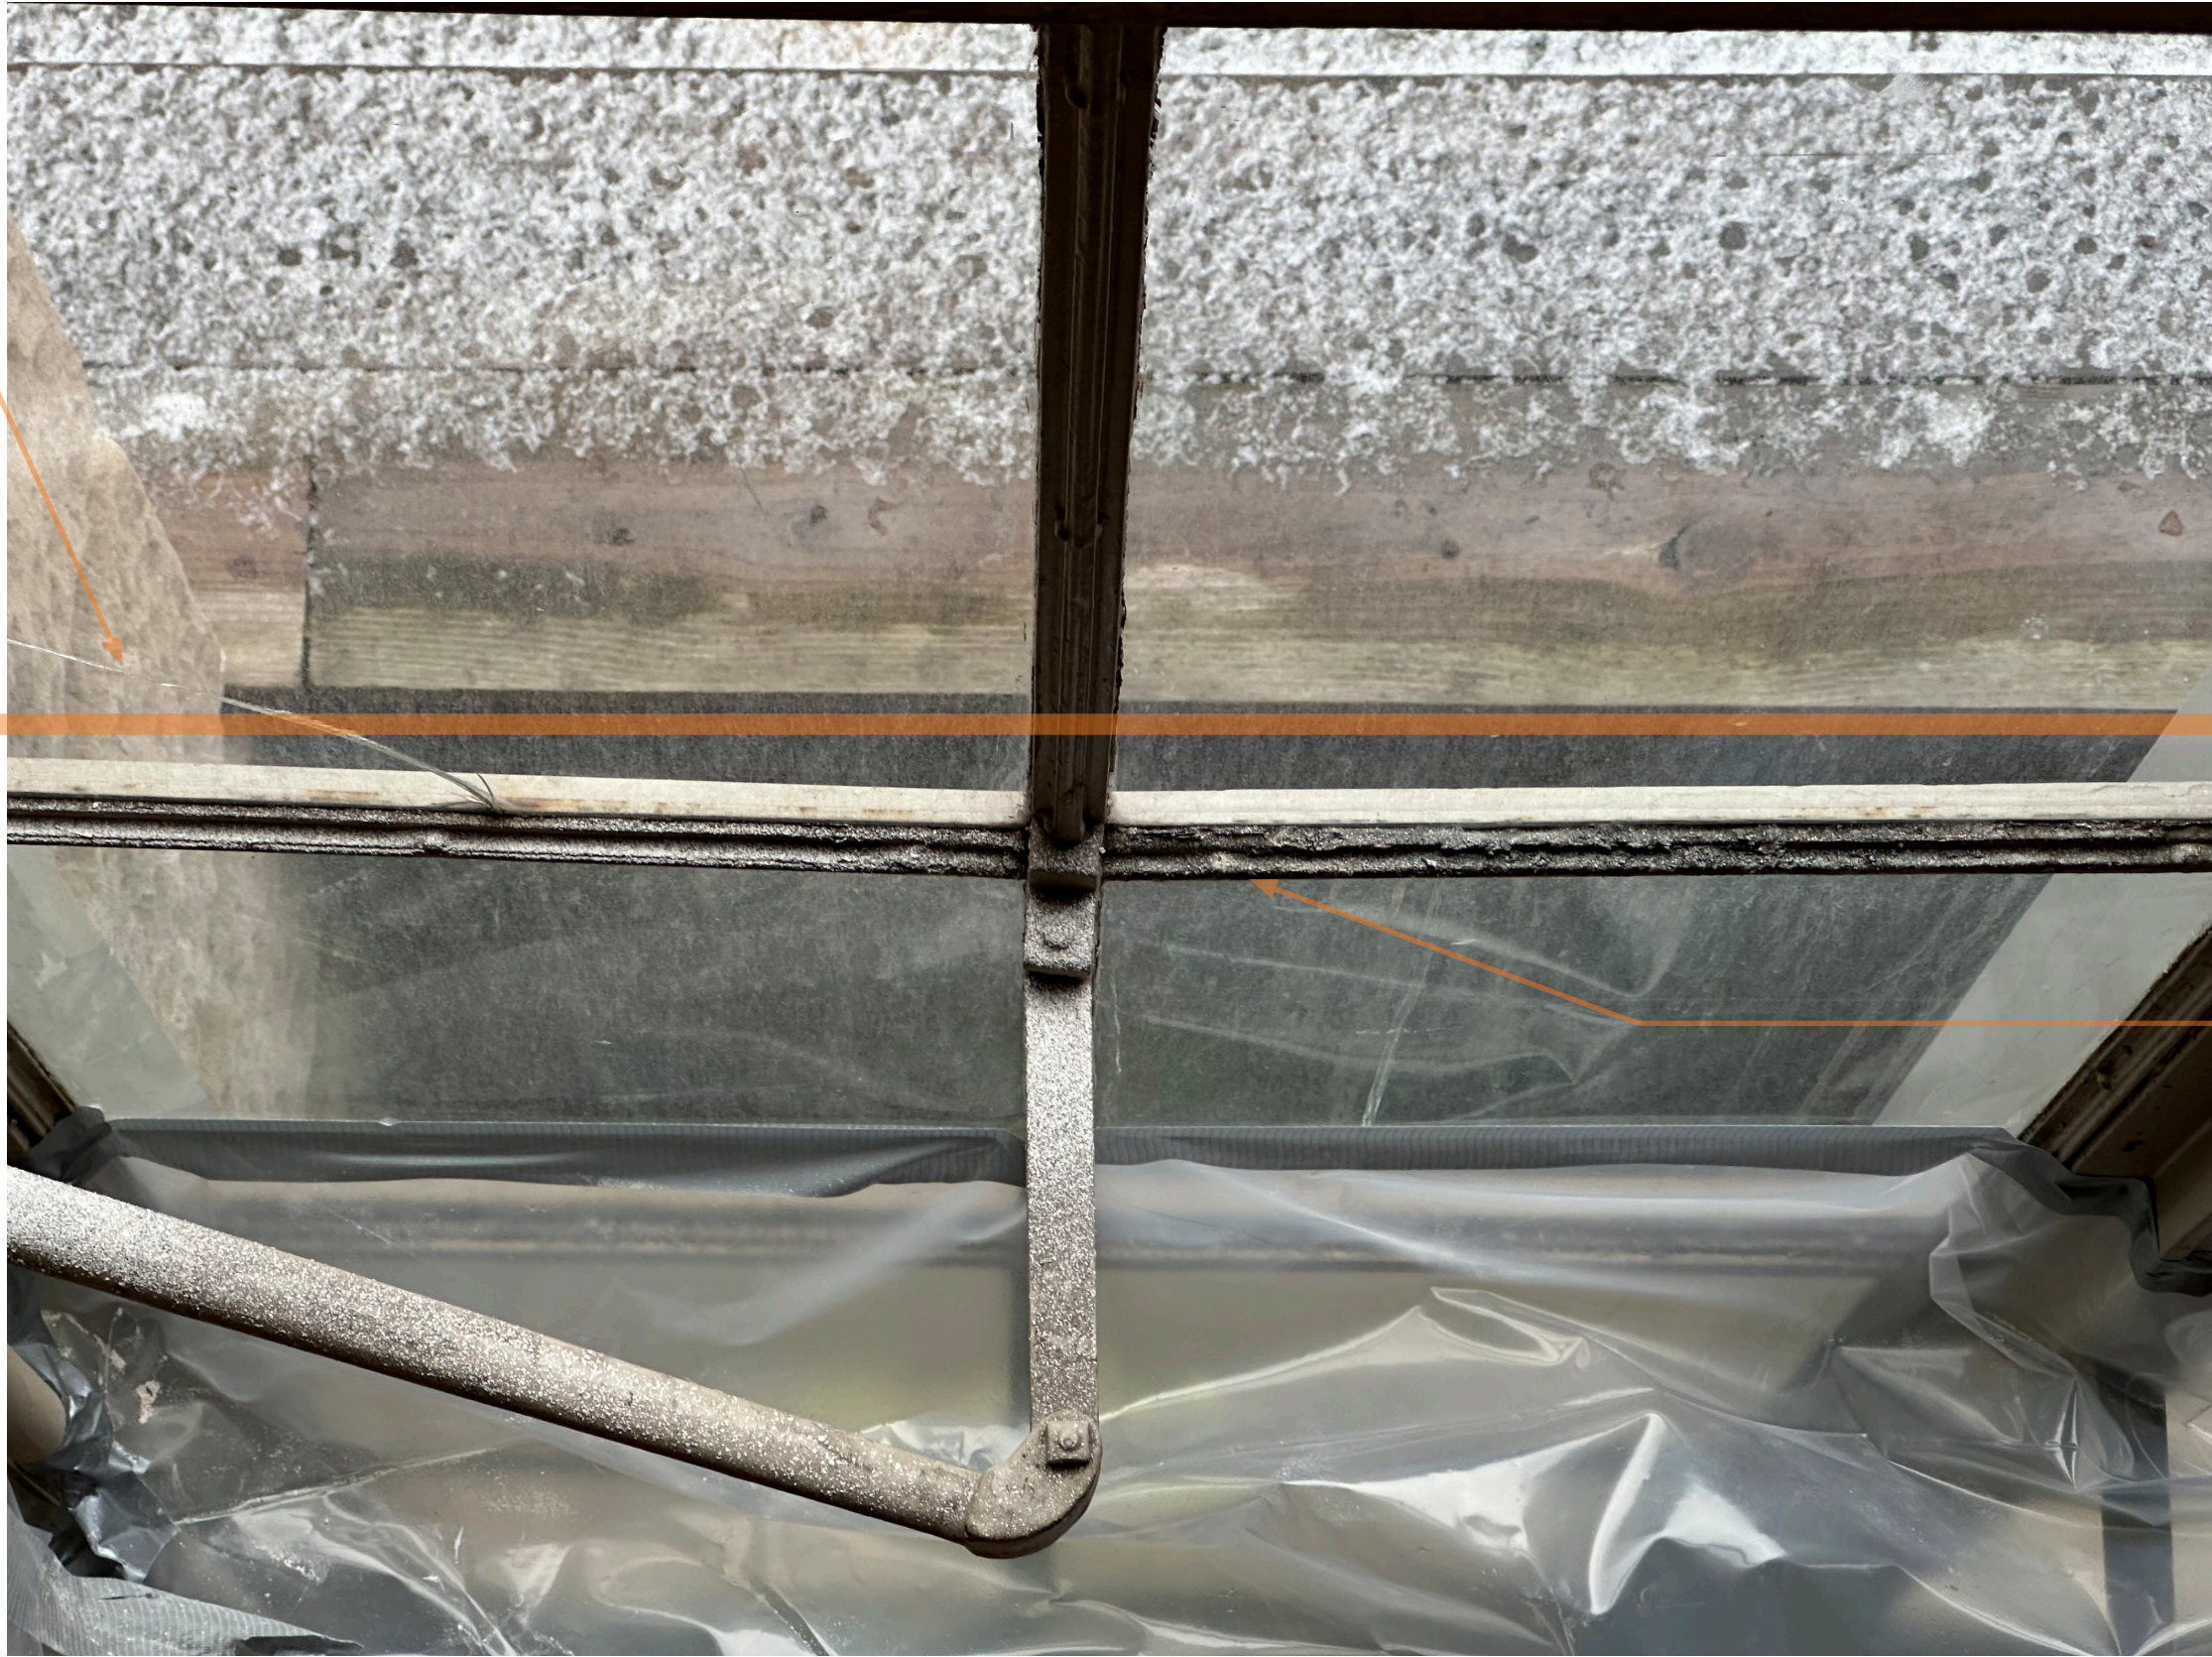
Bent muntins  
from operator

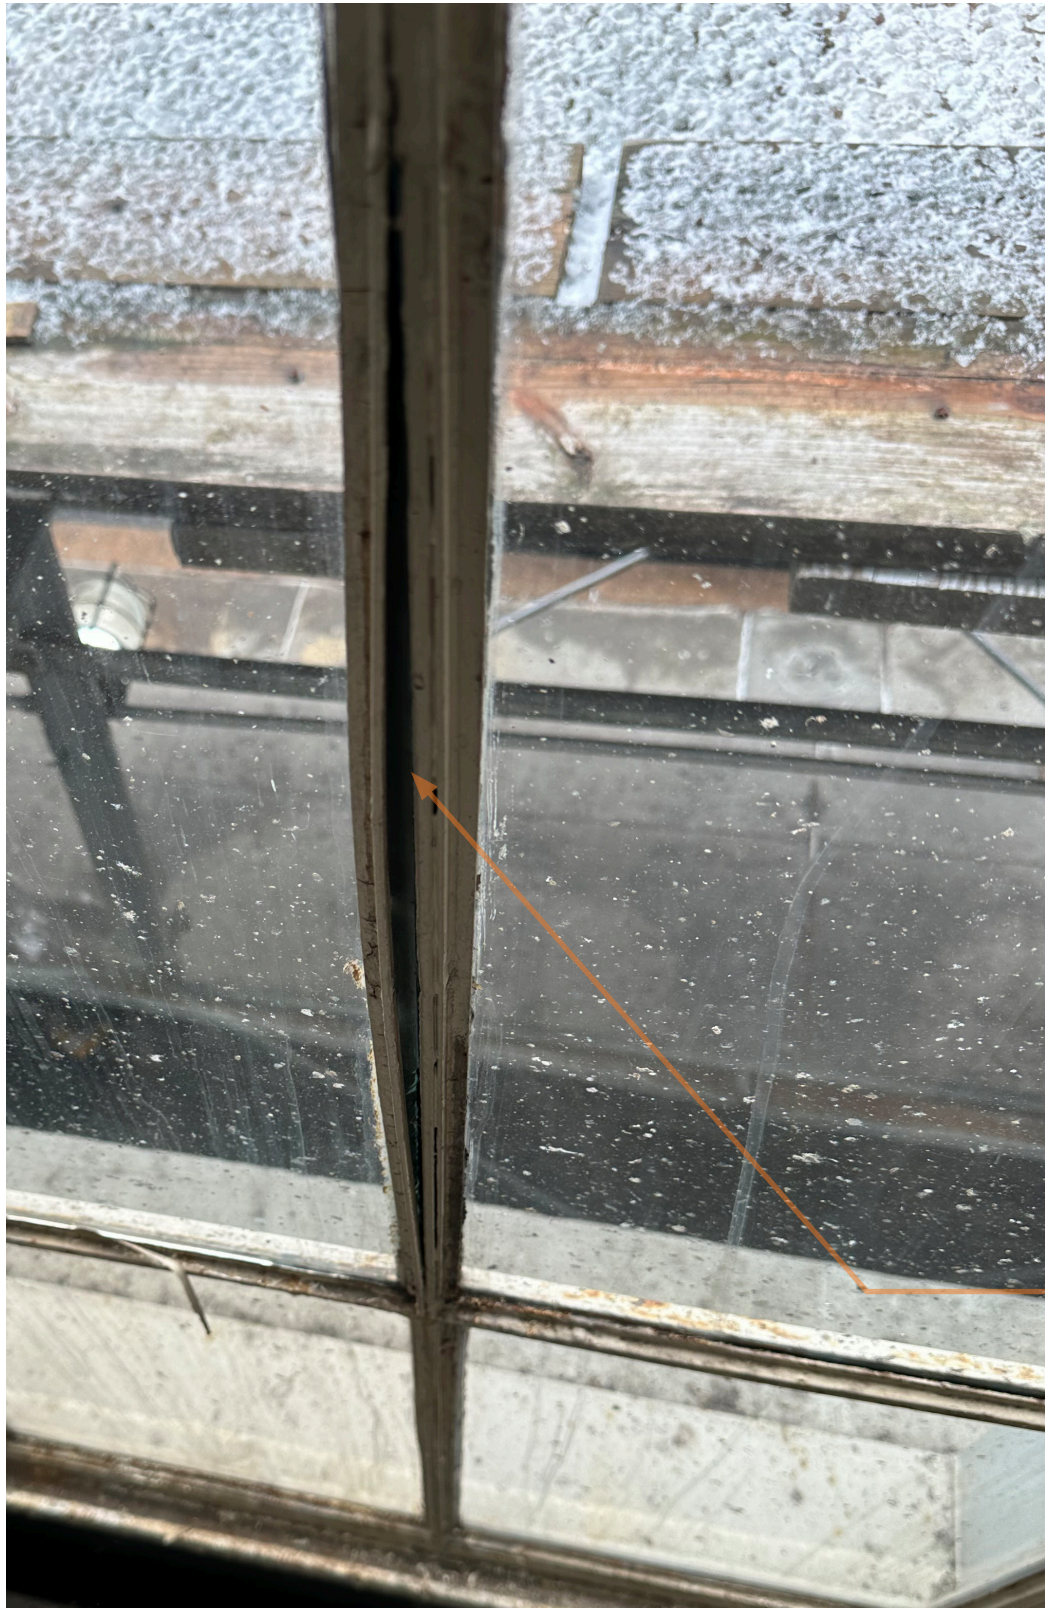
Bent vertical window stops / rust jacking

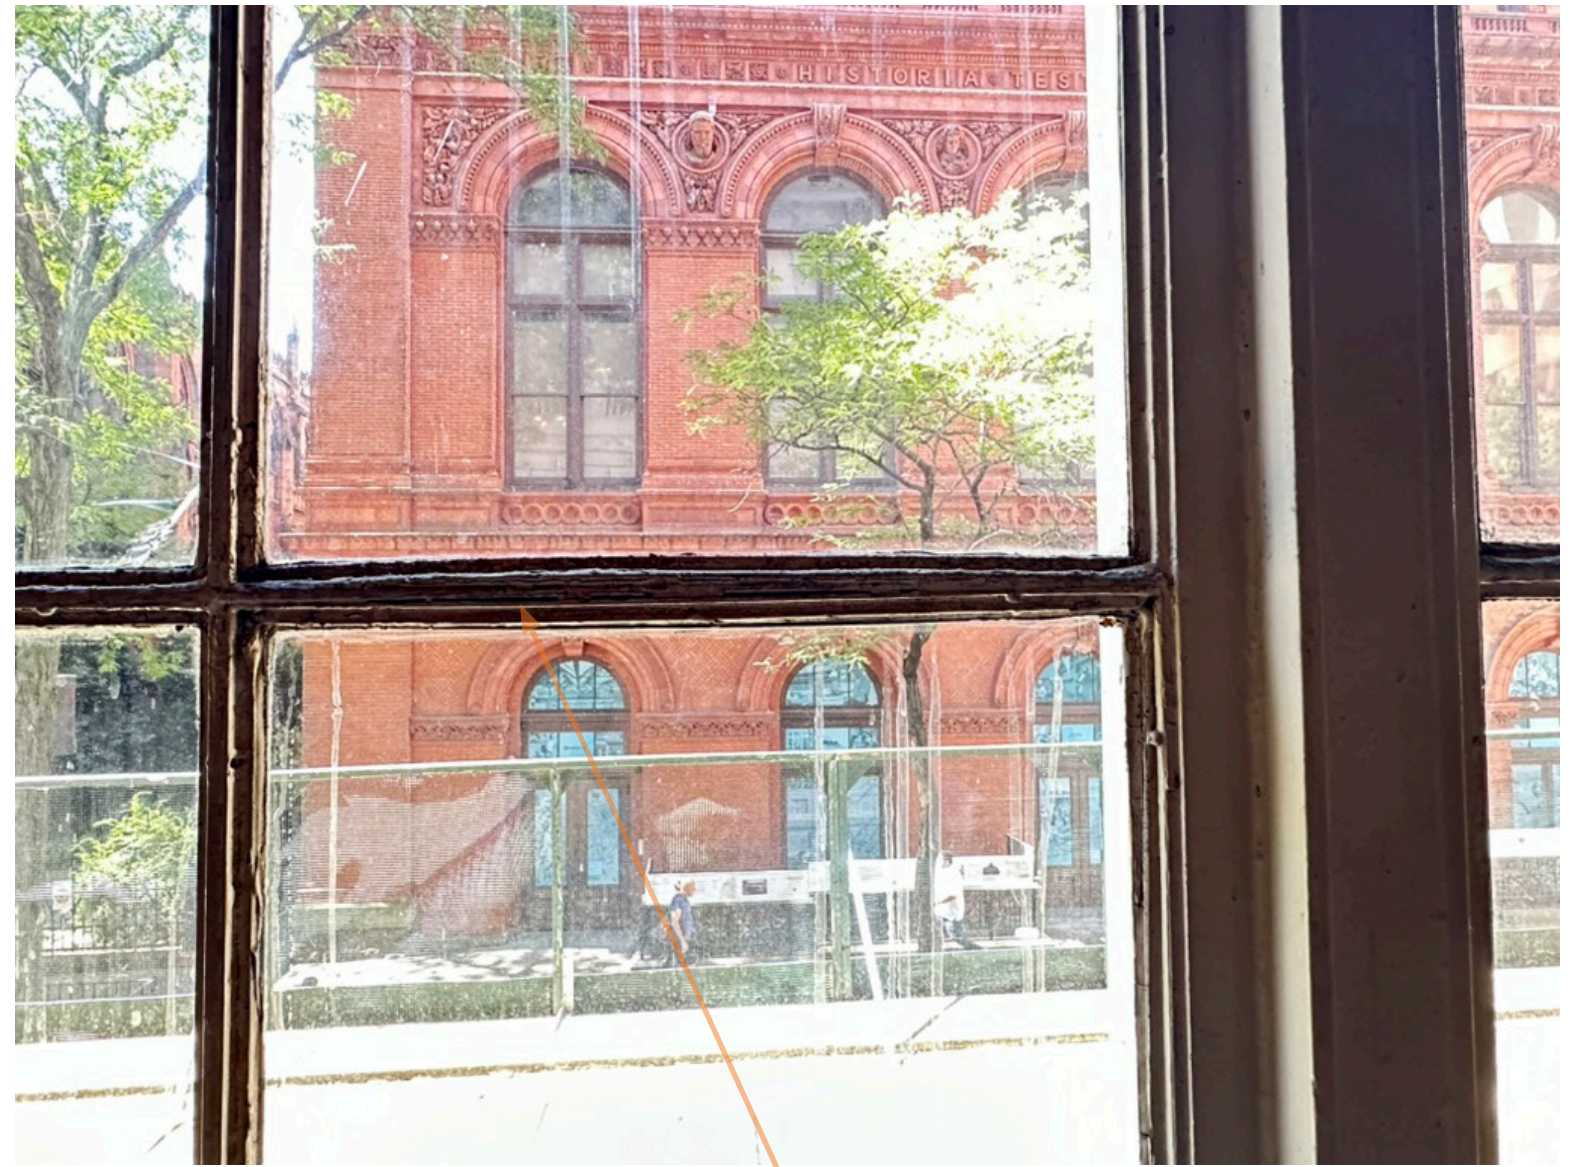
Bent horizontal window stops / rust jacking

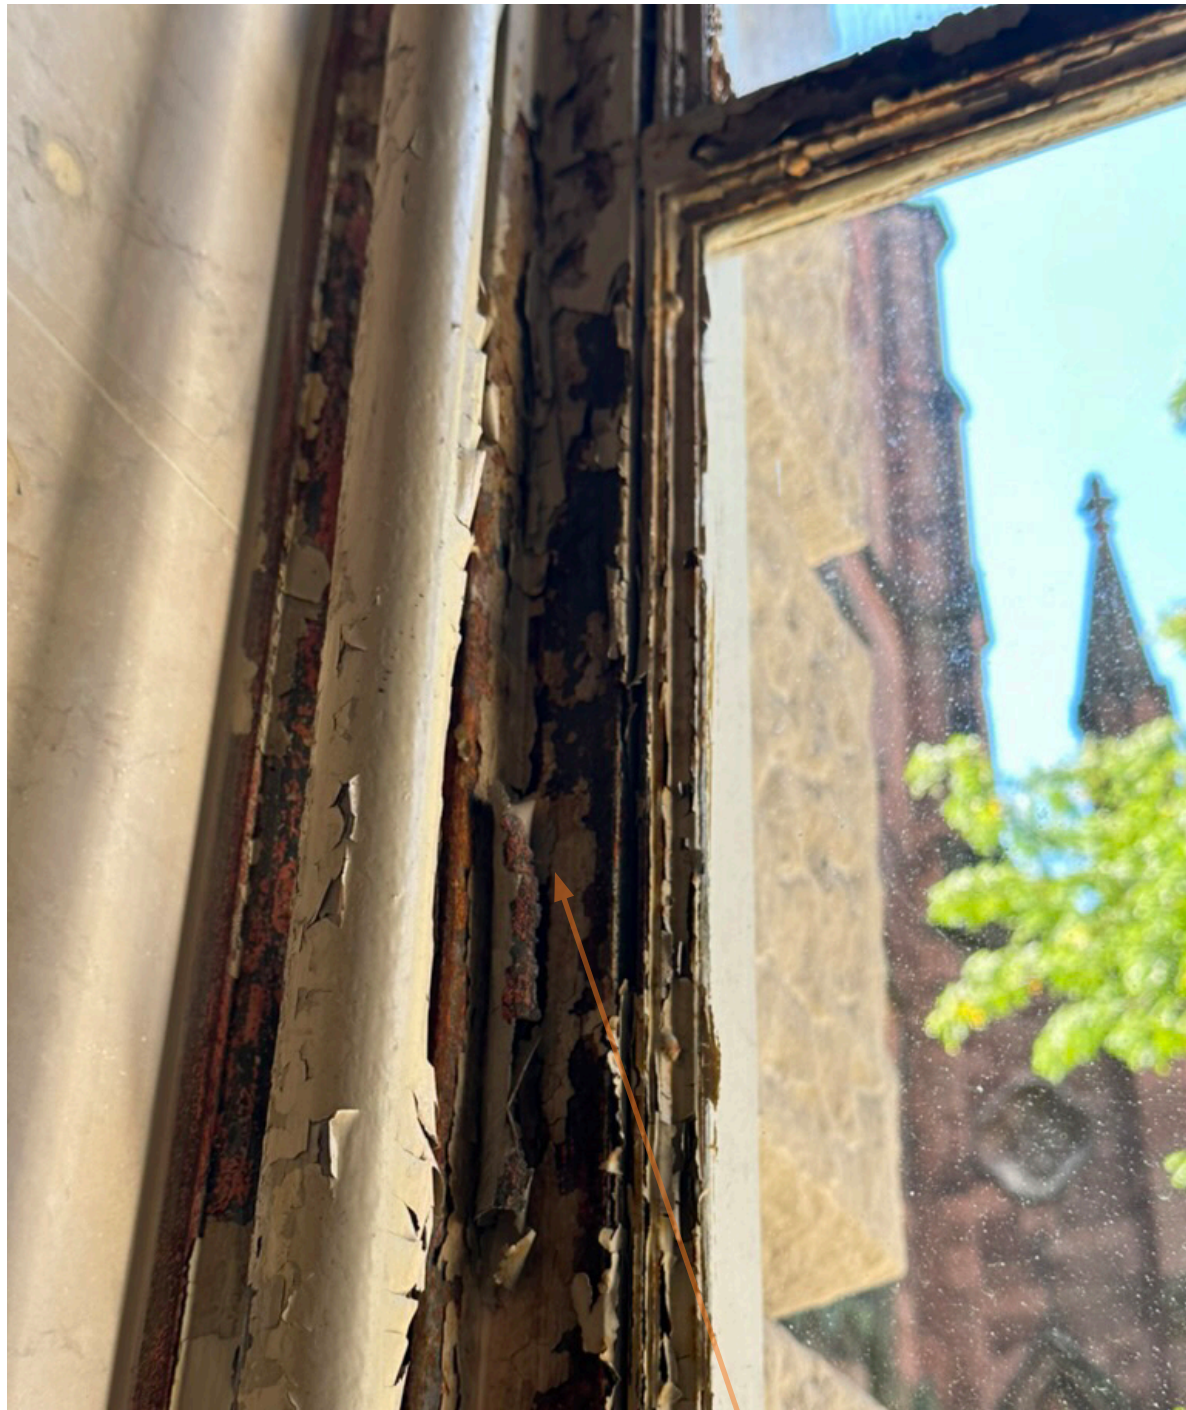
Windows 5, 6, 7 with severe paint peeling and corrosion

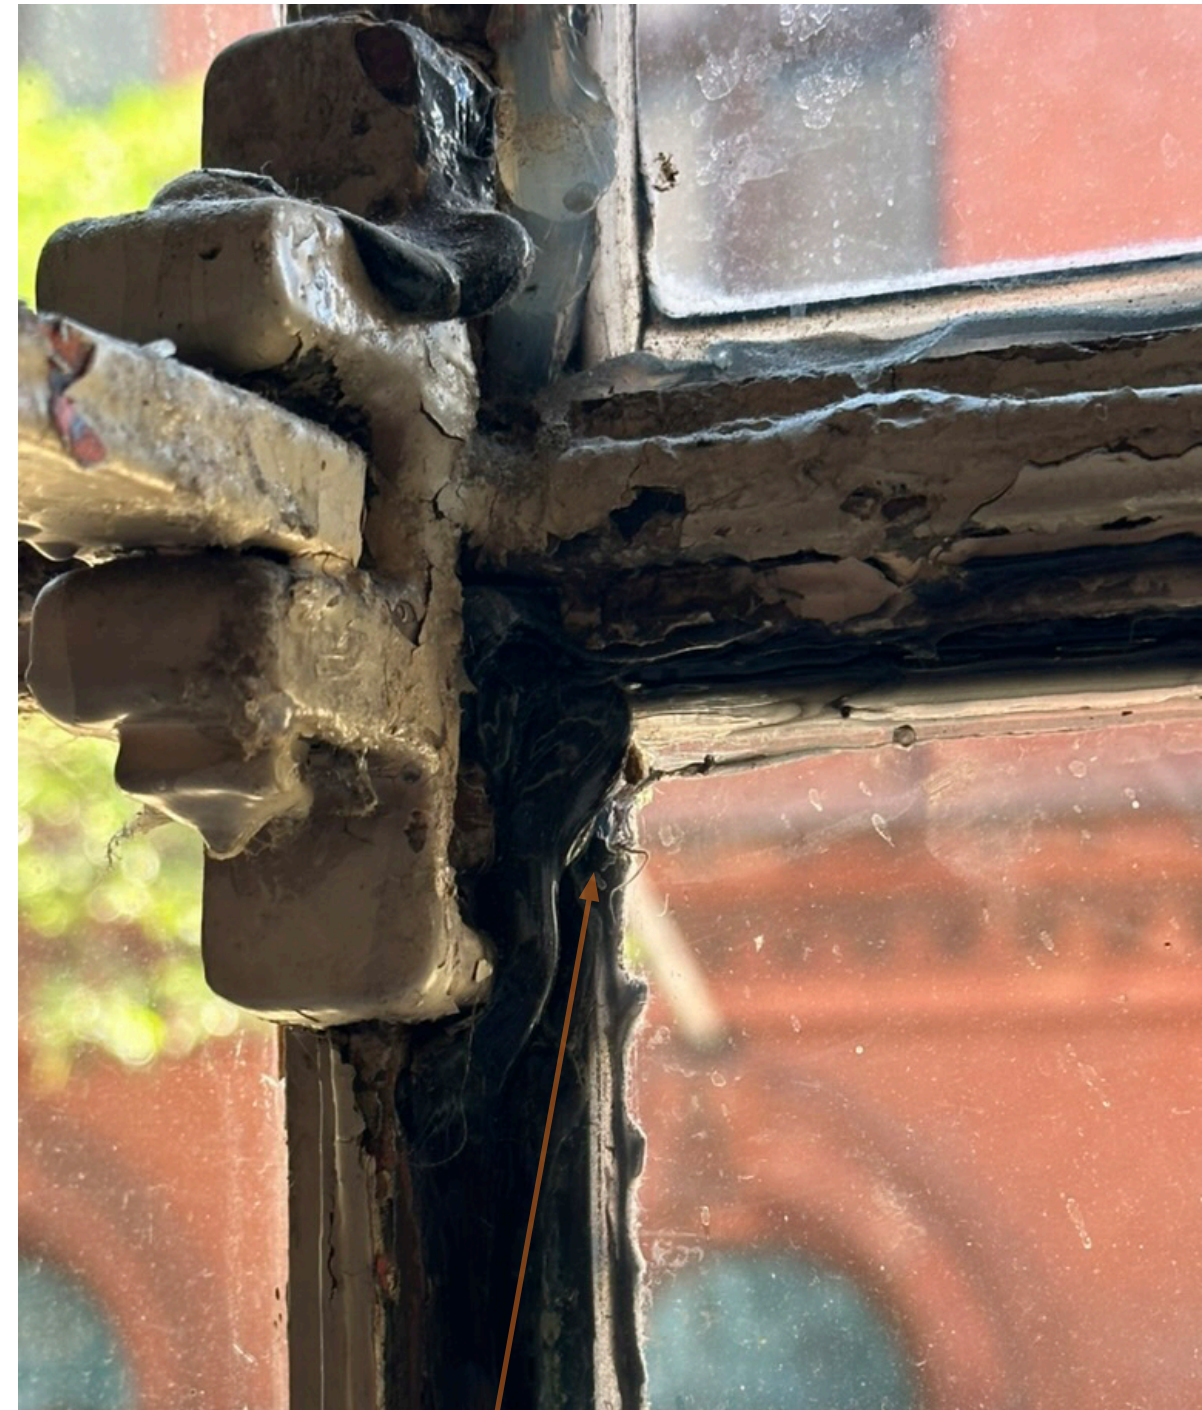
Window frame stops missing and replacement glass is caulked in

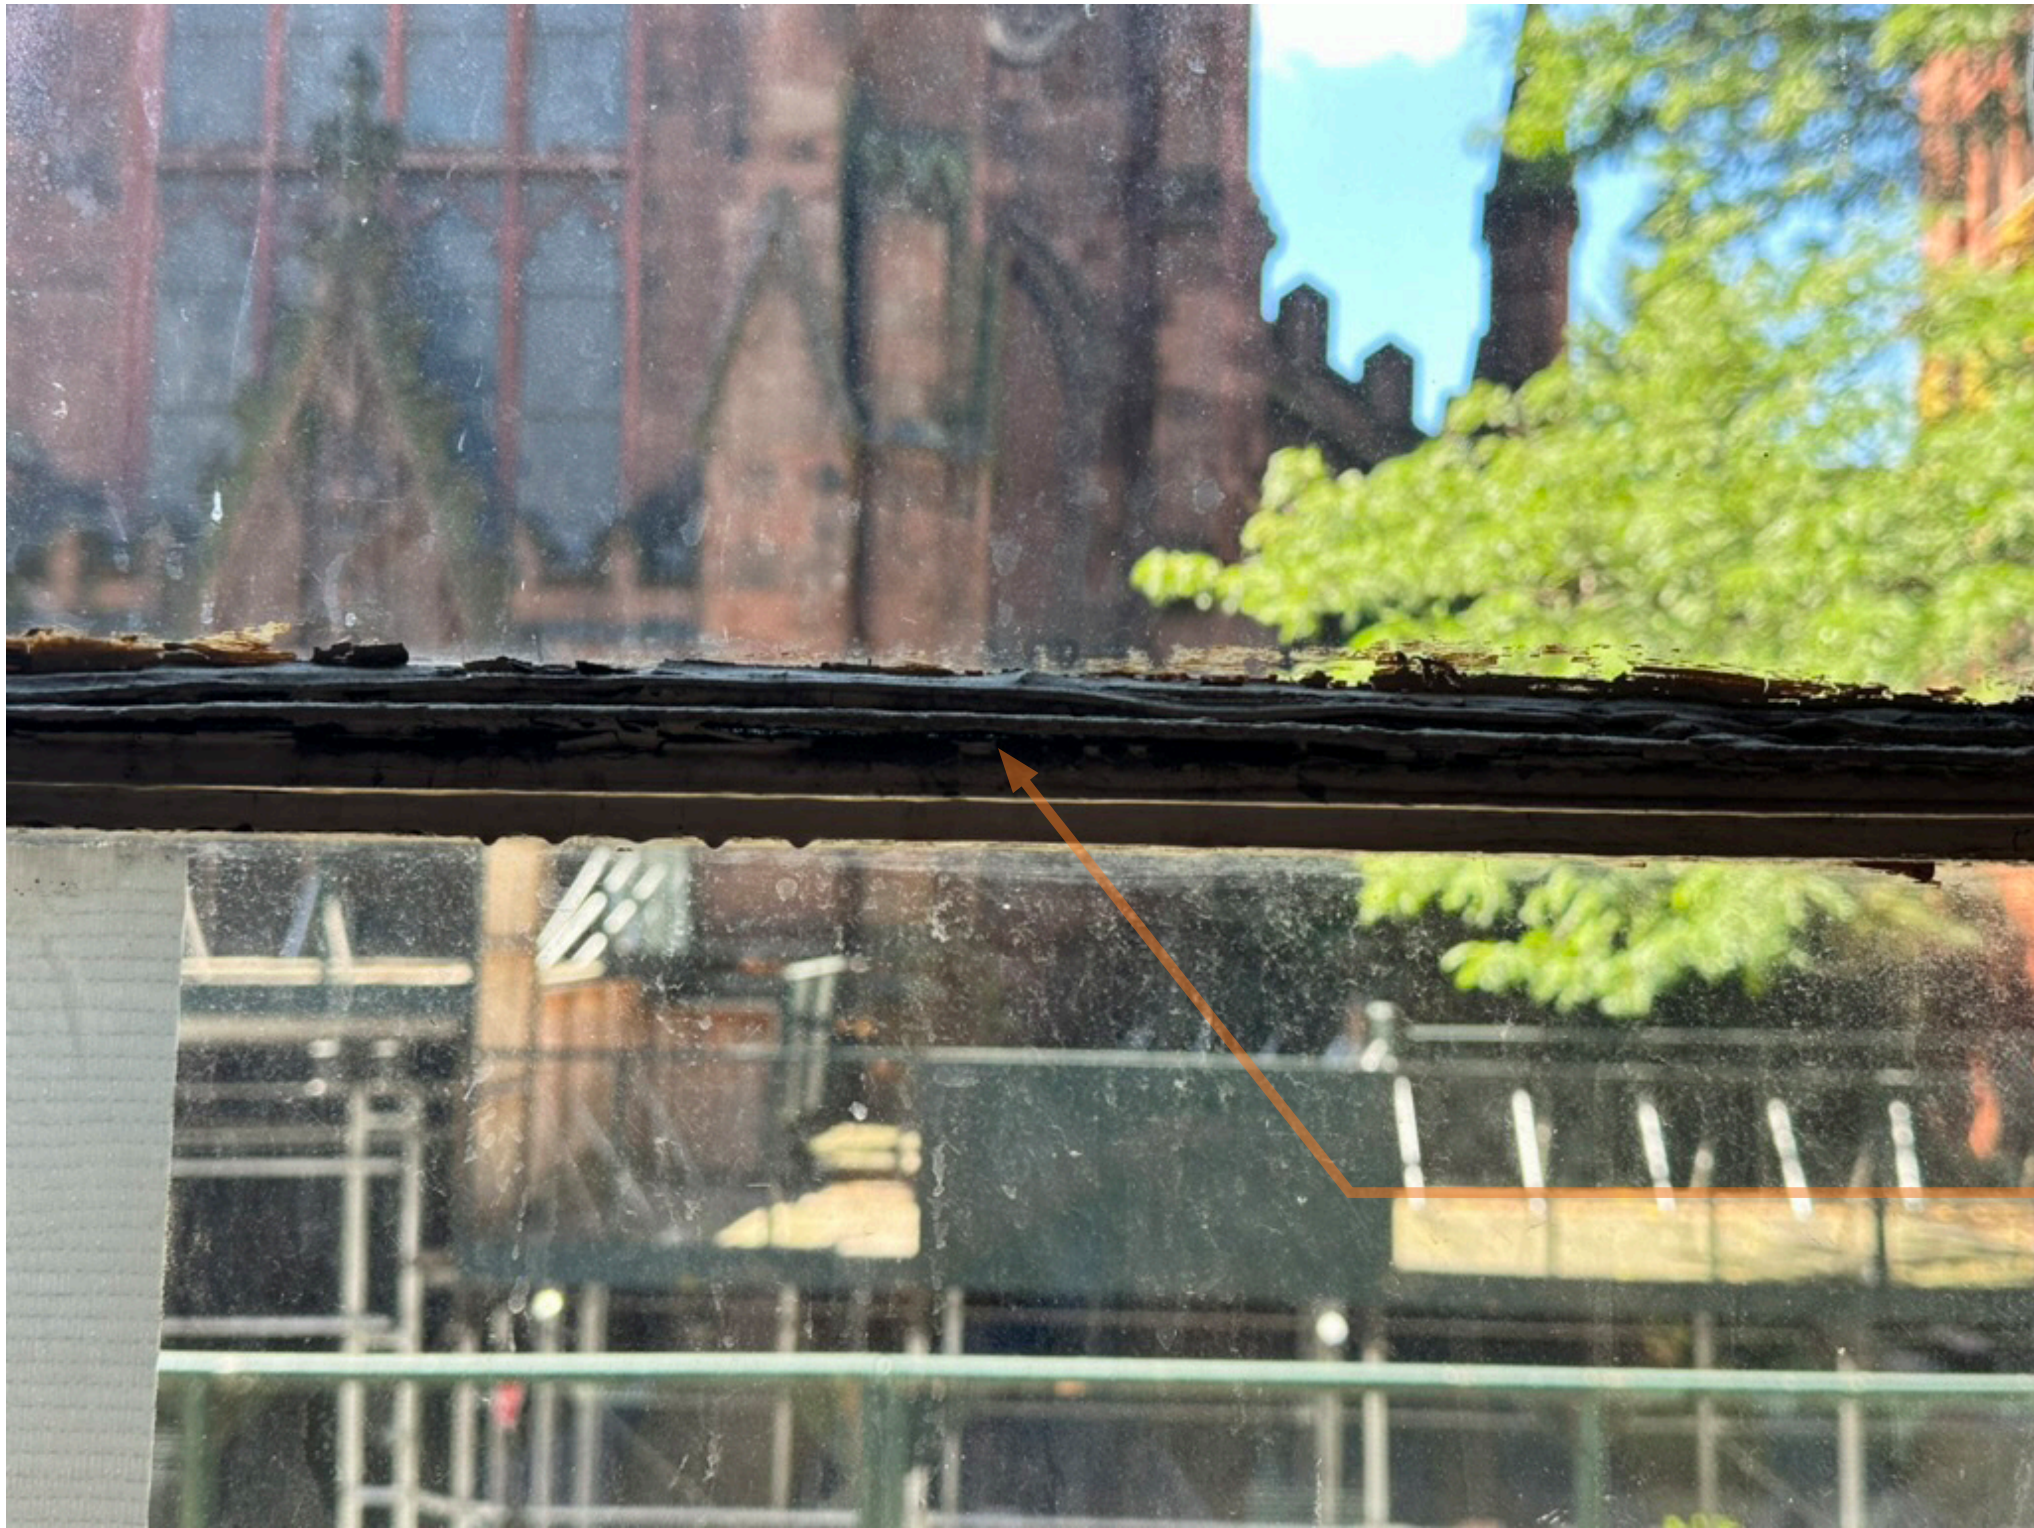
Bent muntin framing with rust jacking and ad hoc caulk repair
