**177 Montague Street, aka 134-138 Pierrepont Street – Brooklyn  
Trust Company Building – Individual and Interior Landmark  
Borough of Brooklyn**

177 Montague Street  
(aka The Brooklyn Trust  
Company Building)

Arched Window Repair/  
Replacement

LPC Presentation

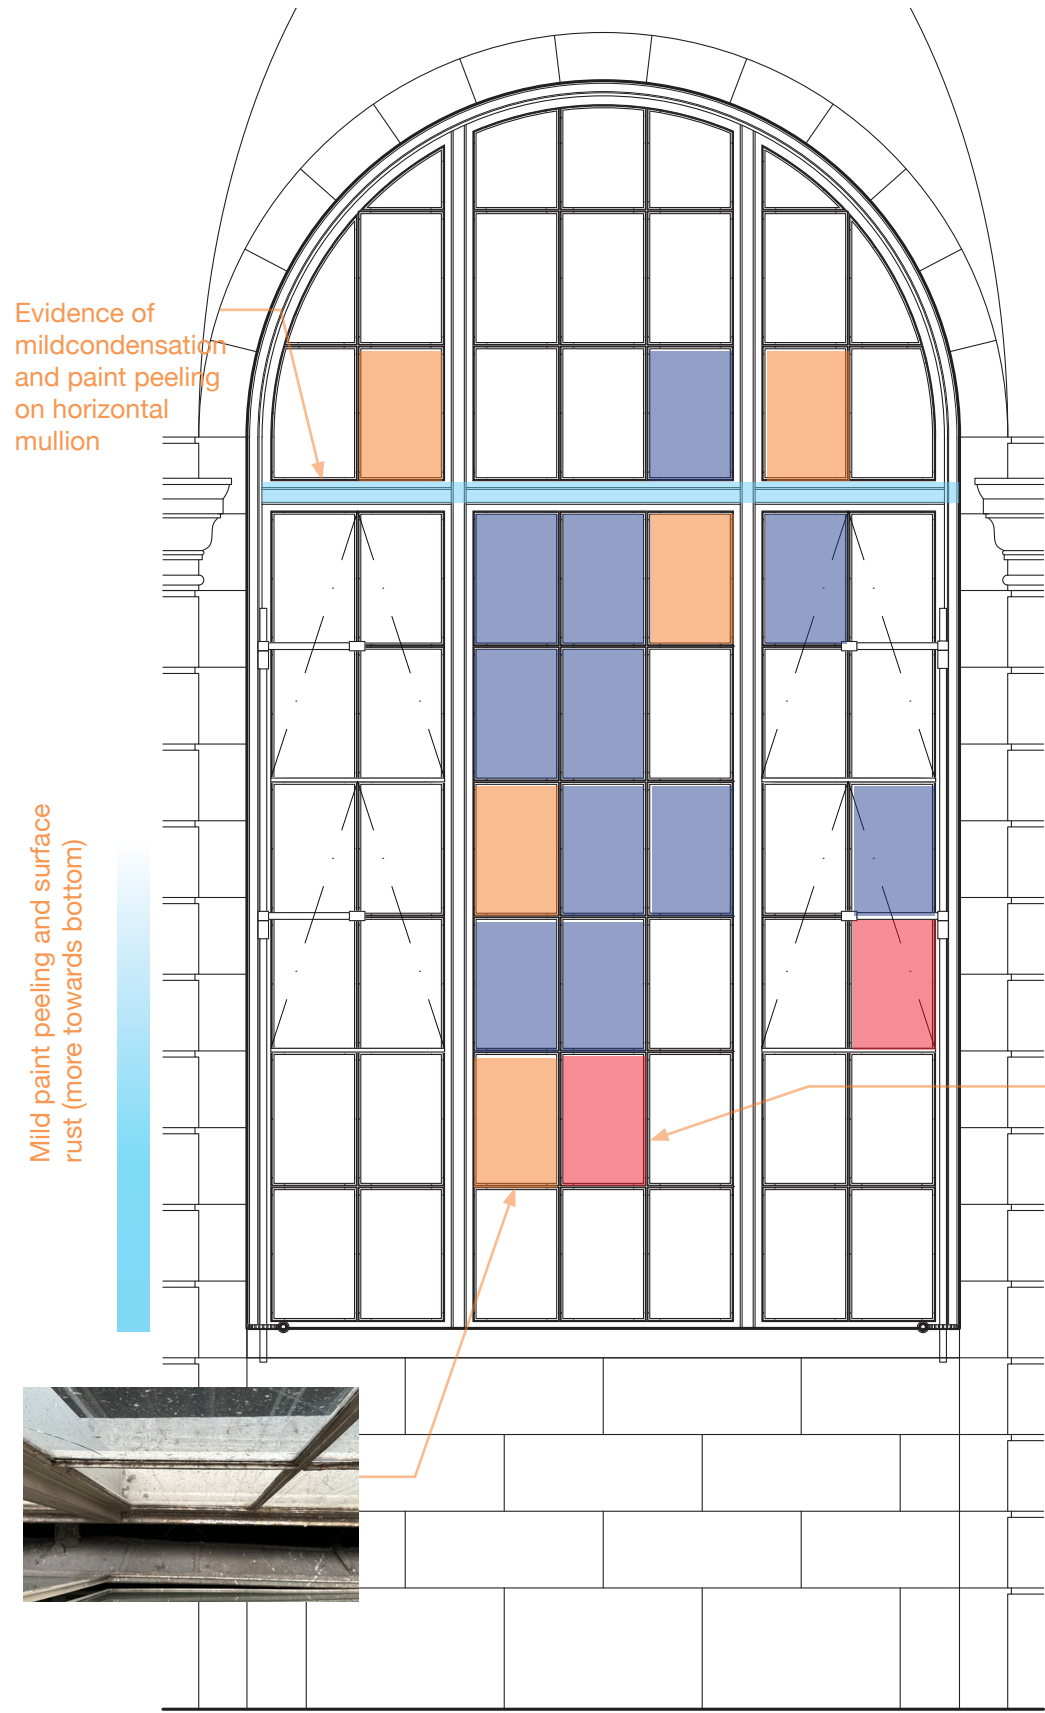
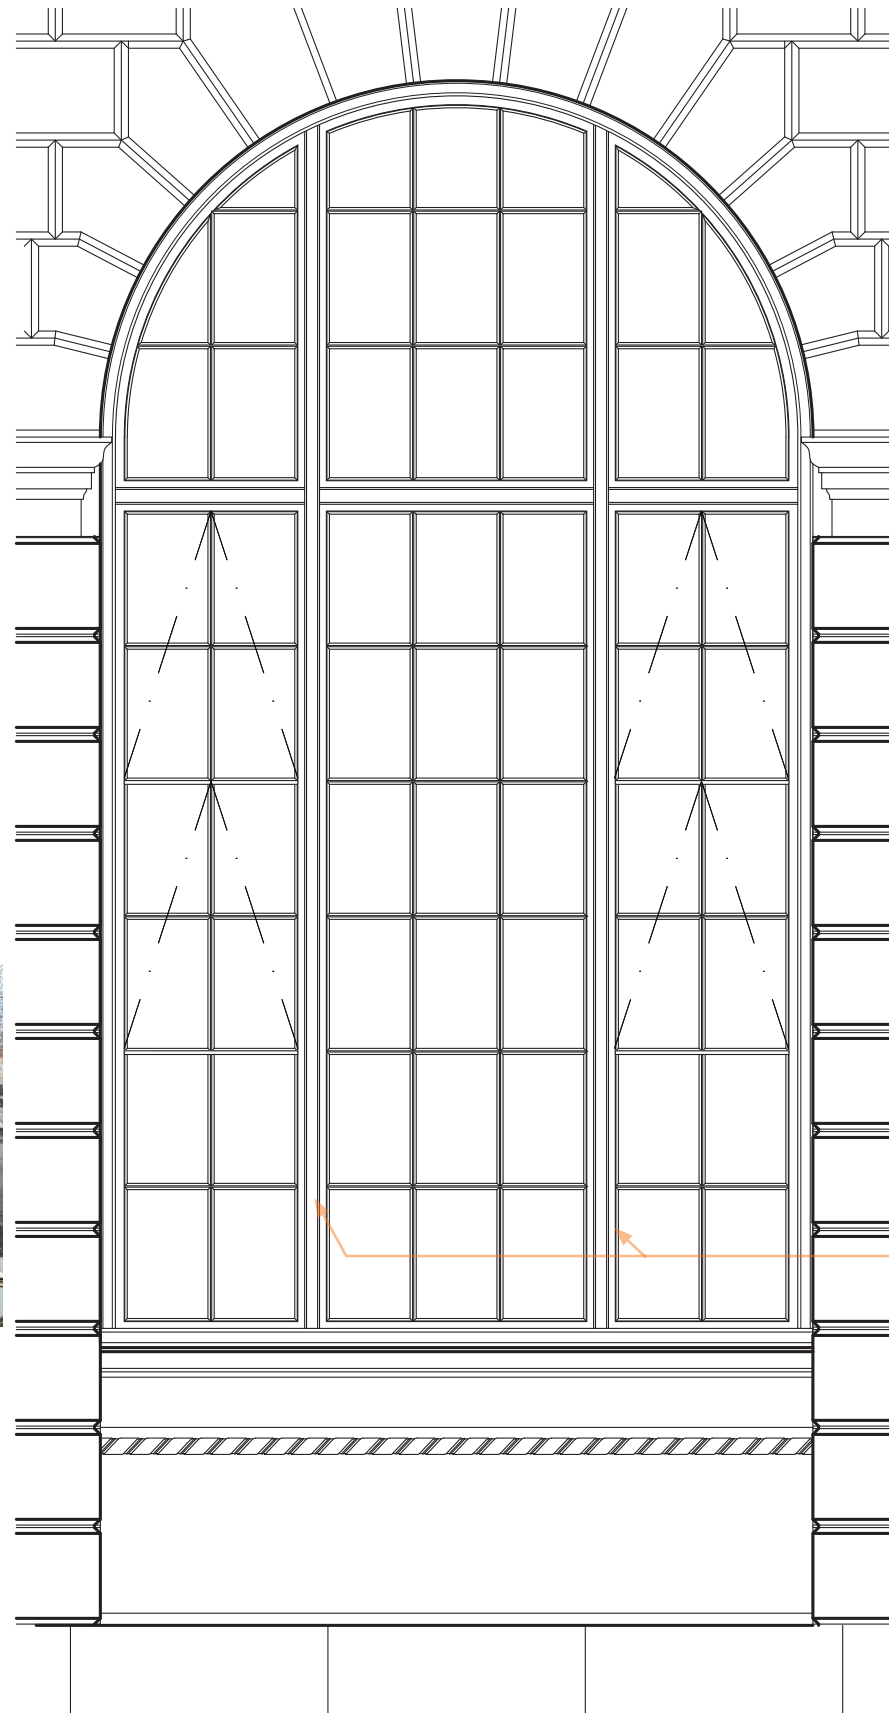
Window 1 Existing Conditions (Other Windows Similar)  
 177 Montague Street Arched Window Repair/Replacement  
 Initial LPC Presentation

- Angle frame glazing stop is missing. Ill fitting glass and substandard caulking installed.
- Angle frame glazing stop is damaged: bowed, bent or broken. Rust jacking may be one of the causes
- Glass is cracked, or glass has been replaced very poorly (bad fit, sloppy caulking)
- Severe issue, see note
- General indication of rust and peeling paint

Lower side plates of vertical mullions to be removed; Rust to be scraped and ground smooth. Rust inhibitor to be applied before reattaching side plates. Typical for all.

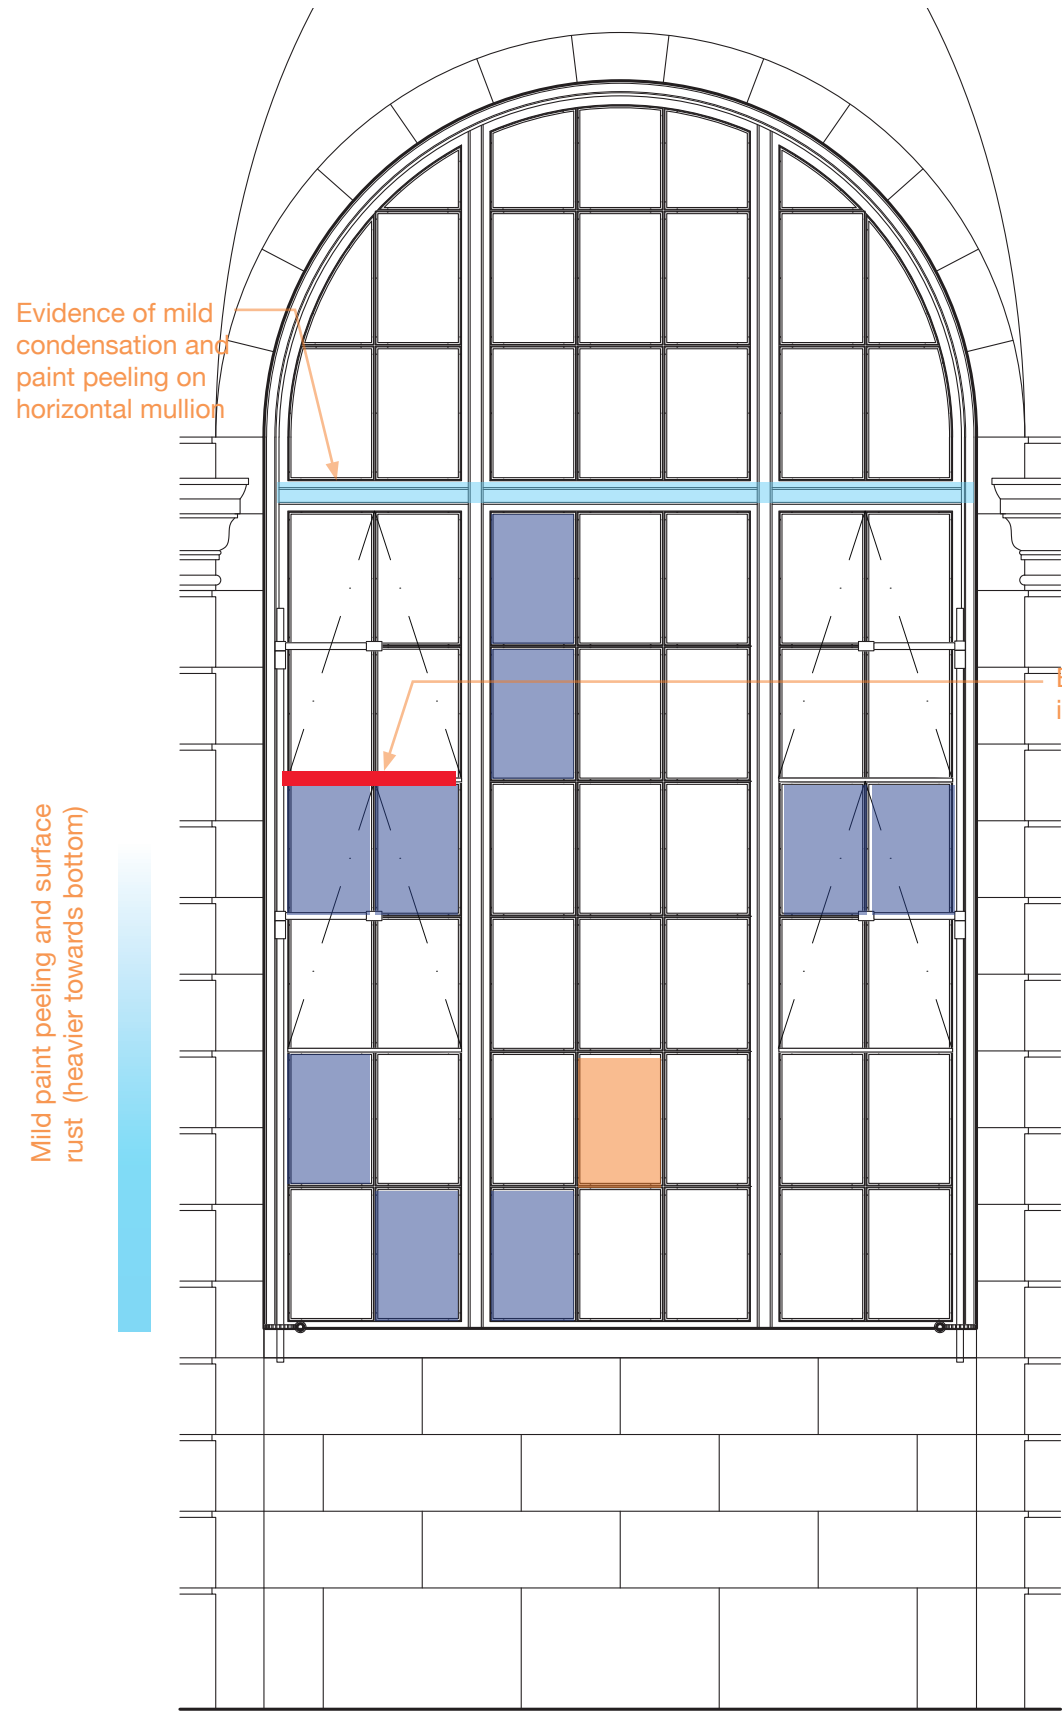
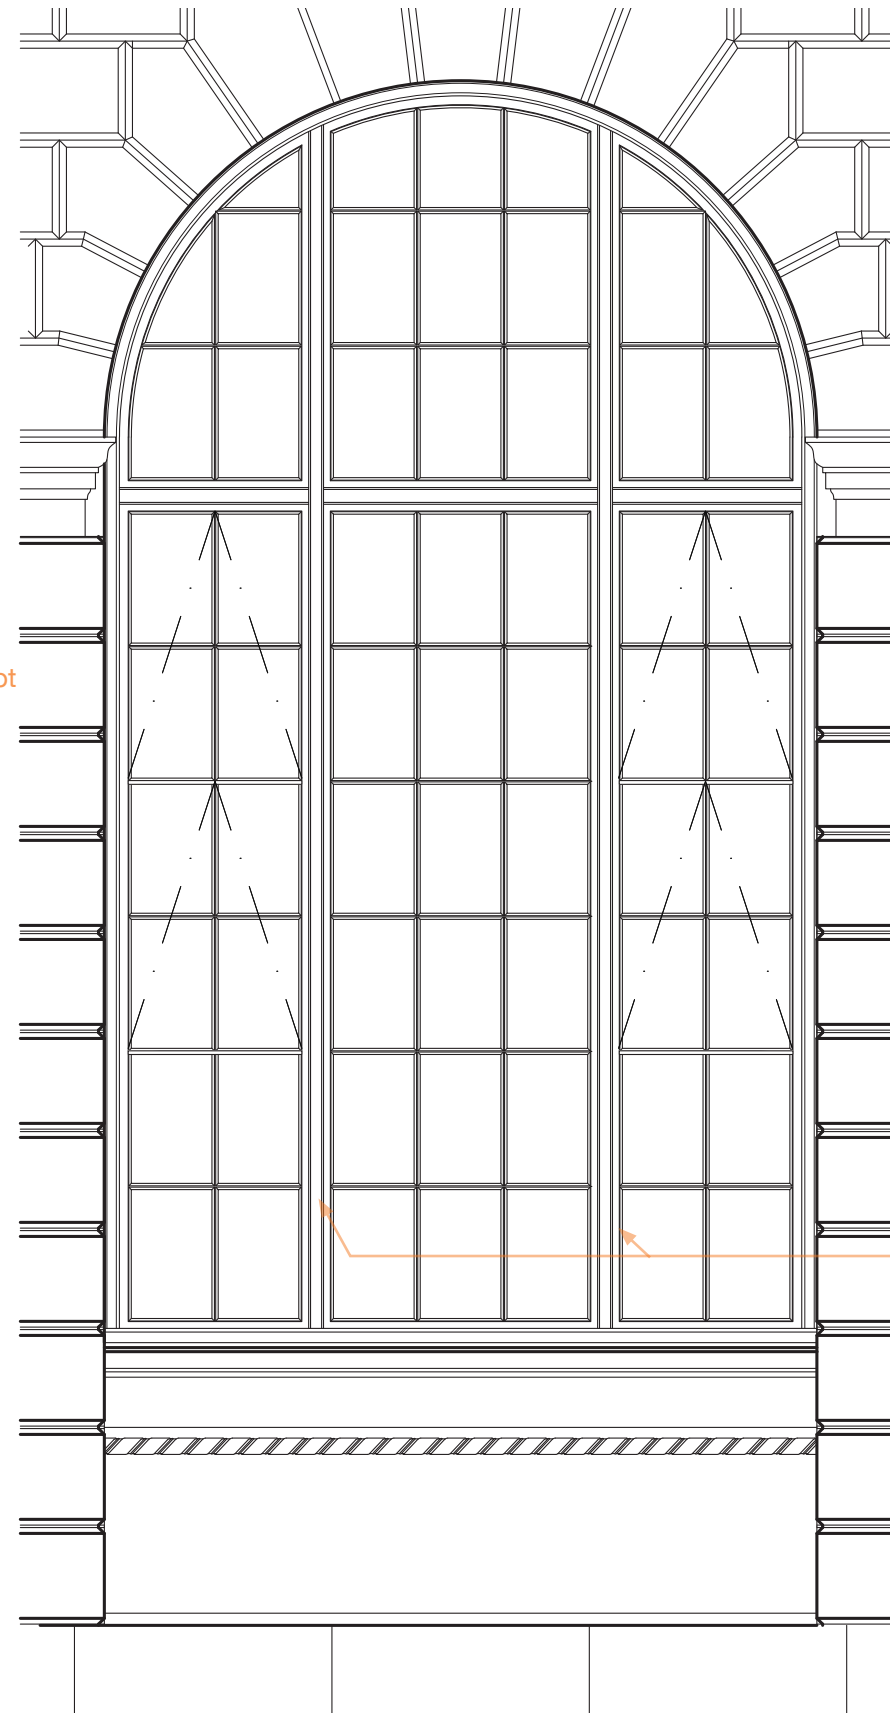
Window 2 Existing Conditions

- Angle frame glazing stop is missing. Ill fitting glass and substandard caulking installed.
- Angle frame glazing stop is damaged: bowed, bent or broken. Rust jacking may be one of the causes
- Glass is cracked, or glass has been replaced very poorly (bad fit, sloppy caulking)
- Severe issue, see note
- General indication of rust and peeling paint

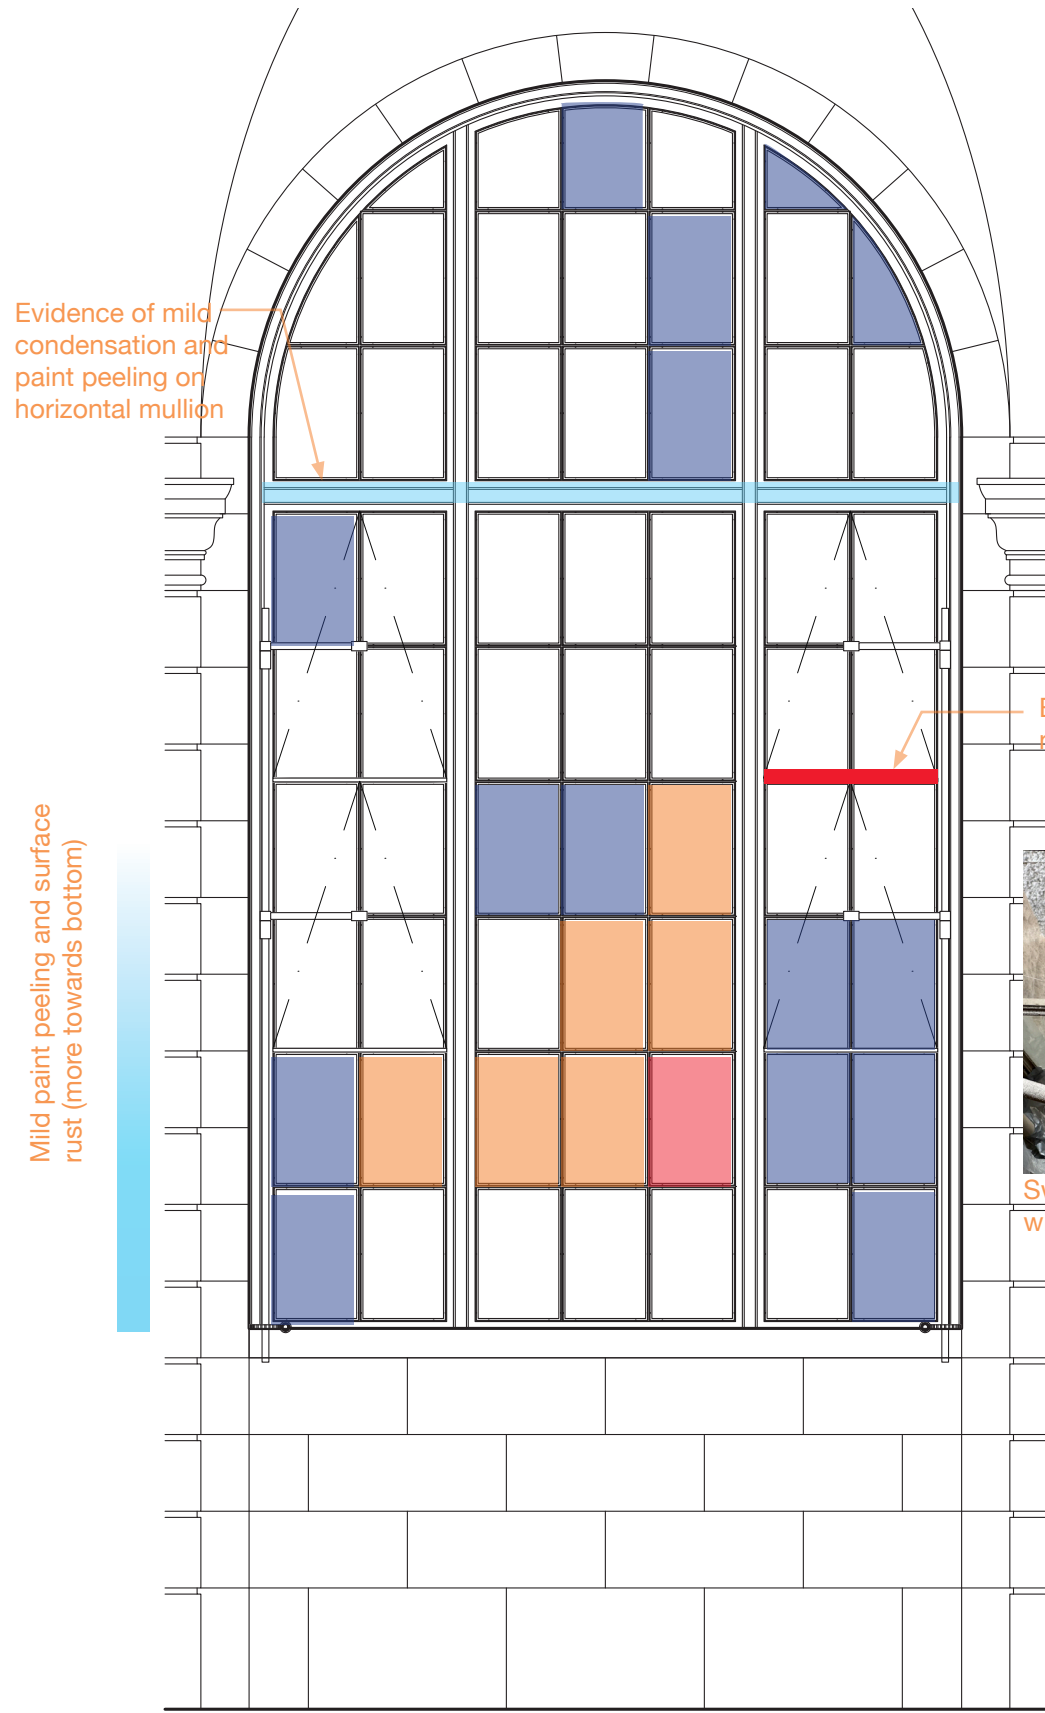
Evidence of mild condensation and paint peeling on horizontal mullion

Mild paint peeling and surface rust (more towards bottom)

Bottom of awning window does not meet frame, large air gap

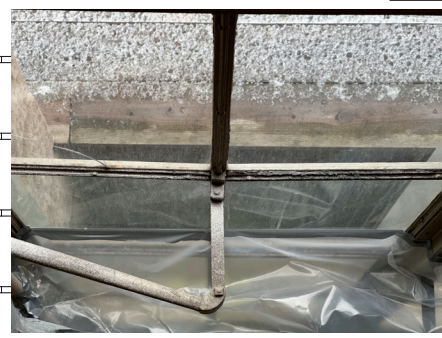
Swing Arm deforming awning window

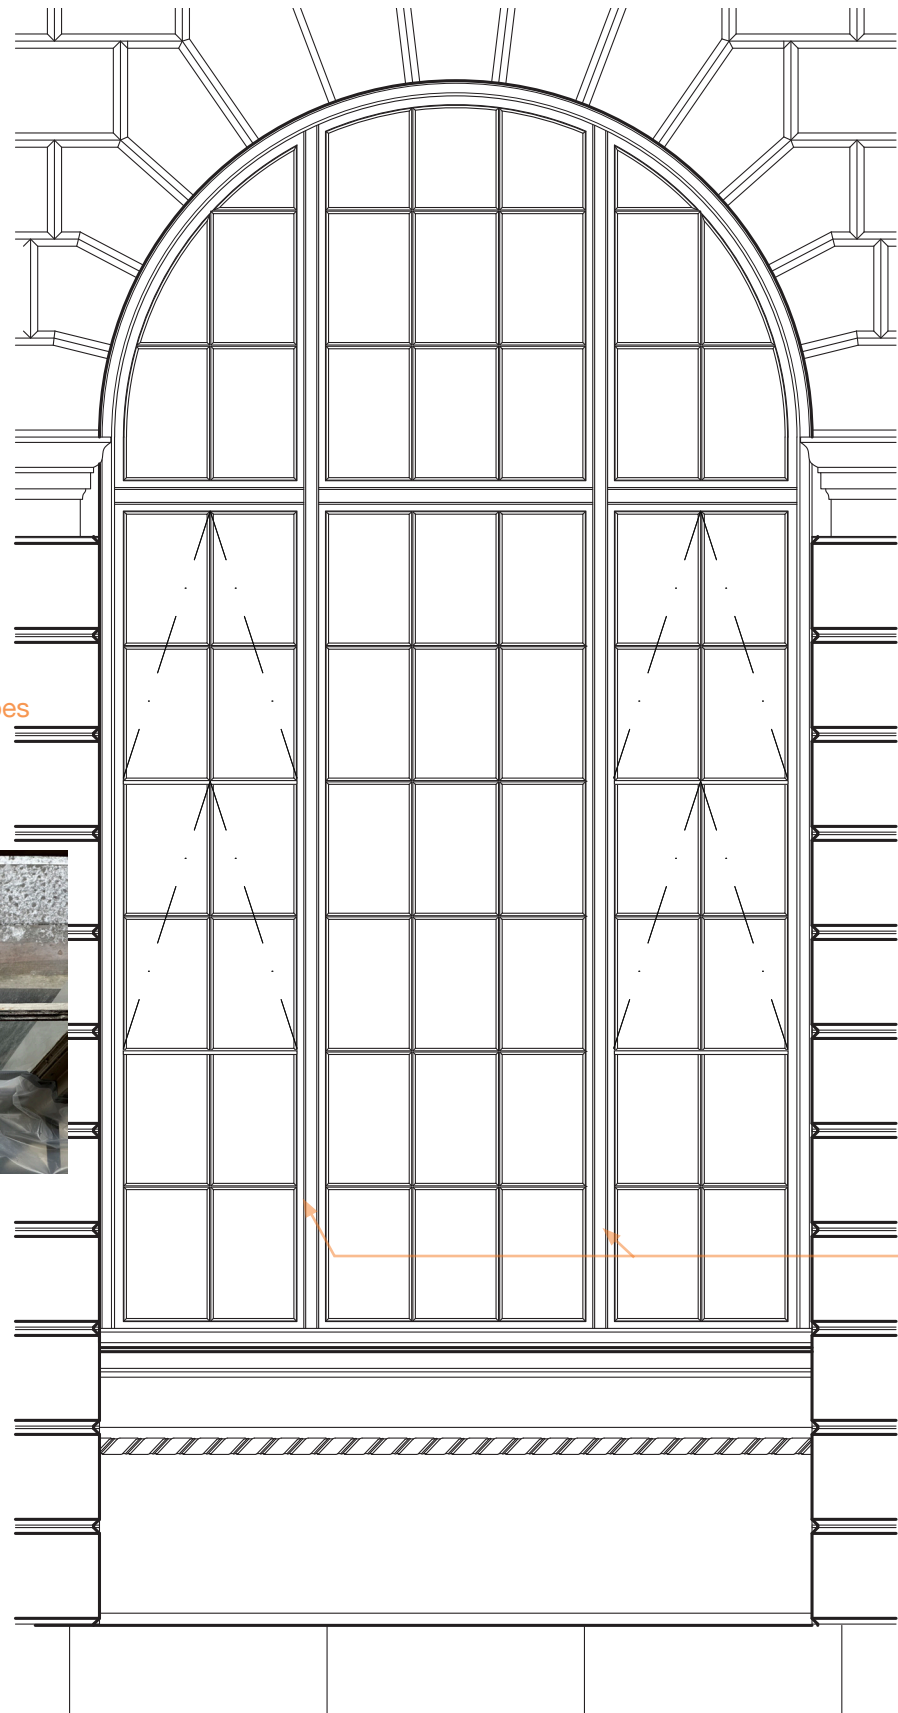
Window 3 Existing Conditions

- Angle frame glazing stop is missing. Ill fitting glass and substandard caulking installed.
- Angle frame glazing stop is damaged: bowed, bent or broken. Rust jacking may be one of the causes
- Glass is cracked, or glass has been replaced very poorly (bad fit, sloppy caulking)
- Severe issue, see note
- General indication of rust and peeling paint

Lower side plates of vertical mullions to be removed; Rust to be scraped and ground smooth. Rust inhibitor to be applied before reattaching side plates. Typical for all.

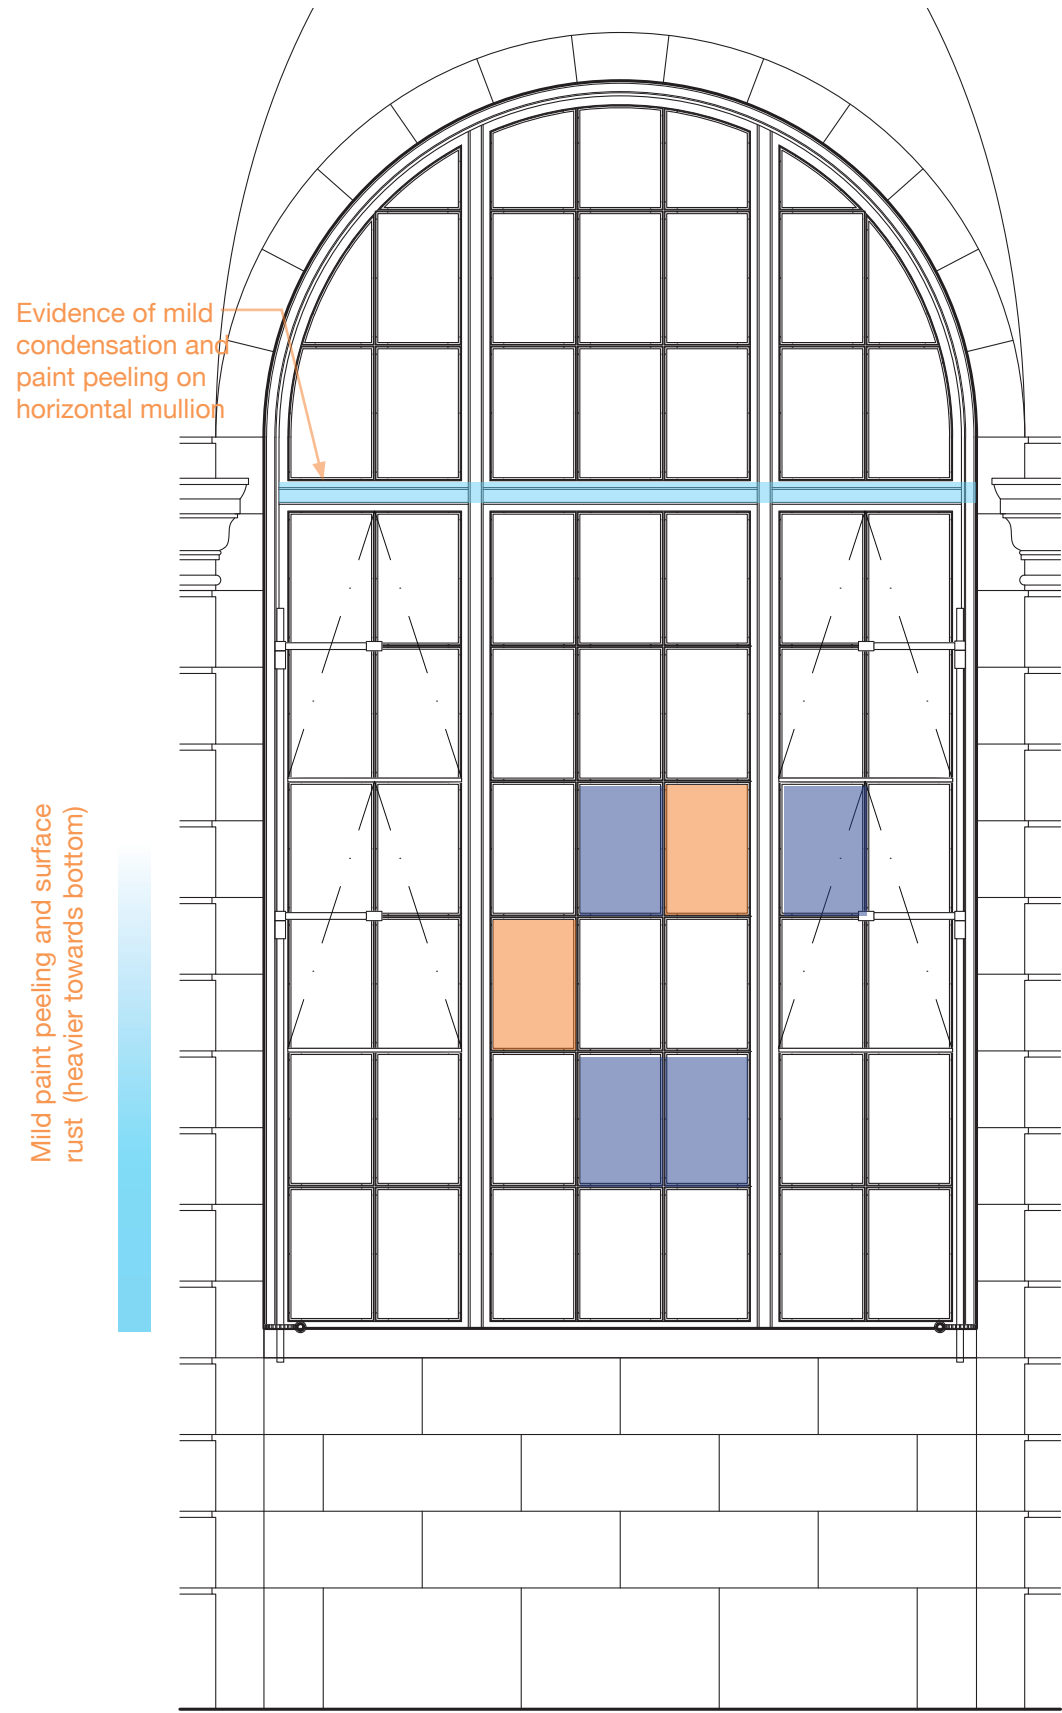
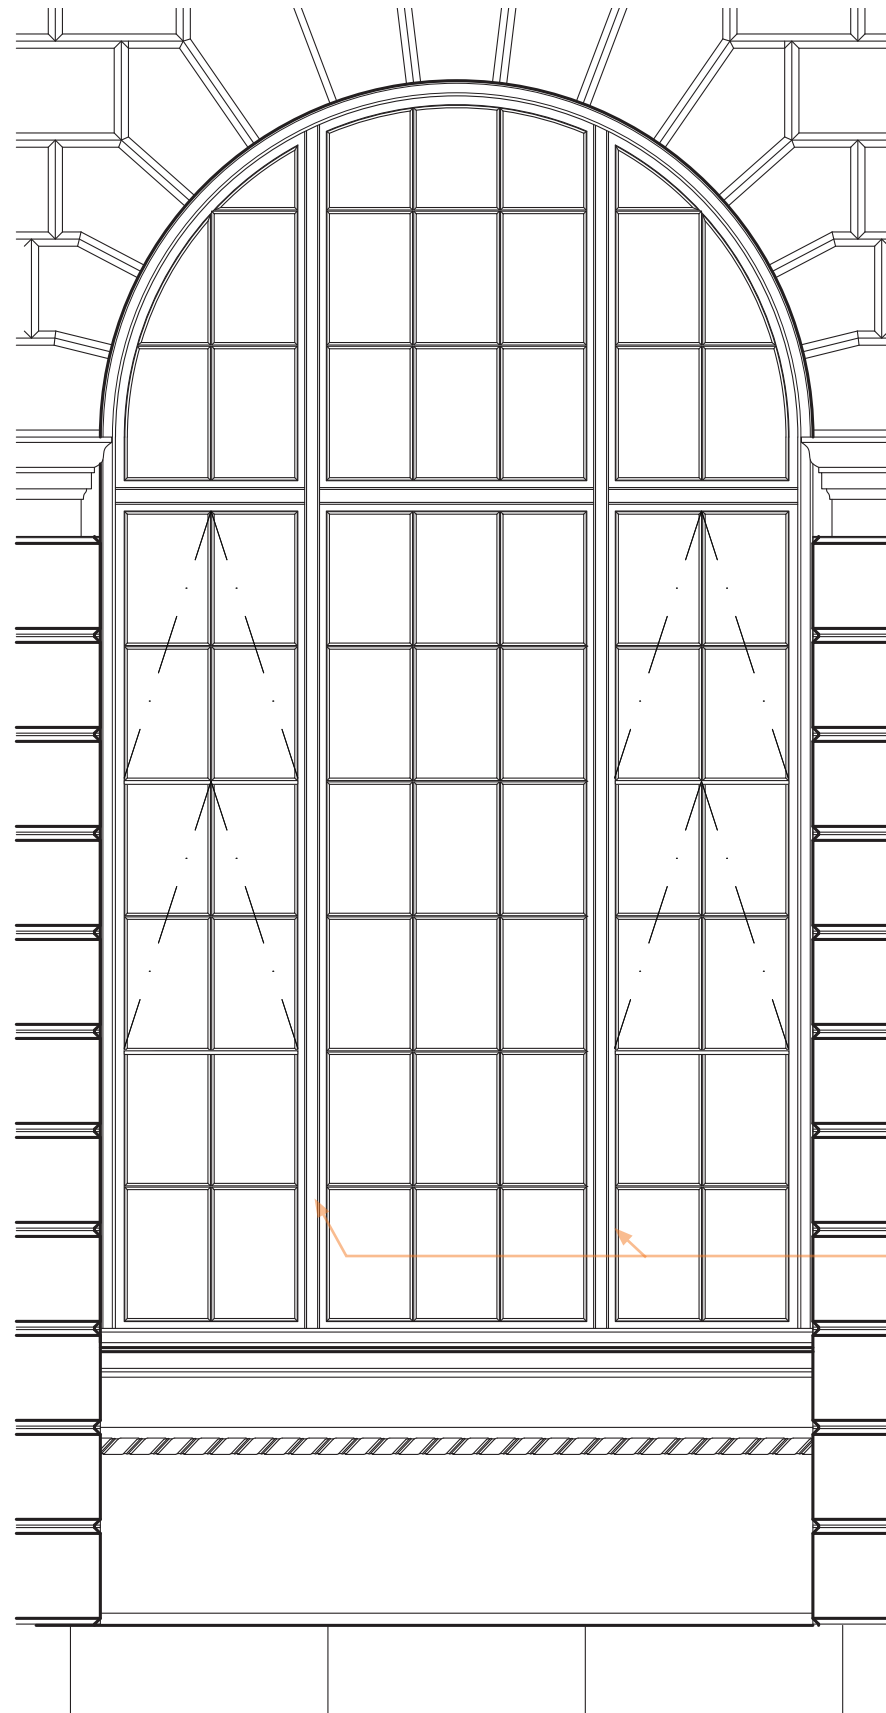
- Angle frame glazing stop is missing. Ill fitting glass and substandard caulking installed.
- Angle frame glazing stop is damaged: bowed, bent or broken. Rust jacking may be one of the causes
- Glass is cracked, or glass has been replaced very poorly (bad fit, sloppy caulking)
- Severe issue, see note
- General indication of rust and peeling paint

Lower side plates of vertical mullions to be removed; Rust to be scraped and ground smooth. Rust inhibitor to be applied before reattaching side plates. Typical for all.

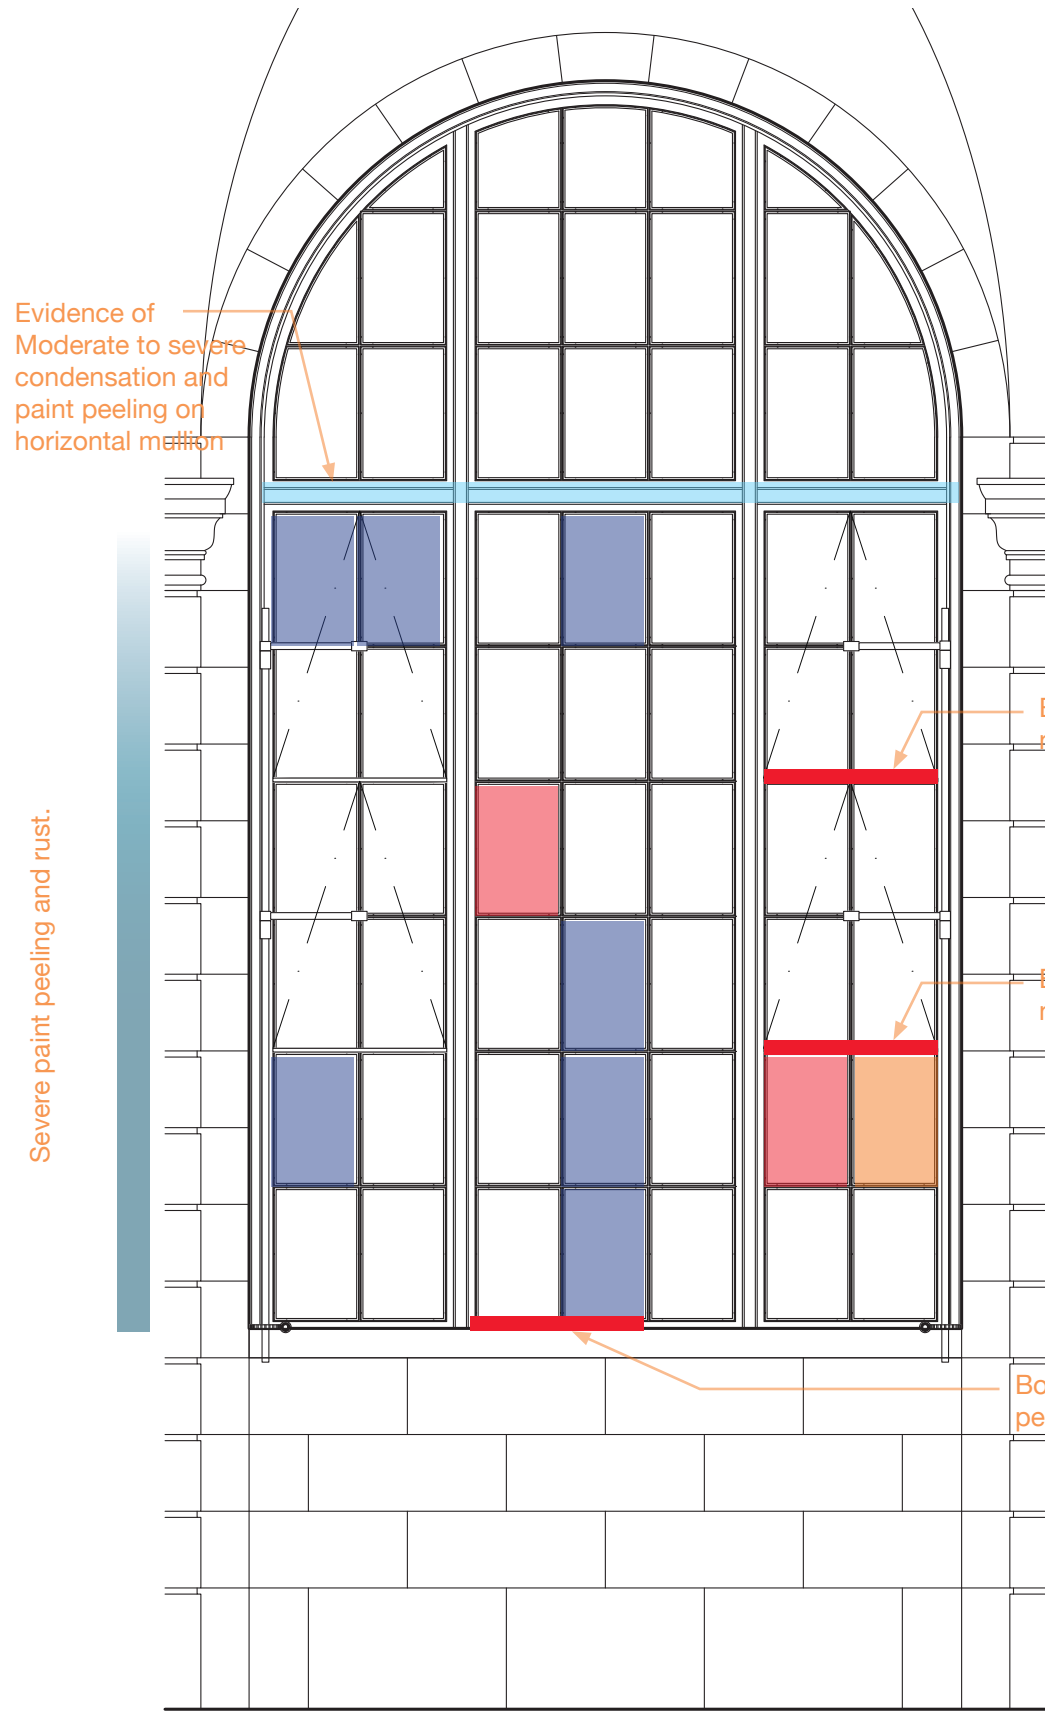
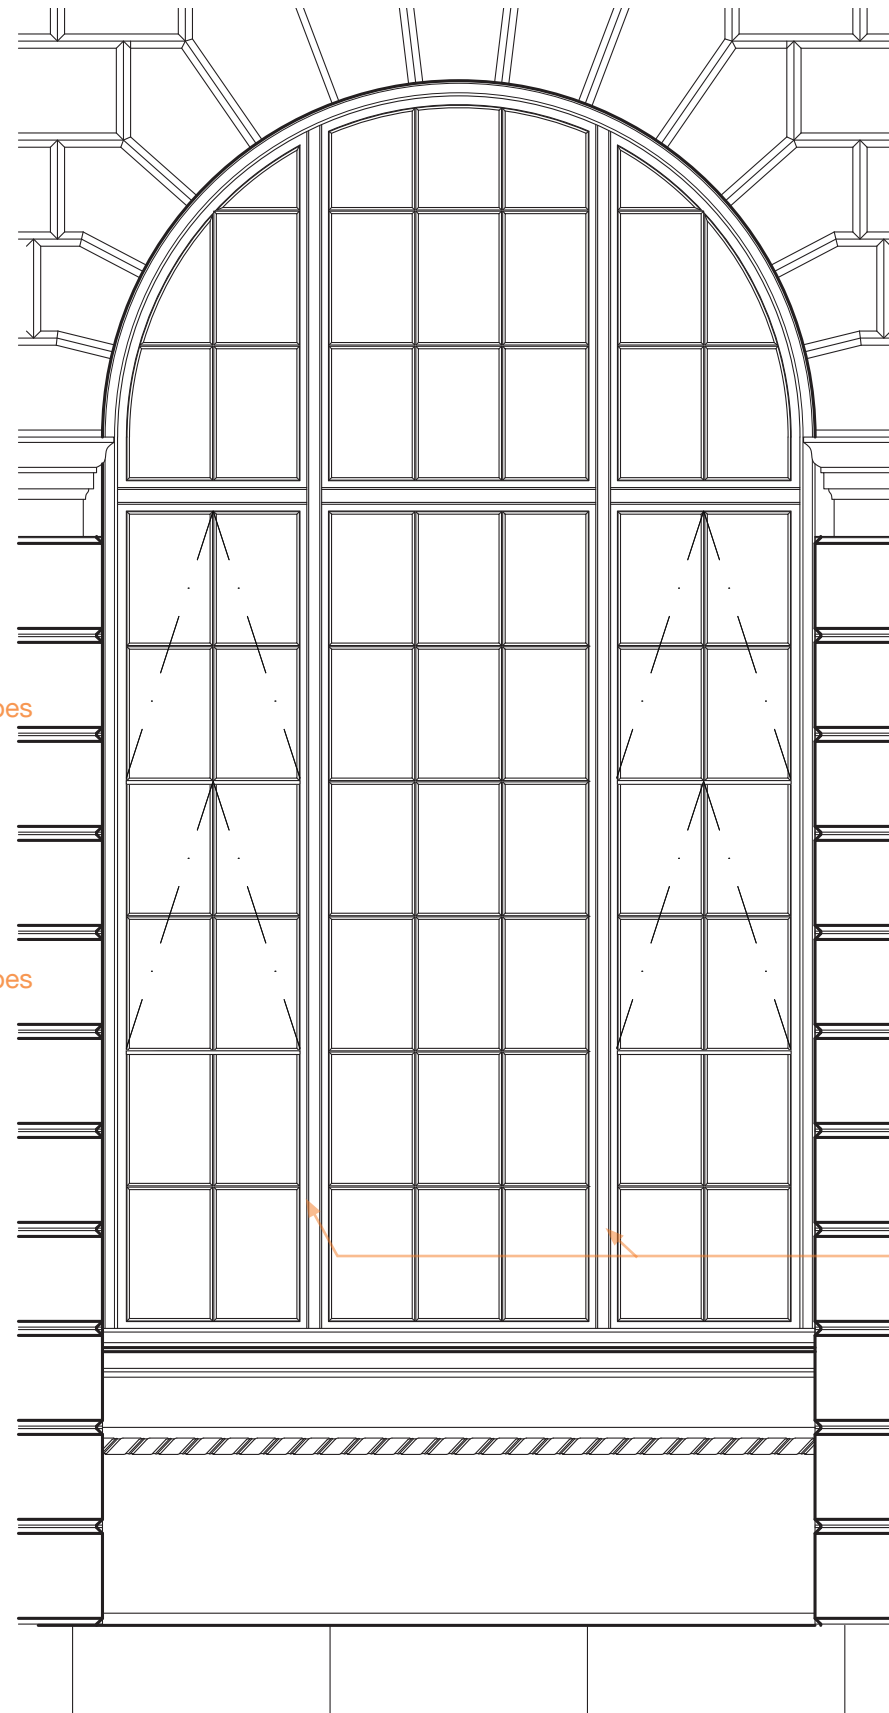
Window 5 Existing Conditions

- Angle frame glazing stop is missing. Ill fitting glass and substandard caulking installed.
- Angle frame glazing stop is damaged: bowed, bent or broken. Rust jacking may be one of the causes
- Glass is cracked, or glass has been replaced very poorly (bad fit, sloppy caulking)
- Severe issue, see note
- General indication of rust and peeling paint

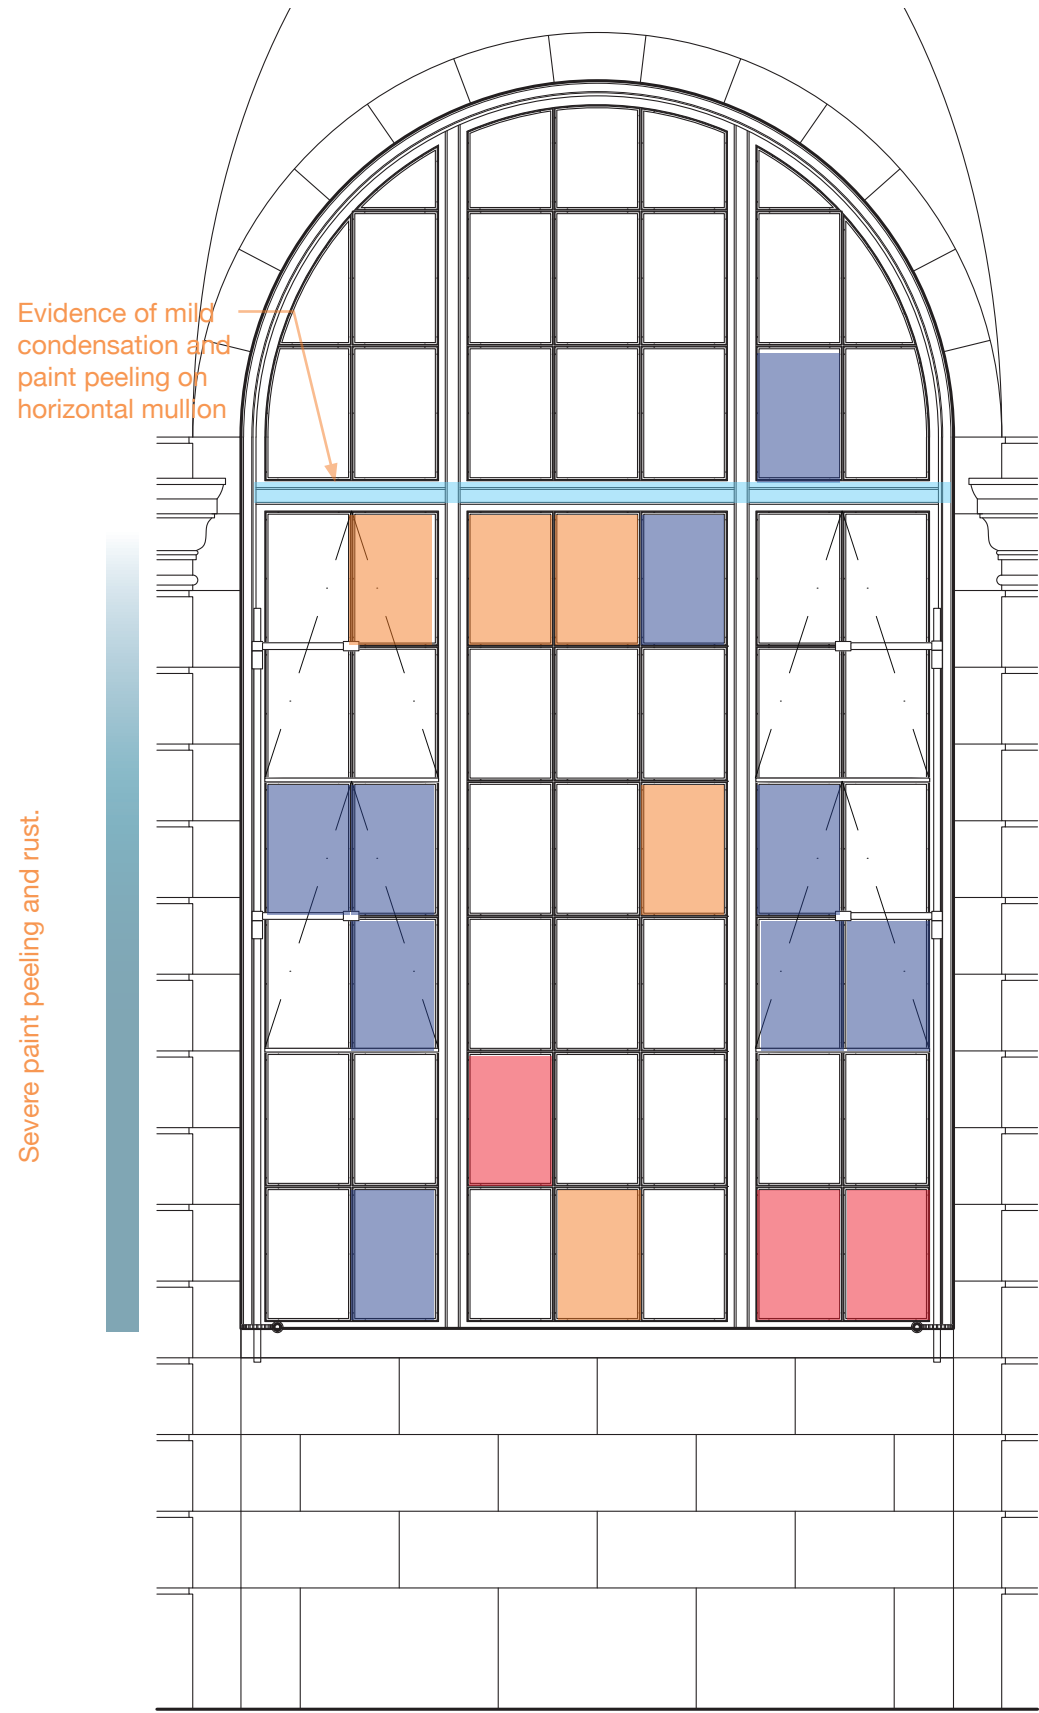
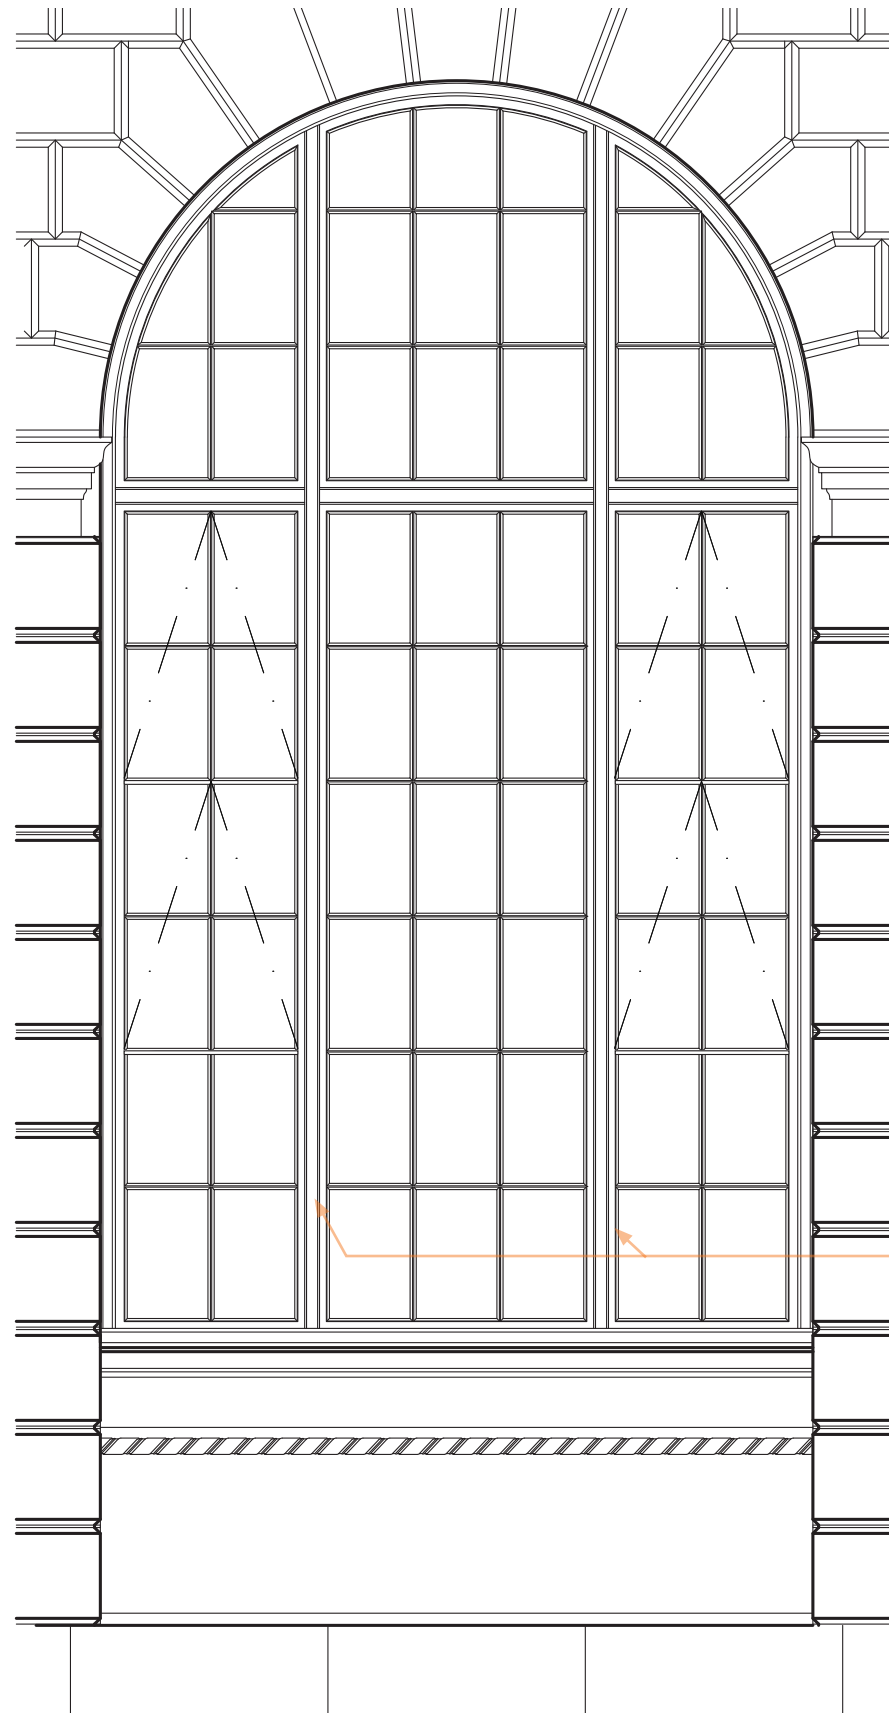
- Angle frame glazing stop is missing. Ill fitting glass and substandard caulking installed.
- Angle frame glazing stop is damaged: bowed, bent or broken. Rust jacking may be one of the causes
- Glass is cracked, or glass has been replaced very poorly (bad fit, sloppy caulking)
- Severe issue, see note
- General indication of rust and peeling paint
