**177 Montague Street, aka 134-138 Pierrepont Street – Brooklyn  
Trust Company Building – Individual and Interior Landmark  
Borough of Brooklyn**

177 Montague Street  
(aka The Brooklyn Trust  
Company Building)

Arched Window Repair/  
Replacement

LPC Presentation

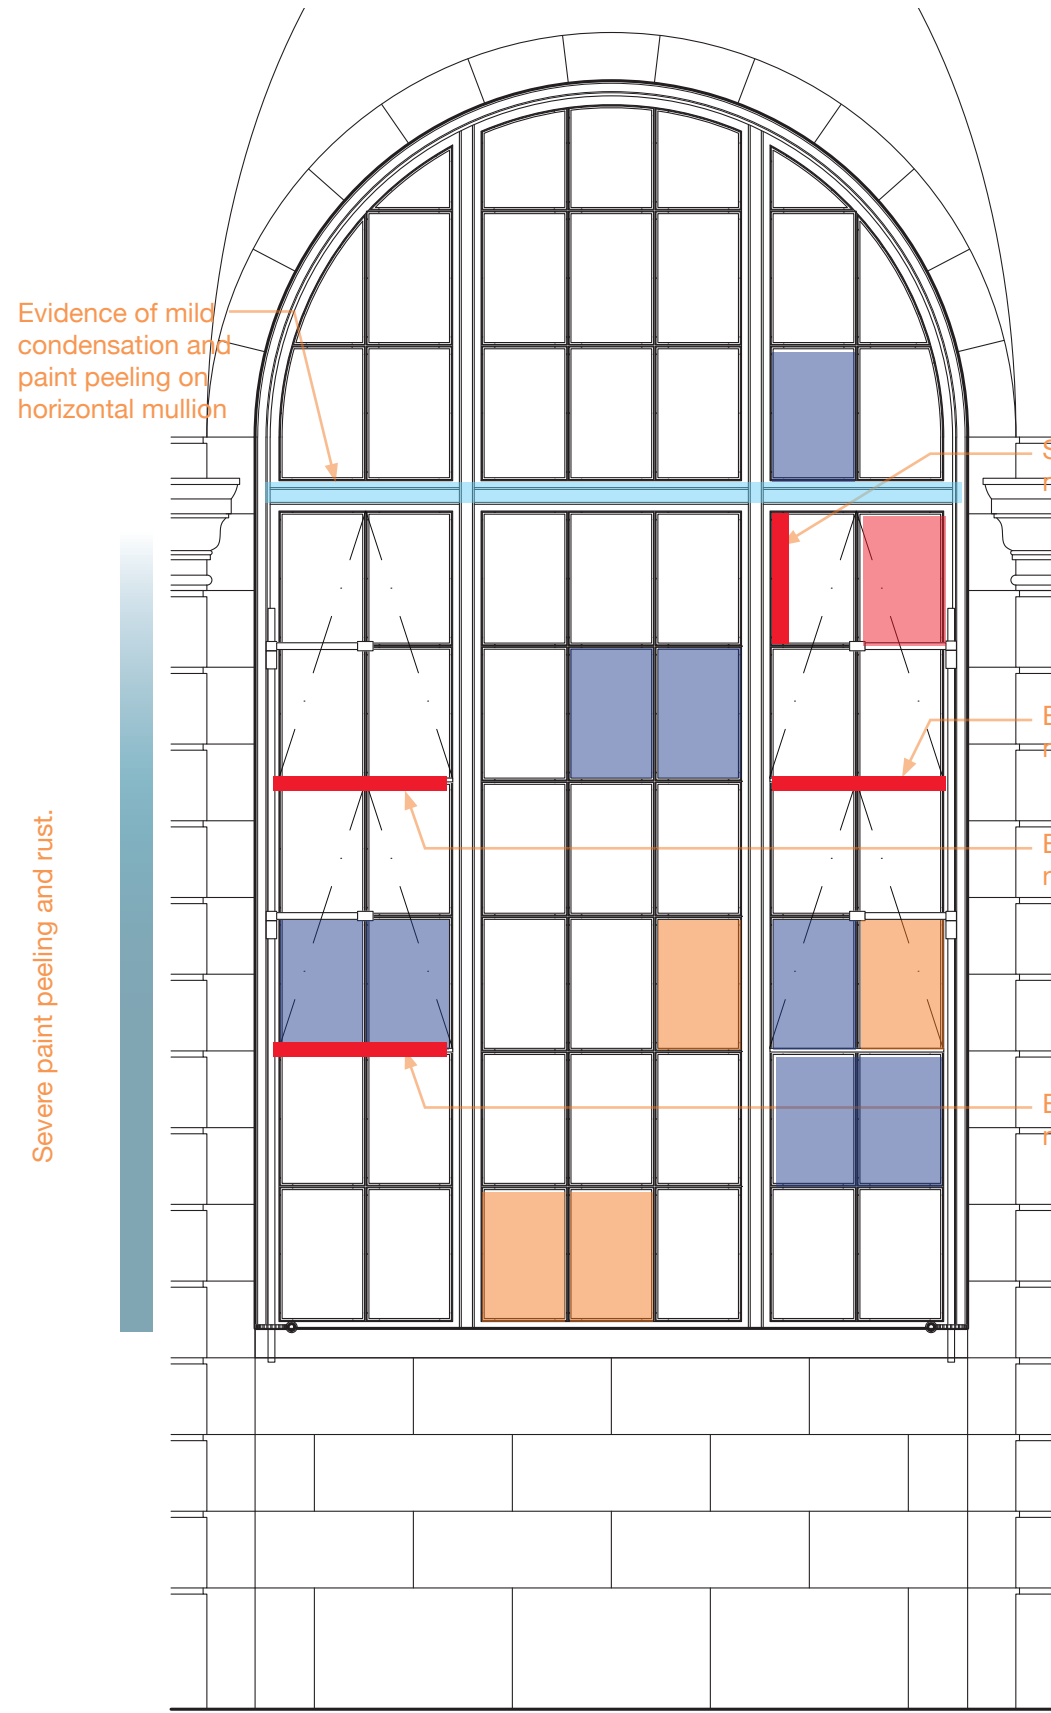
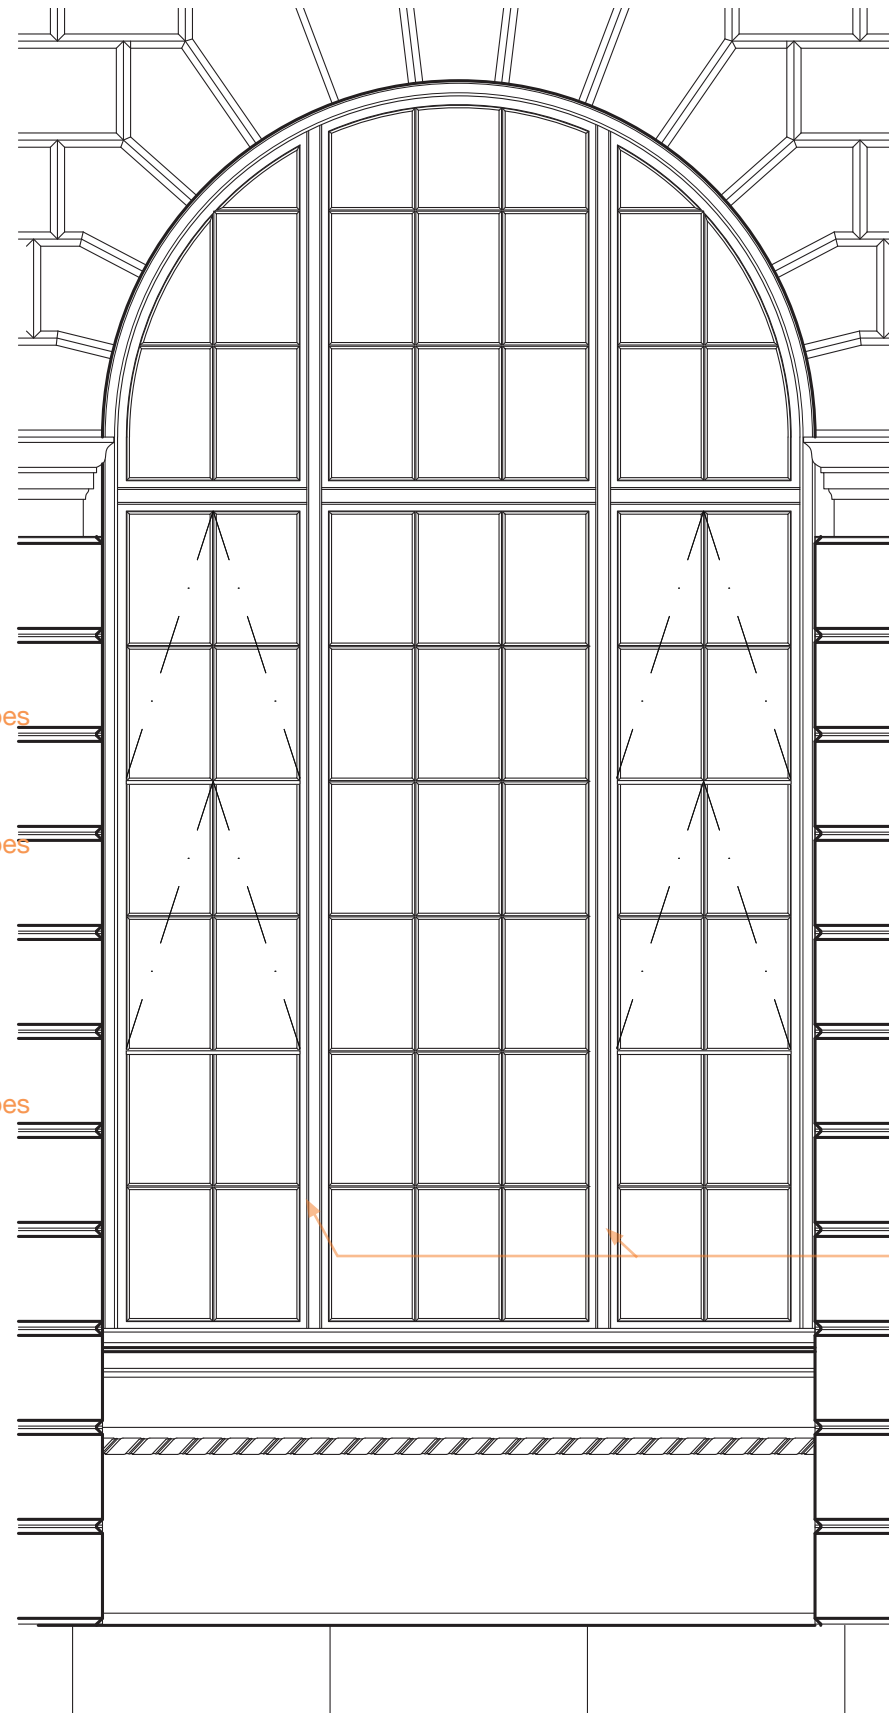
Window 7 Existing Conditions

- Angle frame glazing stop is missing. Ill fitting glass and substandard caulking installed.
- Angle frame glazing stop is damaged: bowed, bent or broken. Rust jacking may be one of the causes
- Glass is cracked, or glass has been replaced very poorly (bad fit, sloppy caulking)
- Severe issue, see note
- General indication of rust and peeling paint

Lower side plates of vertical mullions to be removed; Rust to be scraped and ground smooth. Rust inhibitor to be applied before reattaching side plates. Typical for all.

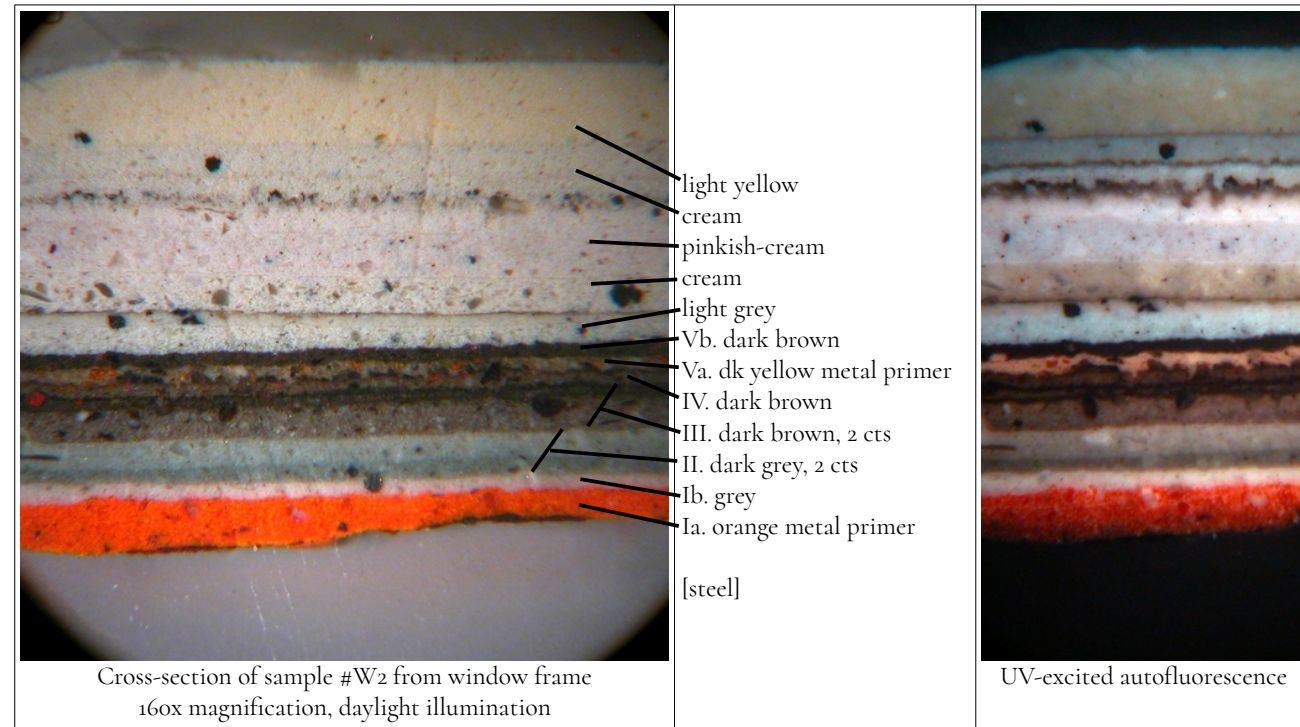
All samples analyzed were found to be intact and consistent in surviving layer stratigraphies, as represented by this cross-section of sample #W.2. Following a foundry sealer, an orange metal primer was applied, then an original finish coat of a grey paint. This grey color would be expected to have complemented the adjacent stone masonry of the facade. Later color treatments venture into darker grey then very dark brown colors before the more modern sequence of pale creams, yellows, and the current light grey.
