Preservation Department – Item 3, LPC-24-08616

# 891 St Mark's Avenue – Crown Heights North Historic District Borough of Brooklyn

HILLBERTZ/MOZO STOOP REPLACEMENT

#### FIELD OBSERVATION REPORT

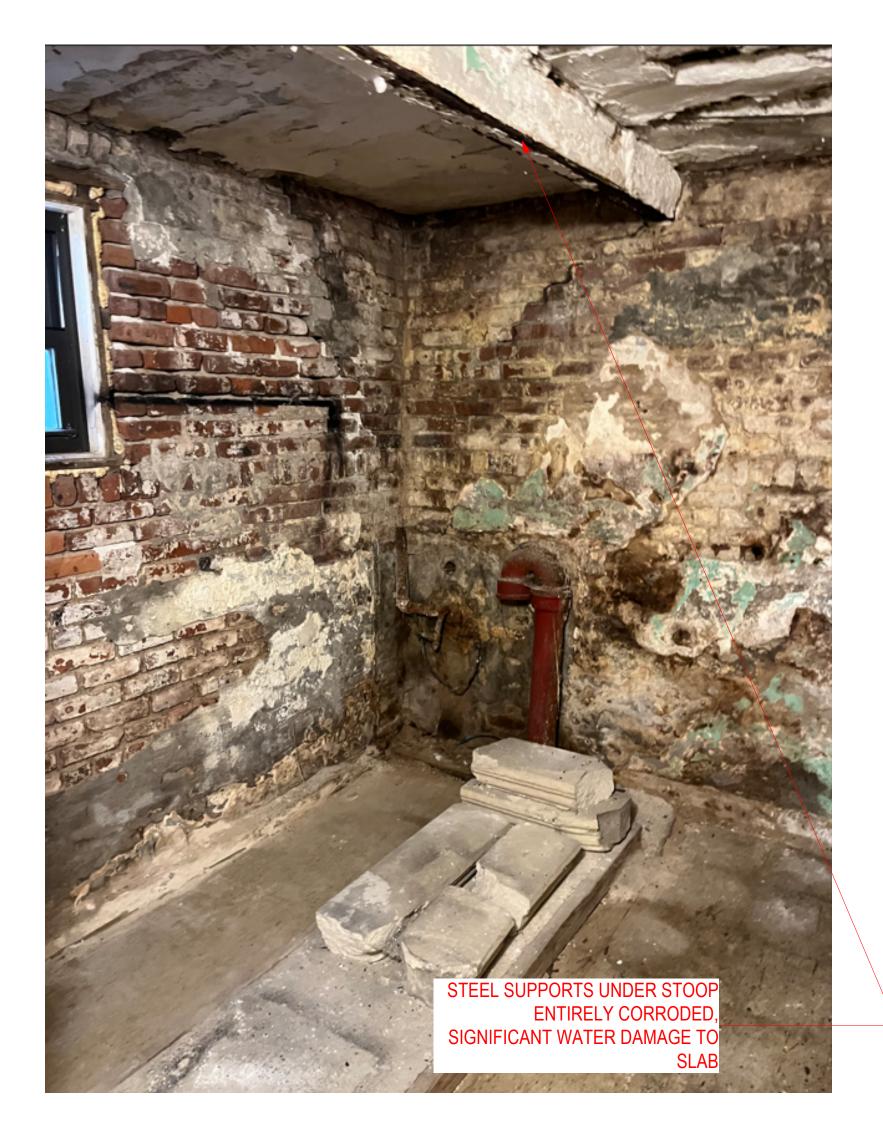
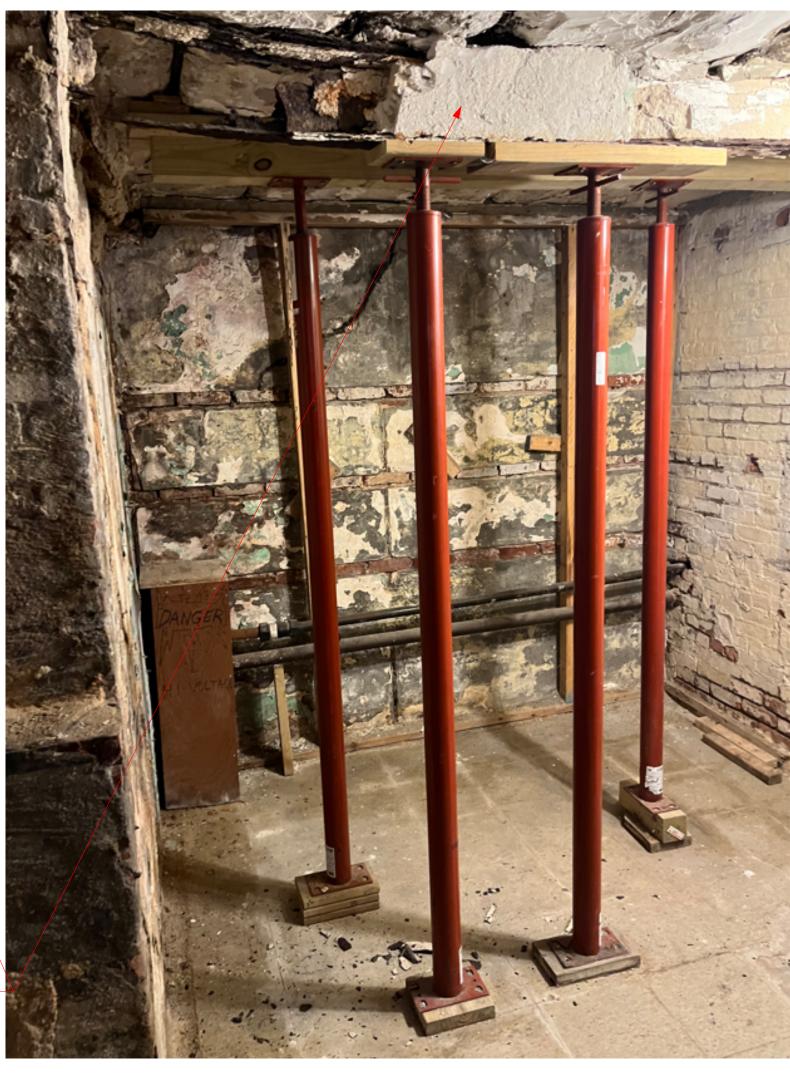
INT DTL - CORRODED SUPPORTS SCALE: NTS

INT DTL - CORRODED SUPPORTS

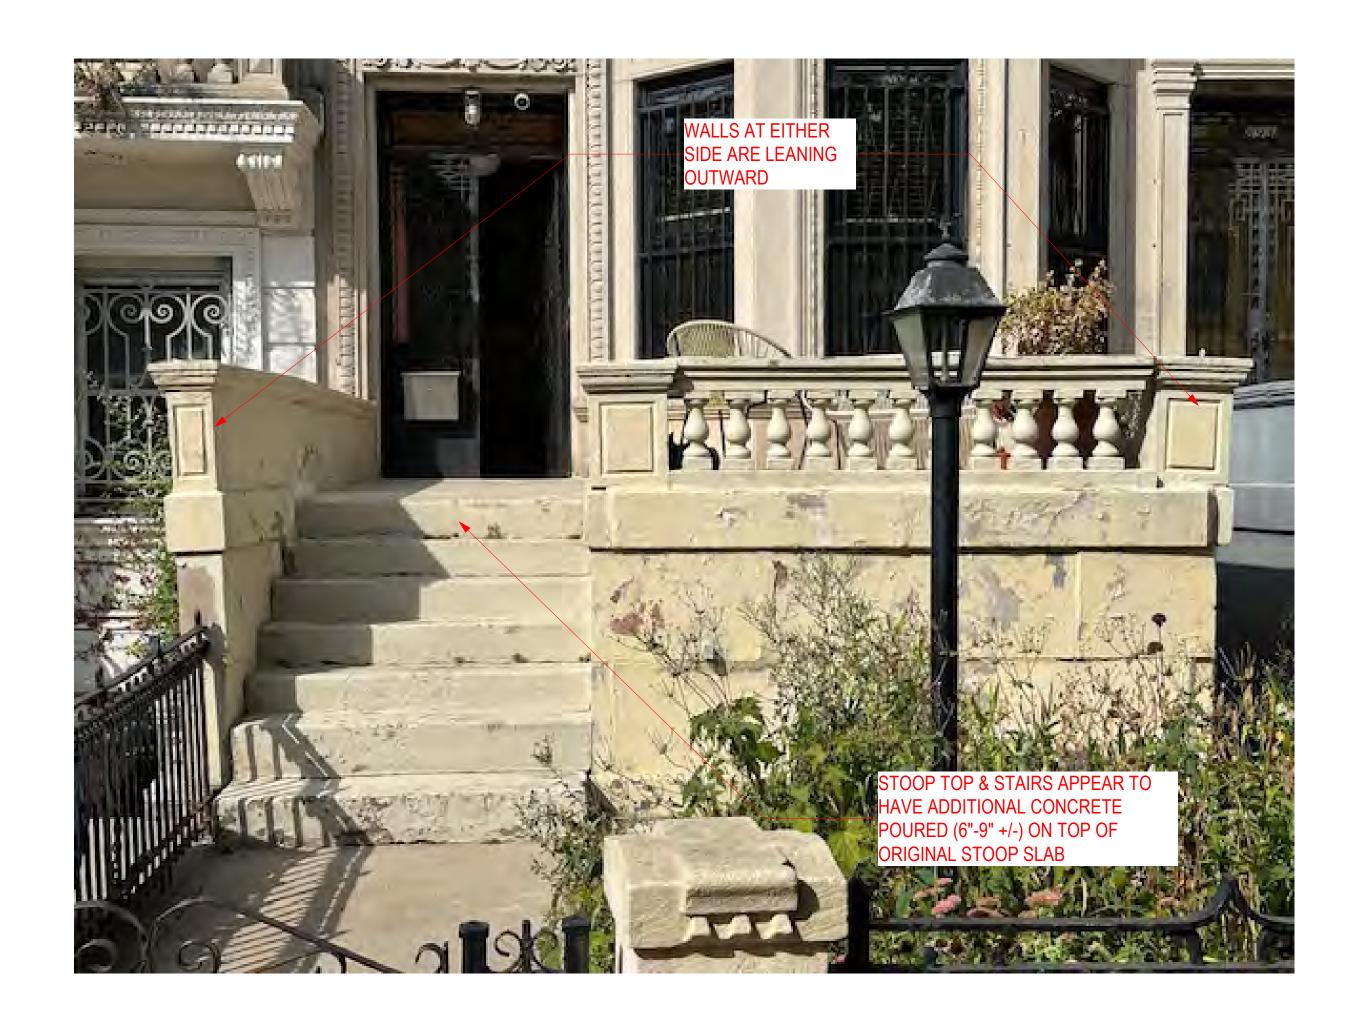
STOOP EXTERIOR CONDITION

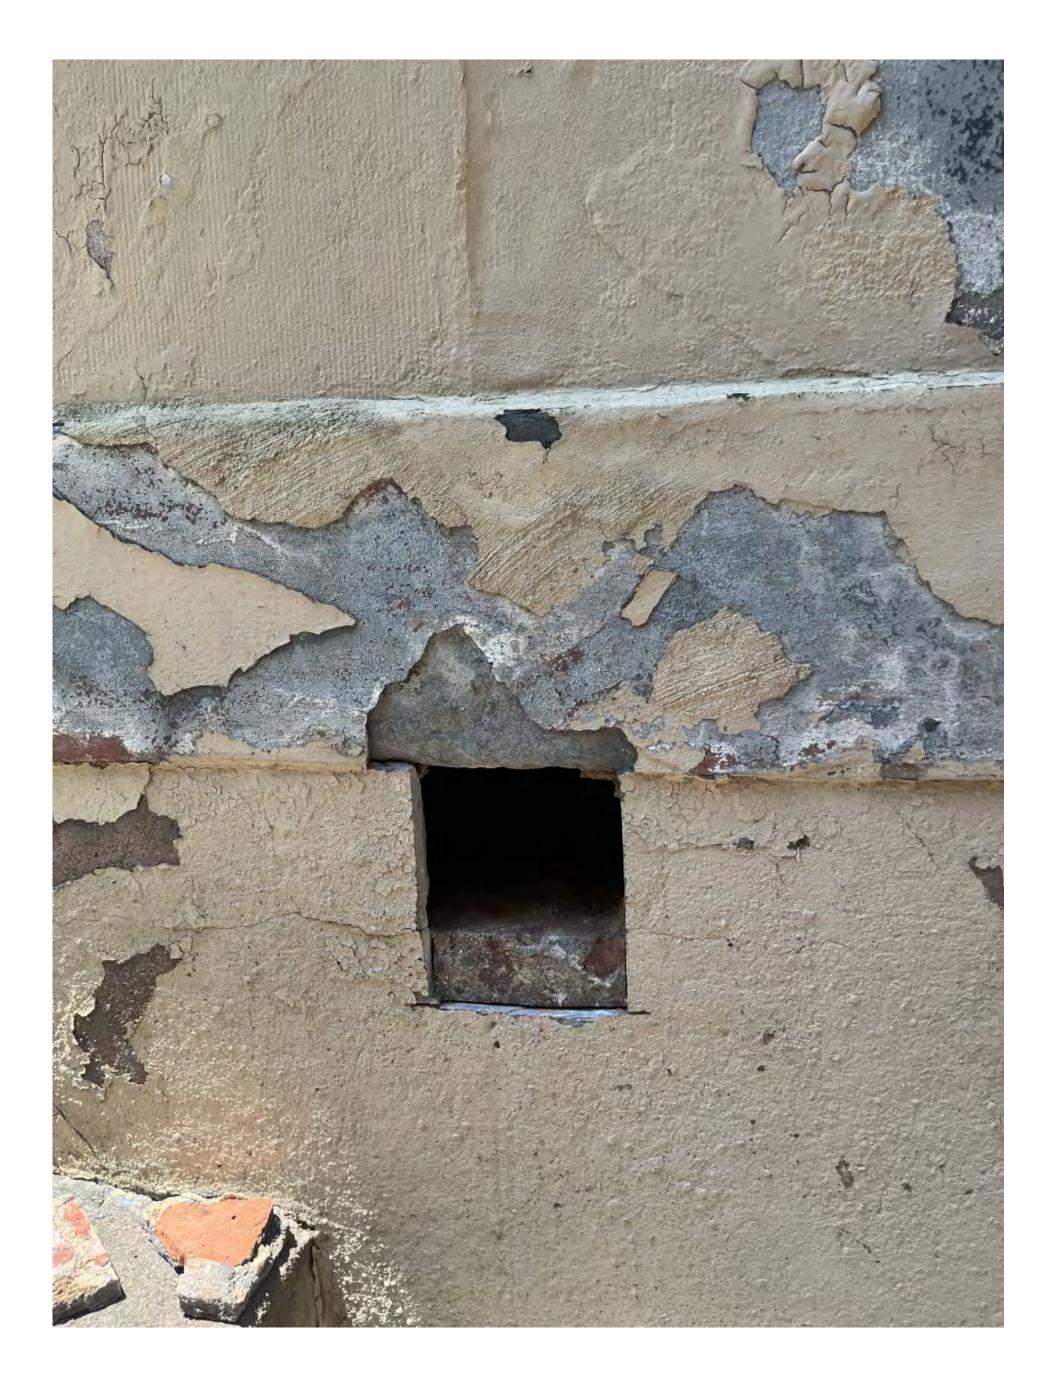
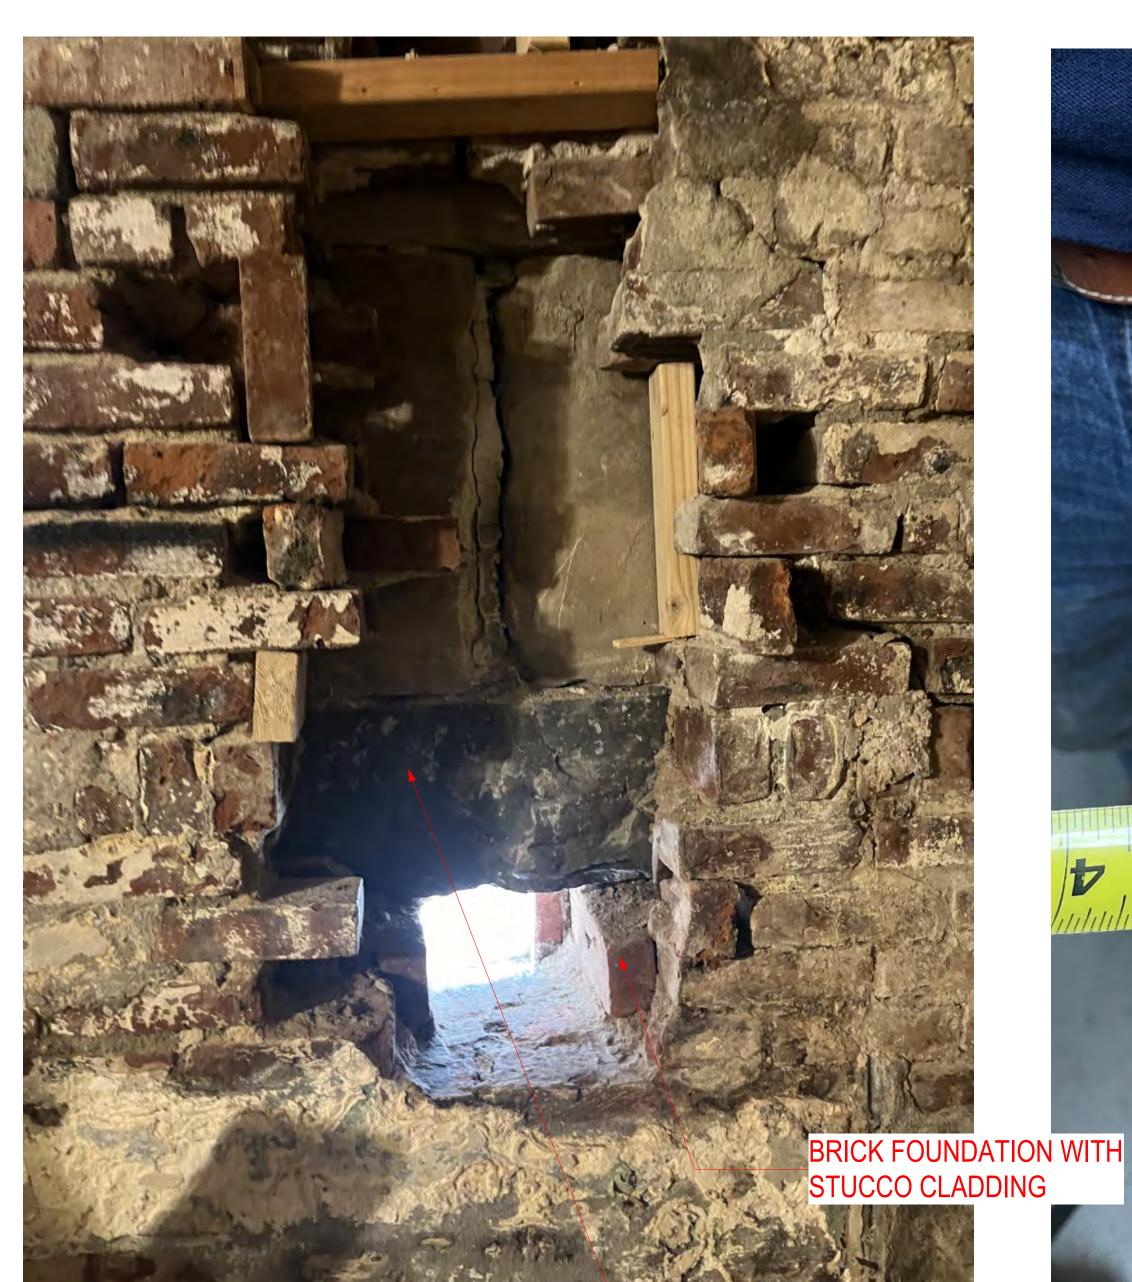
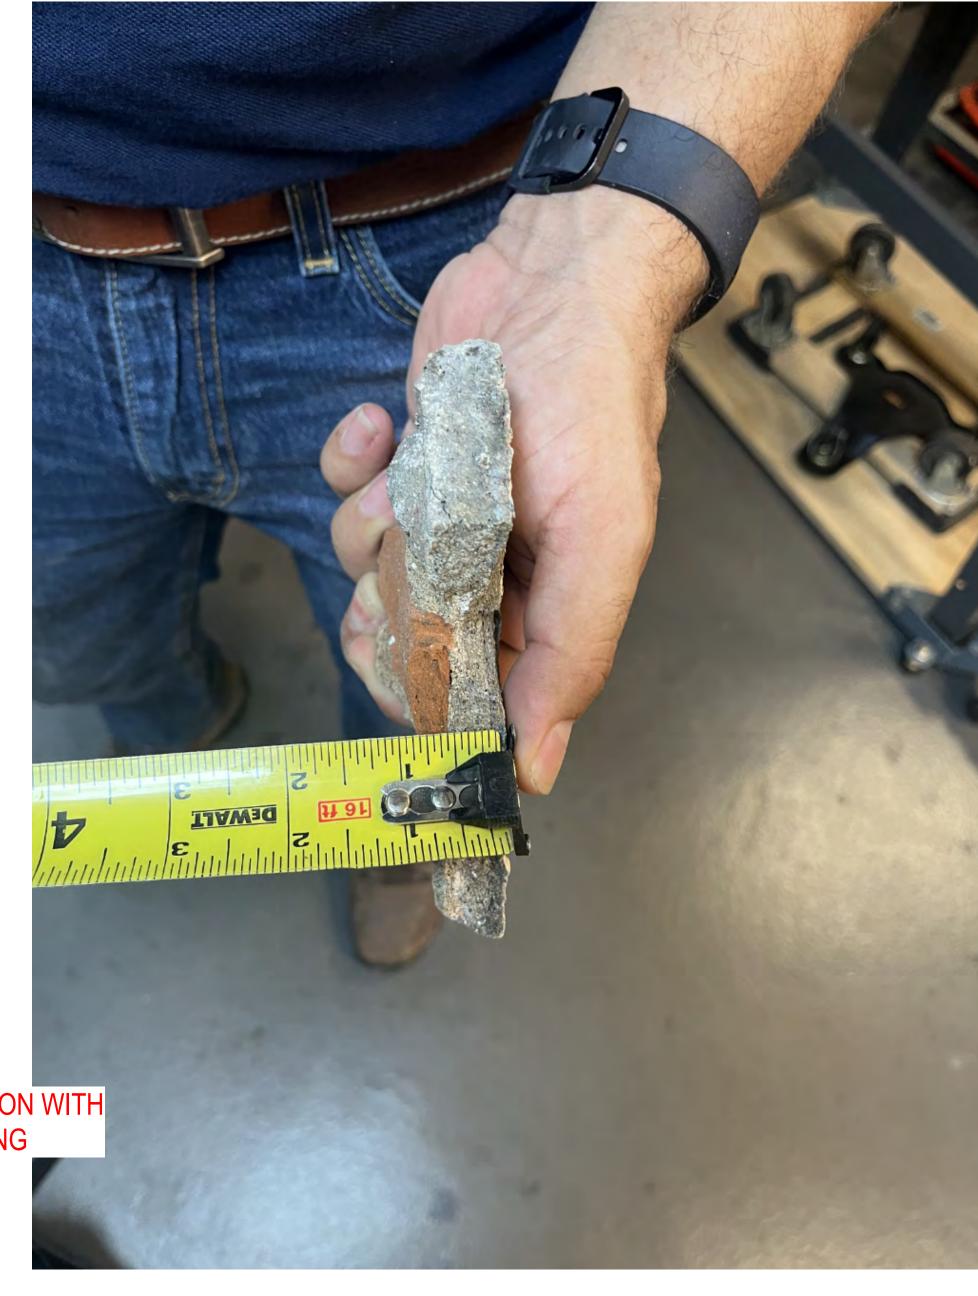
BLUESTONE SLAB

EXTERIOR PROBE

INTERIOR PROBE CONDITION SCALE: NTS

3 PROBE STUCCO DETAIL
SCALF: NITS

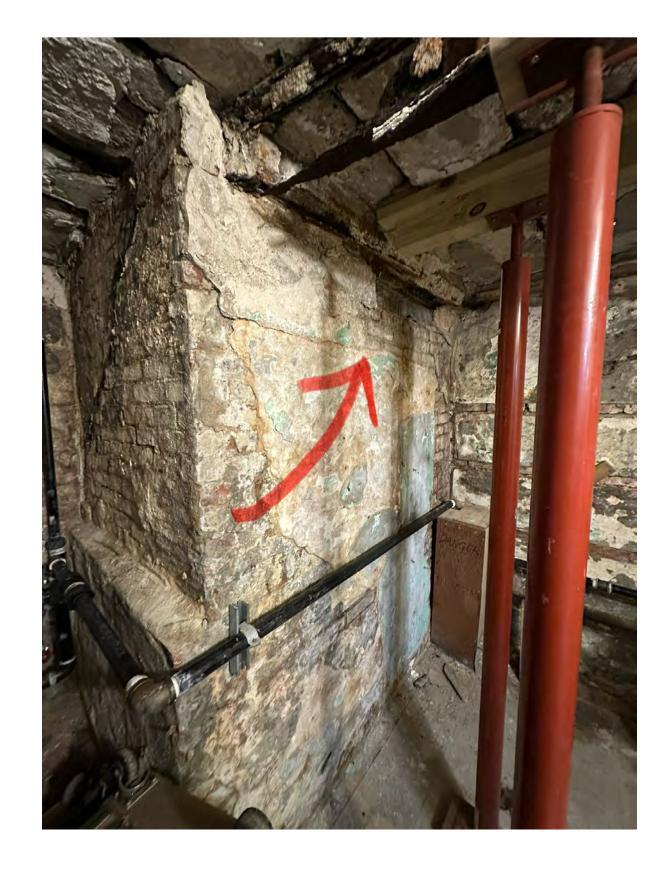
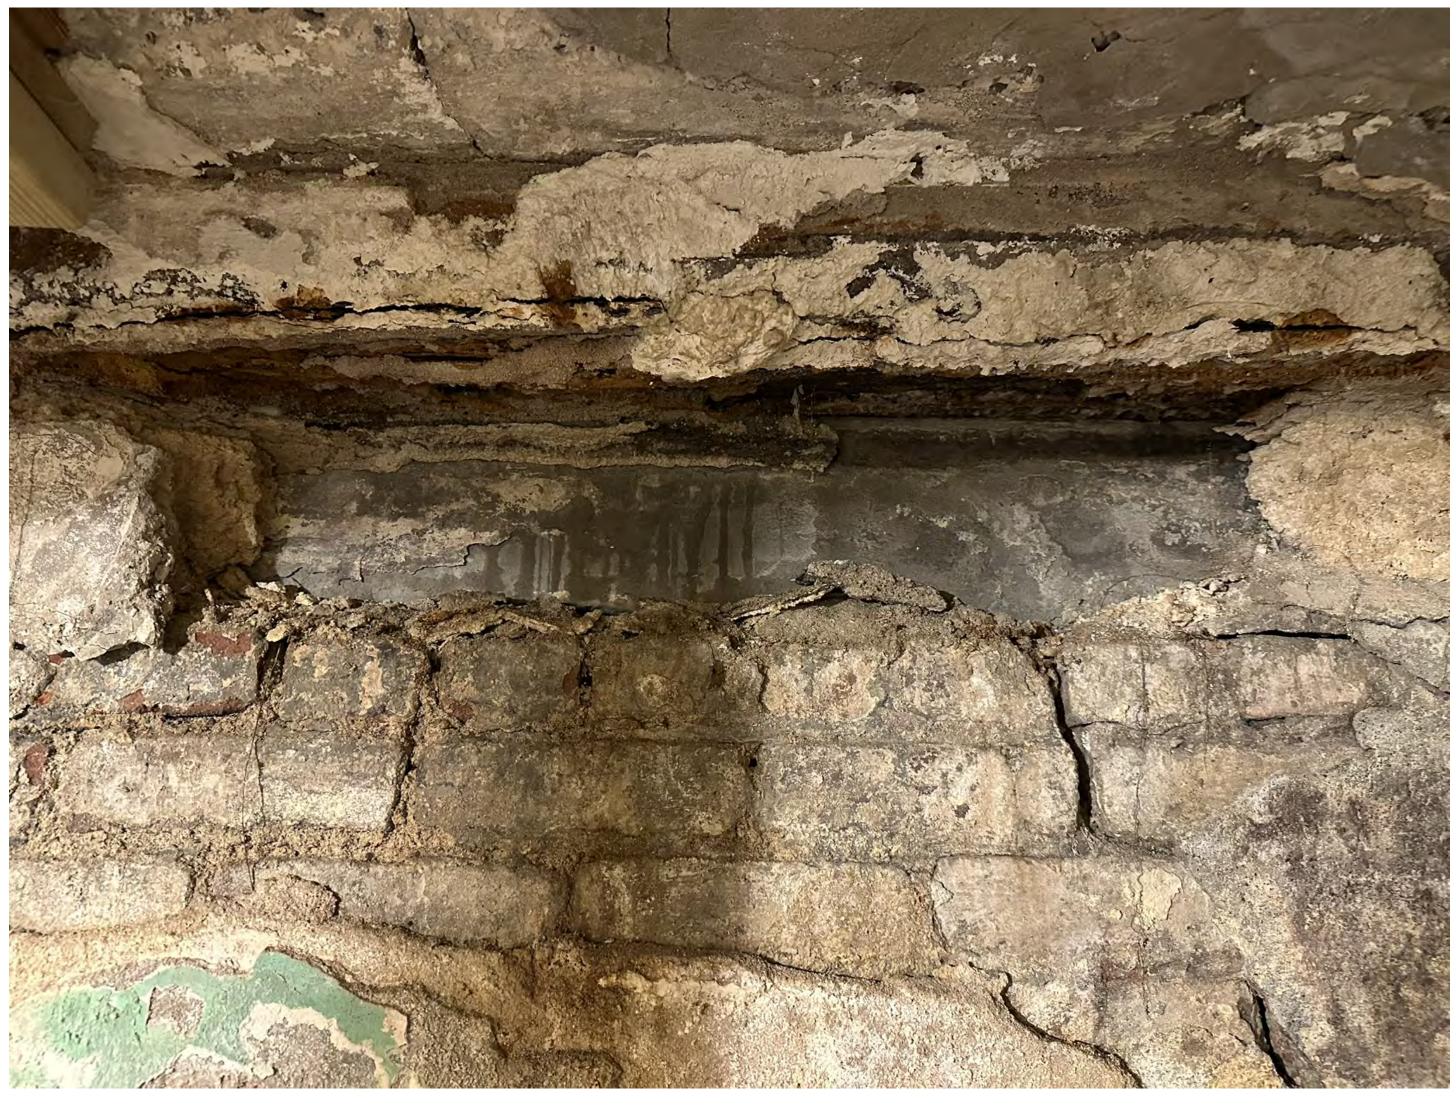
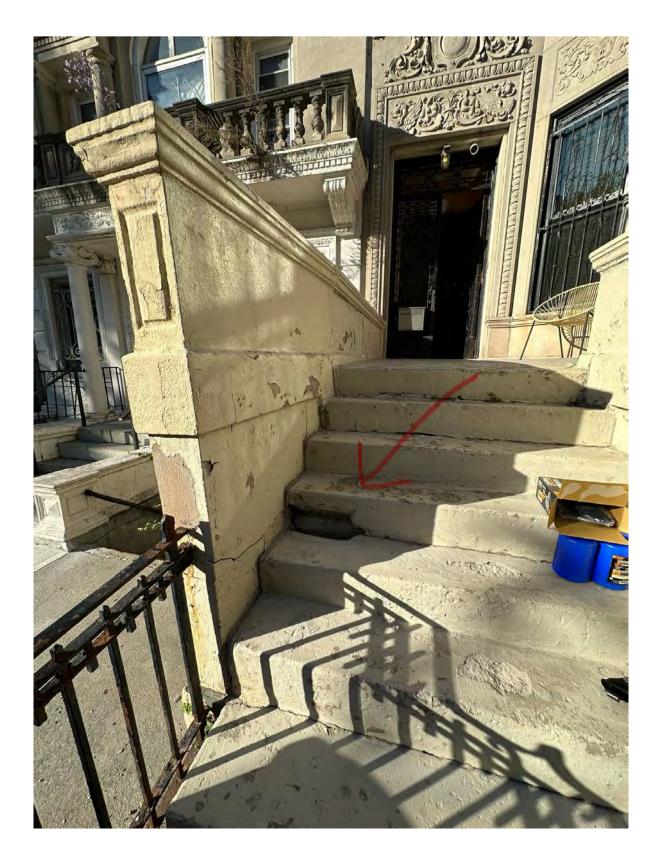
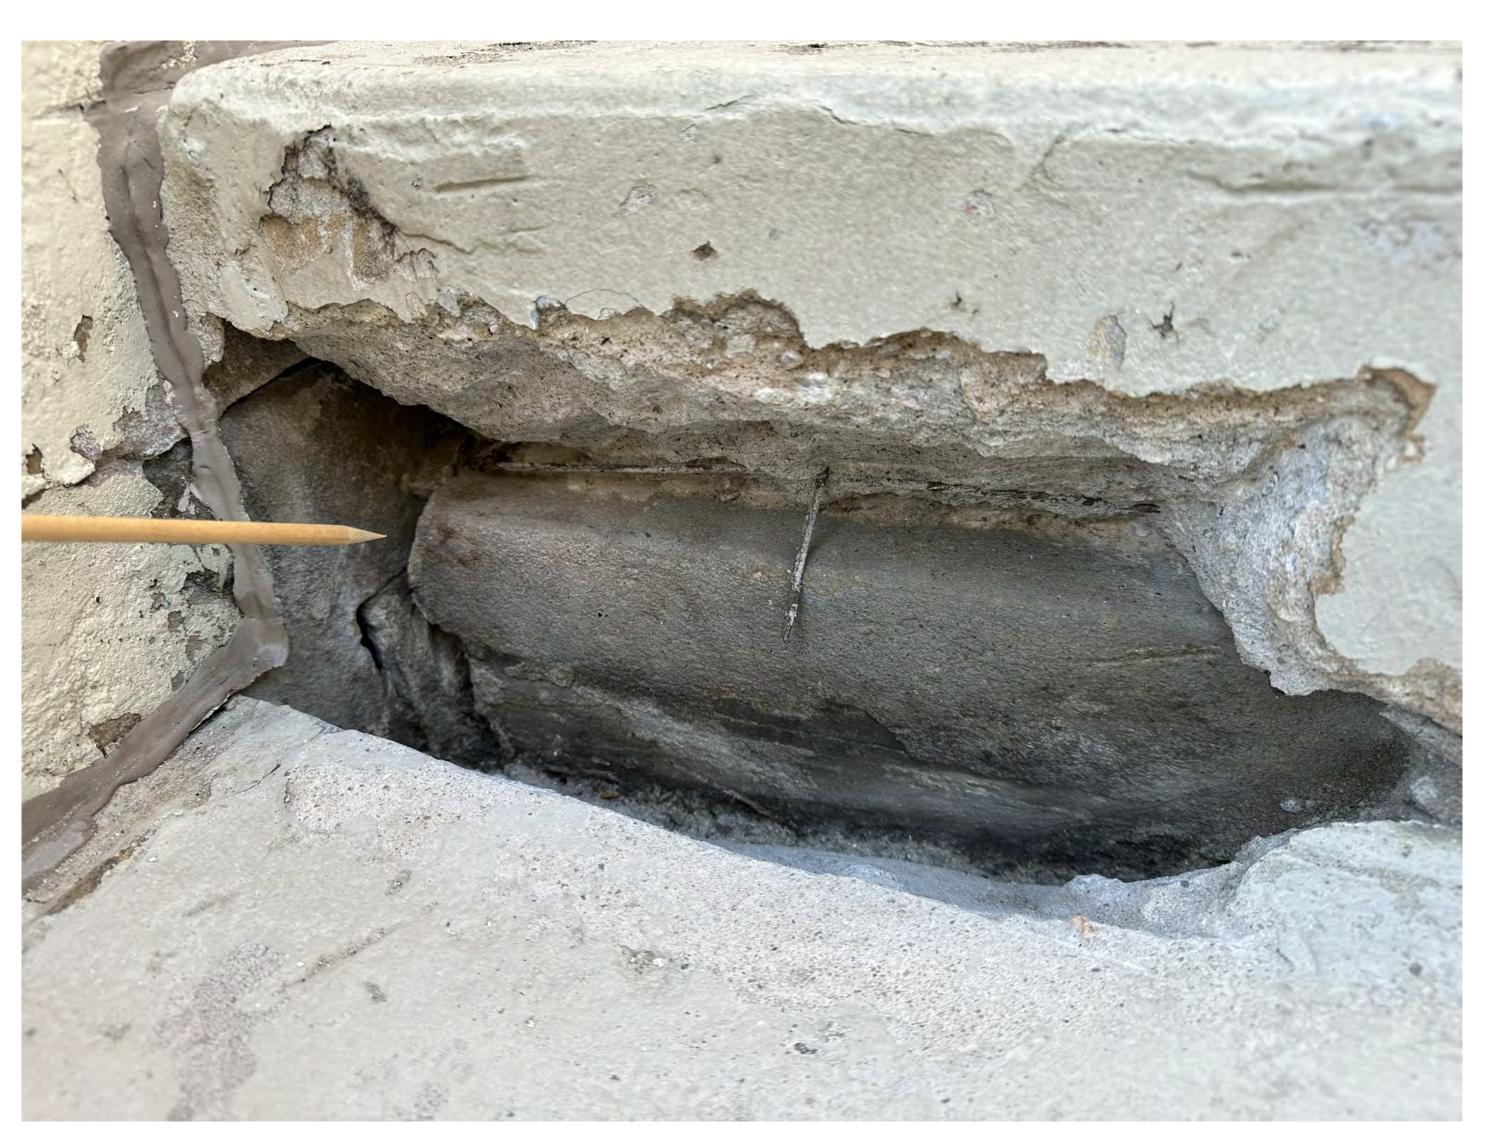
EXISTING STEP CONDITION - EXTERIOR
