Preservation Department – Item 9, LPC-24-04741

**1 West 67th Street – Upper West Side/Central Park West
Historic District
Borough of Manhattan**

IN THE MATTER OF REPLACING WINDOWS AT 1 West 67th Street, NEW YORK, NY 10023

WINDOW CONDITION REPORT

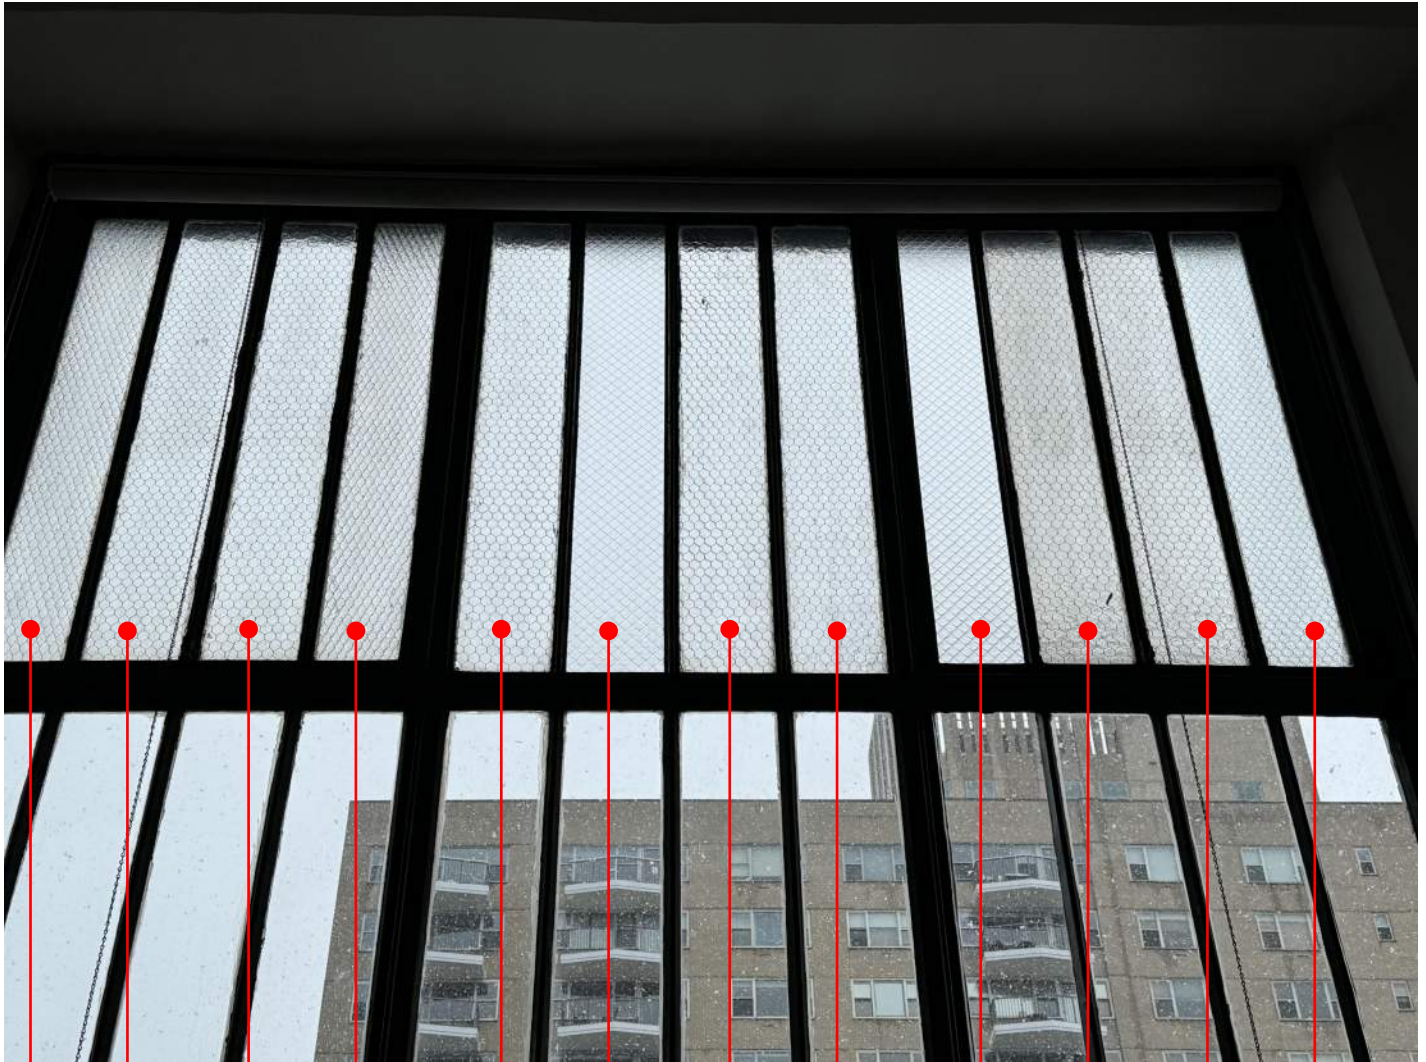
1. Glazing of the historic windows is not consistent
2. Essential structural members have rusted beyond repair
3. Glazing putty is damaged beyond repair
4. Operable units are not historic

Historic Glazing Historic Glazing Replacement Glazing Historic Glazing Historic Glazing Historic Glazing

Historic Glazing Historic Glazing Historic Glazing Historic Glazing Replacement Glazing Historic Glazing

Panorama recommends the replacement of both windows with new, thermally efficient, steel casement windows matching the historic configuration. The replacement of the partially historic window is necessary as there are many structural and aesthetic flaws which are irreparable.

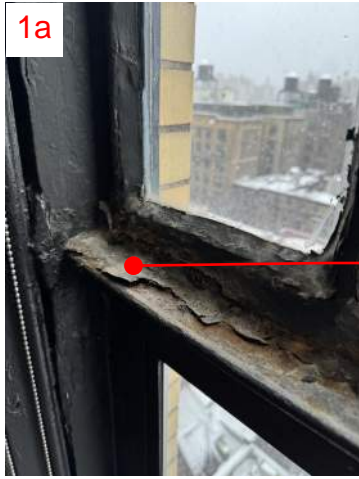
Rust through historic steel

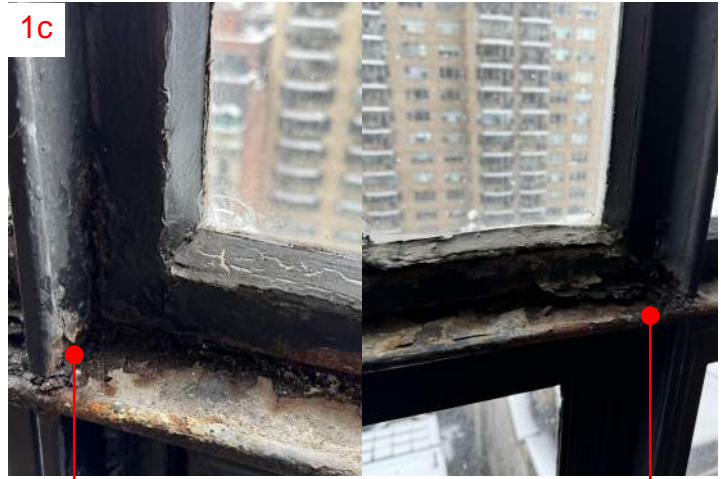
Rust through historic steel structural members

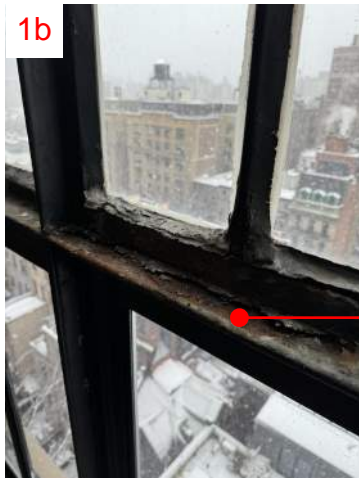
Rust through historic steel

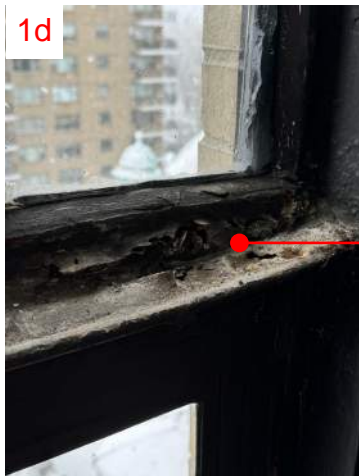
Rust through historic steel

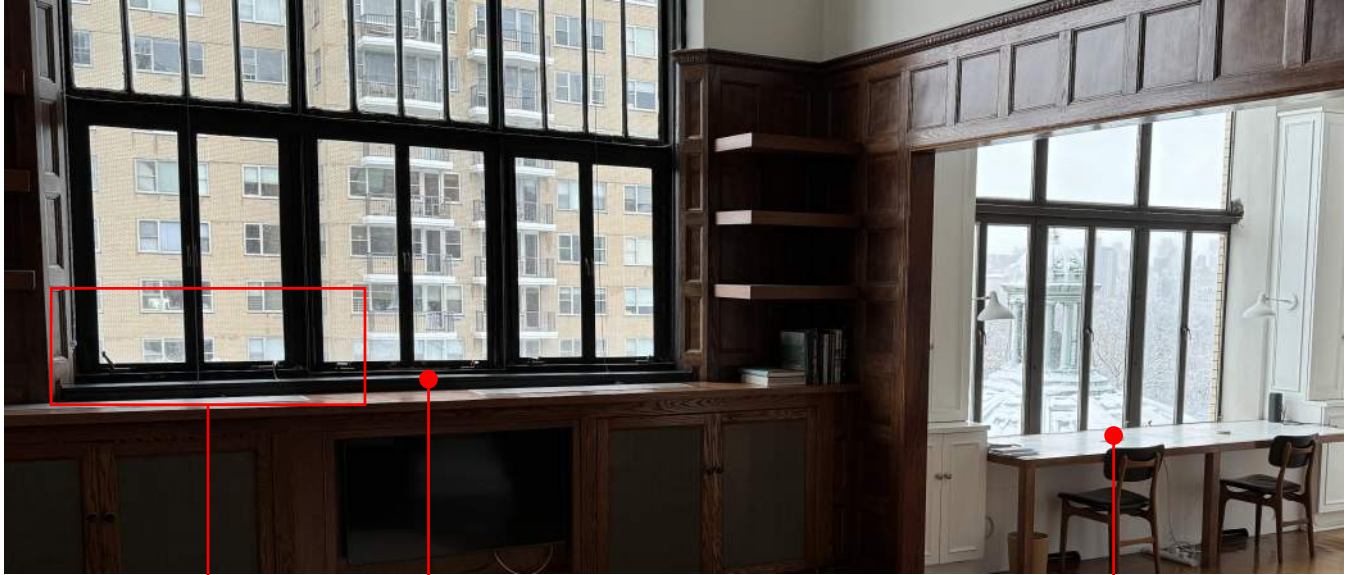
Currently, one of the two *studio* windows have been replaced in its entirety (using all single lite units). The remaining window’s operable (lower row) portion was replaced at the same time.

Replacement windows
matching replacement
windows in adjacent room

Replacement windows
