AREA OF WORK:
5 EAST 63RD STREET

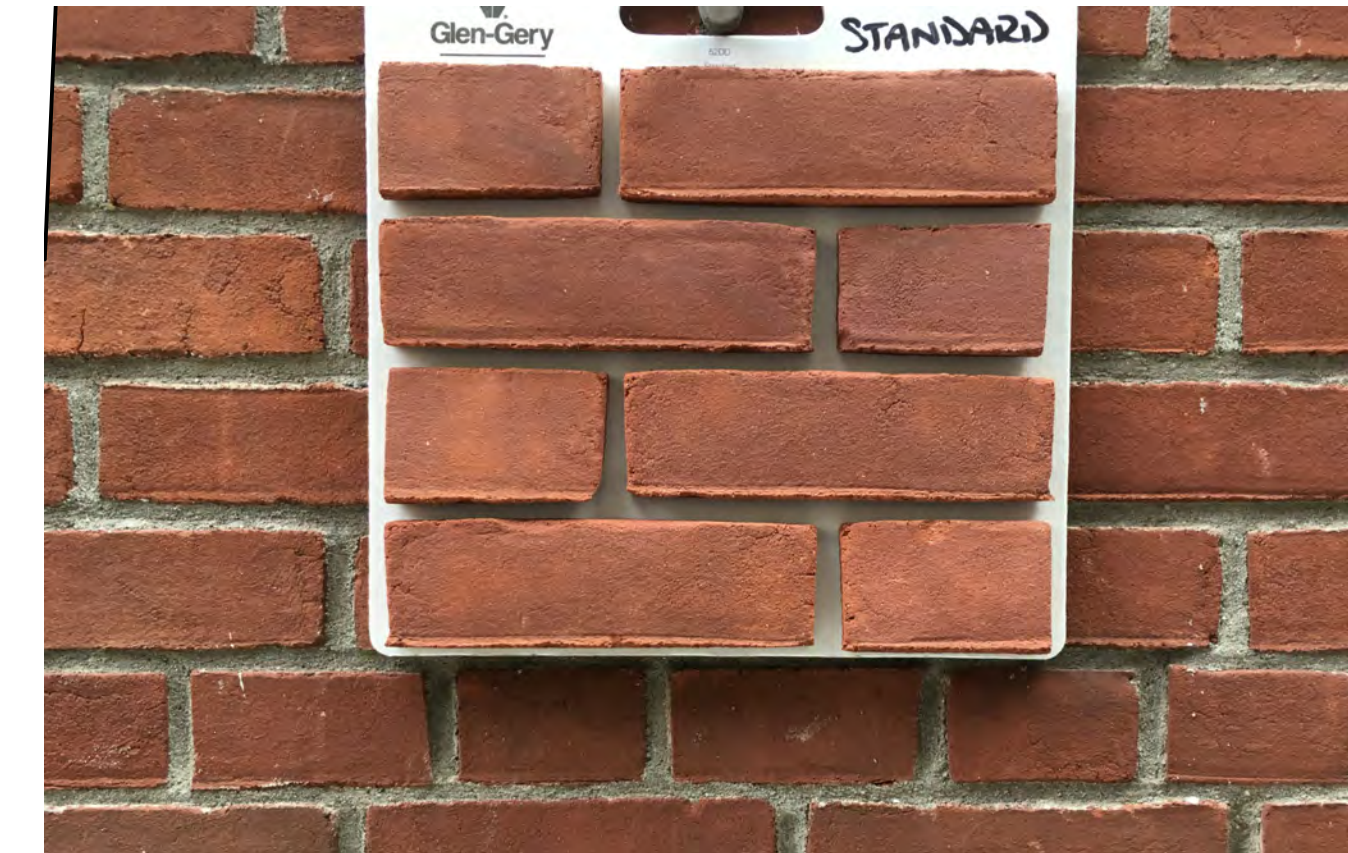
NEW STAIR BULKHEAD
MATERIAL: BRICK
COLOR: GLEN-GERY STANDARD BRICK

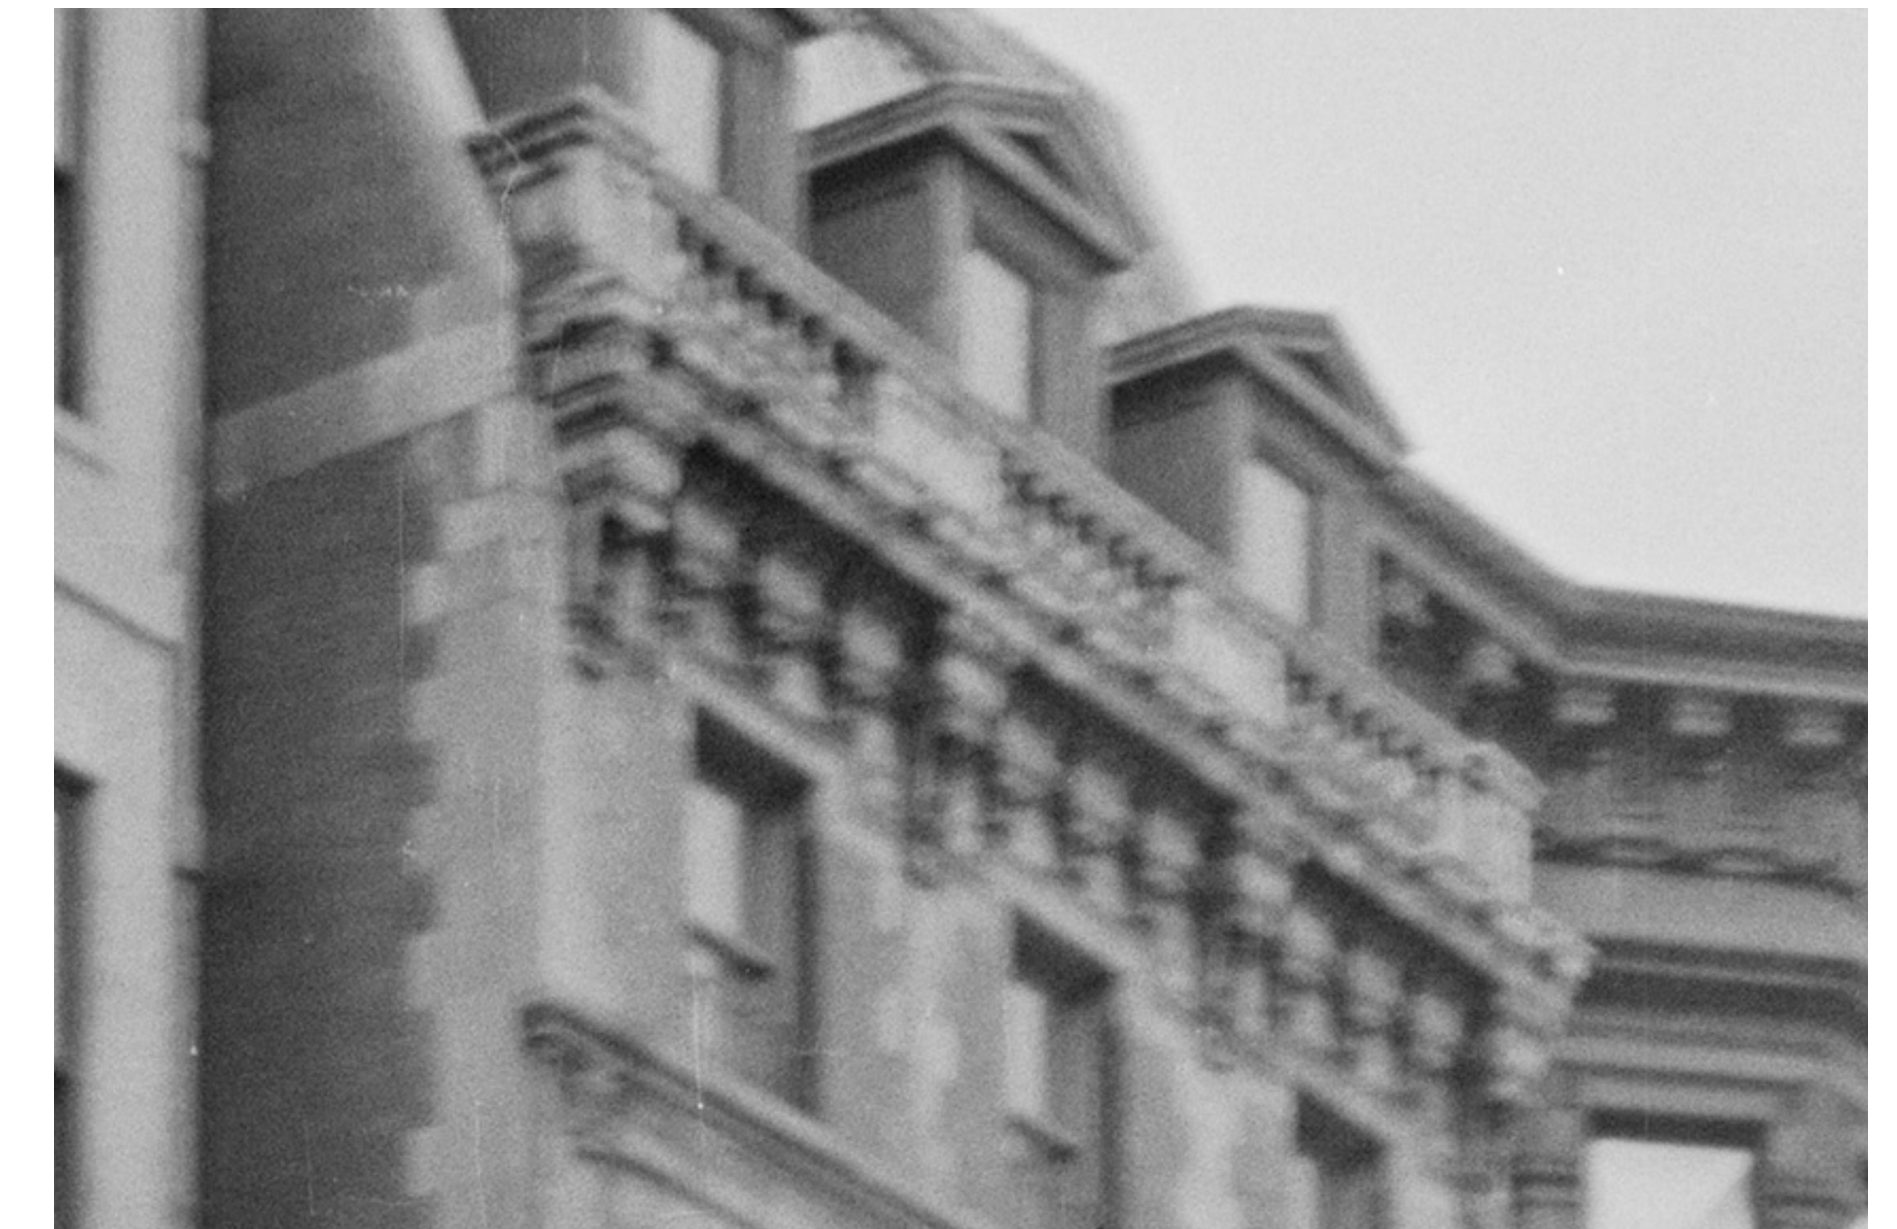
CORNICE REFERENCE (1940'S CORNICE)

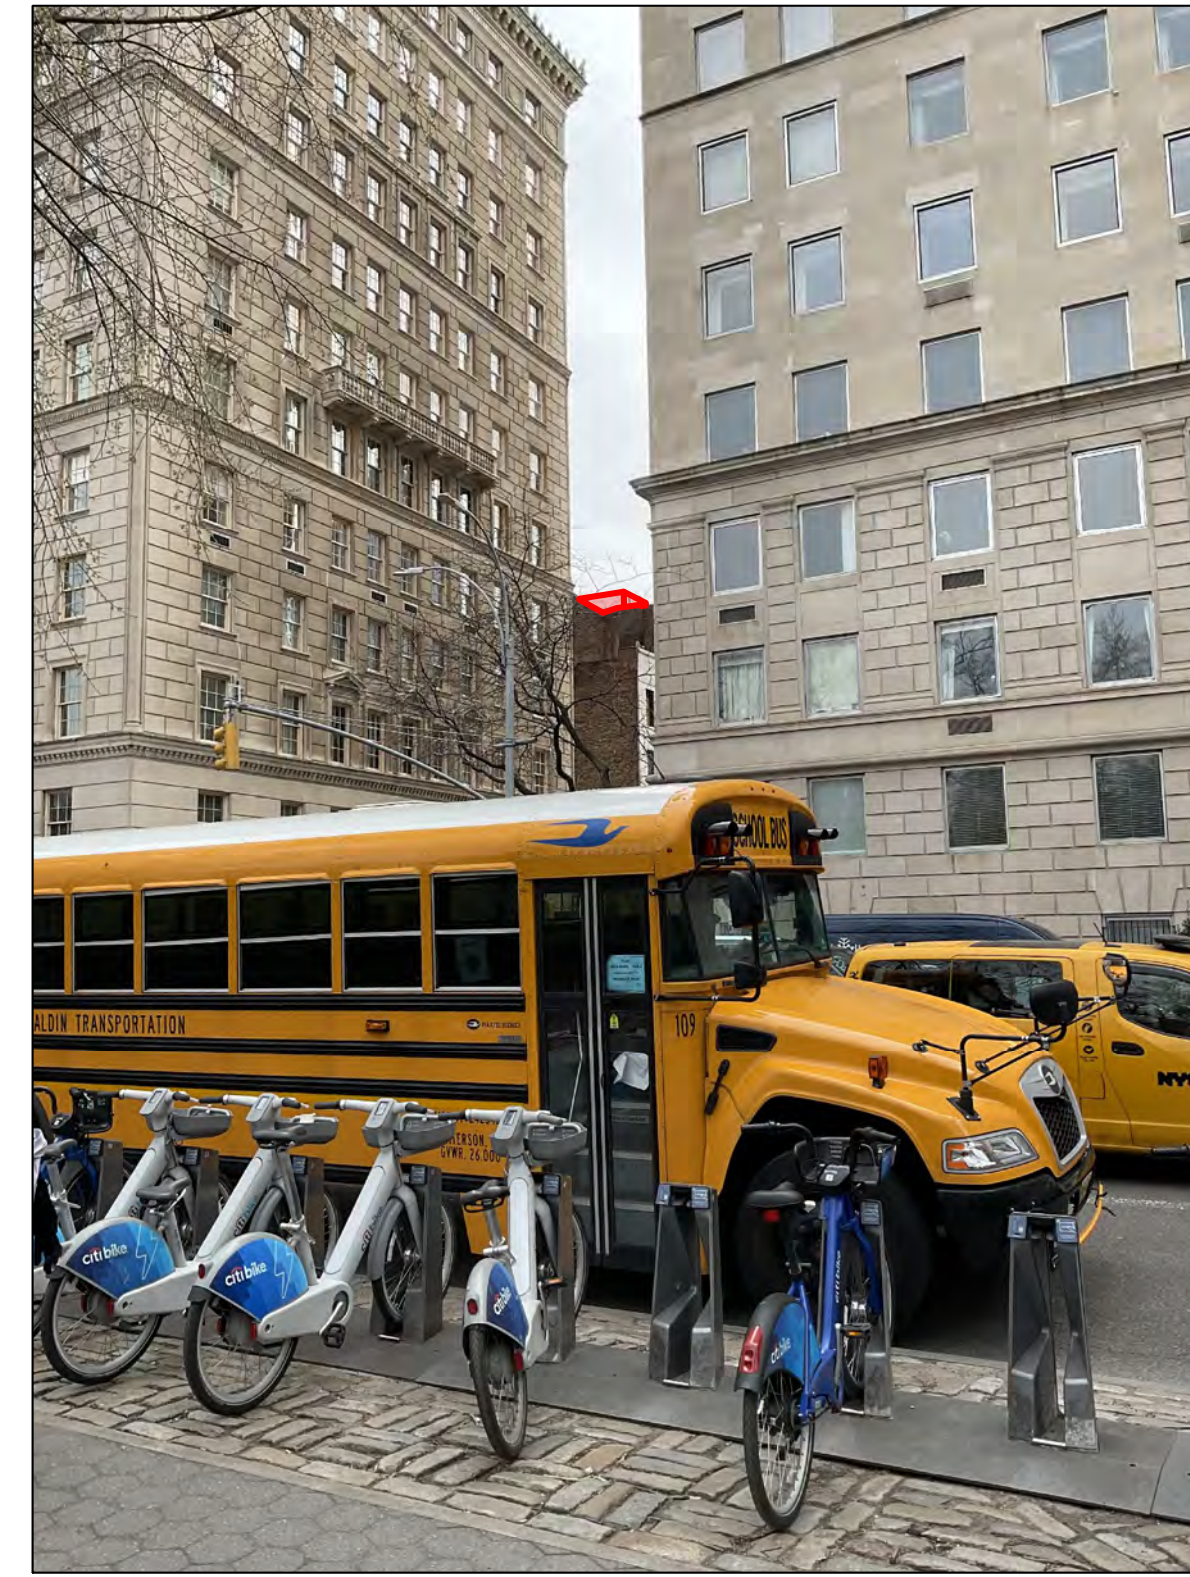
PHOTO 1 - WITH PROPOSED BULKHEAD MOCKUP HIGHLIGHTED

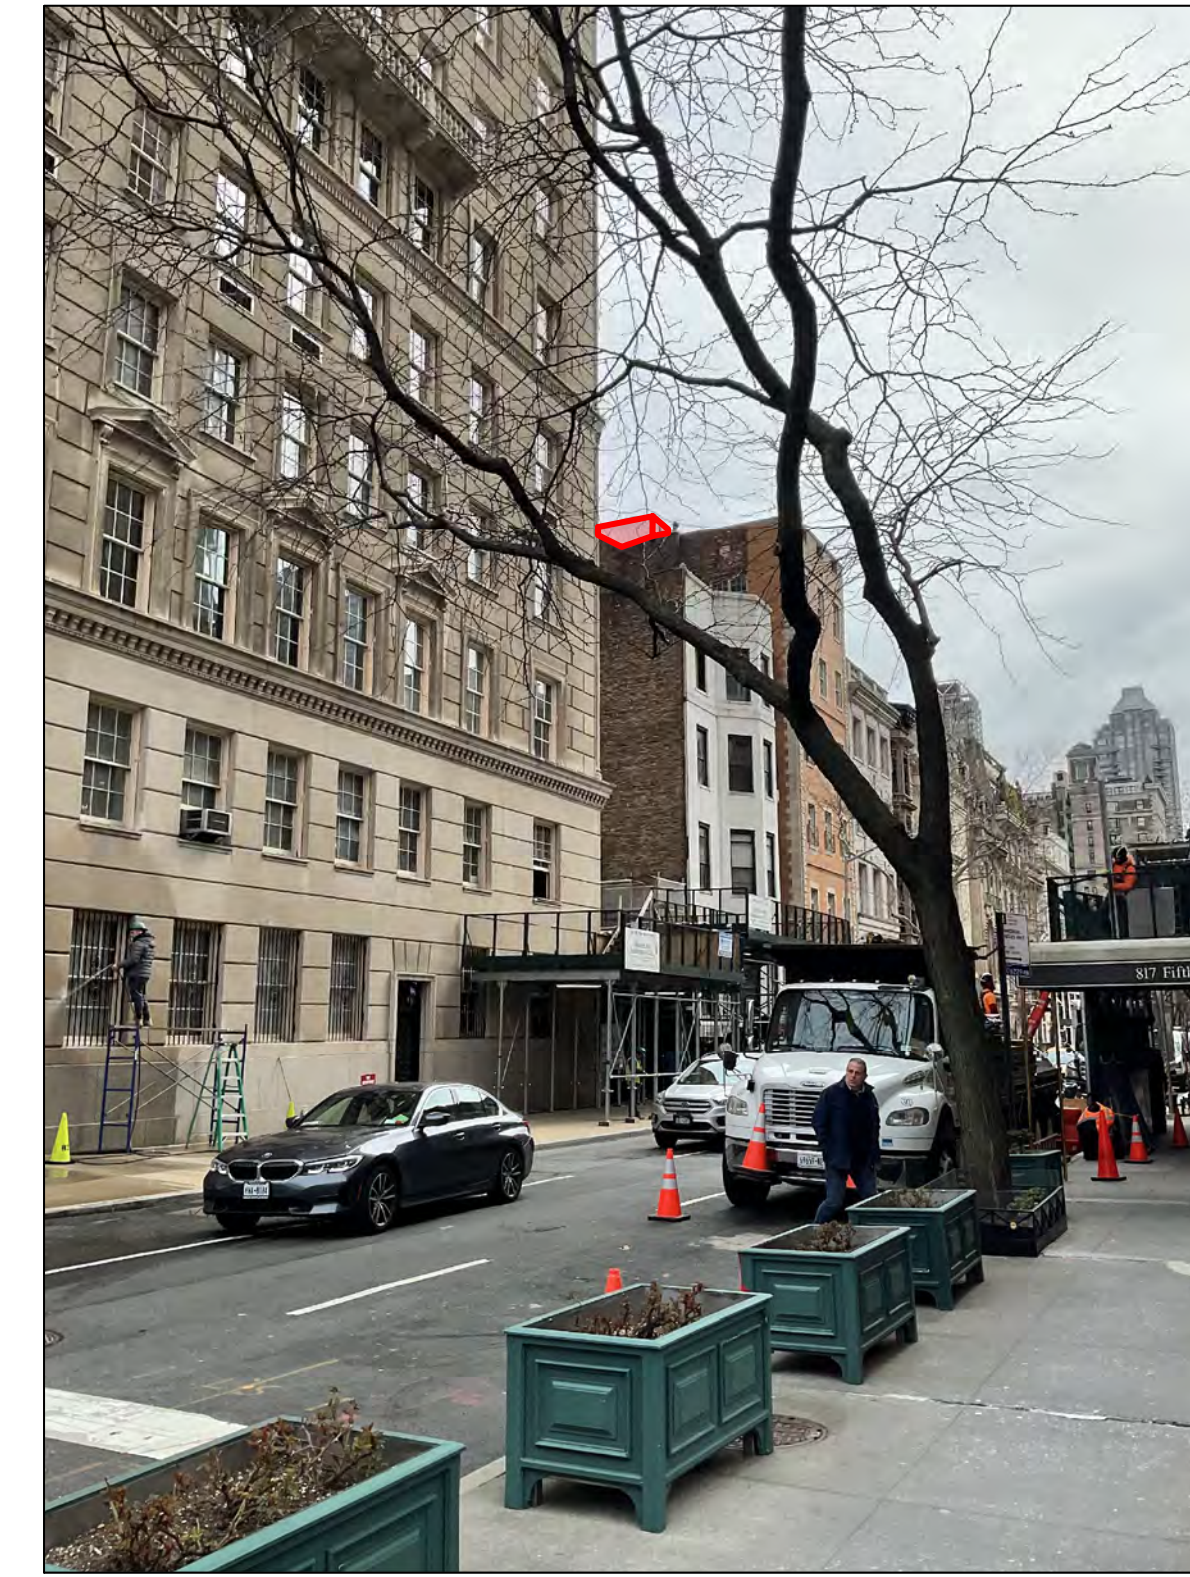
PHOTO 3 - WITH PROPOSED BULKHEAD MOCKUP HIGHLIGHTED

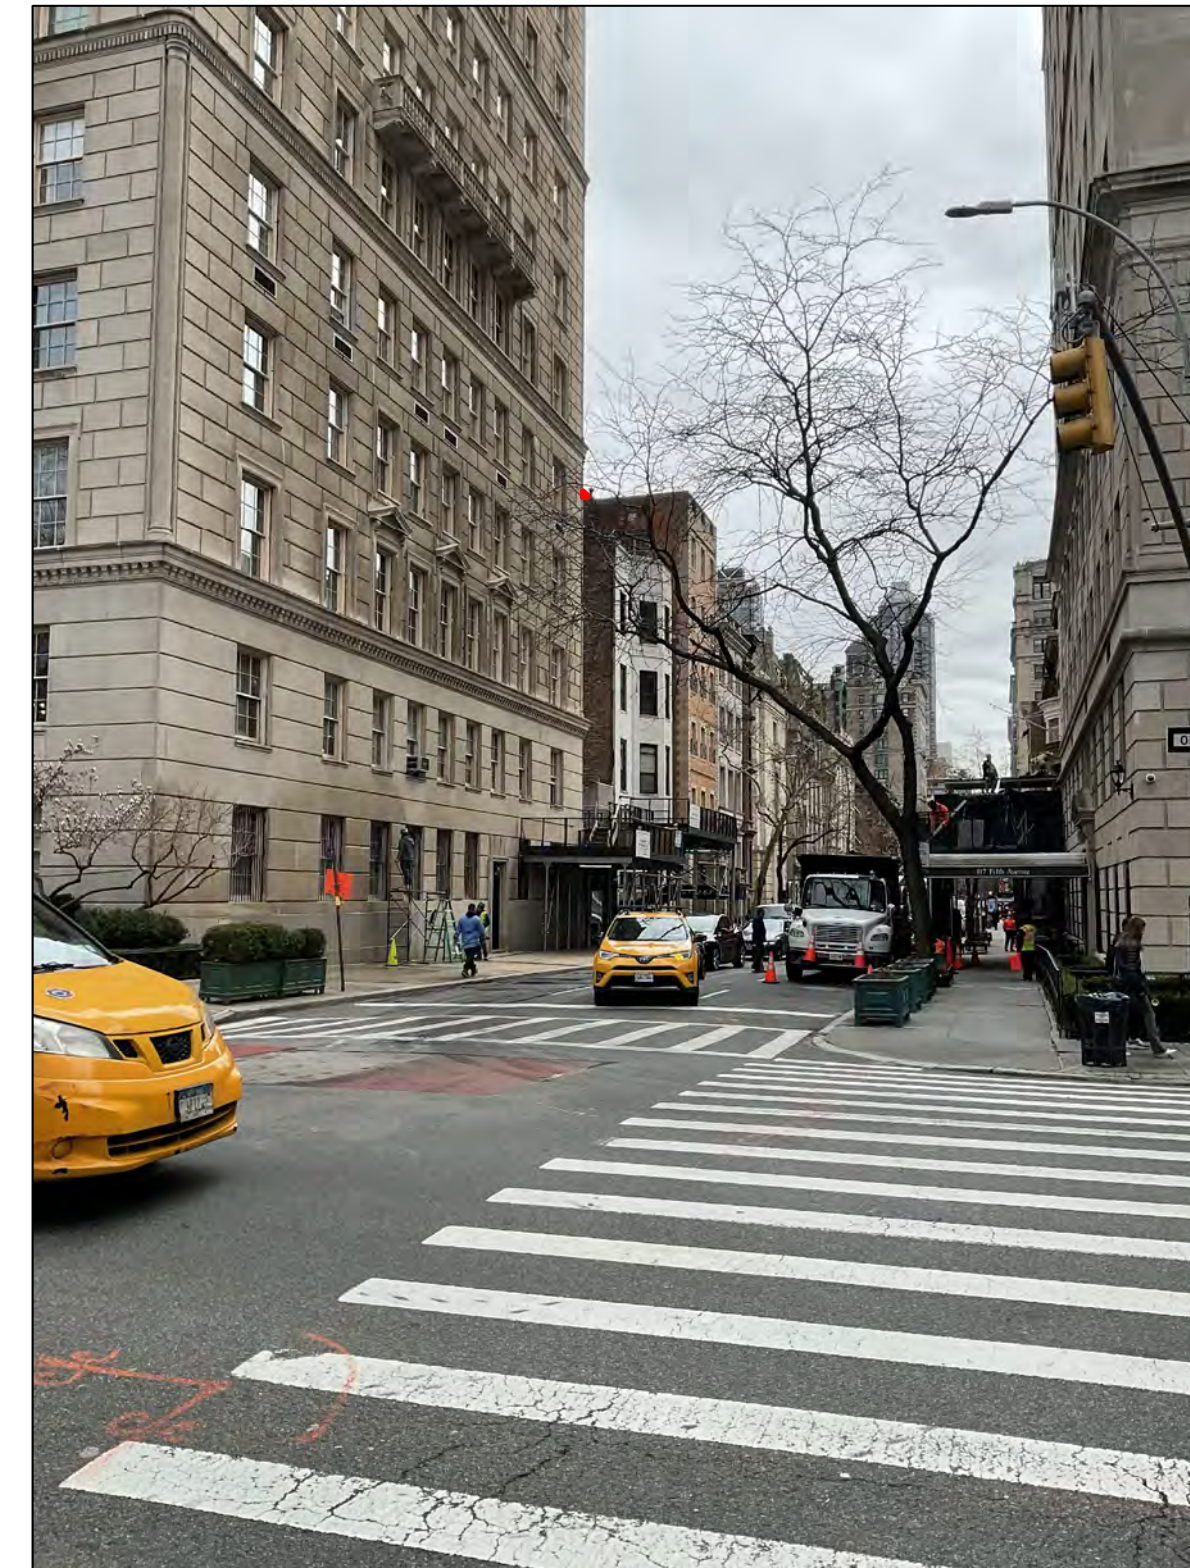
PHOTO 2 - WITH PROPOSED BULKHEAD MOCKUP HIGHLIGHTED

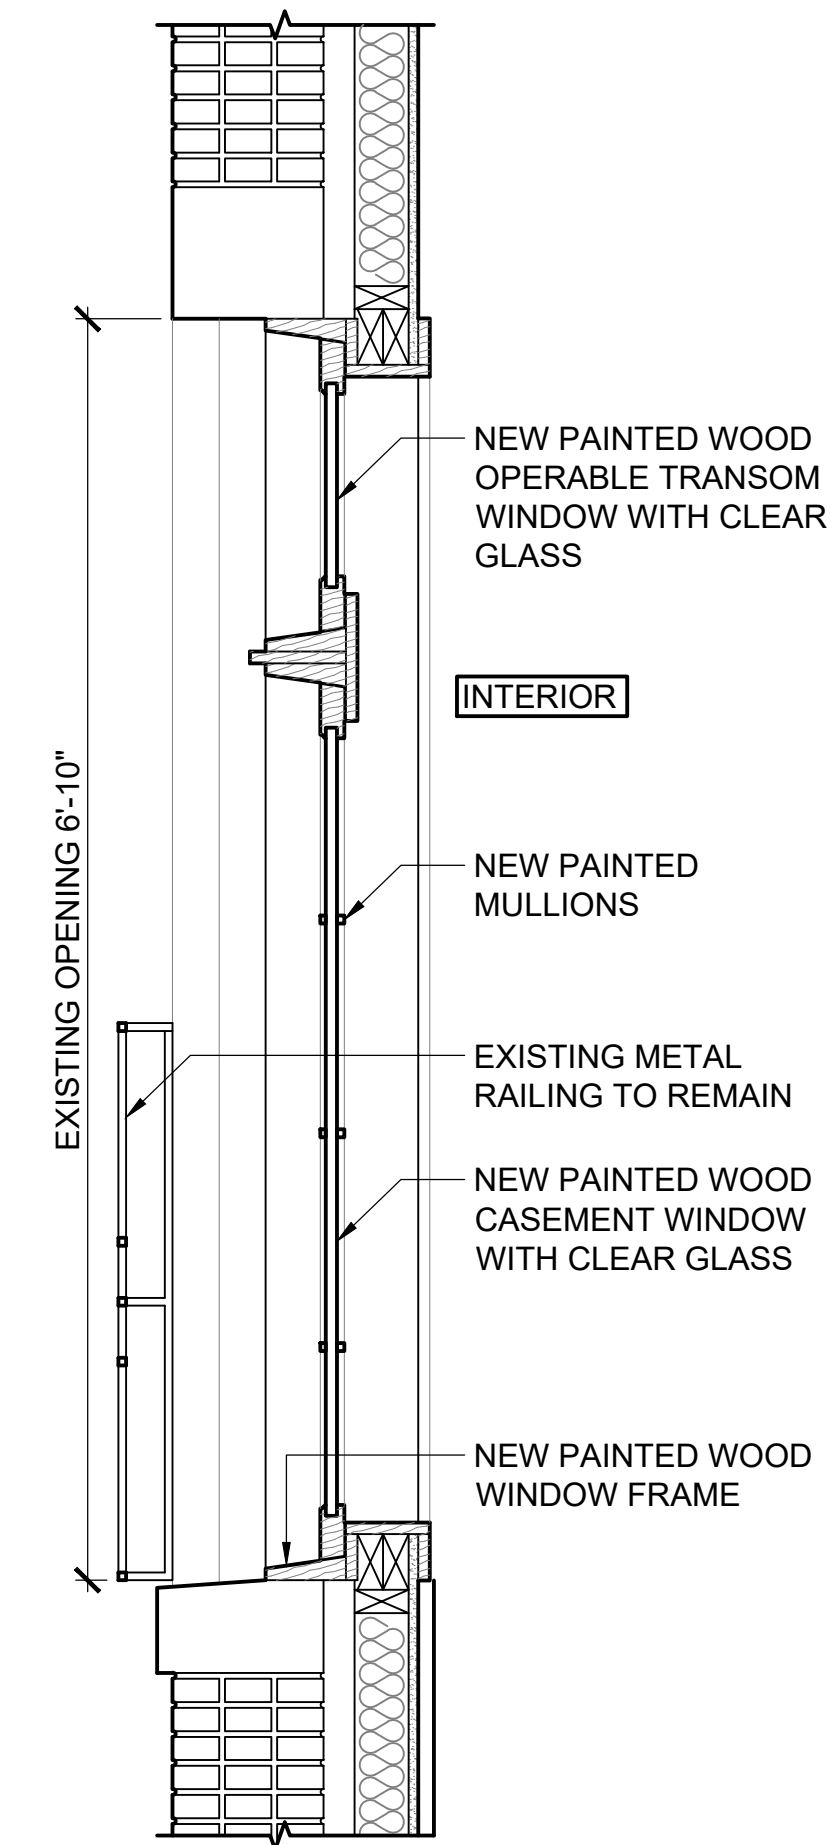
PROPOSED CASEMENT WINDOW

PROPOSED WINDOW FRAME
 MATERIAL: WOOD
 COLOR: BENJAMIN MOORE, GENTLE CREAM OC-96
