QUEENS

QUEENS BOULEVARD

QUEENS BOULEVARD PEDESTRIAN SAFETY STUDY

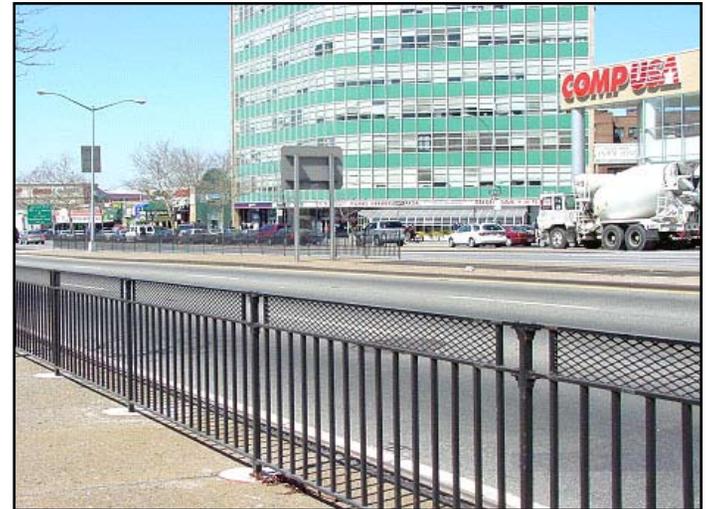
Pedestrian barriers along Queens Boulevard

- 67th Road
 - 68th Avenue
 - Yellowstone Boulevard
 - 70th Avenue
- Installed 3,700 linear feet of pedestrian barriers (36 inches in height) on the service road medians (except in the vicinity of slip ramps where pedestrian barriers were installed on the center medians) for the entire length of Phase I. Work was completed in March 2001.

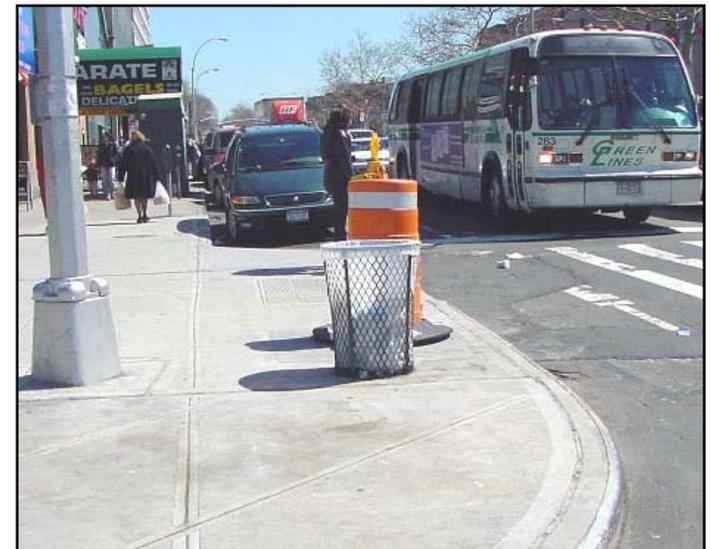
Neckdown on Queens Boulevard

- Yellowstone Boulevard
- Installed sidewalk extensions (neckdowns), including pedestrian ramps, at six intersections:
 - 67th Road (southwest corner)
 - 68th Avenue (northeast corner, south side of crossing)

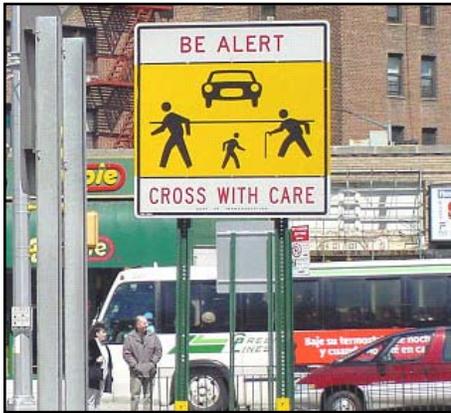
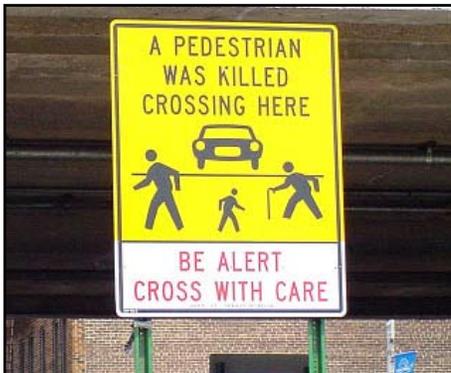
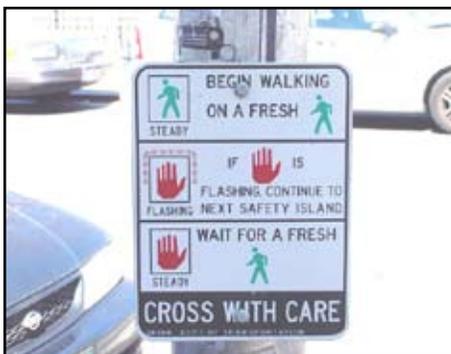
Examples of dedicated signage for pedestrians along Queens Boulevard

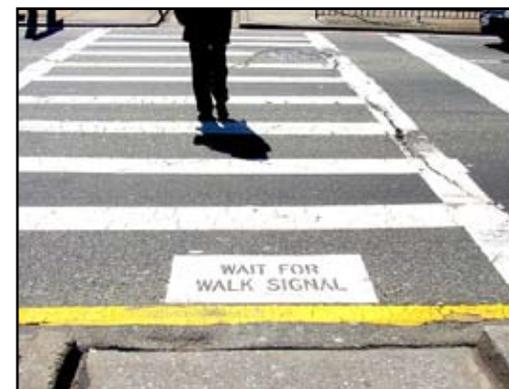
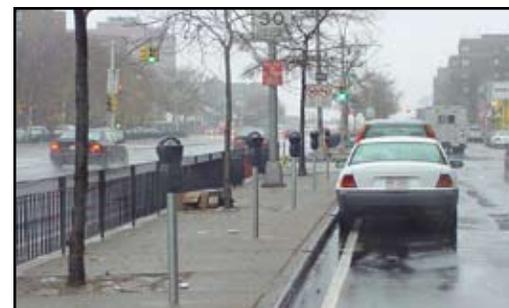
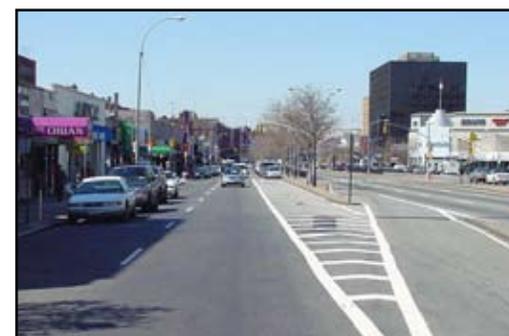
Top: Pavement Marking advising pedestrians to “Wait for Walk Signal”. Middle : Example of parking along the center median. This strategy narrowed the roadway to one lane from two. Bottom: At some locations, parking meters were removed and roadway markings and flexible bollards were installed to improve vehicular and pedestrian safety.

- In June 2001, a new speed calming strategy was completed that allows parking in the left lane of the service road adjacent to the median in a four-mile section of Queens Boulevard between 76th Street/Kneeland Avenue and Union Turnpike. This provided 545 additional parking spaces on this section of the Boulevard. The number of travel lanes on the service roads in both the eastbound and westbound directions were reduced from two to one. In conjunction with this change, channelization was installed to guide vehicles through the slip ramps between the main roadways and the service roads.

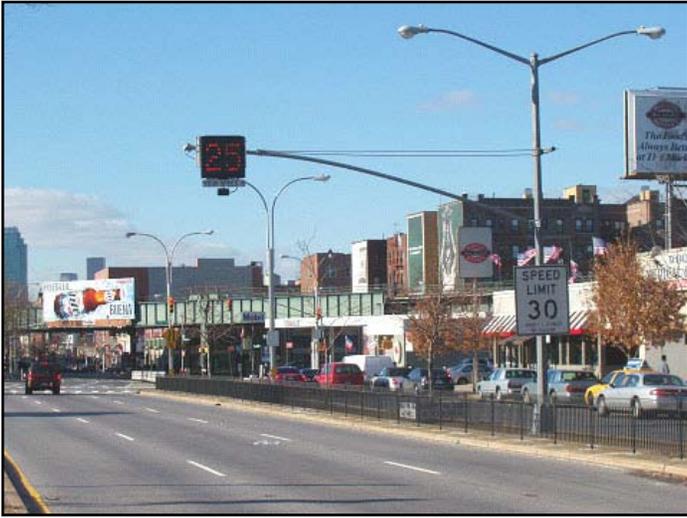
Example of permanently mounted speed detector board to inform motorists of their travel speed

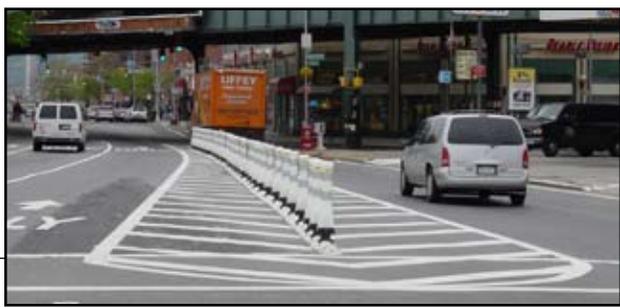
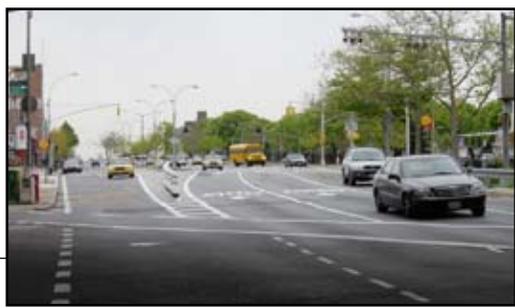
SHEET 3 OF 15

Roadway markings on Queens Boulevard between 51st Street and Roosevelt Avenue

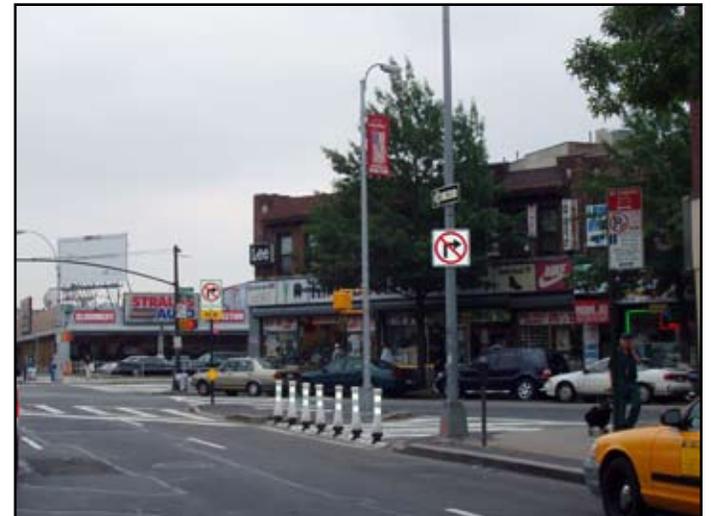
Signage and flexible bollards were used as temporary treatments to eliminate the uncontrolled right turn onto Greenpoint Avenue

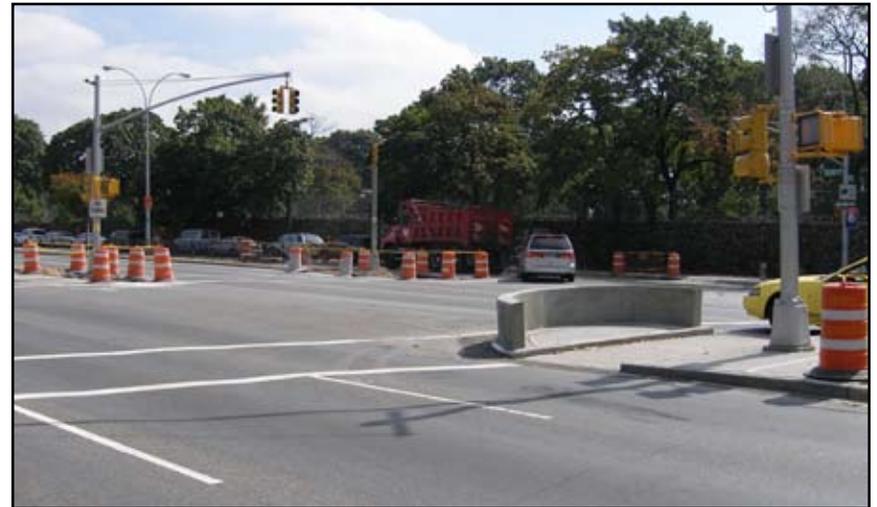
Median extensions and concrete protection devices being constructed along Queens Boulevard

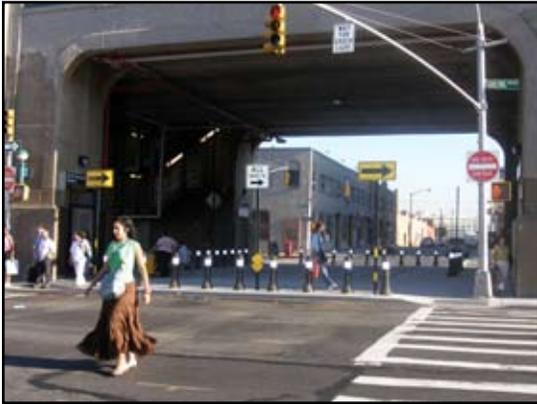
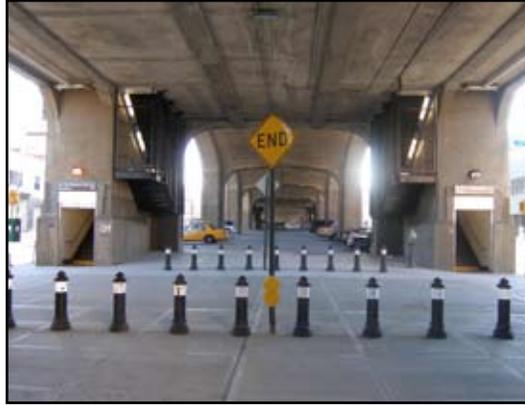
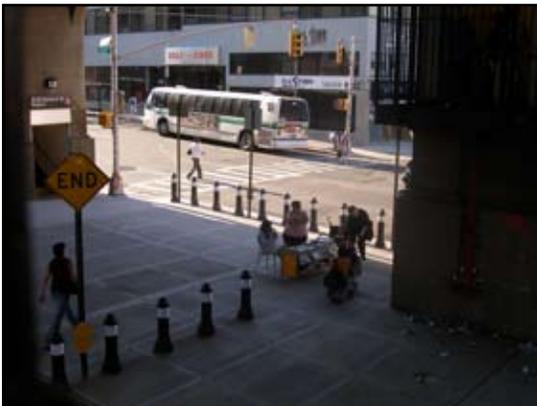
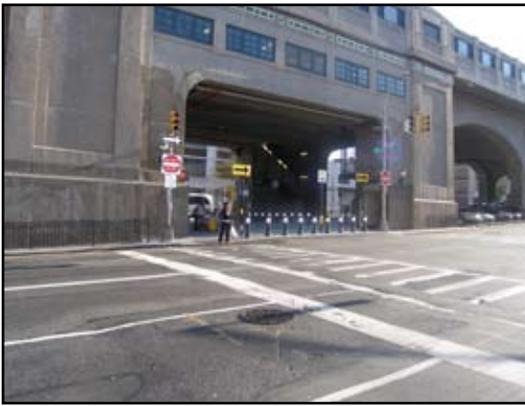
Detailed images and perspectives of full closure of 33rd Street, including signage, reflective bollards, pedestrian fencing and the protected pedestrian plaza

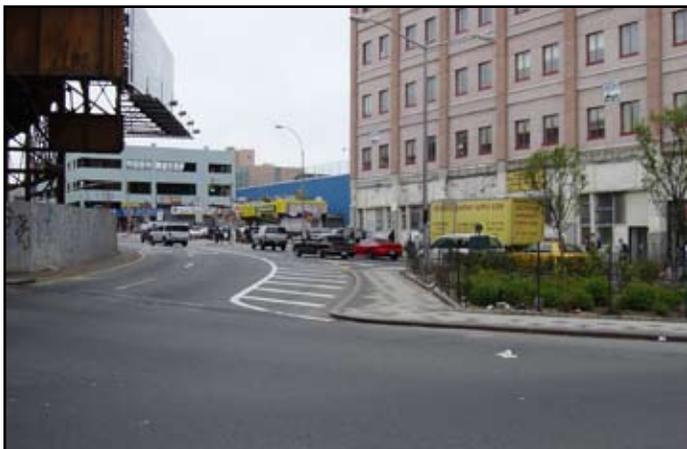
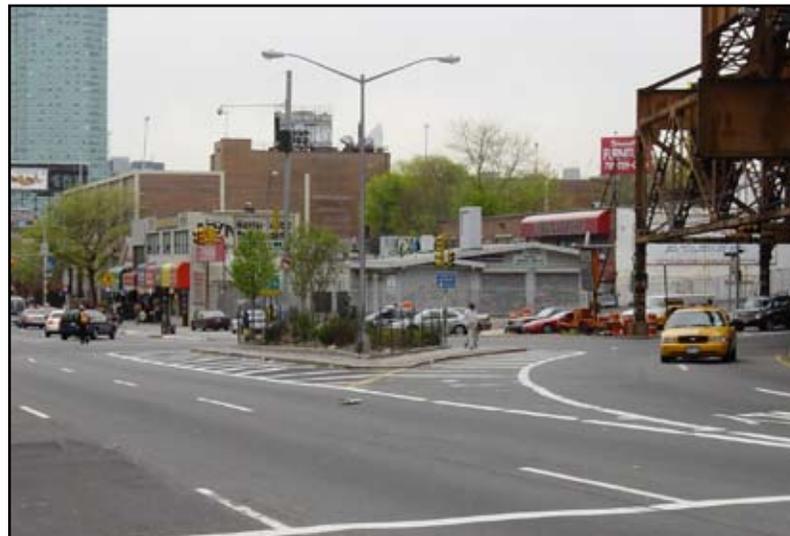
Channelization and markings at the convergence of Queens Boulevard, Van Dam Street and Thomson Avenue

In November 2002, an additional channelization (shown on the following page) was installed to narrow the roadway on eastbound Queens Boulevard to two lanes just north of the traffic island where Thomson Avenue and Queens Boulevard converge. The new channelization removed the conflict between vehicles entering Queens Boulevard from those continuing eastbound on Queens Boulevard.

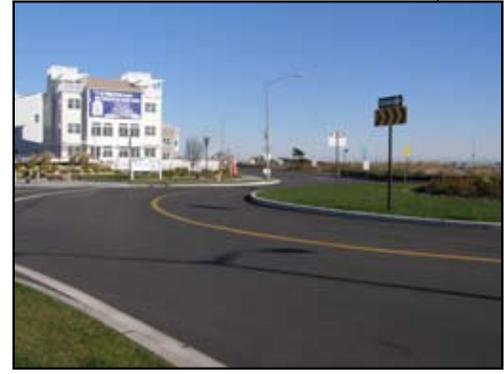
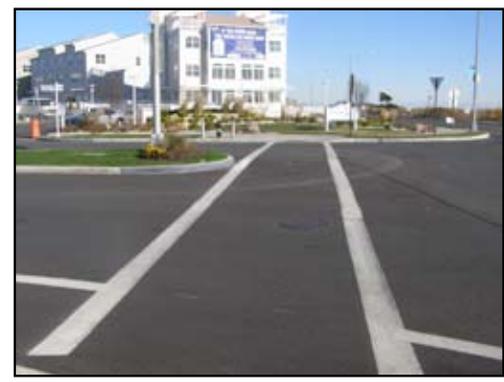
New roundabout at Shore Front Parkway and Beach 73rd St

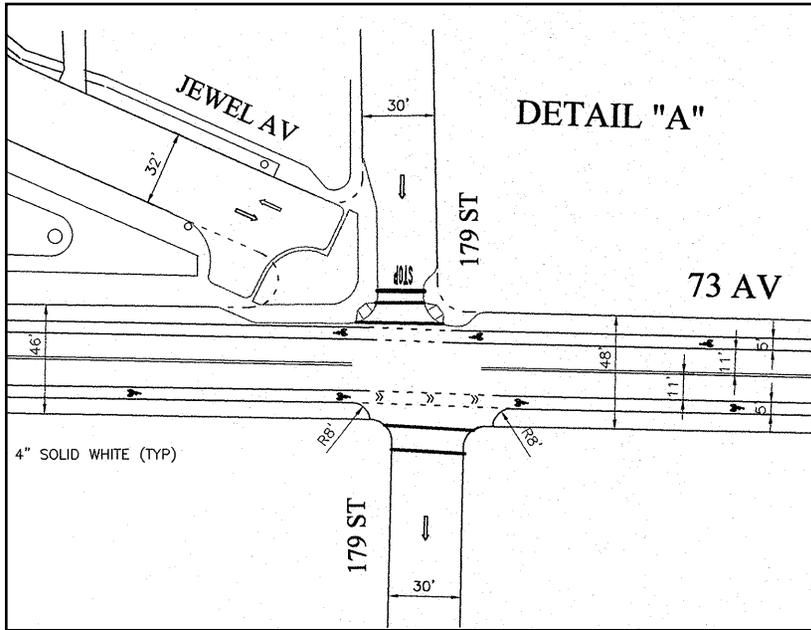
Road closure at Jewel Avenue and 73rd Avenue/179th Street

- Construction closed off the Jewel Avenue slip from 73rd Avenue and 179th Street
- Neck downs were constructed for better alignment
- Pedestrian crosswalk was shortened
- Hammer-head type turn around for emergency and sanitation trucks was constructed
- A continuous sidewalk on 179th street to access the adjacent park was provided

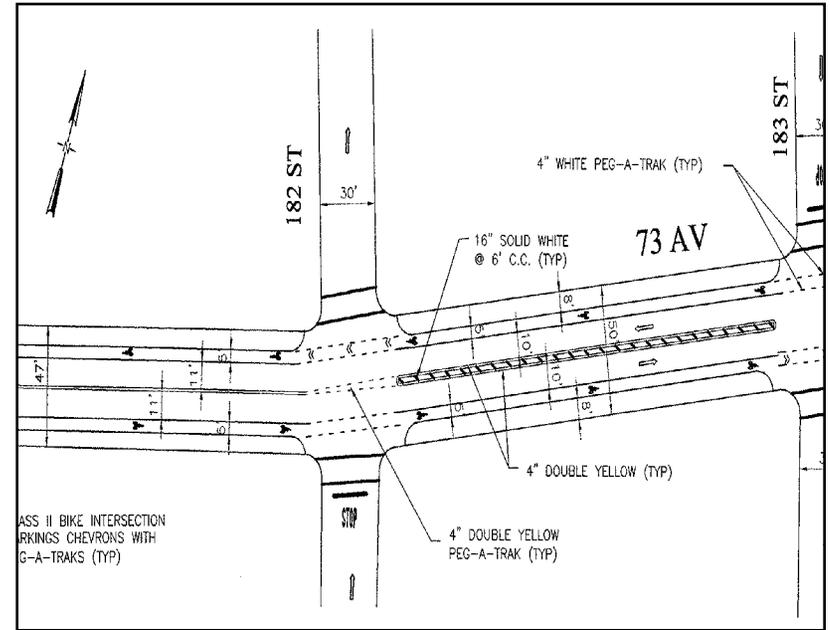
Cross section of 73rd Avenue with and without channelized median

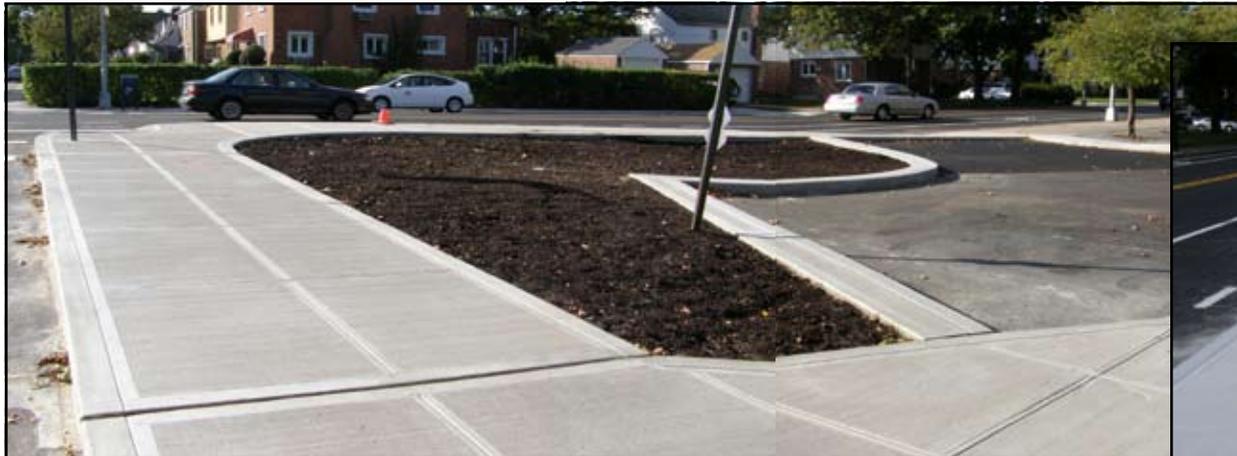
Road closure at Jewel Avenue and 73rd Avenue/179th Street

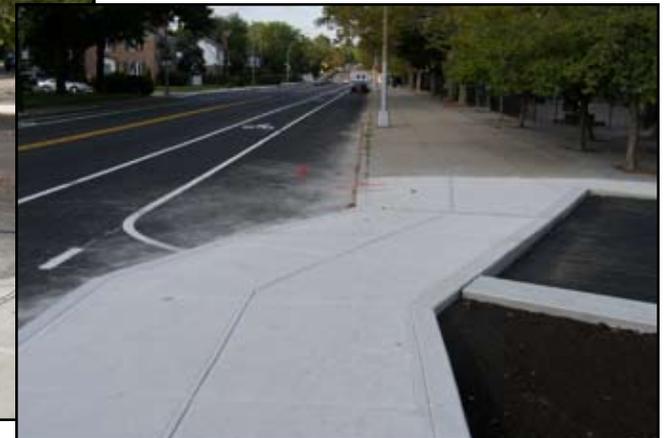
Closed exit from Jewel Avenue onto 179th Street

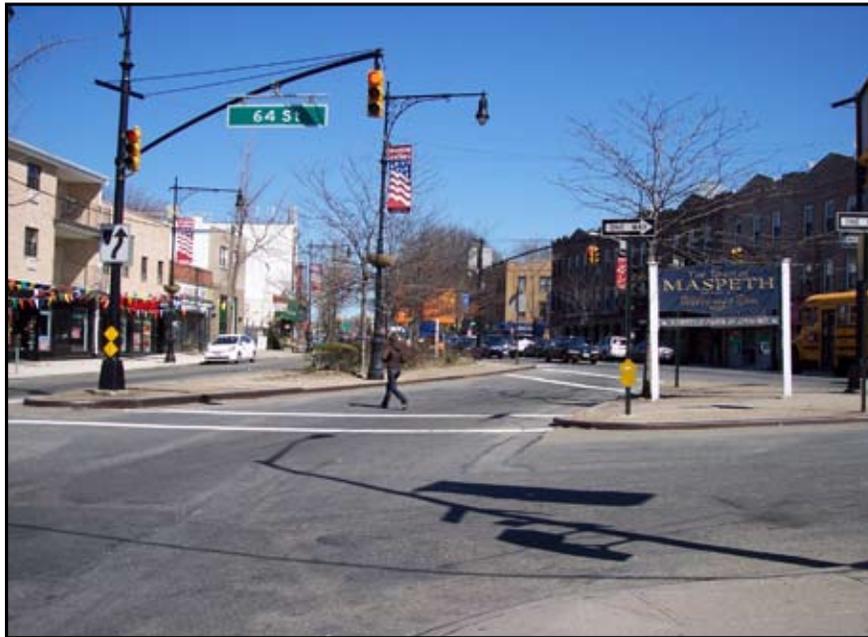
Former view of two small, unjoined islands

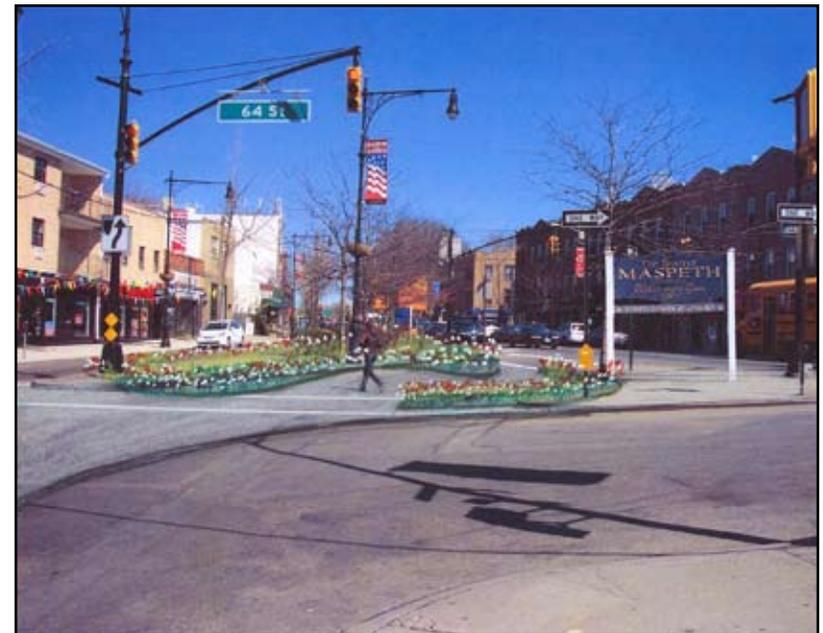
Rendering shows new, joined pedestrian space with plantings

- Improved conditions for students walking to school
- Reduced speeding on Grand Avenue adjacent to school
- Discourages trucks from using Grand Avenue
- Provides shorter and more simplified crossings
- Provides more trees for community
- Provides signal timing coordination with new configuration

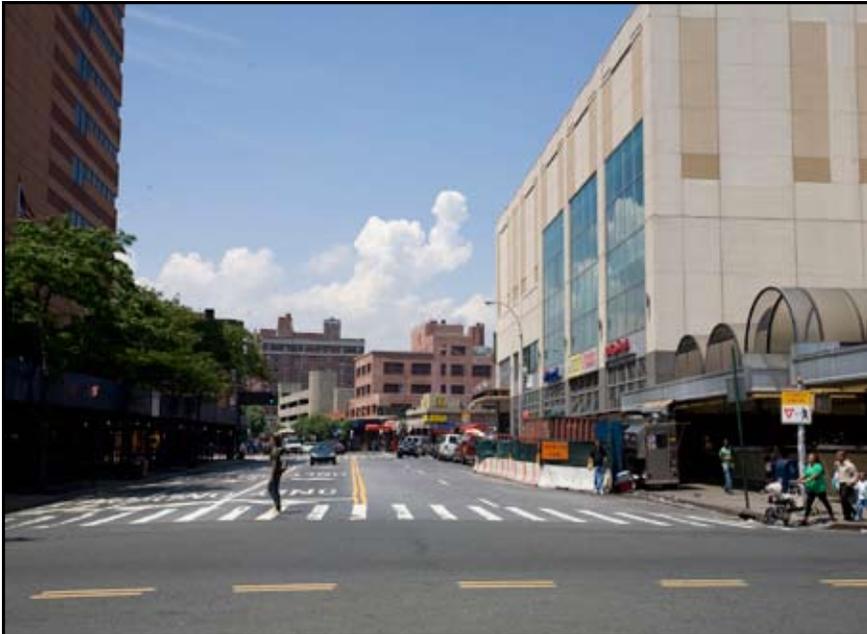
BEFORE: Parsons Boulevard at Archer Avenue facing north.

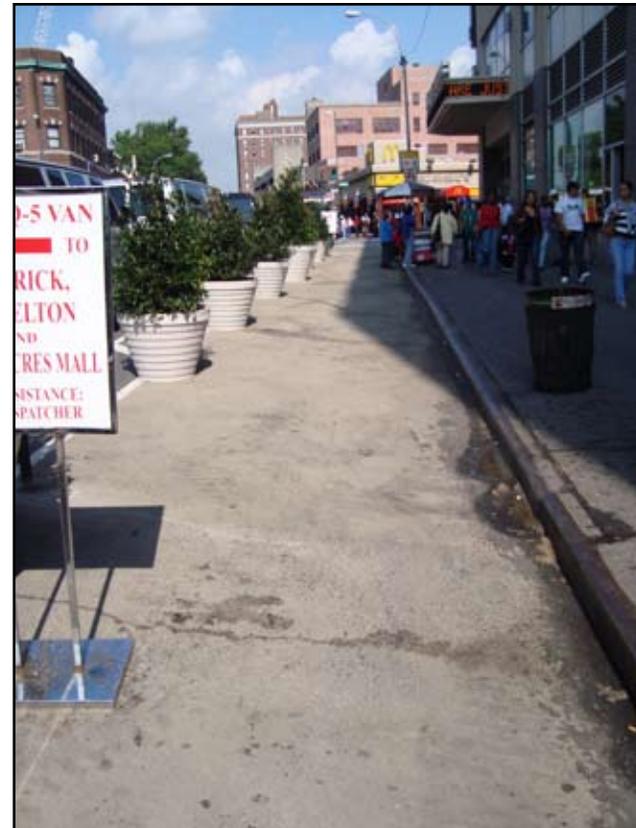
AFTER: Parsons Boulevard facing north. New pedestrian space provided by the removal of a moving lane

- Reduced number of travel lanes and narrowed the roadway to provide additional pedestrian space
- Maintained commuter van parking adjacent to pedestrian space
- Designated pedestrian space with epoxy paint and installed planters

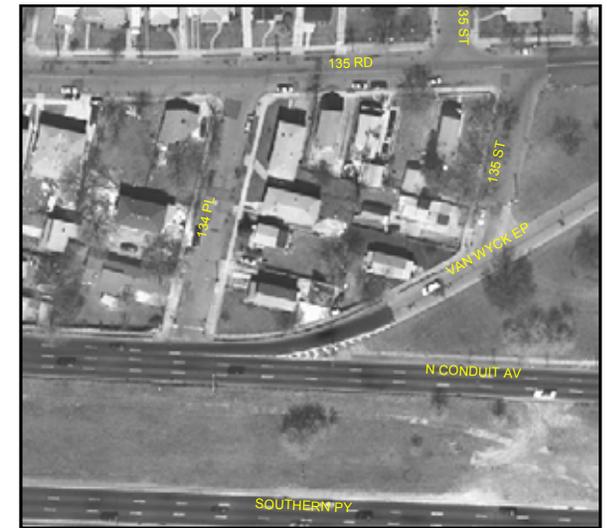
Original configuration and roadway markings at merge

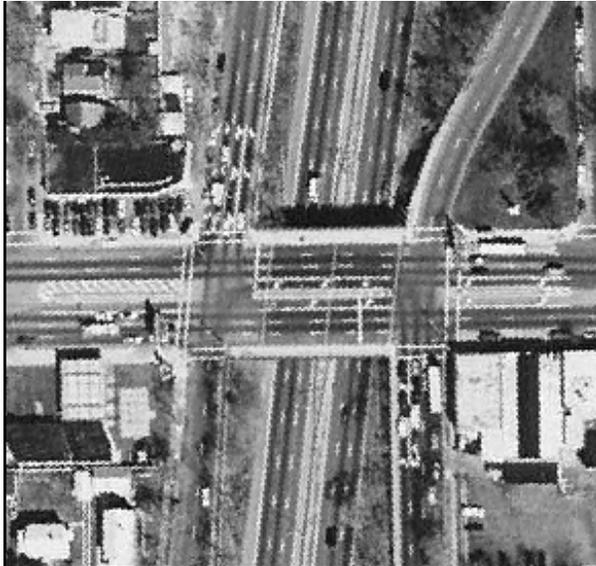
Aerial view of original configuration and roadway markings

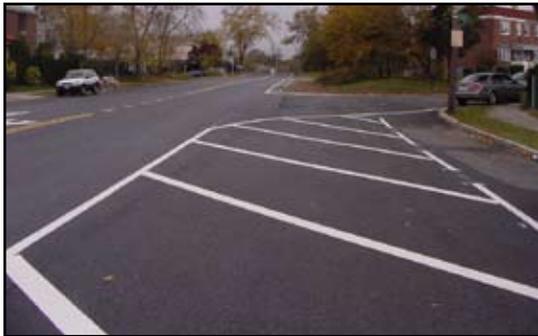
Roadway markings were utilized to improve geometry of roadway, narrow the roadway into one travel lane and provide parking

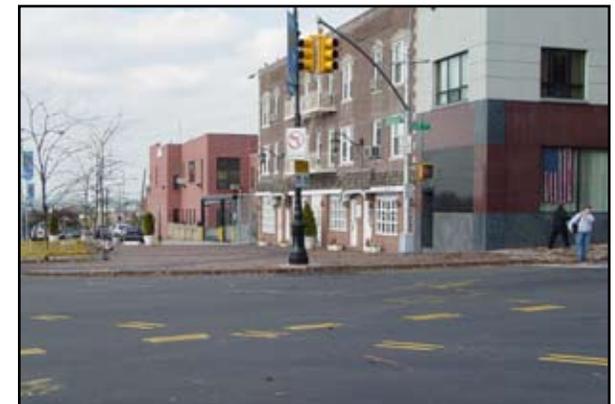
Roadway markings including peg-a-tracs

- Installed bollards at the north end of the traffic island at 69th Street and Grand Avenue.
- Placed a stop sign on the slip roadway of the LIE's eastbound service road at Grand Avenue.
- Posted "No Left Turn" signs on northbound 69th Street at Grand Avenue.
- Upgraded all pedestrian crosswalks to high visibility.
- Installed peg-a-trac markings on 69th Street across Grand Avenue.
- Repositioned the left-turn signal arrow for northbound 69th Street at the westbound service road of the LIE.
- Installed five foot extensions to the signal mast arms at Grand Avenue and 69th Street to enhance visibility.
- Installed edge lines on both sides of Grand Avenue and 69th Street between the service roads of the expressway.
- Louvered the green signal (facing north) at 69th Street and the westbound service road, so they are not visible to southbound 69th Street motorists approaching Grand Avenue.

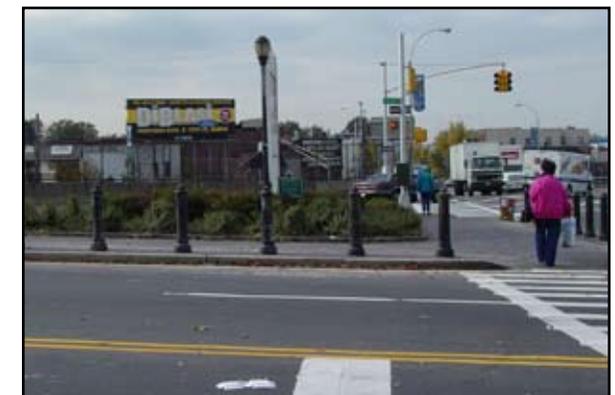
Detail of bollards and high visibility crosswalks

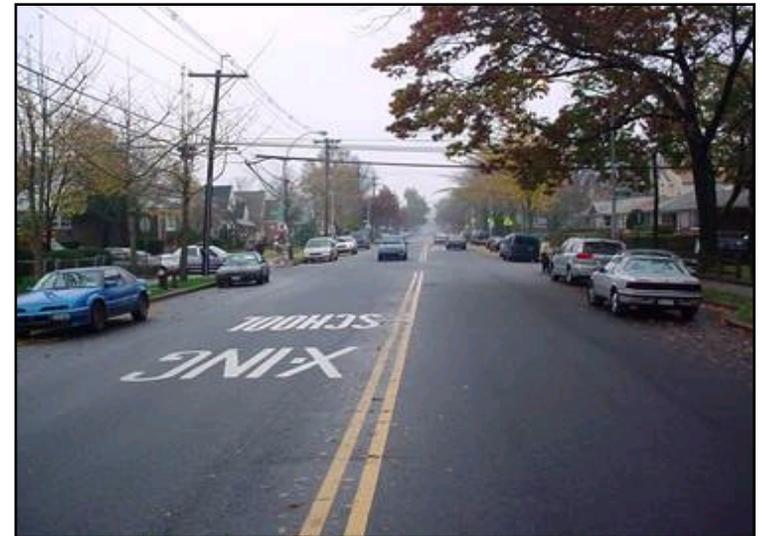
The original configuration and roadway markings

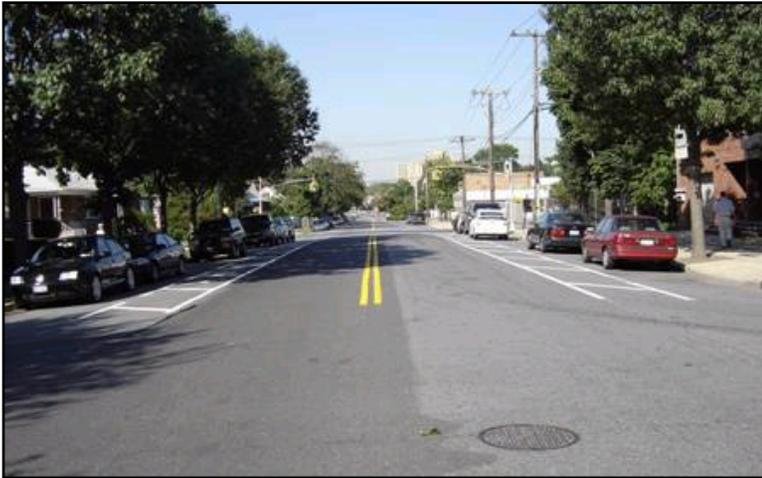
Roadway markings effectively narrowed 80th Avenue to one lane in each direction
