# Safe Streets for Seniors

## Jackson Heights, Queens

### FINAL REPORT

January 7, 2011

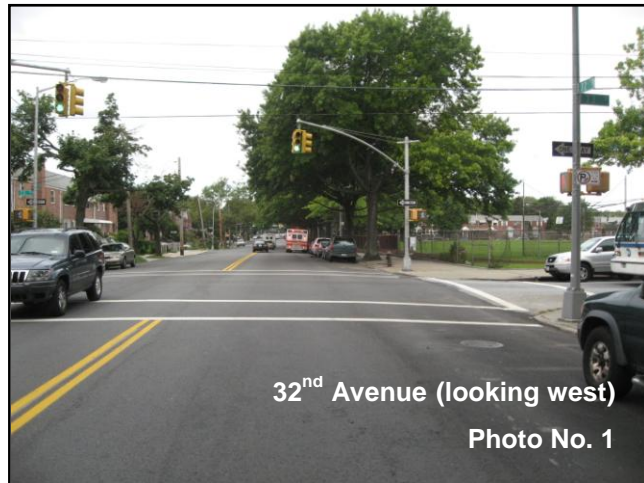
The study segment of 32<sup>nd</sup> Avenue is approximately 0.89 miles long and intersects 19 cross streets. Within the study segment, 32nd Avenue is a two-way arterial with one moving lane in each direction and a parking lane along each curb side (Photo No. 1). This corridor provides east-west access, with parking generally permitted on both sides of the arterial within the study area. The cross streets that intersect 32<sup>nd</sup> Avenue are one-way streets and are mainly categorized as local neighborhood roadways providing north-south access. While 32<sup>nd</sup> Avenue does not provide bus services or a through-truck route, the cross streets provide bus service for the Q33, Q47 and Q49 lines. This study segment of 32<sup>nd</sup> Avenue is generally located adjacent to a residential neighborhood with public schools located at either end of the study area.

The field observations and evaluation of traffic data made along this corridor have resulted in various corridor-wide, as well as localized intersection-specific recommendations. These recommendations are shown in the Site 1 illustrations and are described below.

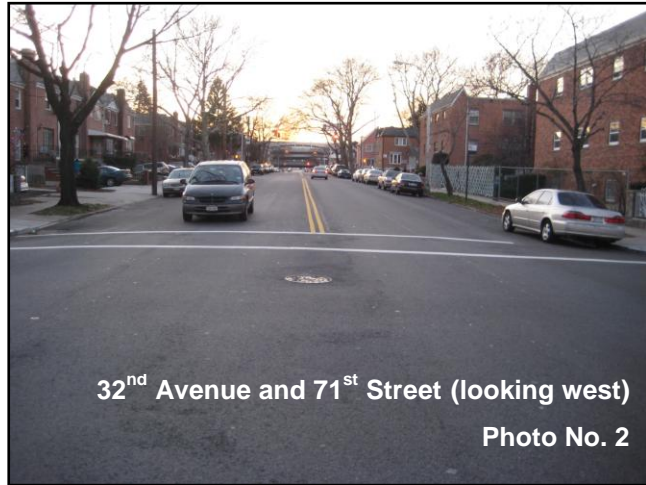
- In order to enhance pedestrian safety by calming traffic operations (reducing vehicular speed), it is recommended that a 6 foot wide painted, hatched median island be installed on 32<sup>nd</sup> Avenue between 70<sup>th</sup> and 75<sup>th</sup> Streets. During the initial field visit, higher vehicular speeds were observed along this section of 32<sup>nd</sup> Avenue (Photo No. 2). These

increased vehicular speeds were attributed to the slightly wider roadway width available within this segment, as compared to other roadway segments along 32<sup>nd</sup> Avenue. As a result of this initial observation, spot speed surveys were conducted during the morning and midday peak hours. These survey results showed higher peak hour vehicular speeds, further confirming that non-peak hour speeds could be even higher, thus, resulting in the above-noted recommendation. Backup spot speed survey data can be found in Appendix E.

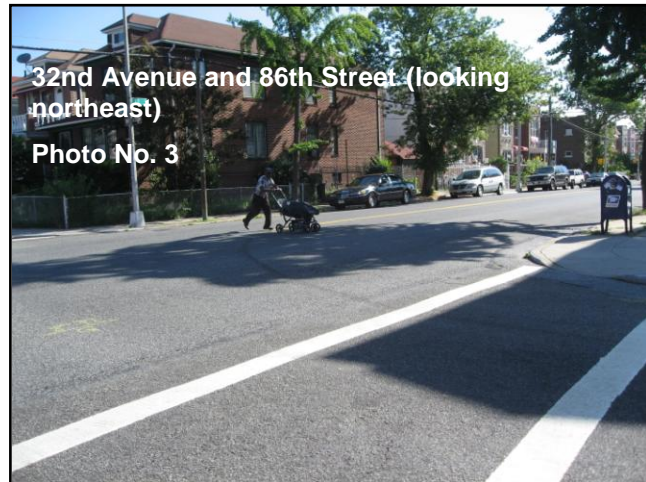
- Under the present condition, this intersection is unsignalized with no crosswalk provisions on 32<sup>nd</sup> Avenue (Photo No. 3). Consistent with past practice, it is not recommended that crosswalks be installed on 32<sup>nd</sup> Avenue at this intersection; however, it is recommended that positive guidance be provided to pedestrians so that they are

directed to cross 32<sup>nd</sup> Avenue via the adjacent signalized intersections. It is recommended that pedestrian signs be installed, including “No Pedestrian Crossing” (MUTCD: R9-3a) signs, supplemented with the directional “Use Crosswalk” (with appropriate arrow) (MUTCD: R9-3b) signs, to discourage pedestrians from crossing at this unsignalized intersection. These signs should be appropriately located facing

pedestrians on the intersection corners so that pedestrians are guided to cross 32<sup>nd</sup> Avenue via the adjacent signalized intersections.

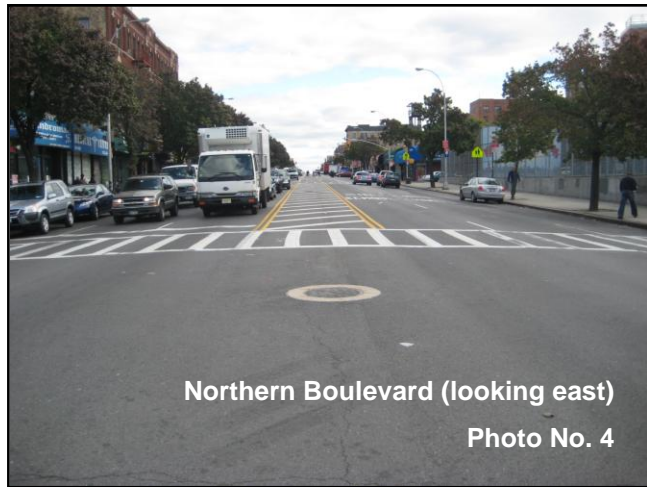
The study segment of Northern Boulevard is located one block south of 32<sup>nd</sup> Avenue. It is approximately 0.89 miles long and intersects the same 19 north-south one-way cross streets that intersect 32nd Avenue. Within the study segment, Northern Boulevard is a major two-way arterial with two moving lanes in each direction and a metered parking lane along each curb side (Photo No. 4). This corridor provides east-west access. As

per the typical one-way side street setup, left turn lanes (bays) are provided along Northern Boulevard at alternate blocks and, where possible, the traffic is separated by a hatched median island. Northern Boulevard provides a designated through-truck route and bus services for the Q66 bus line. The cross streets provide bus services for the Q32, Q33, Q47 and Q49 lines. Within the study segment, Northern Boulevard is a major east-west arterial with a broad range of retail as well as residential land-use activities that attracts a significant number of pedestrians, including senior citizens.

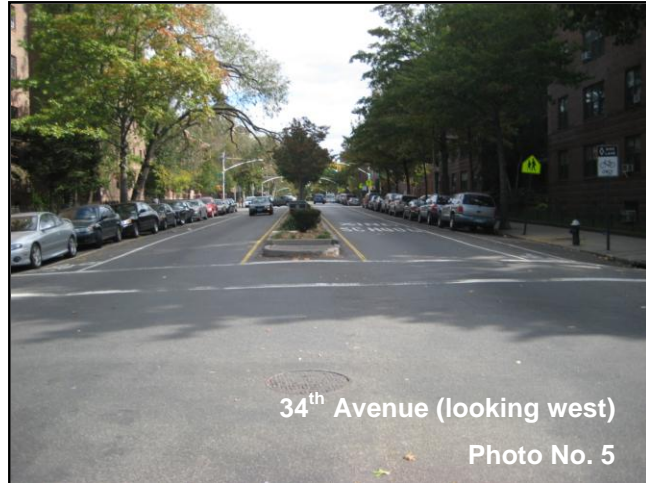
The study segment of 34<sup>th</sup> Avenue is approximately 0.20 miles long and intersects five cross streets. Within the study segment, 34<sup>th</sup> Avenue is a two-way local roadway with one moving lane, a bicycle lane and a curb side parking lane in each direction (Photo No. 5). This corridor provides east-west access and the traffic is separated by a continuous raised median island. The cross streets that intersect 34<sup>th</sup> Avenue are

one-way streets and are mainly categorized as local neighborhood roadways providing north-south access. While 34<sup>th</sup> Avenue does not provide any transit or through-truck route services, the cross streets do provide bus services for the Q32 and Q33 lines. This corridor is located adjacent to a residential land use, and is mainly surrounded by four- to seven-story apartment buildings.

The field observations and evaluation of traffic data made within this corridor have resulted in the following intersection-specific recommendations. These recommendations are shown in the Site 3 illustrations.

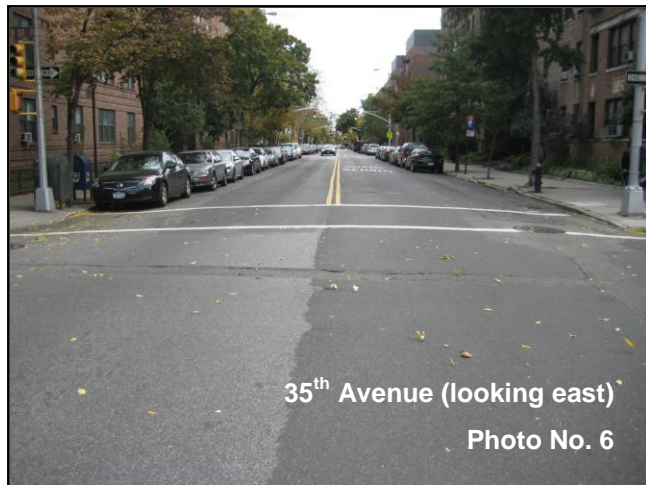
The study segment of 35<sup>th</sup> Avenue is located one block south of 34<sup>th</sup> Avenue. The segment is approximately 0.20 miles long and intersects the same five north-south one-way cross streets intersected by 34<sup>th</sup> Avenue. Within the study segment, 35<sup>th</sup> Avenue is a two-way local roadway with one moving lane in each direction and a parking lane along each curb (Photo No. 6). This corridor provides east-west access. The

The cross streets that intersect 35<sup>th</sup> Avenue are one-way streets and are mainly categorized as local neighborhood roadways providing north-south access. The study segment of 35<sup>th</sup> Avenue provides services to the Q49 bus line and the cross streets provide bus services for the Q32 and Q33 lines. The study segment is located adjacent to a residential land use, and is mainly surrounded by six- to seven-story apartment buildings.

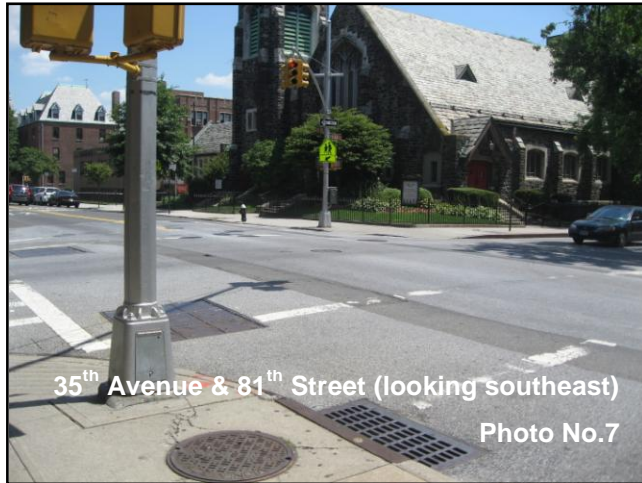
- It is recommended that the northbound nearside bus stop on 81<sup>st</sup> Street be moved to the far side and that one parking space be removed in advance of the south crosswalk on the east side of the street by installing a “No Standing Any Time” sign. These recommendations are mainly proposed in order to make pedestrians more visible to approaching drivers. Under the present conditions, pedestrians crossing the side streets are often hidden behind parked cars and stopped buses at this intersection (Photo No. 7).

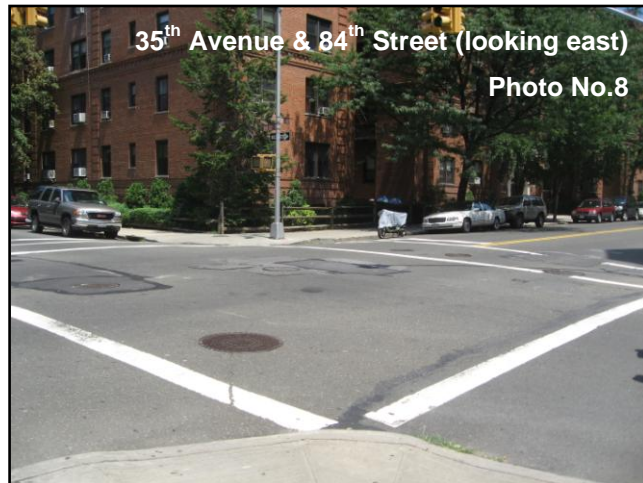
- It is recommended that new high visibility crosswalks be installed on all approaches to this intersection (Photo No. 8).

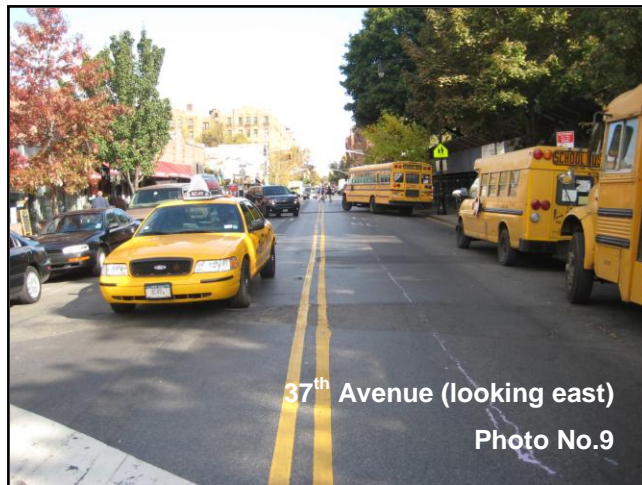
The study segment of 37<sup>th</sup> Avenue is approximately 0.82 miles long and intersects 18 north-south one-way cross streets. Within the study segment, 37<sup>th</sup> Avenue is a two-way roadway with one moving lane in each direction and a parking lane along each curb (Photo No. 9). This corridor provides east-west access. The cross streets that intersect 37<sup>th</sup> Avenue are one-way streets and are mainly categorized as local

neighborhood roadways providing north-south access. While 37<sup>th</sup> Avenue does not provide transit or through-truck route services, the cross streets provide service to the Q47, Q49, Q32, Q33 and Q53 bus lines. The study segment is located adjacent to a mixed residential and retail land use area. It is predominantly surrounded by apartment buildings whose ground floors are mainly utilized by neighborhood shops, restaurants and other retail activity.

The field observations and traffic data evaluation made within this corridor have resulted in various corridor-wide, as well as localized intersection-specific recommendations. These recommendations are shown in the Site 5 illustrations and are described below.

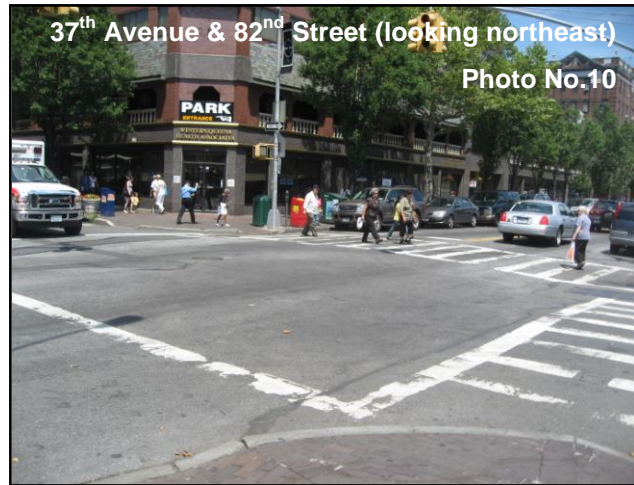
- Due to the large number of retail stores in this area, pedestrian activity is very prominent. Southbound buses Q32 and Q33 stop at the nearside corner on 82<sup>nd</sup> Street at 37<sup>th</sup> Avenue. It is recommended that the location of this bus stop be moved to the far side corner. This recommendation is mainly proposed to improve pedestrian visibility while crossing the side street (Photo No. 10).

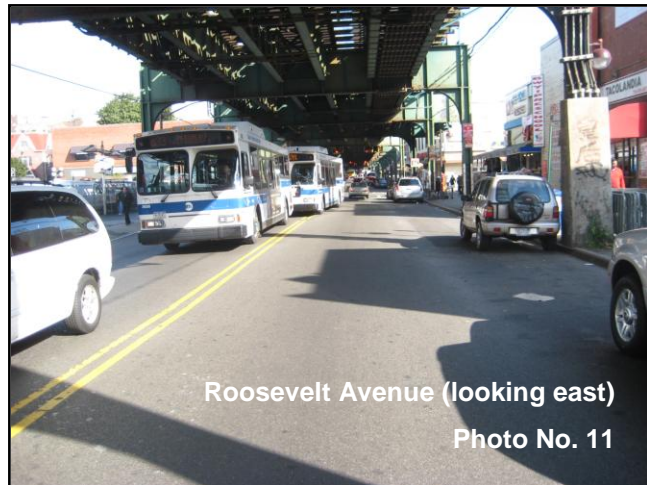
The study segment of Roosevelt Avenue is approximately 0.90 miles long and intersects 19 north-south one-way cross streets. Within the study segment, Roosevelt Avenue is a two-way arterial with one moving lane in each direction and a metered parking lane along each curb side (Photo No. 11). This corridor provides east-west access. Roosevelt Avenue is a designated local truck route and provides bus services to the Q53, Q32, Q33, Q45, Q49 and Q47 bus lines. This corridor also has elevated and underground subway lines (7, E, F, R, and M) that provide convenient services to Manhattan and Brooklyn. The sidewalks along this roadway have steel columns at frequent intervals to support the elevated subway line running above Roosevelt Avenue. The 74<sup>th</sup> Street subway station located on Roosevelt Avenue is one of the busiest subway stations in Queens and it attracts a significant number of subway passengers. Roosevelt Avenue is a busy commercial strip with a broad range of retail activities that attract a significant number of pedestrians including senior citizens. It also supports residential apartment buildings and can be considered a densely populated area. It is one of the more heavily travelled roadways within the study area.

The field observations and traffic data evaluation made within this corridor have resulted in various corridor-wide recommendations and intersection-specific recommendations. These recommendations are shown in the Site 6 illustrations and are described below.

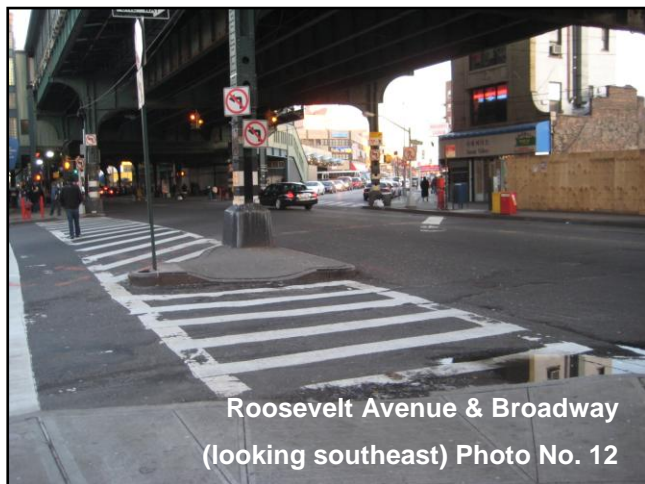
- Install Do Not Block Intersection pavement markings at these closely spaced intersections (Photo No. 12).

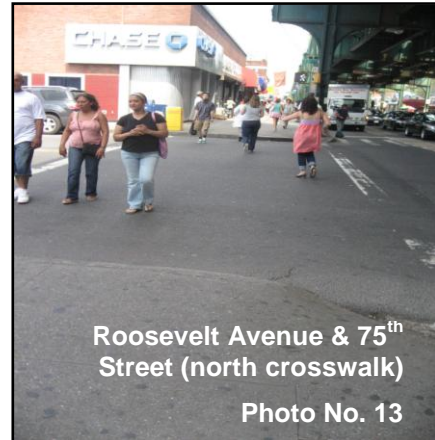
- It is recommended that one parking space be removed in advance of the east and west crosswalks by installing “No Standing Any Time” signs. These recommendations are mainly proposed to make pedestrians more visible to approaching drivers (Photo No. 13).

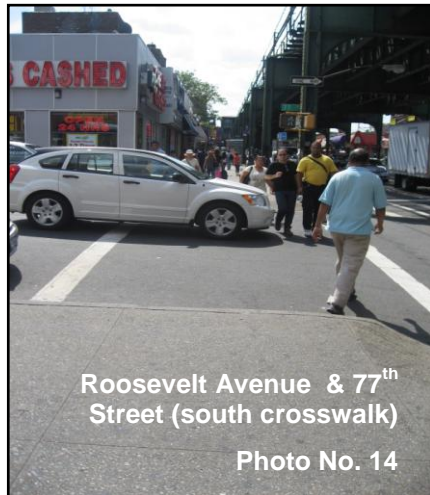
### ***Roosevelt Avenue and 77<sup>th</sup> Street***

- It is recommended that one parking space be removed in advance of the west crosswalk by installing a “No Standing Any Time” sign (Photo No. 14).

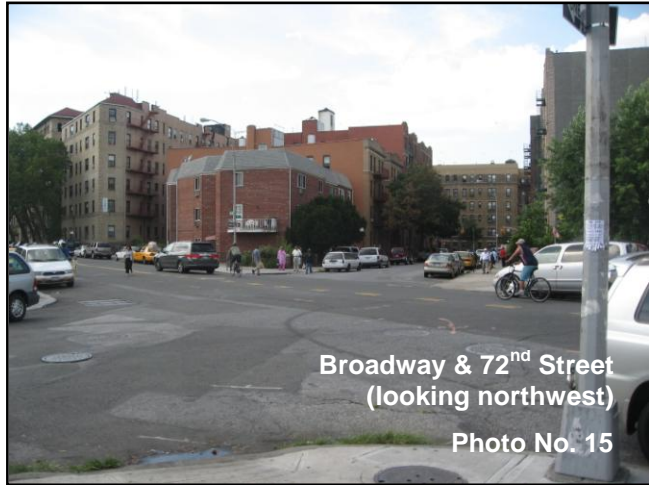
- This is a four-legged intersection that is surrounded by residential buildings and restaurants (Photo No. 15). During field visits, a sizable number of pedestrians were observed crossing Broadway at this unsignalized intersection. The NYCDOT, however, has since installed a traffic signal at this location to increase pedestrian

safety. It is recommended that new pedestrian ramps be constructed on the southeast and northeast corners of this intersection to facilitate the Broadway pedestrian crossings. These recommendations are shown on the Site 7 illustration.

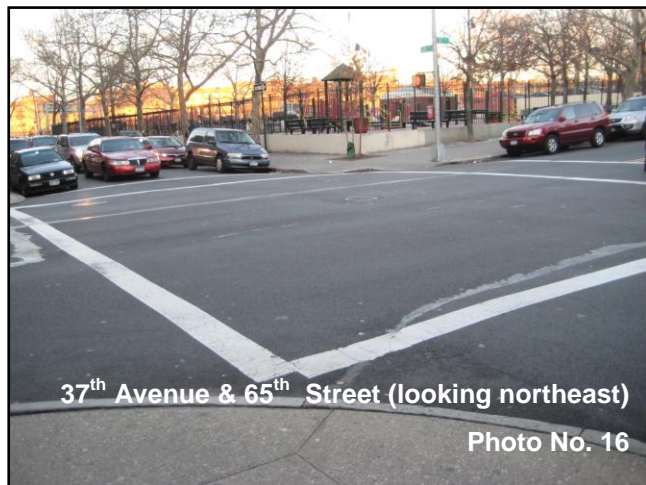
### ***37<sup>th</sup> Avenue and 65<sup>th</sup> Street***

- This is a four-legged intersection that is surrounded by multi-story residential buildings and a playground (Photo No. 16). At this intersection, the installation of high visibility crosswalks is warranted on all four approaches. It is also recommended that standard 24 inch wide stop bars be installed on the west, east and north legs of this intersection. A new

pedestrian ramp should also be constructed on the southeast corner of this intersection to facilitate the 37<sup>th</sup> Street pedestrian crossings. These recommendations are shown on the Site 7 illustration.

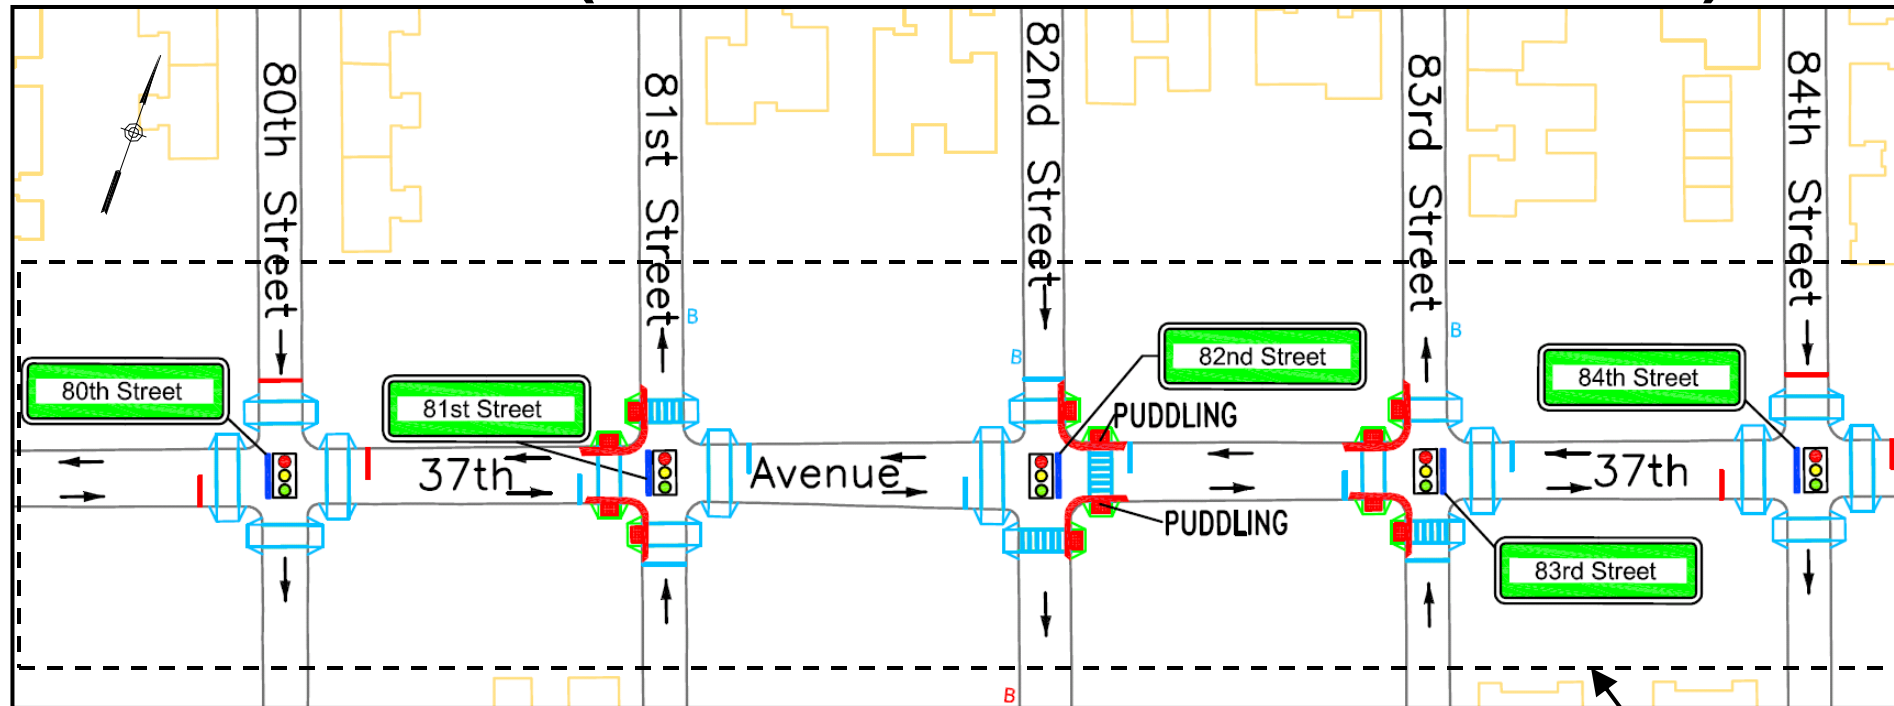
- Recommended improvements include:**
- Install new advanced stop bars
  - Install oversized street name signs at various intersections along 37<sup>th</sup> Avenue. The signs are to be located on the signal mast arm facing 37<sup>th</sup> Avenue traffic in both directions
