East Houston St at Crosby St

Pedestrian Accessibility

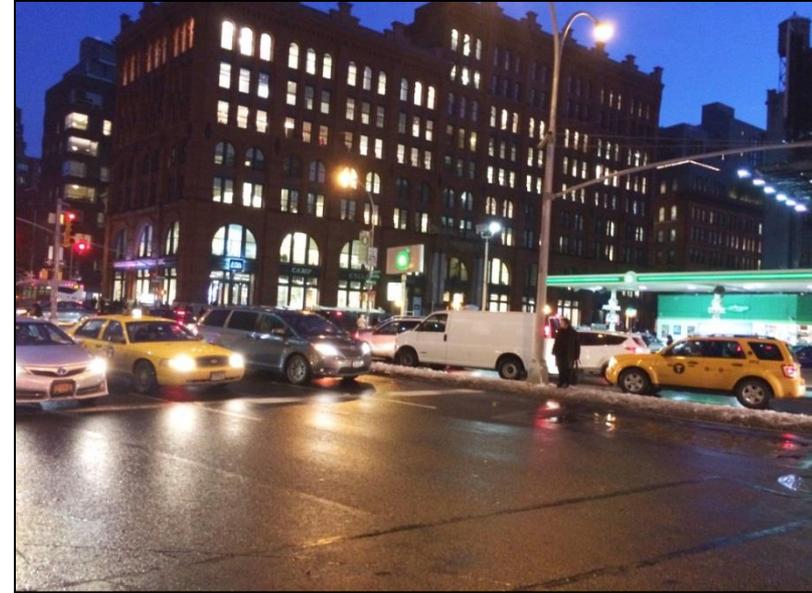
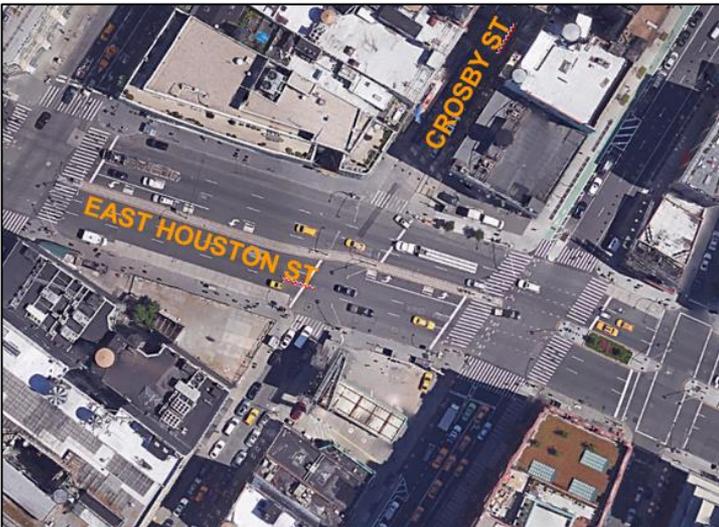
- Remove section of Houston St median at Crosby St
- Install marked crosswalks on east and west side of Houston St/Crosby St intersection
- Allow vehicles proceeding north on Crosby St to continue through Houston St intersection
- Install enhanced median tips at new crosswalks matching DOT standard
- Adding new pedestrian ramp on northwest corner
