Park Ave Tunnel: Safety Improvements in Manhattan

May 14, 2009

Park Ave Tunnel Safety Improvements

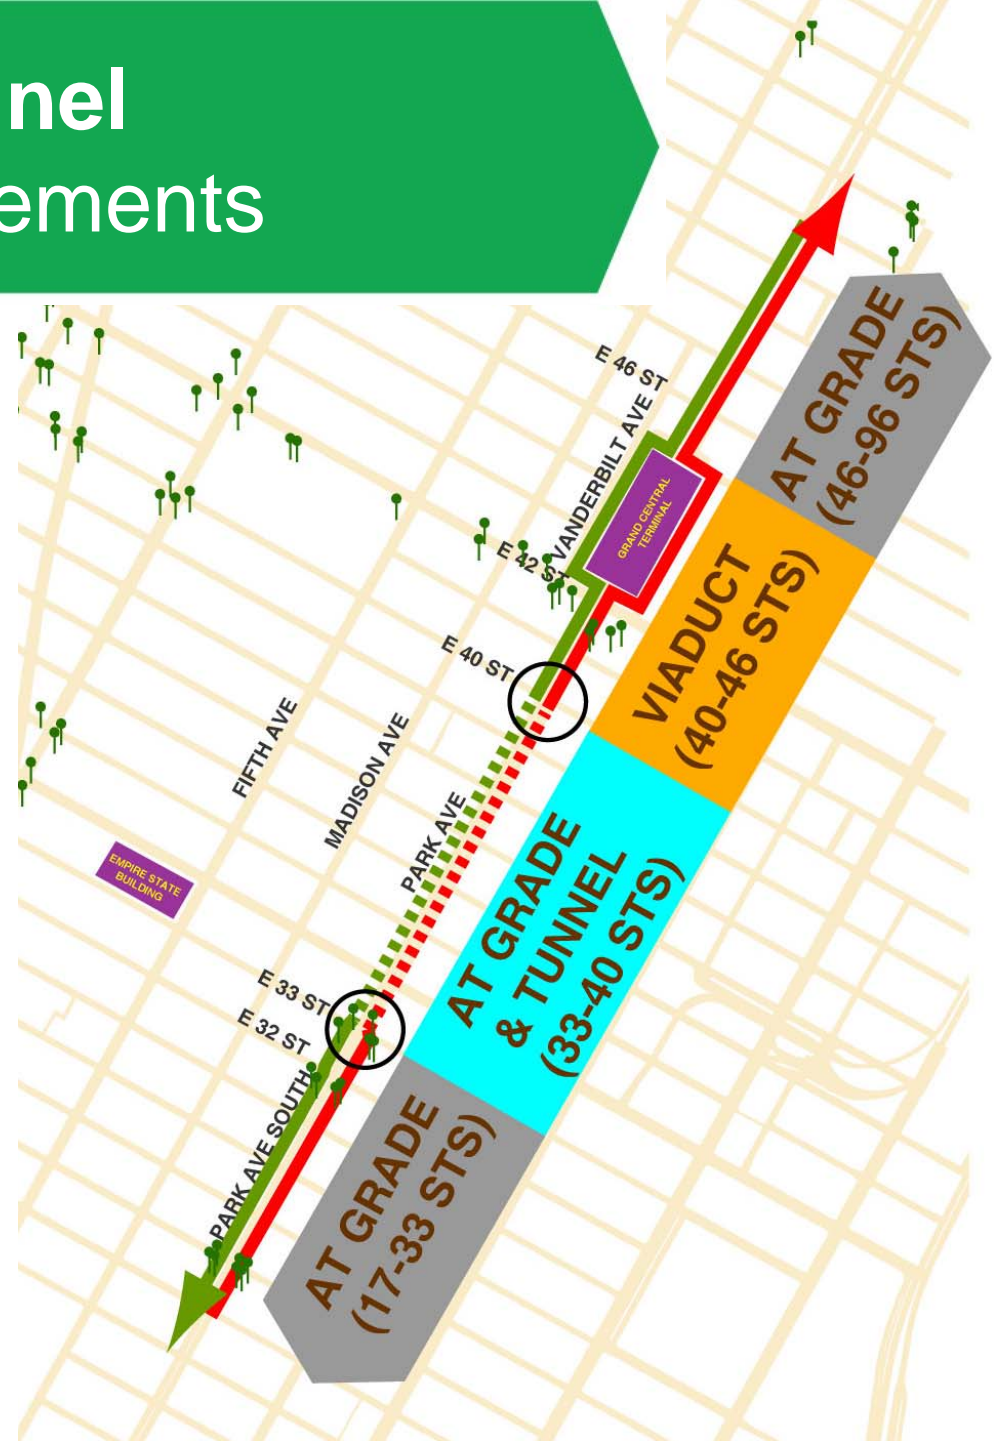
Park Avenue at E. 33rd Street

BEFORE

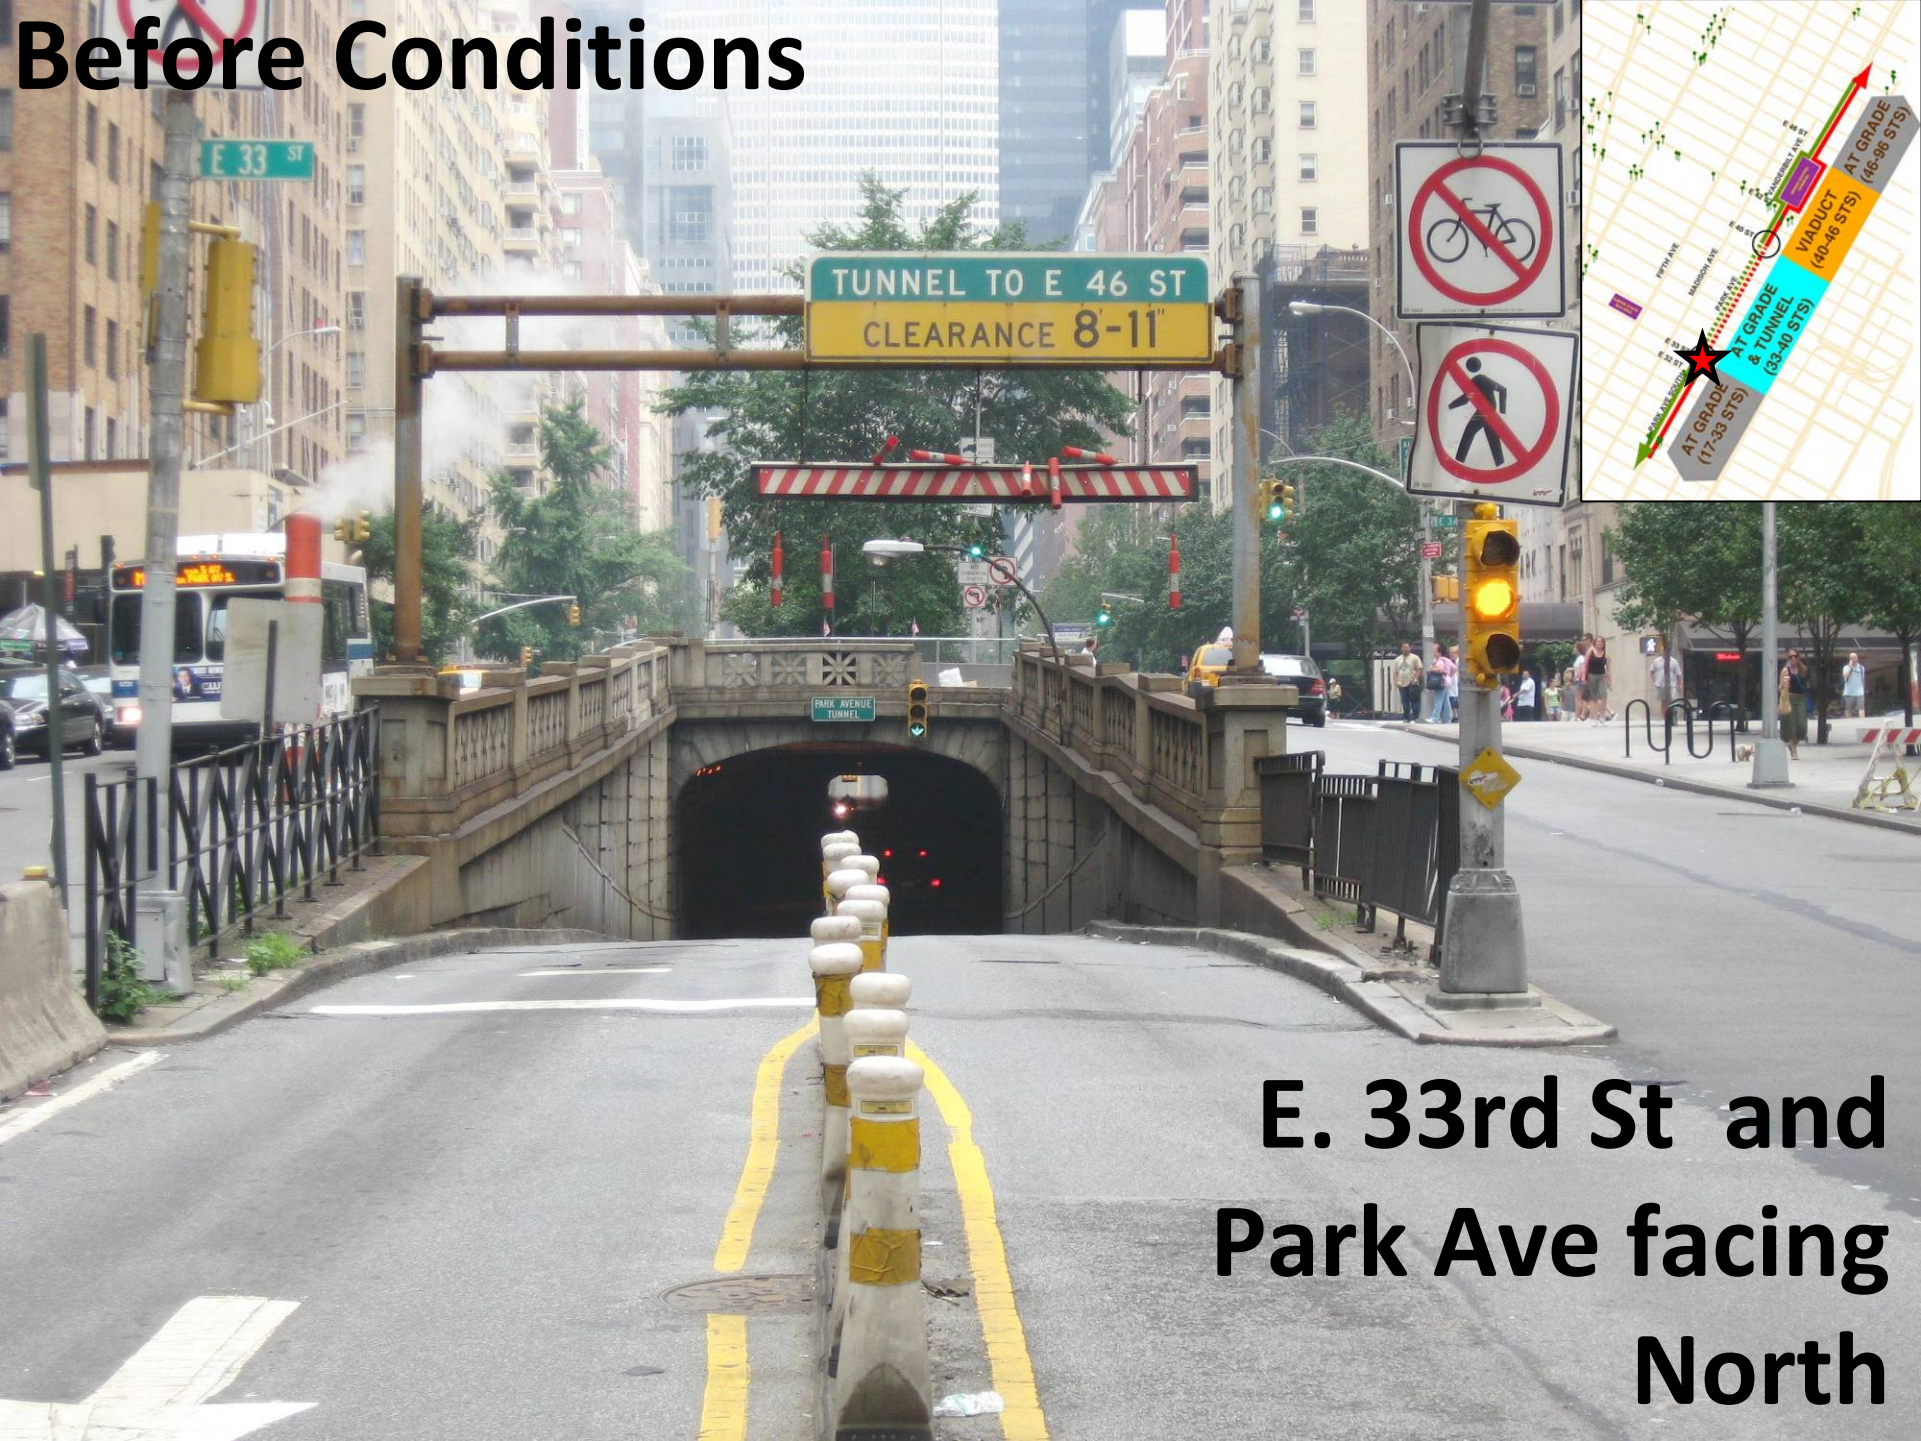
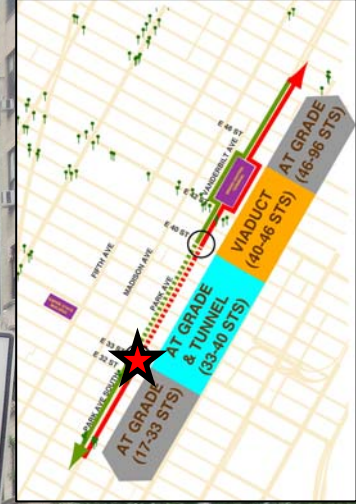
**E. 33rd St and
Park Ave facing
North**

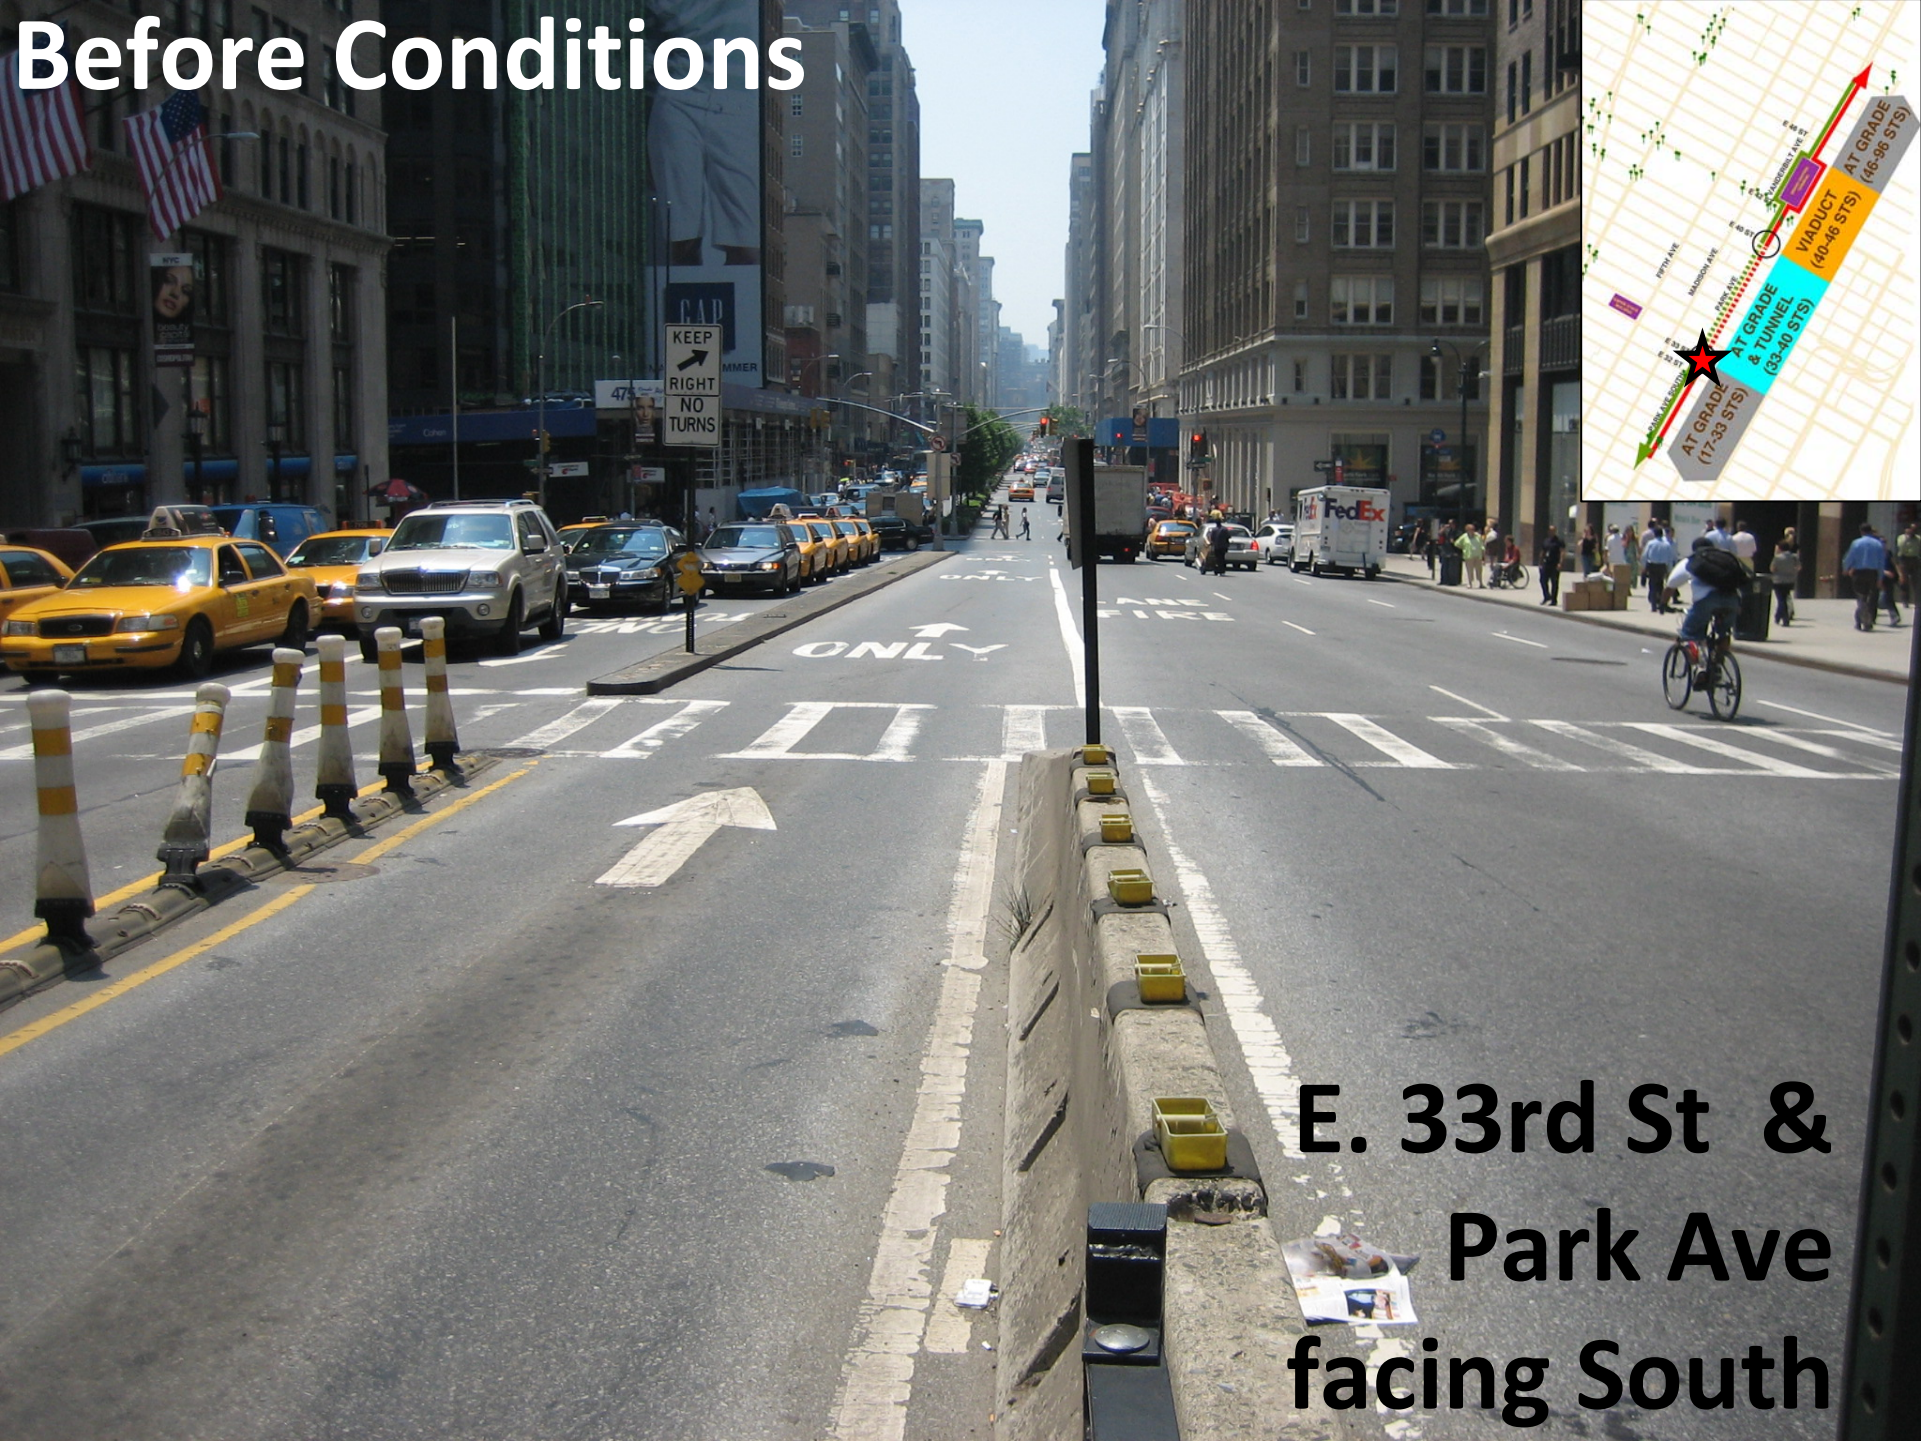
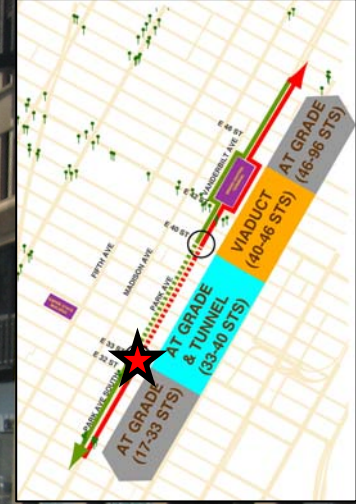
**E. 33rd St &
Park Ave
facing South**

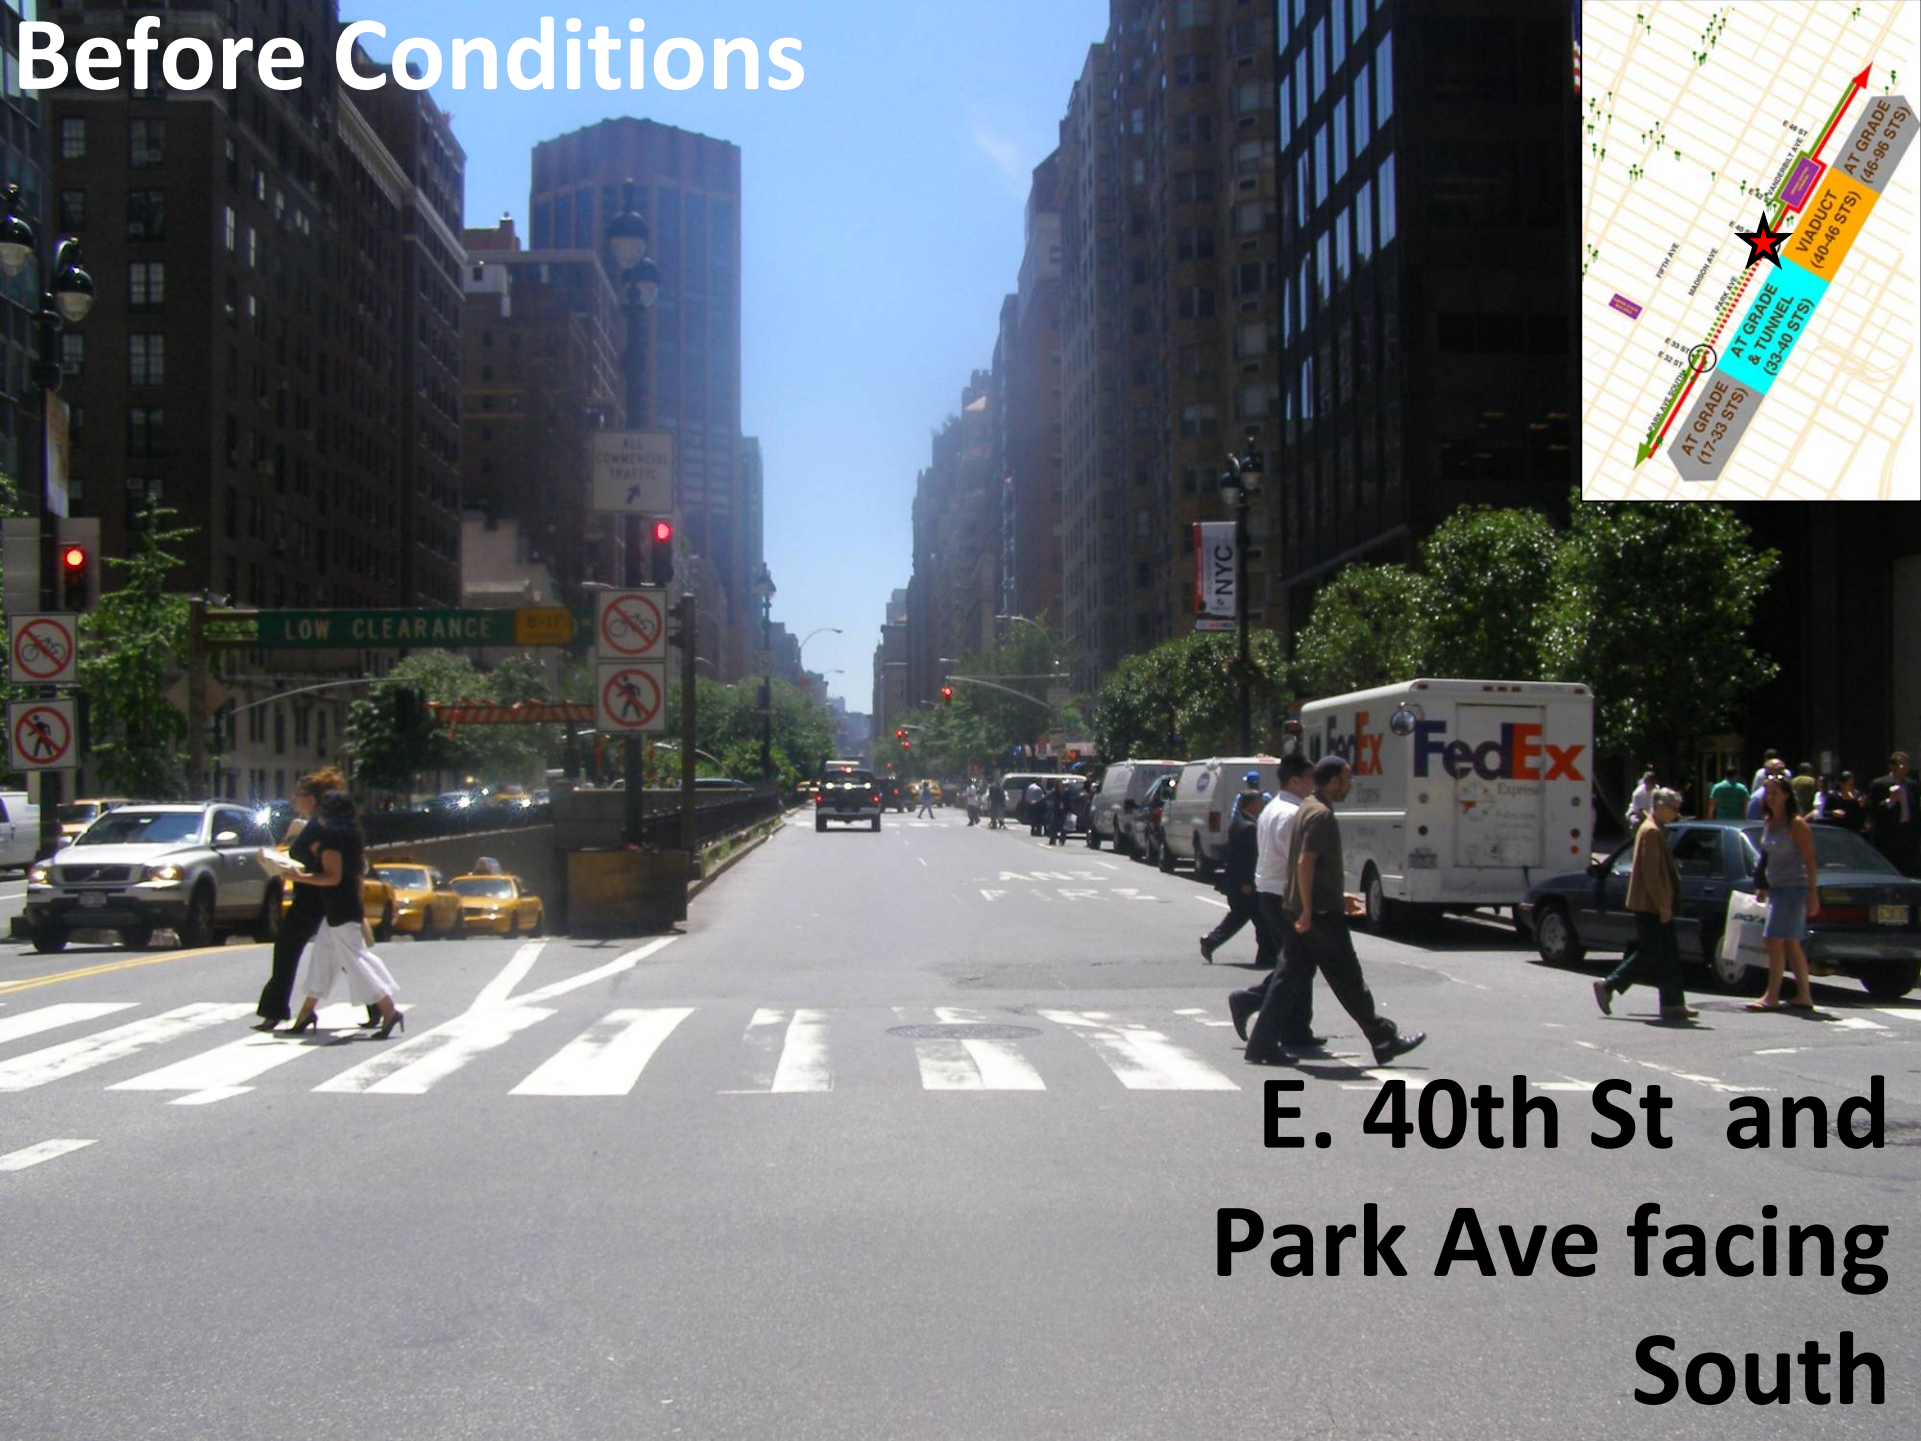
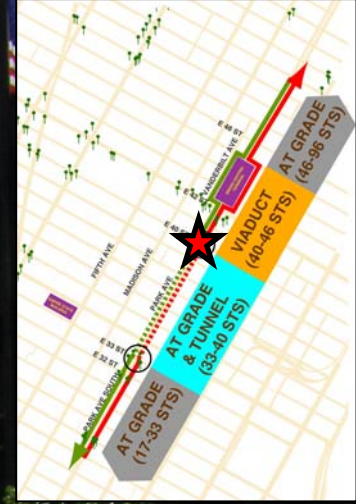
**E. 40th St and
Park Ave facing
South**

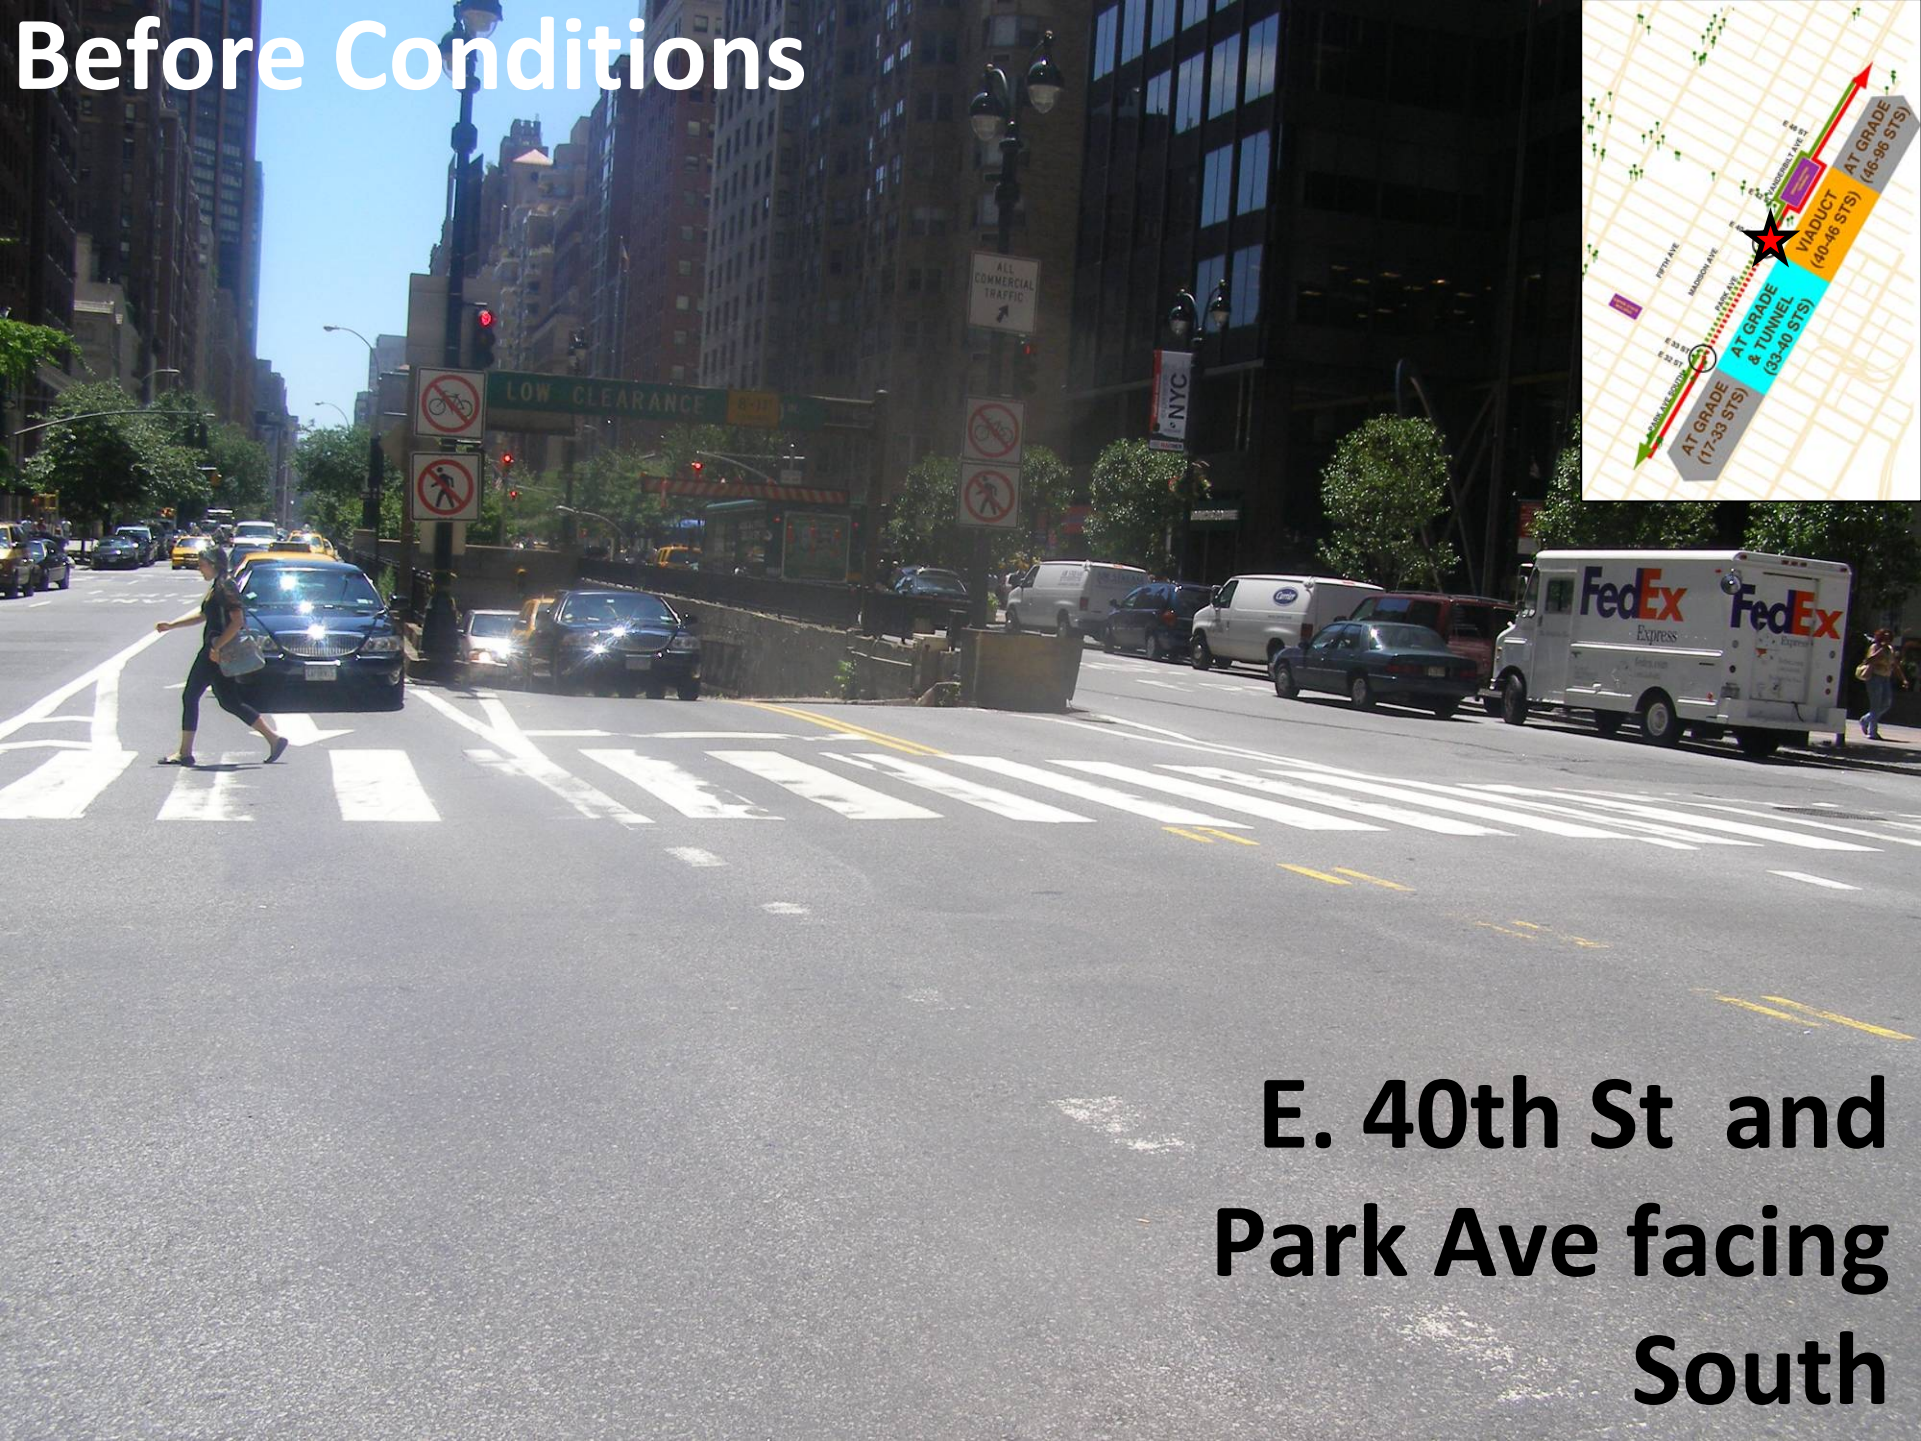
**E. 40th St and
Park Ave facing
South**

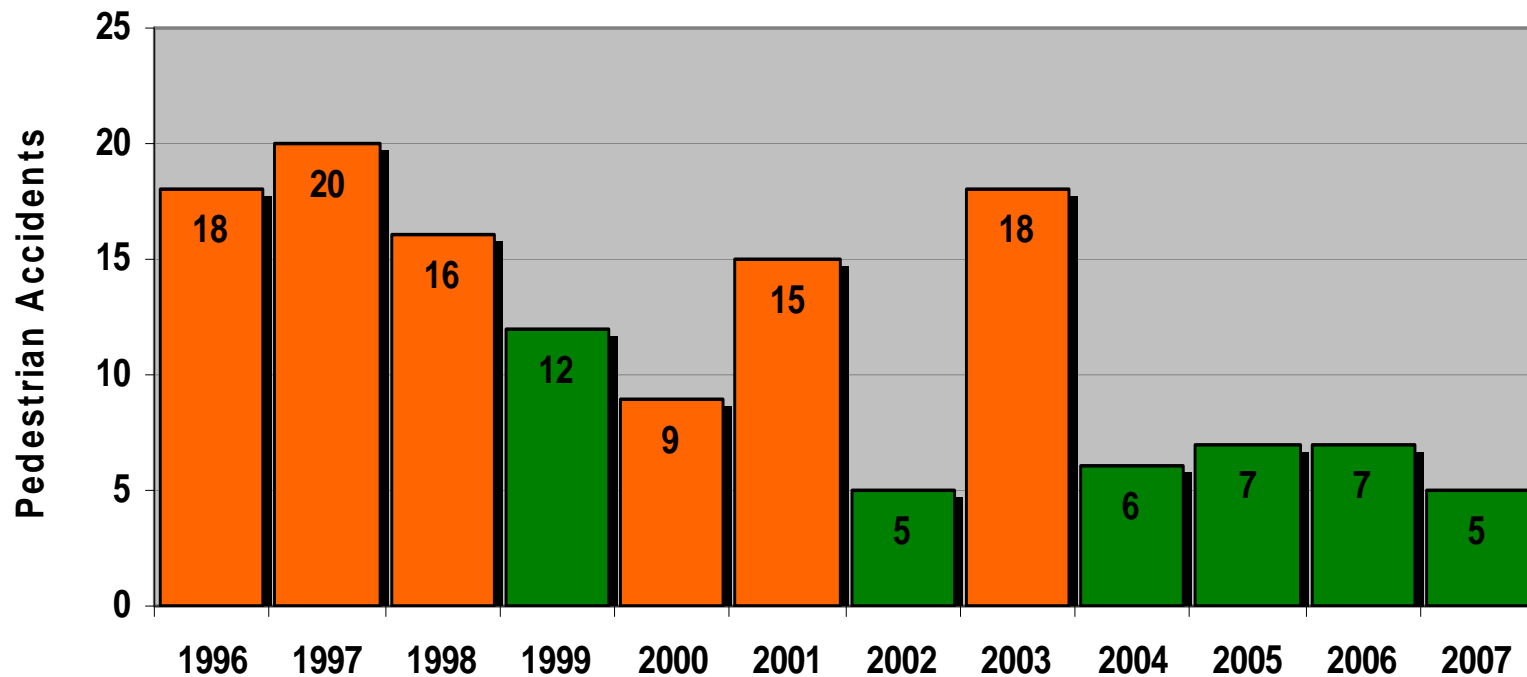
- **#1 Pedestrian Crash Location in NYC**

(1996, 1997, 1998, 2000, 2001, 2003)

- Average 1996-2007 = 11.6 per year

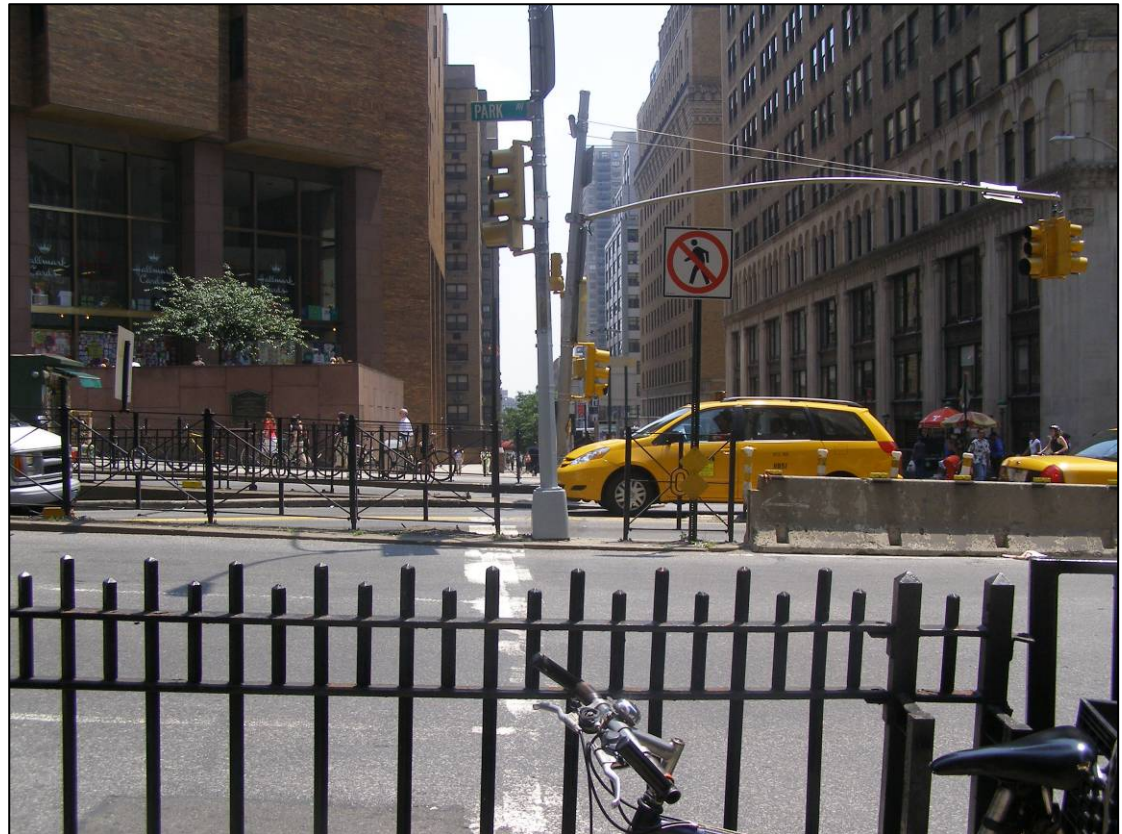
- WB through movement on E 33rd St. banned
- Jersey barriers installed
- High risk northern crosswalk eliminated
- Pedestrian fencing installed at NW corner and median

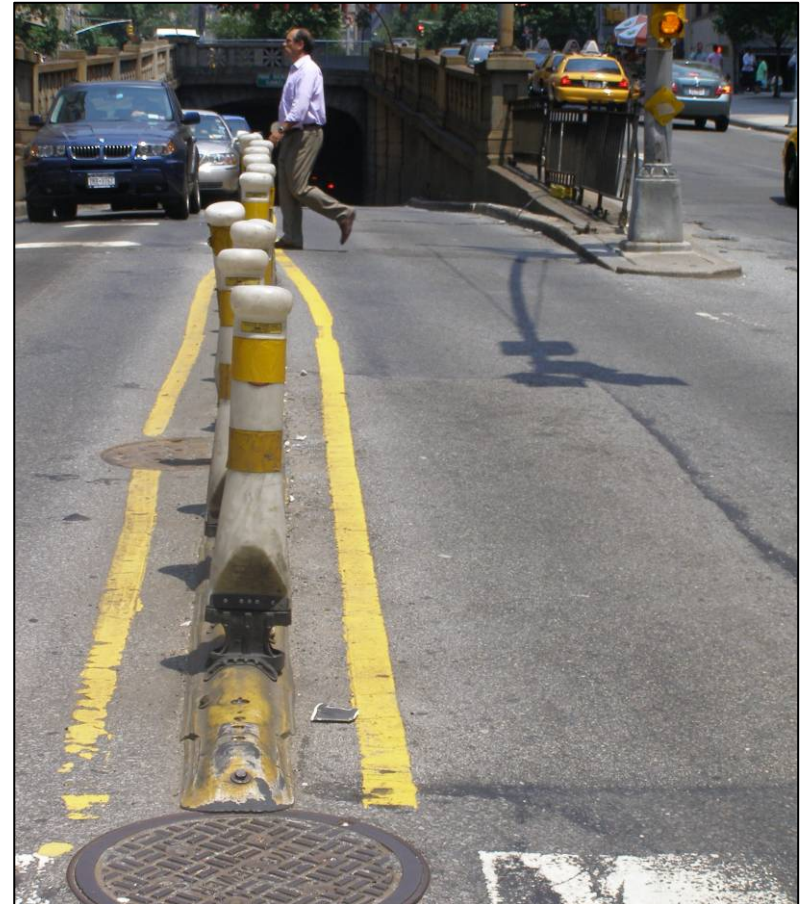
- Flexible delineators installed to separate tunnel entrance and exit

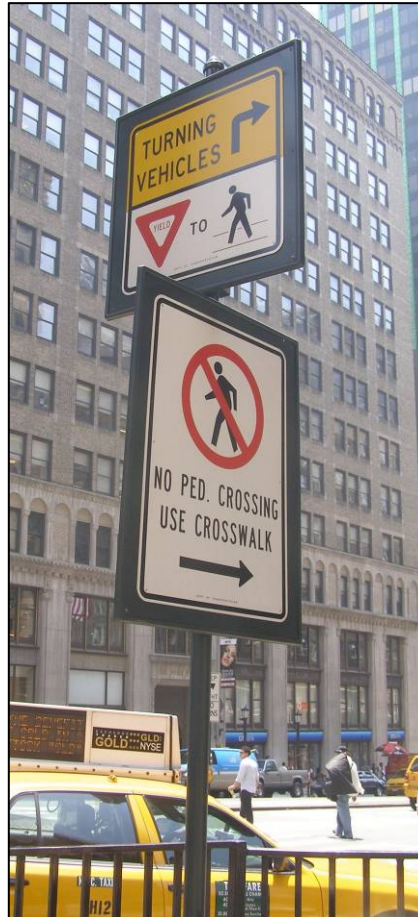
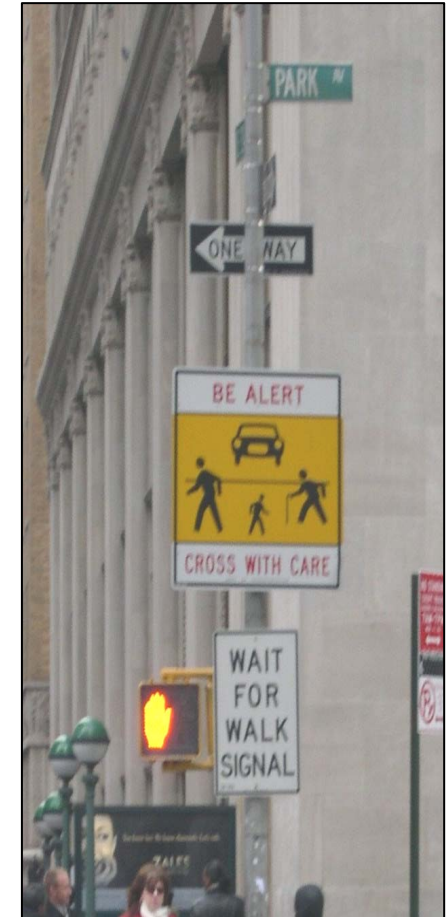
Park Avenue at E. 33rd Street

BEFORE

AFTER

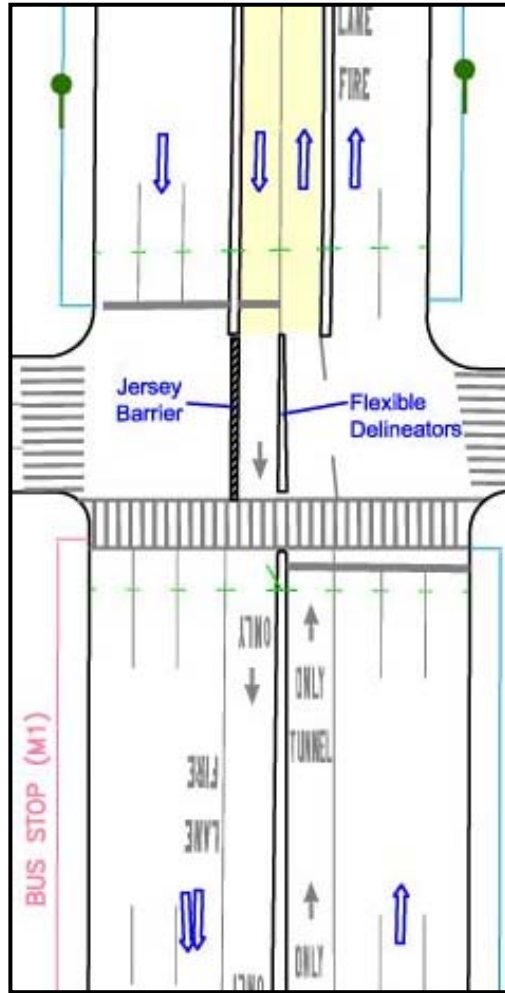
2008 Improvements at E. 33rd St

- Converted Park Ave Tunnel to **One-Way Traffic Only**, closing SB lane

- Neckdown on SE corner to shorten crossing, align with NE corner

- Realigned Jersey barriers to separate NB tunnel traffic from SB local traffic

- 10' pedestrian refuge island in south crosswalk

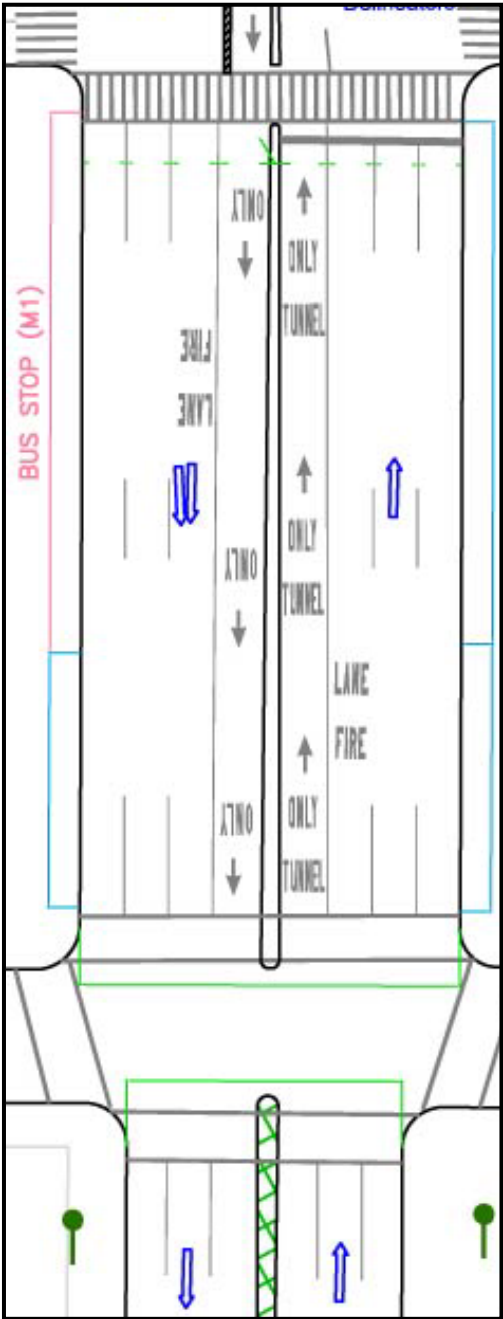
- Channelize moving lanes on SB Park Avenue south of East 33rd St. to align with downstream traffic south of East 32nd St.

Before Conditions

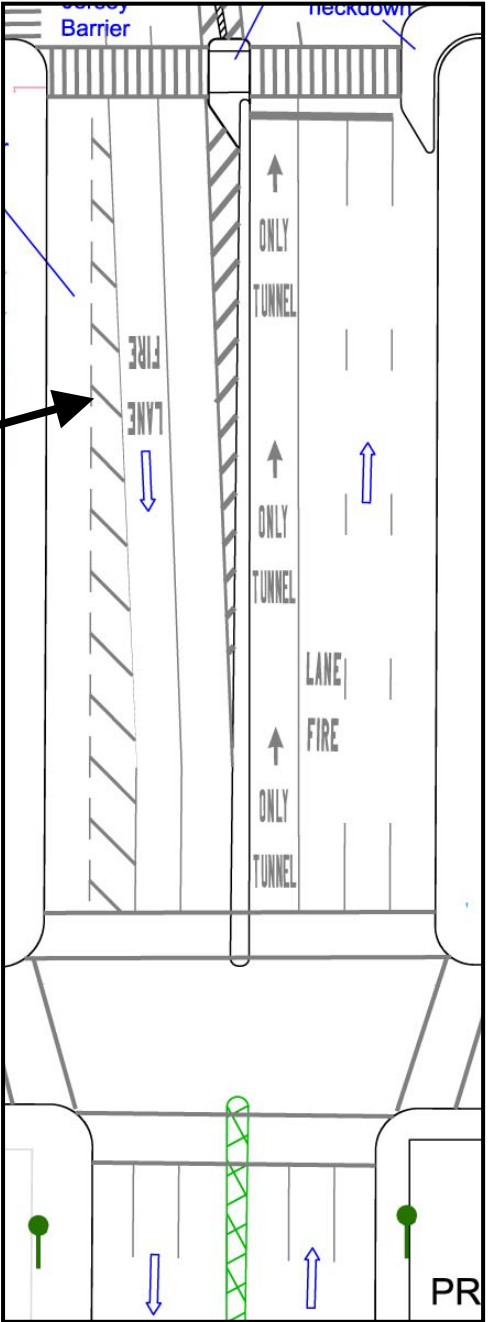
After Conditions

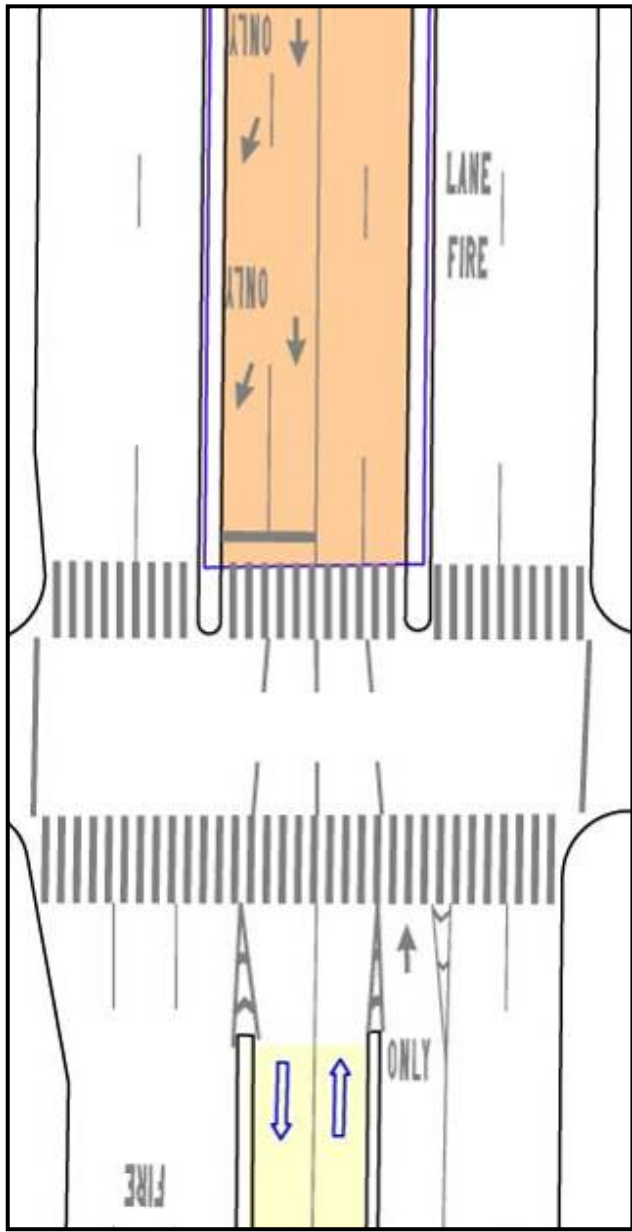
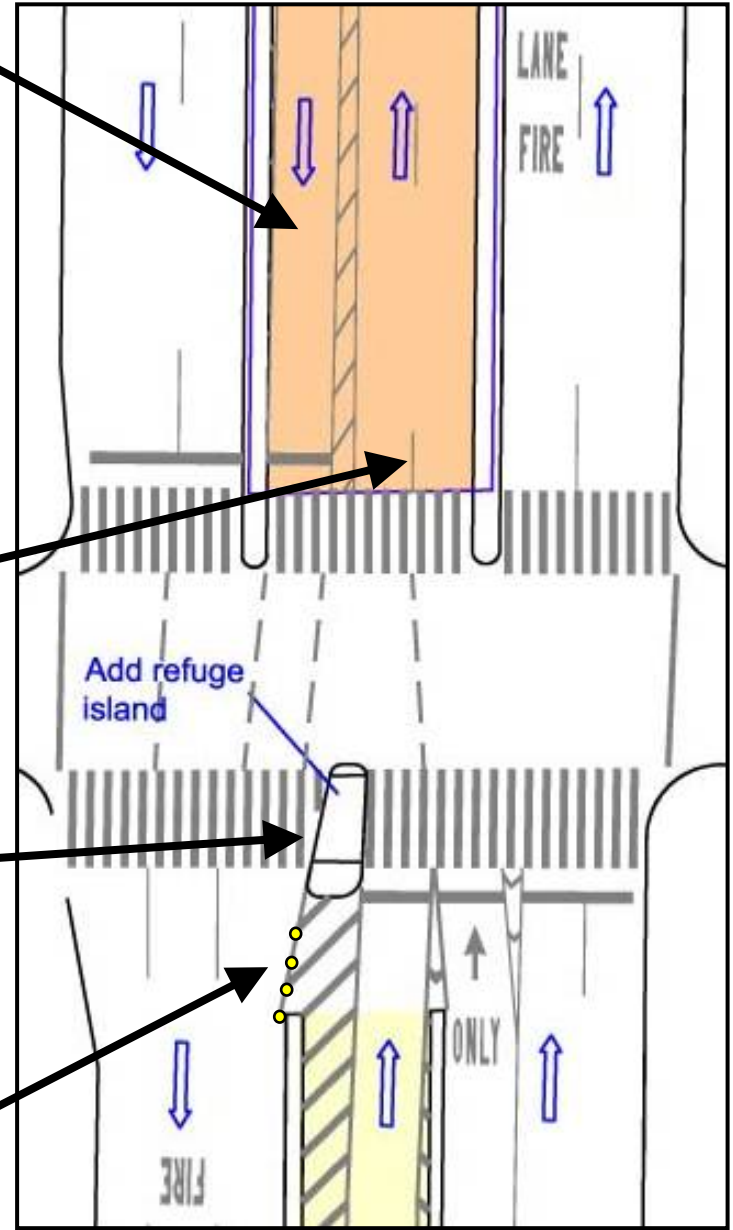
2008 Improvements at E. 40th St

- SB viaduct lanes reduced from two to one
- SB viaduct directs vehicles to SB Park Avenue main line
- NB viaduct lanes widened to 10' from 9'
- 8' pedestrian refuge island on the south crosswalk of East 40th St.
- Installed flexible delineators

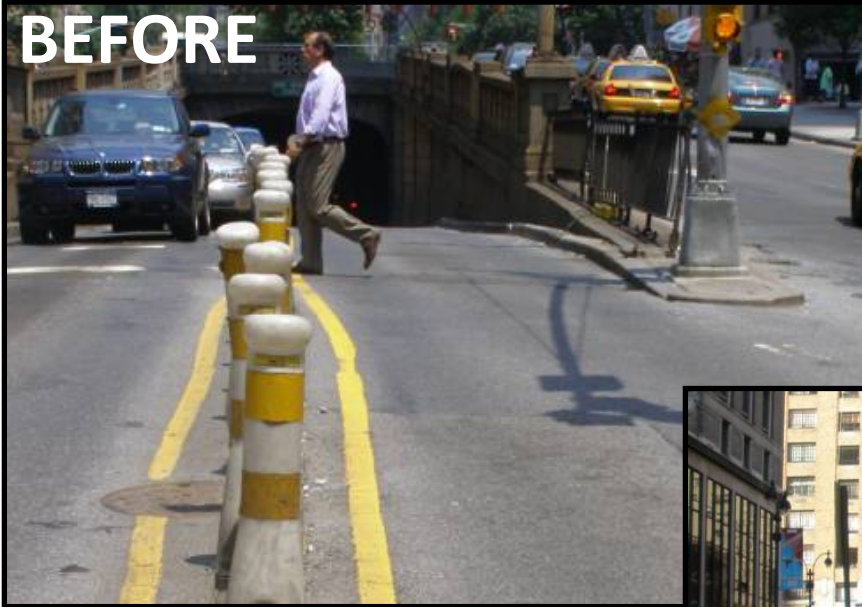
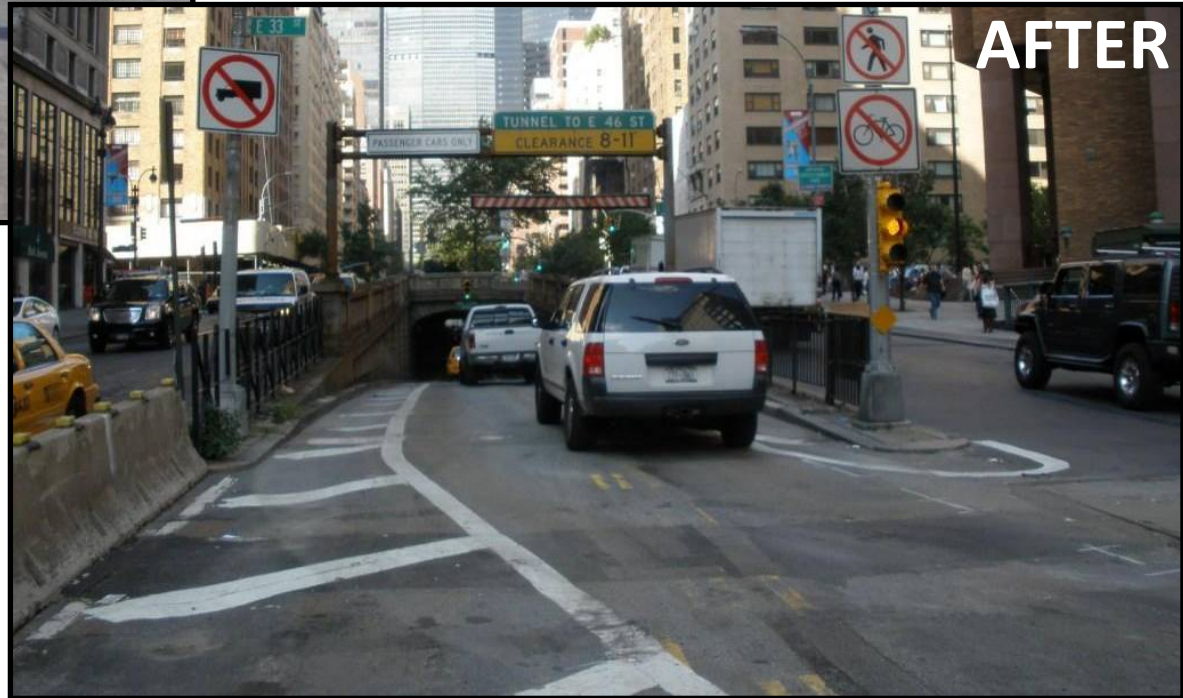
E. 33rd St & Park Ave Facing North

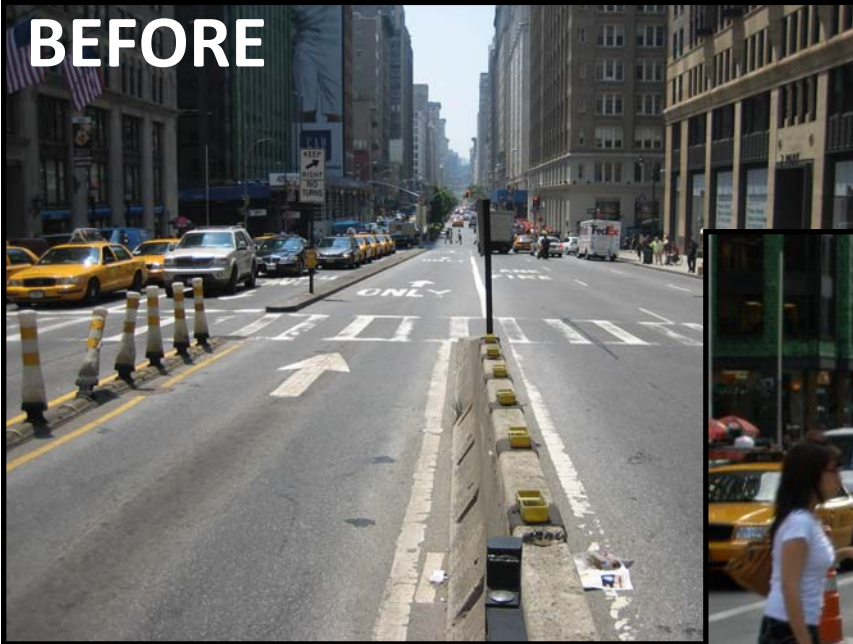
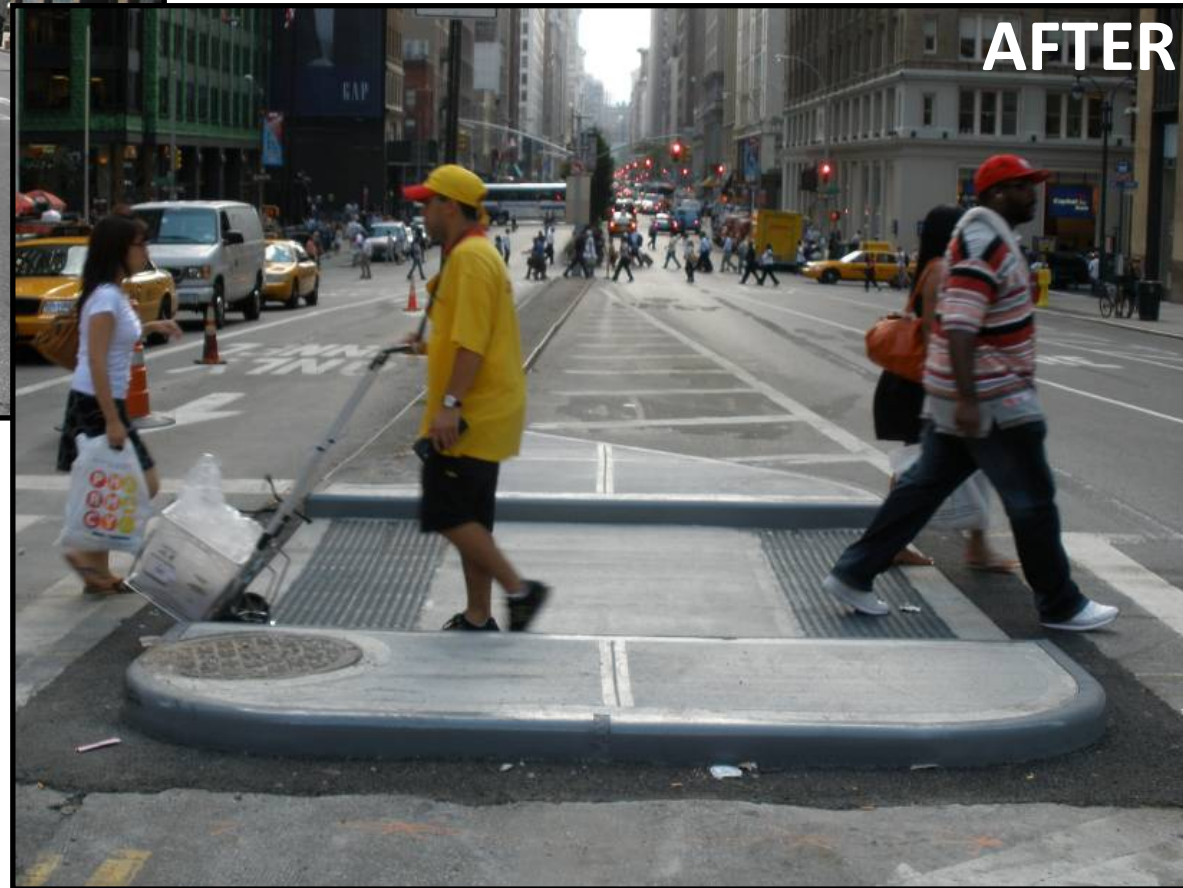
**E. 33rd St at Park Ave facing
South**
