Park Ave Tunnel: Safety Improvements in Manhattan

May 14, 2009

Park Ave Tunnel Safety Improvements

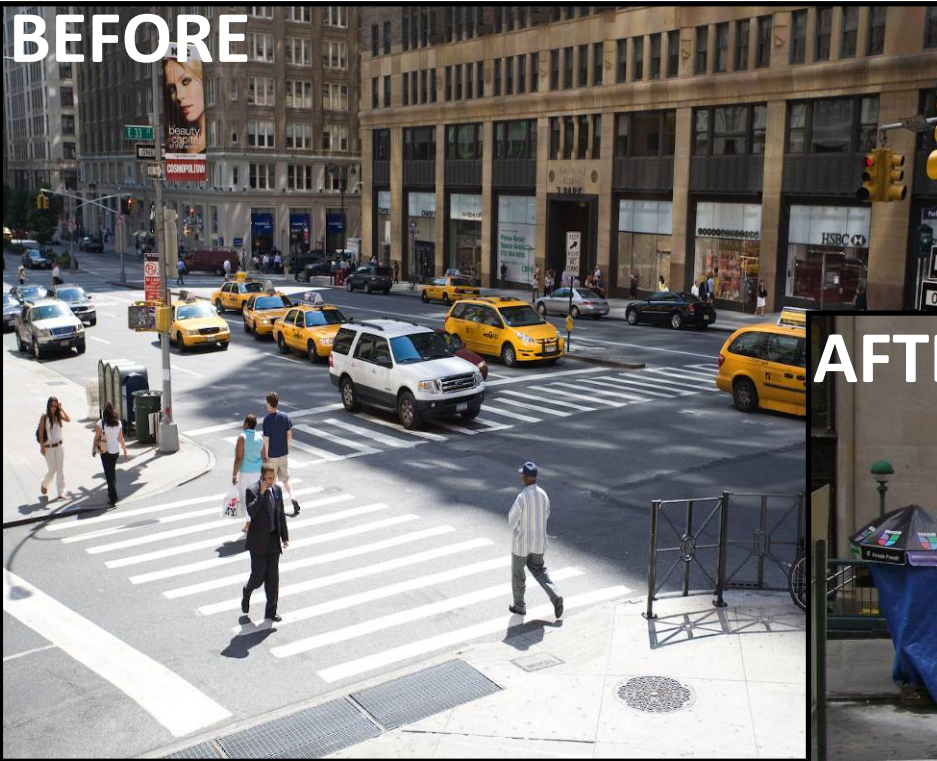
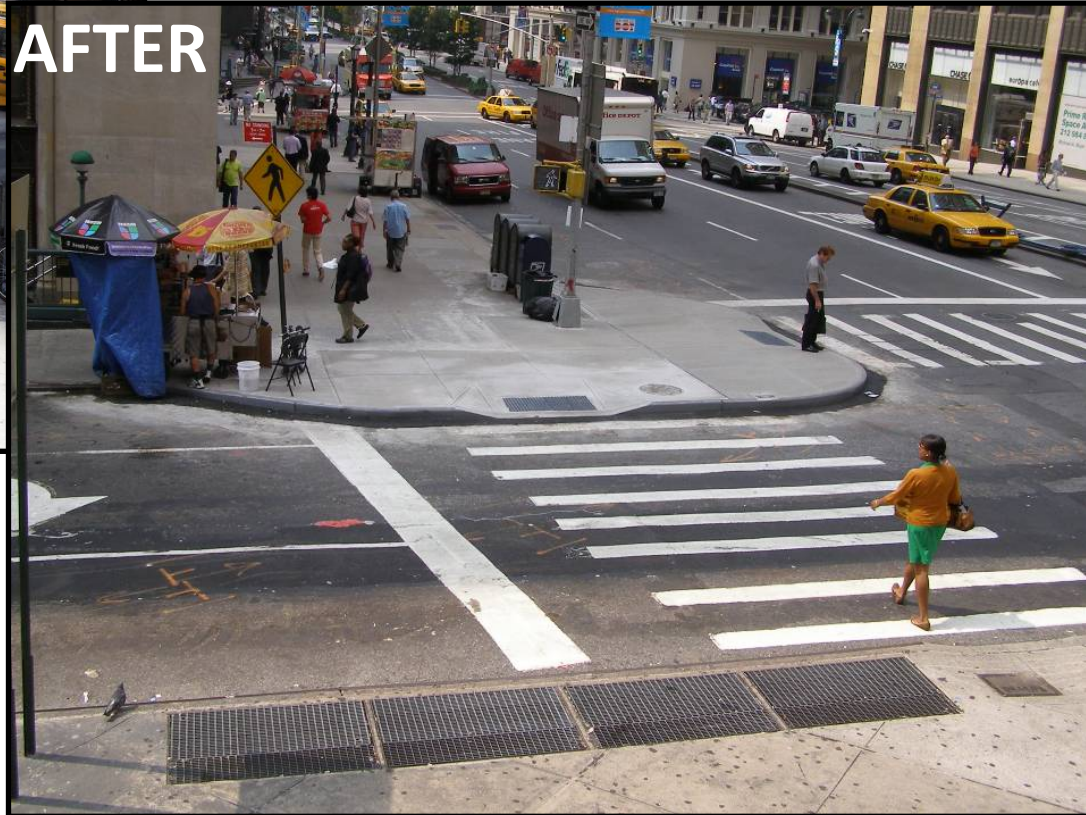
E. 33rd St Southeast Corner

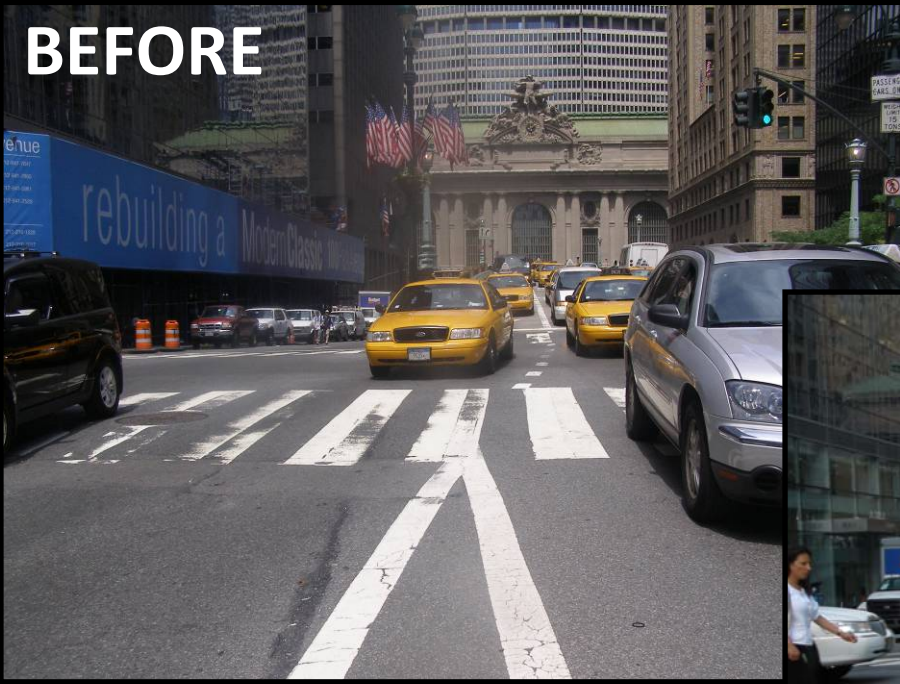
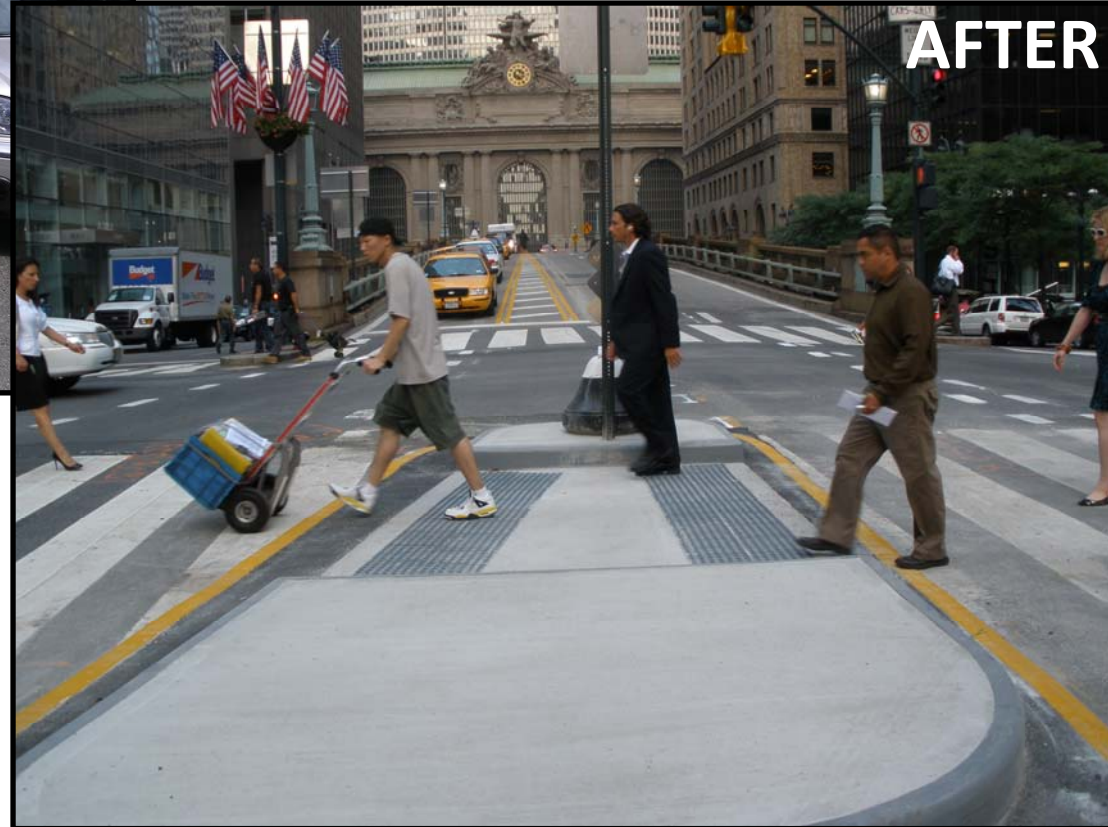
E. 40th St & Park Ave Facing North

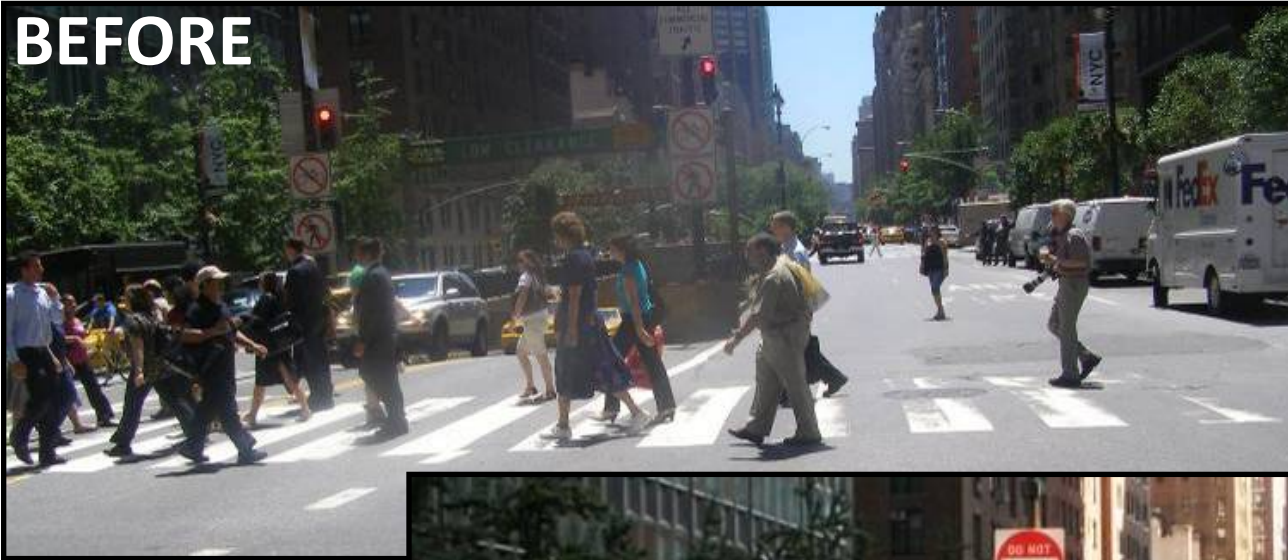
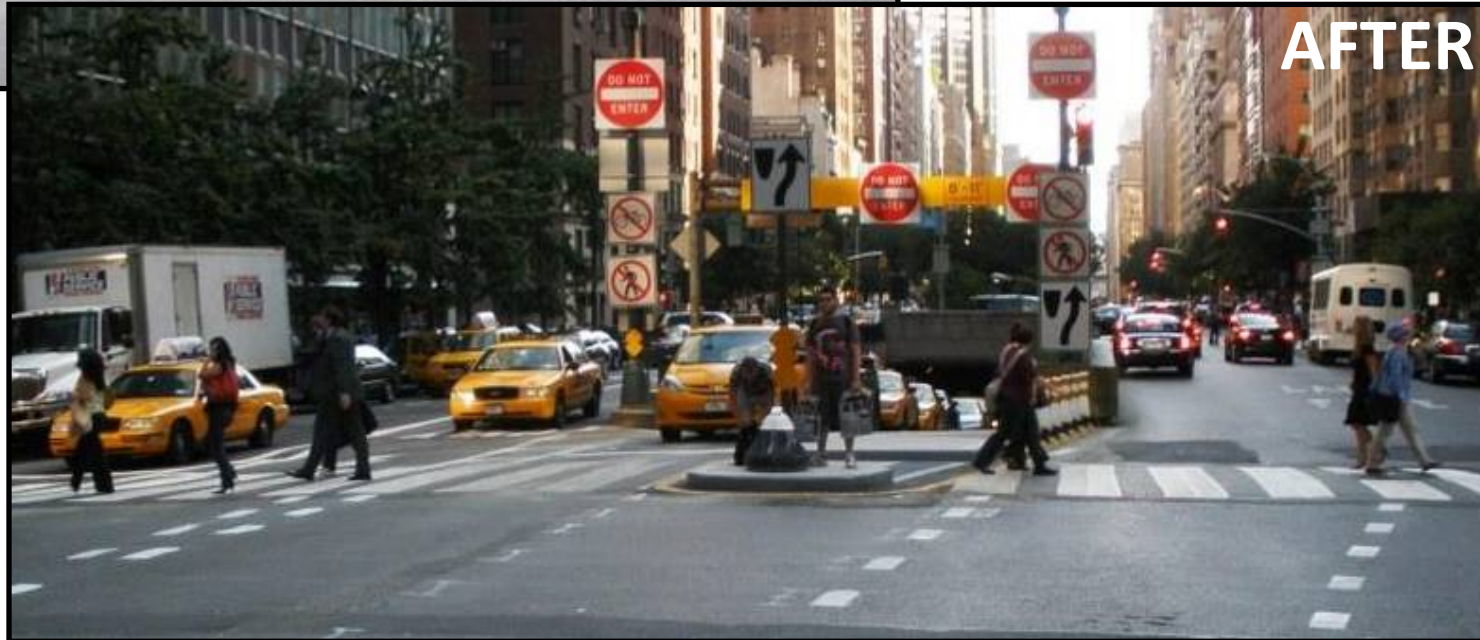
**E. 40th St &
Park Ave
Facing
South**

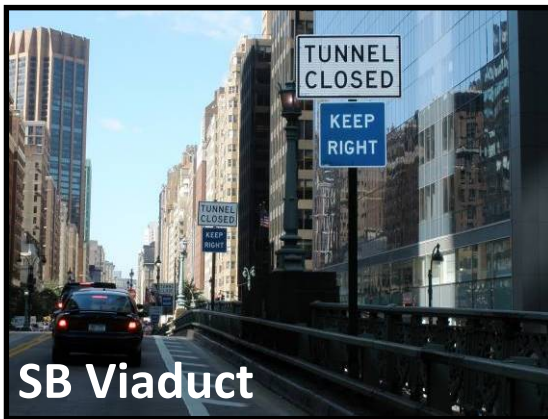
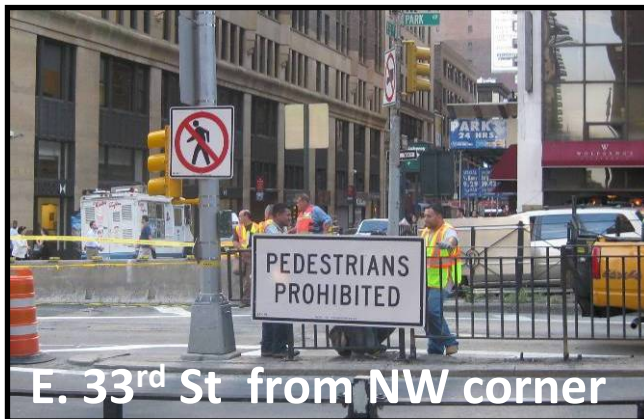
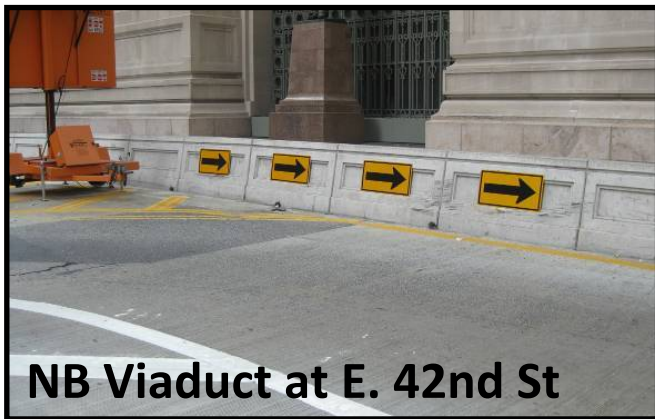
Signage (After)

- Pedestrian and vehicle signage upgraded
