60 Norfolk St (Beth Hamedrash Hagadol Synagogue)

Landmarks Preservation Commission

Post-Fire Condition (June 22nd, 2017)

BHH Stabilization: Current Condition

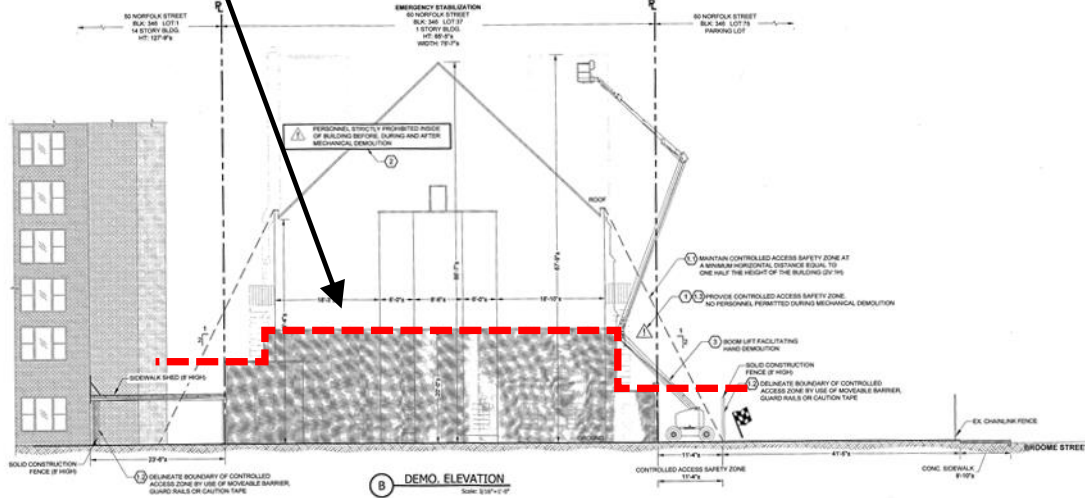
DEMOLITION ELEVATIONS A & B

July 11th, 2017 level of approved removals

- DEMOLITION SHALL PROCEED FROM THE TOP DOWN, STARTING AT THE HIGHEST POINT OF THE STRUCTURE. DEMOLITION SHALL BE PERFORMED BY HAND, OPERATING BY ARTIFICIAL BOOM LIFE, USING CONVENTIONAL HAND TOOLS. PRESSURE ARE PROHIBITED. HIGH-RISE ROOM STRUCTURES TO BE DEMOLISHED BY HAND AND OPERATING CUT STRUCTURAL MEMBERS, E.G., WOOD, STEEL, TO FACILITATE CUTTING BY HAND AND OPERATING CUT STRUCTURAL MEMBERS. STRUCTURAL MEMBERS SHALL NOT BE PULLED OR FRANTED BY THE EXCAVATOR.

- UPON COMPLETION OF DEMOLITION THE BUILDING CONDITION SHALL BE AS FOLLOWS:
 - CEILING SHALL BE SHED TO GROUND AND WHERE POSSIBLE AT THE EXTERIOR OF THE BUILDING.

- UPON COMPLETION OF DEMOLITION OPERATIONS THE ENGINEER OF RECORD SHALL PERFORM A STRUCTURAL STABILITY ASSESSMENT AND RETENEMENT STABILIZATION MEASURES, E.G., SHADING AND BRACING, NECESSARY TO MAINTAIN STRUCTURAL STABILITY.

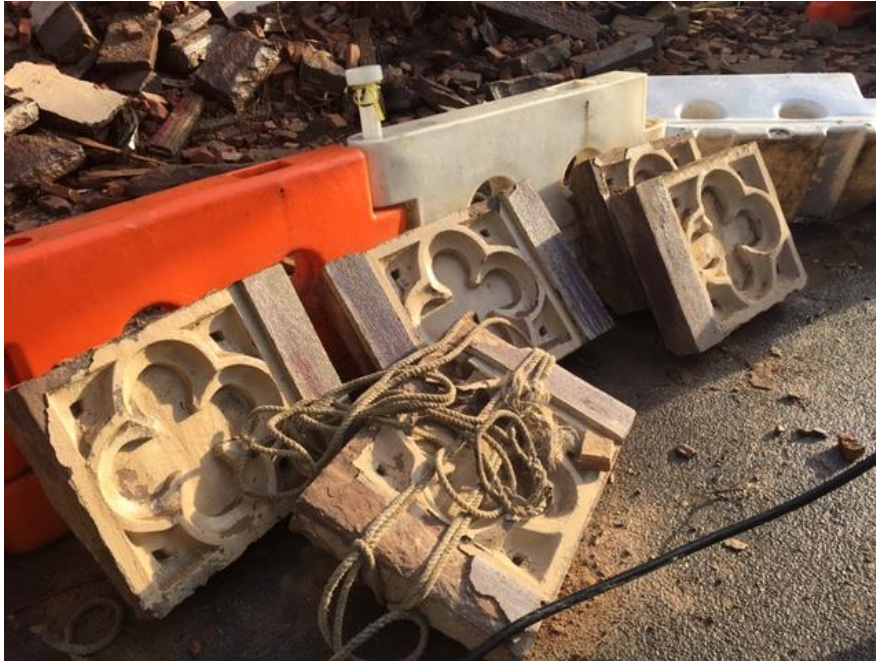
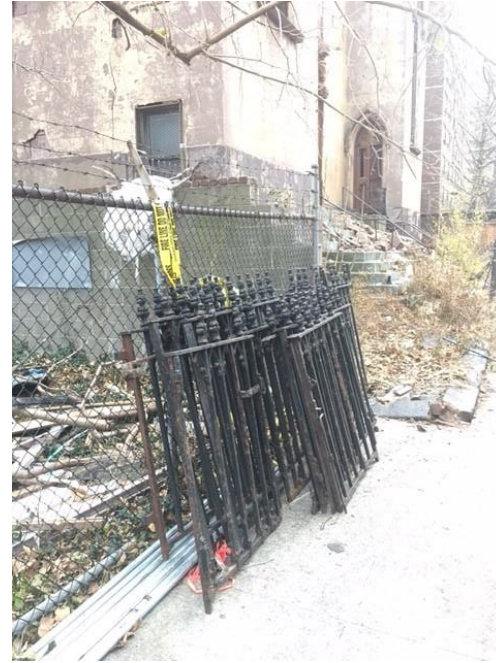
Proposed Development: Salvaged Artifacts

- Salvaged artifacts from the existing historic structure can be reused at the interior of the new BHH space.

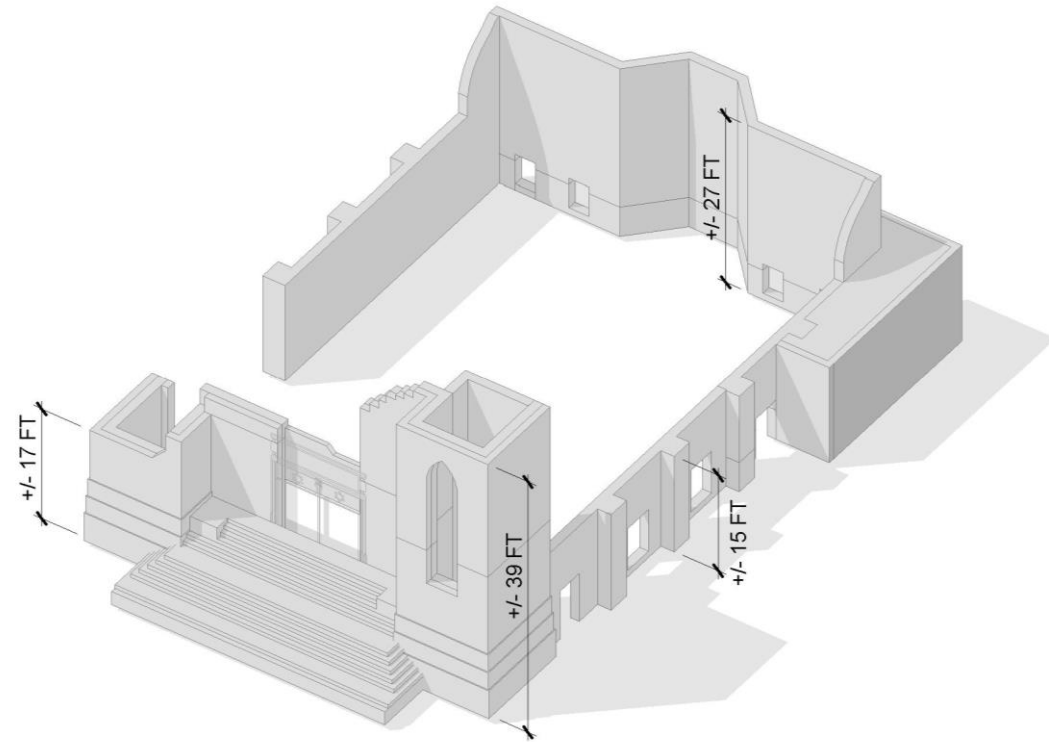
Current Condition of BHH Structure

- The objective of the removals was to remove unstable and unsound portions of the building to a safe level.
- To date, removals have progressed to the limits established by LPC, at which point removals were halted.
- Currently unstable and unsound portions of the building remain; and additional measures are necessary to establish a safe condition.
- Site safety measures including perimeter fencing and perimeter bridging remains on site.
- LPC approval of further removals of the existing structure is requested to further stabilize existing structure.
- The integration of synagogue remnants into the future site redevelopment is proposed. The next slides identify a level at which the remnants could be integrated, pending stabilization, and associated architectural precedents.

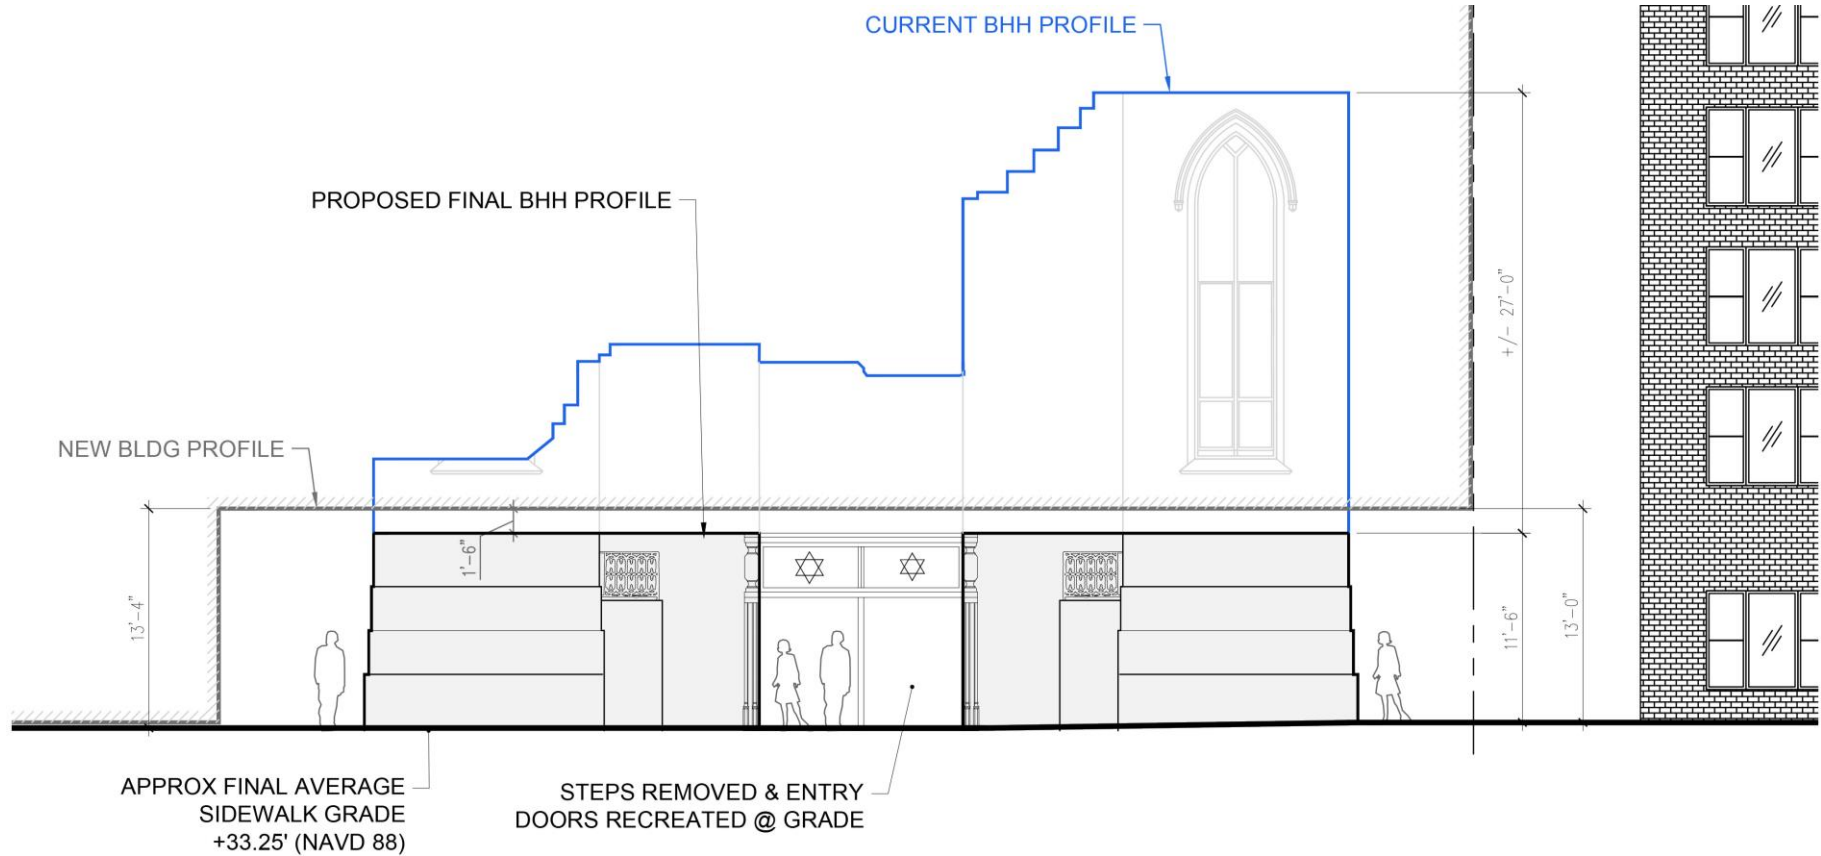
Proposed Further Removals: Norfolk Street (West) Elevation

- The historical towers are enclosed in a new, glazed lobby space that will provide views from the exterior and a tactile connection with the stone base from within.

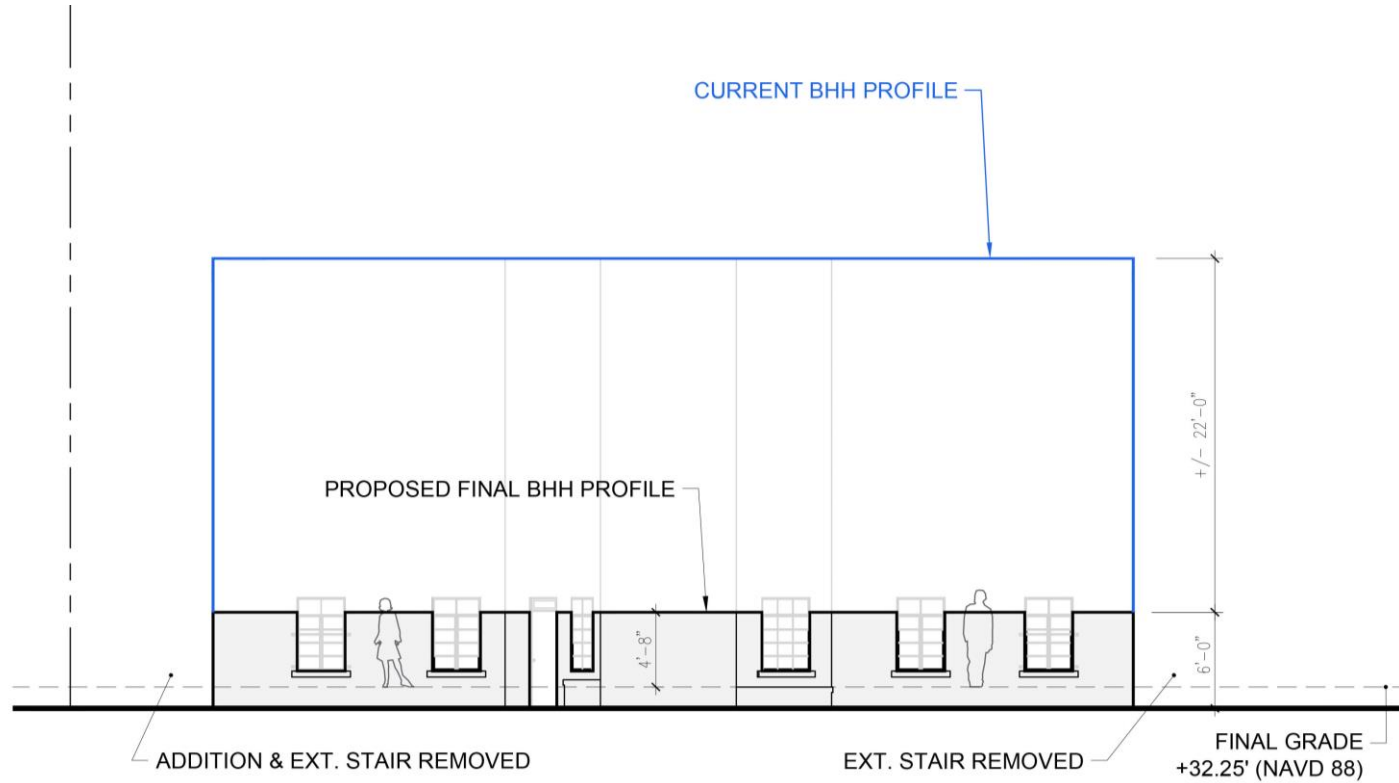
Proposed Further Removals: East Elevation

- The existing perimeter walls of the historic building are proposed to be reused as garden walls enclosing a space for BHH's use. The exterior garden can be used for social gatherings and holiday traditions.

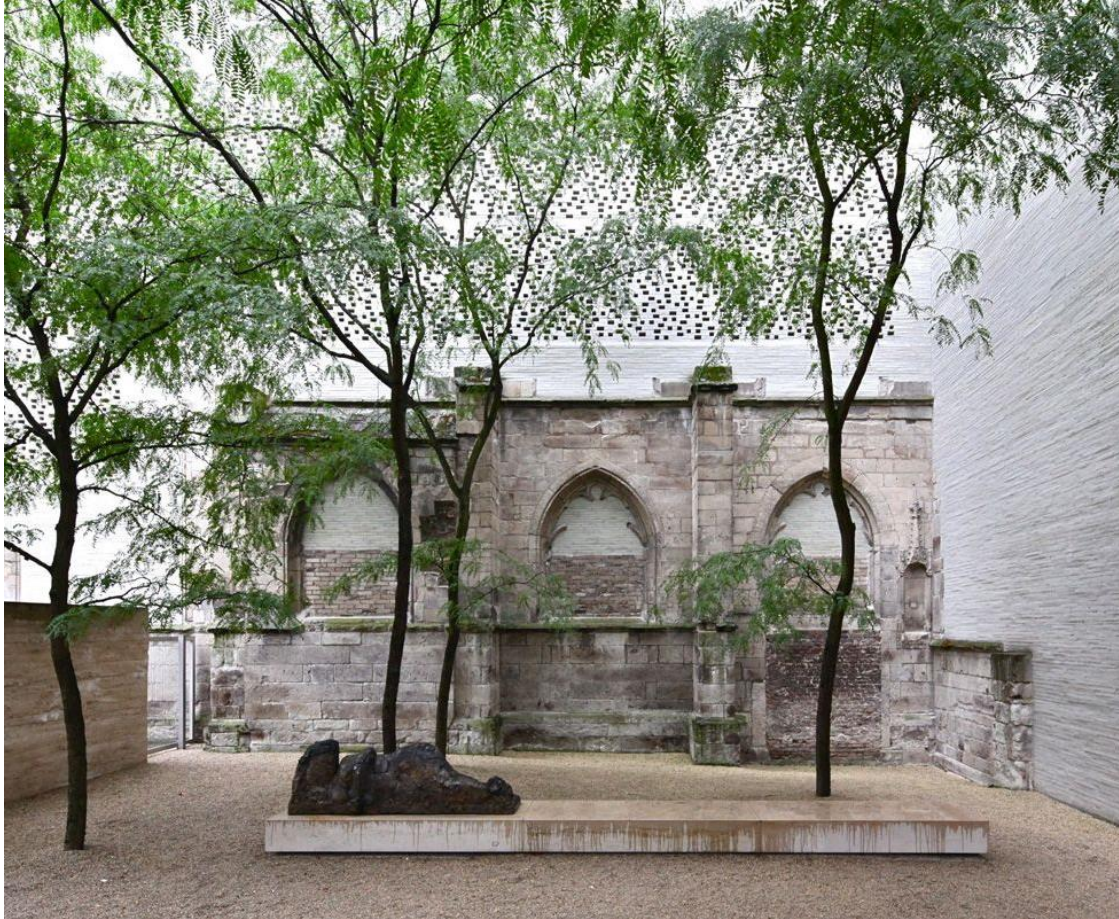
Kolumba Art Museum, Cologne (Zumthor)

1. The incorporation of fragments of a medieval church into the structure of a modern museum .
2. The transformation of a 19th century church into a contemporary landscape feature.
3. A modification of a historic museum facade that creates a new entry space defined by juxtaposing existing and modern building elements.

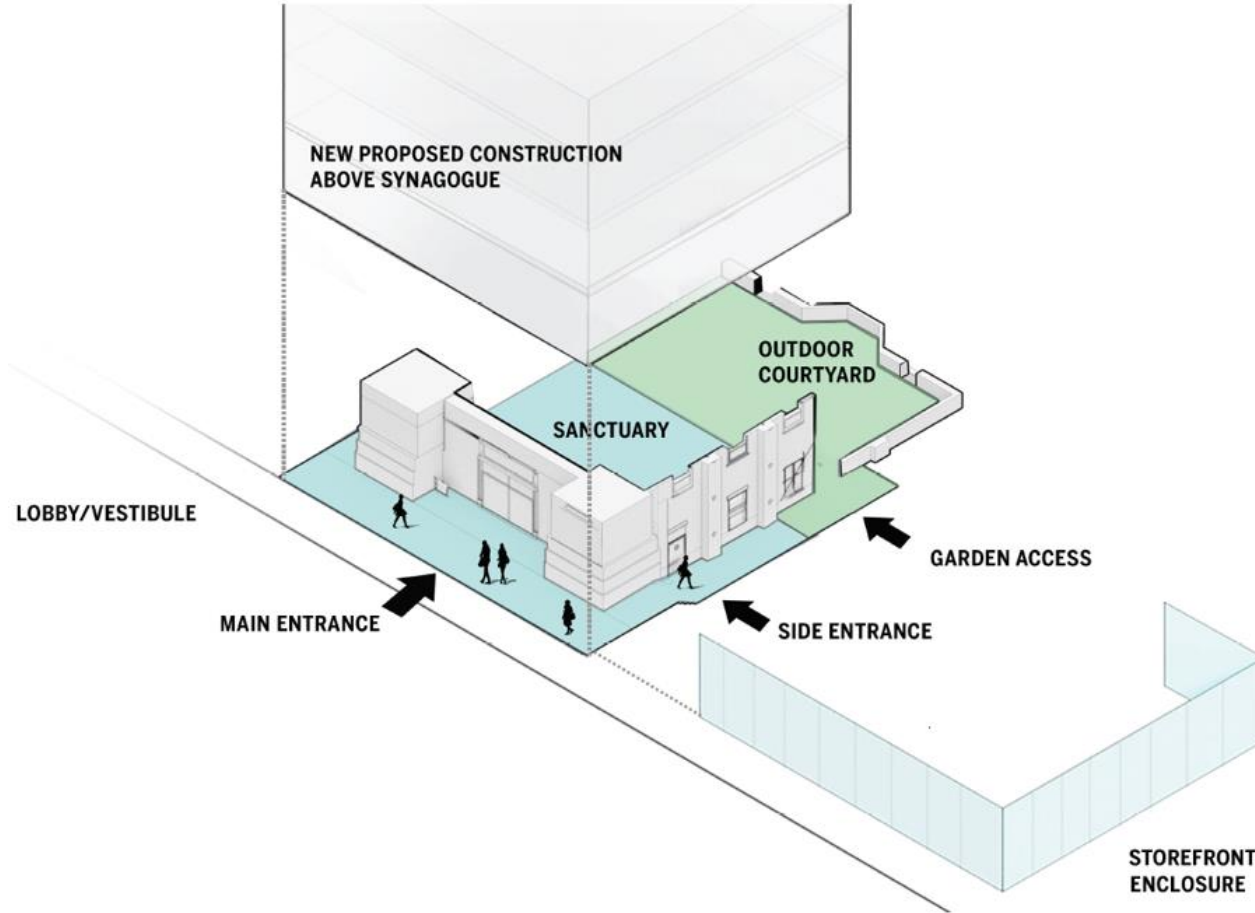
Proposed Development Concept: BHH Integration

The proposed integration of the BHH synagogue into the project involves several key features:

Preservation of the historic trace of the synagogue, by keeping the sanctuary plan and orientation visible.

Addition of a glass enclosed vestibule facing the street that creates a new entrance space of the congregants, a gallery for surviving artifacts, and protects the remaining ruins from the elements.

Memorialization of the former Sanctuary by marking Bima (pulpit) and Aron Hakodesh (ark) locations as features of an outdoor courtyard which can be used for worship and other purposes.

Separation of the old from the new by having the new building "float" above and around the ruins, without touching them.
