**165-167 West 86th Street – West Park**

**Presbyterian Church Individual Landmark**

# WEST-PARK PRESBYTERIAN CHURCH

## ***Application for a Notice to Proceed to allow for Demolition on the Grounds of Hardship***

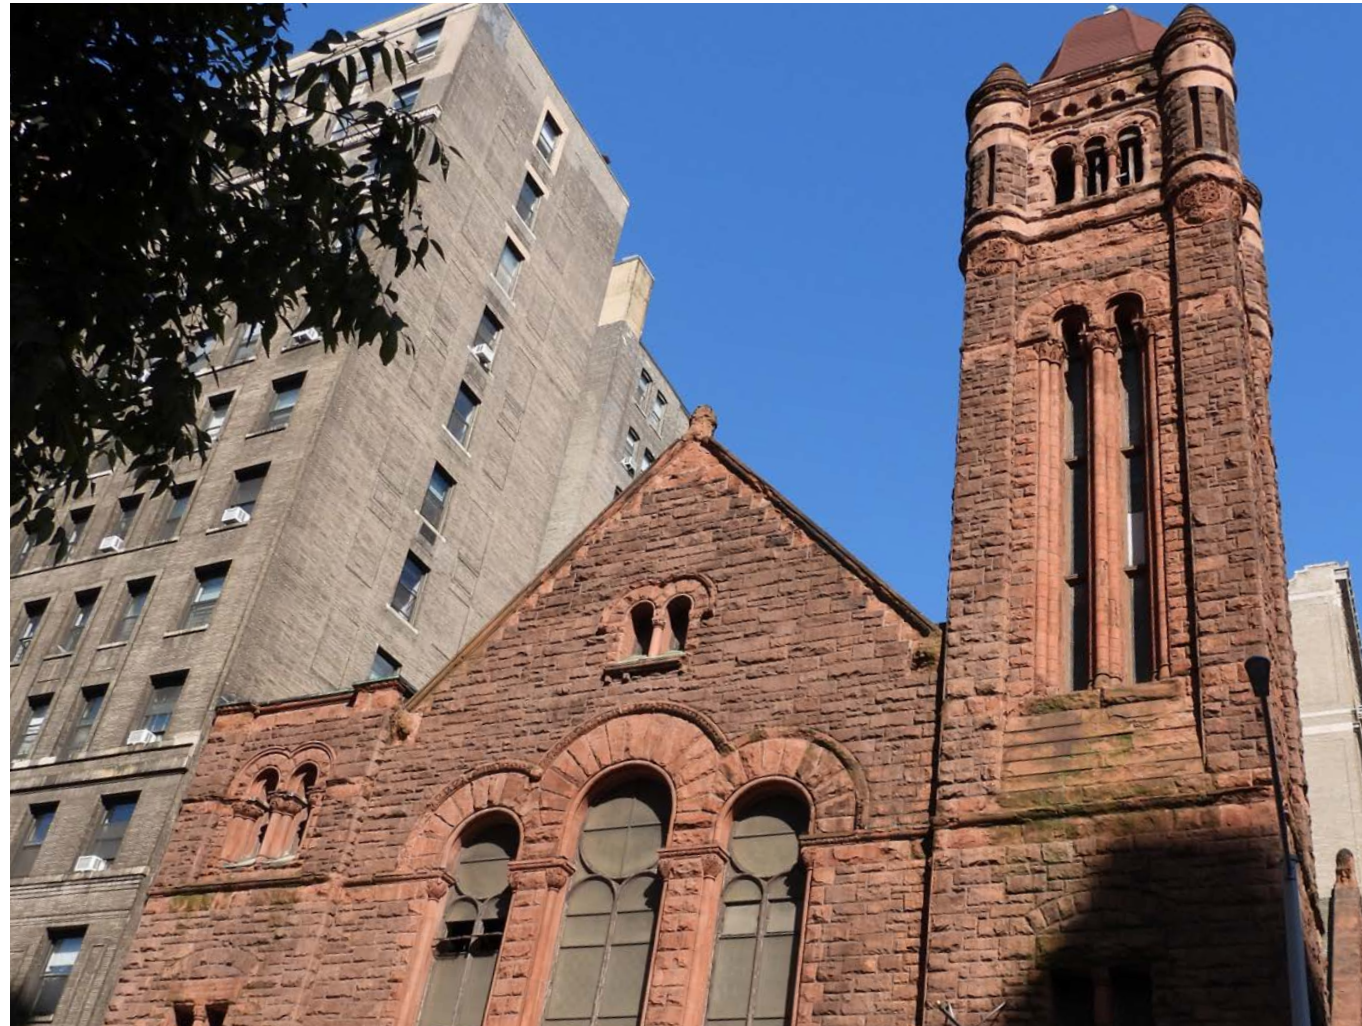
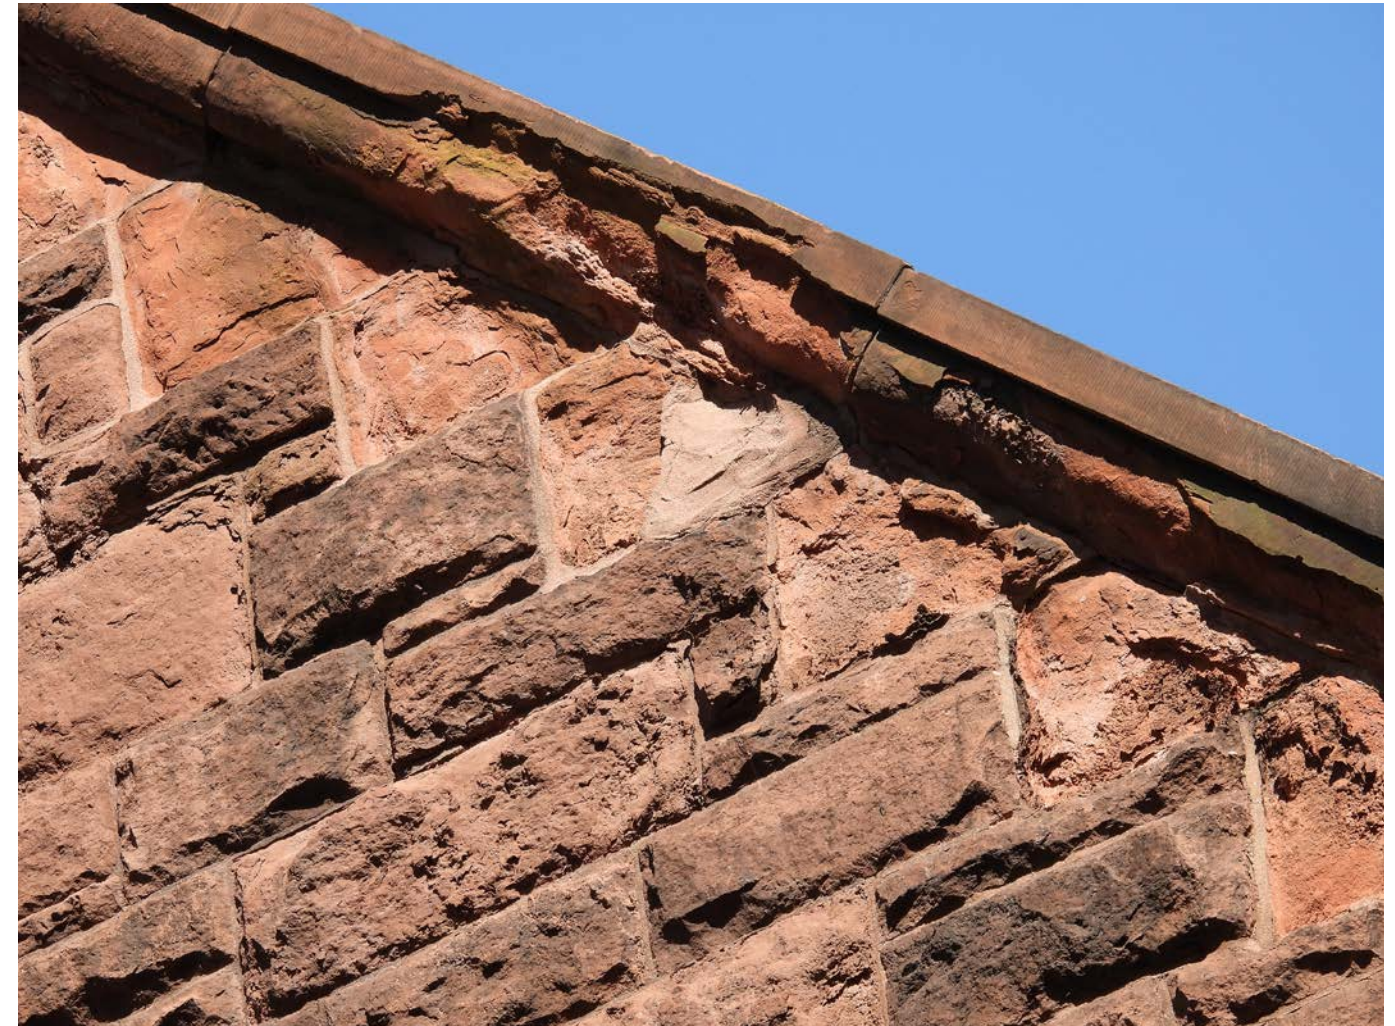
# Existing Conditions

- Facade
- Structure
- Fire Protection and Life Safety
- Accessibility

- Facade Description
- Facade Analysis Methodology
- Extent of Probing
- Types of stabilization, repair and restoration
- Extent of restoration and replacement

\* Façade MD Report to NYC Department of Buildings dated December 2,2021

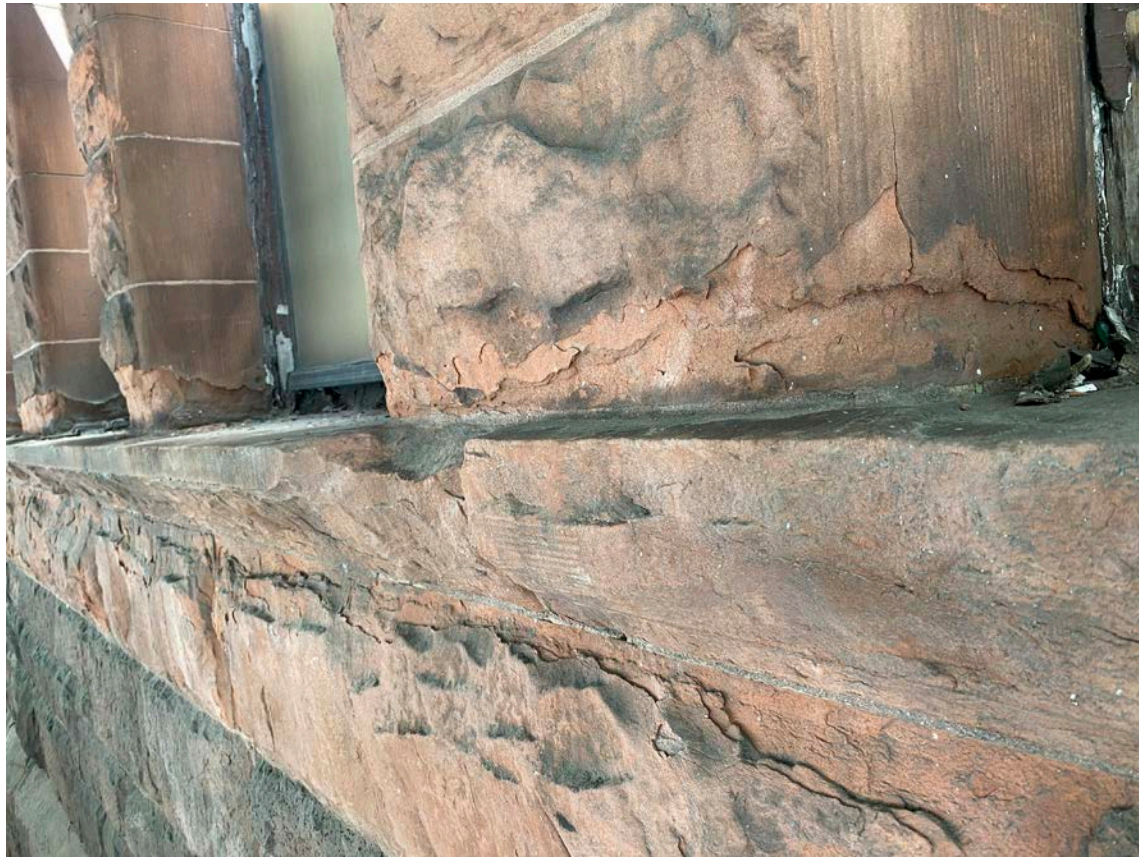
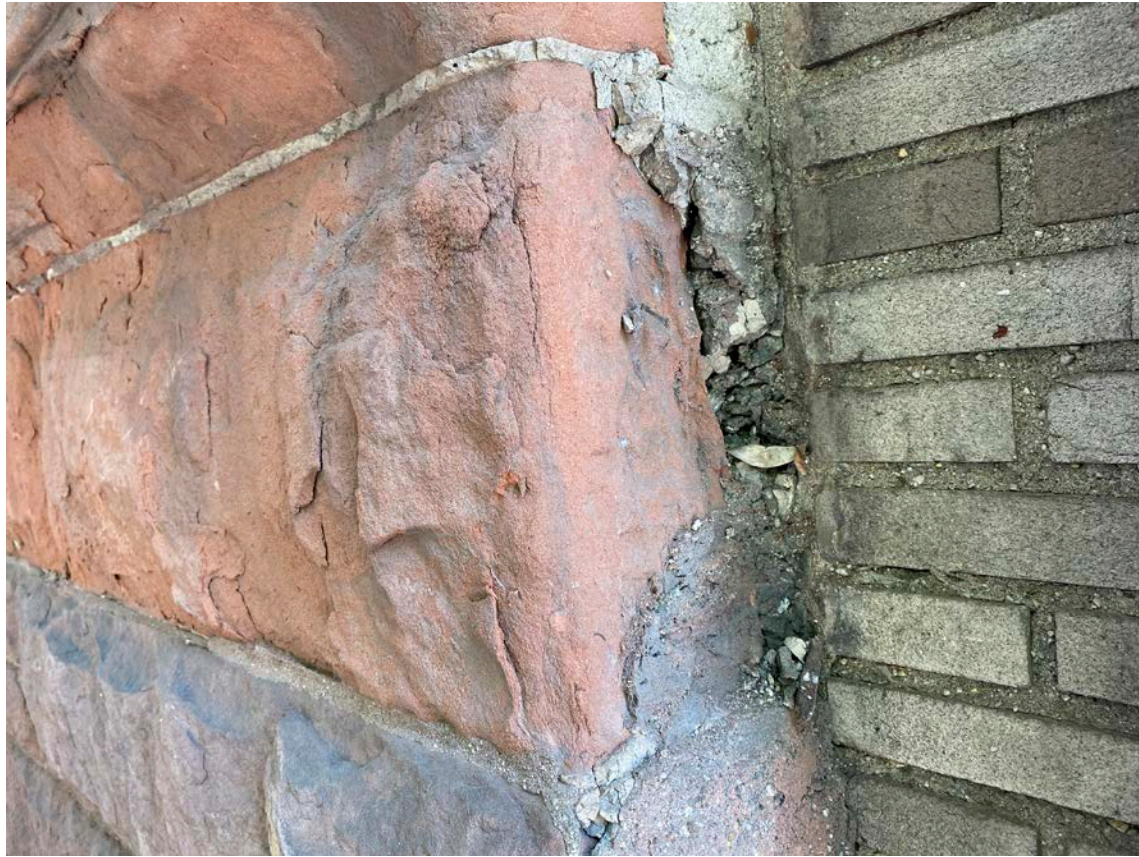
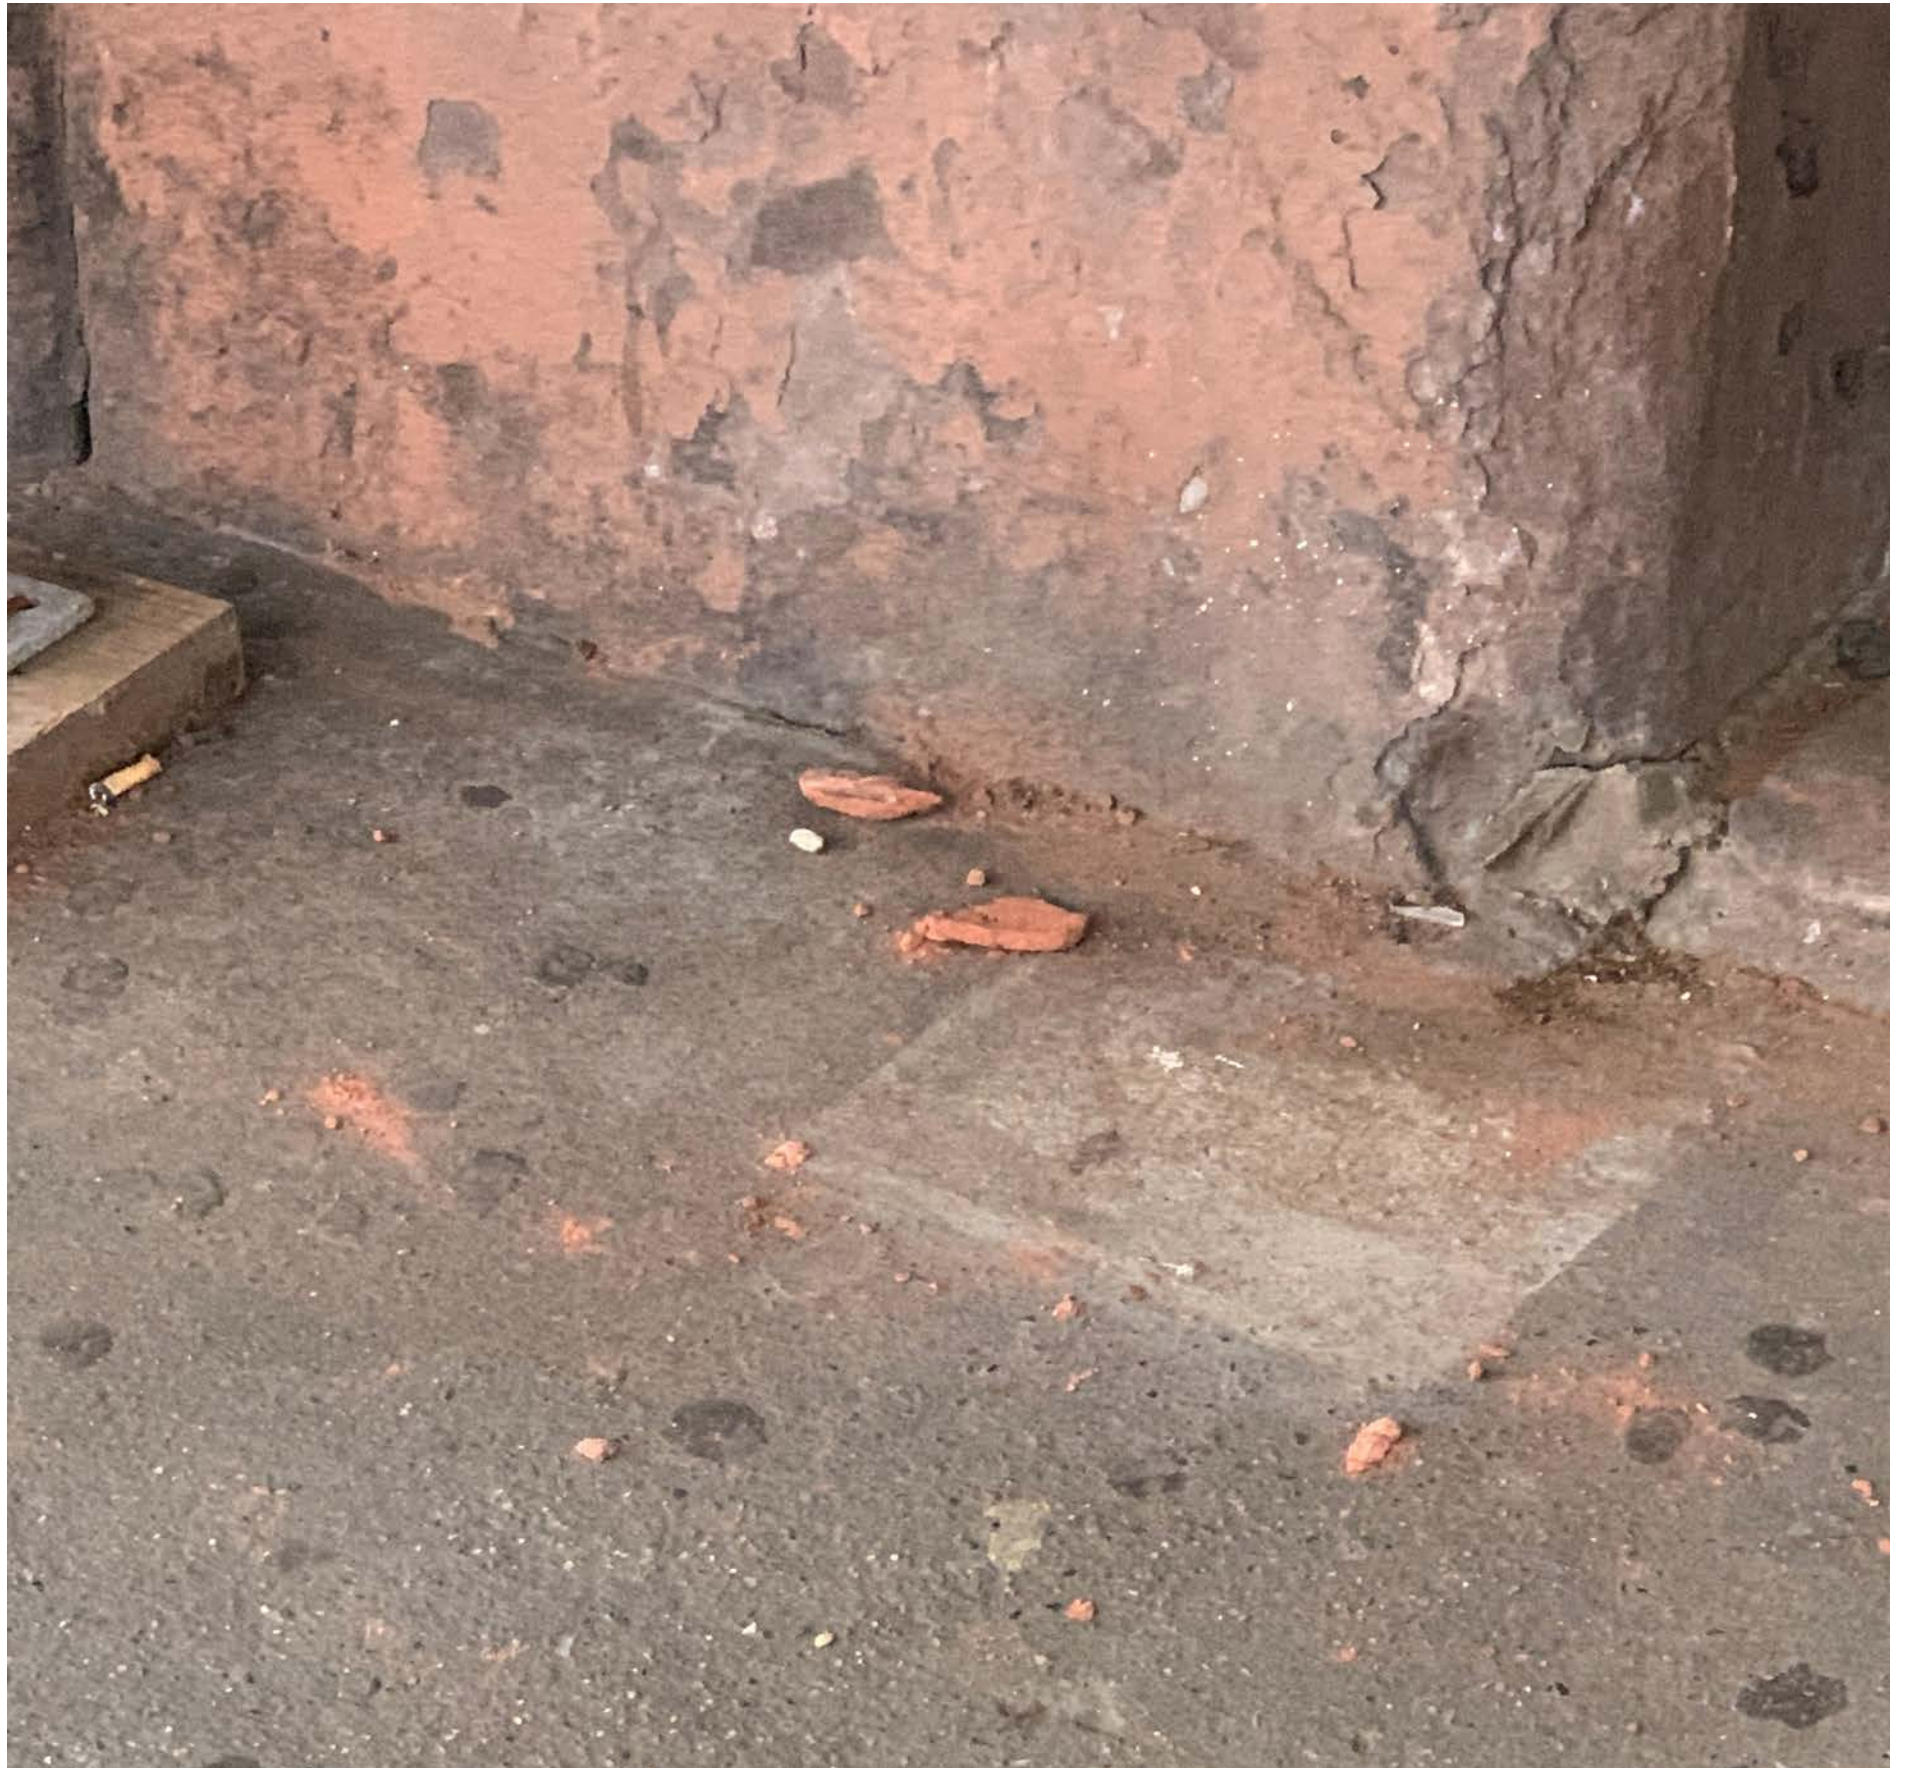
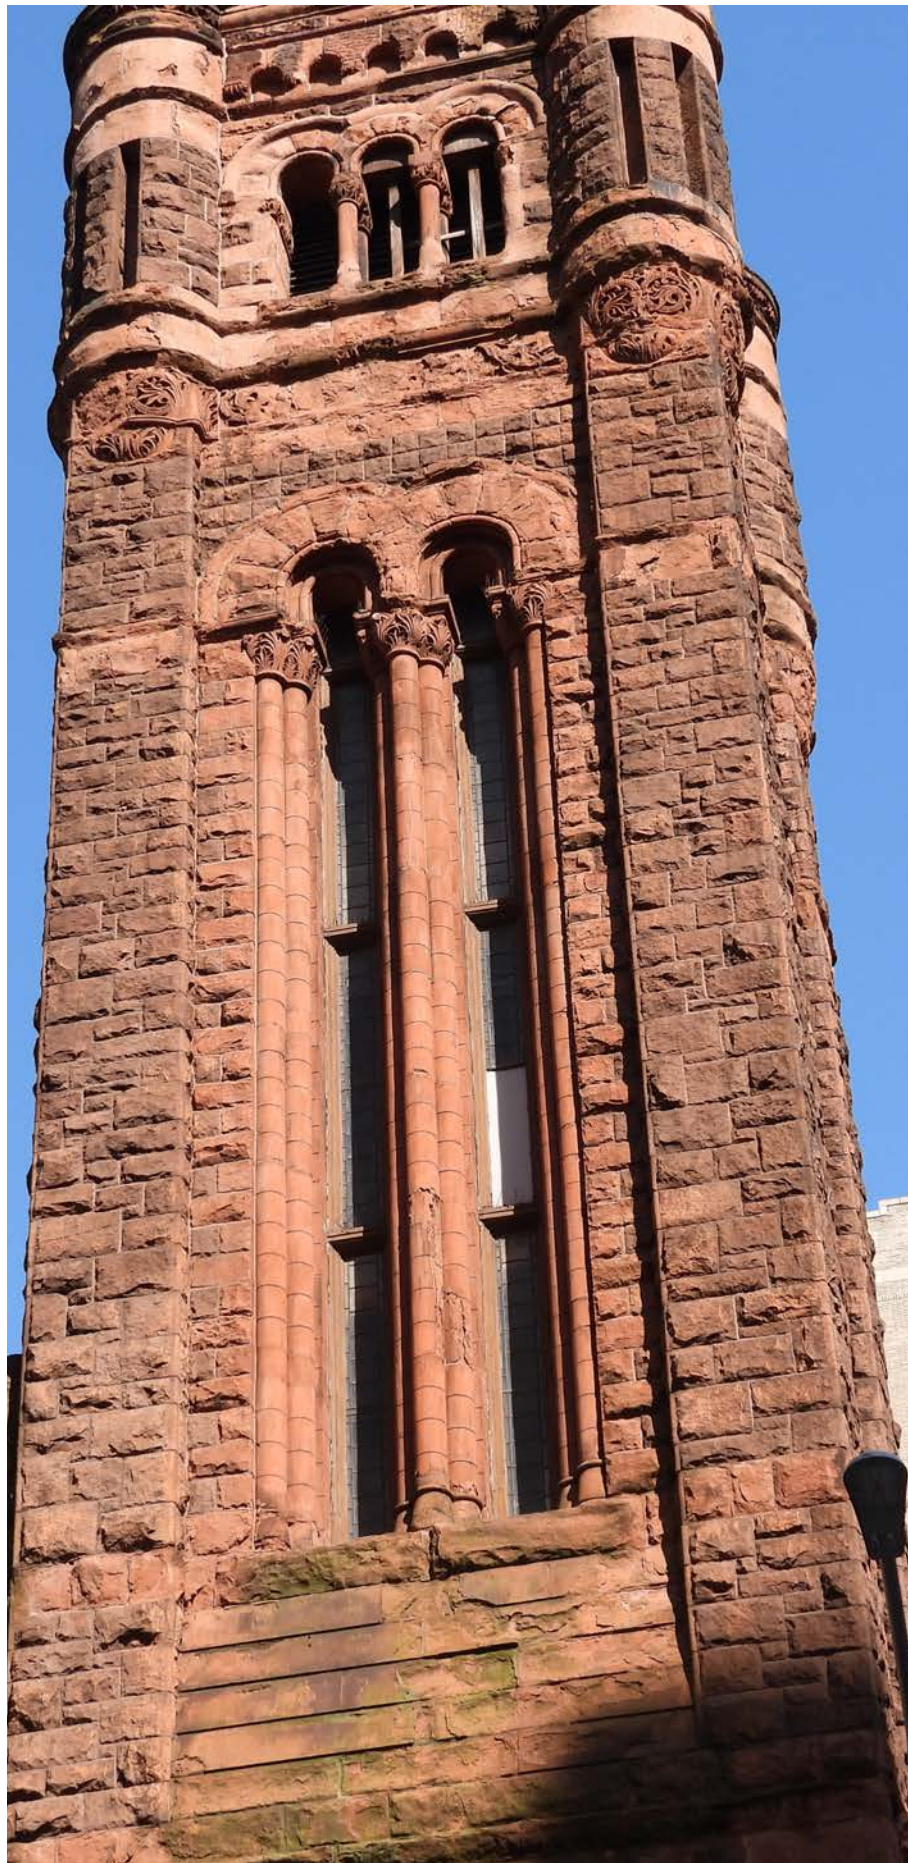
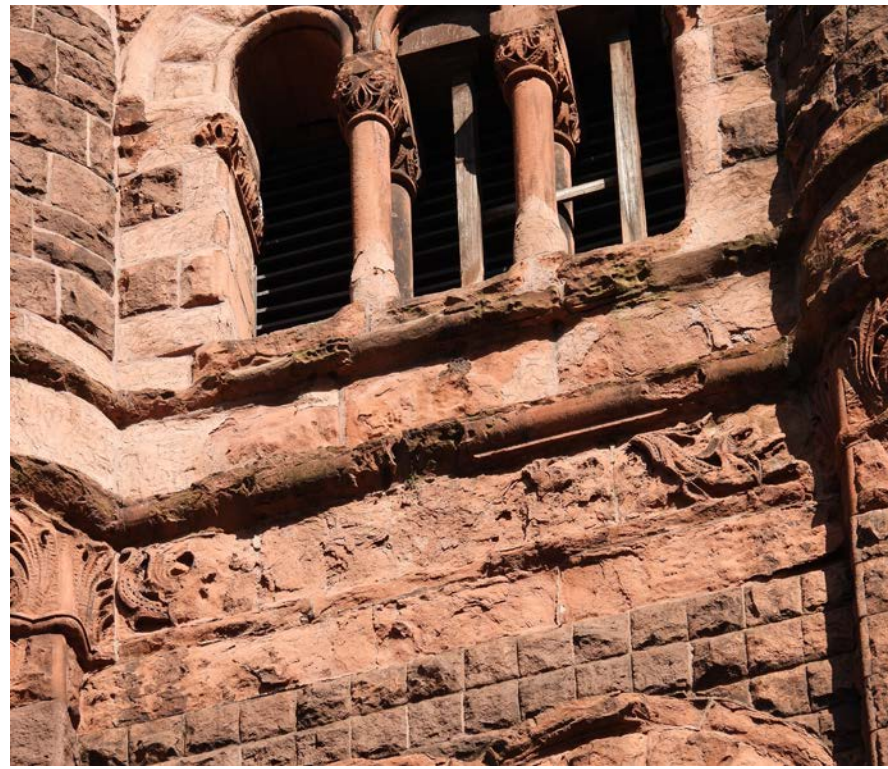
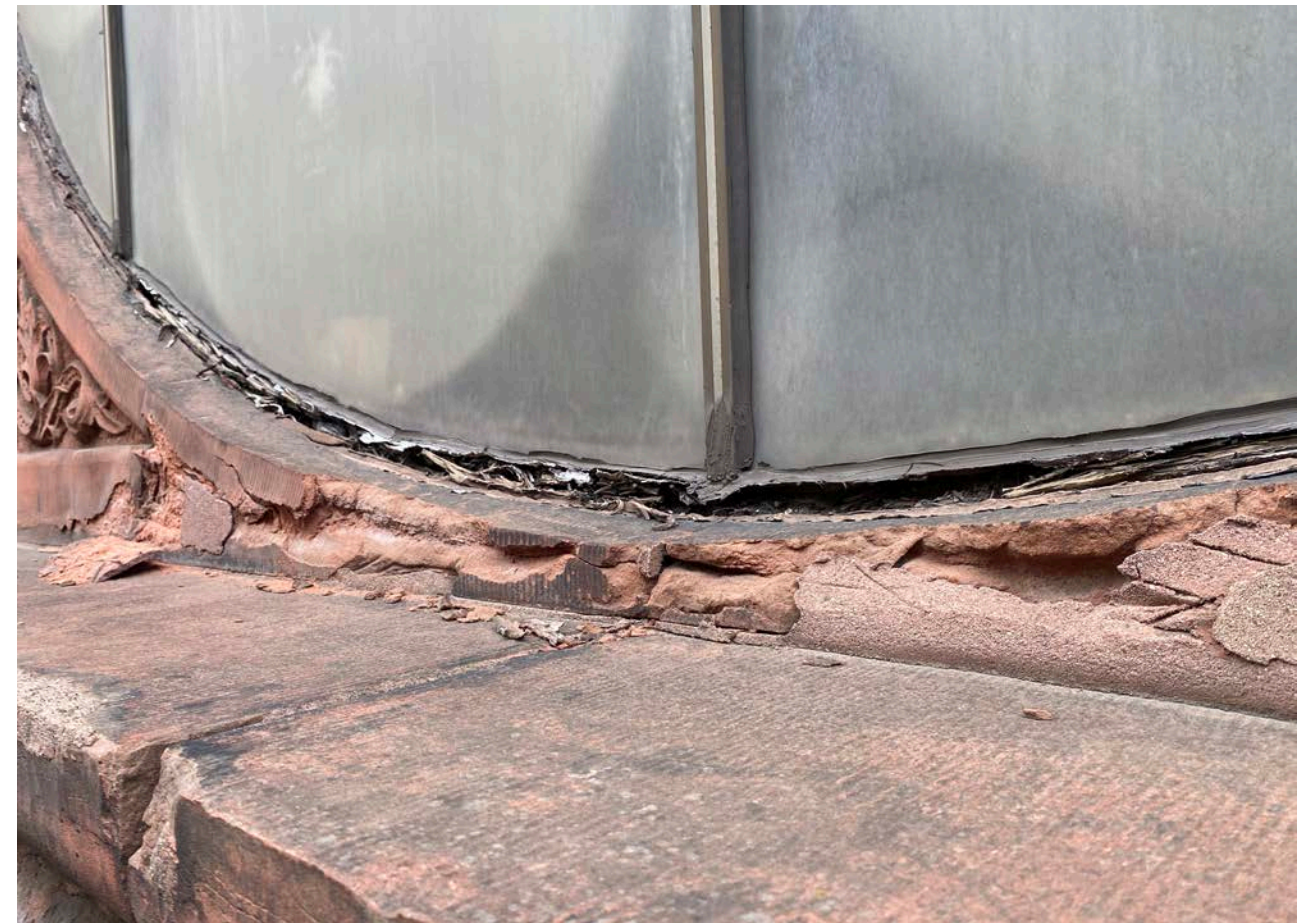
**EXISTING CONDITIONS**  
(12/2/21 FACADE MD REPORT)

## ***Facade Conditions Report Summary \****

- Extensive stone spalling, cracks, mortar deterioration and deteriorated windows noted throughout the building.
- Façade conditions are unsafe.
- Loose or unsafe material should be removed and the remaining masonry stabilized.
- Ornamental sandstone Finial located at top of the West 86th Street Chapel façade at the end of the roof ridge beam is severely cracked and spalled.

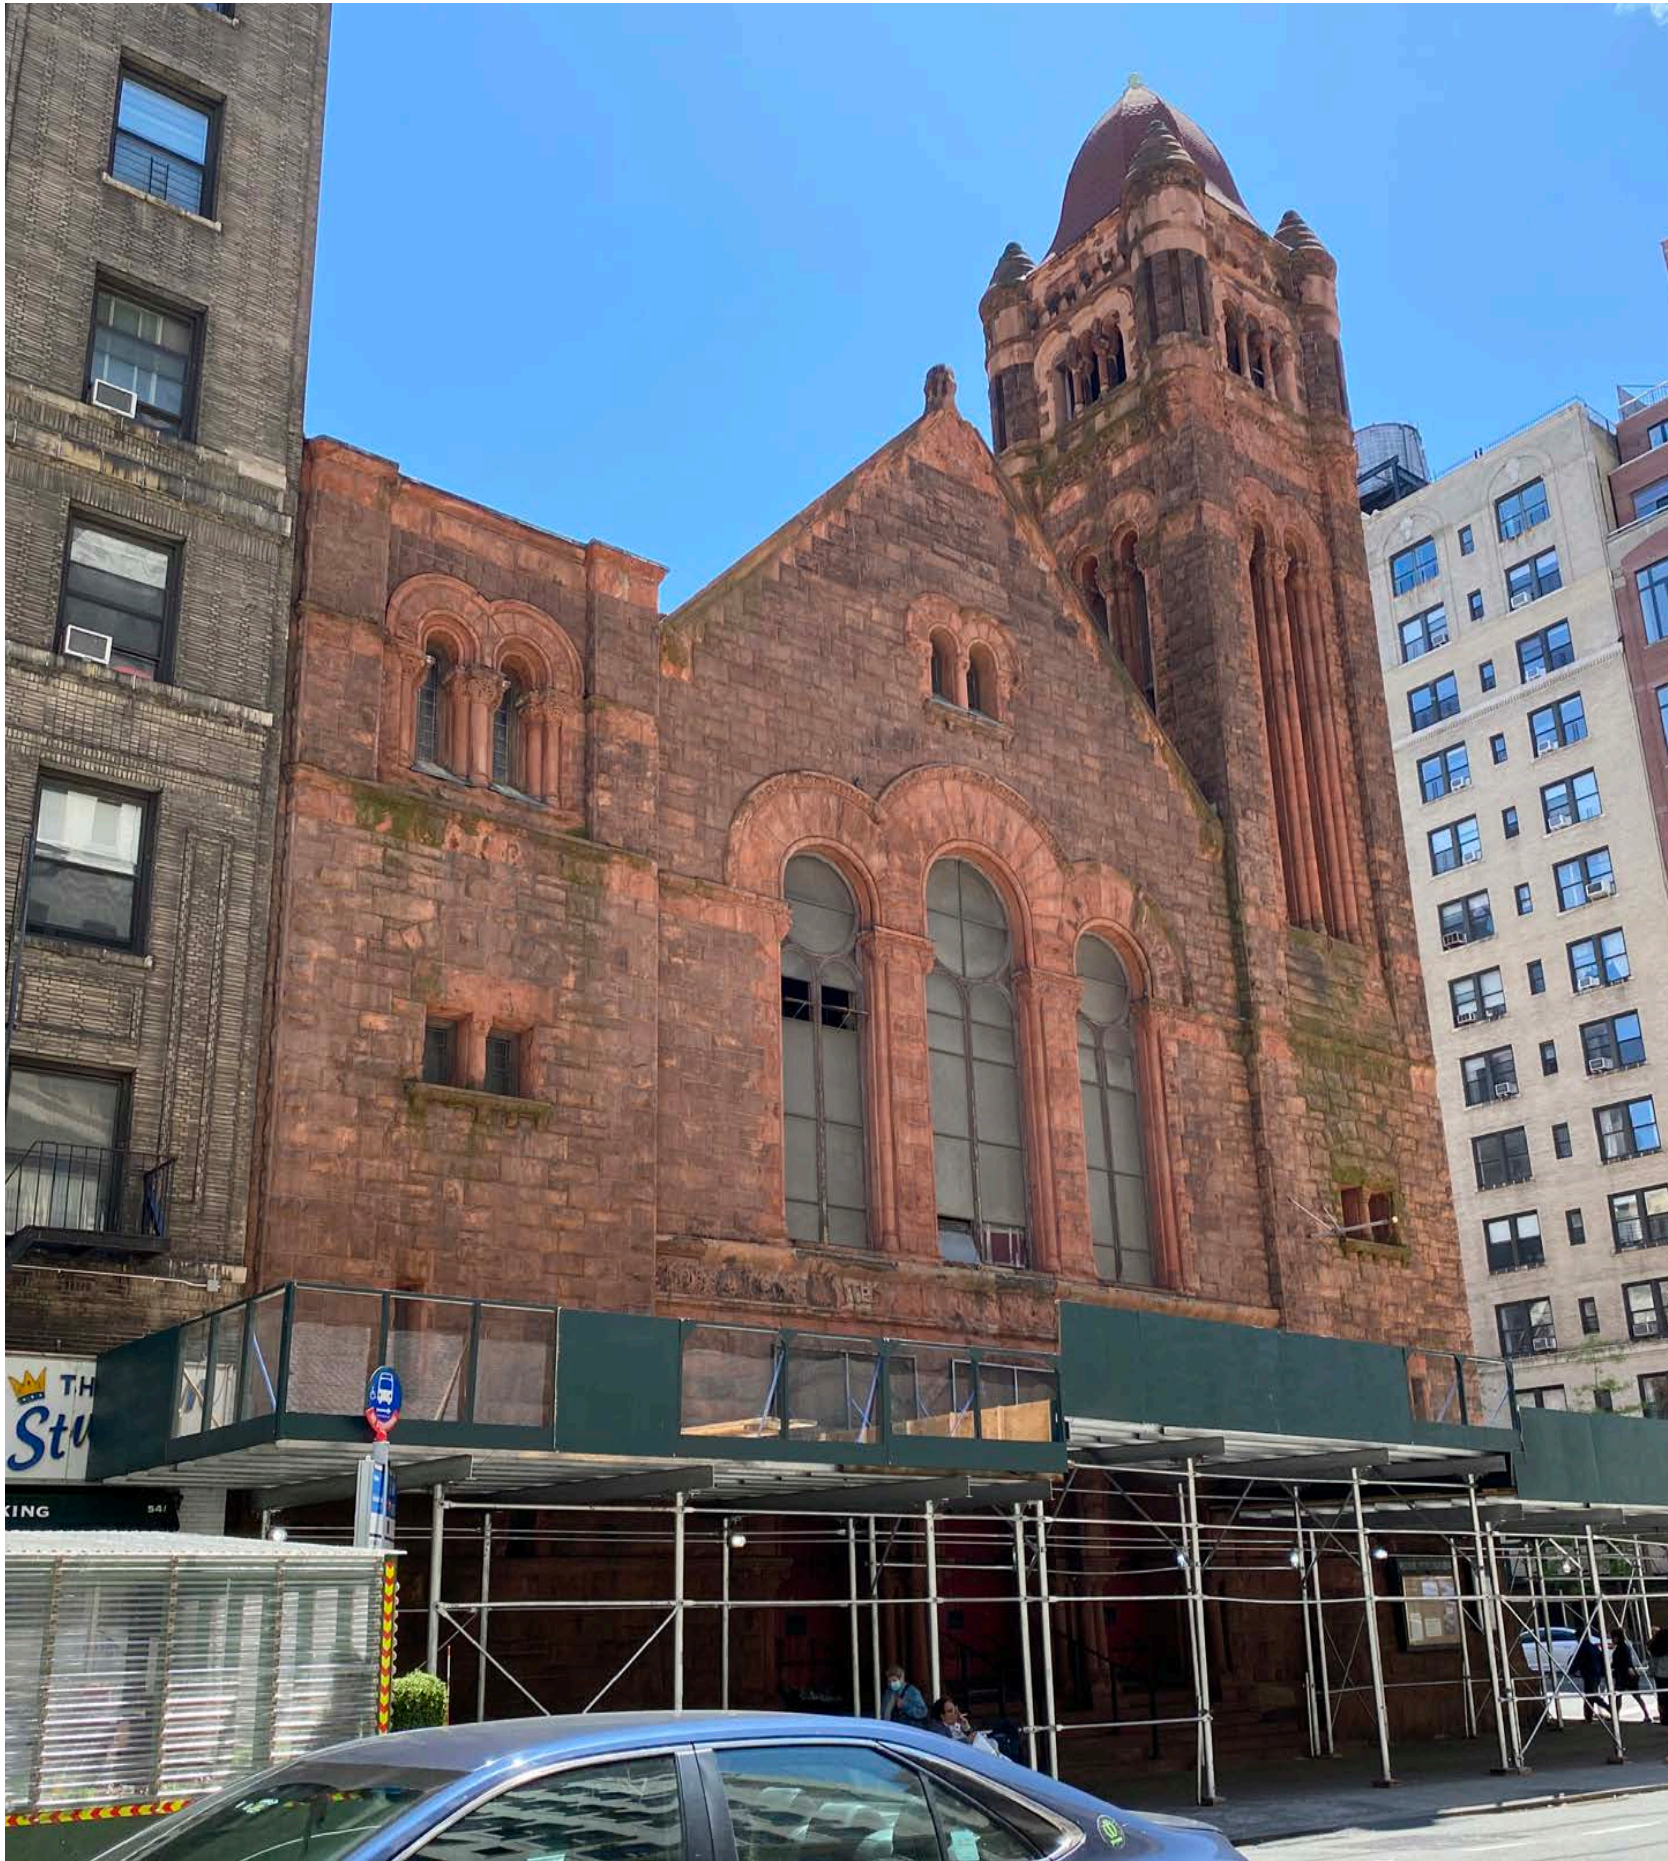
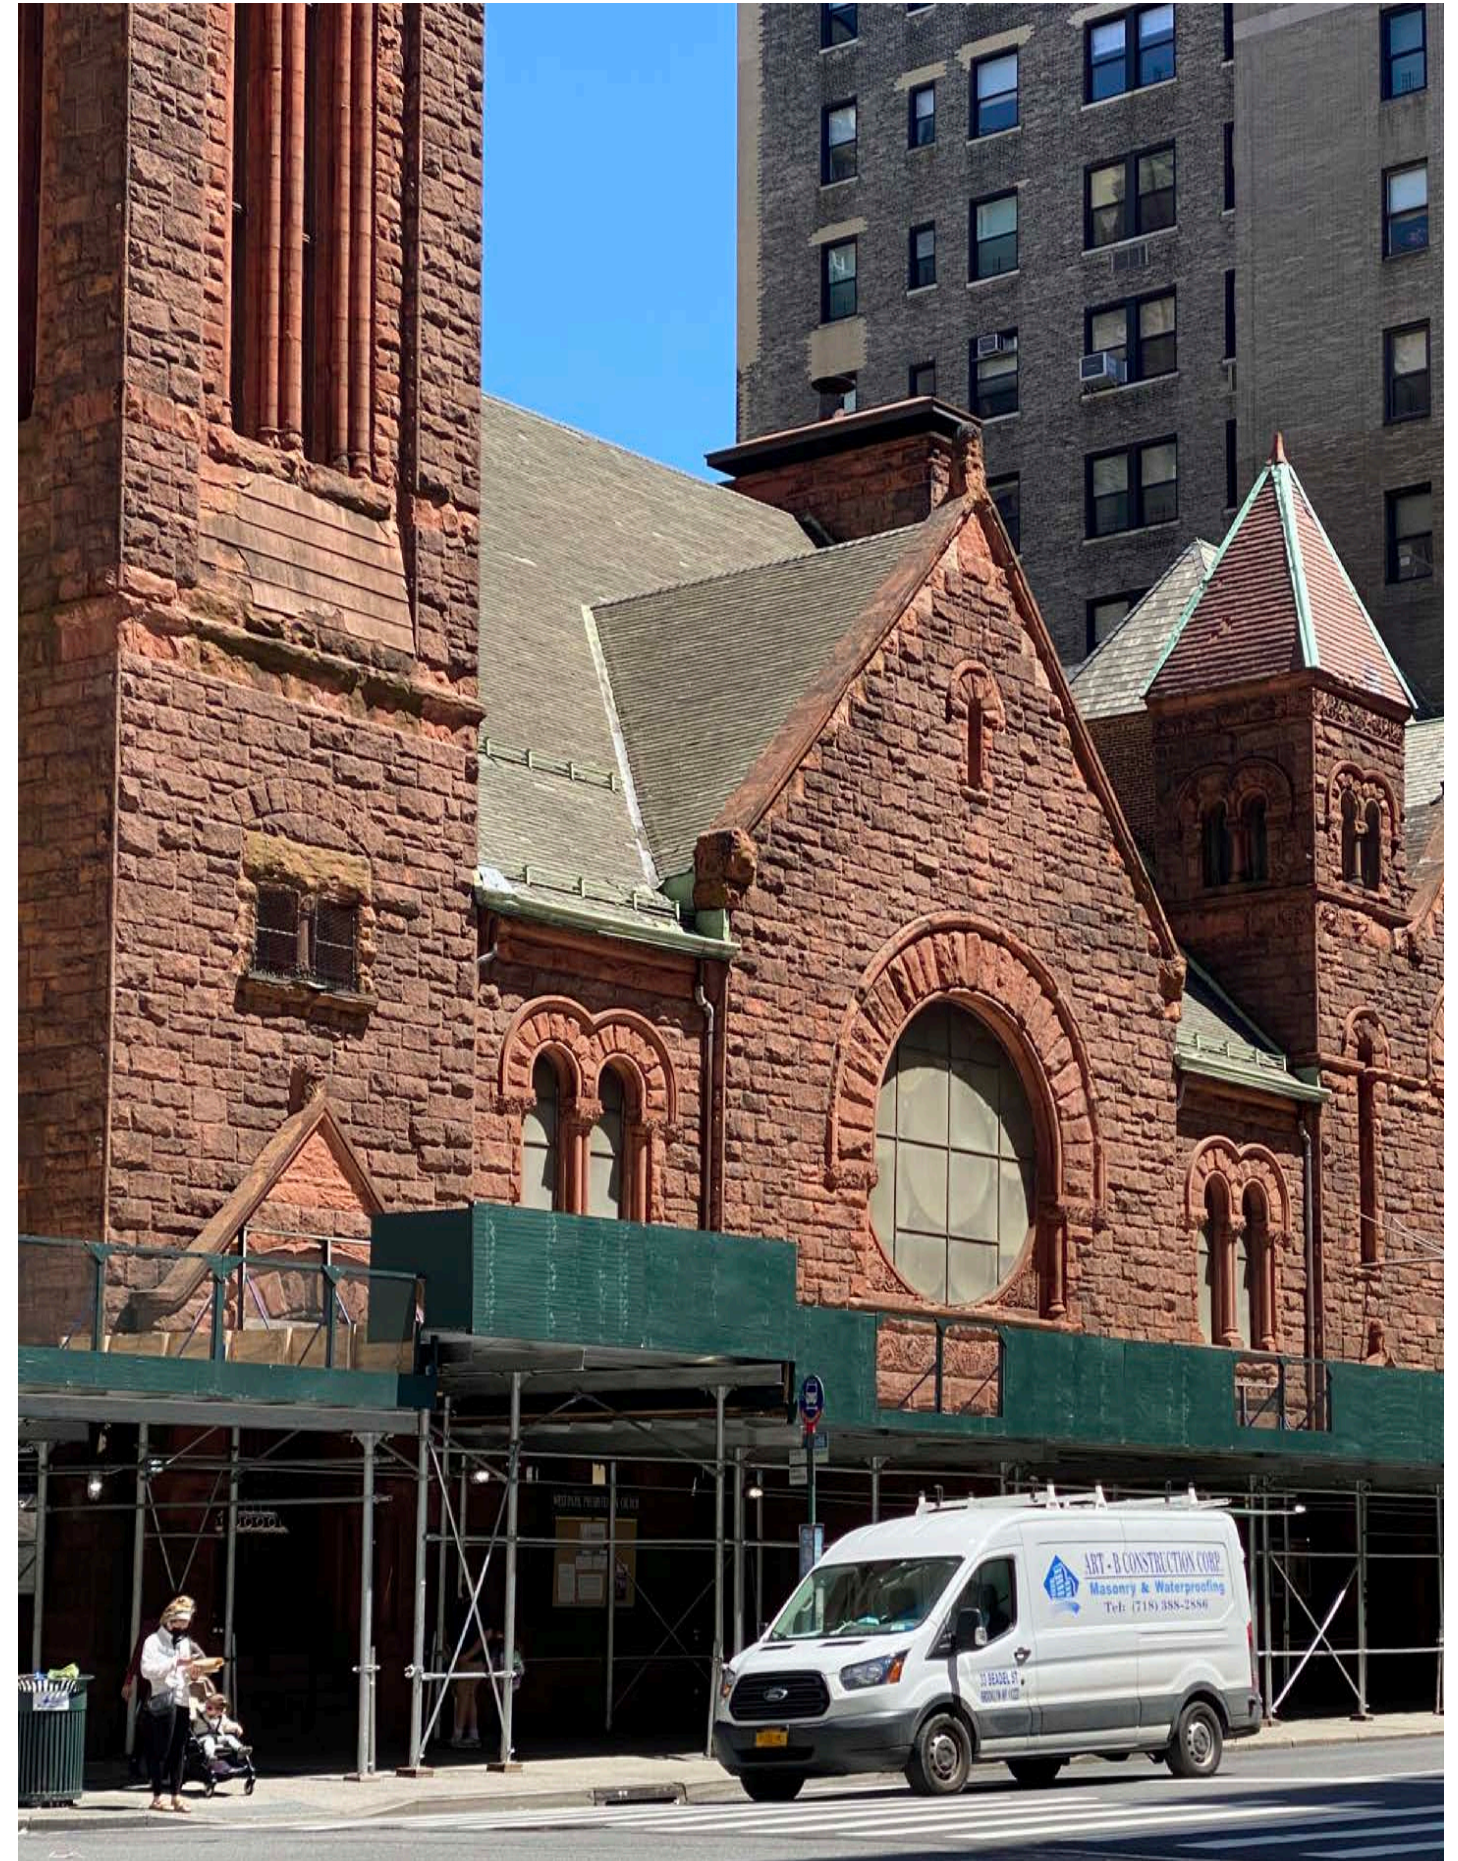
## EXISTING CONDITIONS

## Structural Conditions Report Summary \*

- Sandstone façades exhibit deterioration in varying degrees from minor to severe. Areas of cracked, hollow sounding and delaminated surface observed, Large spalls, voids pits and cracks observed throughout.
- Section of façade adjacent to 86th St. separated from roof by up to 4". Wall is not adequately braced against wind loads and roof and sanctuary ceilings are not adequately supported.

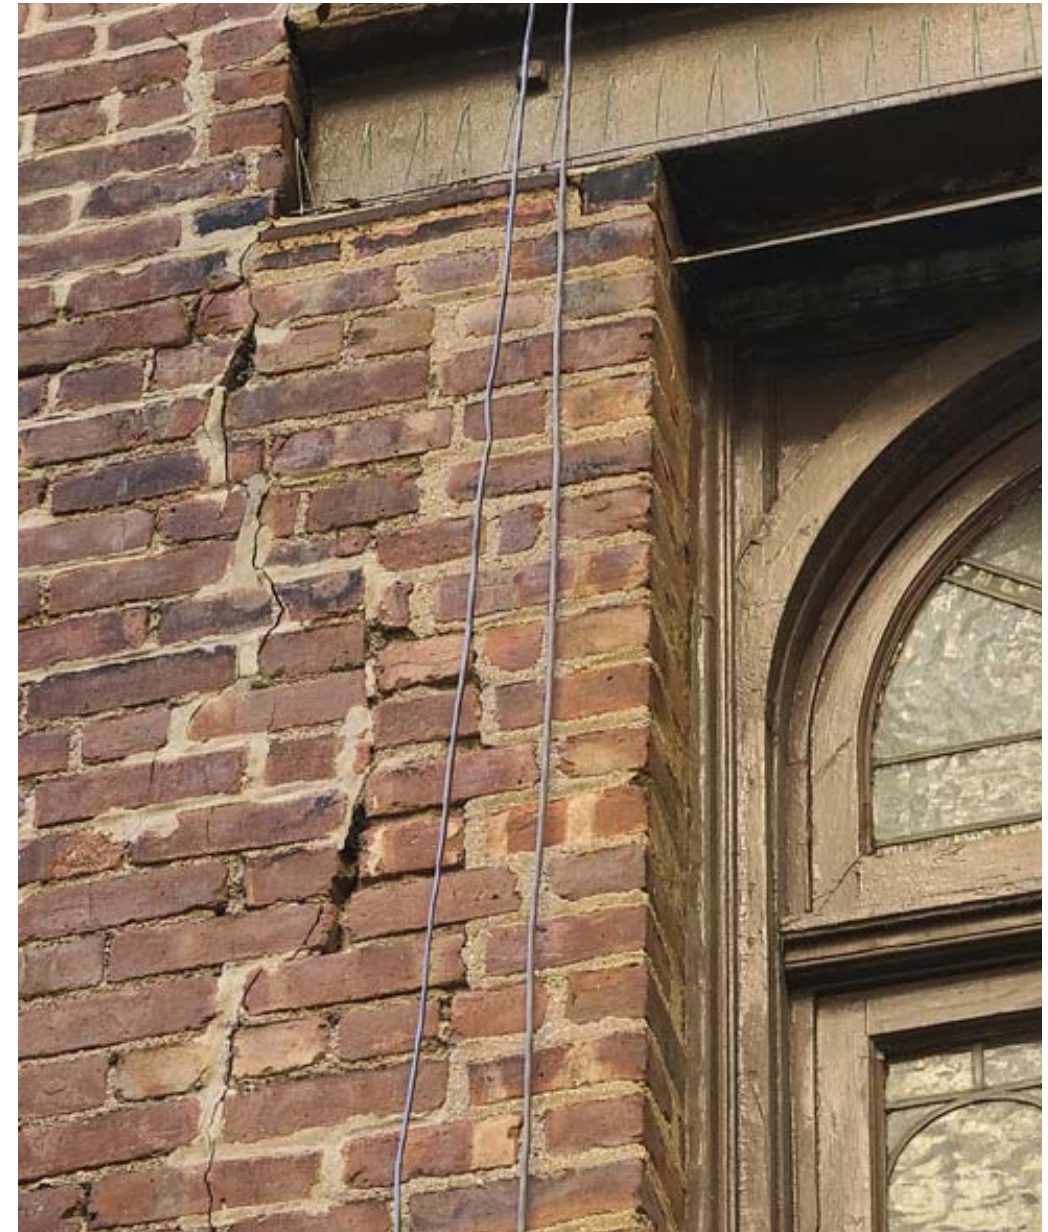
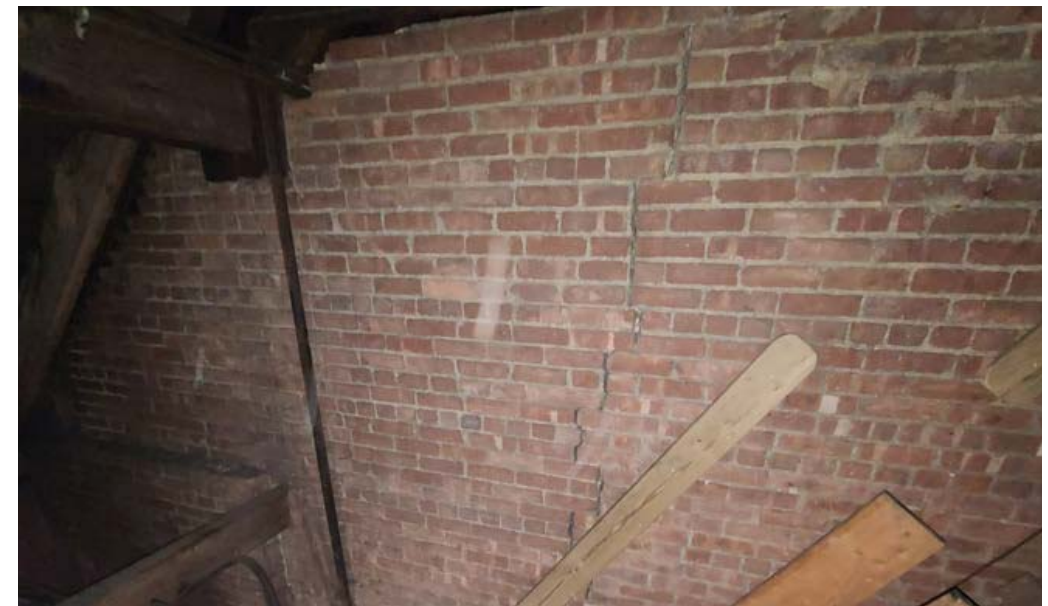
## ***Structural Conditions Report Summary (Continued) \****

- 25% of brick on interior walls of bell tower which support the tower and serve as backup to the sandstone façade has cracked, deteriorated or missing mortar.
- Various through-cracks, areas of missing and deteriorated mortar or signs of trapped moisture observed at the exterior brick bearing walls at north and east faces. Interior signs of trapped moisture.

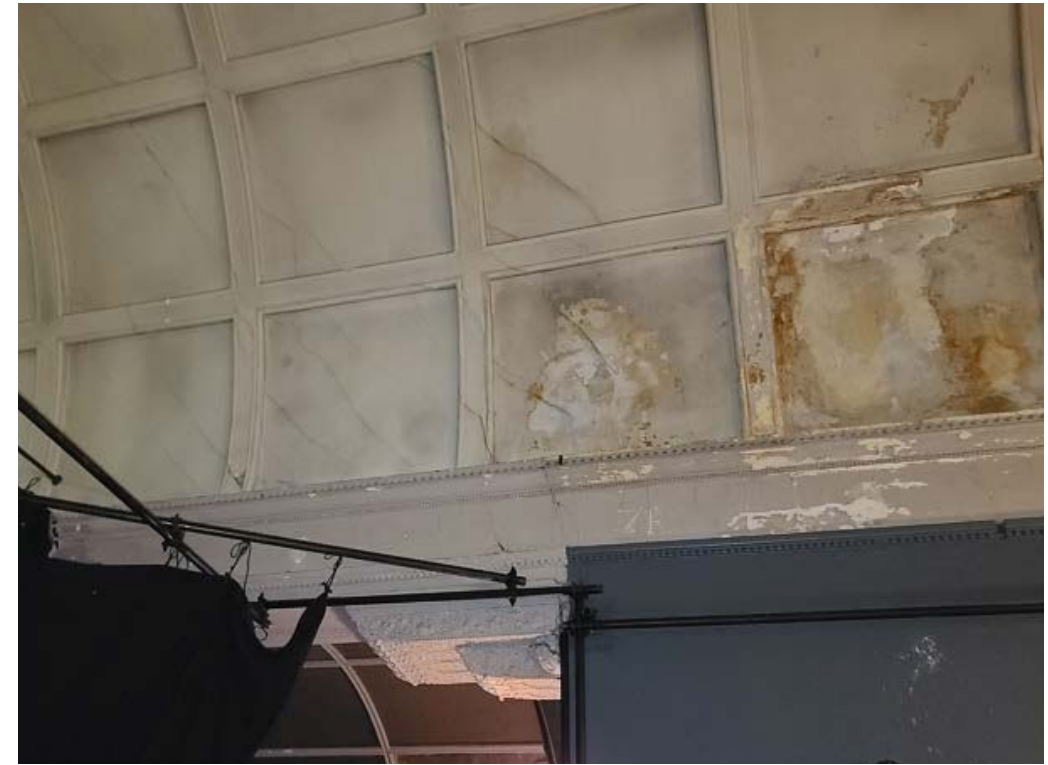
## ***Structural Conditions Report Summary (Continued) \****

- Various cracks and water discoloration at sanctuary walls and ceilings and near wood trusses indicating excessive deformation of wood truss and/or excessive lateral movement or settlement at the truss bearing points.
- 20 foot long wide vertical and stepped crack at east end of southernmost roof truss.
- Wood header and joist supporting a stair and portion of storage room east of 86th Entrance observed to be severely cracked and deformed.
- Cracks at underside of north-east egress stair at second floor indicate excessive deflection of floor.
