**165-167 West 86th Street – West Park**

**Presbyterian Church Individual Landmark**

# WEST-PARK PRESBYTERIAN CHURCH

## ***Application for a Notice to Proceed to allow for Demolition on the Grounds of Hardship***

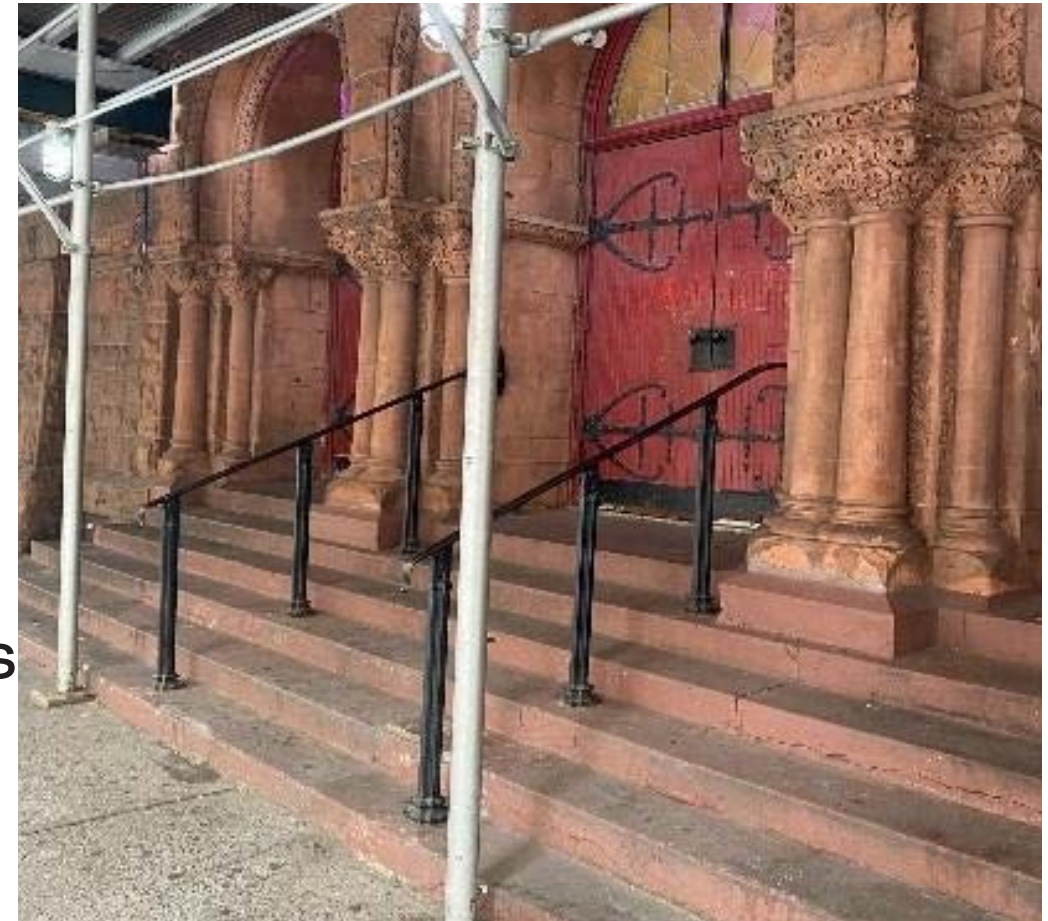
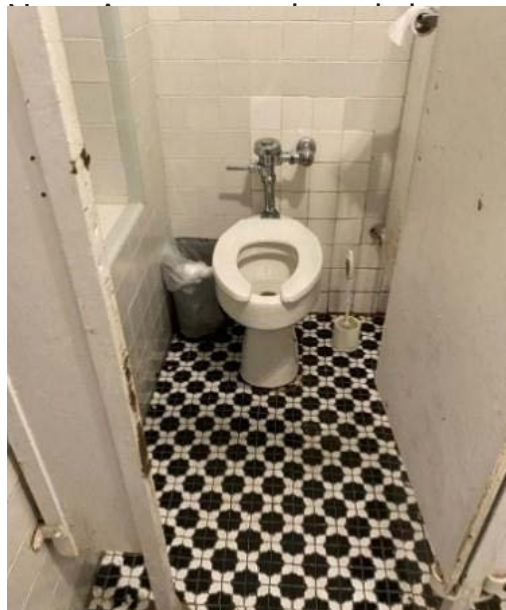
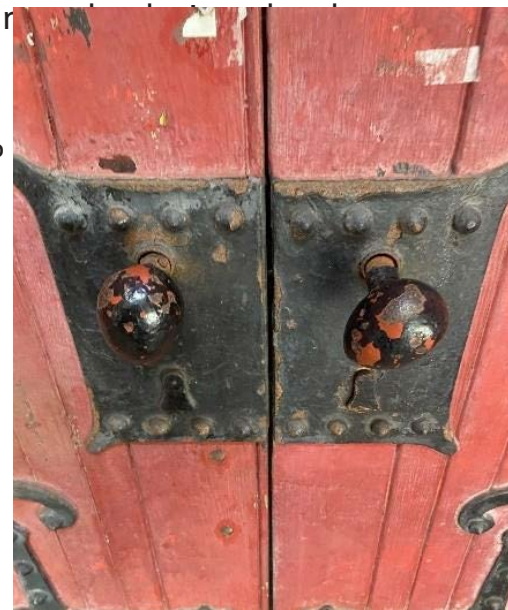
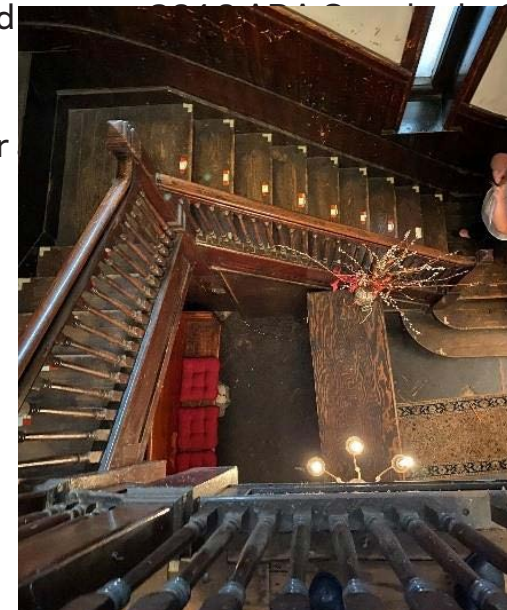
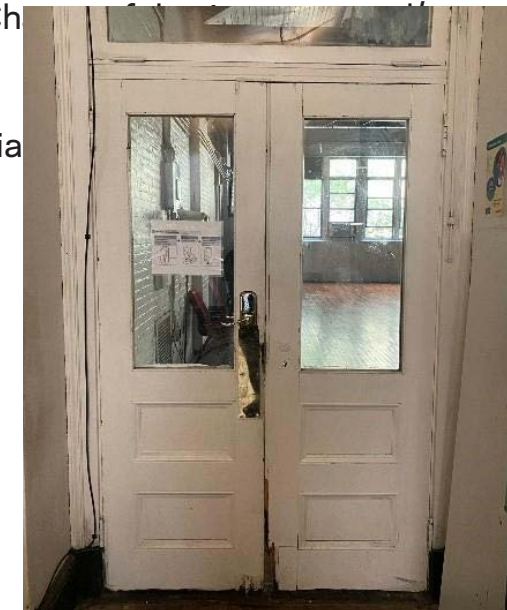
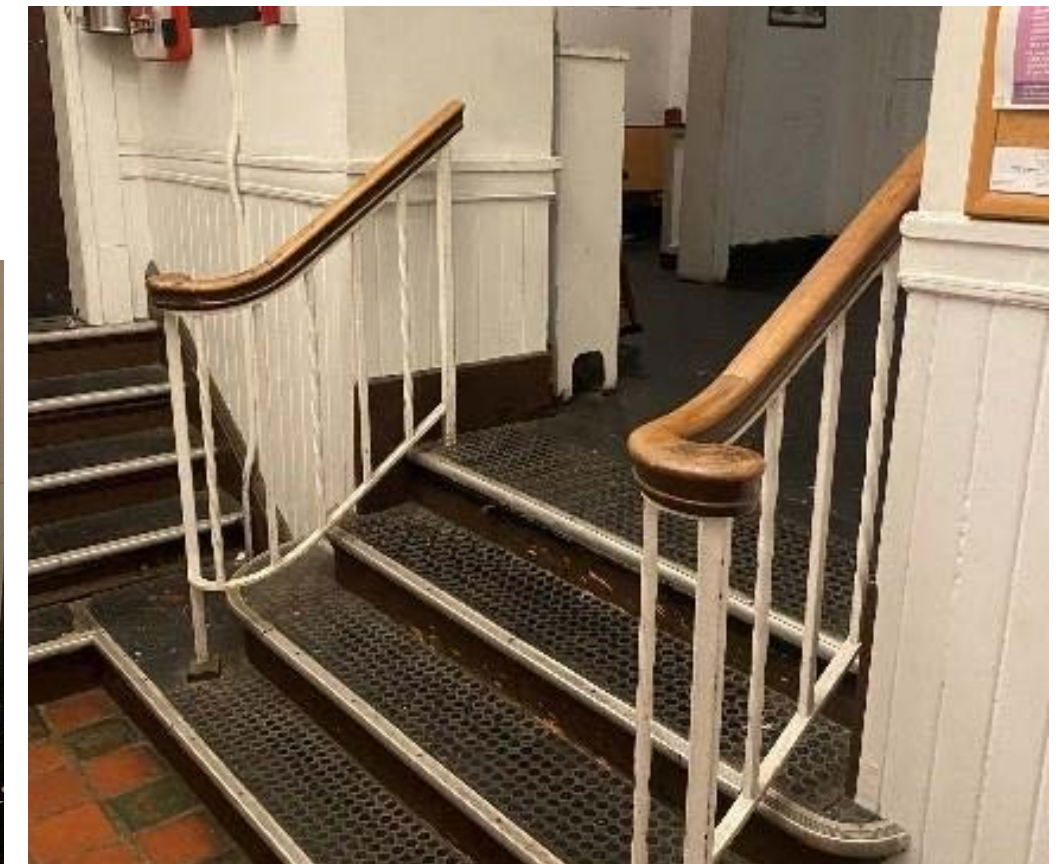
## Accessibility Report Summary \*

- Amsterdam Avenue and West 86th Street entrances are not accessible.
- No accessible routes from sanctuary to any of the levels of the building including the balcony.
- No accessible restrooms.
- Interior doors, hardware and railings are non-compliant.

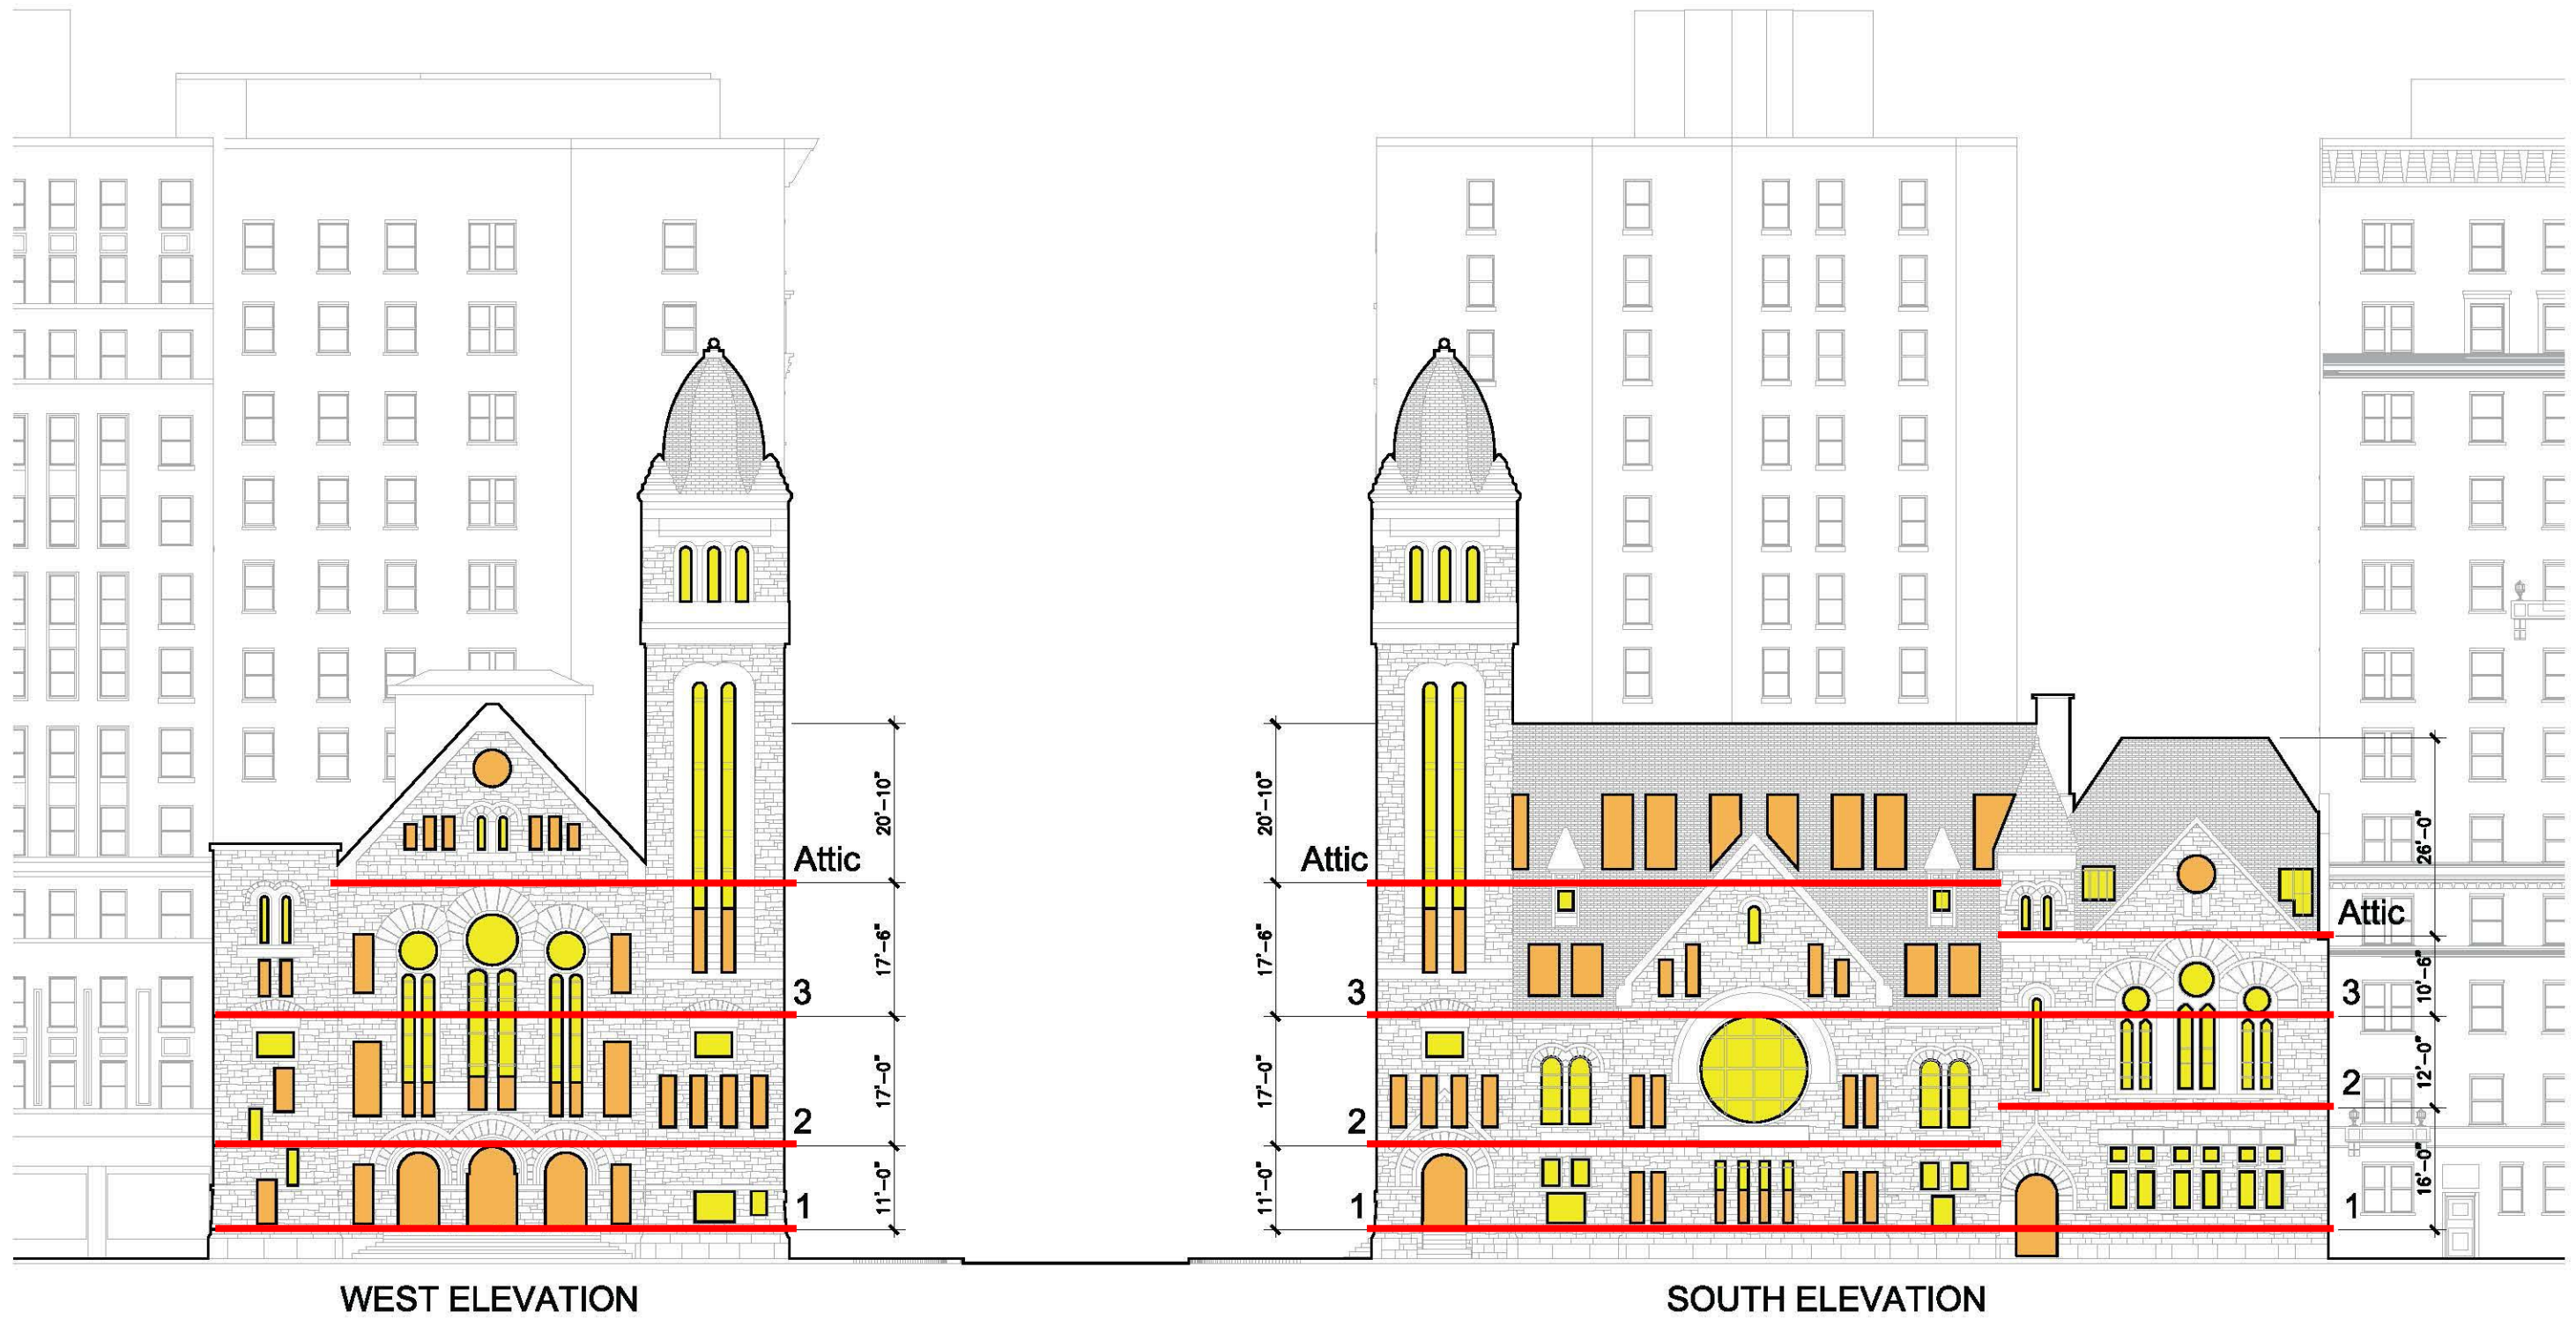
**Scenario 1**  
**Existing & Proposed New Fenestration & Proposed New Floors**
