Preservation Department – Item 5, LPC-24-00959

301 Park Avenue – Waldorf-Astoria Hotel – Individual and

WALDORF ASTORIA BALLROOM GUARDRAILS

Landmarks Preservation Commission Public Meeting August 15, 2023 Dajia US Group SOM

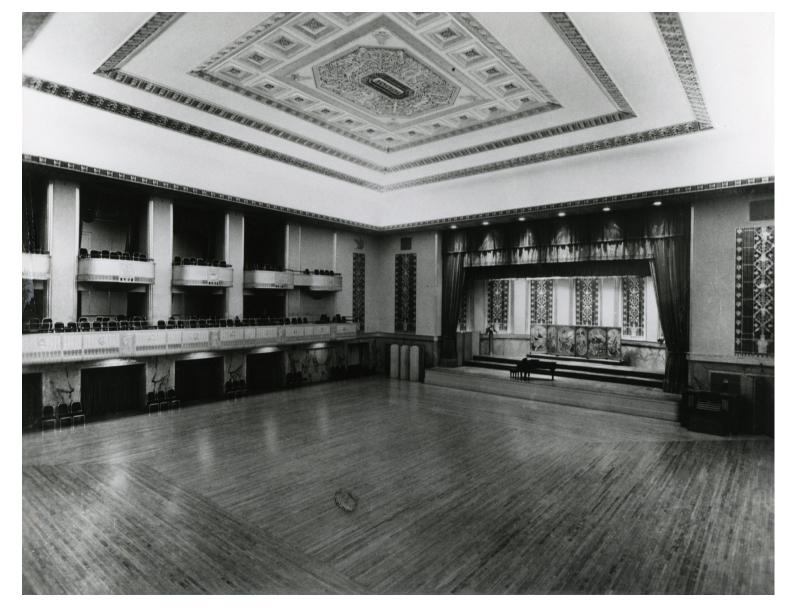
VIEW TOWARDS STAGE

ORIGINAL CONDITION

- "The general lighting scheme is indirect, from the ceiling"
 - Facts about the Waldorf

"This chandelier-less scheme enhanced the room's exceptional height and breadth..."

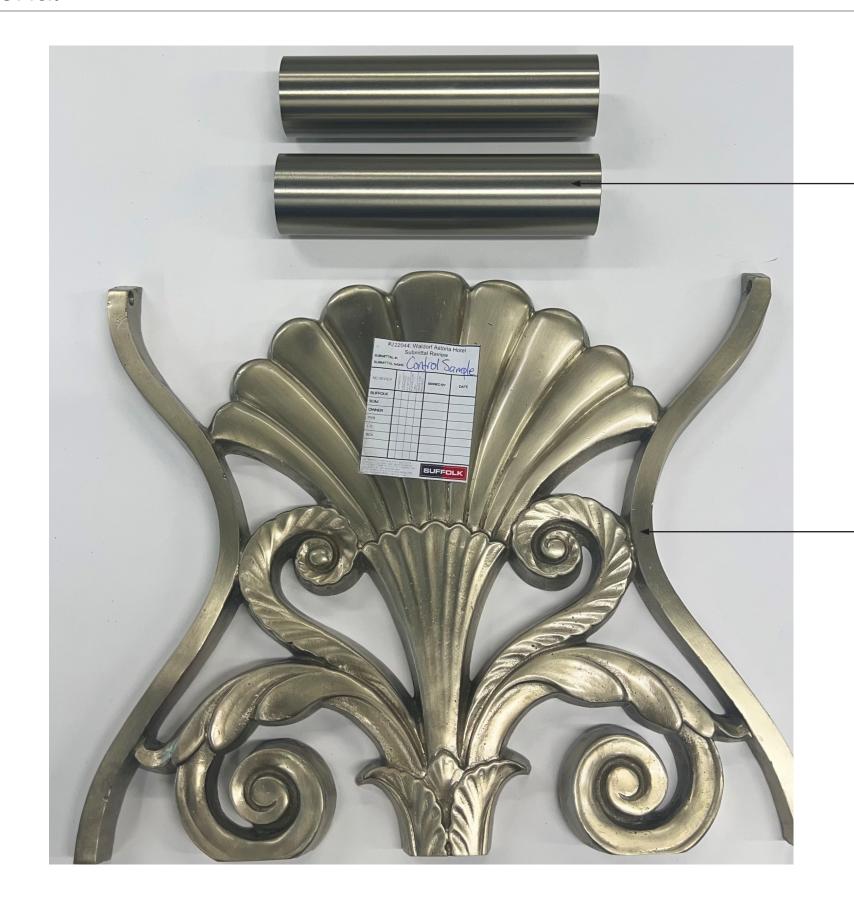
Ballroom Guardrail Material

- Stainless Steel Lacquered Sample

– Nickel Silver Control Sample
