Preservation Department – Item 14, LPC-25-01988

Morningside Park 114th, 116th and 122nd Street Staircases Reconstruction

Located between 112th and 123rd Streets between Morningside Drive and Morningside Avenue in the Borough of Manhattan

Landmarks Preservation Commission of New York Public Hearing
October 29, 2024
Laura Drawbaugh RLA, NYC Parks

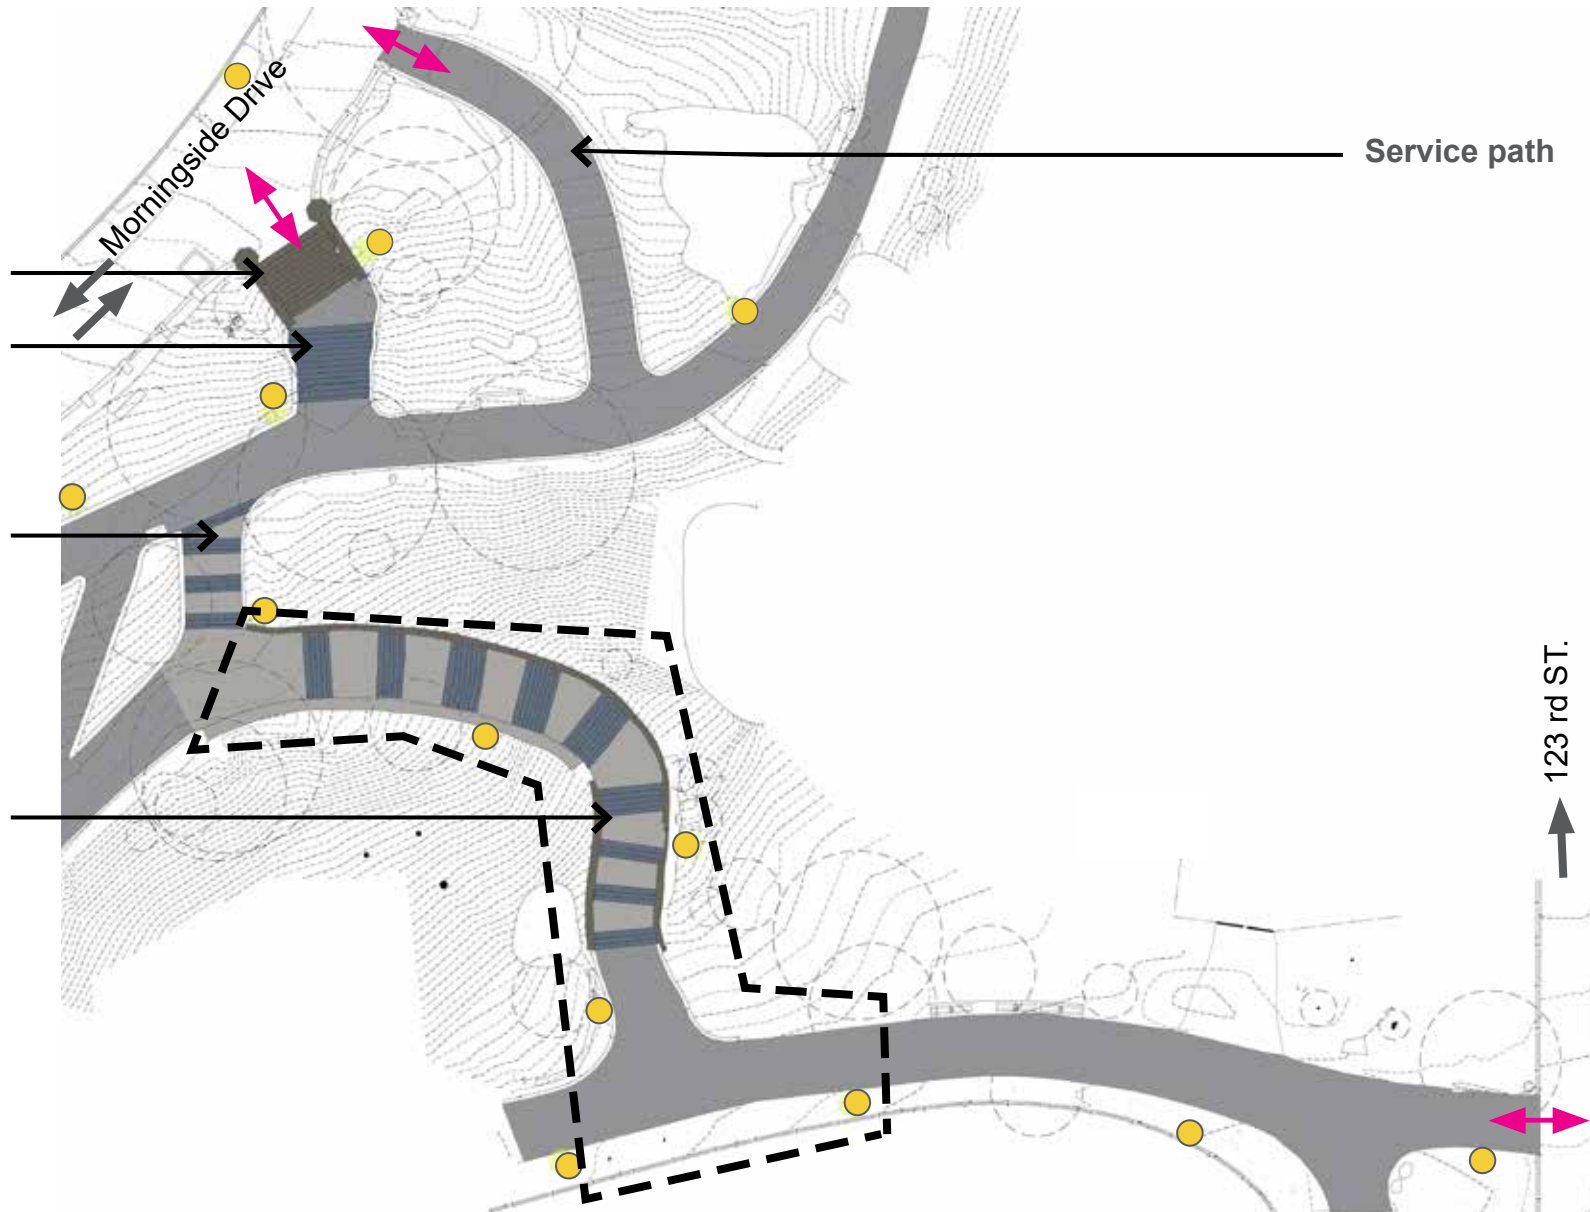
Morningside Park | C. 122nd Street Stairs-Existing Conditions

- Granite stairs-good condition
- No handrails
- Misaligned bluestone treads
- No handrails
- Asphalt landing
- Carved boulder cheekwalls
- Misaligned bluestone treads
- No handrails
- Concrete landings
- Concrete cheekwalls in poor condition
- Misaligned bluestone treads
- Pipe handrail in poor condition
- Concrete landings in poor condition
- Granite block cheekwalls, disintegrating

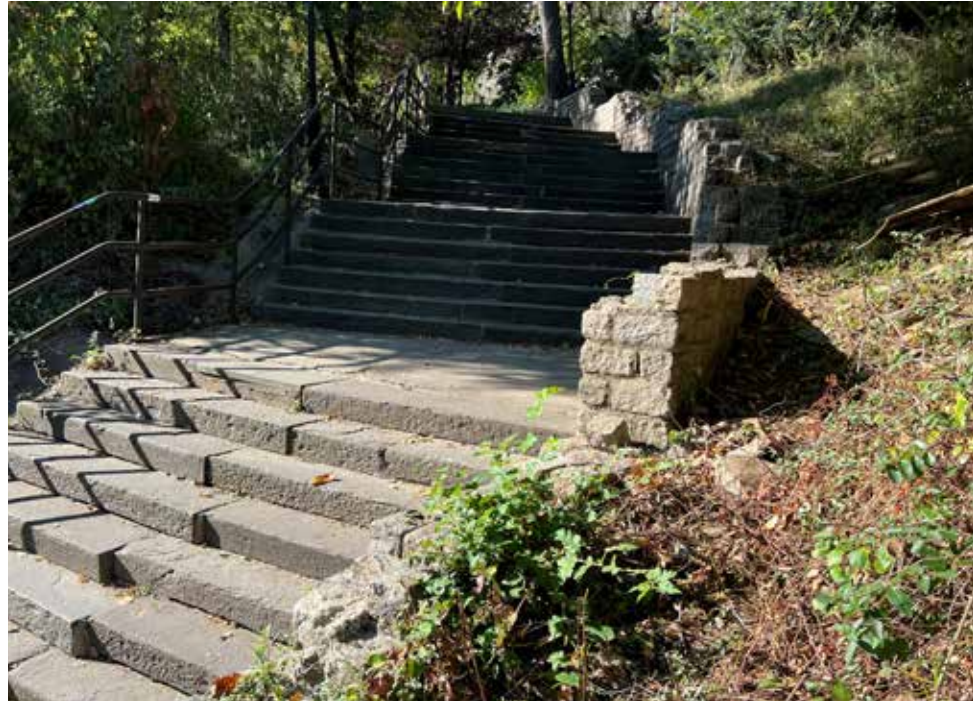
D. 1940's-1960's Granite block cheekwall at 122nd St. to be reconstructed

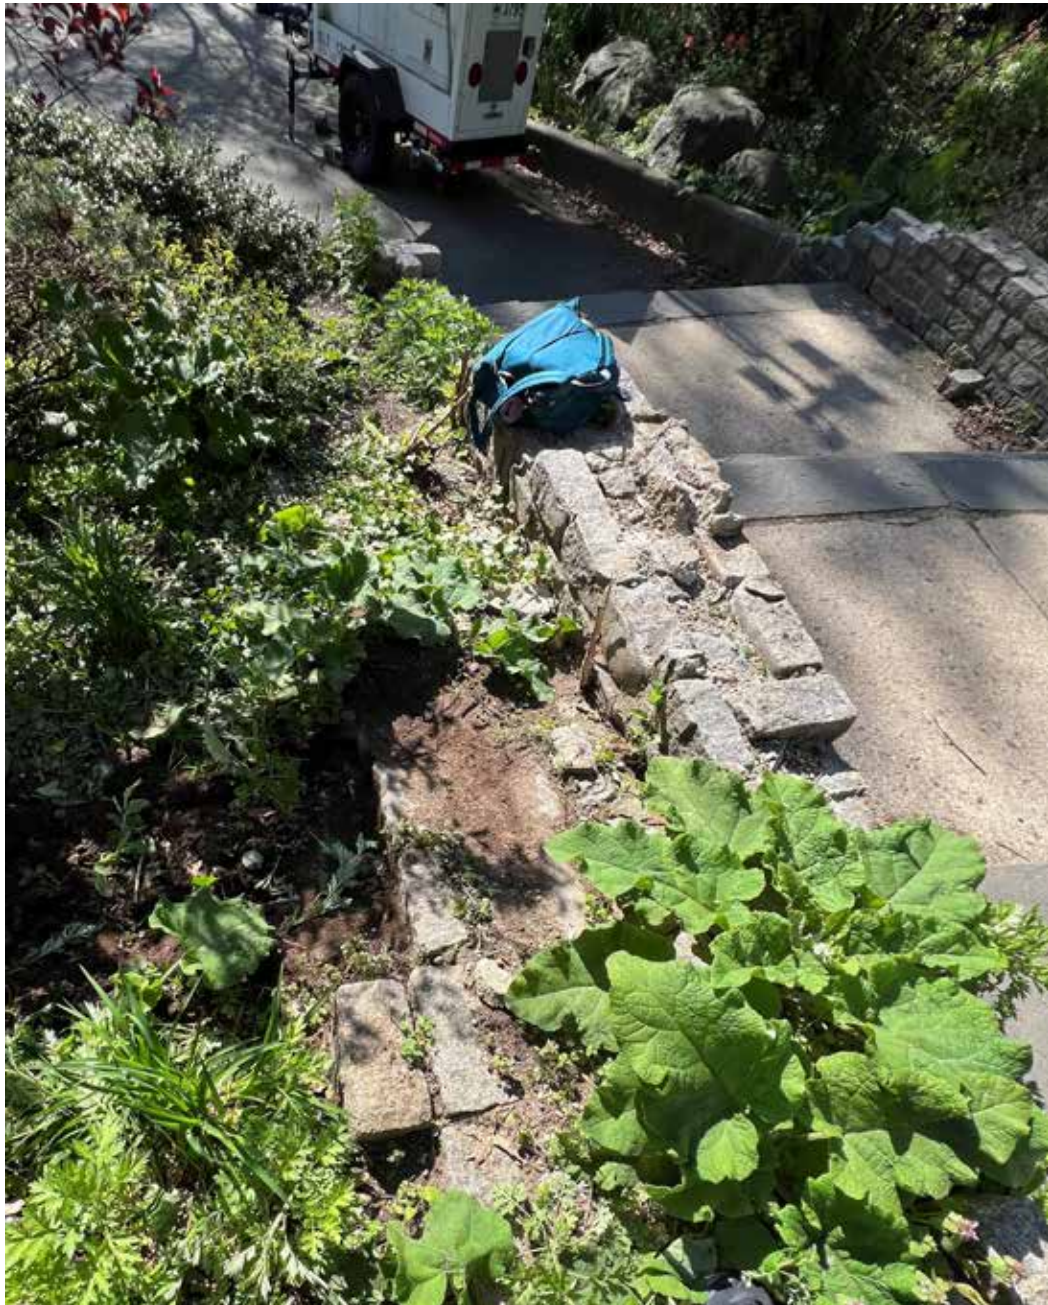
Overgrown swale on the left. 1966 cheekwall was built on top of pre-1964 cheekwall wall but also overlapping the treads, narrowing the stairways.

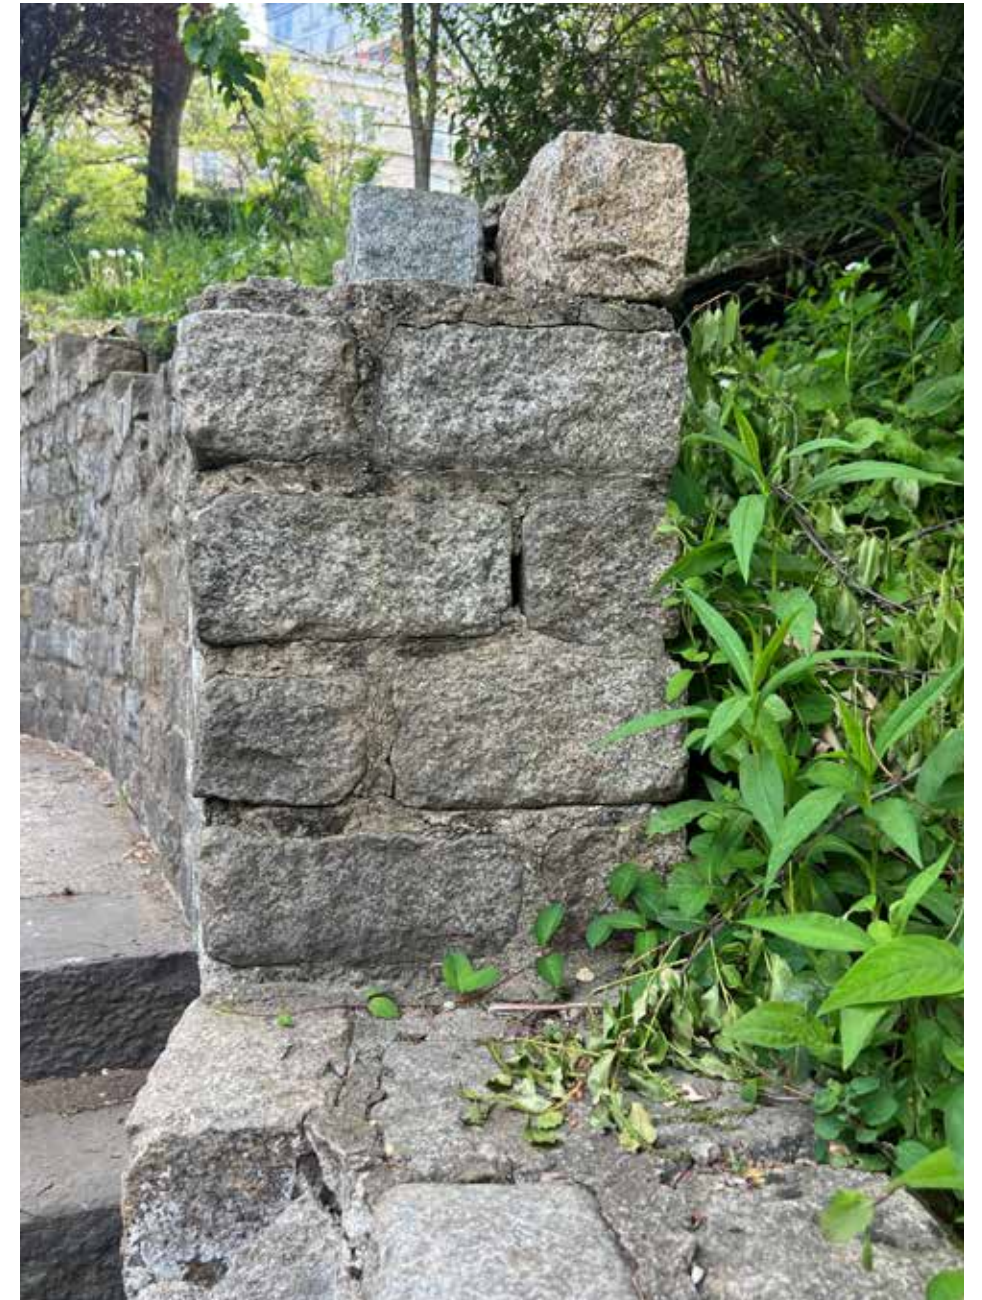
1966 wall overlaps treads by 1-3 granite blocks. Existing wall is 16" wide. No coping allows water in the joints and poor base is causing granite blocks to separate.

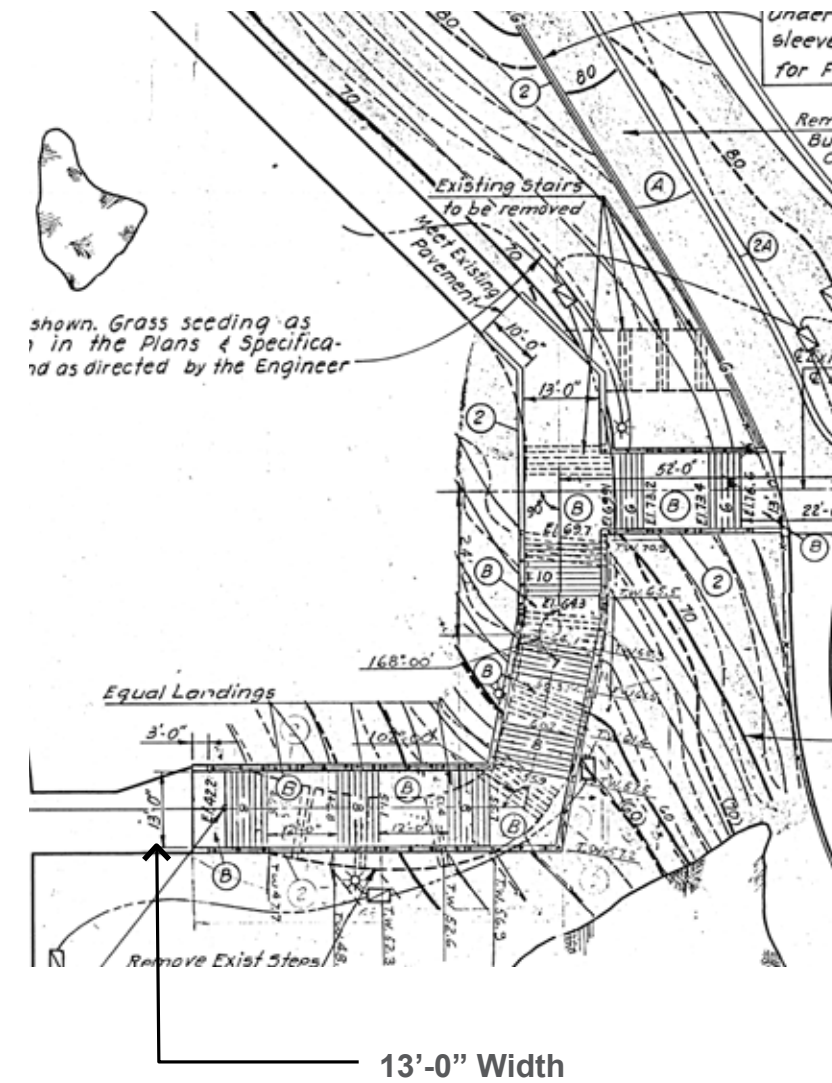
No change in original 13'-0" stair width.

(1964 drawing shows proposed change to the stairs to make them orthogonal. This was never built. The stairs are still an irregular curve.)

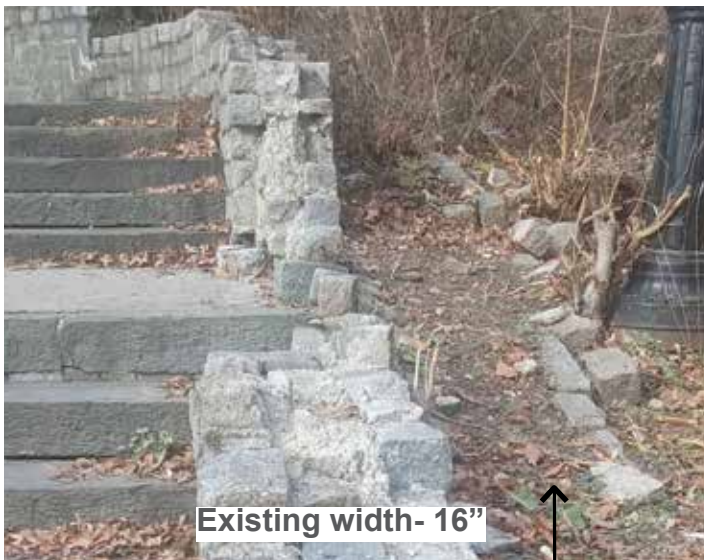
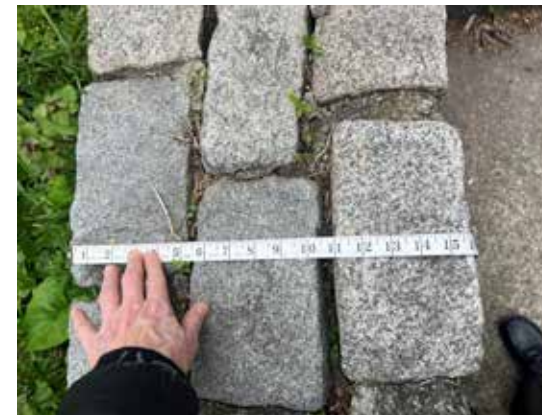
1966 Reconstruction of retaining wall at 122nd St. stairs: Granite block wall, built on top of existing "rubble wall".

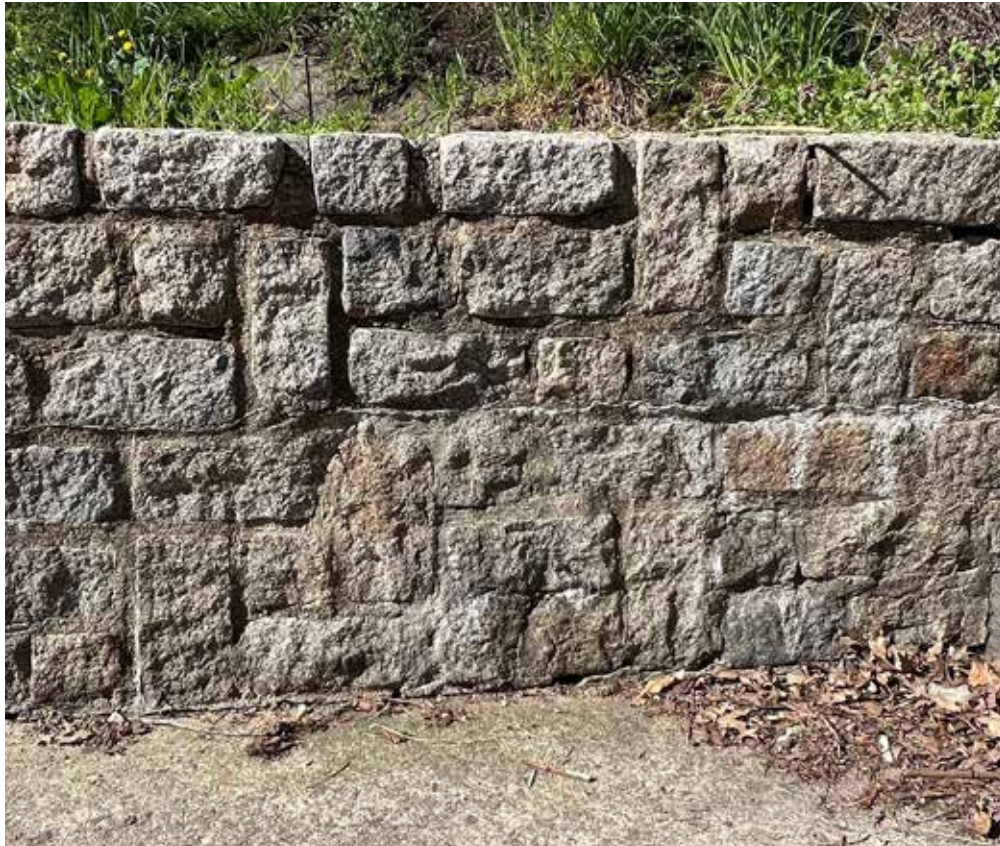
Existing granite block- to be cut thinner and re-used as facade, both sides, in the same layout as existing pattern

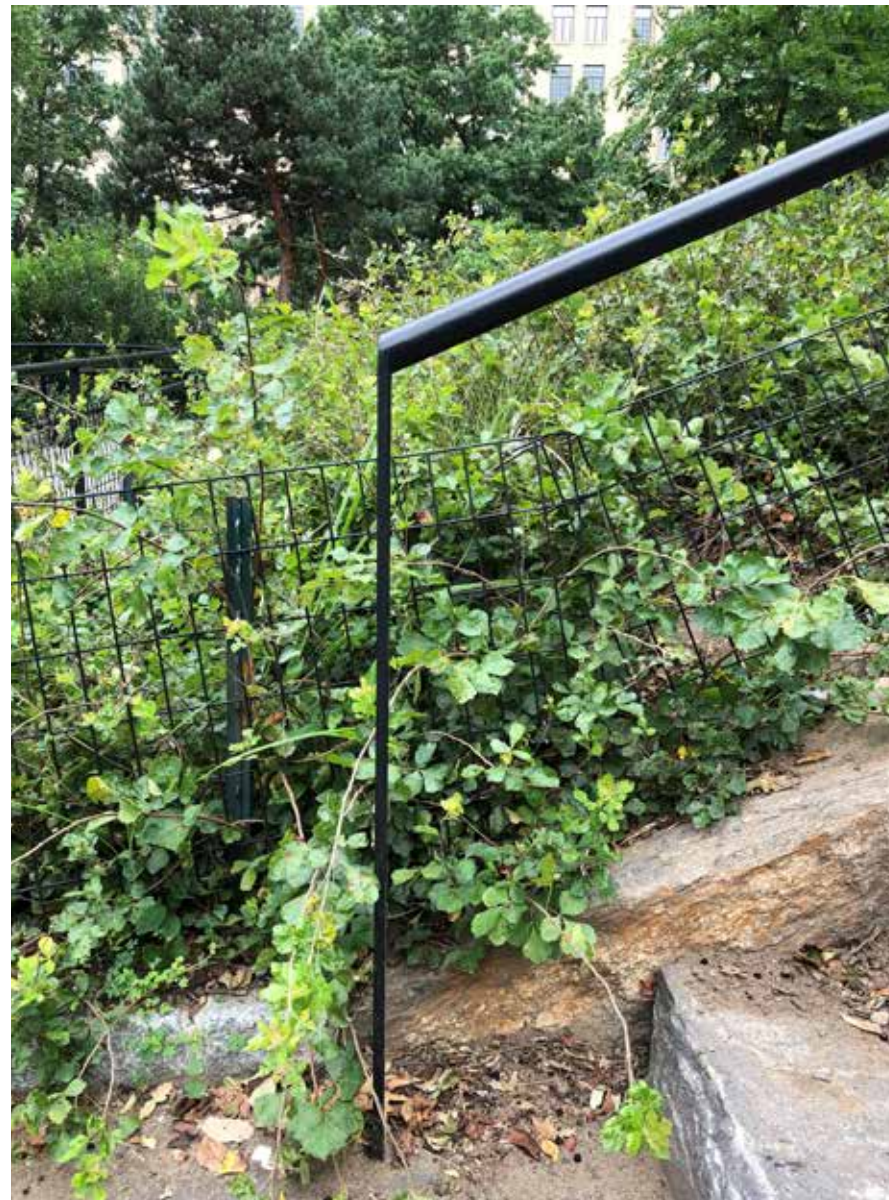
Handrail previously approved by LPC for Morningside Park

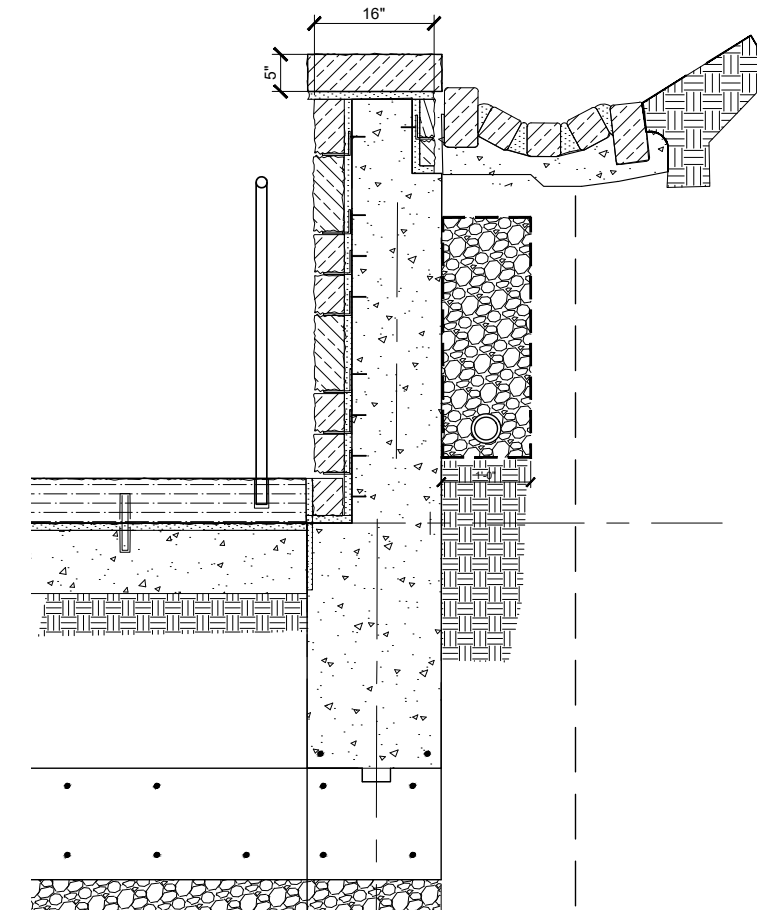
New rustic granite coping 5" thick
 New granite block swale
 Reuse existing granite block for cheek wall facade, cheekwall to be 16" wide
 New concrete foundation
 Reset existing bluestone treads
