The current proposal is: <u>Preservation Department – Item 8, LPC-25-01663</u>

23 East 9th Street – Greenwich Village Historic District Borough of Manhattan

23 EAST 9TH ST TOWNHOUSE

DOCKET # LPC-25-01663 BUILDING HISTORY

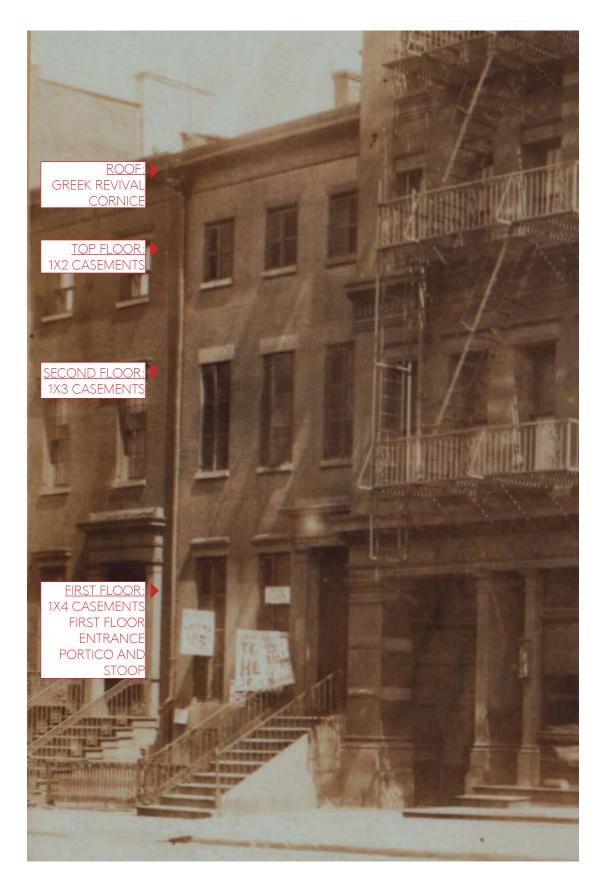
PHOTO DATE: 1913

NOTES: Building built in 1843 by hardware merchant Aquila G. Stout.

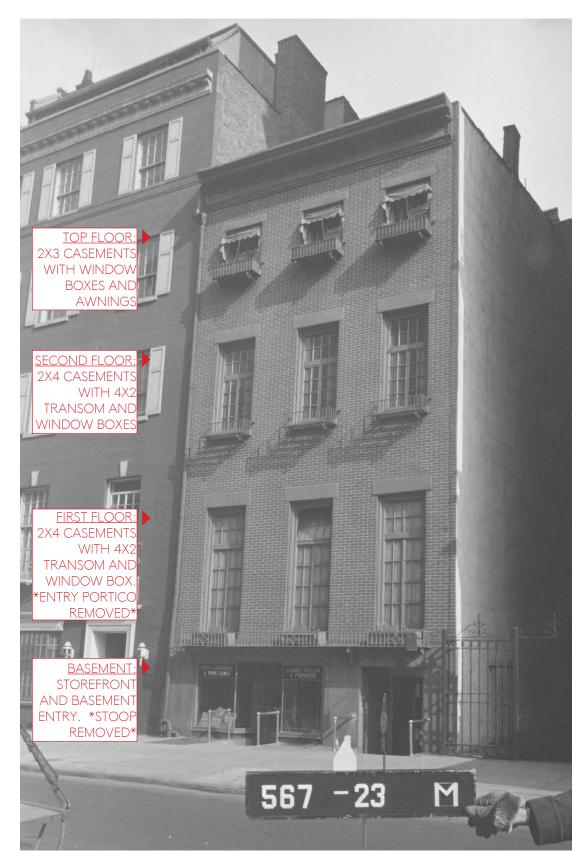
PHOTO DATE: 1940

Renovated in the early 1920's to include a store on the ground floor and apartments on the upper floors according to DOB records.

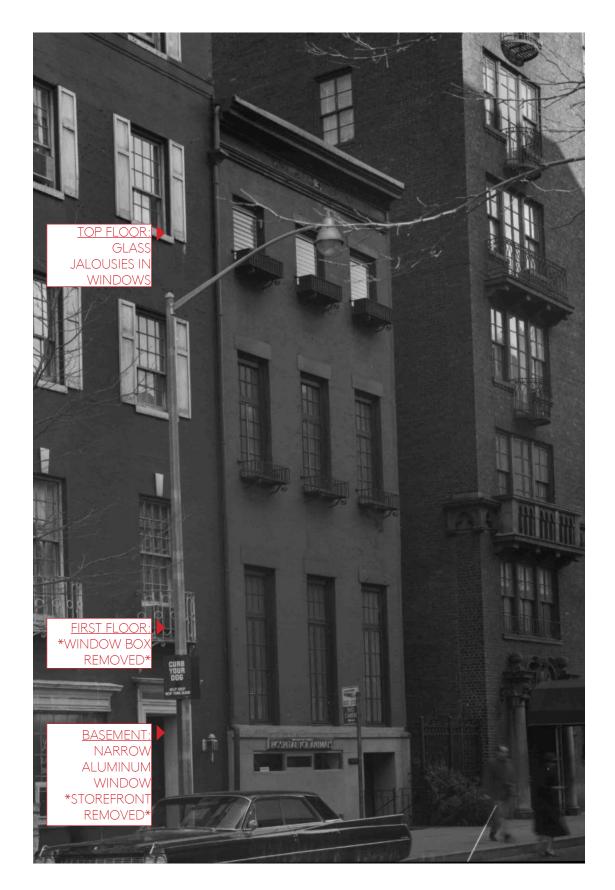
PHOTO DATE: 1969

Storefront removed and basement converted to an animal hospital between 1962 and 1965 according to DOB records.

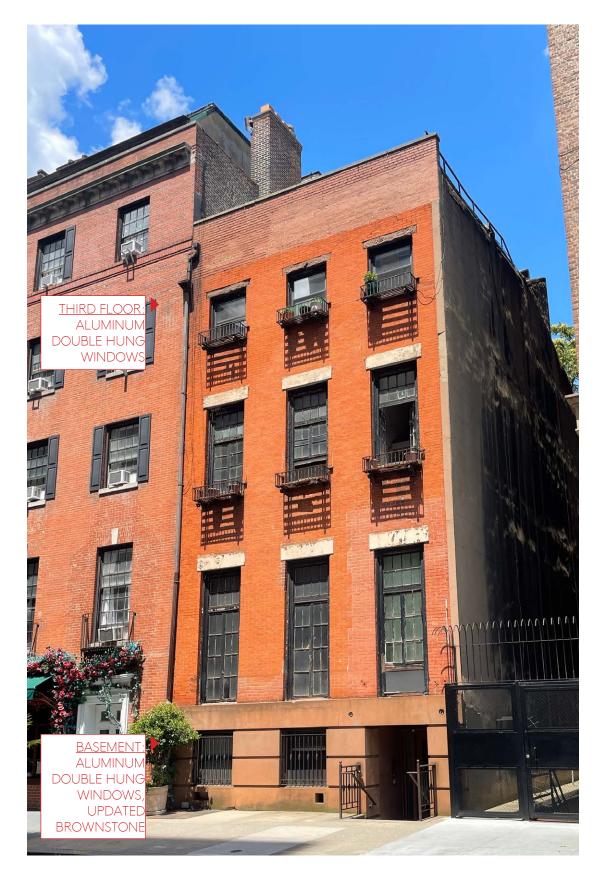
PHOTO DATE: 2024

NOTES: Windows replaced in 2001

without LPC consent according to LPC violation 02-0392. No DOB or LPC record of brownstone base being changed. #23

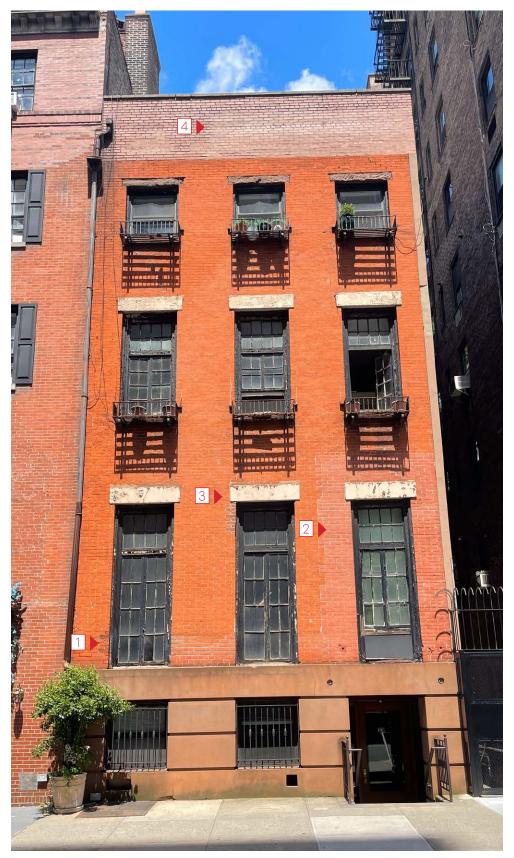
EAST 9TH STREET FACADE

The brick facade of the 181-year-old townhouse exhibits significant deterioration and inconsistencies due to extended neglect and inadequate maintenance. The damage is extensive and uniformly distributed across the entire facade, with numerous repairs made using bricks of varying colors, particularly noticeable around the window openings. A distinct outline remains where a portico entryway was infilled with non-matching bricks. Additionally, a parapet wall, constructed later with a much lighter-colored brick, is mismatched with the historic facade.

The brick surfaces have deteriorated severely over time, with many units showing signs of acute wear. Surface-level cracks and spalling are prevalent. Mortar joints are in various states of disrepair.

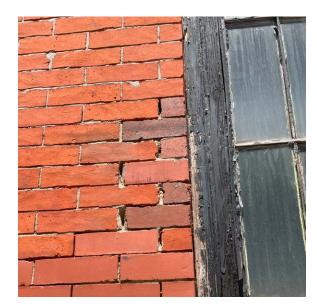
1. Brick repairs have been made with mismatched bricks

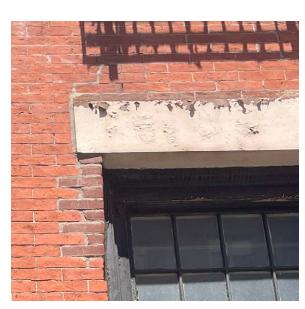
3. Lintels are in poor condition with the existing paint peeling

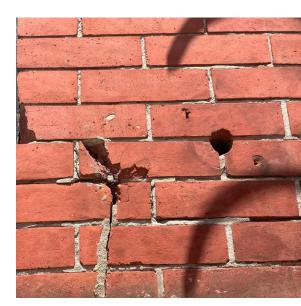
5. Broken brick units and holes are common across the facade

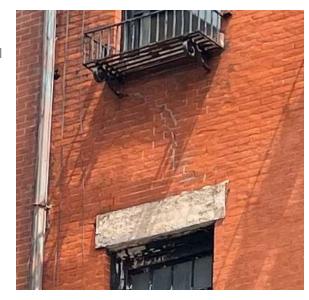
7. Hairline cracks and poor brick face condition are typical

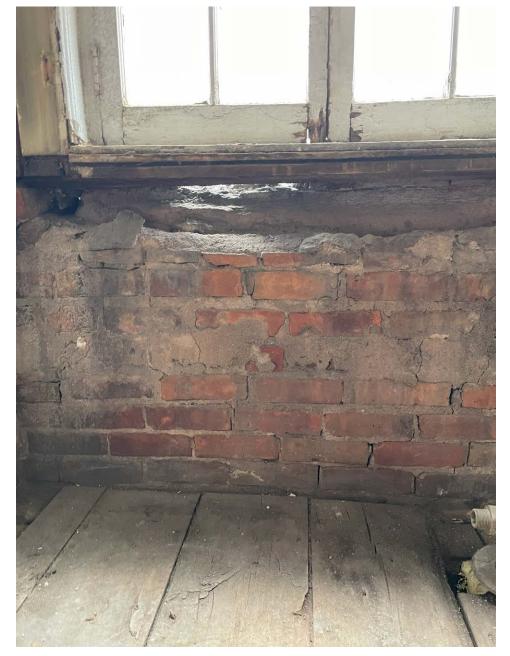
PRIMARY FACADE WALL INTERIOR / Second Floor

At the interior, the discoloration, efflorescence, failing mortar joints, evidence of repairs, decaying window frames, and damaged brick are consistent with that of continued water infiltration.

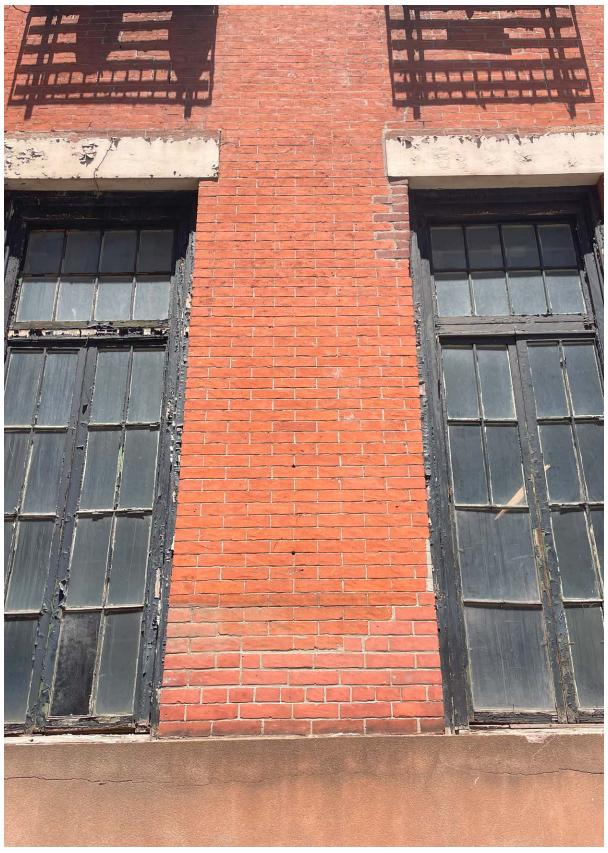
PRIMARY FACADE / Proposed Materials / Scale (1/8)" 1'-0"

To protect the aging masonry from further weathering and act as a waterproofing layer in place of the damaged fire skin; all masonry and stucco surfaces are to be painted with KEIM "Soldalit" silicate paint in BM OC-46 "Halo".

Note: The proposed coating is not reversible but is intended to provide the best protection against water intrusion while allowing the masonry to breathe as a vapor-permeable coating. As an alternate we would be willing to work with staff to find a reversible soft white coating

CURRENT BRICK CONDITION IS VERY POOR

For paint to properly adhere to surface of masonry, prior to painting, masonry must be clean, dry, and dull. To achieve this existing masonry and stucco surfaces are to be prepped using a pressure washer with water pressure not to exceed 500psi to avoid surface damage. After the surface prep the wall will be given 48 hours to fully dry before painting.

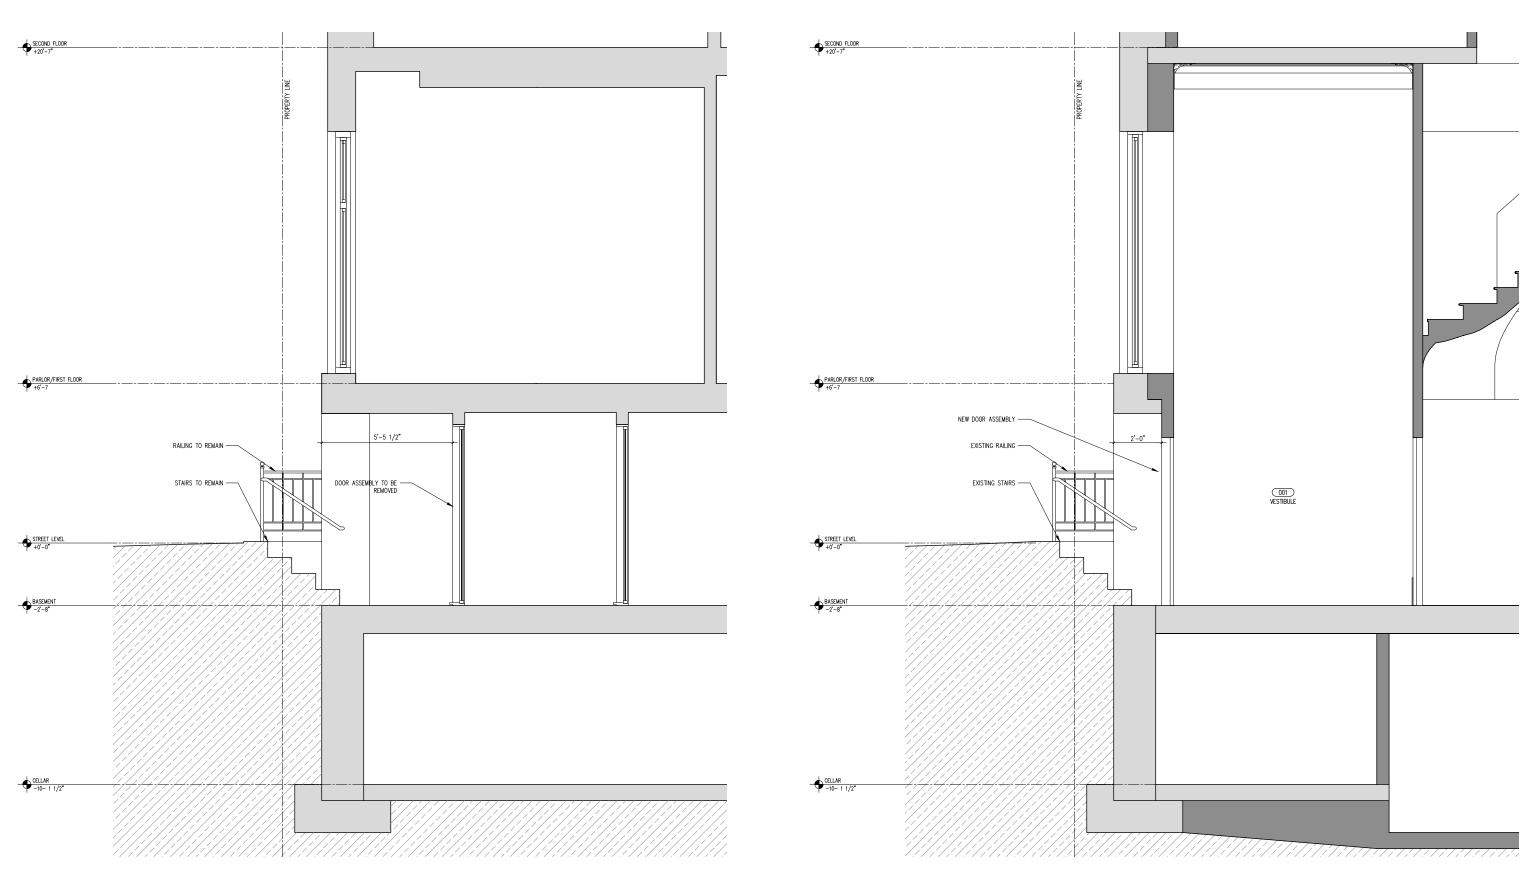
EXISTING AREAWAY SECTION / Scale (1/4)" 1'-0"

PROPOSED AREAWAY SECTION / Scale (1/4)" 1'-0"

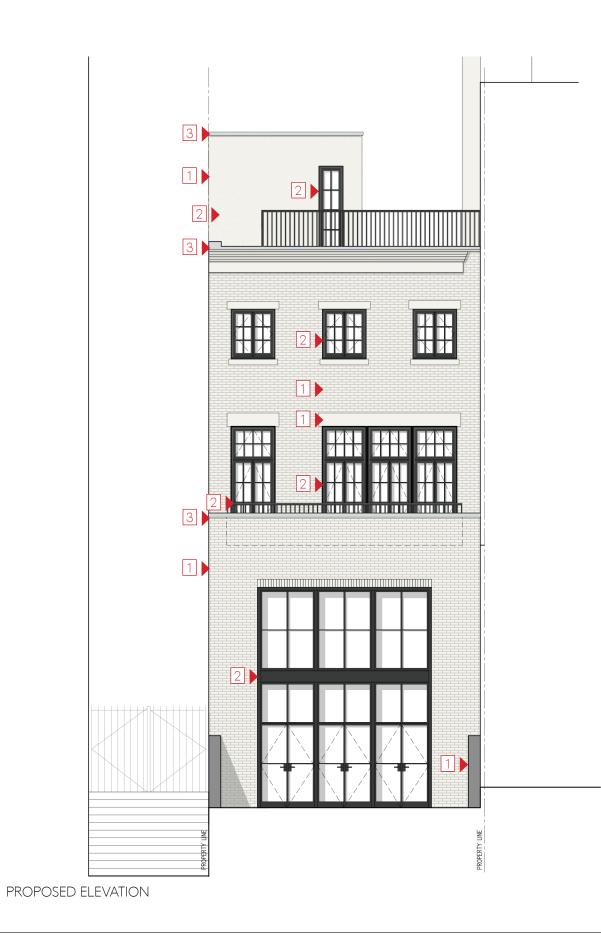
REAR FACADE / Proposed Materials / Scale (1/8)" 1'-0"

1. KEIM soldalit masonry paint in BM-46 "Halo" will be used to coat all new and existing masonry surfaces including the stucco bulkhead, stucco side facades, garden wall, and all brickwork.

2. Benjamin Moore 2131-20 "Midnight" will be used to paint all metalwork and exterior wood which includes the roof terrace railings and windows

3. New bluestone coping at the existing parapet wall, extension parapet wall, and the new bulkhead.

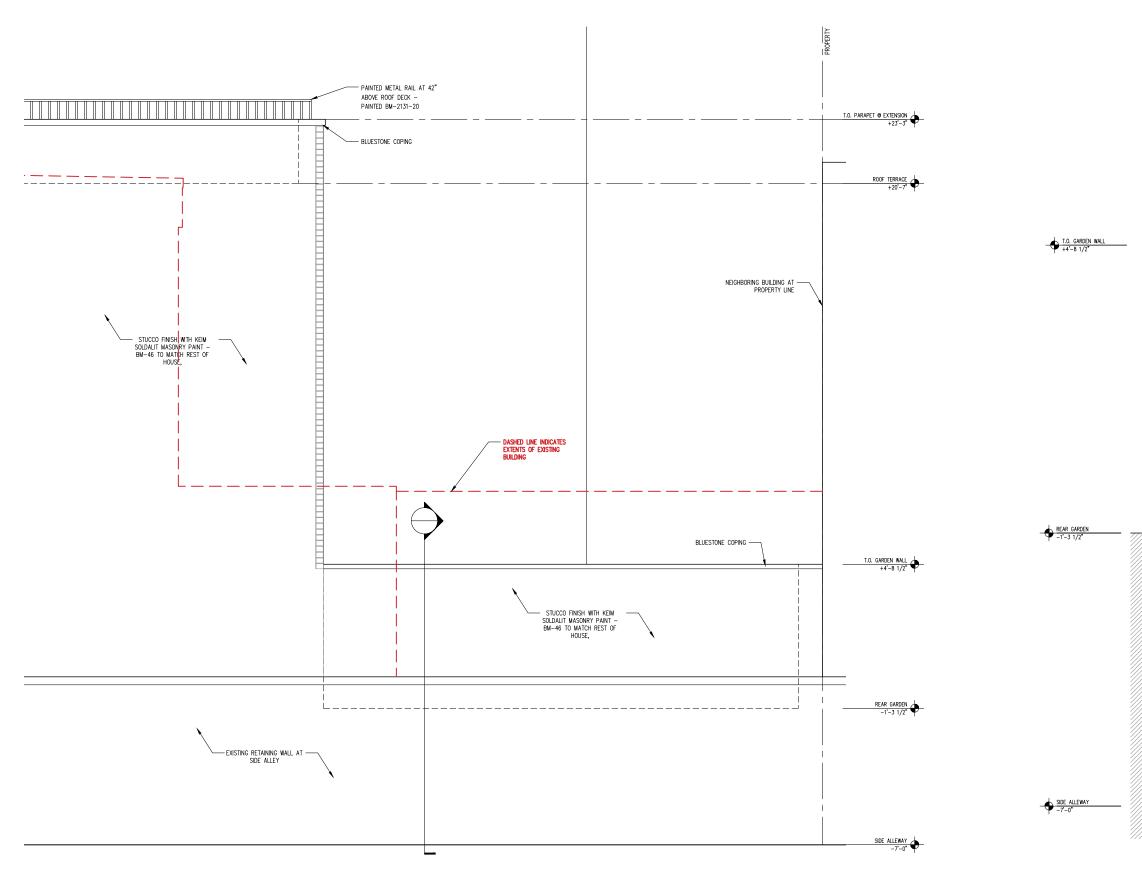
REAR GARDEN WALL DETAIL ELEVATION / Scale (1/4)" 1'-0"

REAR GARDEN WALL DETAIL SECTION / Scale (1/2)" 1'-0"
