THE BRONX

GRAND CONCOURSE

PEDESTRIAN SAFETY DEMONSTRATION PROJECT

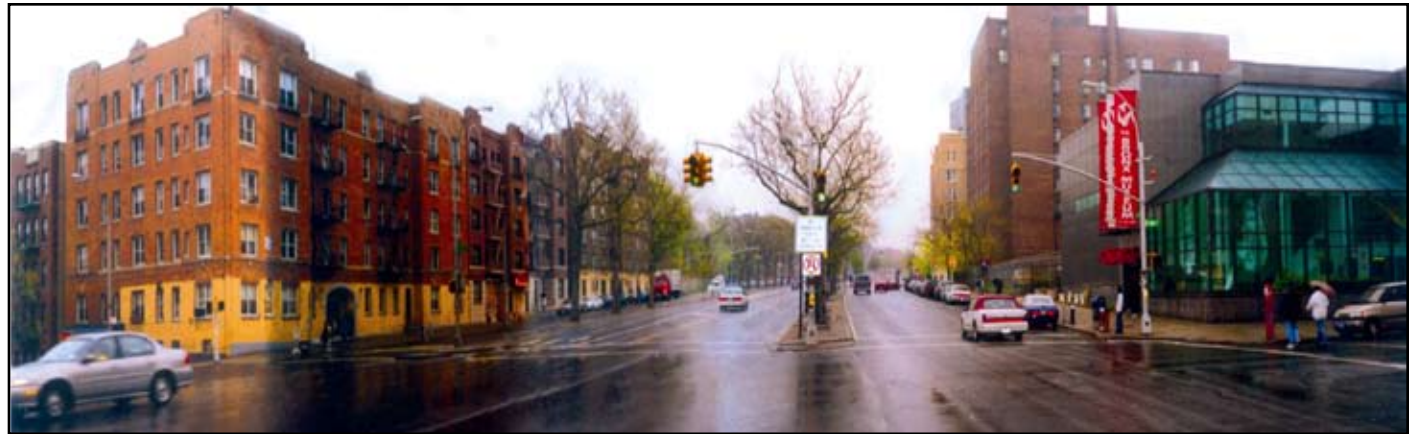
Panoramic view of Grand Concourse prior to implementation of Pedestrian Safety Demonstration Project at East 165th Street

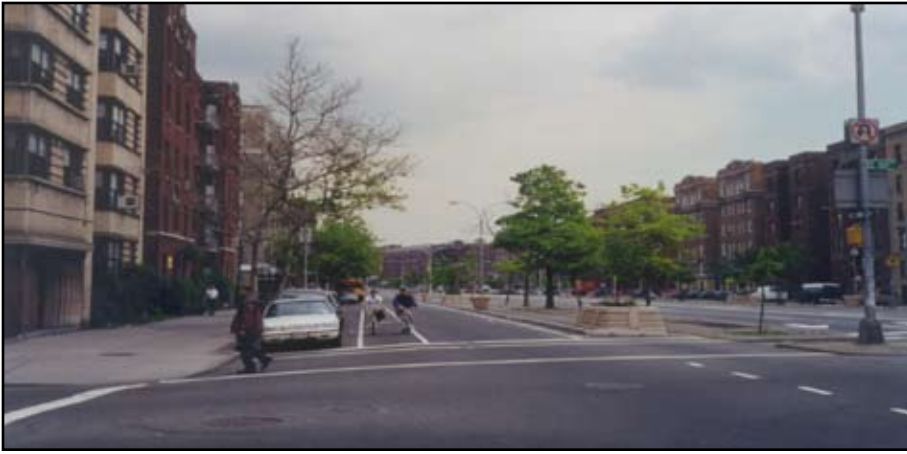
Grand Concourse/East 169th Street Service Road after implementation of safety project with planters and bike lane

Bicycle lane installation, median widening with striping, lane transitions prior to and at the end of the study area. In addition, existing striping on the service roads were scarified. The markings work was completed in mid-November 1999. The markings were refurbished in April 2002.

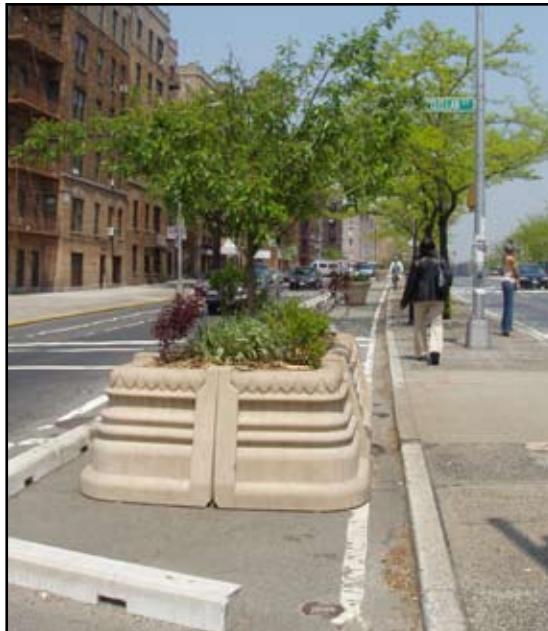
Typical roadway planter and parking stops along the Grand Concourse

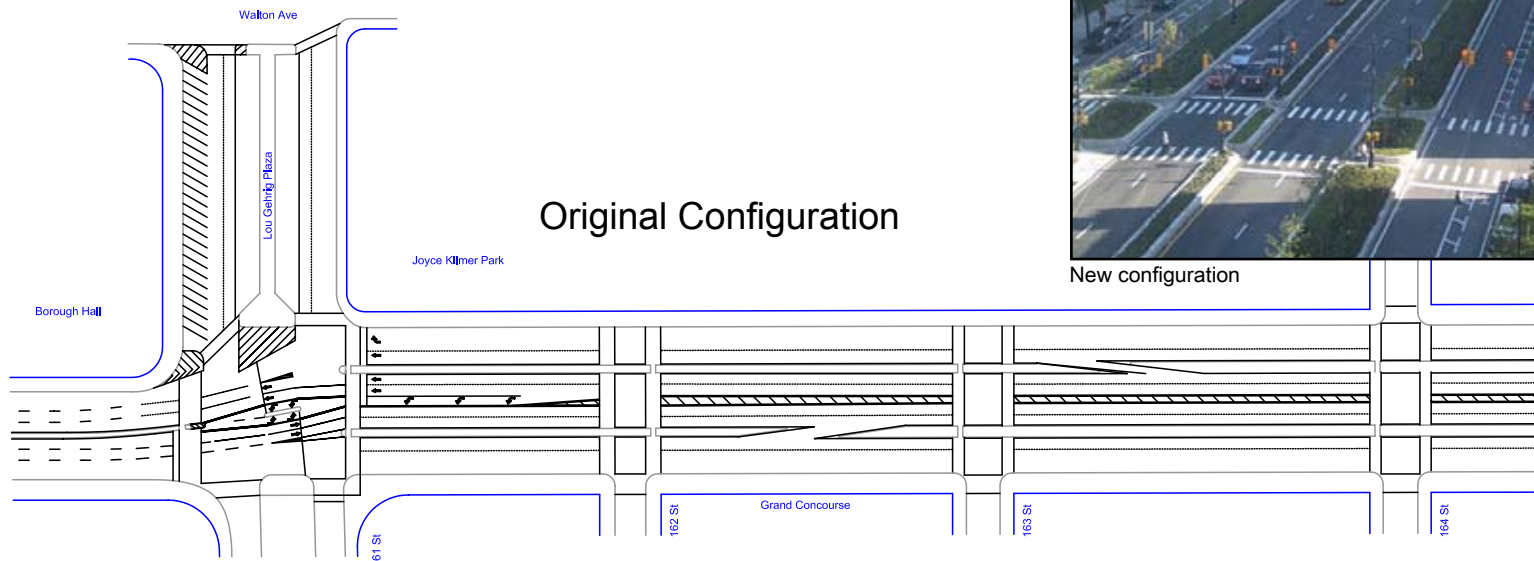
Grand Concourse Pedestrian Safety Improvements E. 161st to E. 166th Street

- **The section of the Concourse between East 161st Street and the Bronx Museum of the Arts (north of East 165th Street) was included in the East 161st Street Bridge reconstruction project completed in November of 2008.** As part of this project, NYCDOT replaced the East 161st Street Underpass Arch Structure, incorporated landscaped urban design features for Lou Gehrig Plaza and add more open space to the neighborhood. Additionally as part of the bridge reconstruction project, the Grand Concourse/East 161st Street intersection, where the service and main roads merge in the center of the intersection resulting in multiple conflict points between vehicles and pedestrians and between vehicles with other vehicles, was reconfigured. The plan shifted the northbound merge between the service and main roads to a midblock non-pedestrian location, and lengthens the merge for a smoother transition. The southbound merge between the service and main roads will be removed by forcing traffic on the service road to turn right onto westbound East 161st Street.

The new roadway realignment is shown on the following page.

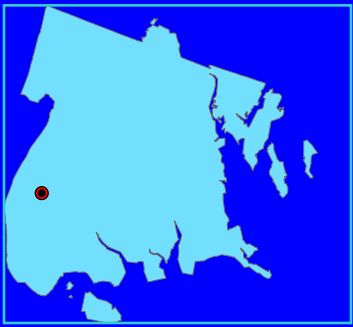
GRAND CONCOURSE / EAST 170TH STREET

- Northbound articulated buses destined to far side bus stop spill back across intersection
- Pedestrians cross against signals
- Vehicle operators make U-turns on the main roadway
- Pedestrians cross mid-block on the Grand Concourse
- Steep upgrade causes visibility problems on eastbound East 170th Street approaching the Grand Concourse

- Installed 12" red lenses on all signals
- Installed Peg-a-Tracs to guide traffic across wide intersection
- Replaced all missing signs (September 1999)
- Upgraded Yield to Pedestrian signs
- Installed additional No U-turn signs
- Upgraded all crosswalks to high visibility
- Installed pedestrian crossing signals on all medians and upgraded them to international pedestrian signals in October 2000
- Installed dual left turn signal phases (October 1999)
- Installed signs stating "Left Turn on Green Arrow Only" in coordination with the installation of the left-turn signal
- Installed "Wait For Walk Signal" signs on all signal posts

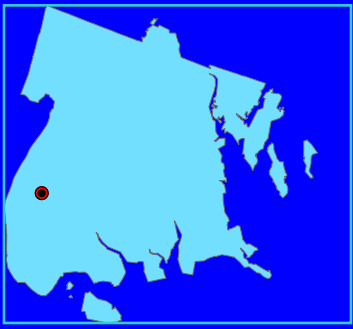
GRAND CONCOURSE / EAST 183RD STREET

- 12" red lenses on signal faces
- High visibility crosswalks installed at all four legs of the intersection
- Pedestrian barriers installed at medians to prevent mid-block crossings
- Modified the signal timing to allow for increased time for pedestrian crossing
- Replaced all missing signs
- Installed "Wait for Walk Signal" signs
- Installed pedestrian crossing signals on all medians and upgraded them to international pedestrian signals in October 2000
- Repaired three streetlights
- Increased the all-red interval to ensure that left-turning vehicles clear the intersection

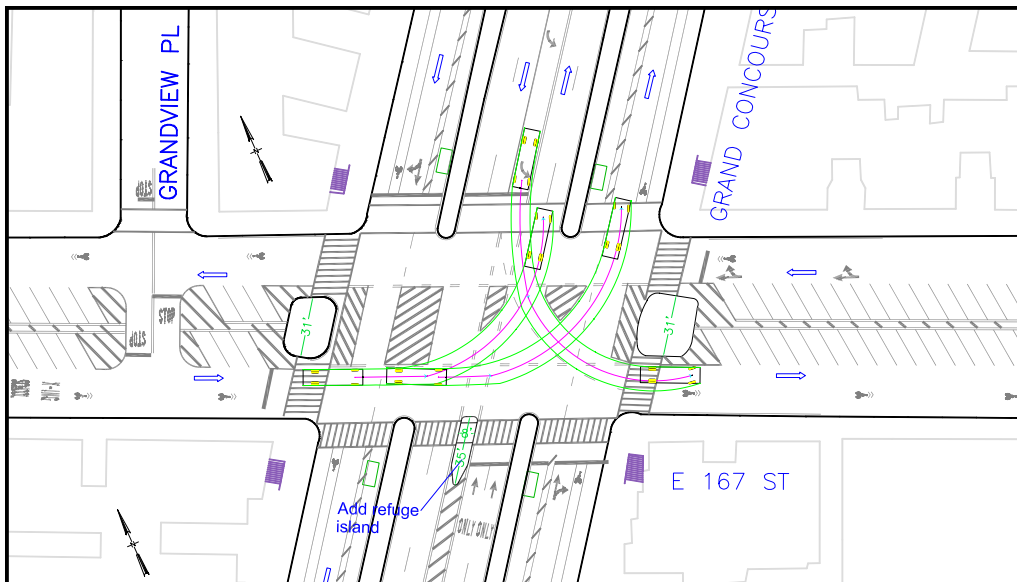
New intersection geometry with channelized markings and new pedestrian refuge island in south crosswalk.

- All signs were refurbished
- All markings were refurbished
- The design of this wide intersection encouraged chaotic and unpredictable vehicle turning movements as vehicles on East 167th Street were permitted to turn right or left onto both the main and service roads of Grand Concourse. Intersection channelization was introduced to better direct traffic and make vehicle movements more predictable for pedestrians
- The northbound left turn from Grand Concourse onto East 167th was eliminated to provide a protected walk phase for the south crosswalk, which is a designated school crosswalk and experiences high pedestrian volumes.

- The westbound left turn was eliminated to control unrestrained turning movements in the intersection and to protect pedestrians on the north crosswalk.
- Pedestrian signals were installed on the refuge islands at the east and west legs of East 167th St.
- Two “No Left Turn Ahead, Use Service Road, Right Upward Arrow” signs for the Grand Concourse main road prior to the slip-off exit for the service road and “No Left Turn” signs on Grand Concourse main road for new turn restriction were installed.
- The “Yield to Pedestrian” signs were upgraded and “No Left Turn” signs for westbound East 167th Street were installed.
- The left turn lane was channelized and a pedestrian refuge island was installed in its place, providing a safer refuge for pedestrians.

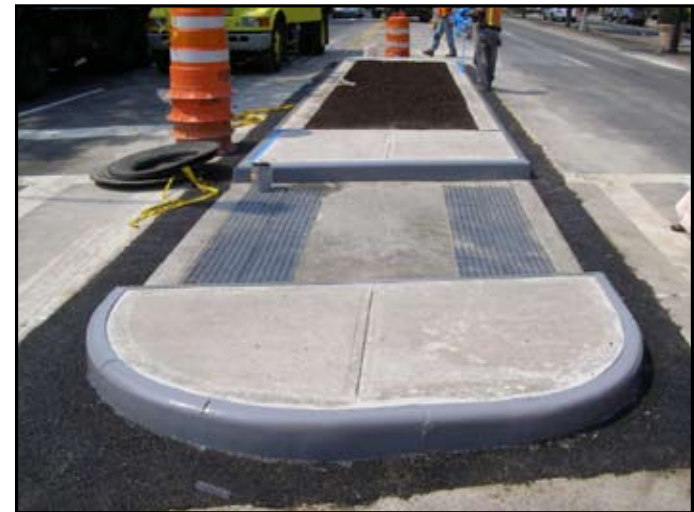
New pedestrian refuge island in south crosswalk

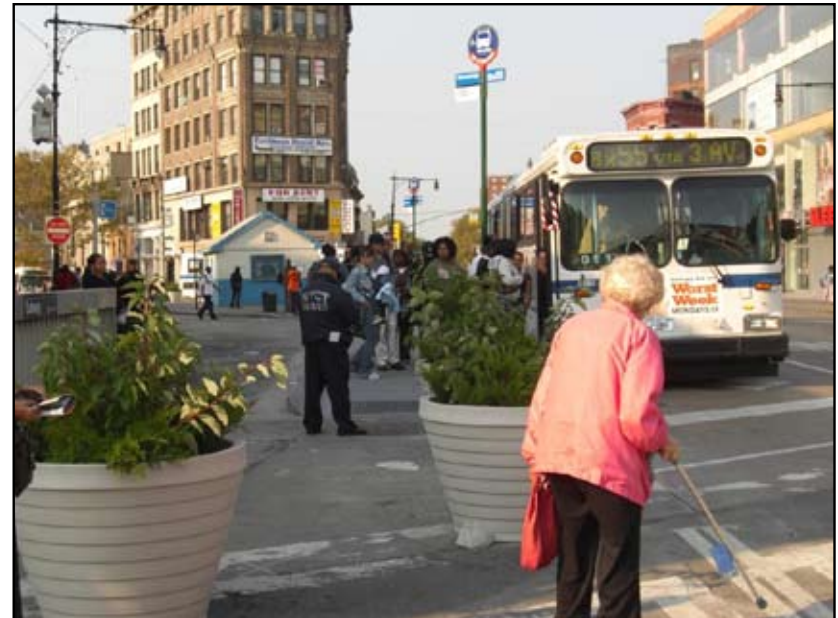
New Public Space and Bus Stop Island on Third Avenue

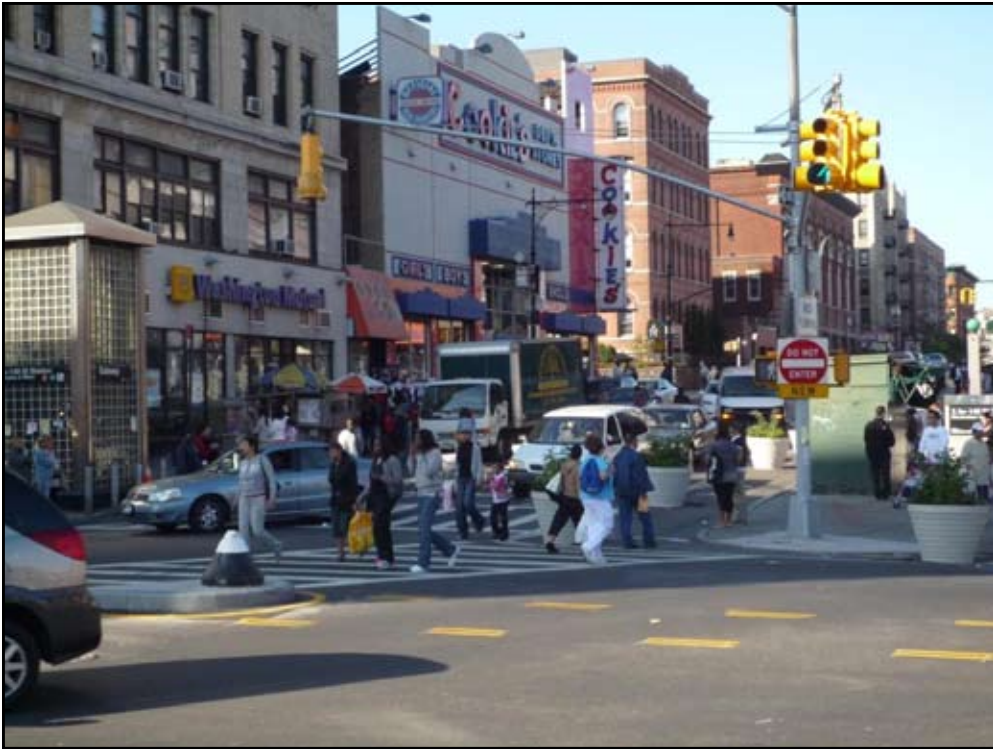
Crosswalk on west side of Third Avenue with pedestrian refuge island

unsafe crowding at subway entrances. Other operational changes include the construction of pedestrian refuge islands on East 149th Street in the east and west crosswalks on Third Avenue; and on Westchester Avenue in Third Avenue's east crosswalk. Both Willis and Melrose Avenues were narrowed with roadway striping and planters. This shortened crosswalks and added new pedestrian space that can one day be built out with a raised sidewalk. A new bus-only lane was added to the west side of Willis Avenue between E. 148th and 149th Streets. The project also introduced key Bronx routes from the NYC Bicycle Master Plan, providing direct access to Manhattan and other Bronx neighborhoods as well as encouraging bike to transit trips.

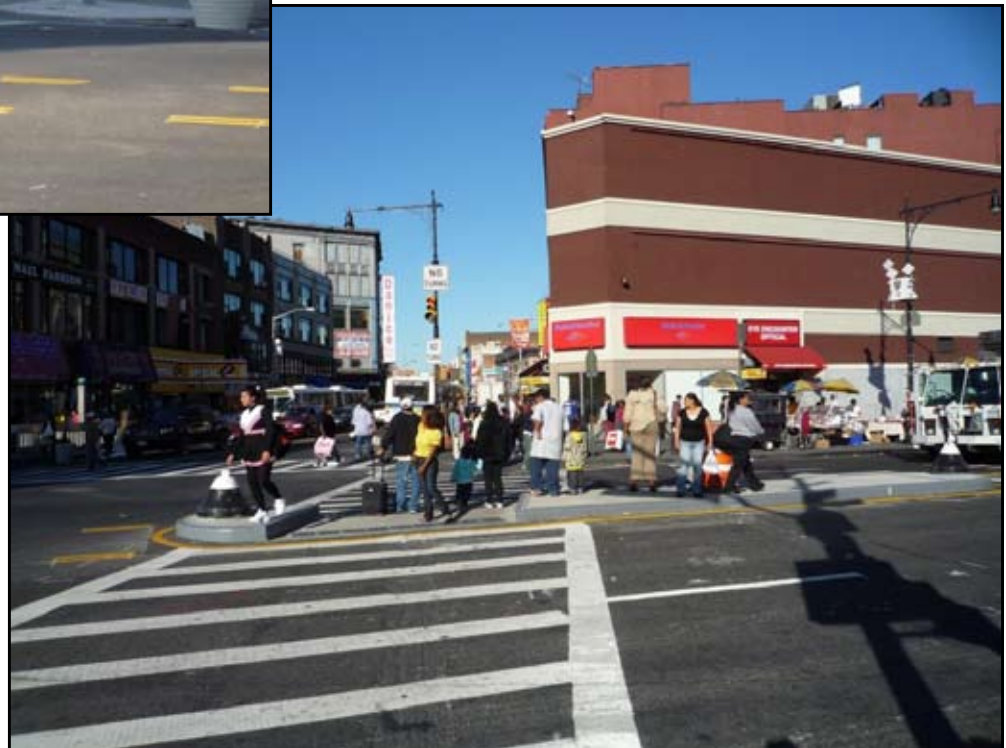
New pedestrian refuge island on East 149th Street at Third Avenue

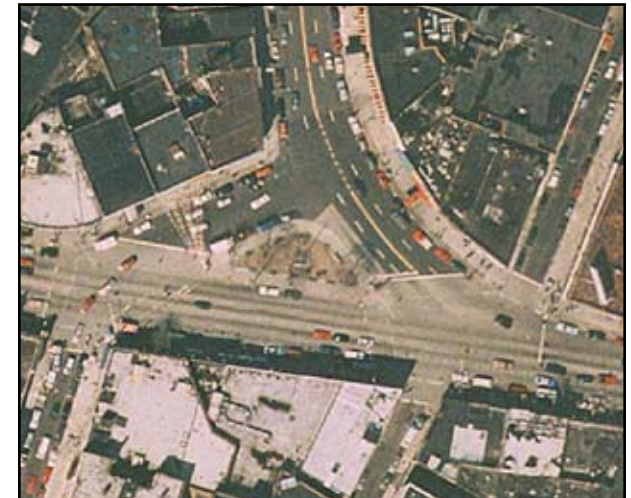
Original Configuration of Intersection

One of the primary concerns at this intersection is that even though the intersection is signalized, the geometry of the roadway guides pedestrians to cross diagonally creating unnecessarily risky vehicle/pedestrian conflicts.

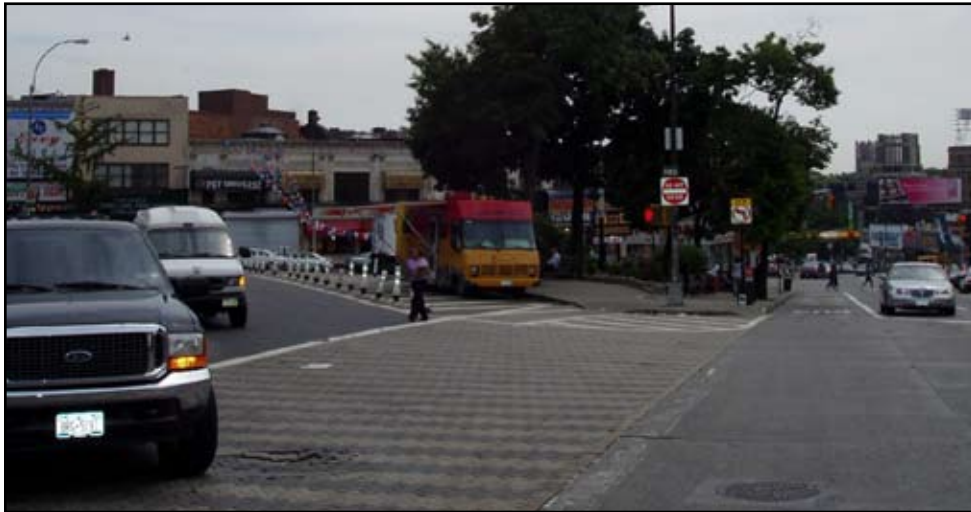
Detailed view of several of the improvements including one-way conversion of slip ramp, modified neckdown and flexible delineators surrounding the park

- Converted the East Kingsbridge Road slip roadway to one-way westbound from East Kingsbridge Road to East Fordham Road mainline to reduce conflicts and improve safety.

- Installed a modified neckdown on the northwest corner of the East Kingsbridge Road slip/East Fordham Road intersection to increase pedestrian sidewalk space and decrease crossing distance.

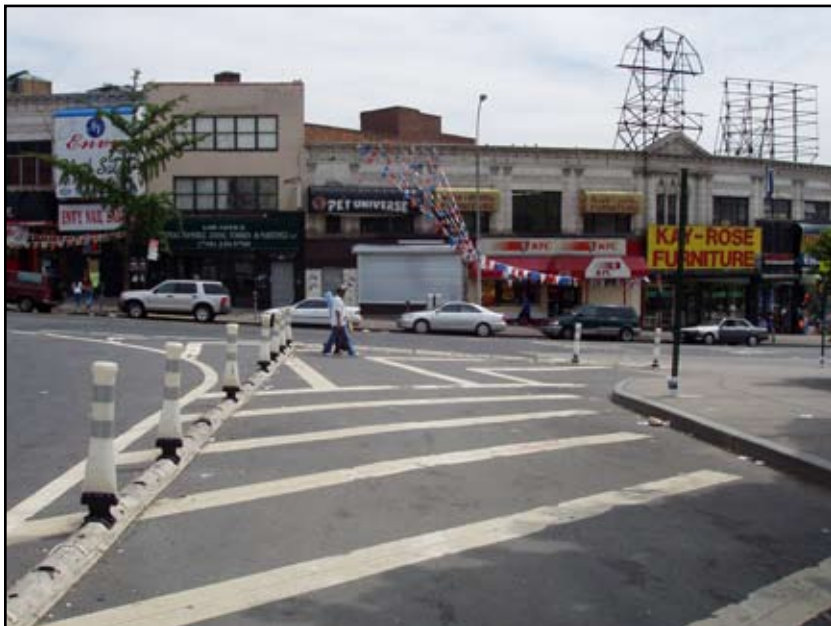
Flexible delineators and markings for increased pedestrian and vehicular safety

- Widened the triangular park to the west and north with pavement markings and flexible delineators to narrow the street, discourage double parking, increase pedestrian sidewalk space, and decrease crossing distance.

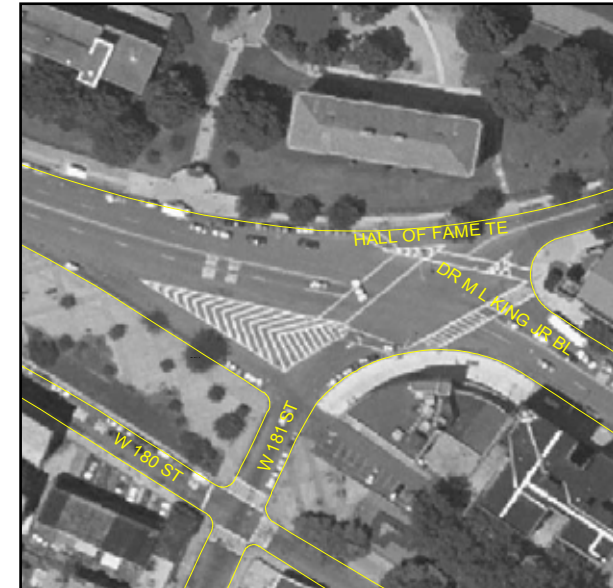
Original Configuration of Intersection

In its original configuration, the intersection of University Avenue, West 181st Street and Hall of Fame Terrace was unusually wide. Due to this configuration, the roadway was configured with large painted islands that channelized traffic resulting in Stop controlled roadways and unusual approaches and turning movements. Hall of Fame Terrace is offset from West 181st Street across University Avenue and there is a steep grade on Hall of Fame Terrace approaching the intersection. Surrounding land uses include Bronx Community College, a park, a library and a church all generating high pedestrian activity.

One of the primary concerns at this location was frequent jaywalking across University Avenue, (approximately 230 feet south of the signal) which was the result of a natural pedestrian path from a park on the east side of University Avenue to the entrance of Bronx Community College on the west. While not a high crash location, this intersection was of concern to the Department due to the surrounding land uses and increase in crashes in 2000, leading the Department to take a proactive approach at this location to address the safety concerns. **In terms of the crash experience at this intersection, there was a 36% increase in crashes to 11 in 2000 from 7 in 1999, but in 2001 and 2002 they declined by 45% and 73% to six and three, respectively. After improvements were made in 2002, the average number of crashes per year decreased by 58% to 3.4 from an average of 8.0 from 1999 to 2001. Overall, the Department believes the improvements made at this intersection will continue to improve both pedestrian and vehicular safety.**

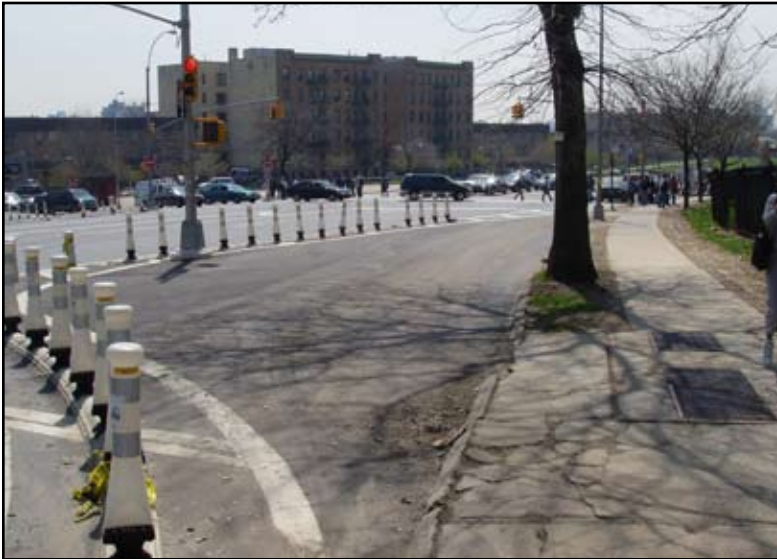
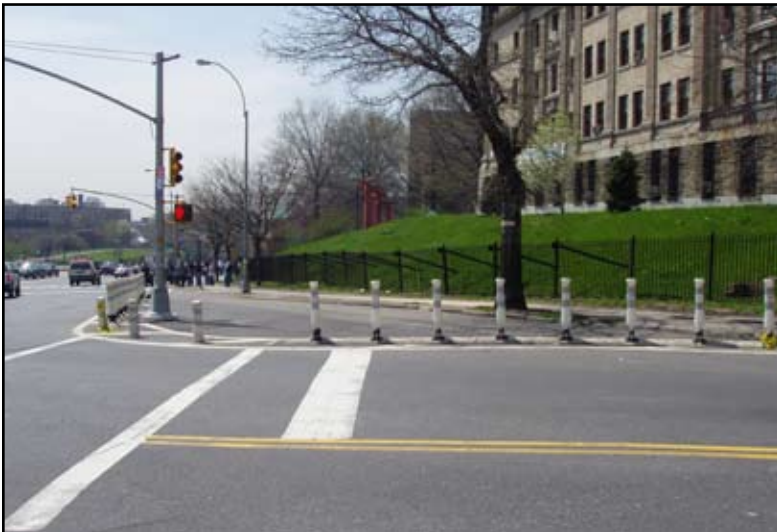
Detailed views of additional pedestrian space created by the use of curb mounted delineators and markings

- Reconfigured the intersection with new channelization markings in combination with curb mounted delineators to create additional pedestrian space.
- Reconstructed the existing signal to conform to the new geometry. The signal provides separate phases for Hall of Fame Terrace and West 181st Street which now operate concurrently.
