Beekman St and Front St

Pedestrian Access Improvements

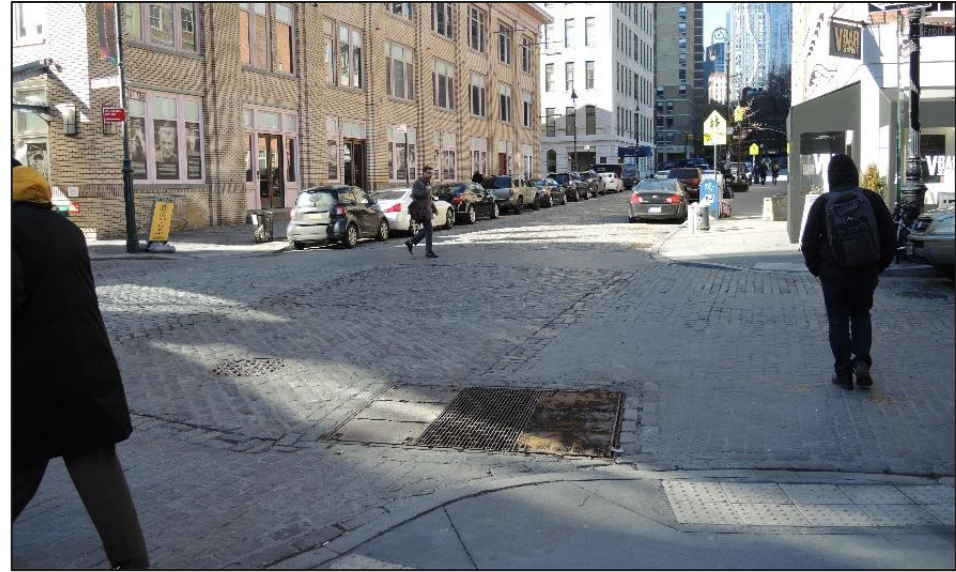
Before: Beekman and Front St

- Uncontrolled crossing without warning signage on Beekman St
- Denied for an all-way stop in June 2017
- 2 pedestrian KSI, both in 2013

- Add pedestrian warning signs at decorative crossings on Beekman St at Front St
- Add 15 feet of daylighting
