# The Citywide Congested Corridor Project

## White Plains Road from East Tremont Street to East 233<sup>rd</sup> Street Borough of the Bronx Final Report

March, 2014

Department of Transportation  
Polly Trottenberg, Commissioner

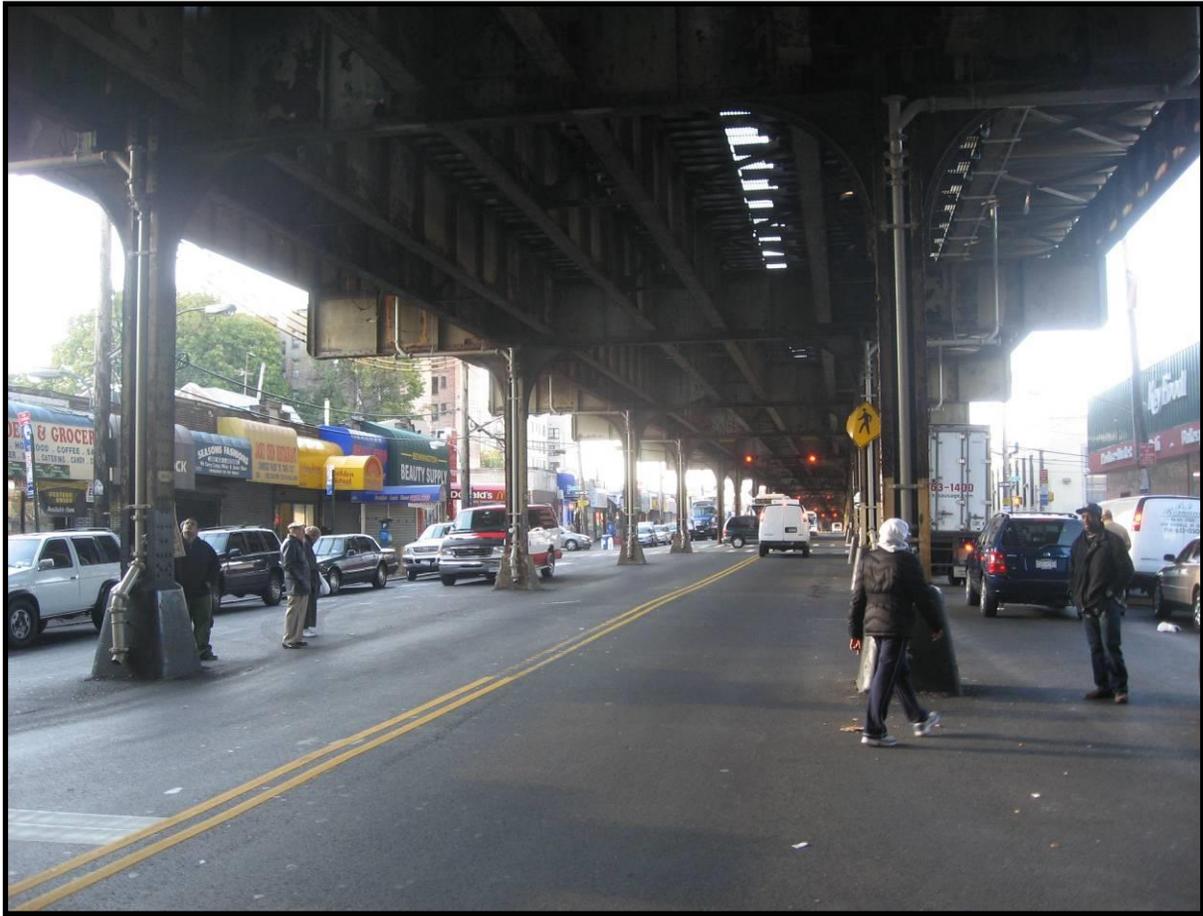
*Figure 2: Typical view of White Plains Road Study Area depicting elevated subway columns & travel lanes*

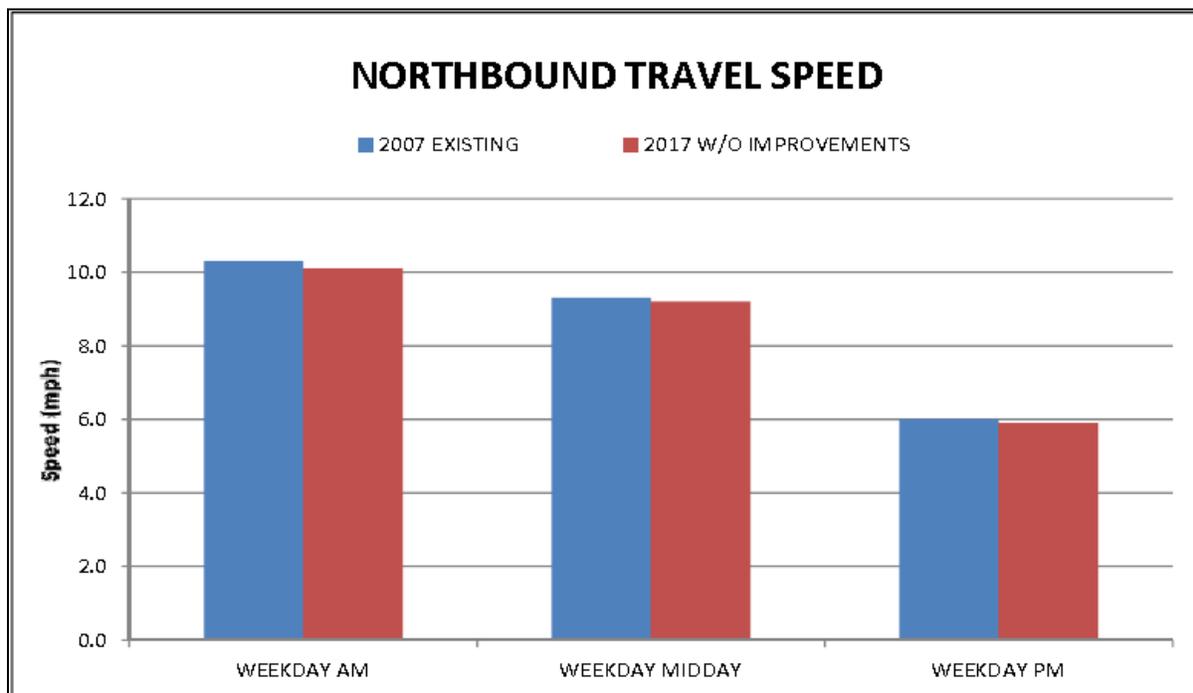
*Figure 3: Northbound Peak Period Average Travel Speeds for White Plains Road from East Tremont Avenue to East 233<sup>rd</sup> Street*

Existing travel speeds during the three peak periods of study varied between 5.7 and 10.3 mph. Congested conditions are projected to worsen in the future without any improvements. Figure 5 illustrates congestion in the northbound direction during the weekday midday peak period, where 2017 future without improvements travel speed is projected to average 9.2 mph. For both the northbound and southbound directions, the PM peak travel speeds are worse than other peak hours, averaging under 6 mph for both directions.

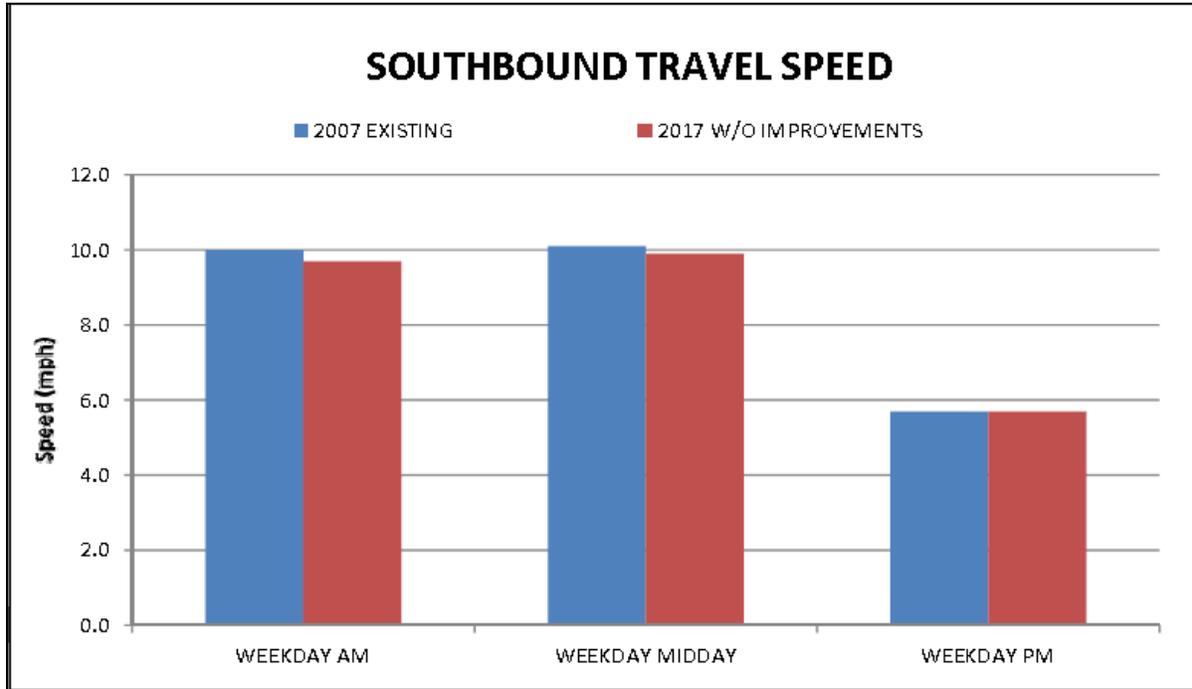
*Figure 4: Southbound Peak Period Average Travel Speeds for White Plains Road from East Tremont Avenue to East 233rd Street*

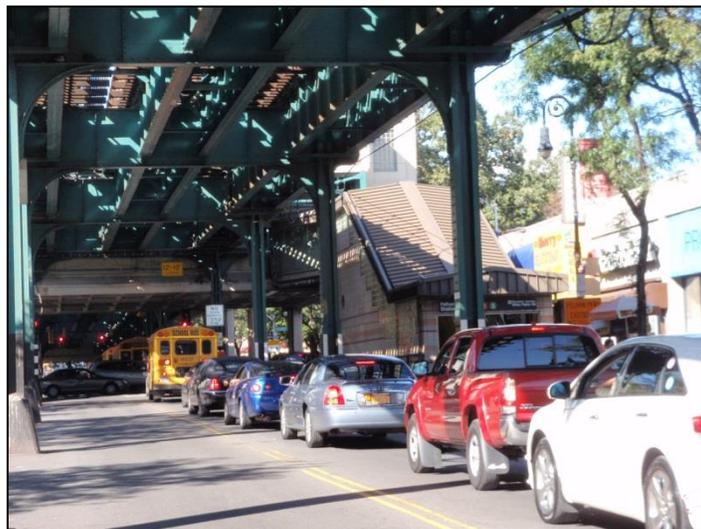
*Figure 5: Typical Midday Peak Hour along White Plains Road*

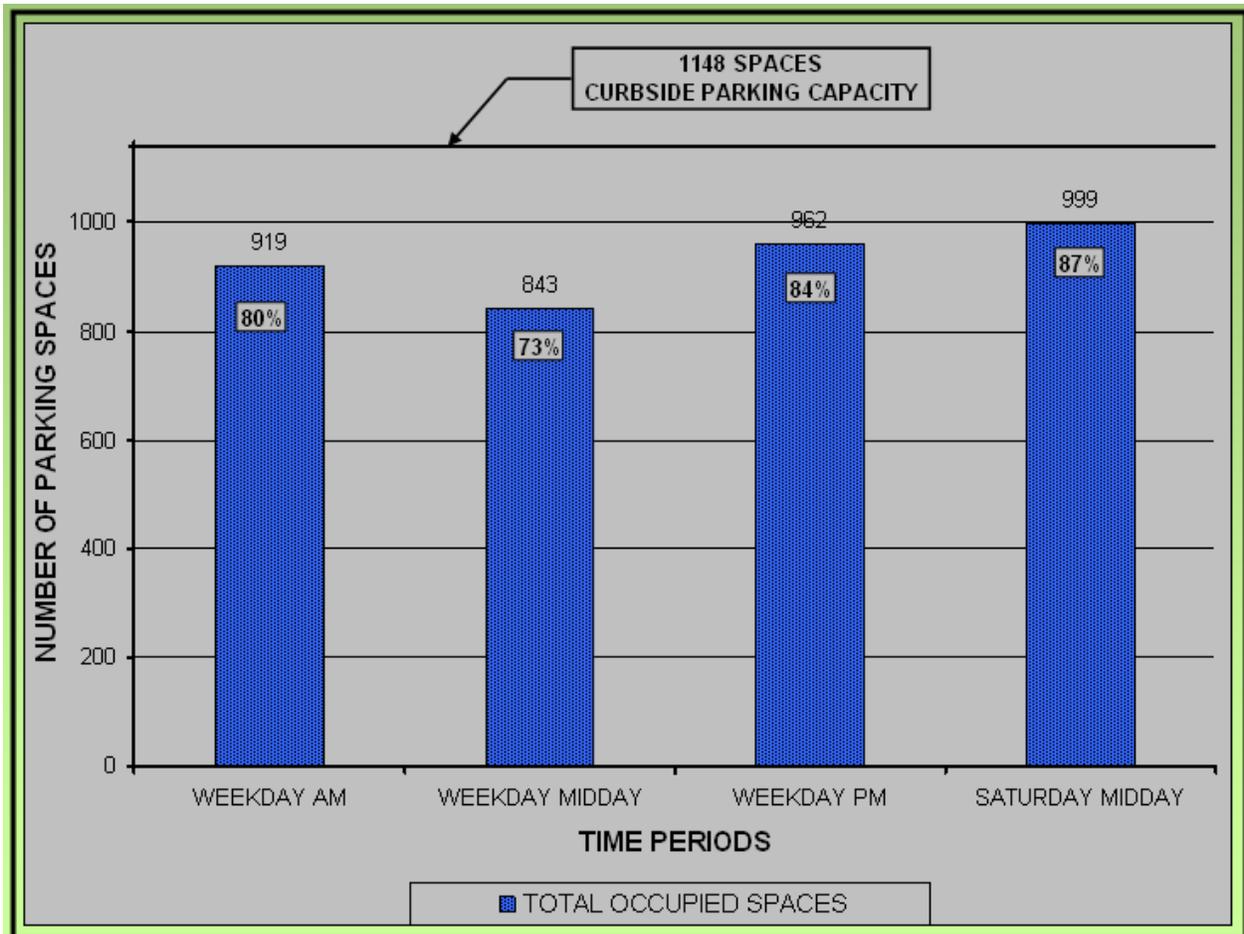
*Figure 6: White Plains Road Peak Hour Curbside Parking Utilization*

On-street parking utilization within the 48 block project study area is close to capacity during the weekday AM, PM and Saturday midday peak hours (See Figure 6). Of the available legal 1148 curbside parking spaces within the study area, about 80% to 87% are noted to be occupied during these peak hours. Block by block parking assessments have further indicated that during the PM peak about 17 out of the 48 blocks surveyed are operating above their available parking capacity (See Table 1). In addition, there are approximately 390 off-street parking spaces within the study area. Depending upon the time of the day, the off-street parking utilization is also more than 80% during weekdays and about 70% during weekends (Saturday) (See Table 2).

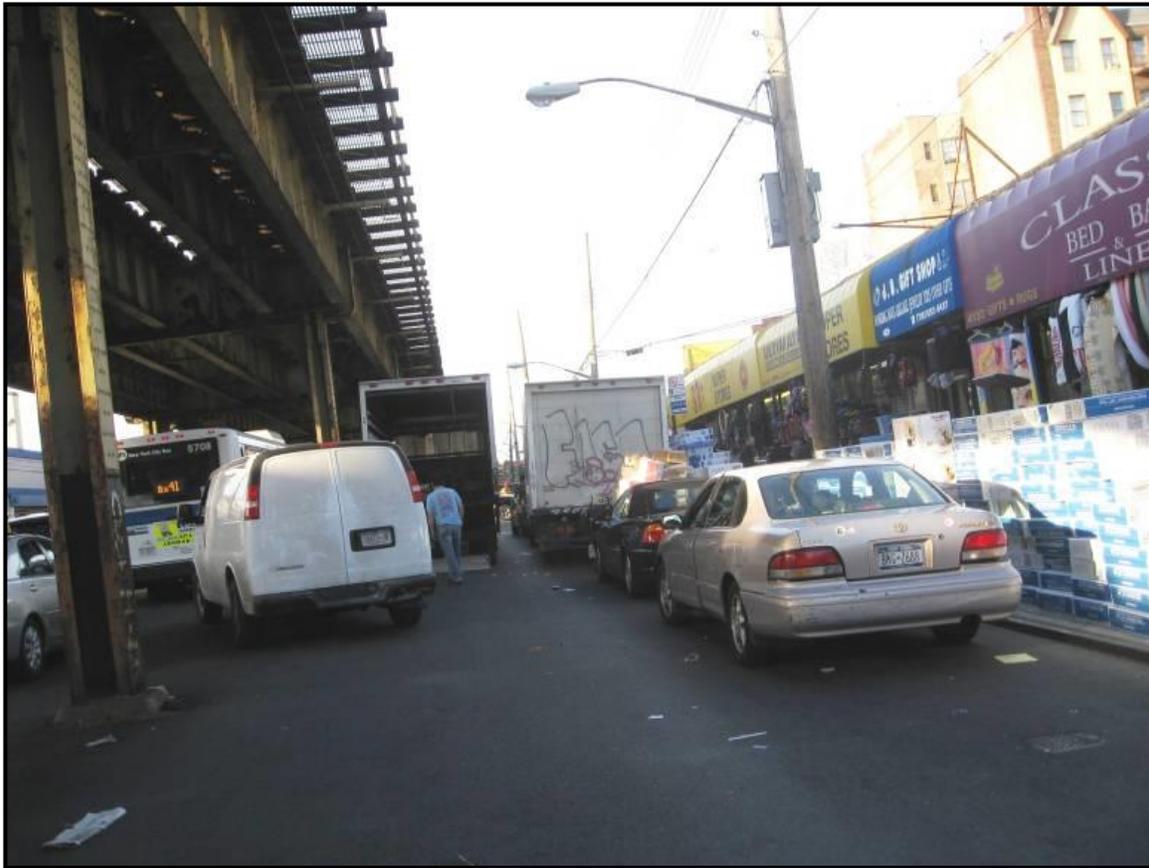
*Figure 7: Typical Illegal Double Parking Activity noted along White Plains Road*

Illegally parked vehicles during these peak hours further exacerbate roadway safety and operations. The lack of loading zones makes it difficult for trucks to make deliveries (See Figure 7). High parking utilization that is noted to be concentrated along various blocks (mainly busy retail blocks) also results in increased congestion due to the circulation of traffic on White Plains Road as motorists attempt to find vacant parking spaces near their desired destination point.

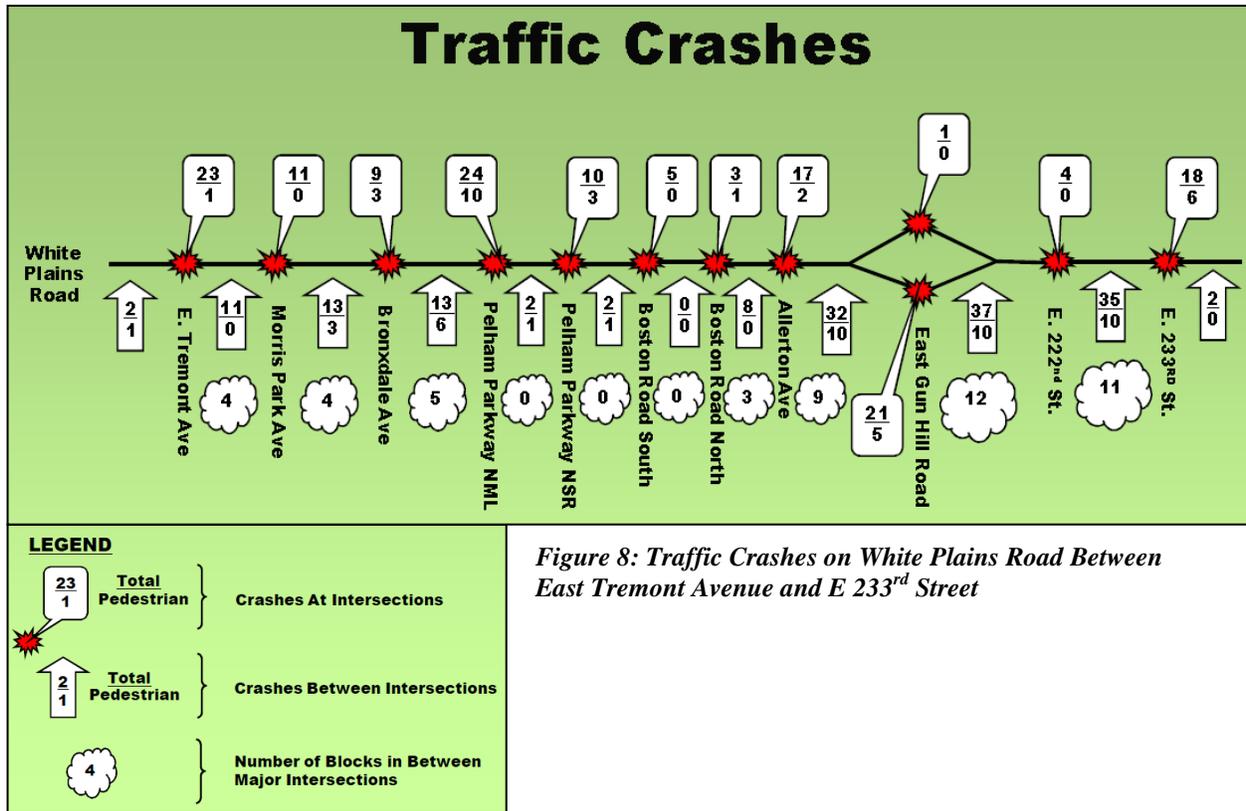
Figure 8: Traffic Crashes on White Plains Road Between East Tremont Avenue and E 233<sup>rd</sup> Street

A crash inventory conducted within the study area during a three-year period has indicated a total of 303 reportable crashes (Figure 8). Among these crashes, 200 were vehicle-to-vehicle crashes, 74 involved pedestrians and 17 involved bicycles. The greatest number of intersection crashes occurred at the intersection of White Plains Road and Pelham Parkway North Mainline. At this intersection, there were a total of 24 crashes within the three year study period. Similarly, the East Tremont Avenue intersection with White Plains Road had a total of 23 crashes within the same period. There were two fatal crashes, one just outside the study area near East Tremont Avenue and the other at the intersection of Allerton Avenue, involving a pedestrian. The top contributing factors for these crashes, based on police reports, were vehicle malfunction, driver inattention, failure to yield right of way, and pedestrian error/confusion.

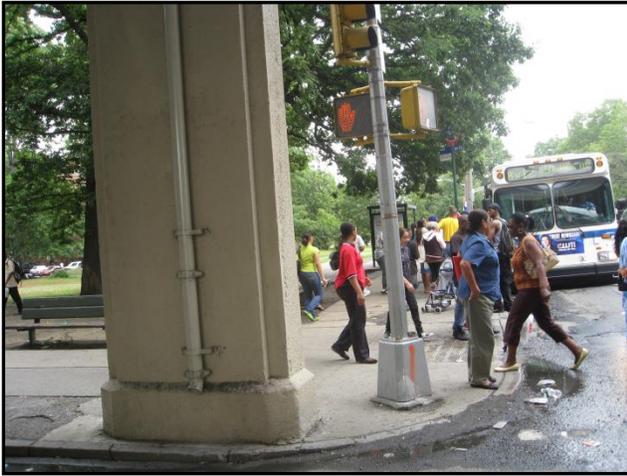
*Figure 9: Pedestrian Activity at White Plains Road and Pelham Parkway North Service Road, Northeast Corner*

An existing condition pedestrian assessment was conducted at all the study intersections shown in Figure 1. The crosswalk and street corner analysis at these intersections has shown no negative capacity impacts resulting from pedestrian activity along White Plains Road. Thus, from a pedestrian capacity standpoint (during peak hours of traffic operations) comfortable pedestrian LOS exists at all analyzed locations within the study area. However, it is important to note that due to the presence of the elevated subway columns, there are many intersection corners where the pedestrians are not visible to vehicular traffic while emerging to cross the intersection. These blind spots make pedestrians vulnerable to vehicular and pedestrian conflicts (see Figures 9 & 10). The subway columns also prohibit buses from using the curb lanes, so passengers are often picked-up or dropped-off within the travel lanes, creating unsafe conditions for these pedestrians. Additionally, there are wide pedestrian crossings at the signalized intersections along the study corridor which further exposes pedestrians to traffic operations and increases the potential for vehicle-pedestrian conflicts.

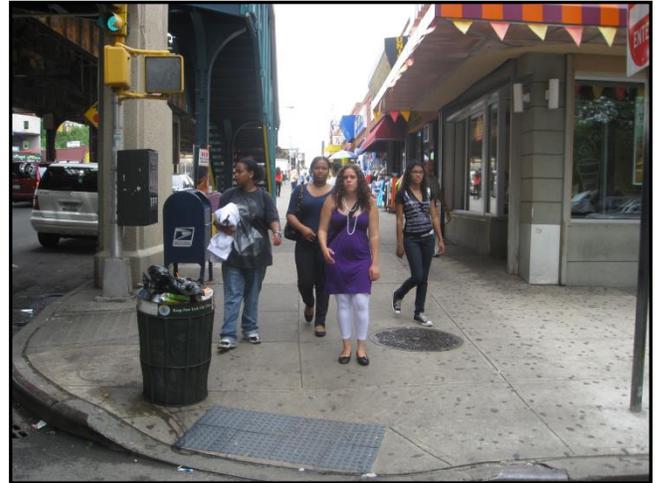
*Figure 10: Typical Pedestrian Activity at White Plains Road Sidewalks*

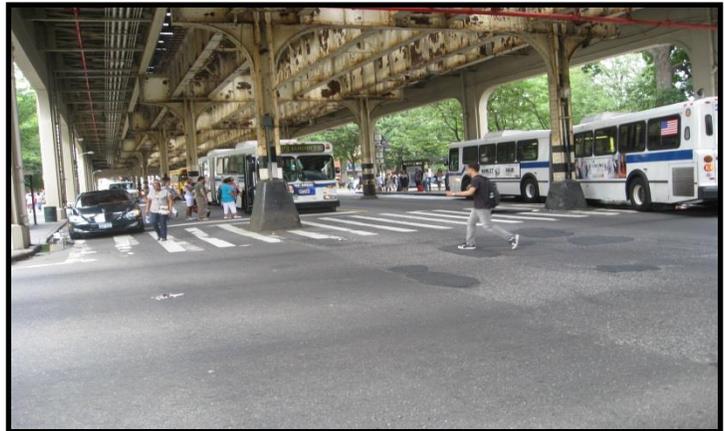
*Figure 11: Southbound Bus Picking-Up/Dropping-Off Passengers within Travel Lanes While Northbound Bus Maneuvers Between Columns to Access Bus Stop On White Plains Road*

White Plains Road is well connected to mass transit service. Operating within the White Plains Road study area are 18 bus lines (BX39, BX22, BX41, BX8, BX40/42, BX21, BX12, BL60, BL61, BL62, BX25/26, BX28, BX30, BX55, BX31, BL42, BXM10, BXM10, & BXM11) and two subway lines (Nos. 2 and 5). There are four major subway-bus transfer points within the study area. During peak commuting hours, the subway-bus transfer points are subject to significant traffic and pedestrian activity. Since the positioning of elevated subway columns on White Plains Road does not allow buses to continuously use the curb lanes in either direction, passengers are often picked-up or dropped-off within the travel lane (sometimes behind these elevated subway columns). This creates unsafe conditions and adds the potential for pedestrian-vehicle conflicts. Additionally, since the roadway segment is limited to the use of only one effective moving lane at a majority of roadway segments (due to the elevated subway columns), these mid-travel lane bus stops block the continuous flow and create additional delays to traffic operations (See Figures 11 thru 13).

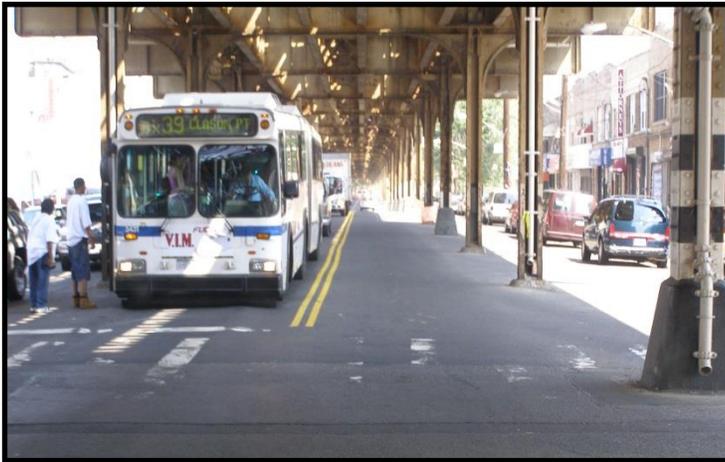
*Figure 12: Typical Bus Stop Activity along White Plains Road*

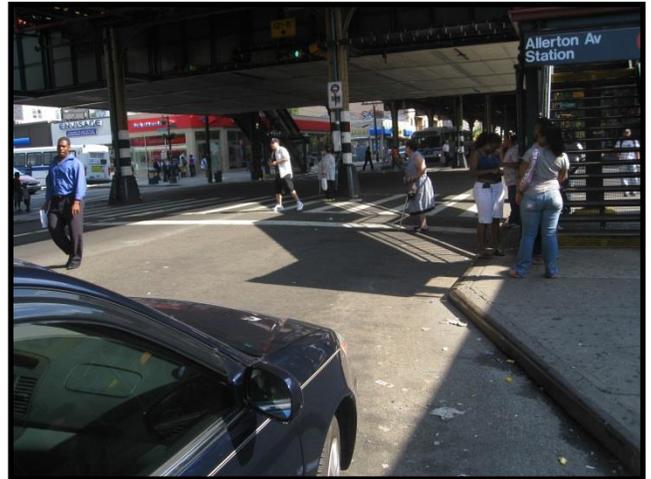
*Figure 13: Bus Passengers Waiting Within Travel Lanes For Pick-Up At A Subway-Bus Transfer Point On White Plains Road*

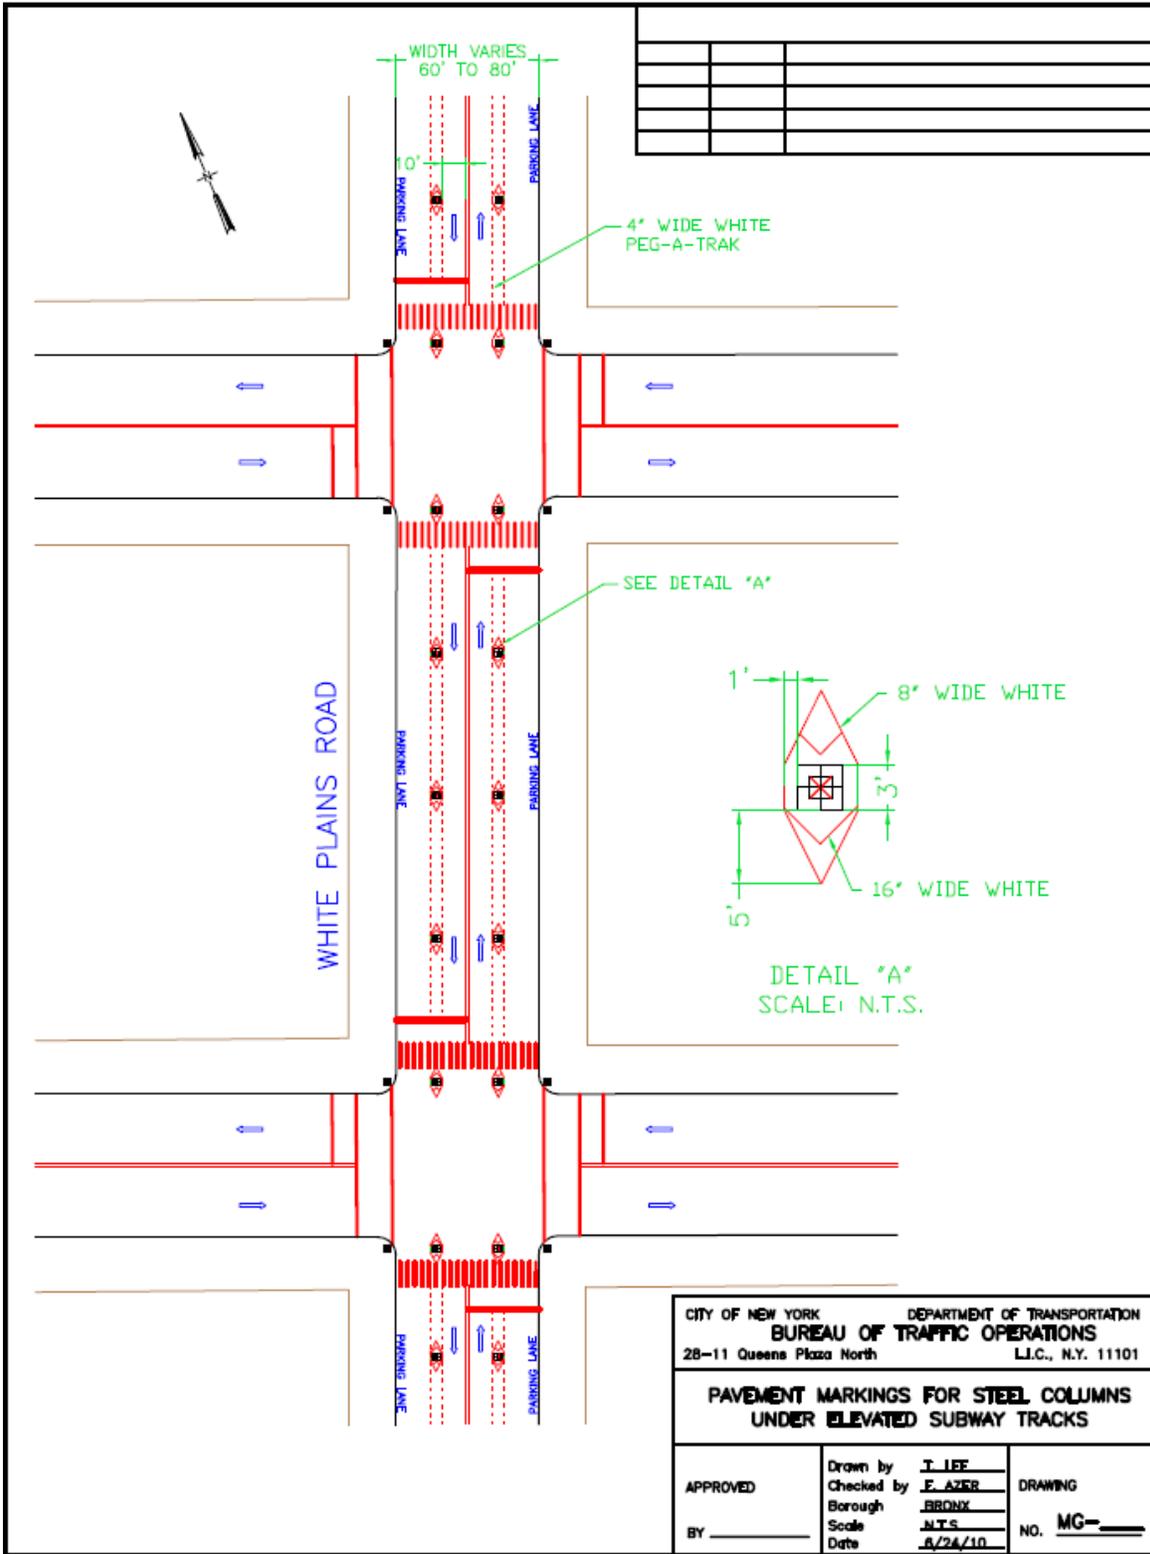
*Figure 14: Typical Pavement Markings for Street Columns under Elevated Subway Tracks - White Plains Road*

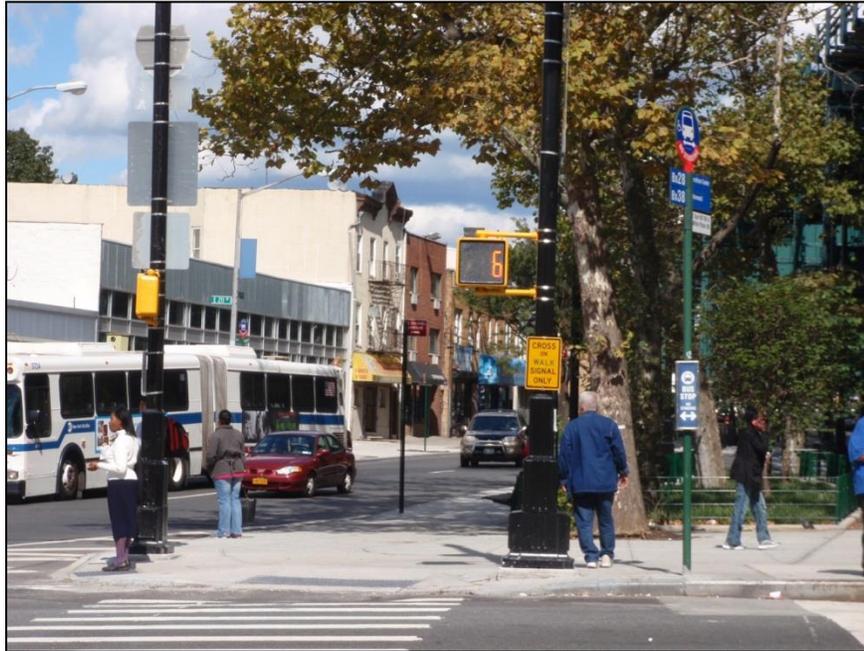
*Figure 15: Pedestrian Countdown Signals along the White Plains Road Study Corridor*

This recommendation has already been implemented at all signalized intersections throughout the White Plains Road study corridor except at the Bronxdale Avenue and Pelham Parkway (North Mainline, South Mainline and South Service Road) intersections. This recommendation will be implemented at these locations in the future. Figure 15 depicts a typical pedestrian countdown signal that is installed at the White Plains Road (Southbound) and East Gun Hill Road intersection.

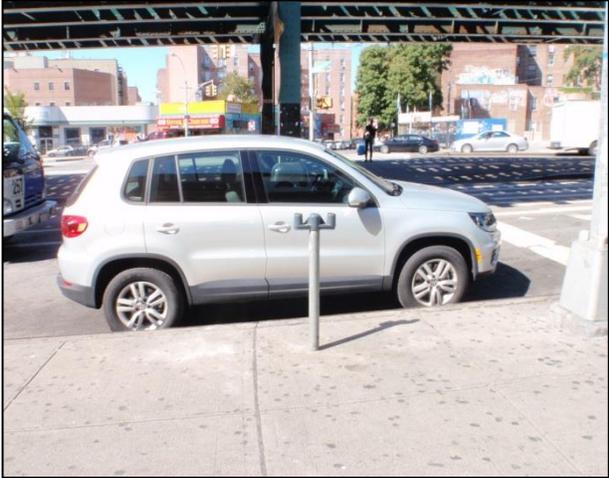
*Figure 16: Traditional Single-Space Parking Meter (During Removal)*

Parking-related recommendations include the replacement of the traditional single-space parking meters with muni-meters. The muni-meter is a proven effective technology to fit more vehicles within the same curbside parking space. Under the traditional one space per meter system, the space allotted (usually 18 to 20 feet) accommodates larger vehicles; thus space is wasted when smaller cars park. Some studies report as much as 15% extra capacity when converting to muni-meters. In addition, parking can be paid by credit card or pre-paid parking card, eliminating the incidence of having to “run for change.” (This measure has already been implemented throughout the White Plains Road study corridor (see Figures 16 and 17) except along the northbound curbside between Bronxdale Avenue and Brady Street (in front of Staples).)

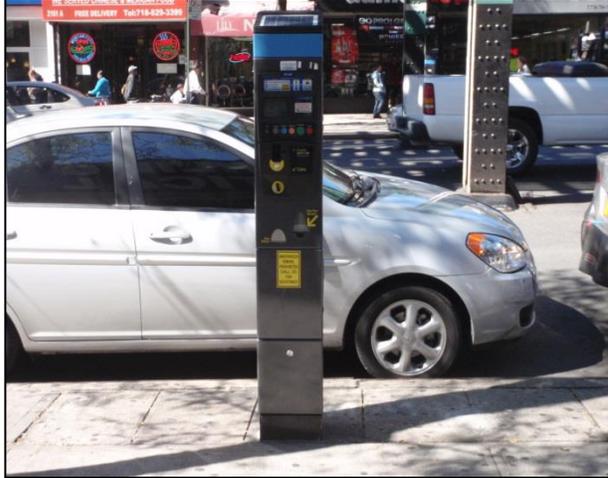
*Figure 17: A Typical Muni-Meter Installation*

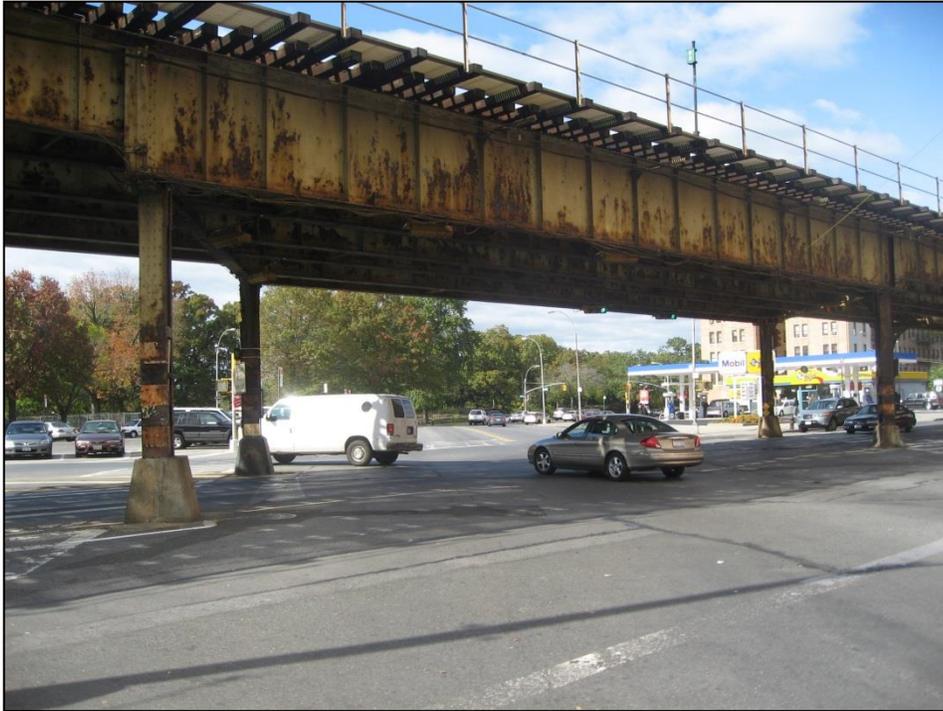
*Figure 18: White Plains Road at Bronxdale Road intersection (Before Condition) - Worn-out paint on subway columns and subway steel structure*

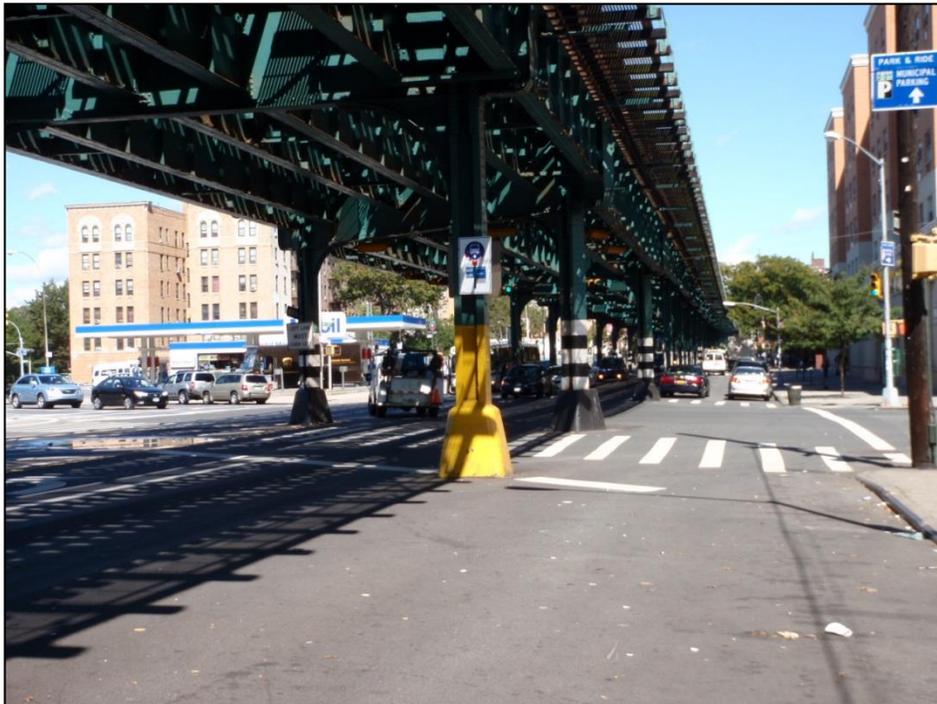
*Figure 19: White Plains Road at Bronxdale Road intersection (After Condition) - New paint applied on subway columns and subway steel structure in 2011/2012 for positive delineation and safer traffic operations*

<b>FIGURE 19 - White Plains Road at Bronxdale Road intersection (After Condition) - New paint applied on subway columns and subway steel structure in 2011/ 2012 for positive delineation and safer traffic operations .....</b>	<b>32</b>

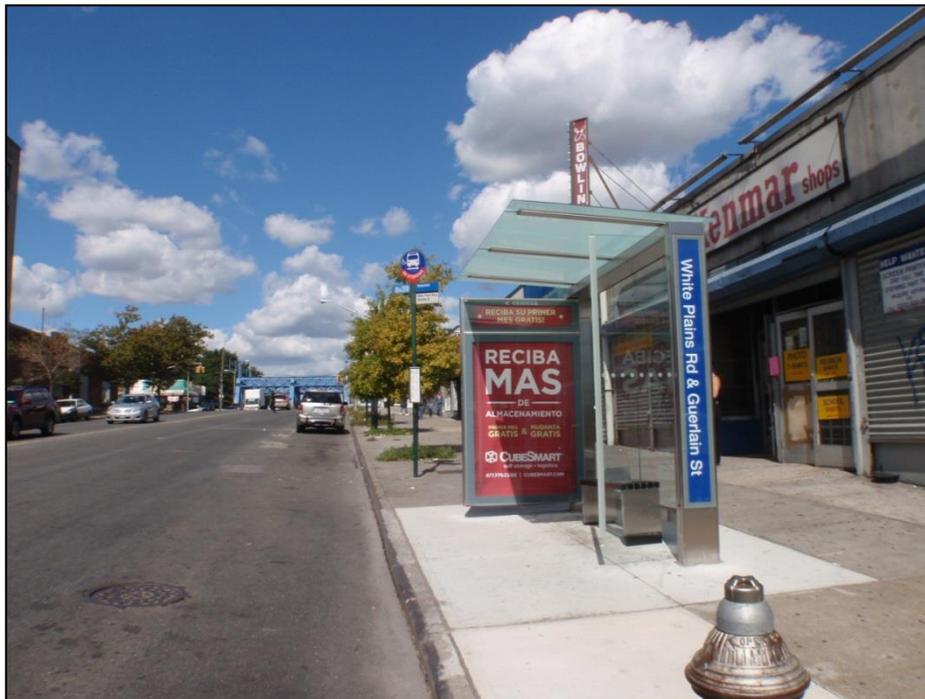
*Figure 20: Recently installed bus shelter at White Plains Road and East Tremont Avenue (northbound approach)*

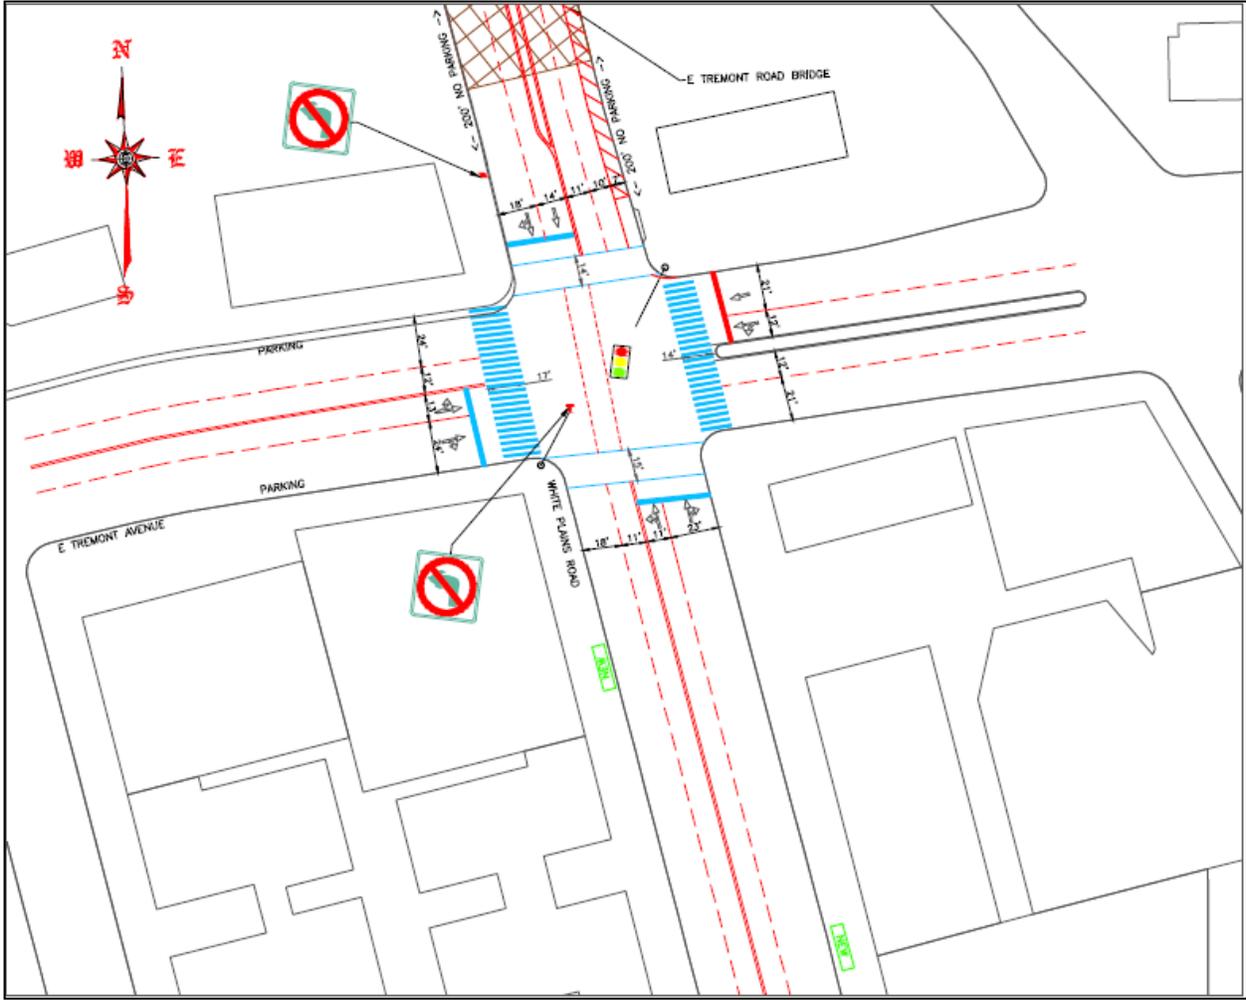
- Green time will be reallocated as shown in Table 4.
- Crosswalks, stop bars and lane lines will be restriped.
- Stop bars will be provided 10 feet from crosswalks.
- Southbound left turns will be prohibited by installing "No Left Turn" signs.
- Peg-A-Track striping will be installed for positive guidance across a wide intersection box in the southbound direction.
- A new bus shelter will be installed on the far side of the southbound approach along White Plains Road. A second proposed bus shelter, located midblock northbound between East Tremont Street and Guerlain Street, has already been installed, as shown in Figure 20.
- Remove parking for approximately 200 feet along both curbsides on the north leg of the intersection to facilitate turning movements and increase pedestrian visibility.

Improvements for this location are presented in Figure 21.

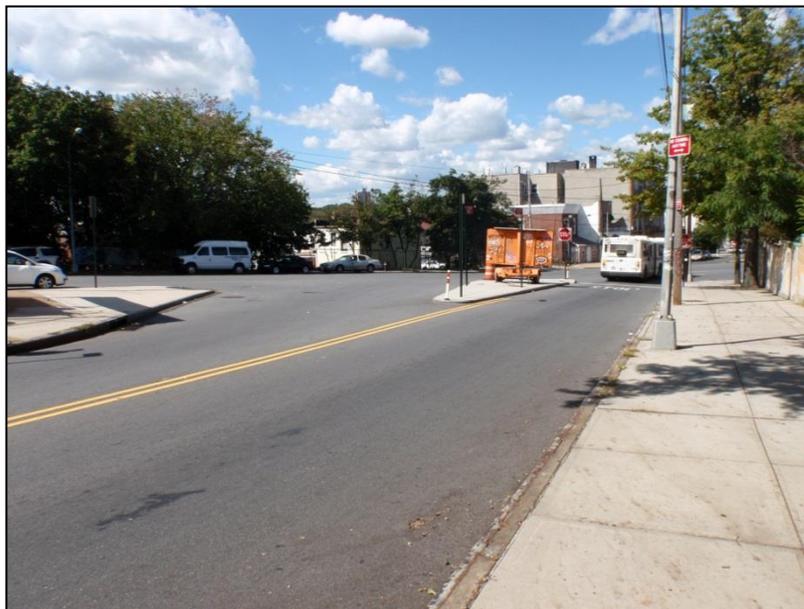
*Figure 22: Curb extension installed on the southeast corner of White Plains Road and Unionport Road intersection*

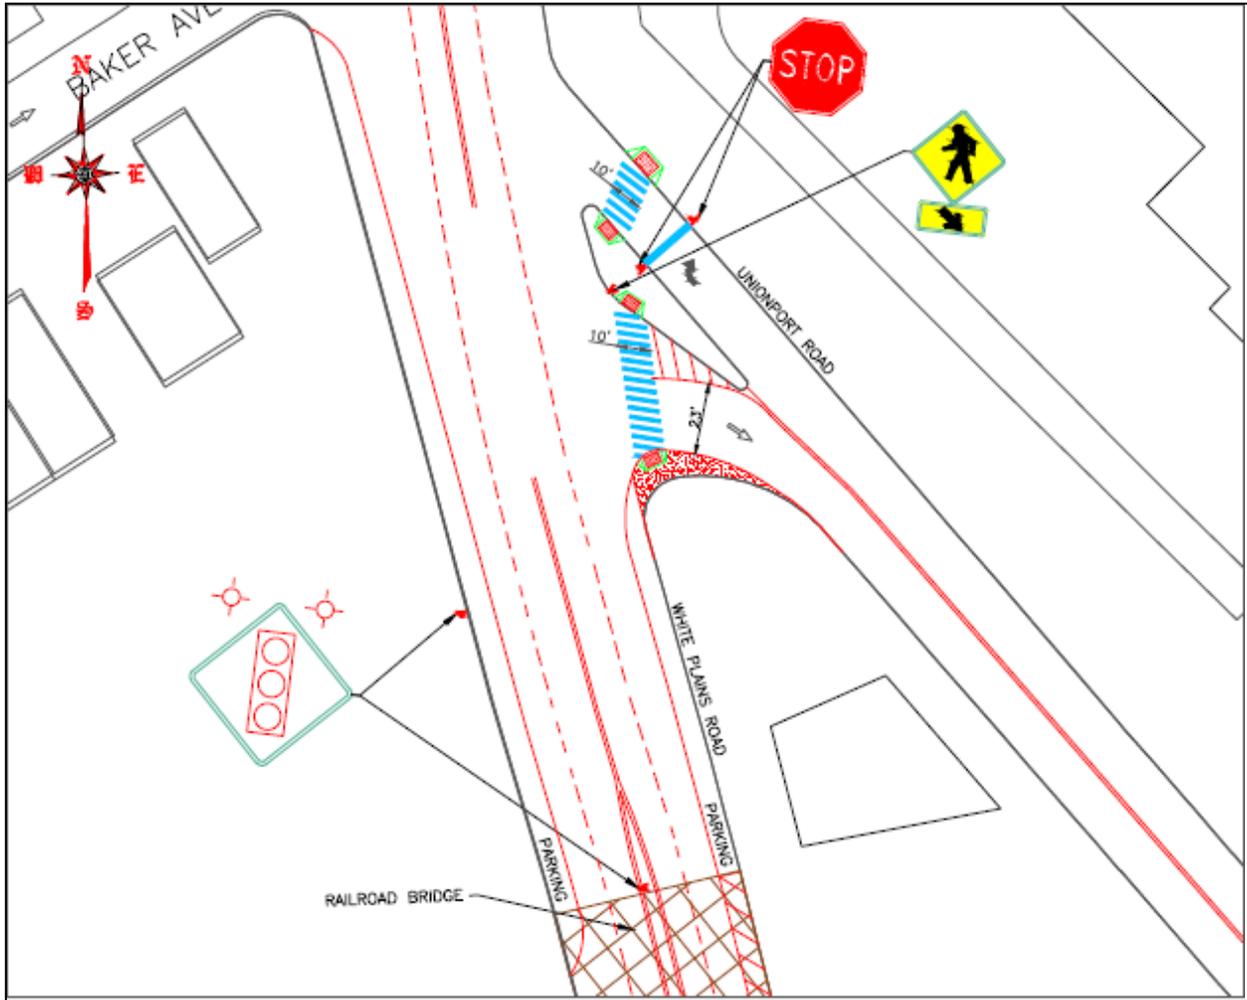
- Crosswalks, stop bars and lane lines will be restriped.
- Stop bars have been provided 10 feet from crosswalks.
- “Signal Ahead” signs with flashing beacons will be installed on southbound White Plains Road in advance of the bridge due to the limited sight distance on this approach.
- New traffic signs (stop signs and pedestrian warning signs) will be installed on the Unionport Road leg of this intersection.
- Curb extension has been installed on the southeast corner of this intersection (see Figure 22).
- Pedestrian ramps have been installed on the northeast and southeast corners and on the east median island of the White Plains Road and Unionport Road intersection.

Improvements for this location are presented in Figure 23.

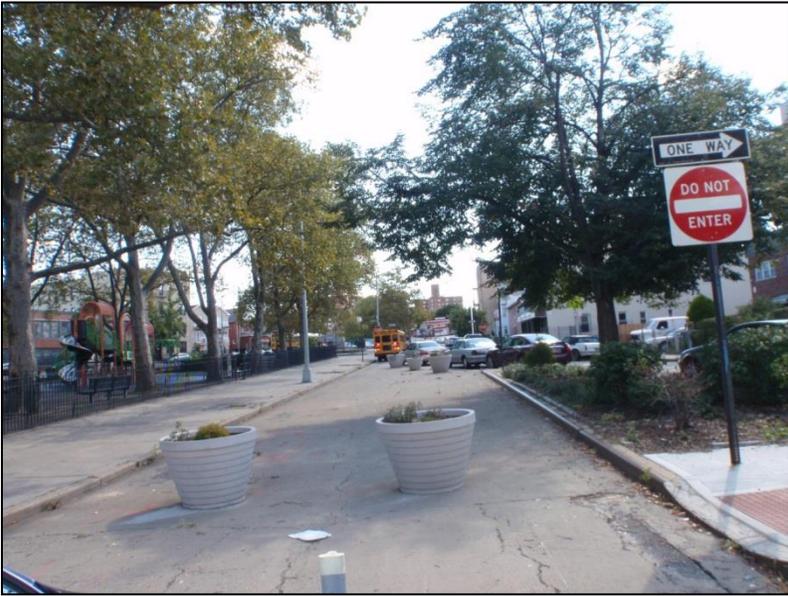
***Figure 24: Unionport Road closure looking southbound between Van Nest Avenue and Mead Street***

- Unionport Road has been made one-way southbound between Van Nest Avenue and Mead Street by closing off the northbound lanes in this segment (see Figure 24). This will improve pedestrian safety and allow for the potential expansion of the park area.
- Crosswalks and stop bars have been restriped at the intersection of Unionport Road and Baker Avenue.
- Stop bars will be provided 10 feet from the crosswalk at the Unionport Road and Baker Avenue intersection.
- Stop signs have been installed at the intersection of Unionport Road and Baker Avenue.
- Pedestrian ramps will be installed on the northeast and northwest corners of the White Plains Road and Baker Avenue intersection.

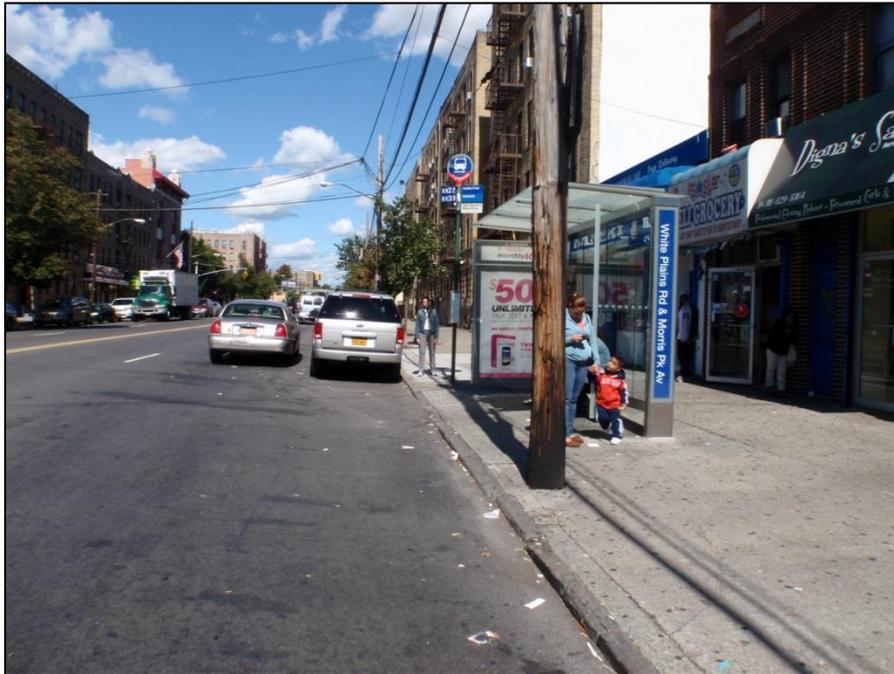
*Figure 26: One of the recently installed bus shelters at White Plains Road and Morris Park Avenue.*

- Green time will be reallocated as shown in Table 4.
- Crosswalks, stop bars and lane lines will be restriped.
- Stop bars will be provided 10 feet from crosswalks.
- Westbound approach will be reconfigured by removing approximately three parking spaces and creating three westbound lanes including a right pocket lane, through and through/left turn shared lane.
- Curb extensions and pedestrian ramps will be installed on the northwest, southeast and southwest corners of this intersection.
- Four new bus shelters have been installed at this intersection (see Figure 26).

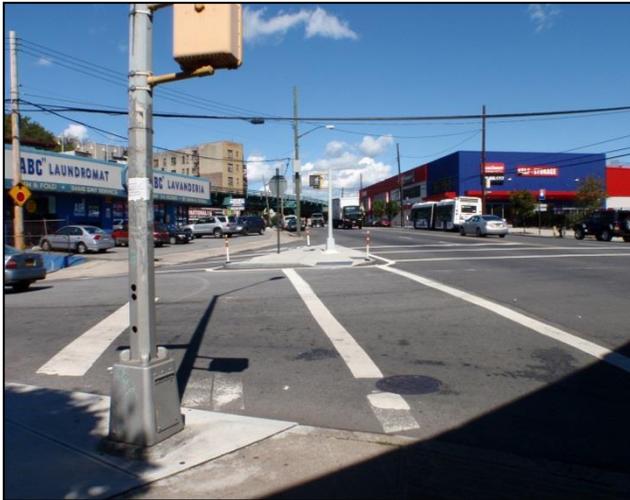
*Figure 28: Recently installed raised island between the southbound right turn bay and the southbound approach at the White Plains Road and Sagamore Street intersection*

- Curb extension at southeast corner of Sagamore Street and Birchall Avenue has been installed.
- Raised island separating the channelized right-turn slip onto Cruger Avenue from southbound White Plains Road has been installed (see Figure 28).
- Raised island with greenstreets landscaping has been installed at the triangle formed by White Plains Road, Cruger Avenue and Sagamore Streets (see Figure 29).
- Curb extension at northwest corner of Sagamore Street and Cruger Avenue is planned.
- Crosswalks, stop bars and lane lines have been restriped.
- New pedestrian ramps have been installed.
- Stop bars have been provided 10 feet from crosswalks.

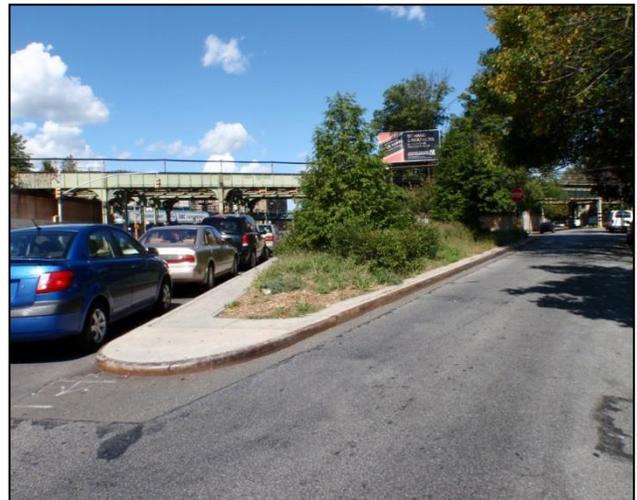
*Figure 29: Recently installed raised green island at White Plains Road and Sagamore Street intersection*

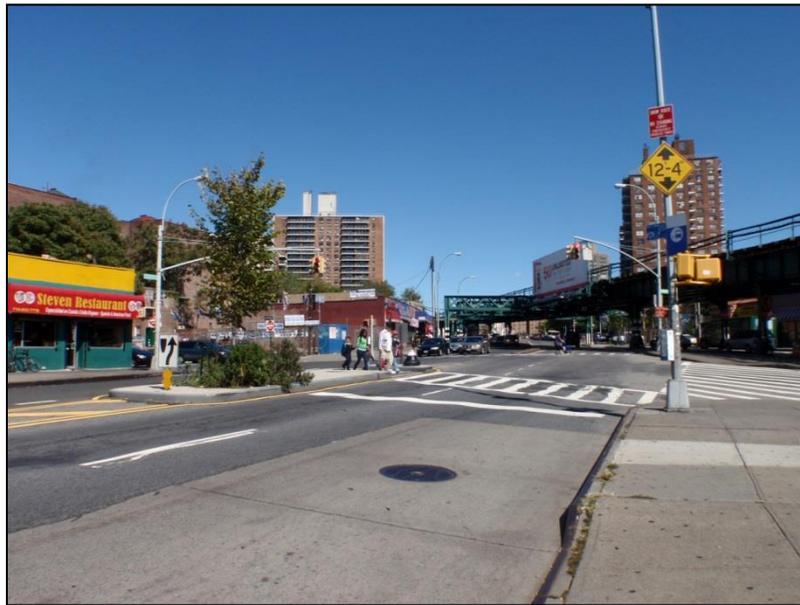
*Figure 32: New median island installed at south side of Boston Road and Thwaites Place intersection*

- A new traffic signal will be installed at the existing unsignalized intersection of White Plains Road and Boston Road (South). This new signal should be installed in coordination with the existing adjacent Thwaite Place traffic signal.
- Stop-control operation in front of the CTown Store will also be removed and a new signal head will be installed that is in coordination with the proposed new signal at the Boston Road (South) intersection.
- Green time will be allocated as shown in Table 4.
- Crosswalks, stop bars and lane lines will be restriped.
- Stop bars will be provided 10 feet from crosswalks.
- A new median island has been installed on the south side of the Boston Road and Thwaites Place intersection (see Figure 32).
- Gore area striping will be extended.
