# The Citywide Congested Corridor Project

## White Plains Road from East Tremont Street to East 233<sup>rd</sup> Street Borough of the Bronx Final Report

March, 2014

Department of Transportation  
Polly Trottenberg, Commissioner

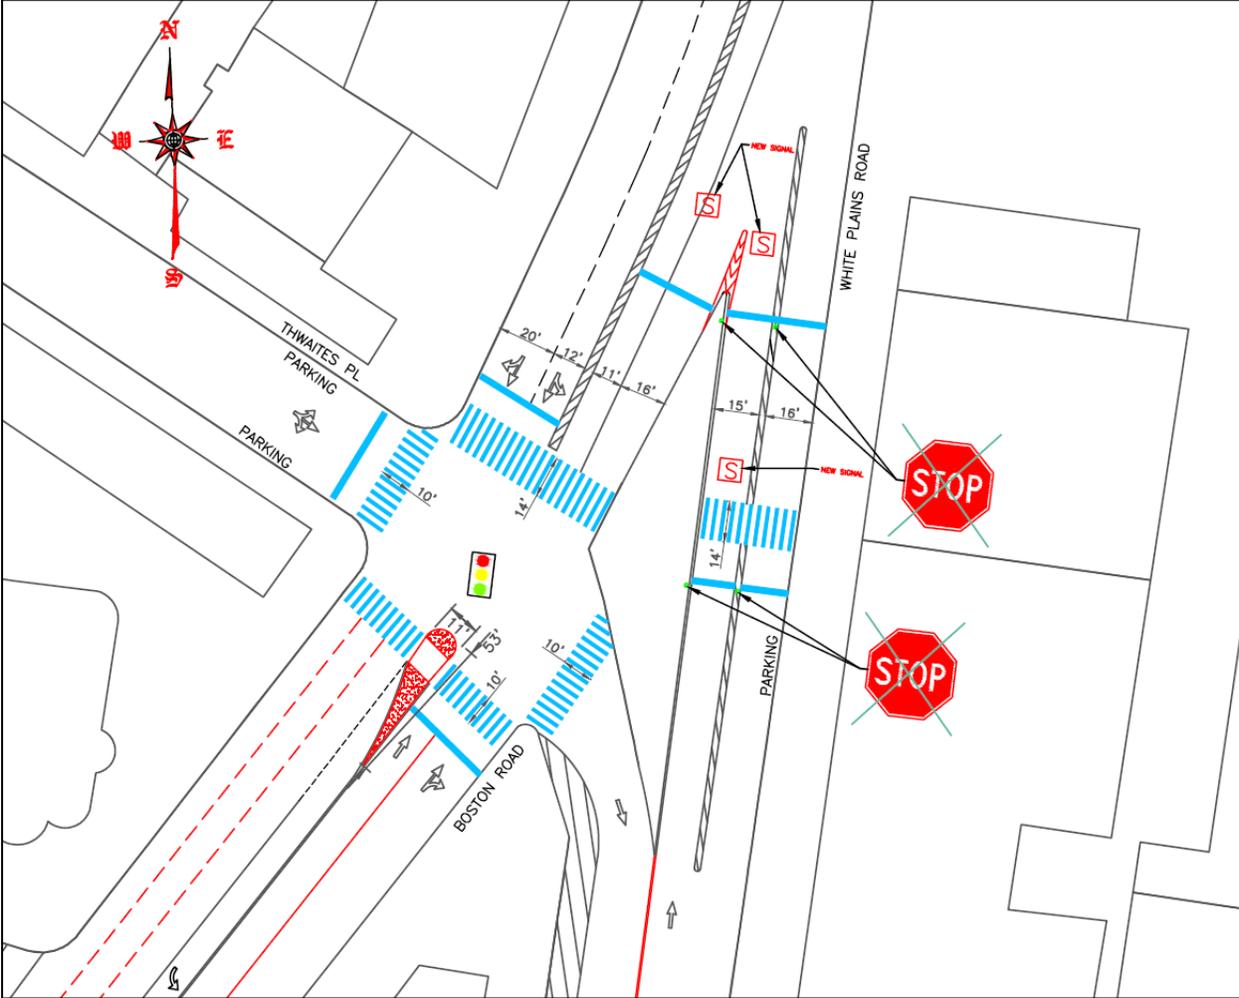
- A new traffic signal will be installed at the existing unsignalized intersection of White Plains Road and Boston Road (South). This new signal should be installed in coordination with the existing adjacent Thwaite Place traffic signal.
- Stop-control operation in front of the CTown Store will also be removed and a new signal head will be installed that is in coordination with the proposed new signal at the Boston Road (South) intersection.
- Green time will be allocated as shown in Table 4.
- Crosswalks, stop bars and lane lines will be restriped.
- Stop bars will be provided 10 feet from crosswalks.
- A new median island has been installed on the south side of the Boston Road and Thwaites Place intersection (see Figure 32).
- Gore area striping will be extended.

Improvements for this location are presented in Figure 33.

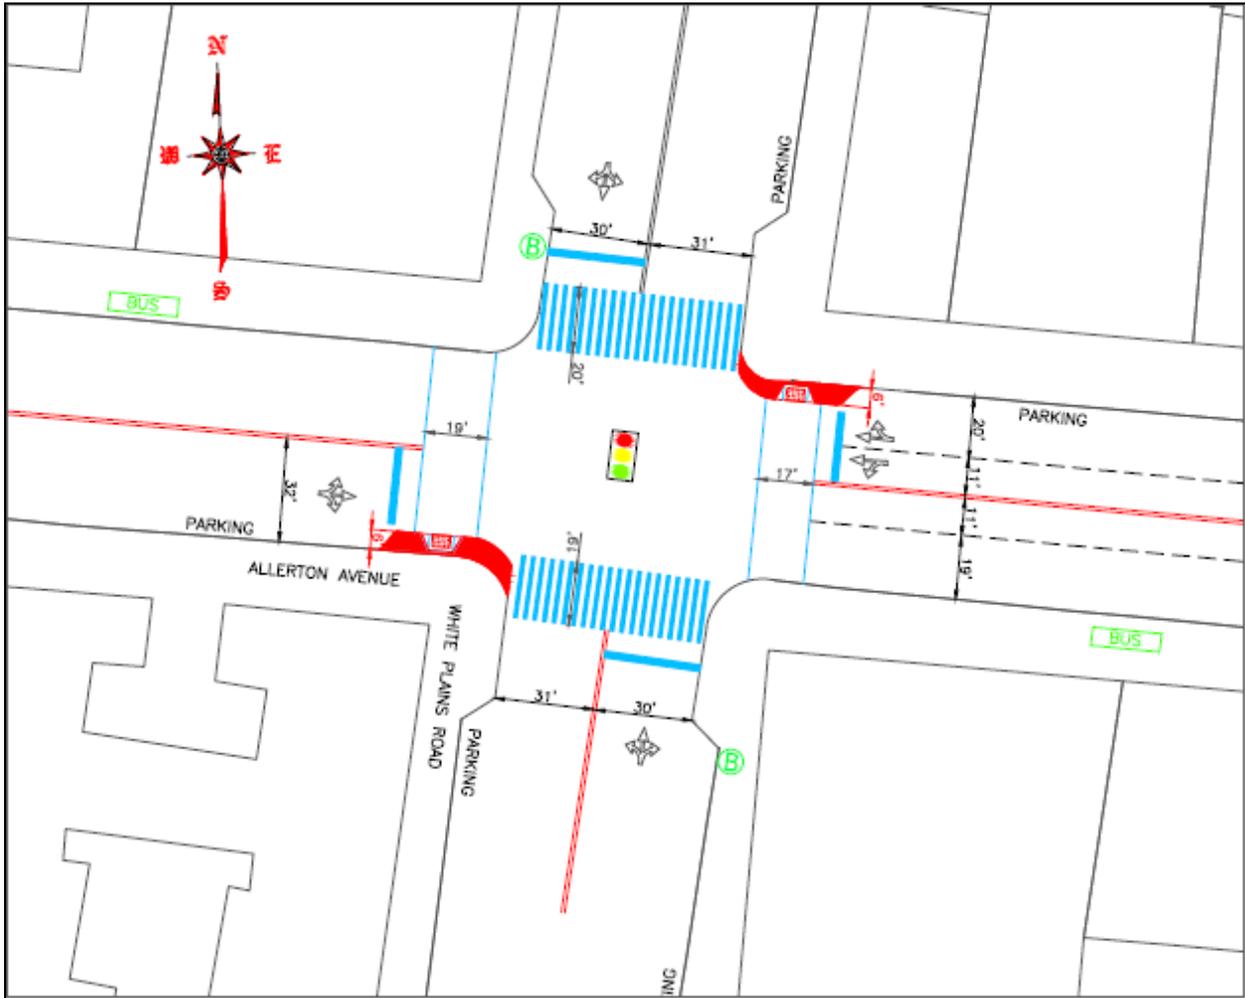
- Green time will be allocated as shown in Table 4.
- Curb extensions and new pedestrian ramps will be installed on Allerton Avenue at the northeast and southwest corners of the intersection (This recommendation was proposed under the “Safe Routes to Transit Project”). It should be noted that single curb extensions (Case A) already exist at all four corners on White Plains Road. With the installation of the new curb extensions on Allerton Avenue, the northeast and southwest corners will now have double curb extensions (Case B).
- Crosswalks, stop bars and lane lines will be restriped.
- Stop bars will be provided 10 feet from crosswalks.

Improvements for this location are presented in Figure 35.

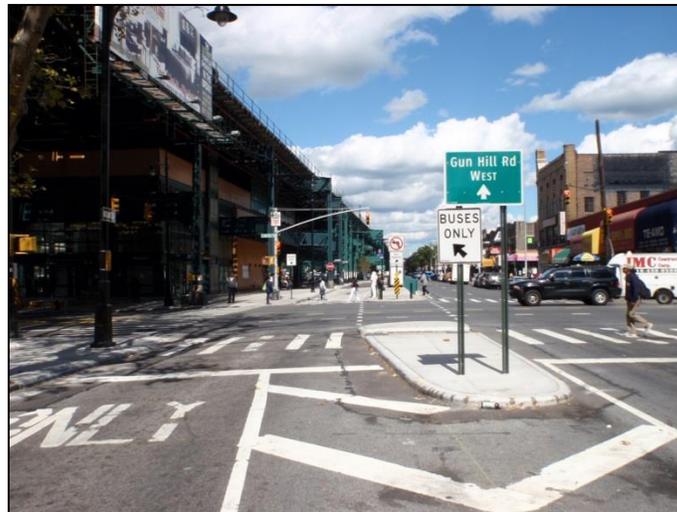
***Figure 36: Median island and bus ramp work completed under the Gun Hill Road Intermodal Project***

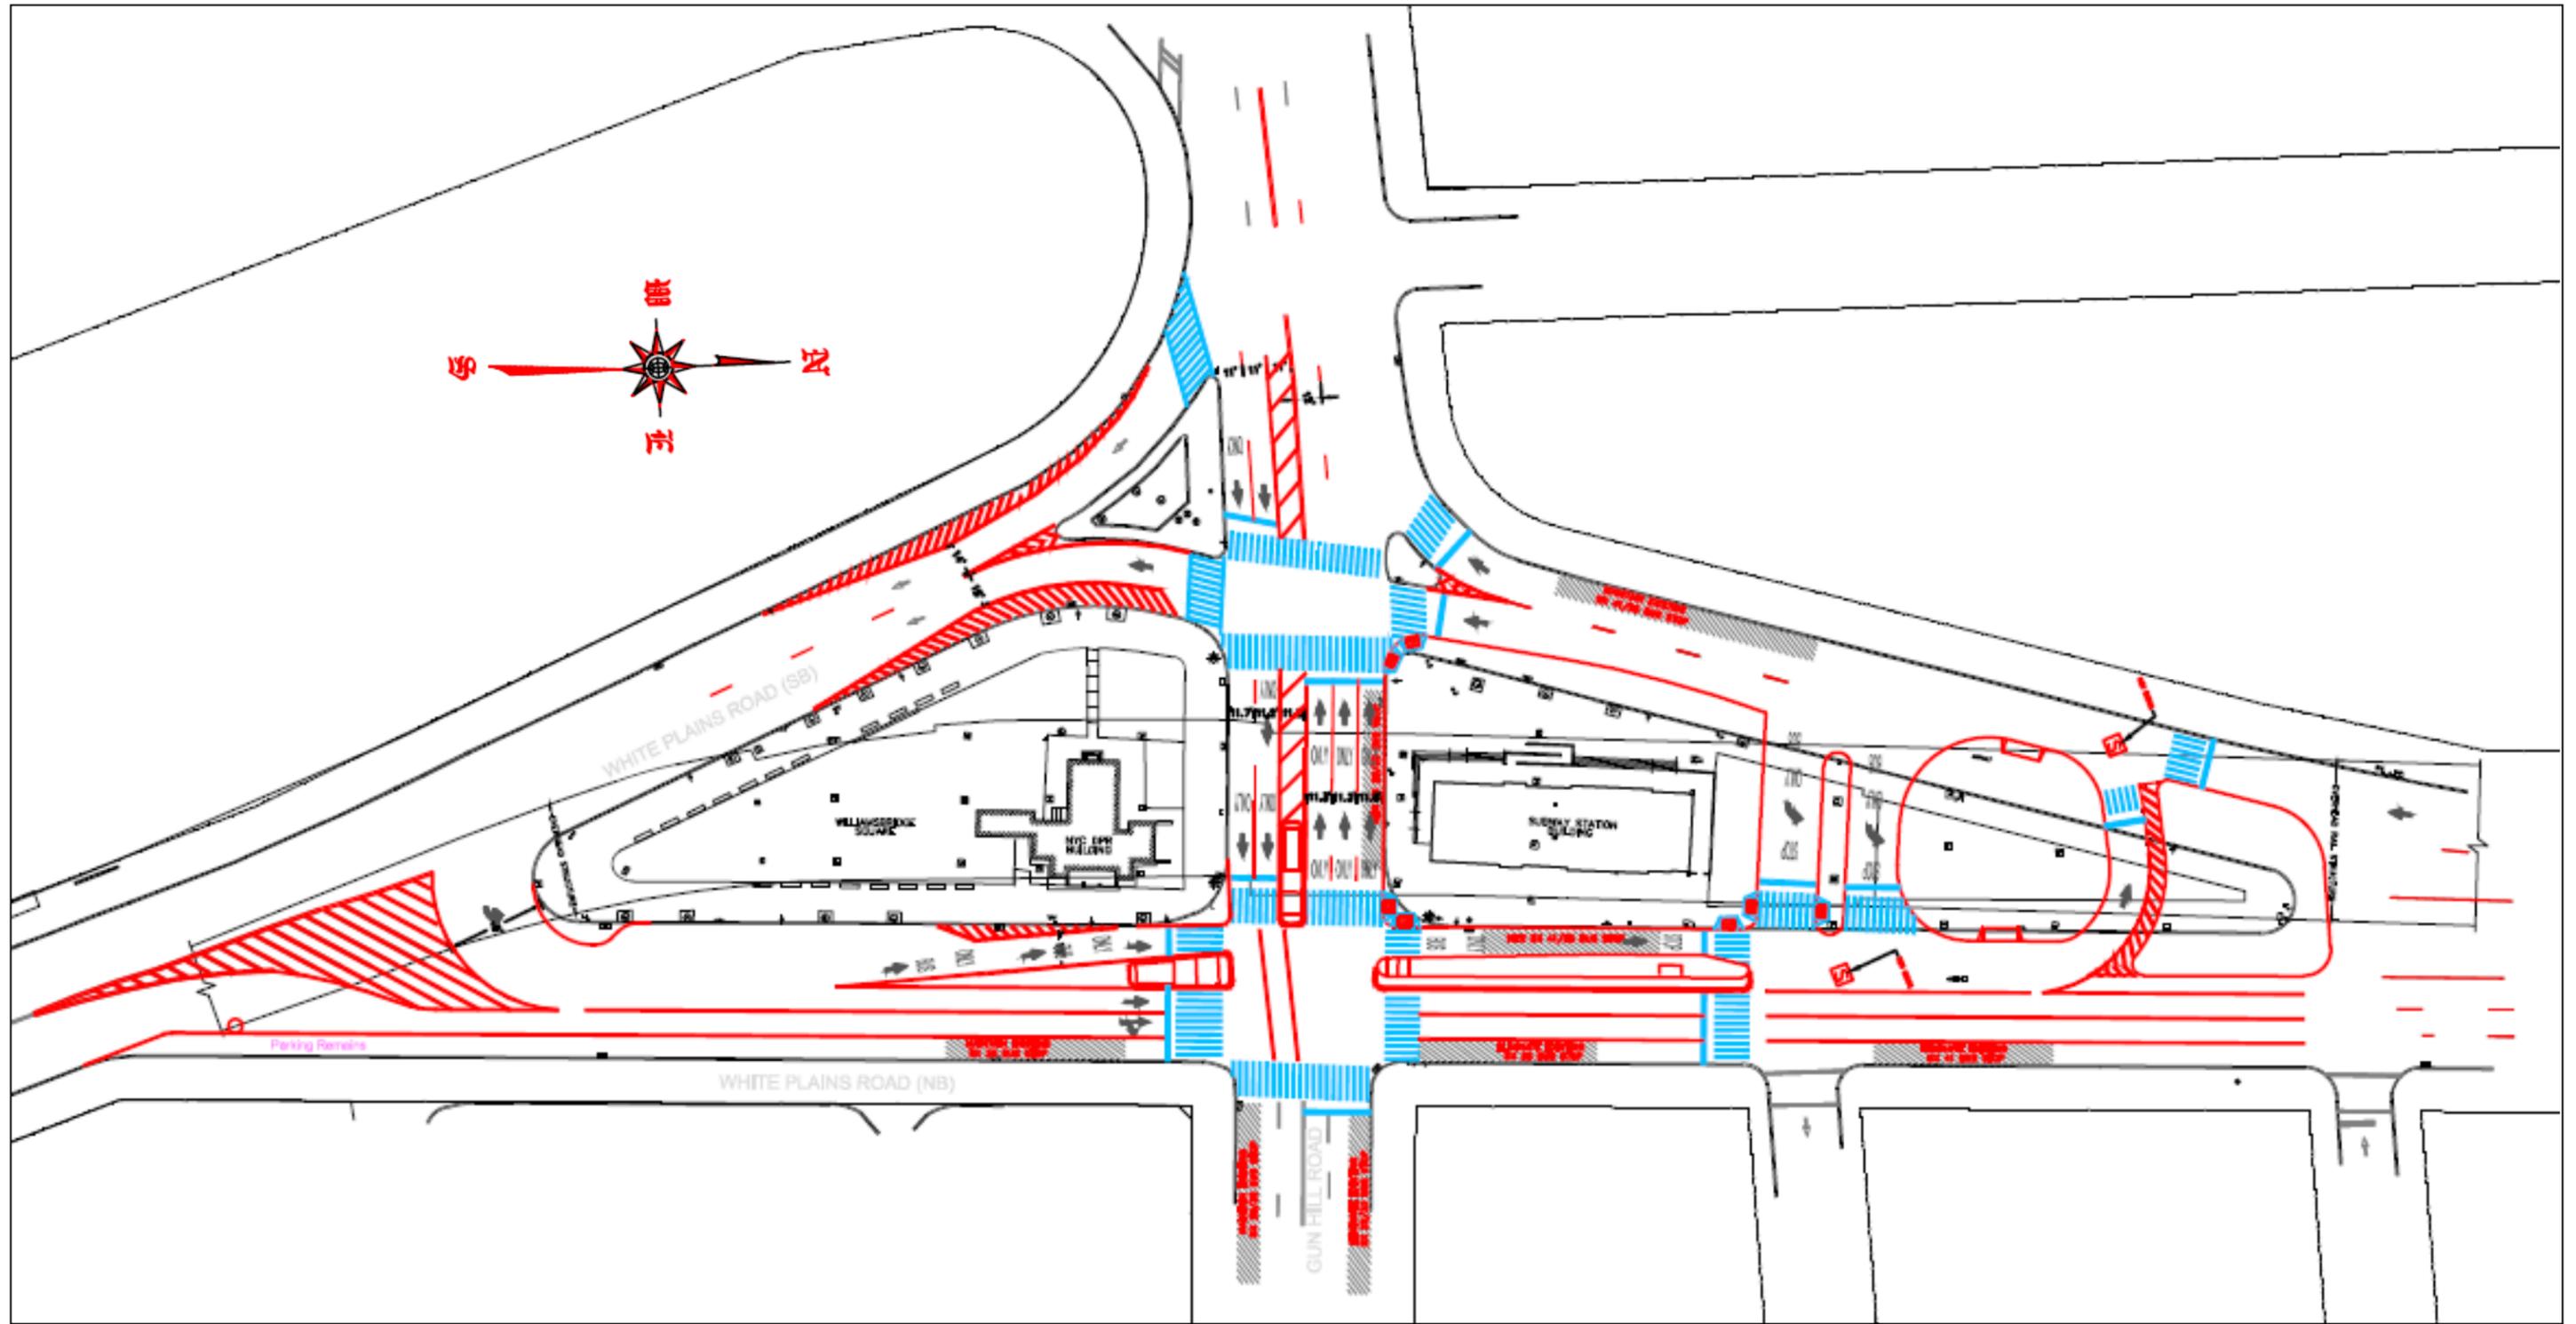
- Left turns will be restricted from the east, west and north approaches to the White Plains Road (Northbound) and East Gun Hill Road intersection.
- A raised median island will be installed on the north, south and west approaches to the White Plains Road (Northbound) and East Gun Hill Road intersection.
- Green time will be reallocated as shown in Table 4.
- Crosswalks, stop bars and lane lines have been restriped.
- Stop bars have been provided 10 feet from crosswalks.
- Peg-A-Track striping will be installed in the eastbound direction for positive guidance across the wide intersection box at the White Plains Road (Northbound) and East Gun Hill Road intersection.

Figure 37: White Plains Road (Northbound and Southbound) and East Gun Hill Road Improvements

Improvements for this location are presented in Figure 37.

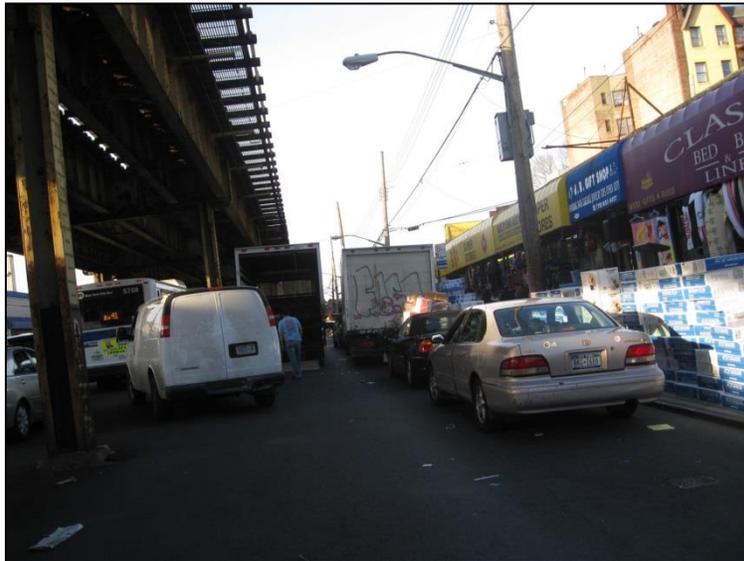
*Figure 40: Typical Situation Resulting From Lack of Truck Delivery Zones Along White Plains Road*

*Truck Delivery Zone Window Study:* Due to the lack of off-street loading docks and on-street loading space along White Plains Road, delivery trucks are frequently double-parked, as shown in Figure 40. This creates unsafe traffic operating conditions for through vehicles as well as for drivers searching for parking spaces. It is recommended that a study be conducted in collaboration with the local businesses to help set up truck delivery zone windows along the project corridor. This study will determine the number of deliveries, the frequency and duration, and the daily commercial delivery trends in order to develop a delivery window program for loading and unloading use. This study will help in designing truck delivery zones and the number of spaces needed to provide a balanced truck delivery operation. The delivery window program would be sensitive to the typical weekday parking demand of customers and that of daily truck delivery needs. Implementation of these delivery zone windows will be made in conjunction with the local community boards, and will further help to improve traffic operations along White Plains Road.

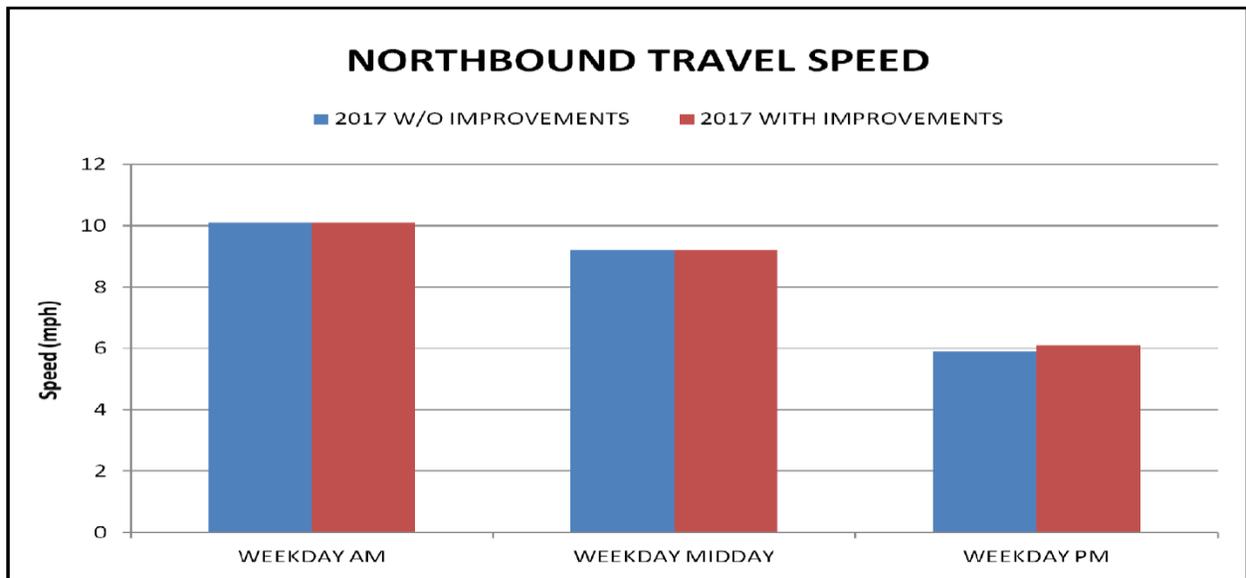
**Figure 41: Northbound Peak Period Travel Speeds for White Plains Road from East Tremont Avenue to East 233<sup>rd</sup> Street**

NORTHBOUND			SOUTHBOUND		
	2017 W/O IMPROVEMENTS (MPH)	2017 WITH IMPROVEMENTS (MPH)	CHANGE %	2017 W/O IMPROVEMENTS (MPH)	2017 WITH IMPROVEMENTS (MPH)	CHANGE %
WEEKDAY AM	10.1	10.1	0.0%	9.7	10.3	6.2%
WEEKDAY MIDDAY	9.2	9.2	0.0%	9.9	10.6	7.1%
WEEKDAY PM	5.9	6.1	3.4%	5.7	5.9	3.5%

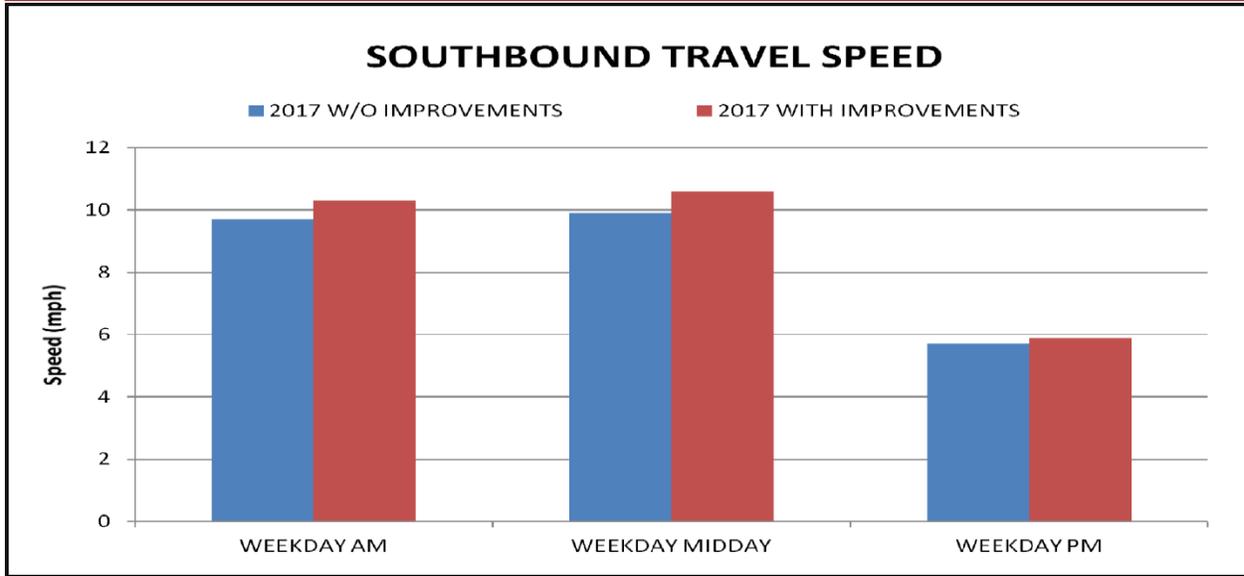
**Figure 42: Southbound Peak Period Travel Speeds for White Plains Road from East Tremont Avenue to East 233<sup>rd</sup> Street**
