# SOUTHWEST BROOKLYN MARINE TERMINAL STATION BULKHEAD INVESTIGATION

ANNUAL BULKHEAD INSPECTION

PROJECT NO.	A092286
DOCUMENT NO.	
VERSION	1
DATE OF ISSUE	12/23/2016
PREPARED	DDJS
CHECKED	JOAC
APPROVED	JOAC

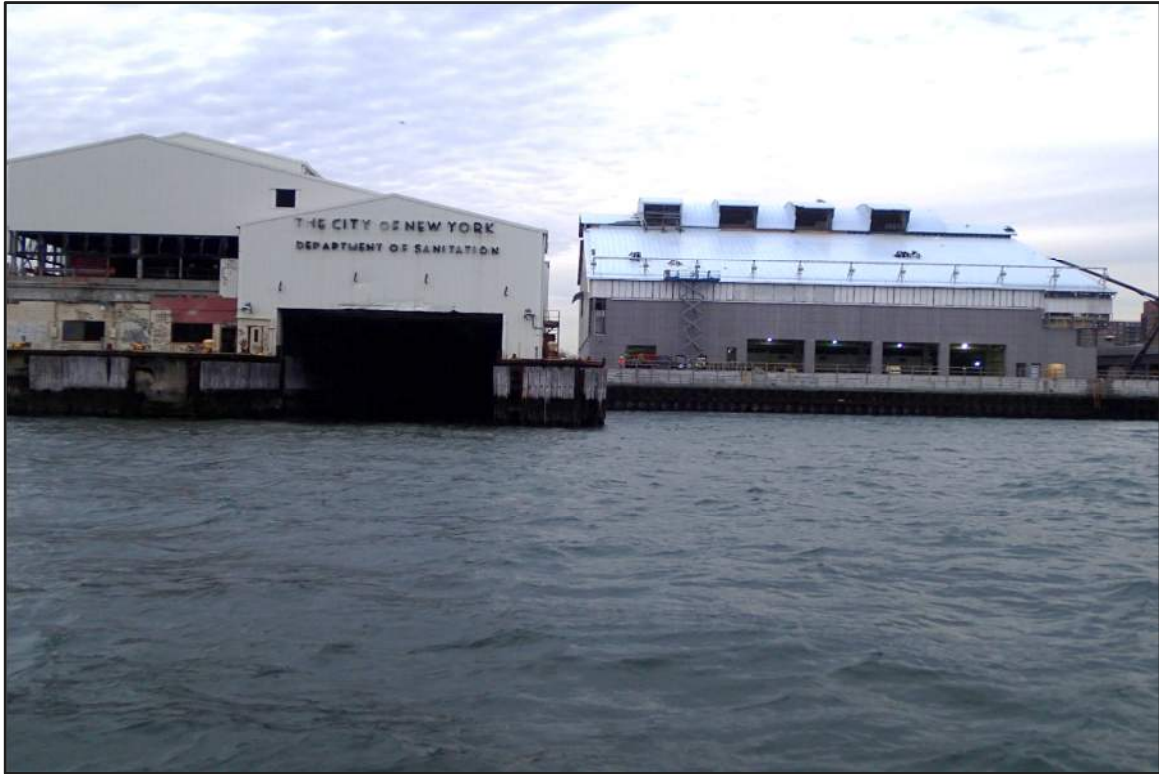
*Photograph 1: Former southwest Brooklyn Marine Transfer Station and ongoing inshore construction (Looking east)*

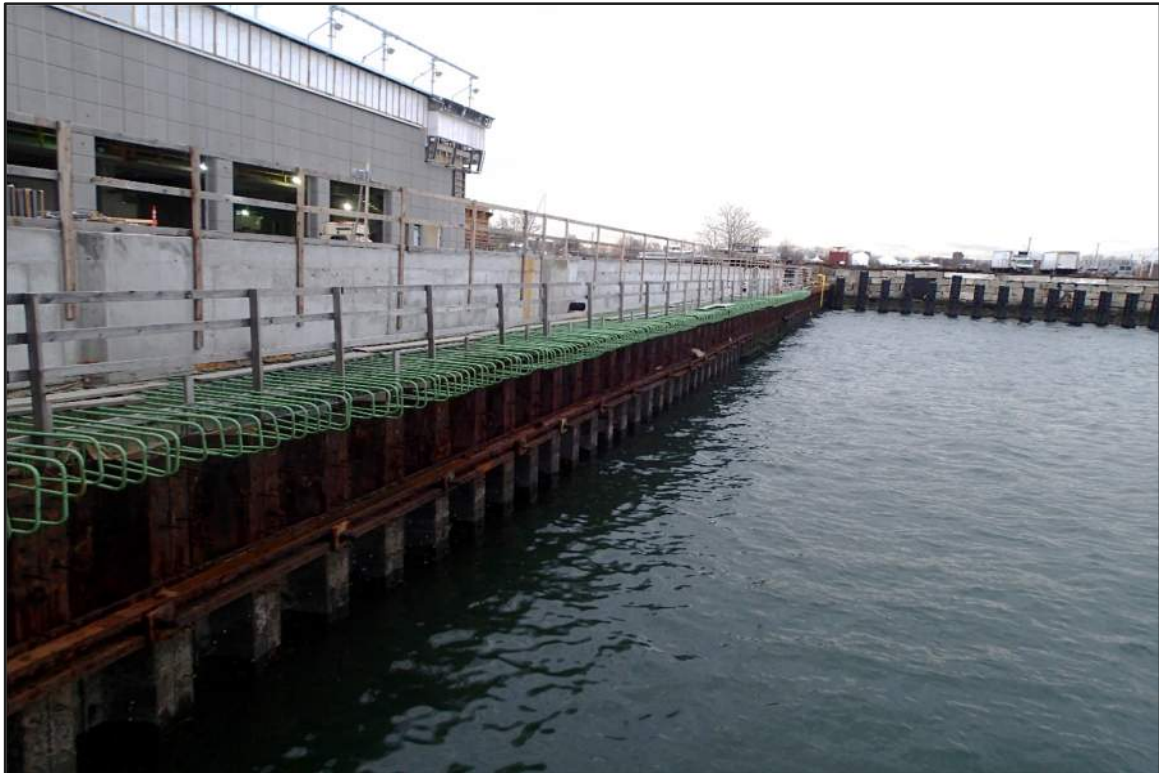
*Photograph 2: Overview of the North Bulkhead and active construction site (Looking southeast)*

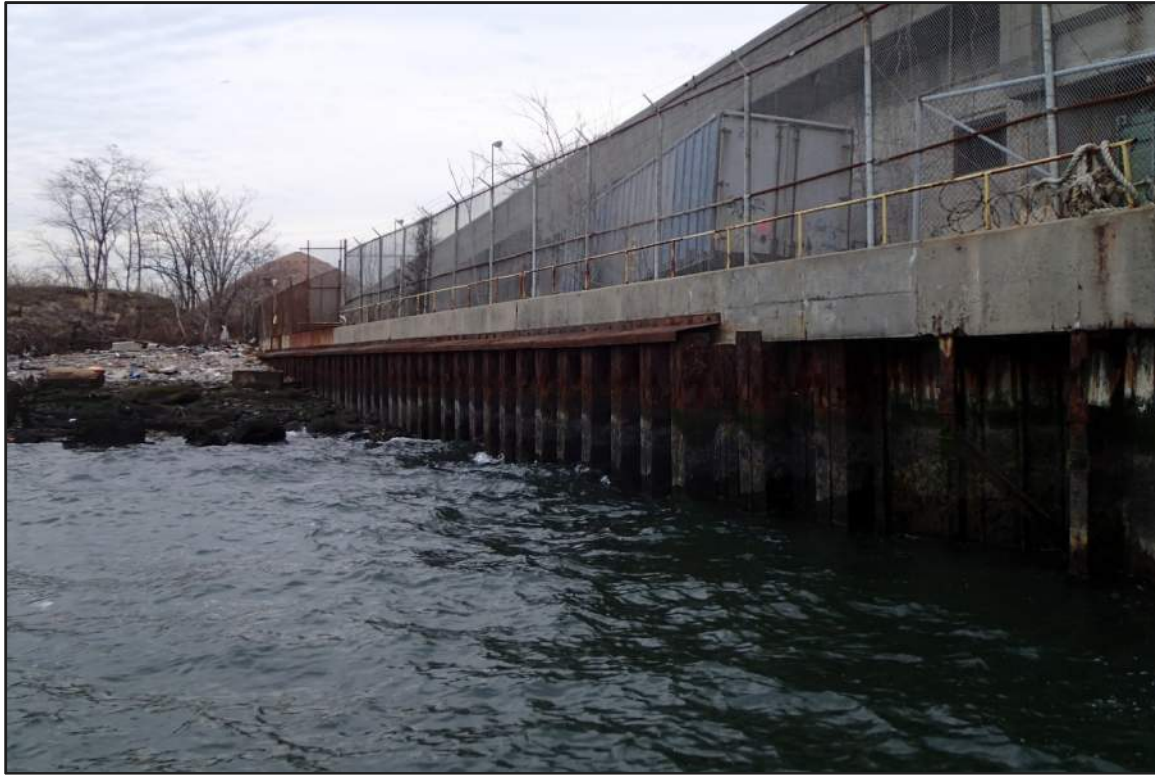
The West Bulkhead extends from the shoreline to the west for approximately 189 LF, and is composed of Z-shape steel sheet piles for the eastern 164 LF (Photograph 3). The western 25 LF of the West Bulkhead is constructed of steel sheet pile cells (Photograph 4), and are within the scope of this inspection. To the west of the West Bulkhead, and outside of the scope of this inspection, the steel sheet pile cellular cofferdams continue along the North Pier (Photograph 5).

*Photograph 3: Overview of the West Bulkhead (Looking southeast)*

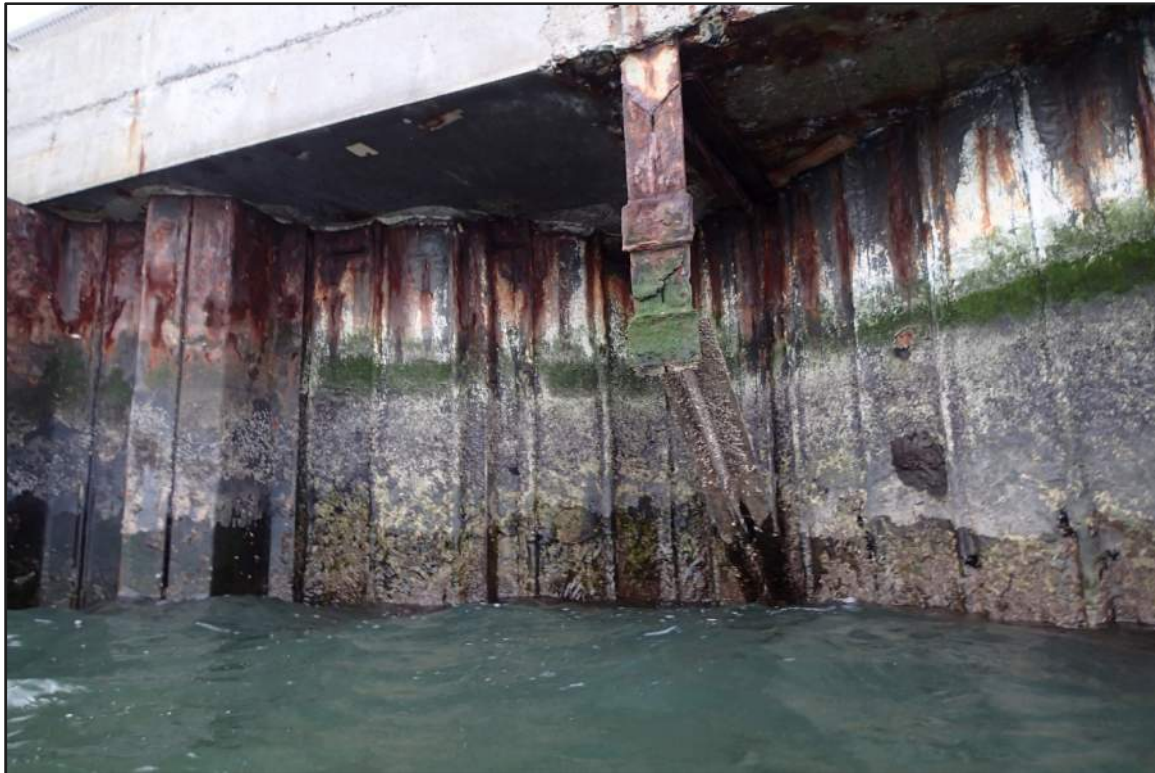
*Photograph 4: West Bulkhead - Steel sheet pile cell interface with steel sheet pile bulkhead (looking southeast)*

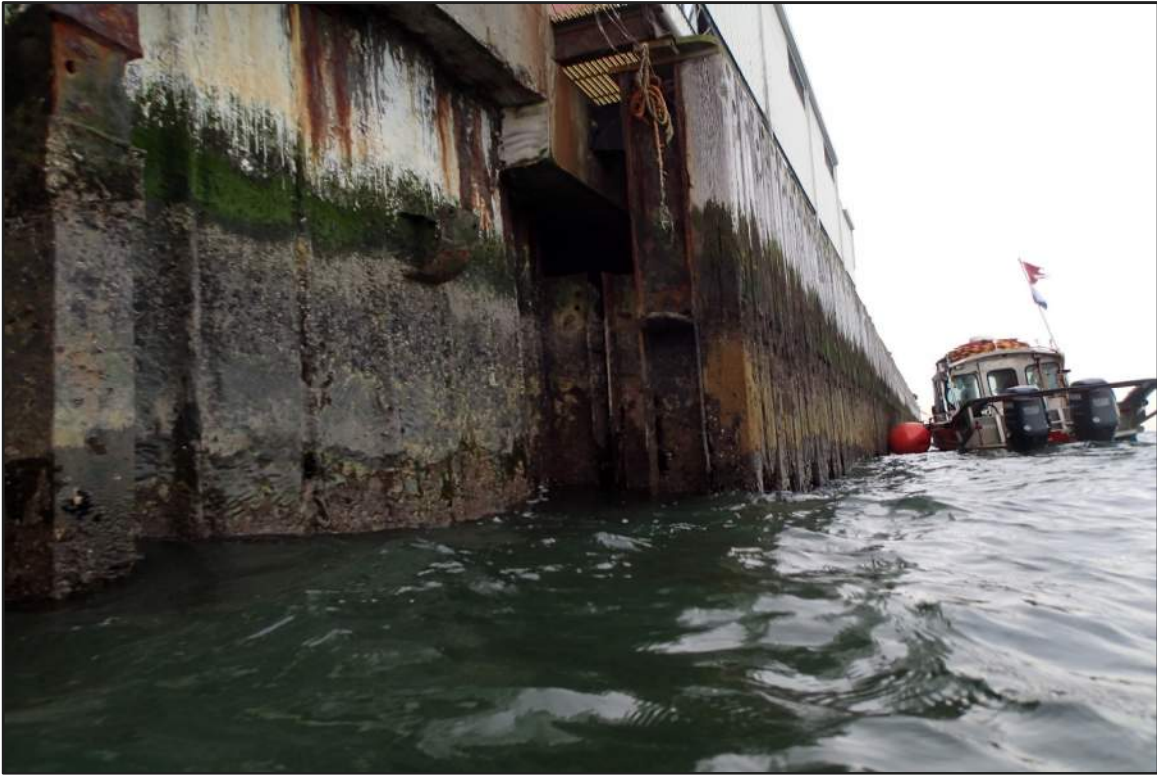
*Photograph 5: West Bulkhead – Transition between West Bulkhead and North Pier steel sheet pile cofferdams (Looking west)*

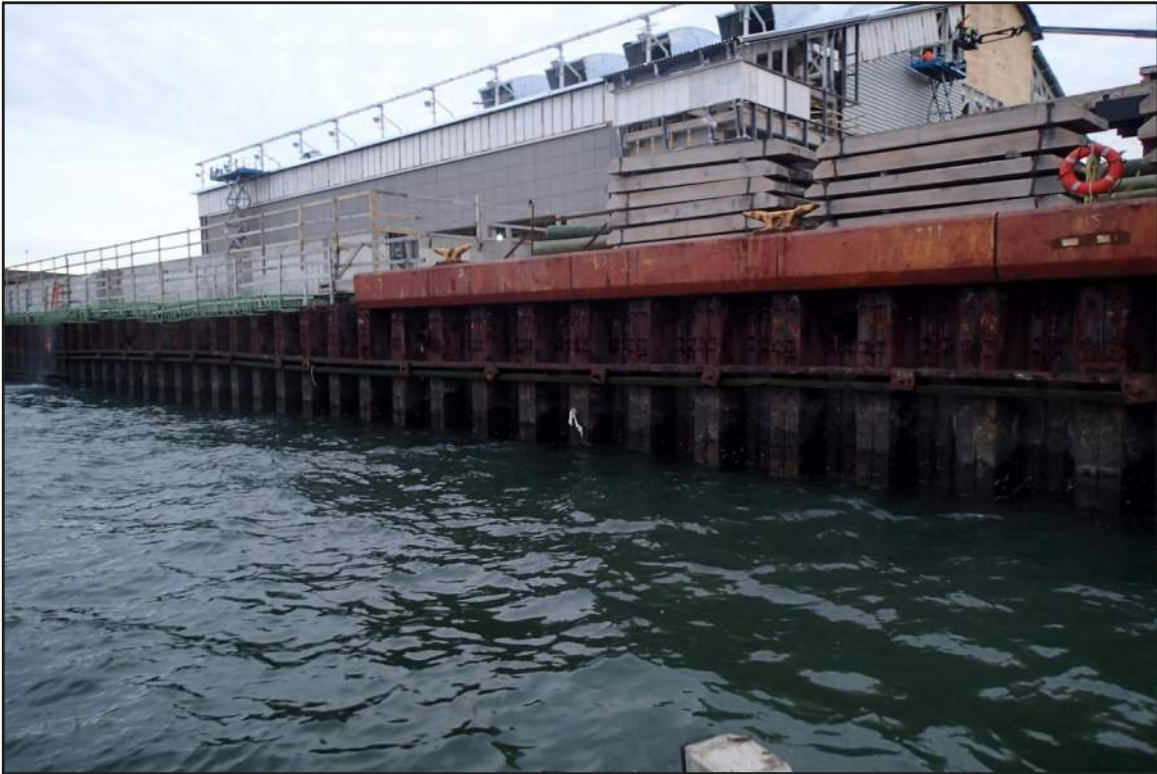
The North Bulkhead is located along the offshore face of the facility, and is parallel to the waterway (Photograph 6). This section of bulkhead intersects the northeast end of the North Pier, and extends south for approximately 426 LF. The northern section of the North bulkhead comprises steel sheet pile cells forming cellular cofferdams (approximately 75 LF) (Photograph 7), which transitions to Z-shape steel sheet piles to the south (approximately 351 LF) (Photograph 8). The steel sheet pile portion of the North Bulkhead is tied back with a series of steel anchor rods, which are attached to an external double channel wale (Photograph 9). The steel anchor rod tie-backs for the North Bulkhead are presumably connected to a deadman system, located inshore of the bulkhead. However, details of the inshore portions of the tie-back system are not known. Additionally, the existing sheet pile was reportedly installed as overshooting, outboard of the original steel sheet pile cells.

*Photograph 6: Overview of the North Bulkhead (Looking northeast)*

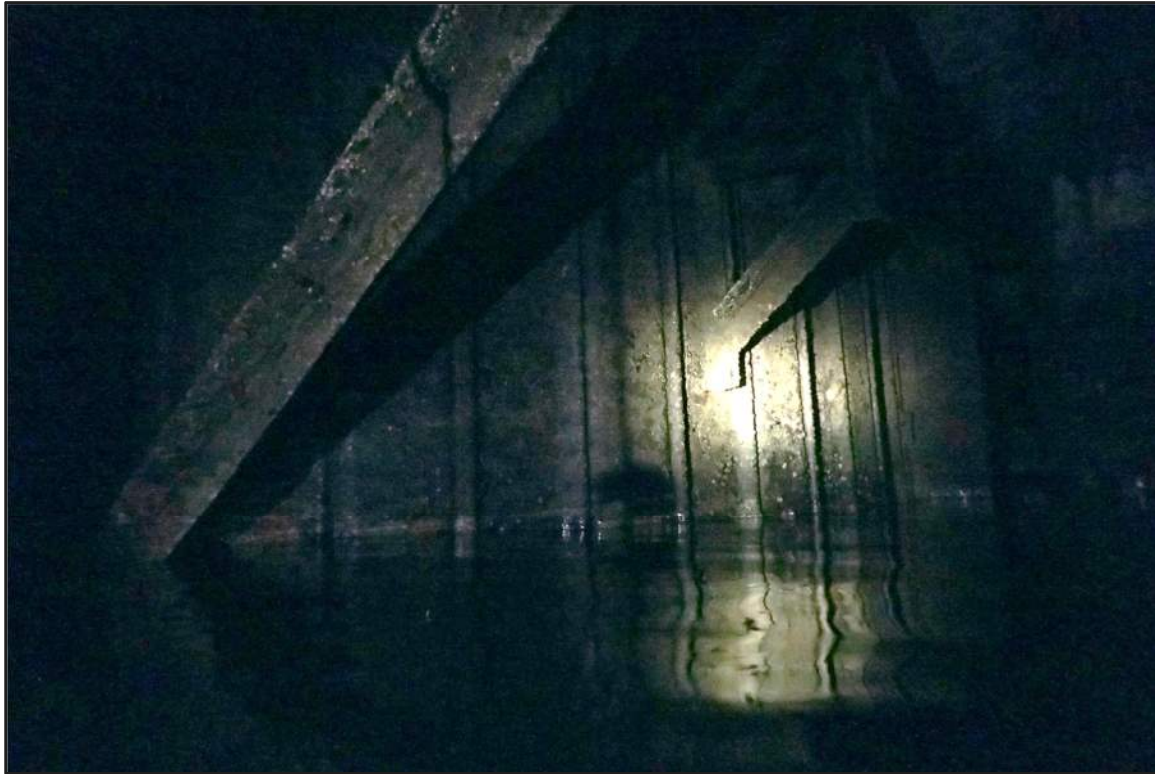
*Photograph 7: North Bulkhead – Steel sheet pile cell under North Pier (looking southeast)*

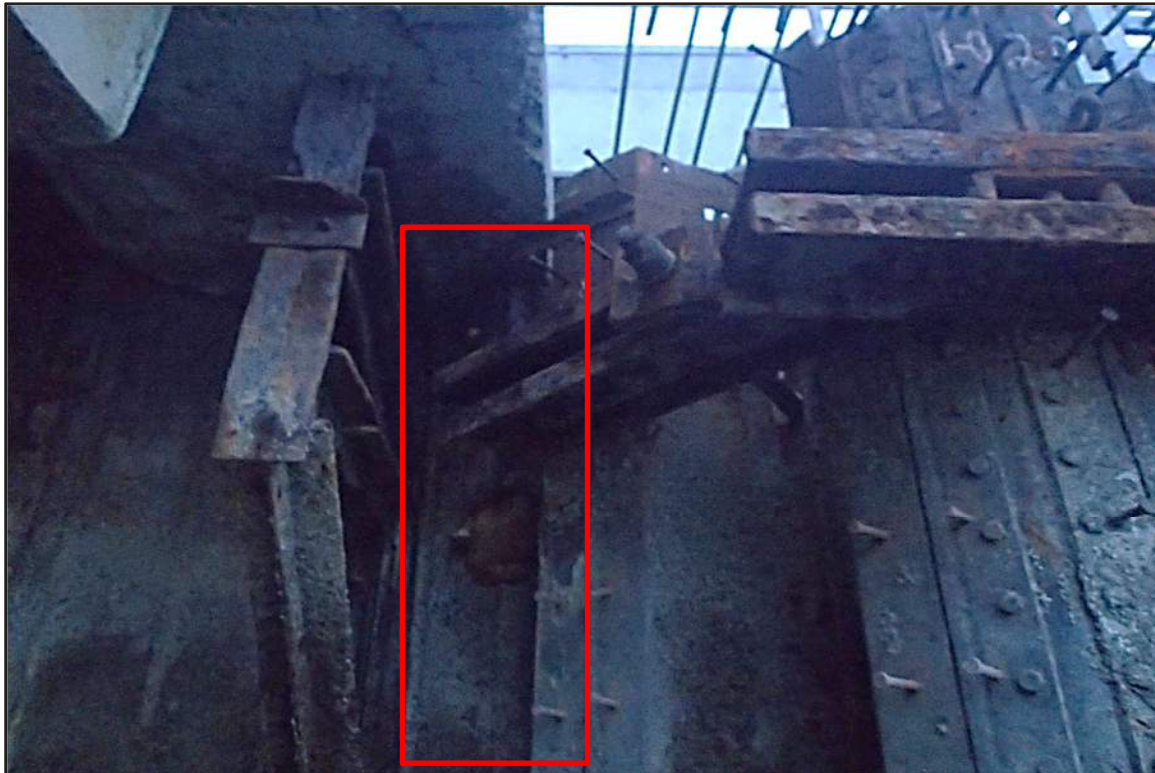
*Photograph 8: North Bulkhead – Transition from steel sheet pile cell to steel sheet pile bulkhead (looking east)*

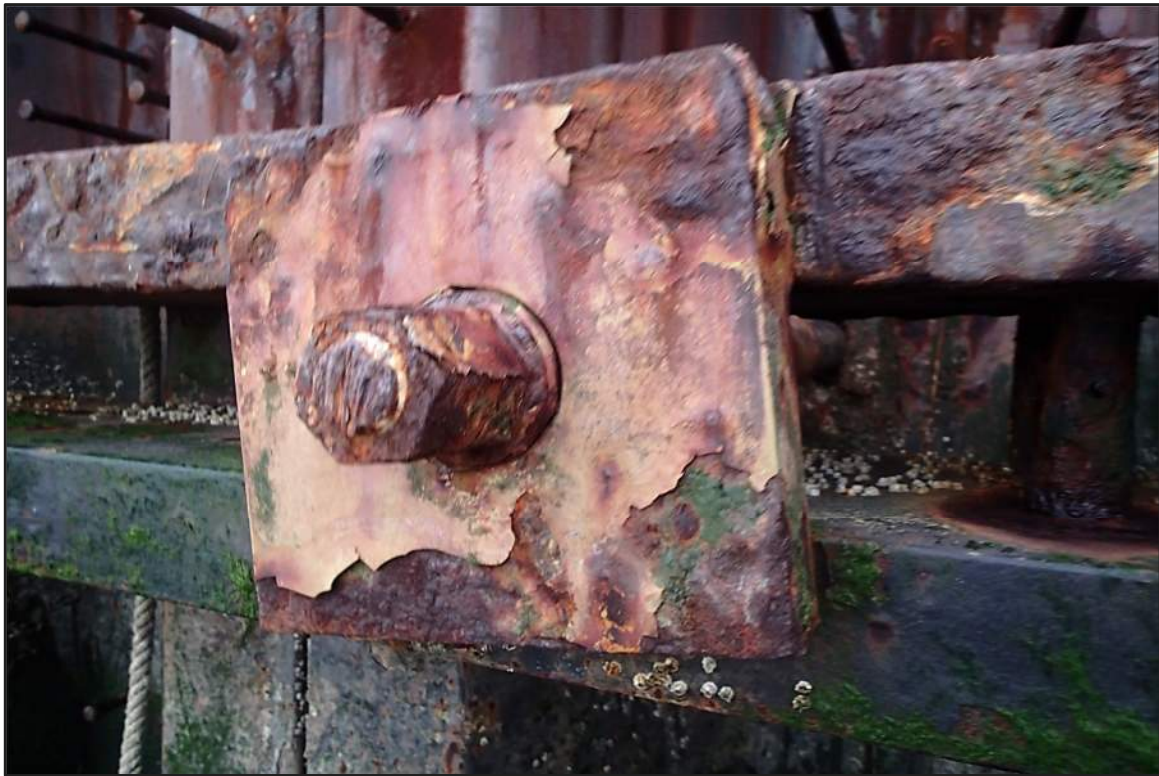
Photograph 9: North Bulkhead - Typical steel double channel wale, anchor rod, and hardware (Looking southeast)

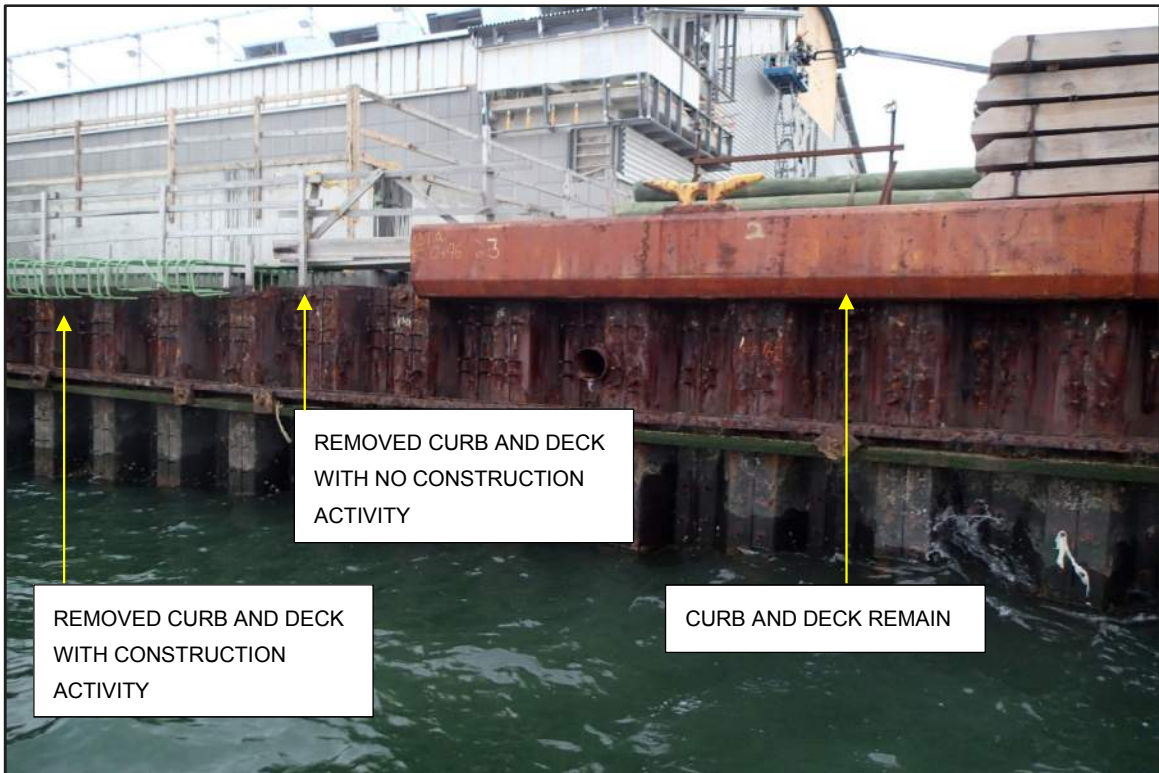
Approximately 234 LF of concrete deck and curb is demolished due to the ongoing construction, inshore of the steel sheet pile bulkhead (Photograph 10). A reinforced concrete bulkhead is currently under construction, approximately 3 LF inshore of the

Photograph 10: North Bulkhead – Removed curb and deck interface with active construction (looking northeast)

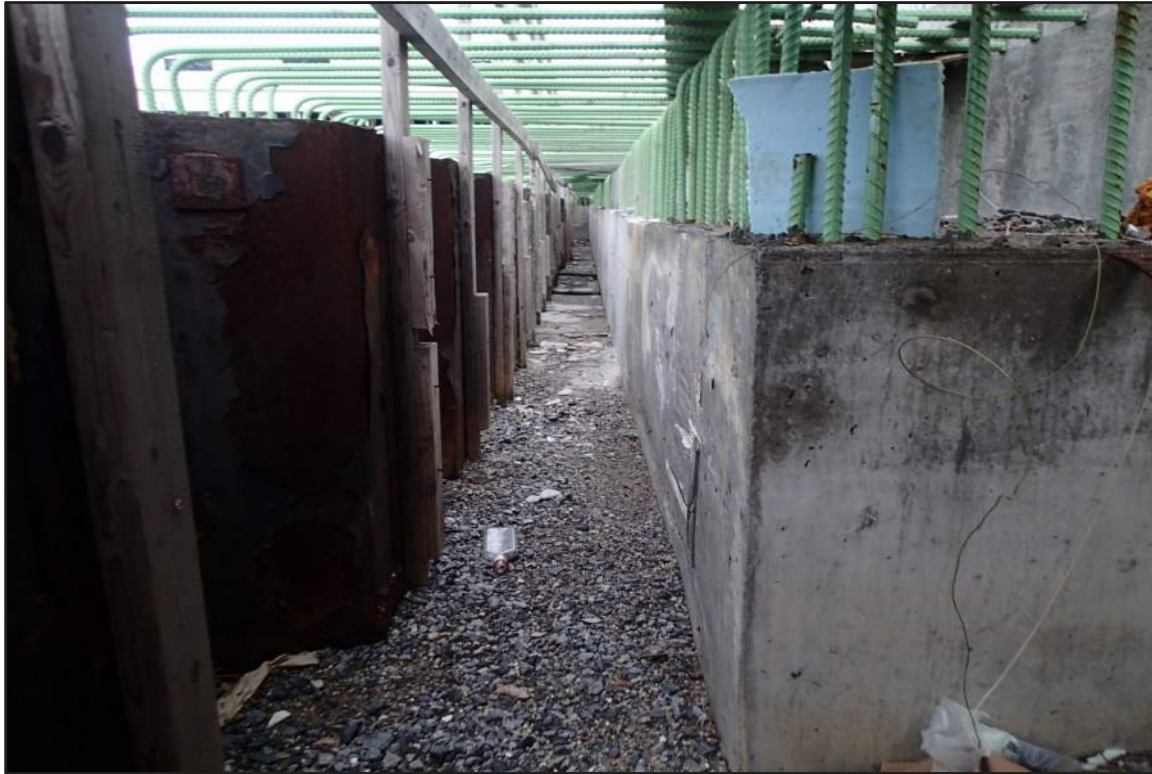
*Photograph 11: North Bulkhead – Concrete bulkhead with partially filled annulus between concrete and steel sheet pile bulkheads (Looking north)*

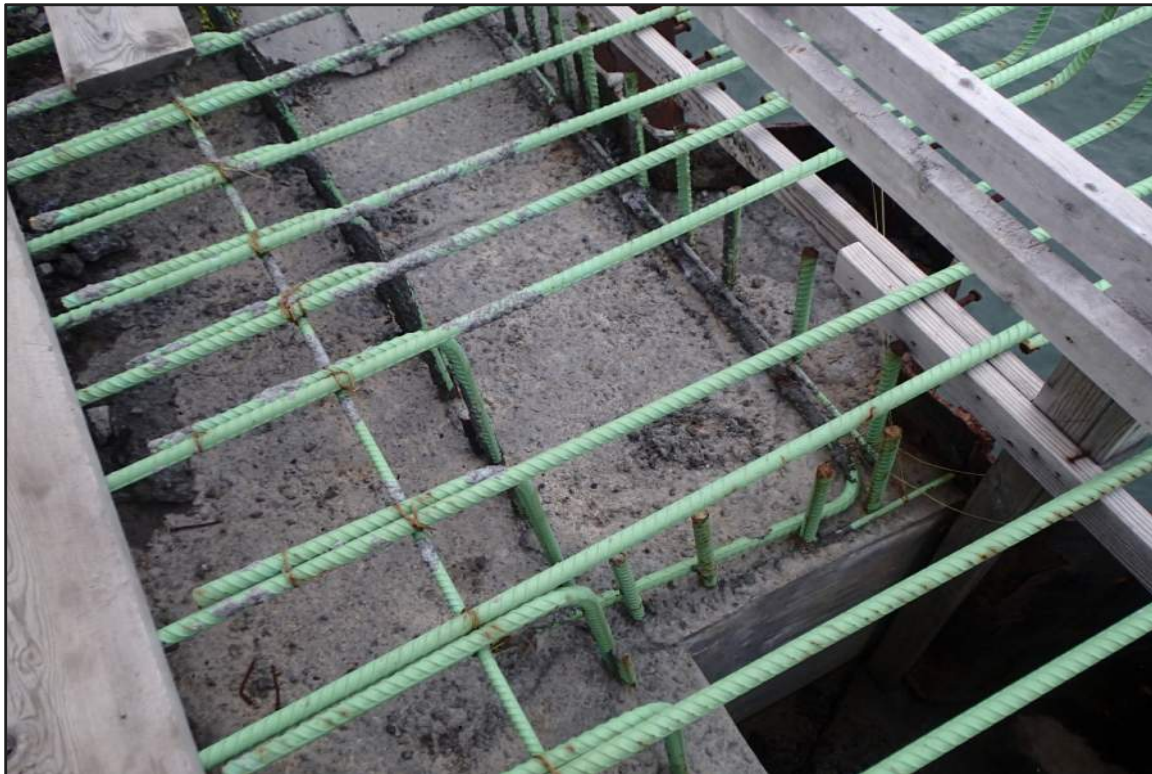
*Photograph 12: North Bulkhead – Extended concrete bulkhead between Sta. 1+90 and 1+97 (Looking southwest)*

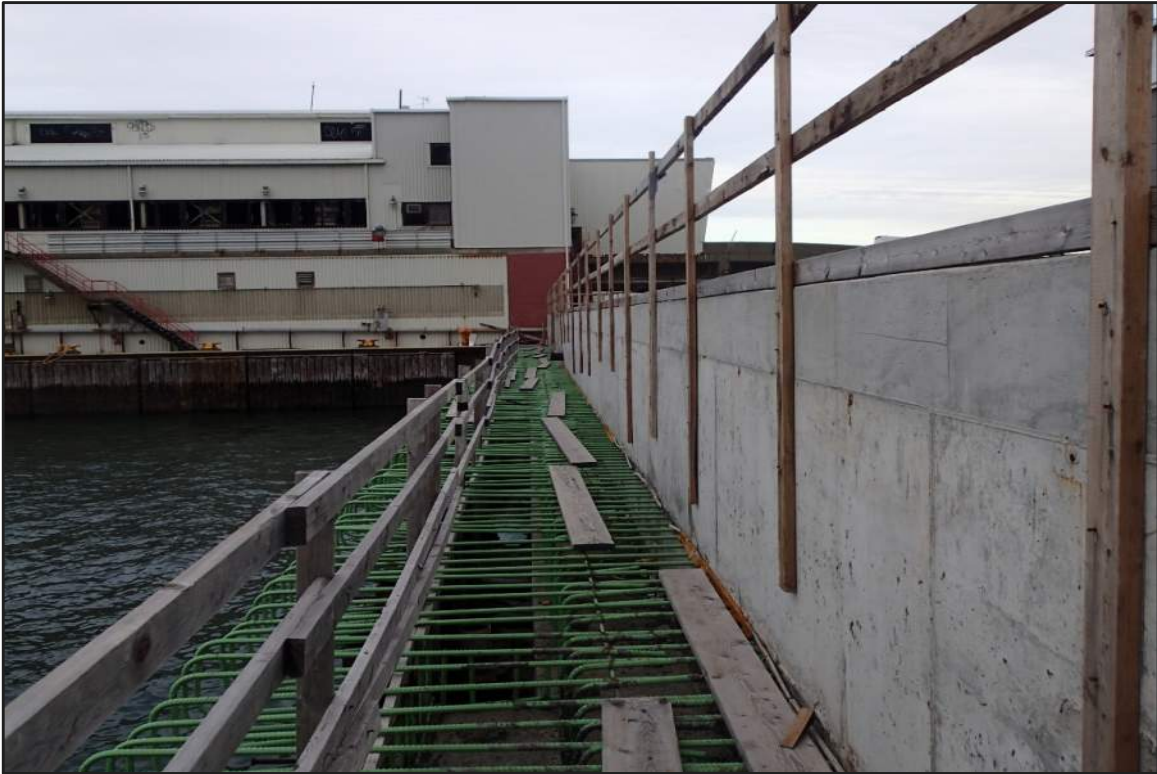
*Photograph 13: North Bulkhead – Partially constructed structure with exposed epoxy coated reinforcement (looking north)*

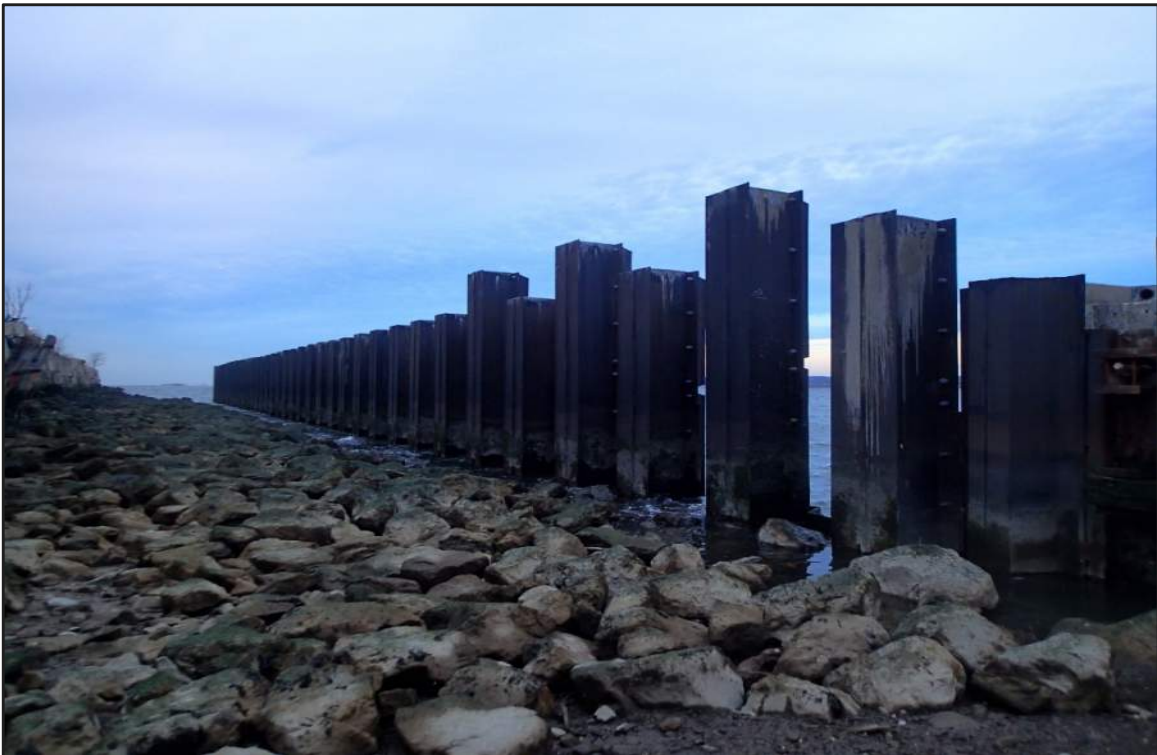
*Photograph 14: North Bulkhead – Interface between North and East bulkheads and steel sheet pile fender and revetment retaining structure to the west (looking northwest)*

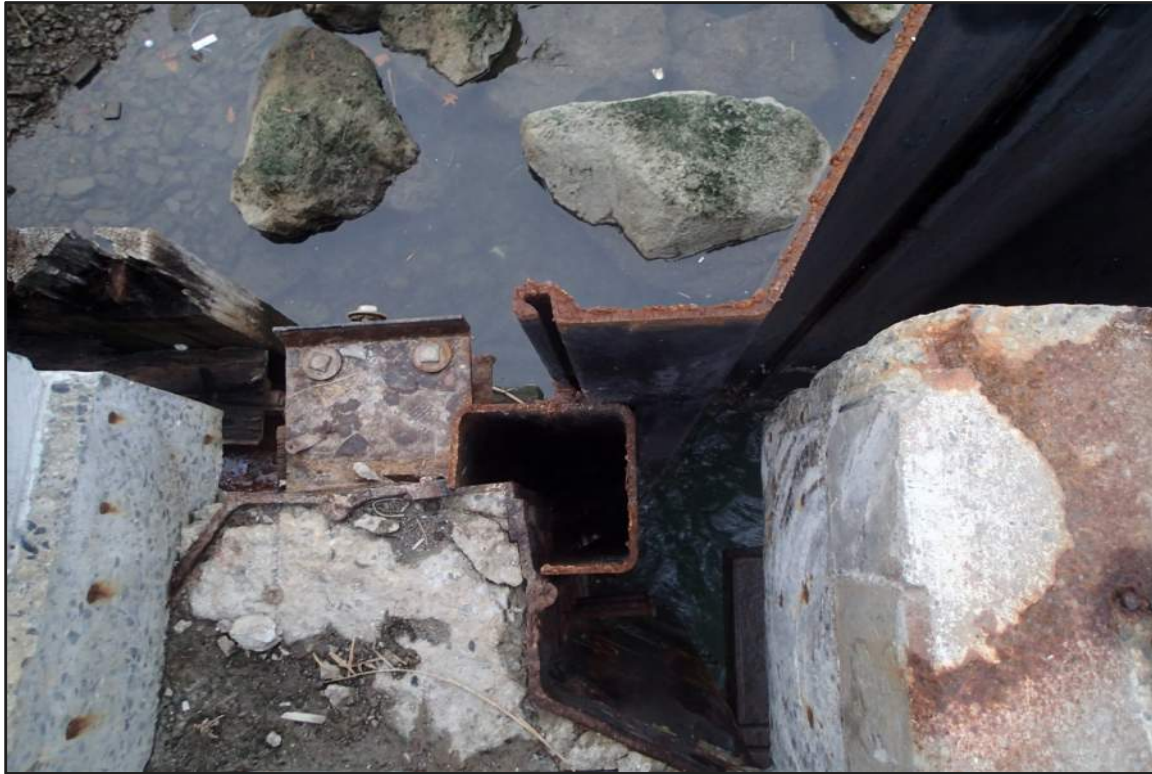
*Photograph 15: North Bulkhead – Deck demolition at North and East bulkhead interface to install transition element for new steel sheet pile to the west*

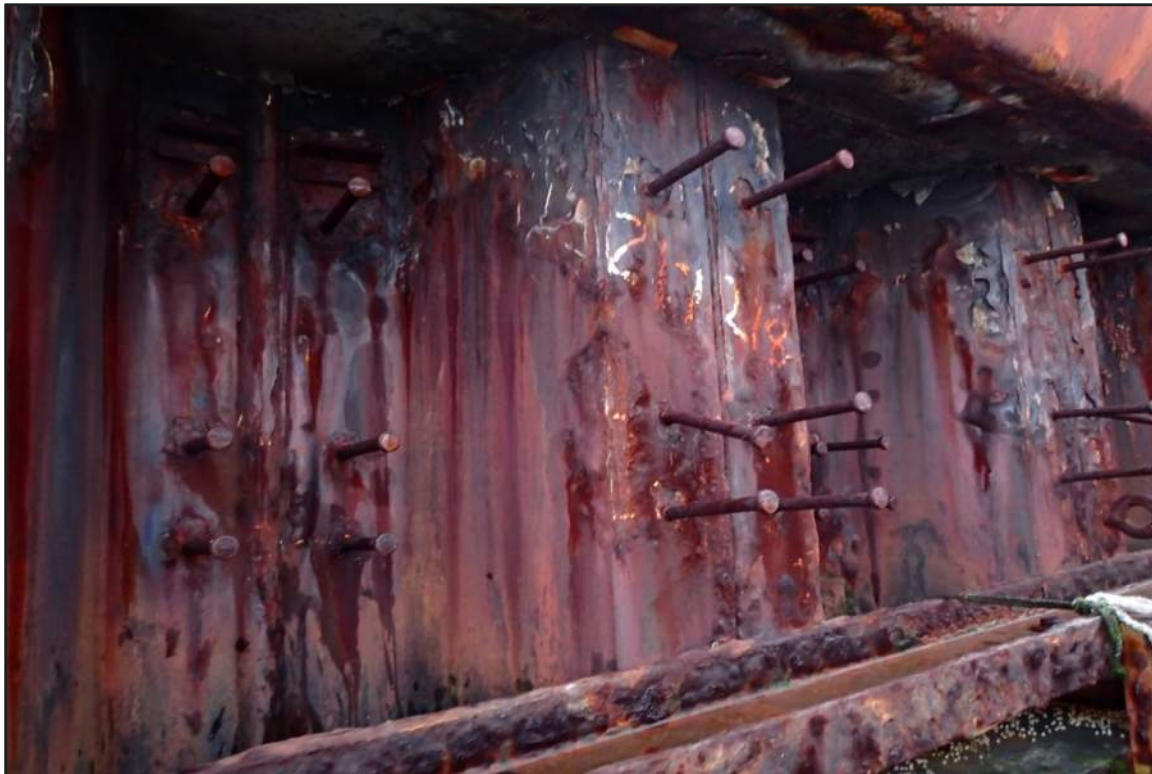
*Photograph 16: North Bulkhead – Typical shear bolt installation above water (Looking southeast)*

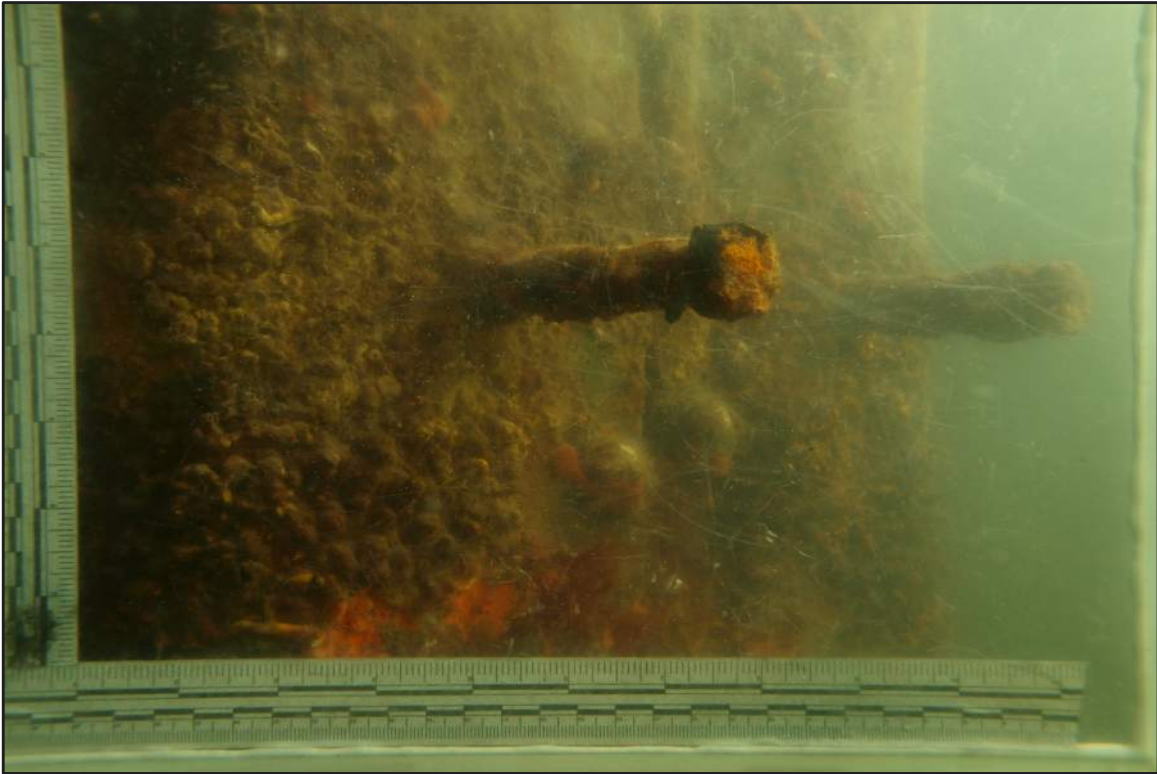
*Photograph 17: North Bulkhead –Elevation of shear bolts below wale system on outer flanges*

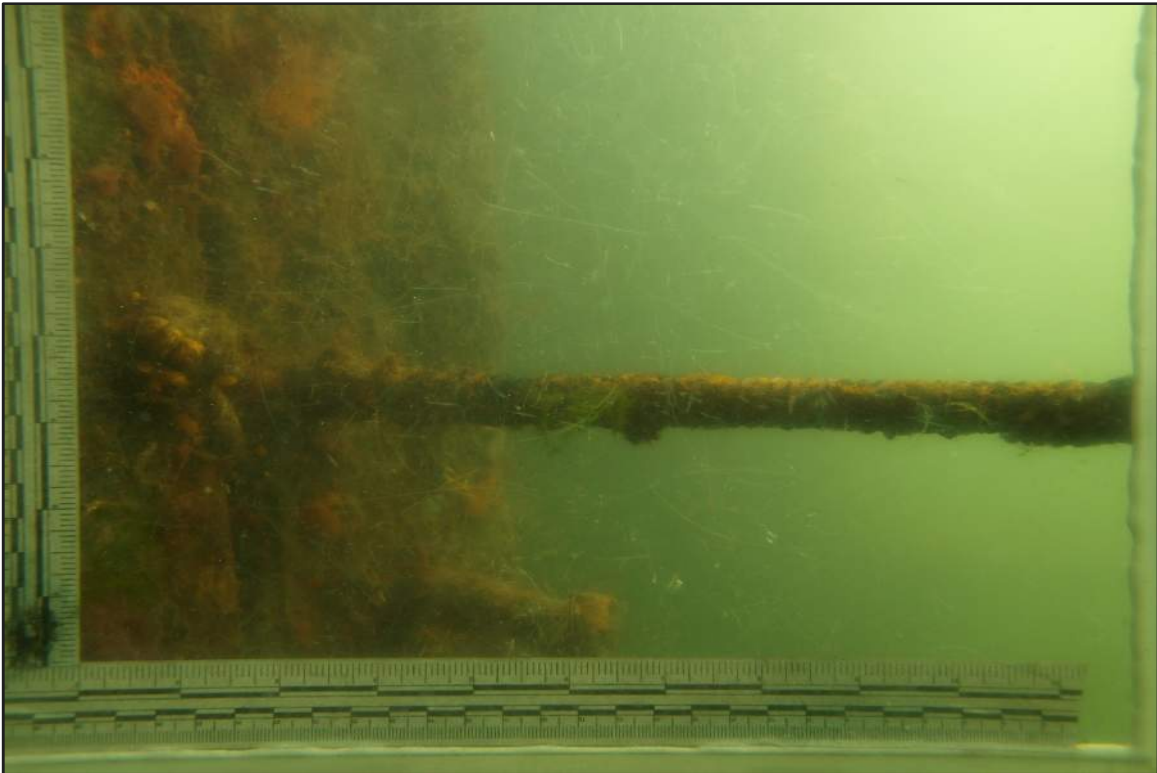
*Photograph 18: North Bulkhead – Threaded rod installed between shear bolt elevations*

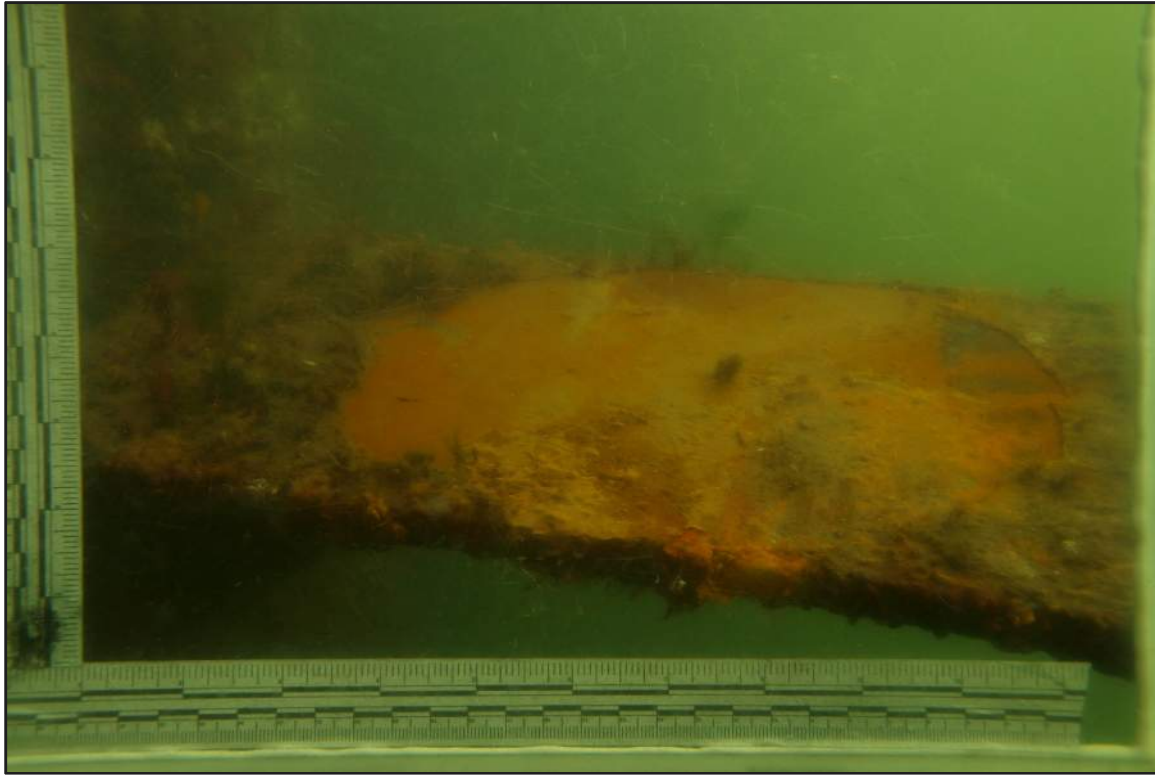
*Photograph 19: North Bulkhead – Steel bracket installed below shear bolts*

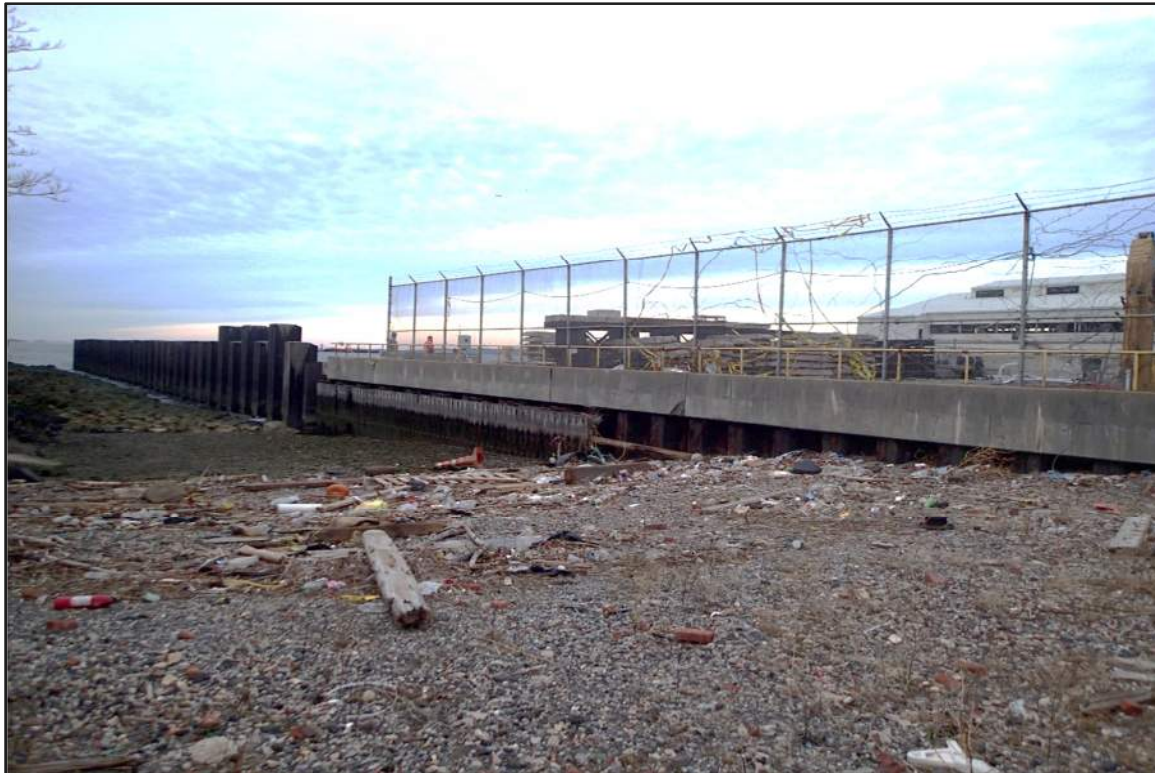
The East Bulkhead intersects the southern extent of the North Bulkhead, and returns inshore, to the east, approximately 144 LF (Photograph 20). Typically, the bulkhead is composed of Z-shaped steel sheet piles with an external double channel wale, which is secured with a series of steel anchor rods. As stated above, new steel sheet piles, that extend west from the intersection between the East and North Bulkheads, are retaining the stone revetment to the south, and providing fendering to the north (Photograph 21). Additionally, the eastern approximate 14 LF of bulkhead is partially demolished, with the concrete deck and curb removed, and a small portion of steel sheet pile bulkhead is visible (Photograph 22 and Photograph 23).

*Photograph 20: Overview of the East Bulkhead (Looking northwest)*

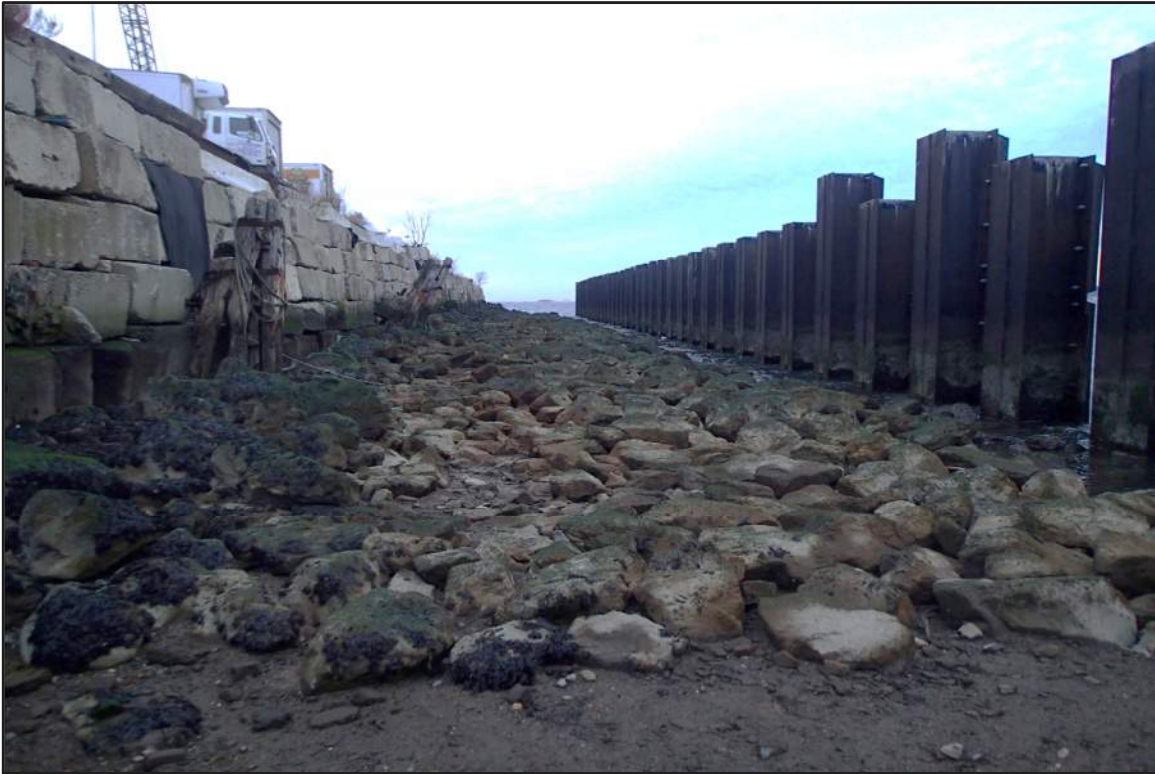
*Photograph 21: Overview of revetment and steel sheet piles extending offshore from intersection of North and East Bulkheads (Looking west)*

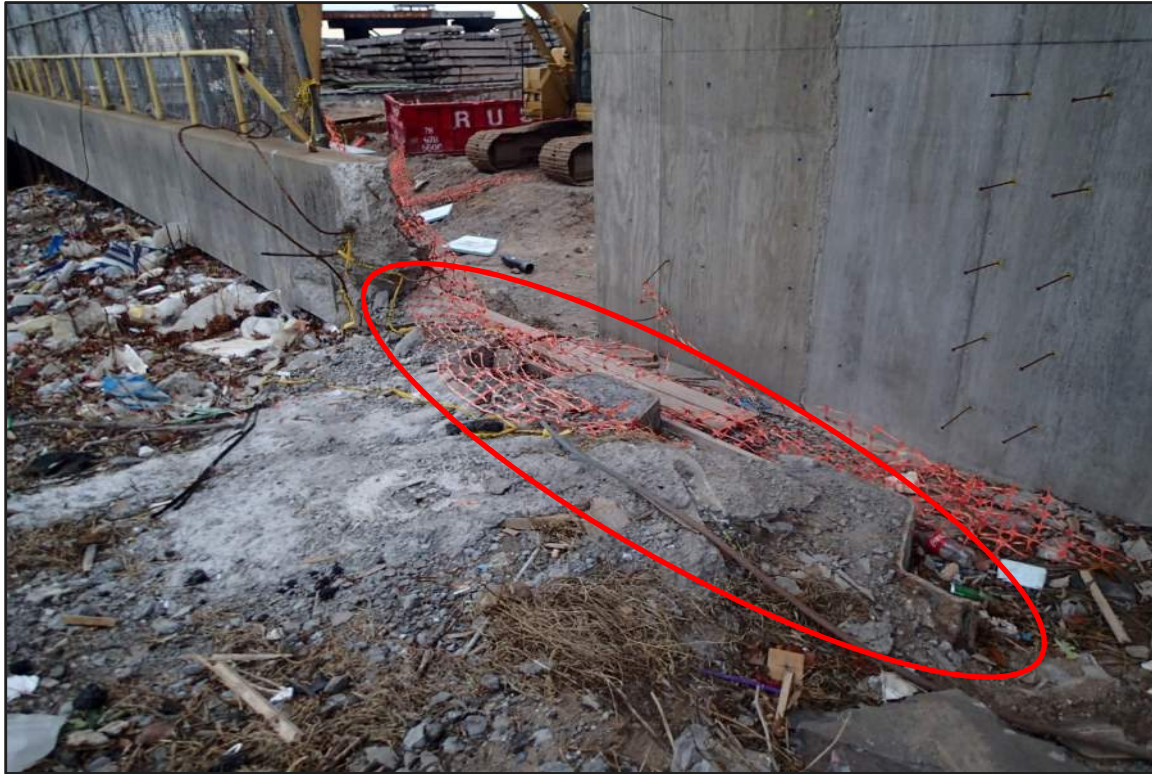
*Photograph 23: East Bulkhead – Exposed steel sheet pile bulkhead where curb and deck are removed (Looking northwest)*

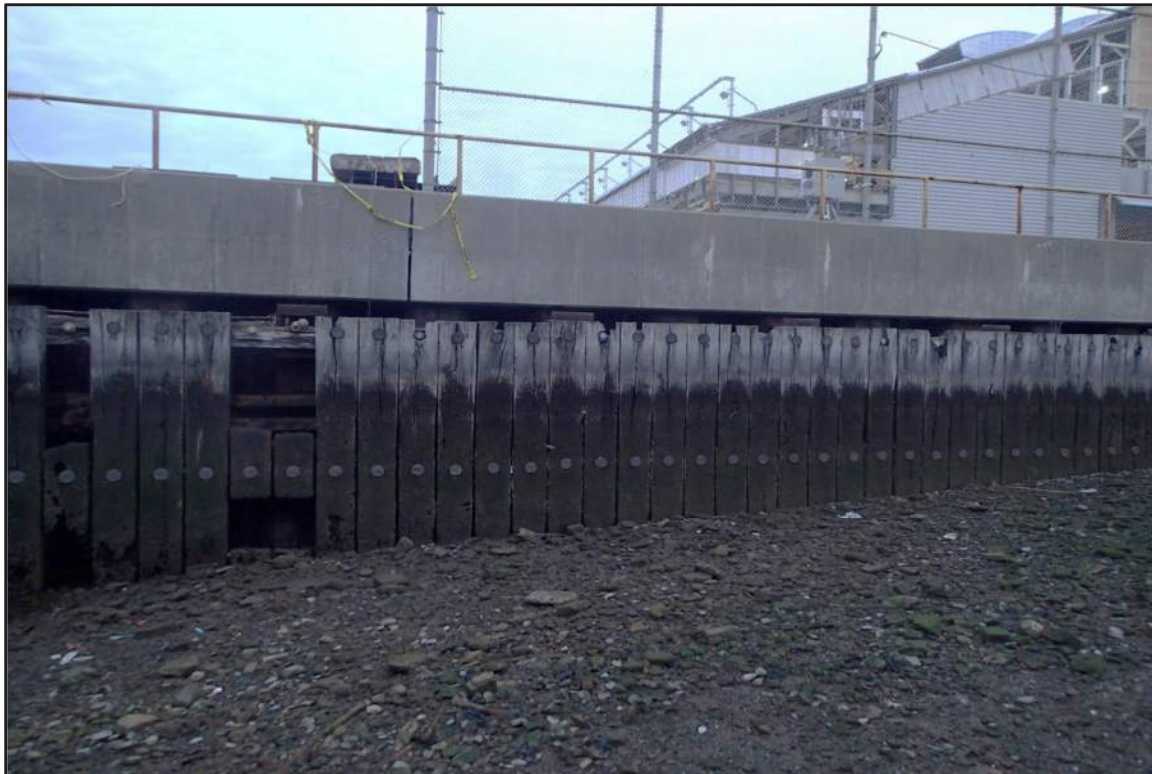
6 inch by 12 inch fender planks, two (2) elevations of 12 inch by 12 inch timber wales, and steel brackets, which tie the system back to the steel sheet pile bulkhead (Photograph 24).

*Photograph 24: East Bulkhead – Timber fender system (looking north)*
