# SOUTHWEST BROOKLYN MARINE TRANSFER STATION BULKHEAD INVESTIGATION

ANNUAL BULKHEAD INSPECTION

PROJECT NO. A092286  
DOCUMENT NO.  
VERSION 4  
DATE OF ISSUE 12/28/2017 (Rev 1 – 02/26/2018)  
PREPARED SPWN  
CHECKED DDJS  
APPROVED JOAC

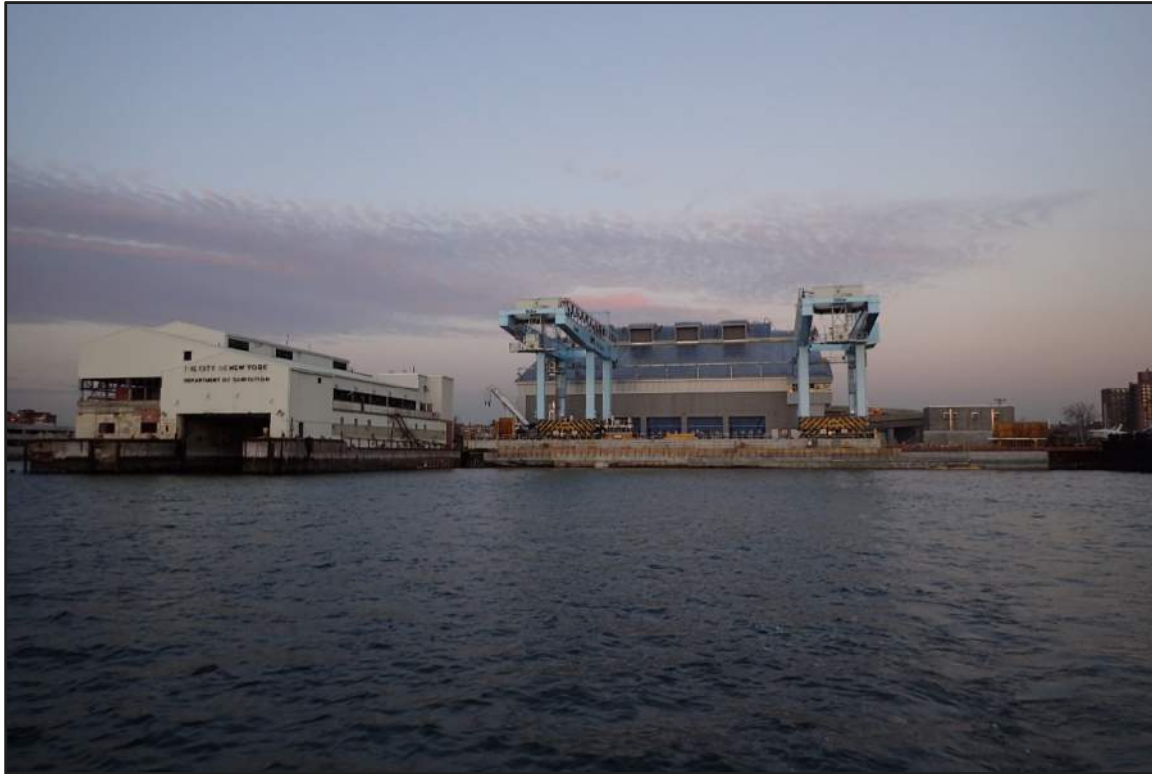
*Photograph 1: Former southwest Brooklyn Marine Transfer Station and ongoing inshore construction (Looking east)*

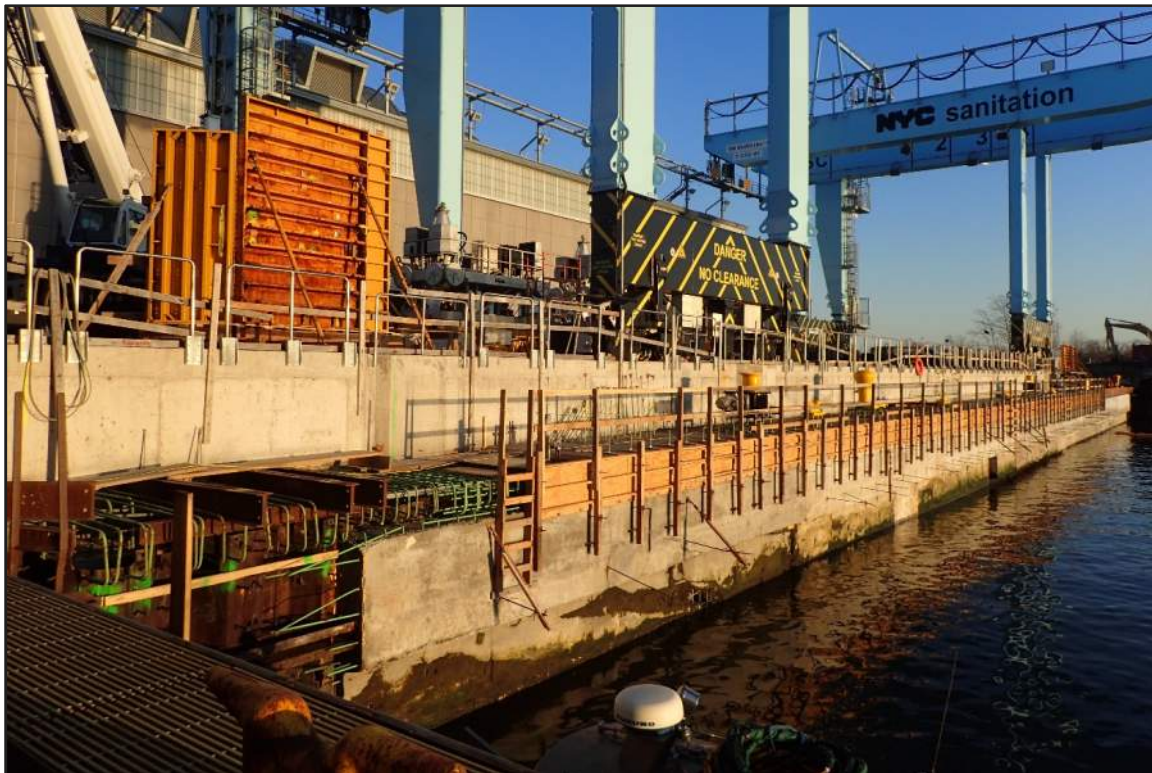
*Photograph 2: Overview of the North Bulkhead and active construction site (Looking southeast)*

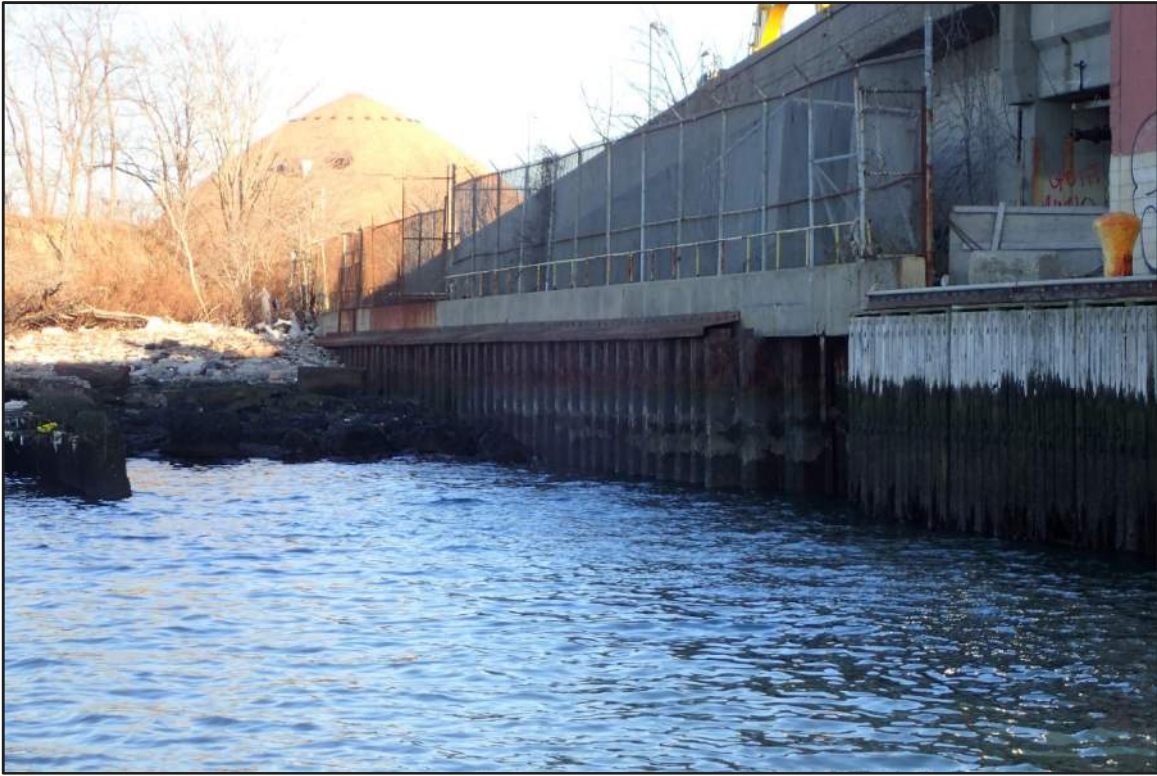
The West Bulkhead extends from the shoreline to the west for approximately 189 LF, and is composed of Z-shape steel sheet piles for the eastern 164 LF (Photograph 3). The western 25 LF of the West Bulkhead is constructed of steel sheet pile cells (Photograph 4), and are within the scope of this inspection. To the west of the West Bulkhead, and outside of the scope of this inspection, the steel sheet pile cellular cofferdams continue along the North Pier (Photograph 5).

*Photograph 3: Overview of the West Bulkhead (Looking east)*

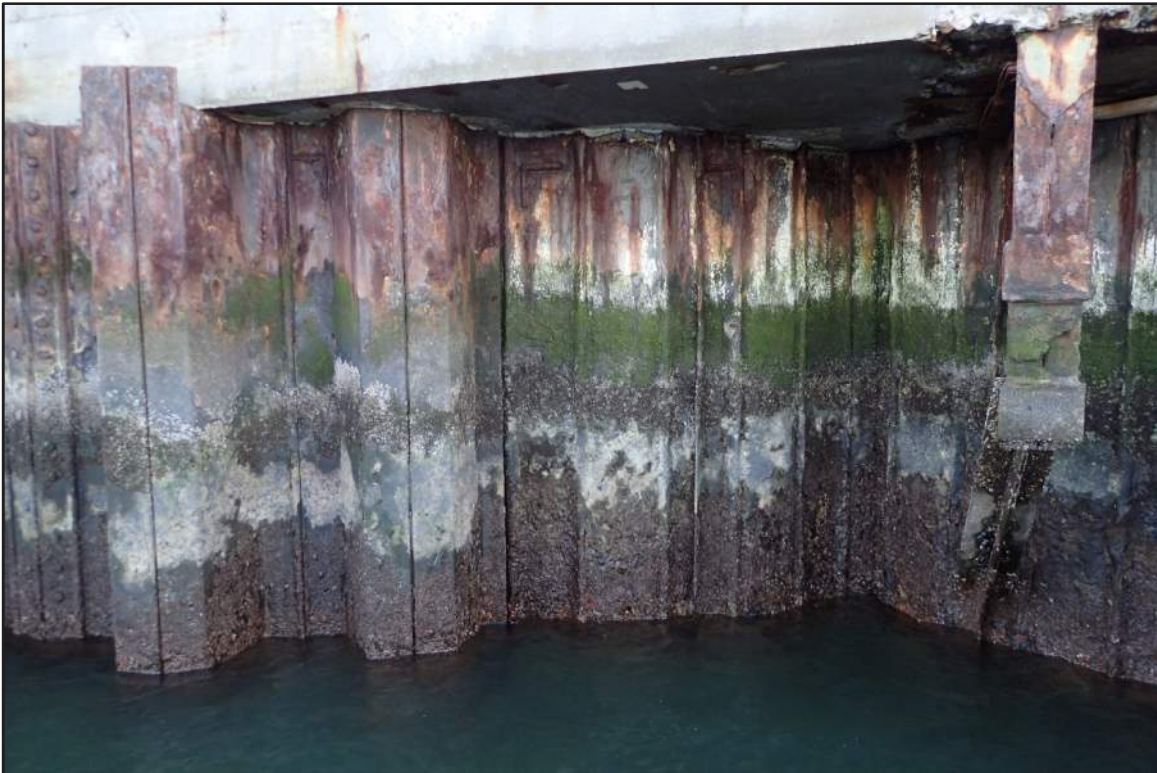
*Photograph 4: West Bulkhead - Steel sheet pile cell interface with steel sheet pile bulkhead (Looking southeast)*

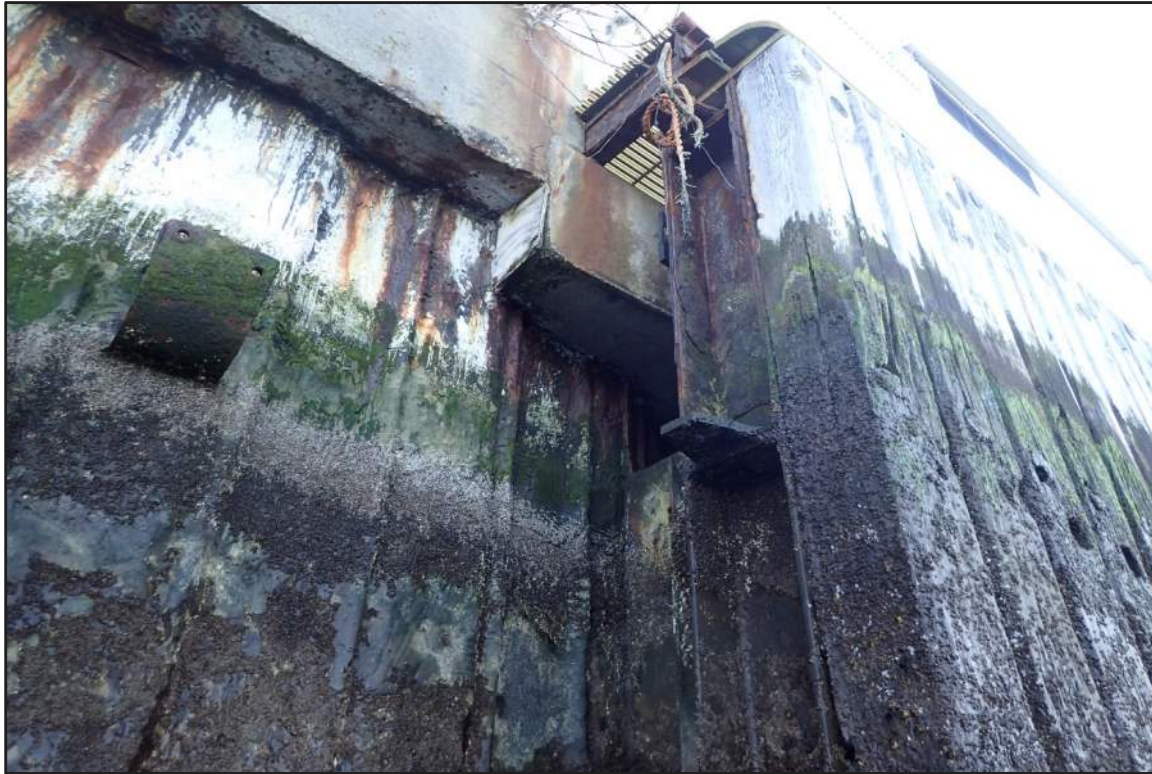
*Photograph 5: West Bulkhead – Transition between West Bulkhead and North Pier steel sheet pile cofferdams (Looking southwest)*

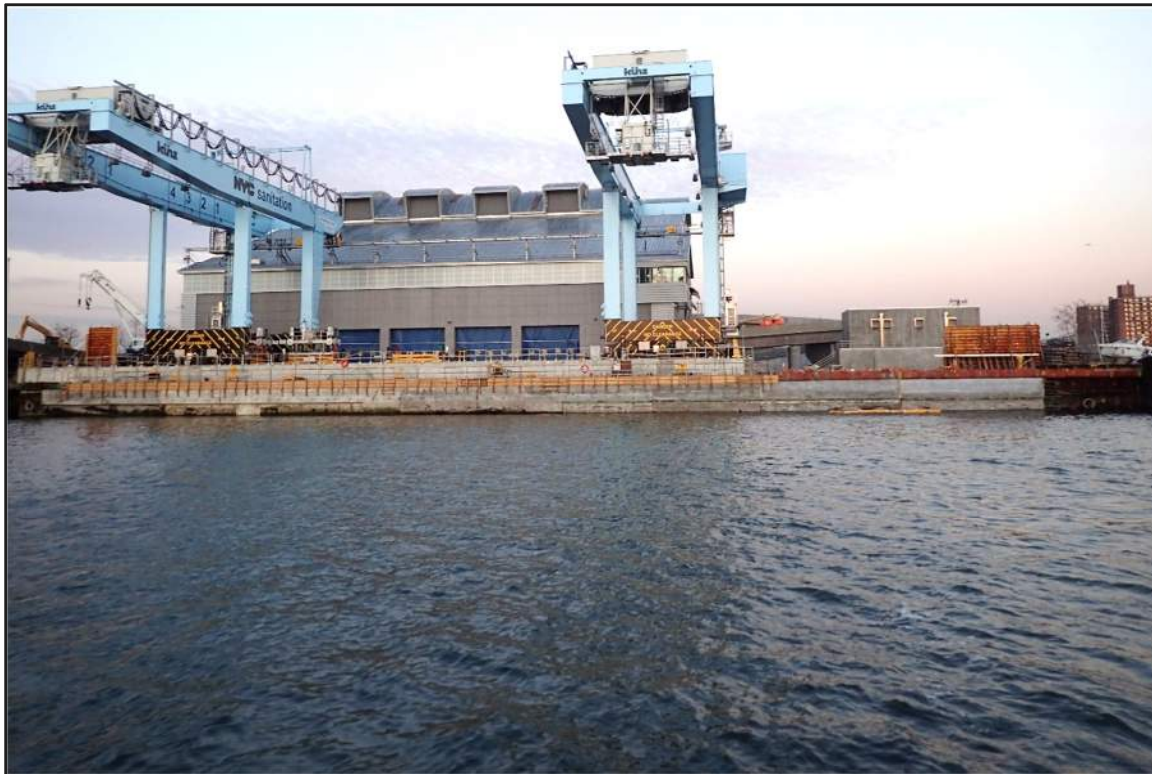
The North Bulkhead is located along the offshore face of the facility, and is parallel to the waterway (Photograph 6). This section of bulkhead intersects the northeast end of the North Pier, and extends south for approximately 426 LF. The northern section of the North bulkhead comprises steel sheet pile cells forming cellular cofferdams (approximately 75 LF) (Photograph 7), which transitions to Z-shape steel sheet piles to the south (approximately 351 LF) (Photograph 8). The steel sheet pile portion of the North Bulkhead is tied back with a series of steel anchor rods, which are attached to an external double channel wale (Photograph 9). The steel anchor rod tie-backs for the North Bulkhead are presumably connected to a deadman system, located inshore of the bulkhead. However, details of the inshore portions of the tie-back system are not known. Additionally, the existing sheet pile was reportedly installed as oversheeting, outboard of the original steel sheet pile cells.

*Photograph 6: Overview of the North Bulkhead (Looking northeast)*

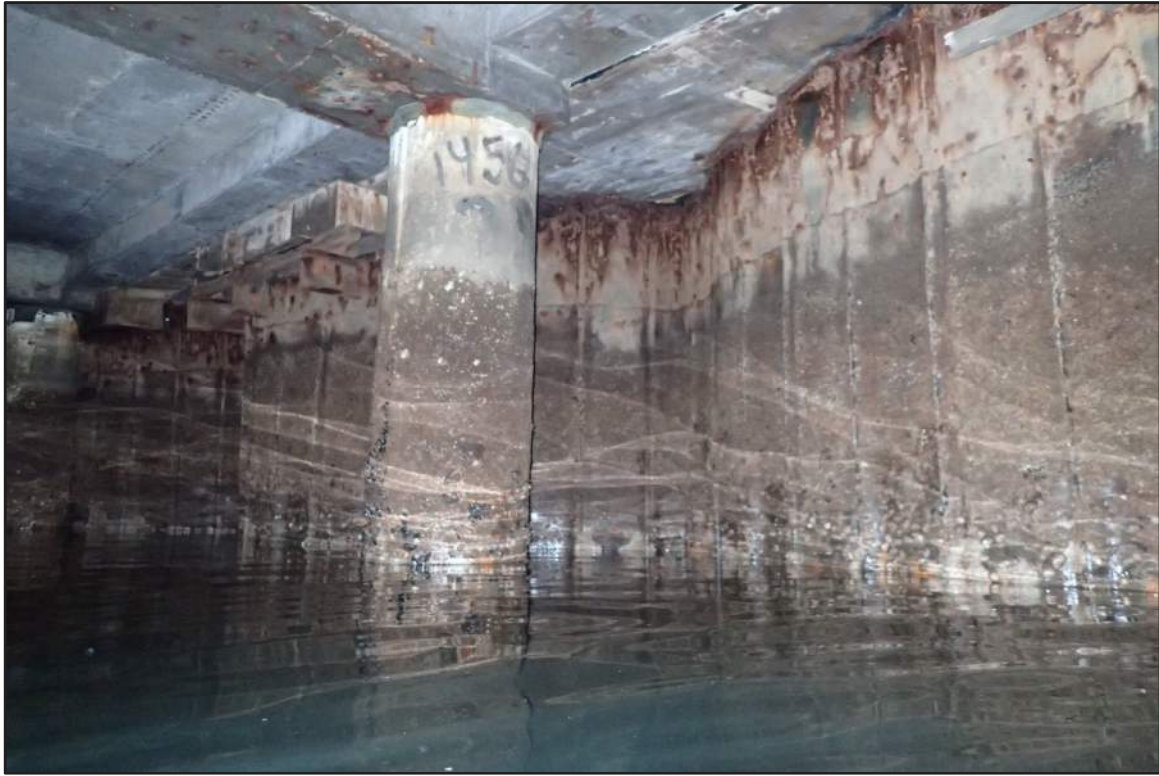
Photograph 7: North Bulkhead – Steel sheet pile cell under North Pier (Looking southeast)

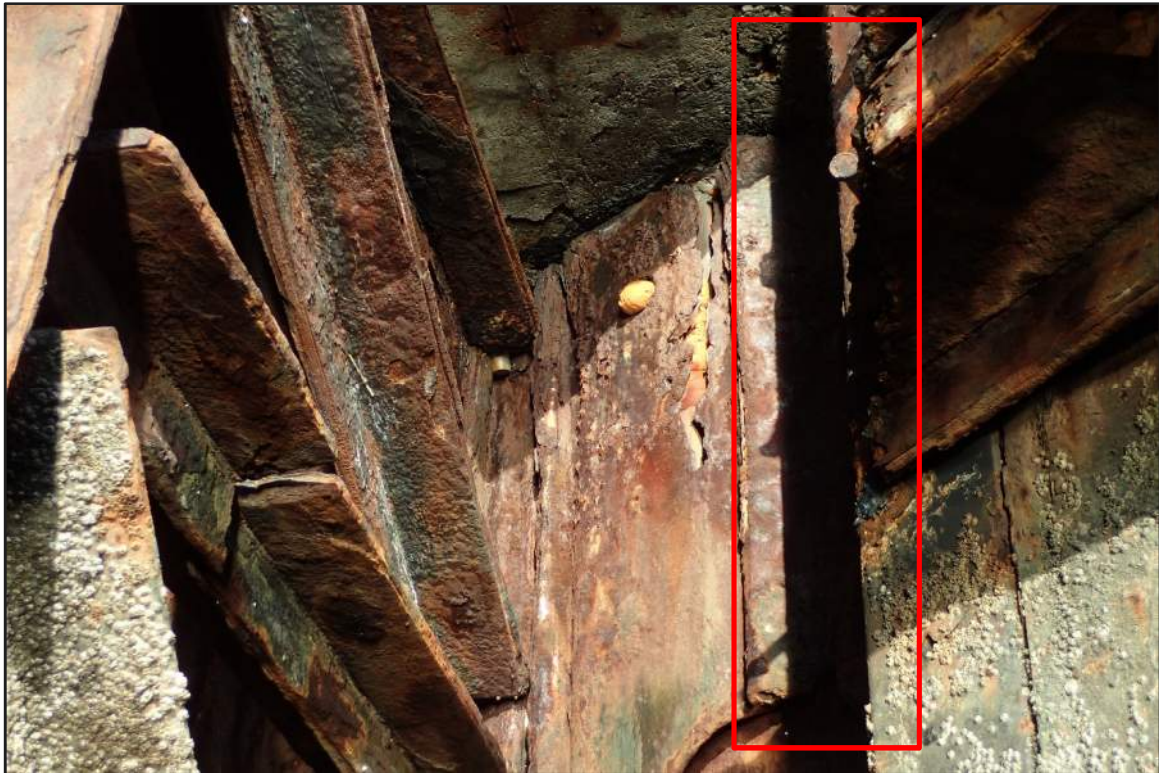
Photograph 8: North Bulkhead – Transition from steel sheet pile cell to steel sheet pile bulkhead (Looking east)

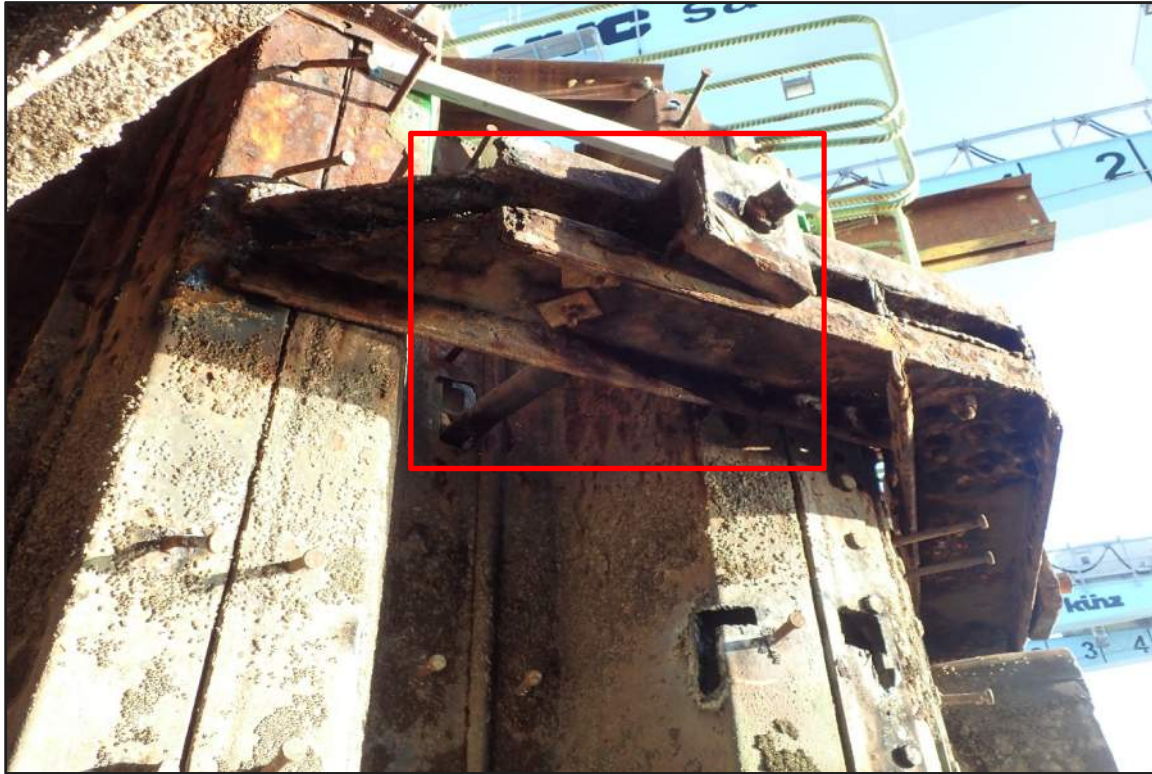
Photograph 9: North Bulkhead - Typical steel double channel wale, anchor rod, and hardware (Looking southeast)

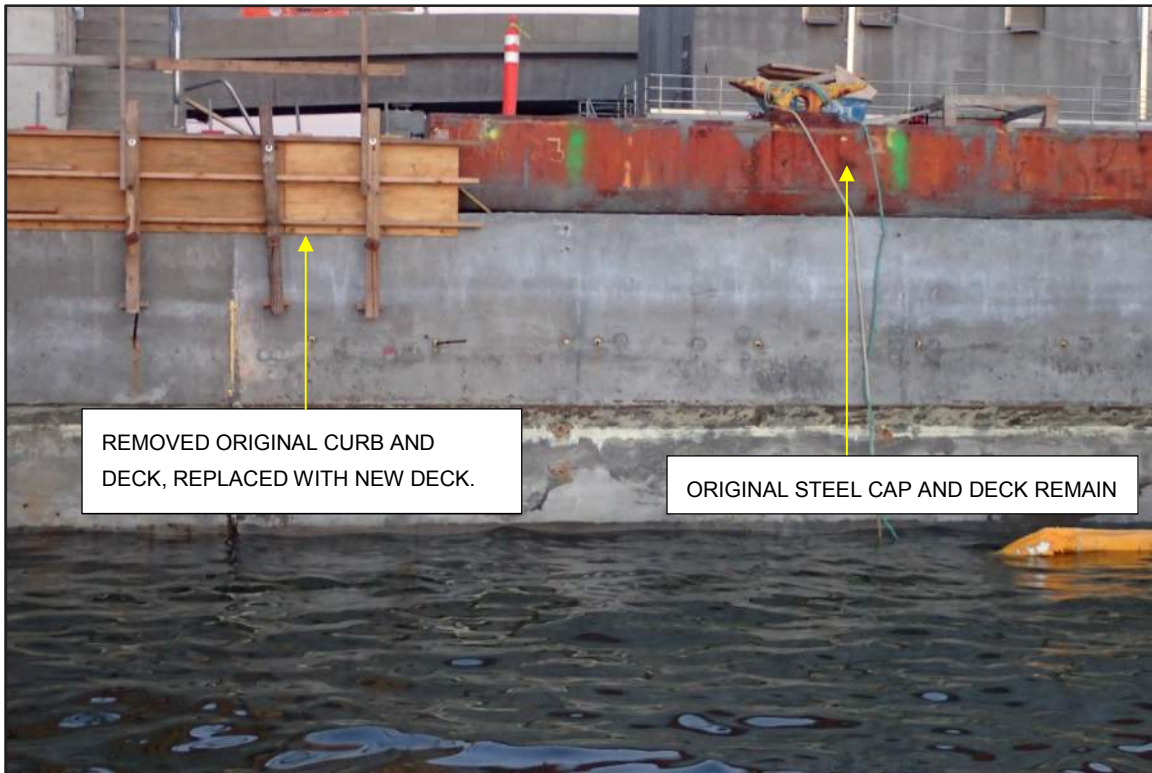
Approximately 234 LF of concrete deck and curb was demolished during construction of a new deck, inshore of the steel sheet pile bulkhead (Photograph 10). A reinforced concrete bulkhead was installed, approximately 3 LF inshore of the existing steel sheet pile bulkhead (Photograph 11). The annulus between these structures was partially filled with concrete prior to the 2016 inspection, typically up to the anchor rod elevation, excluding one 7 LF segment, located between Sta. 1+97 and Sta. 1+90, where the reinforced bulkhead extends to the face of the steel sheet pile bulkhead (Photograph 12). Additionally, epoxy coated reinforcement was installed between 2015 and 2016 and embedded into the new concrete bulkhead along this segment of demolished bulkhead (Photograph 13). The remainder of the annulus has been filled and the epoxy coated reinforcement was formed and poured to create a new concrete deck surface inshore of the steel sheet pile bulkhead. The nearly completed concrete deck is

Photograph 10: North Bulkhead – Area of removed curb and deck replaced with new deck, which interfaces with an original steel cap (Looking northeast)

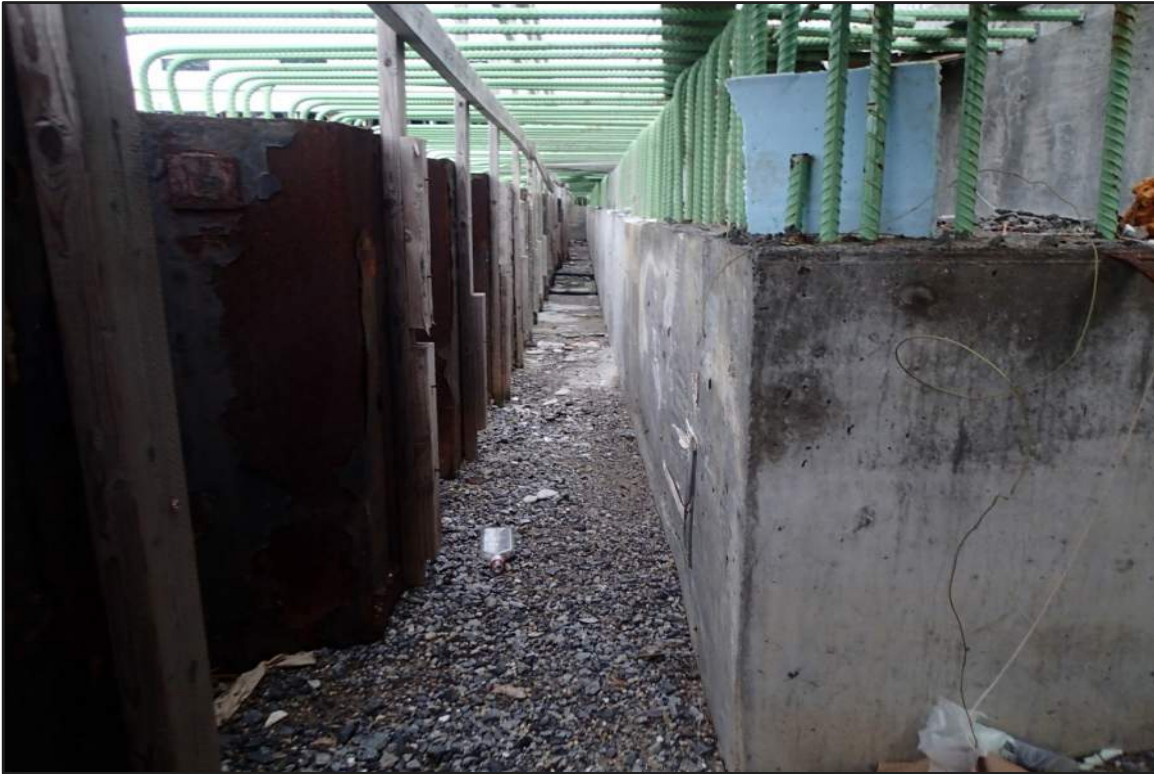
*Photograph 11: North Bulkhead – Concrete bulkhead with partially filled annulus between concrete and steel sheet pile bulkheads from 2016 inspection (Looking north)*

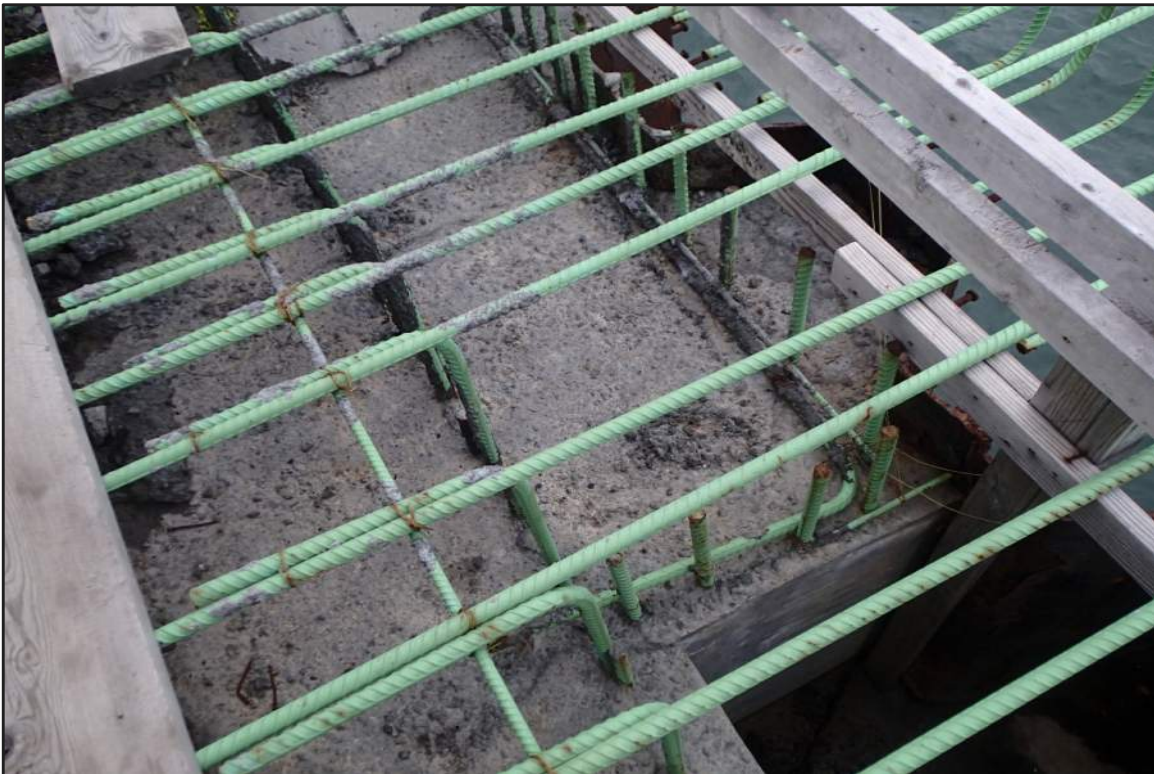
*Photograph 12: North Bulkhead – Extended concrete bulkhead between Sta. 1+90 and 1+97 from 2016 inspection (Looking southwest)*

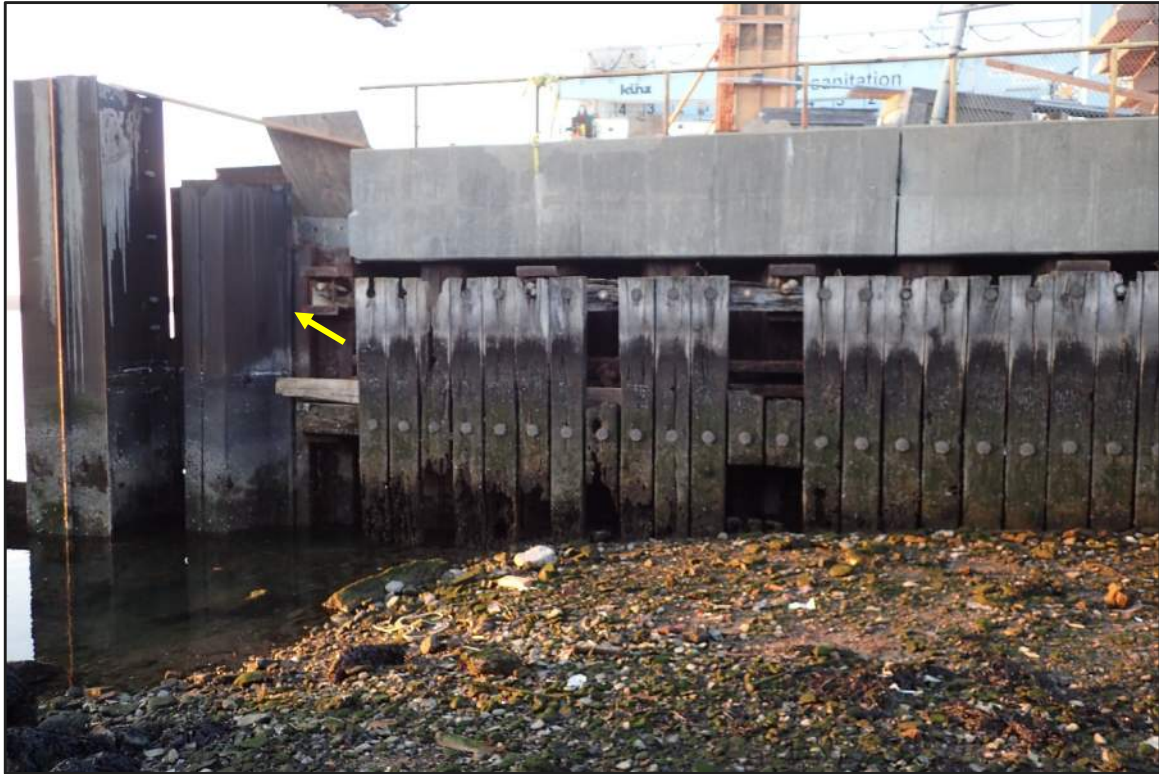
The bulkhead to the south of this area (Sta. 0+96 to Sta. 0+00) remains, excluding a 39 inch by 20 inch section of deck and curb where the North and East Bulkheads intersect. This section of deck and curb was removed prior to the 2016 inspection to accommodate the installation of a transition element between the North and East bulkheads and the steel sheet pile fender and revetment retaining structure, which extends to the west (Photograph 15 and Photograph 16).

*Photograph 15: North Bulkhead – Interface between North and East bulkheads and steel sheet pile fender and revetment retaining structure to the west (Looking northwest)*

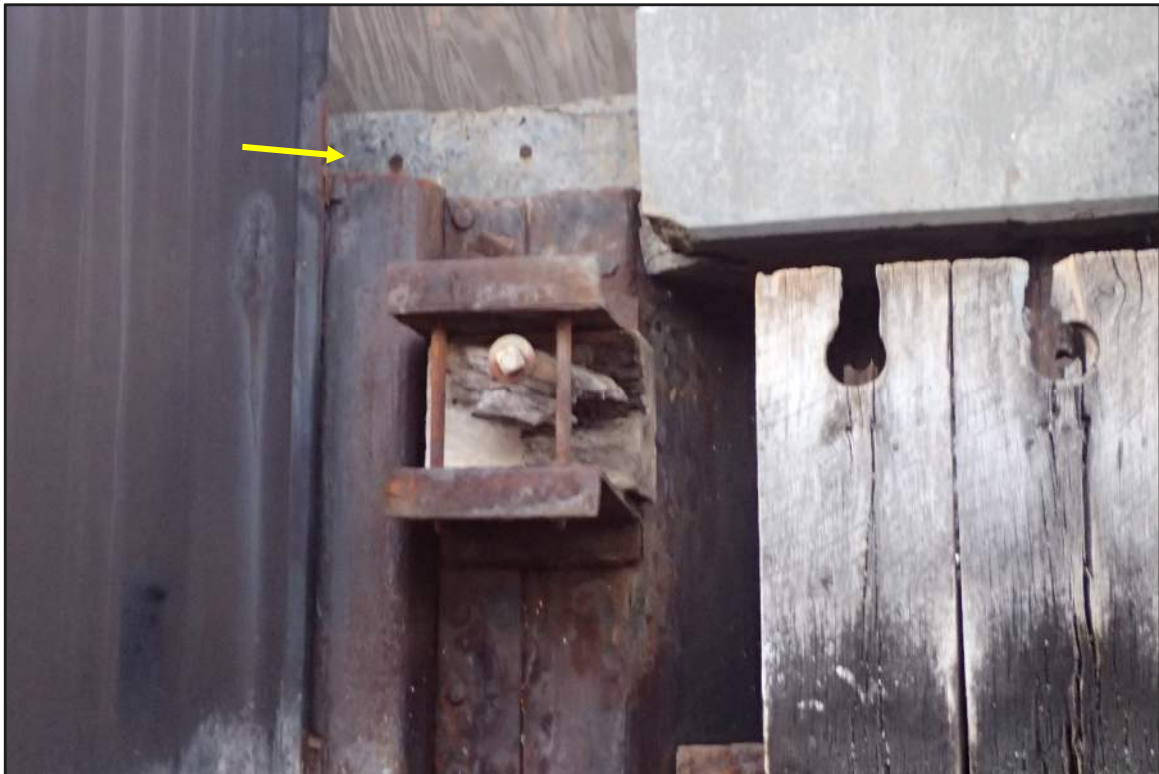
*Photograph 16: North Bulkhead – Deck demolition at North and East bulkhead interface to install transition element for new steel sheet pile to the west*

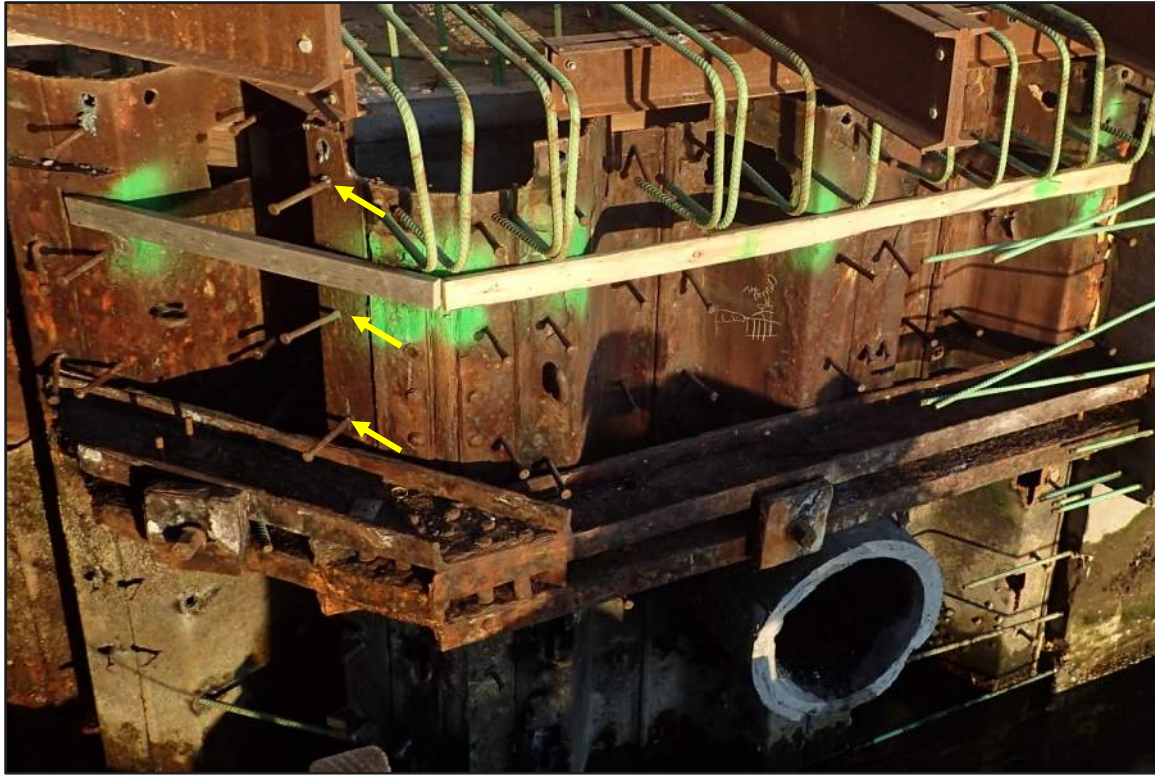
Photograph 17: North Bulkhead – Typical shear bolt installation above water on exposed steel sheet piles (Looking southeast)

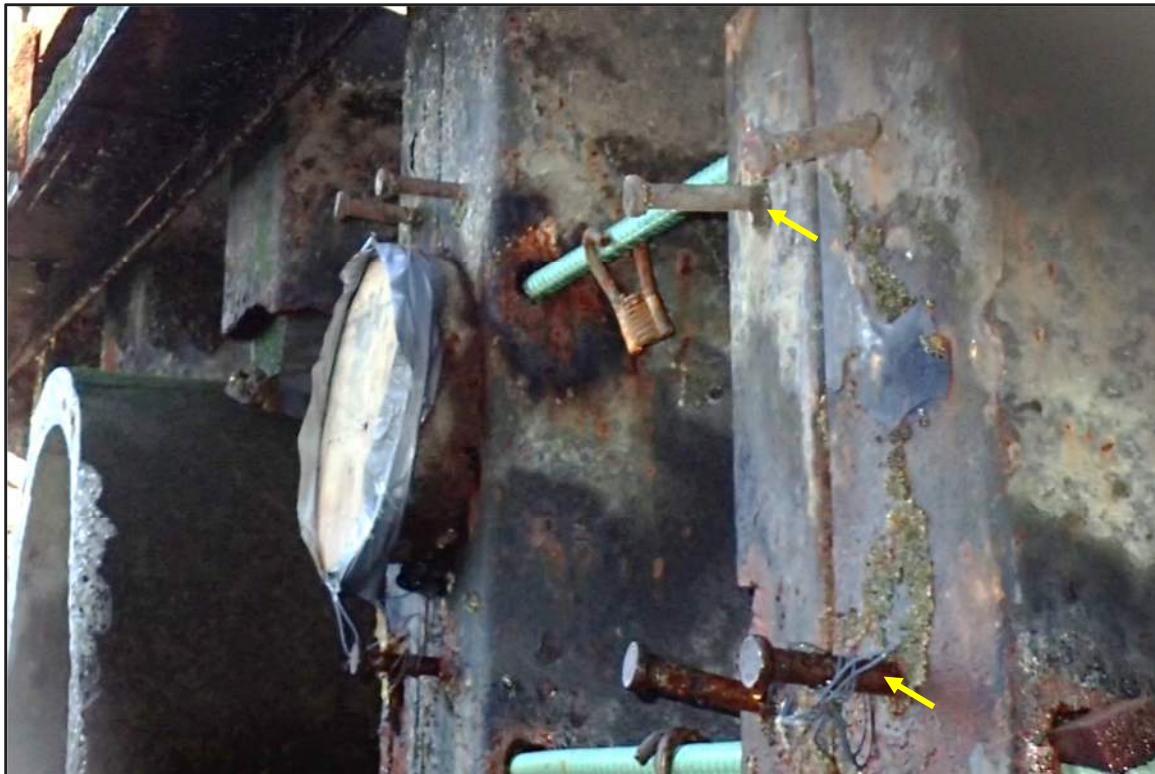
Photograph 18: North Bulkhead –Elevation of shear bolts below wale system on outer flanges

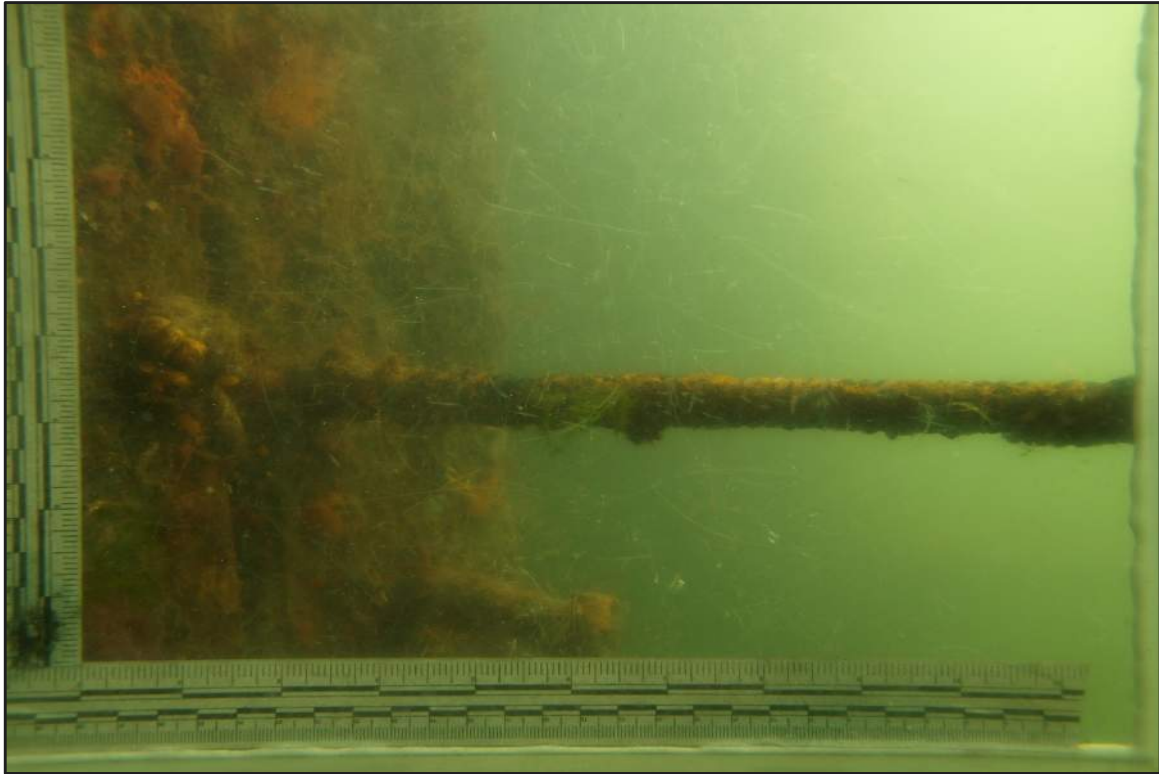
*Photograph 19: North Bulkhead – Threaded rod installed between shear bolt elevations observed prior to installation of partial encasement during the 2016 inspection*

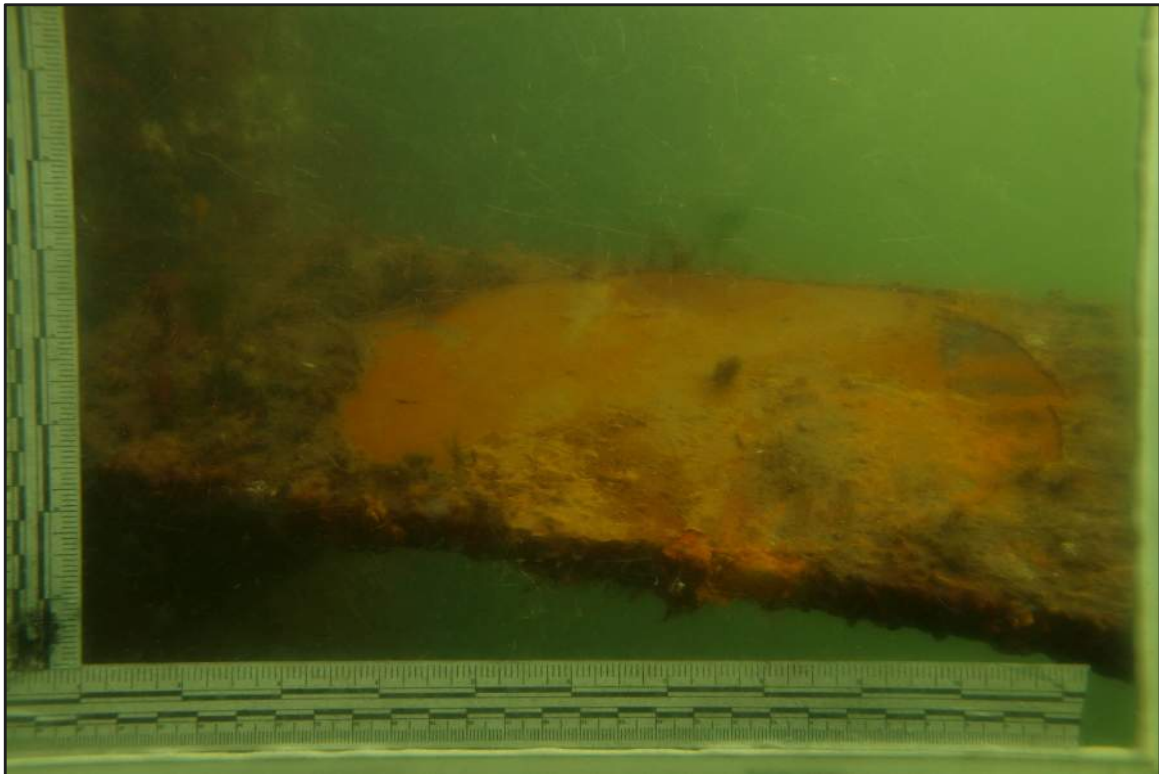
*Photograph 20: North Bulkhead – Steel bracket installed below shear bolts observed prior to installation of partial encasement during the 2016 inspection*

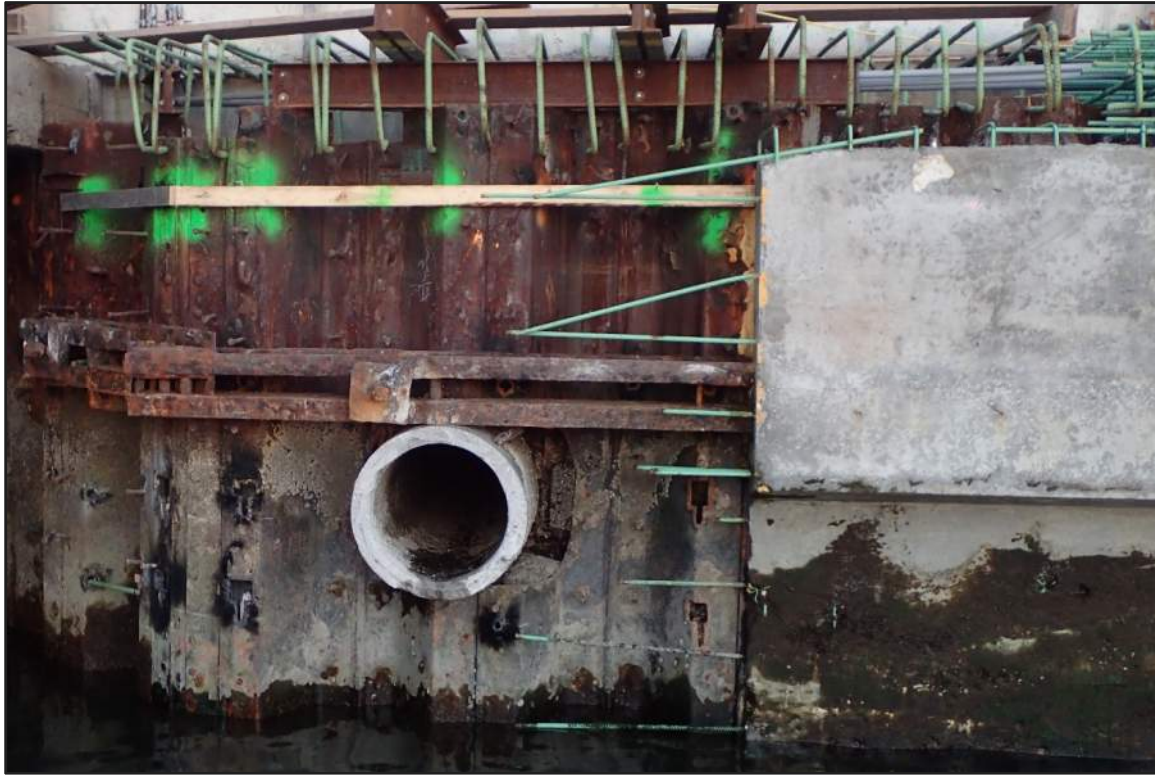
*Photograph 21: North Bulkhead – Encased-to-exposed transition at north end of the North Bulkhead (Looking east)*

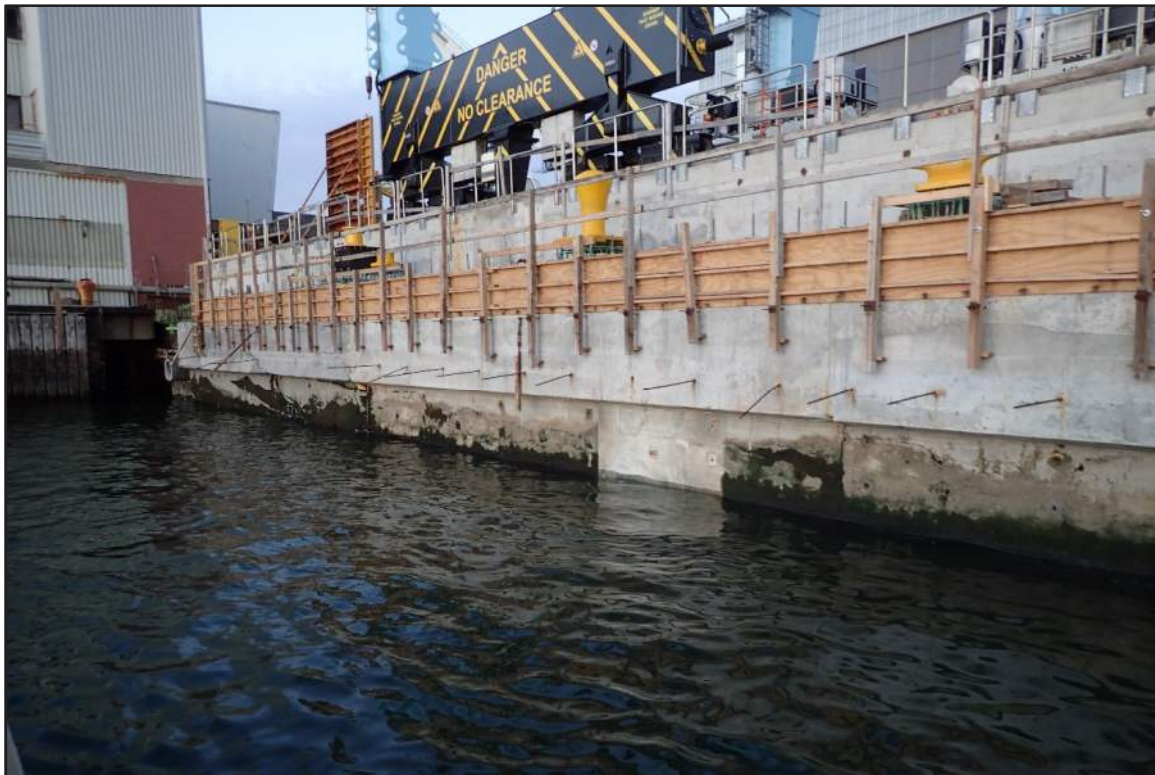
*Photograph 22: North Bulkhead – Typical view of encased length of the North Bulkhead steel sheet piles (Looking northeast)*

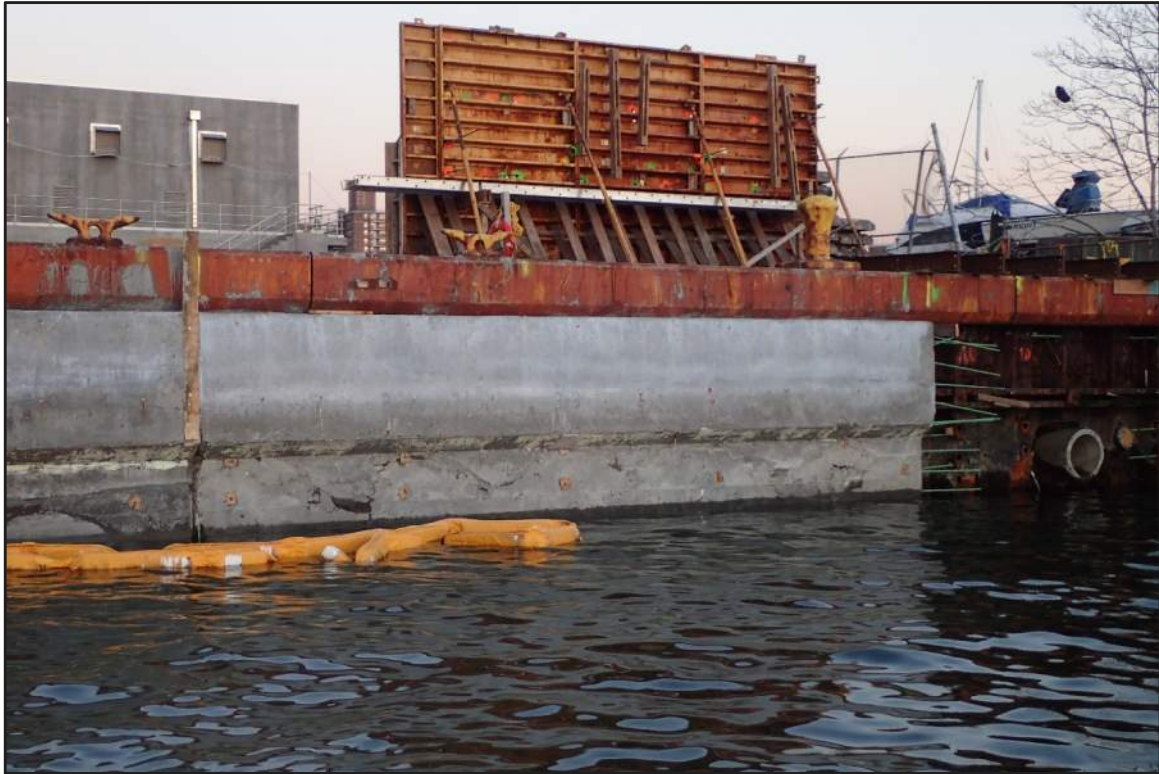
*Photograph 23: North Bulkhead – Encased-to-exposed transition at south end of the North Bulkhead (Looking east)*

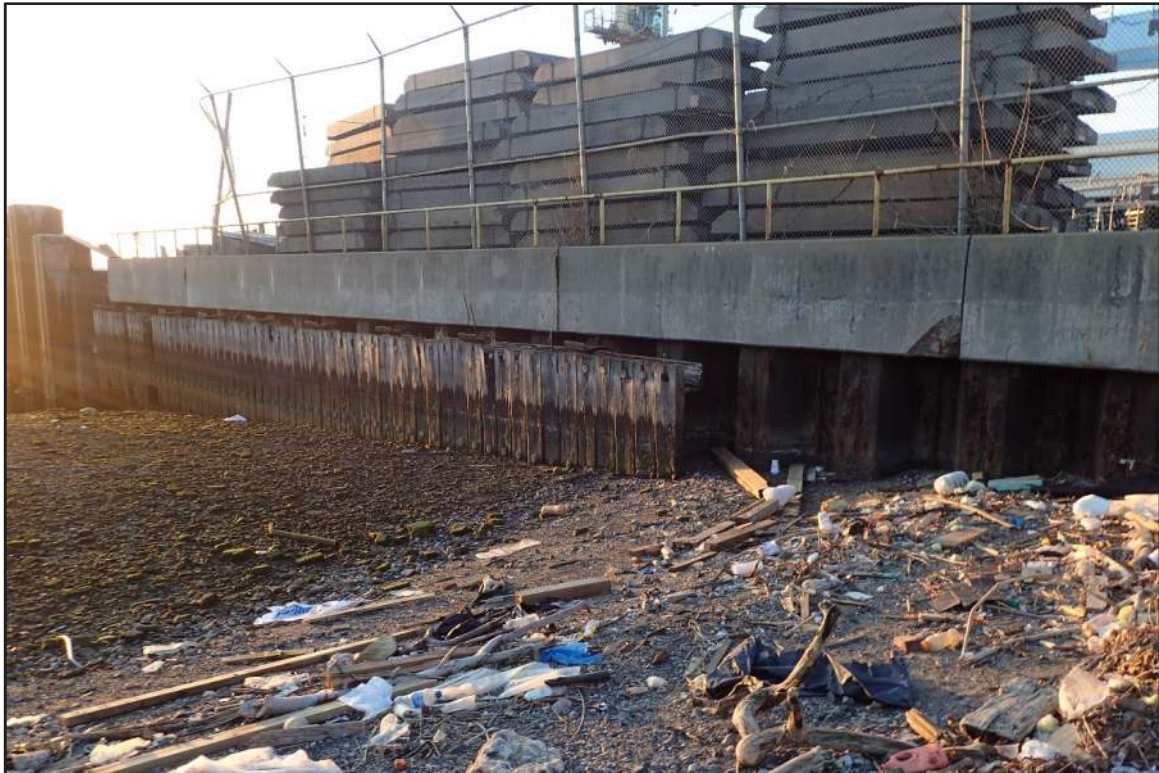
The East Bulkhead intersects the southern extent of the North Bulkhead, and returns inshore, to the east, approximately 144 LF (Photograph 24). Typically, the bulkhead is composed of Z-shaped steel sheet piles with an external double channel wale, which is secured with a series of steel anchor rods. As stated above, new steel sheet piles that extend west from the intersection between the East and North Bulkheads, are retaining the stone revetment to the south, and providing fendering to the north (Photograph 25). Additionally, the eastern 14 LF of bulkhead is partially demolished with the concrete deck and curb removed (Photograph 26).

*Photograph 24: Overview of the East Bulkhead (Looking northwest)*

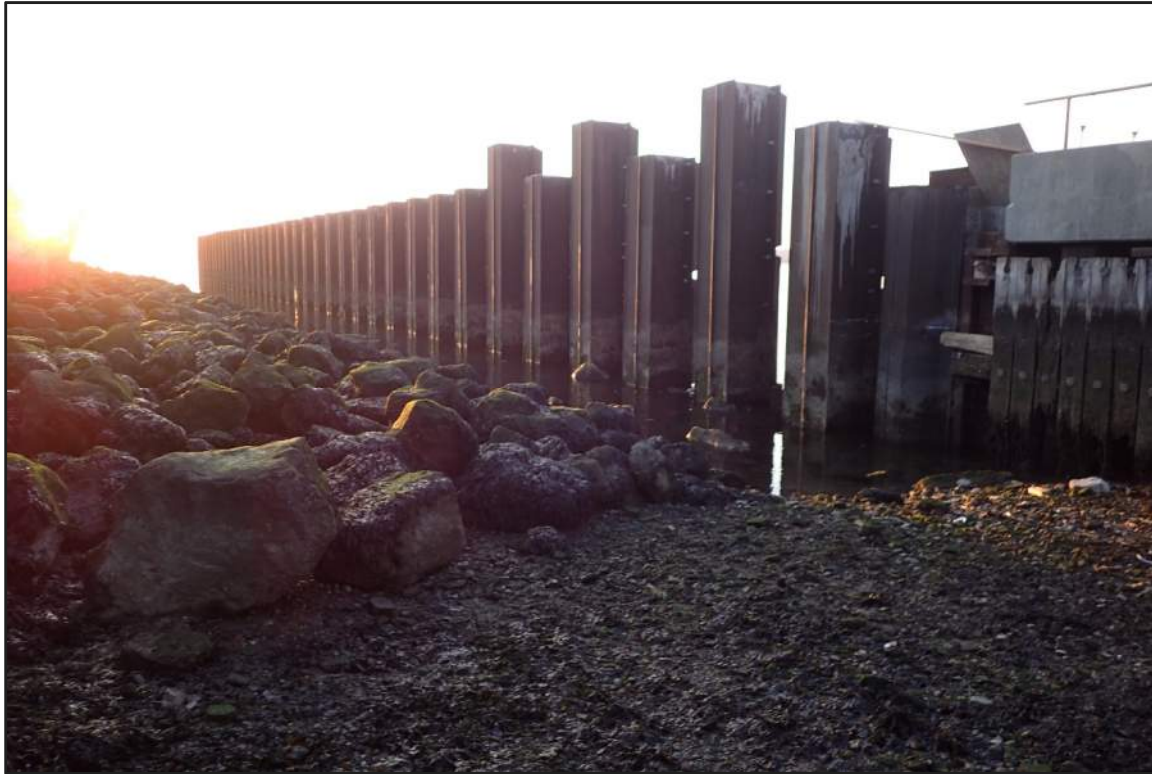
*Photograph 25: Overview of revetment and steel sheet piles extending offshore from intersection of North and East Bulkheads (Looking west)*
