# SOUTHWEST BROOKLYN MARINE TRANSFER STATION BULKHEAD INVESTIGATION

ANNUAL BULKHEAD INSPECTION

PROJECT NO. A092286  
DOCUMENT NO.  
VERSION 4  
DATE OF ISSUE 12/28/2017 (Rev 1 – 02/26/2018)  
PREPARED SPWN  
CHECKED DDJS  
APPROVED JOAC

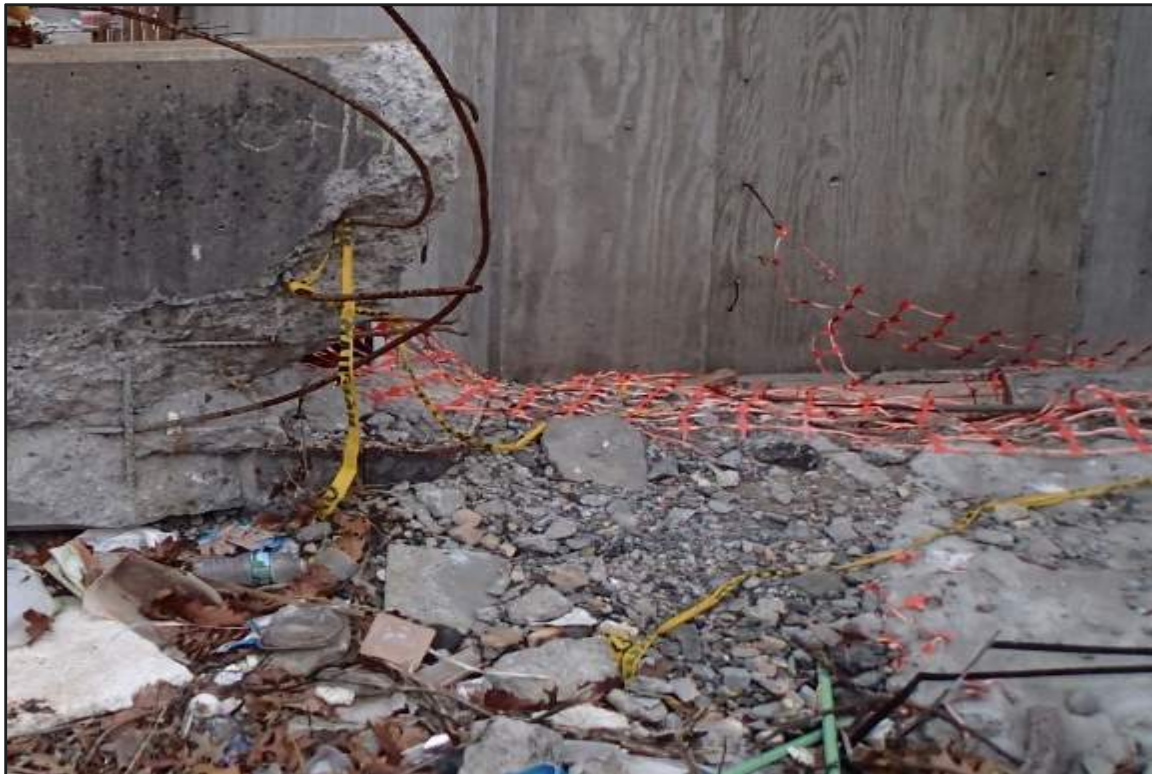
*Photograph 26: East Bulkhead – Demolished concrete curb and deck at Sta. 0+14 (photograph reference from 2016 inspection) (Looking north)*

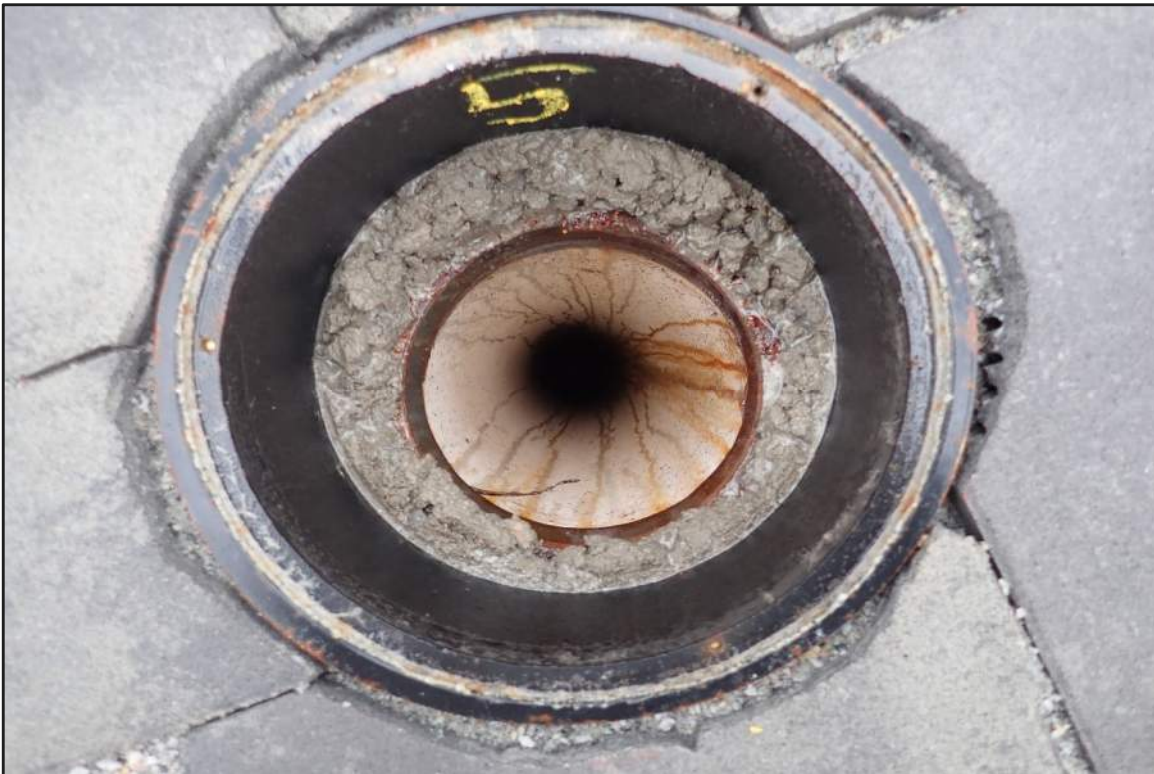
The cellular cofferdam access hatches, located inshore of the rehabilitated steel sheet pile bulkhead, which was previously installed as overshooting for the cofferdams, were accessible during the inspection and sand levels were collected (See Photographs 44 and 45). At each access hatch the sand elevation was contained within the access port, meaning the cofferdam interior was not visible, and the elevation within the cofferdam, rather than within the access port, could not be confirmed. Since the interior cofferdam sand elevation could not be confirmed, the inspection results could not be used to make a determination in regards to the DEC Permit Special Conditions Section 24-ii. Access hatch inspection results are provided in Appendix D.

Photograph 44: North Bulkhead – Cellular cofferdam access port 5.

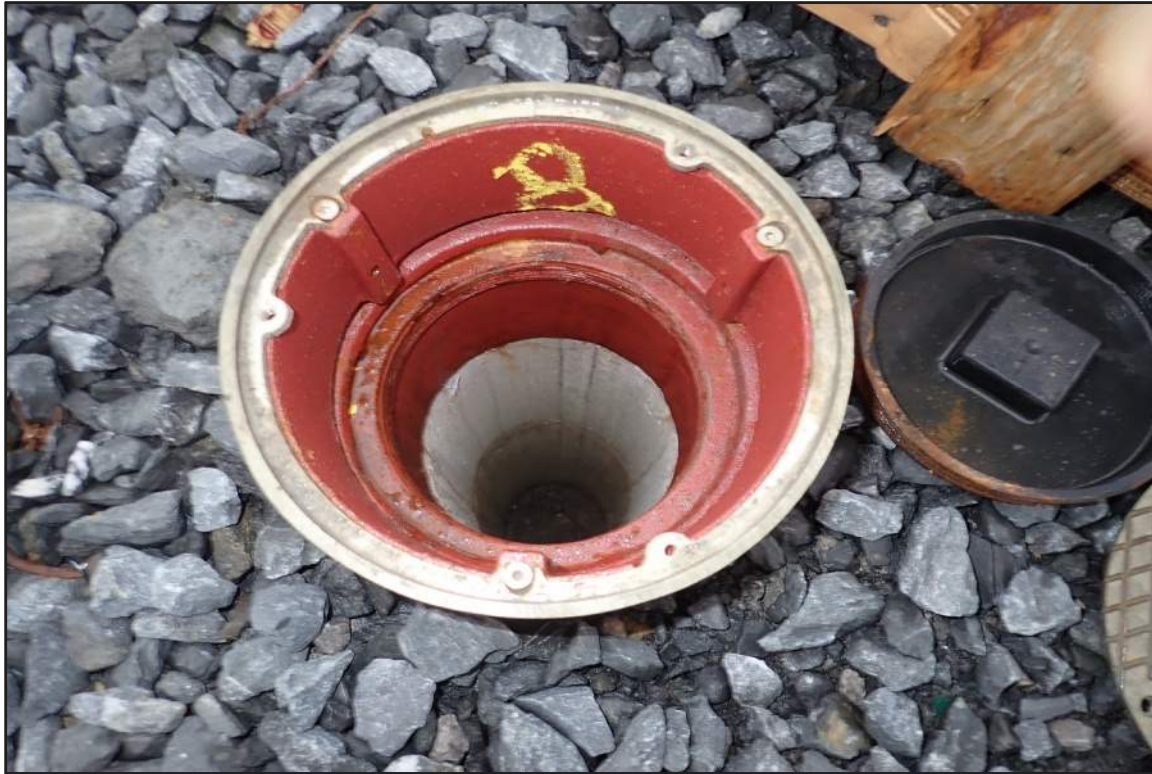
*Photograph 45: North Bulkhead – Cellular cofferdam access port 8.*
