Re: NYSDEC Permit 2-6106-00002/00022 Ren 4 (Permit)
Southwest Brooklyn Marine Transfer Station (MTS)
New York City Department of Sanitation (DSNY)
2023 Bulkhead Inspection Report

Re: Southwest Brooklyn Marine Transfer Station
2023 Bulkhead Fender System Inspection

SOUTHWEST BROOKLYN MARINE TRANSFER STATION
DECEMBER 2023

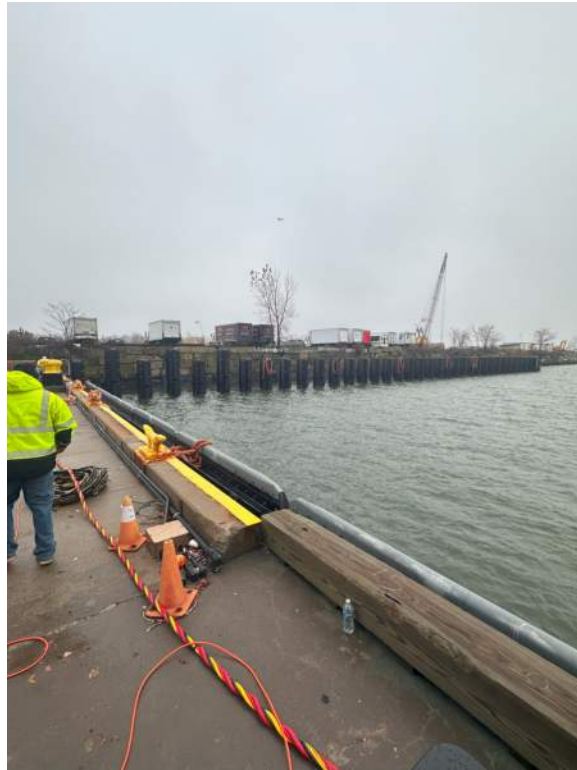
Photo 1. Overall view of East Bulkhead
