**177 Montague Street, aka 134-138 Pierrepont Street – Brooklyn  
Trust Company Building – Individual and Interior Landmark  
Borough of Brooklyn**

177 Montague Street  
(aka The Brooklyn Trust  
Company Building)

Arched Window Repair/  
Replacement

LPC Presentation

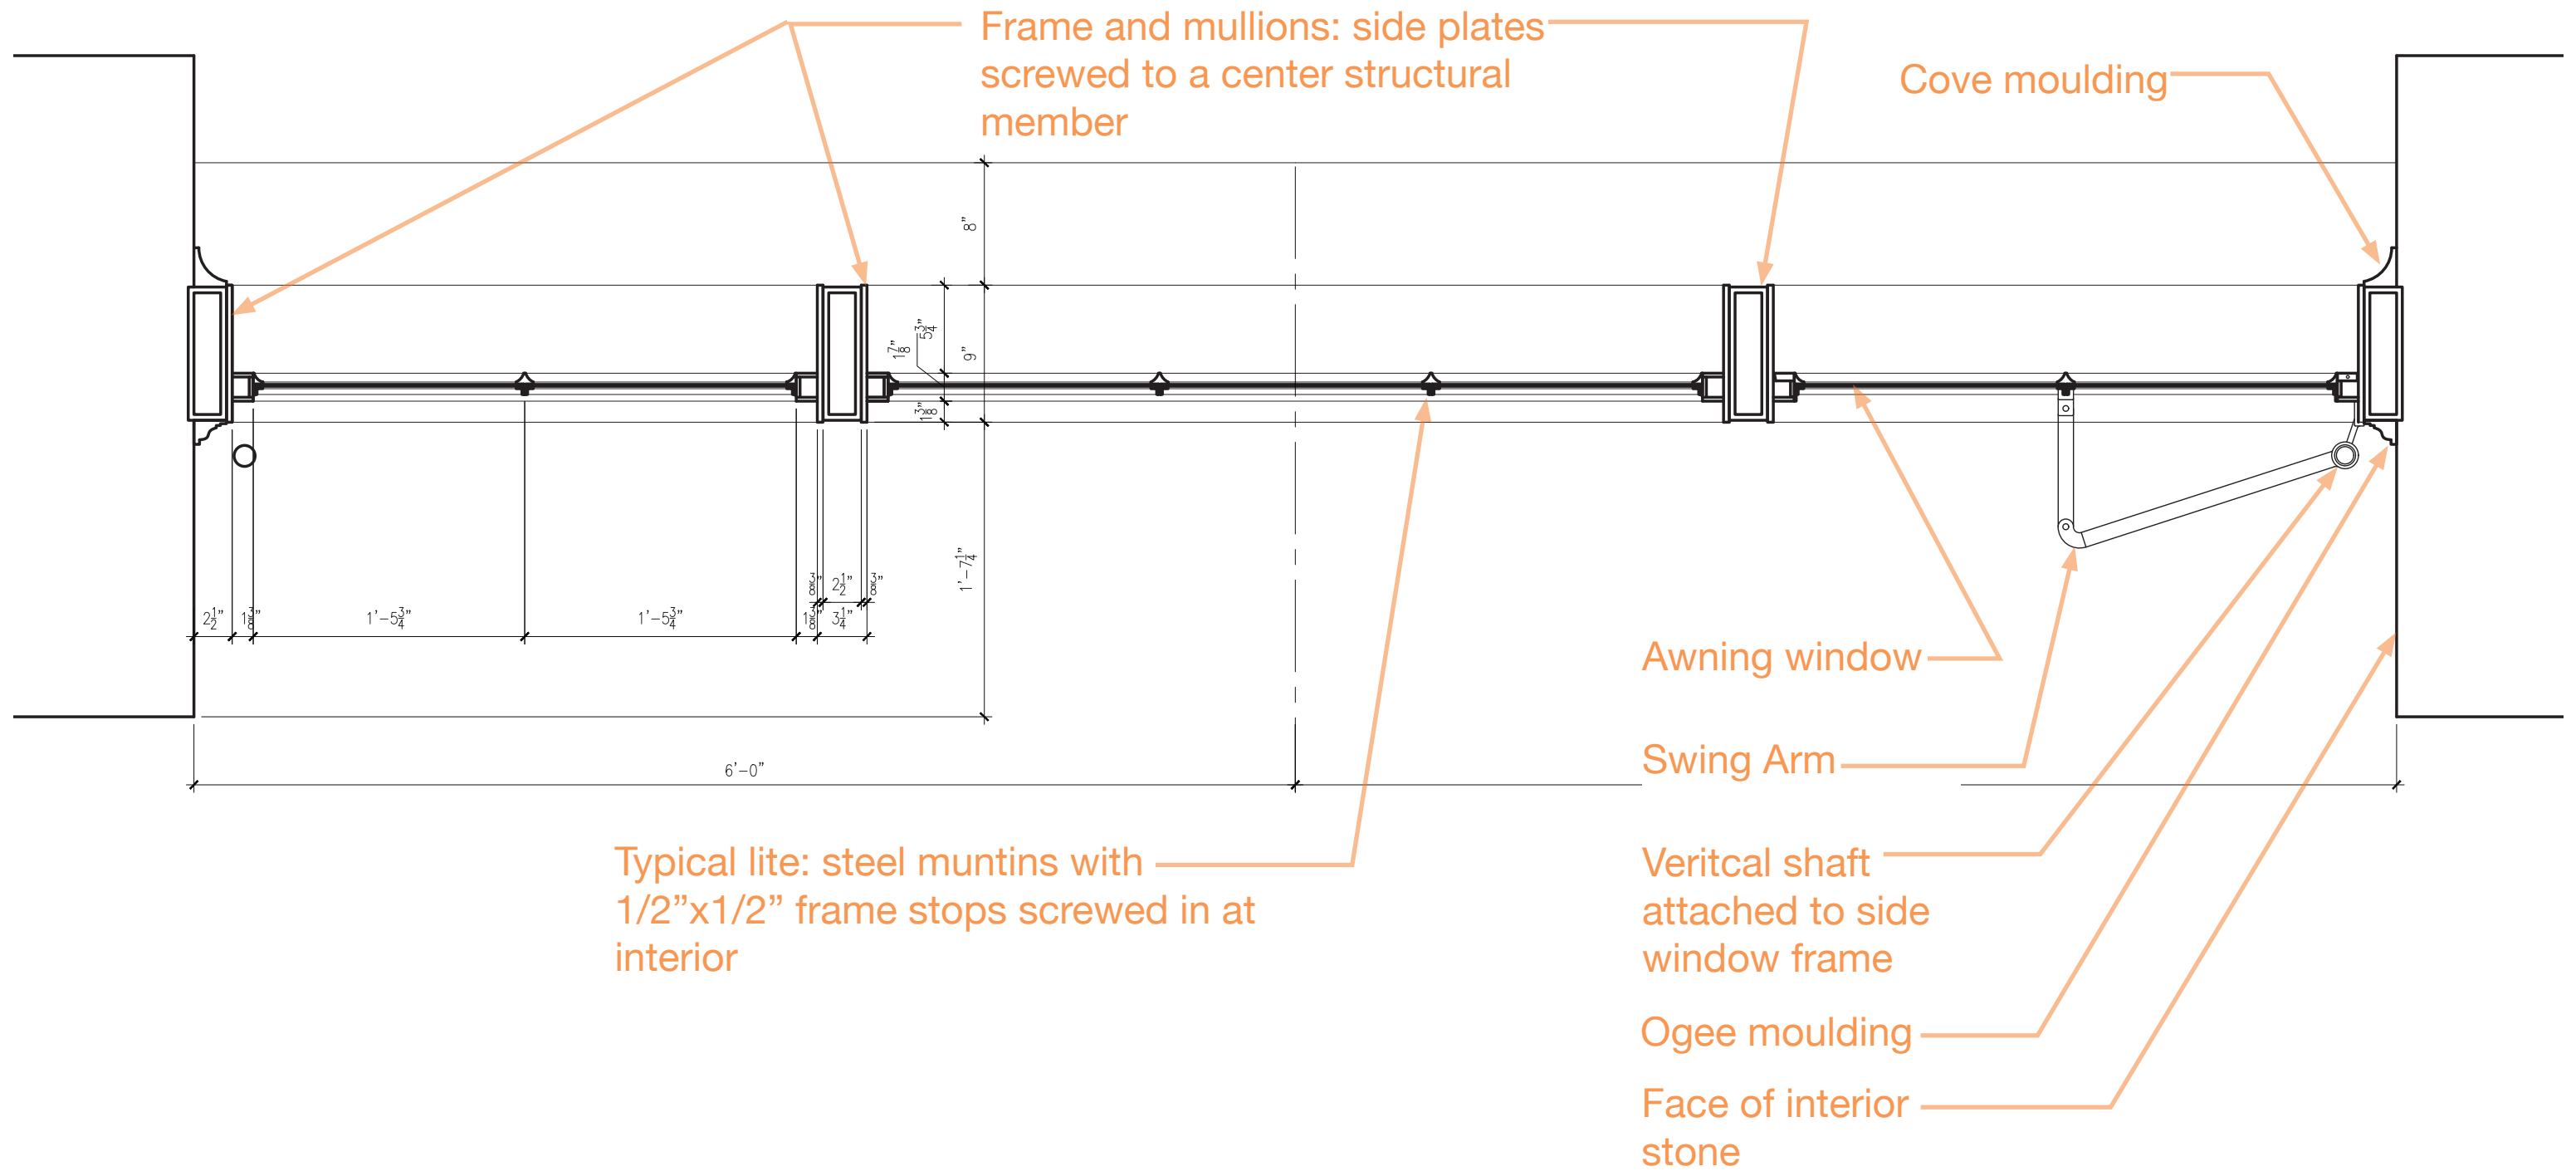
Existing Window Construction (view from interior)

**The major vertical and horizontal mullions, and frame of the 7 arched, identical windows are comprised of heavy built-up steel shapes.**

**The infill framing is composed of much lighter steel profiles to create delicate infill lites inside the the major steel mullions.**

***Concealed within the diaphonous lites, are four operable windows.***

- Evidence of condensation and paint damage along horizontal mullion
- Smaller lites are in poor condition, leaking, and allowing water infiltration. Awning windows are damaged and in non-operable condition.
- Proposed scope is to reattach the original arms to the replacement muntins to mimic the original configuration.
- Crank or mechanism to operate shaft is missing.

- We are proposing to replace all of the infill lites with a similar Hopes Windows steel profile and insulated glass in increase thermal performance.
- Major mullions and frame are to be repaired and are to remain

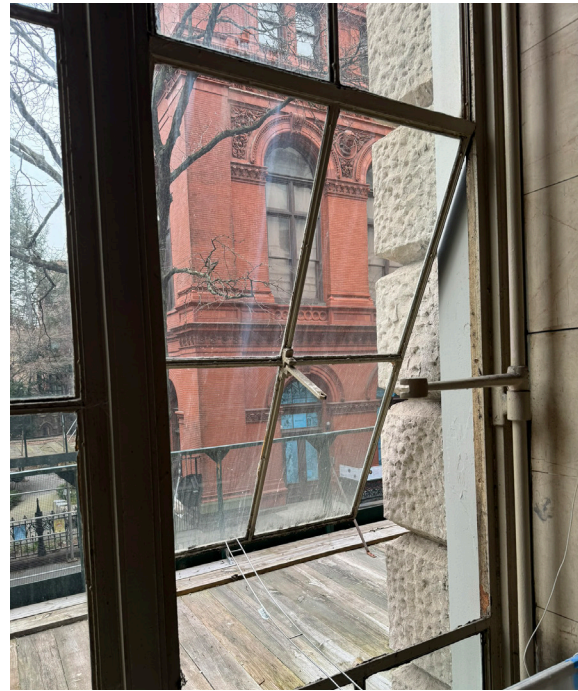
Discovery of operation: Two windows were worked loose. We were expecting casement window swings, but they are awning swings. The window operation is virtually undetectable from the exterior. They appear fixed.

Awning window from interior.

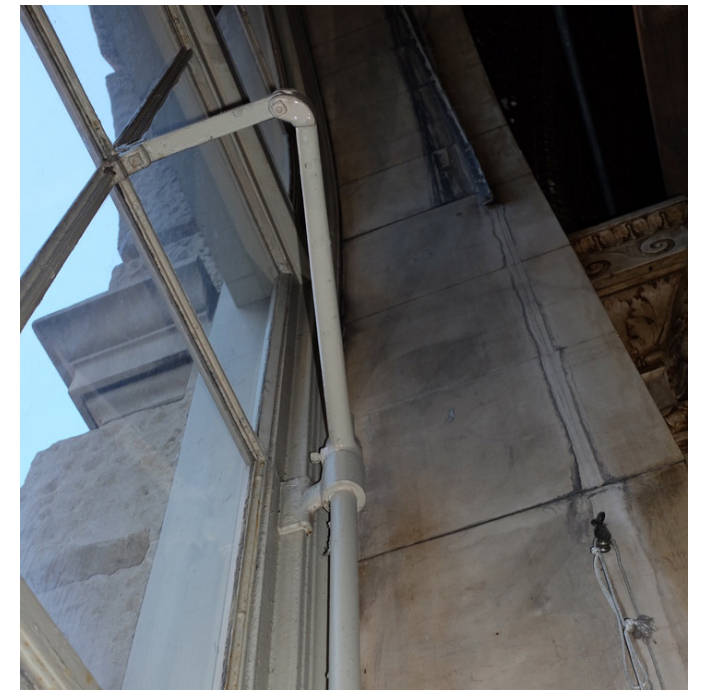
Arm attachments to windows and shaft

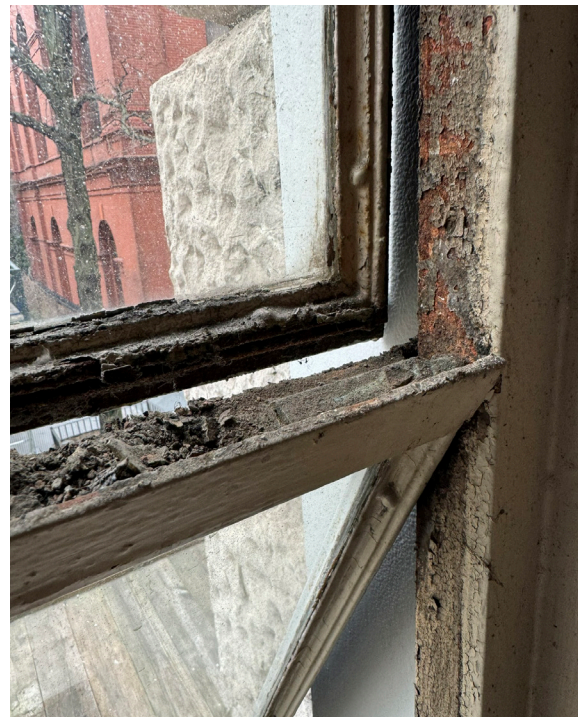
Awning window from interior.

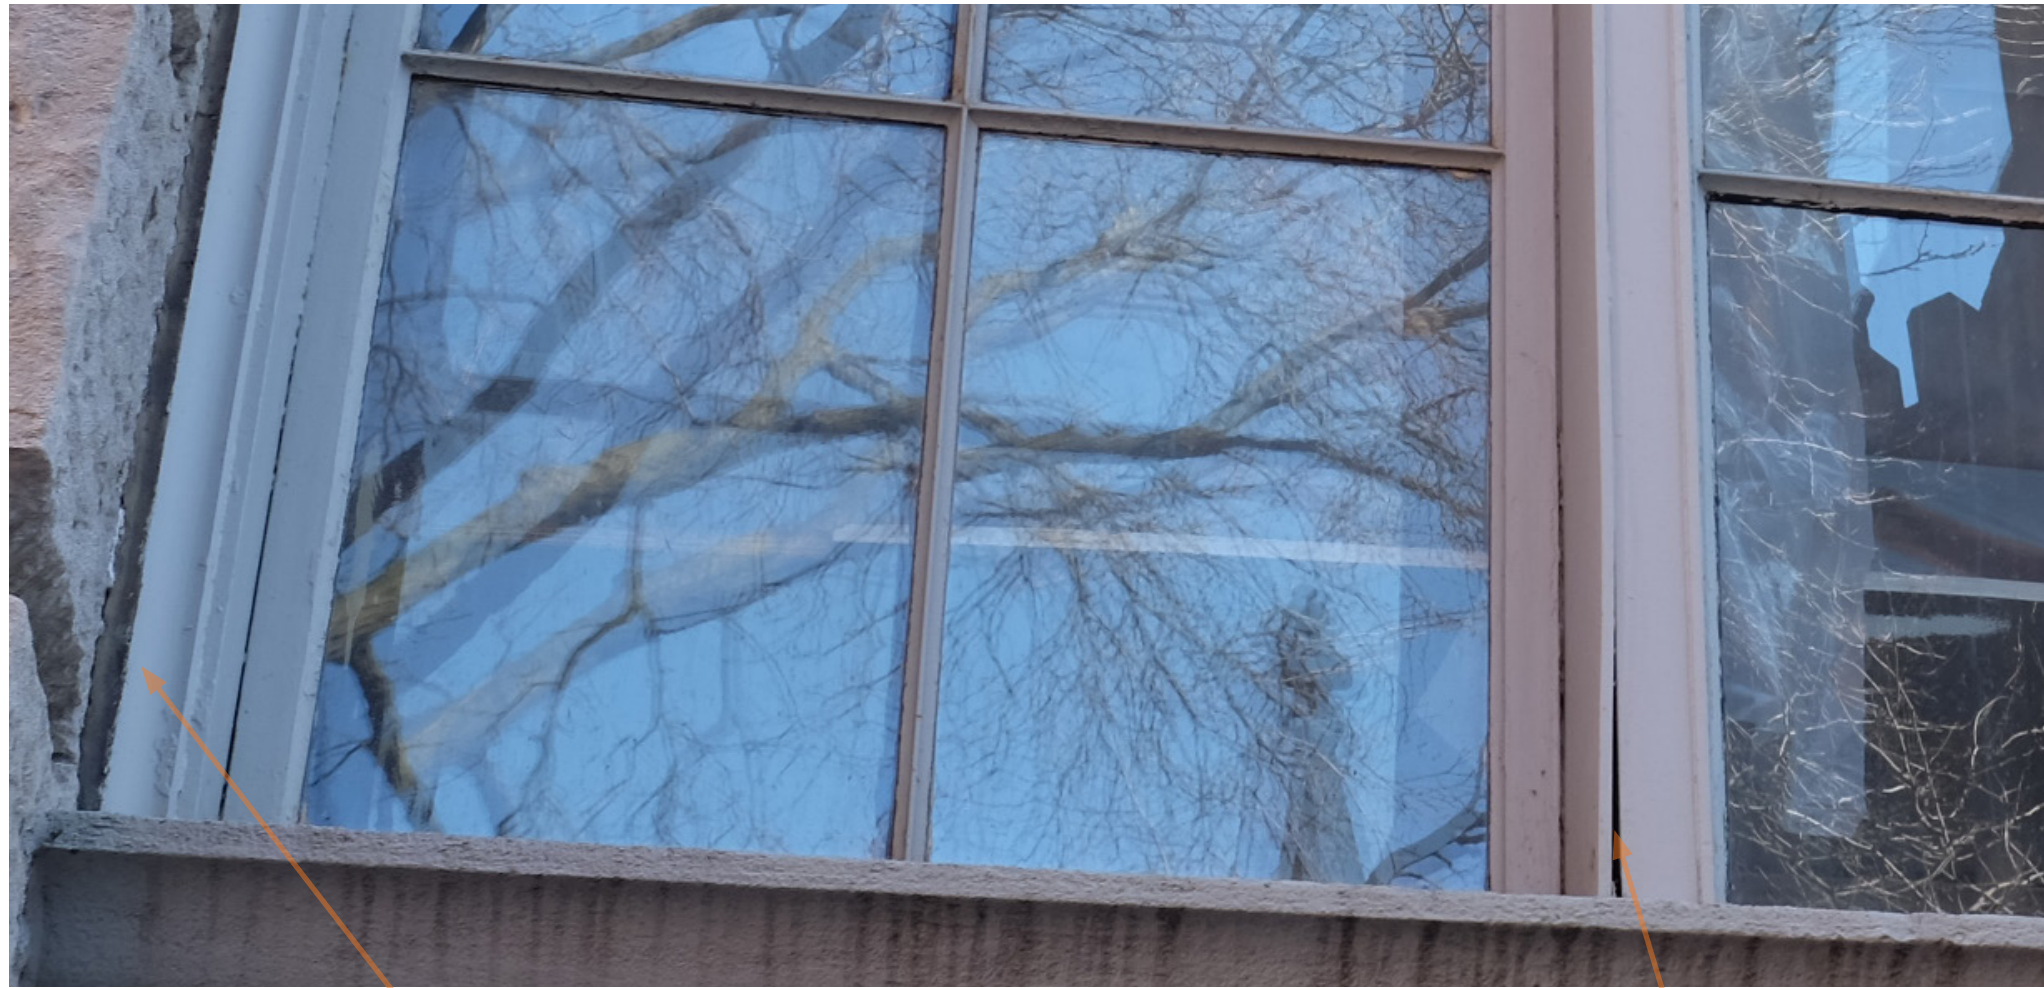
**Window frames are to remain.**

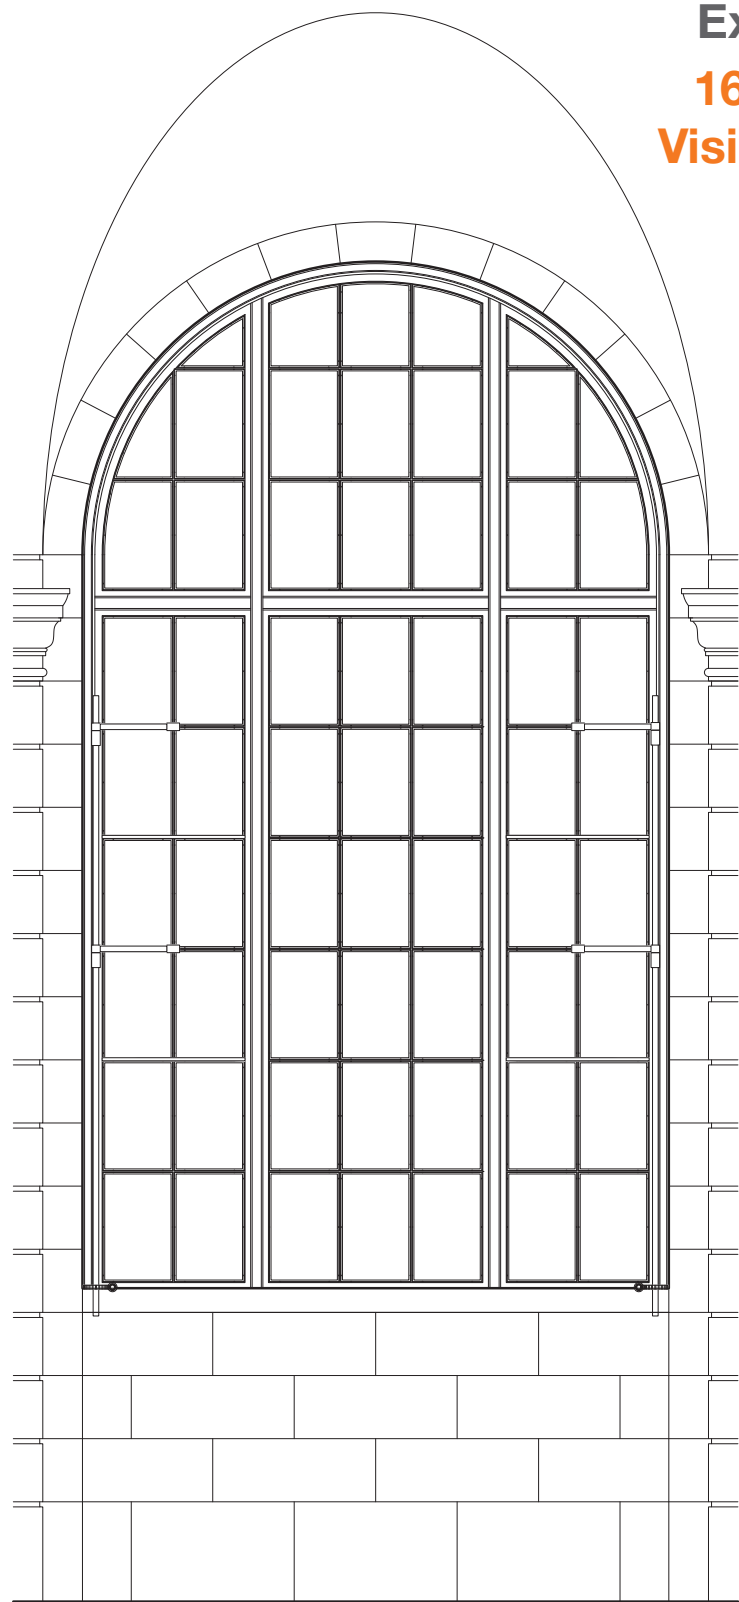
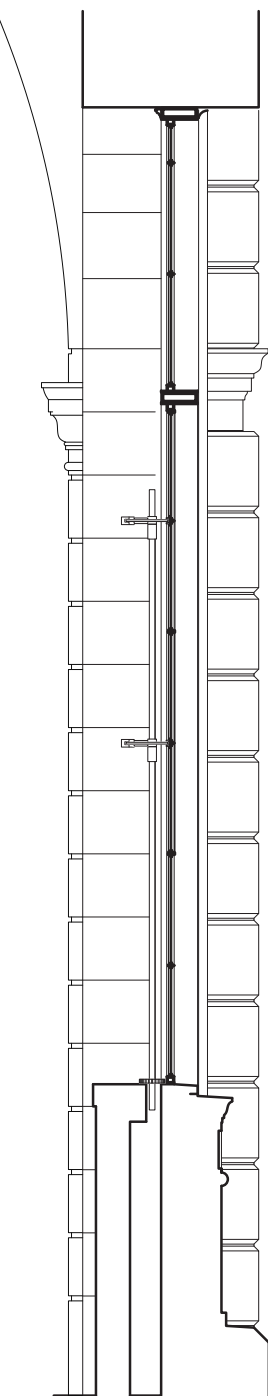
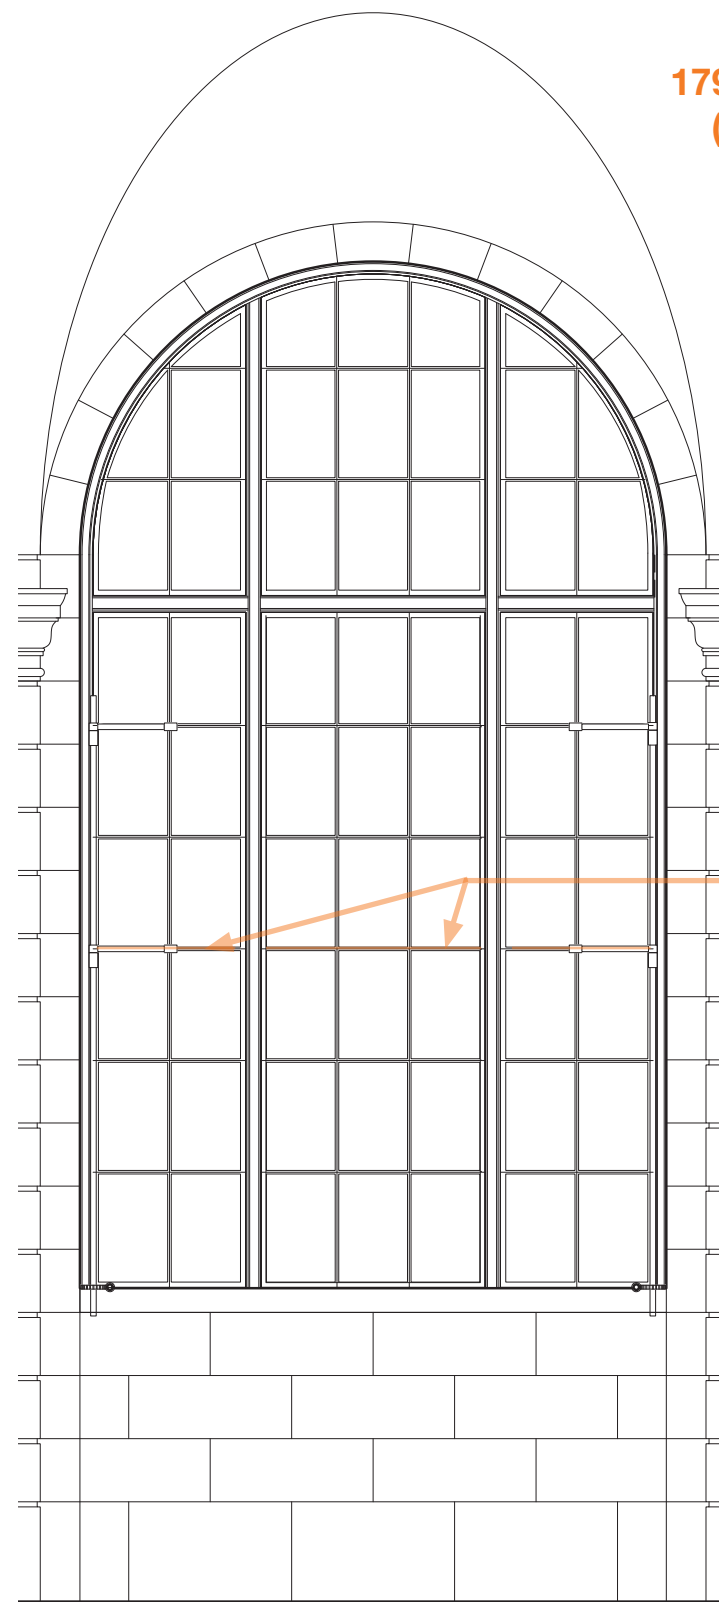
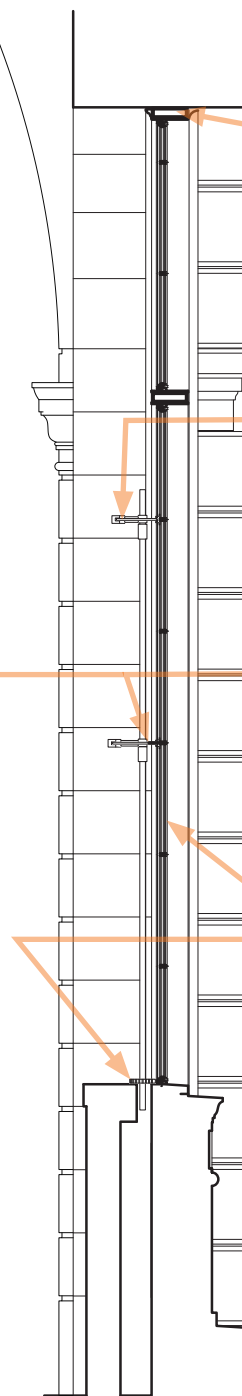
Interior Elevation and Sections:  
Existing and Proposed

Mullions and steel moulding profiles to remain in situ at the interior and exterior

Horizontal plate (10ga. 4" plate) for reinforcing to meet current code wind loads.

Face of glass brought forward +/- 3/4" towards exterior due to thicker insulated glazing and to clear pinion gear below

Awning window mechanism to remain and be reattached to muntins. Window lites will be fixed and not operable

- **Replacement lites by Hopes Windows**

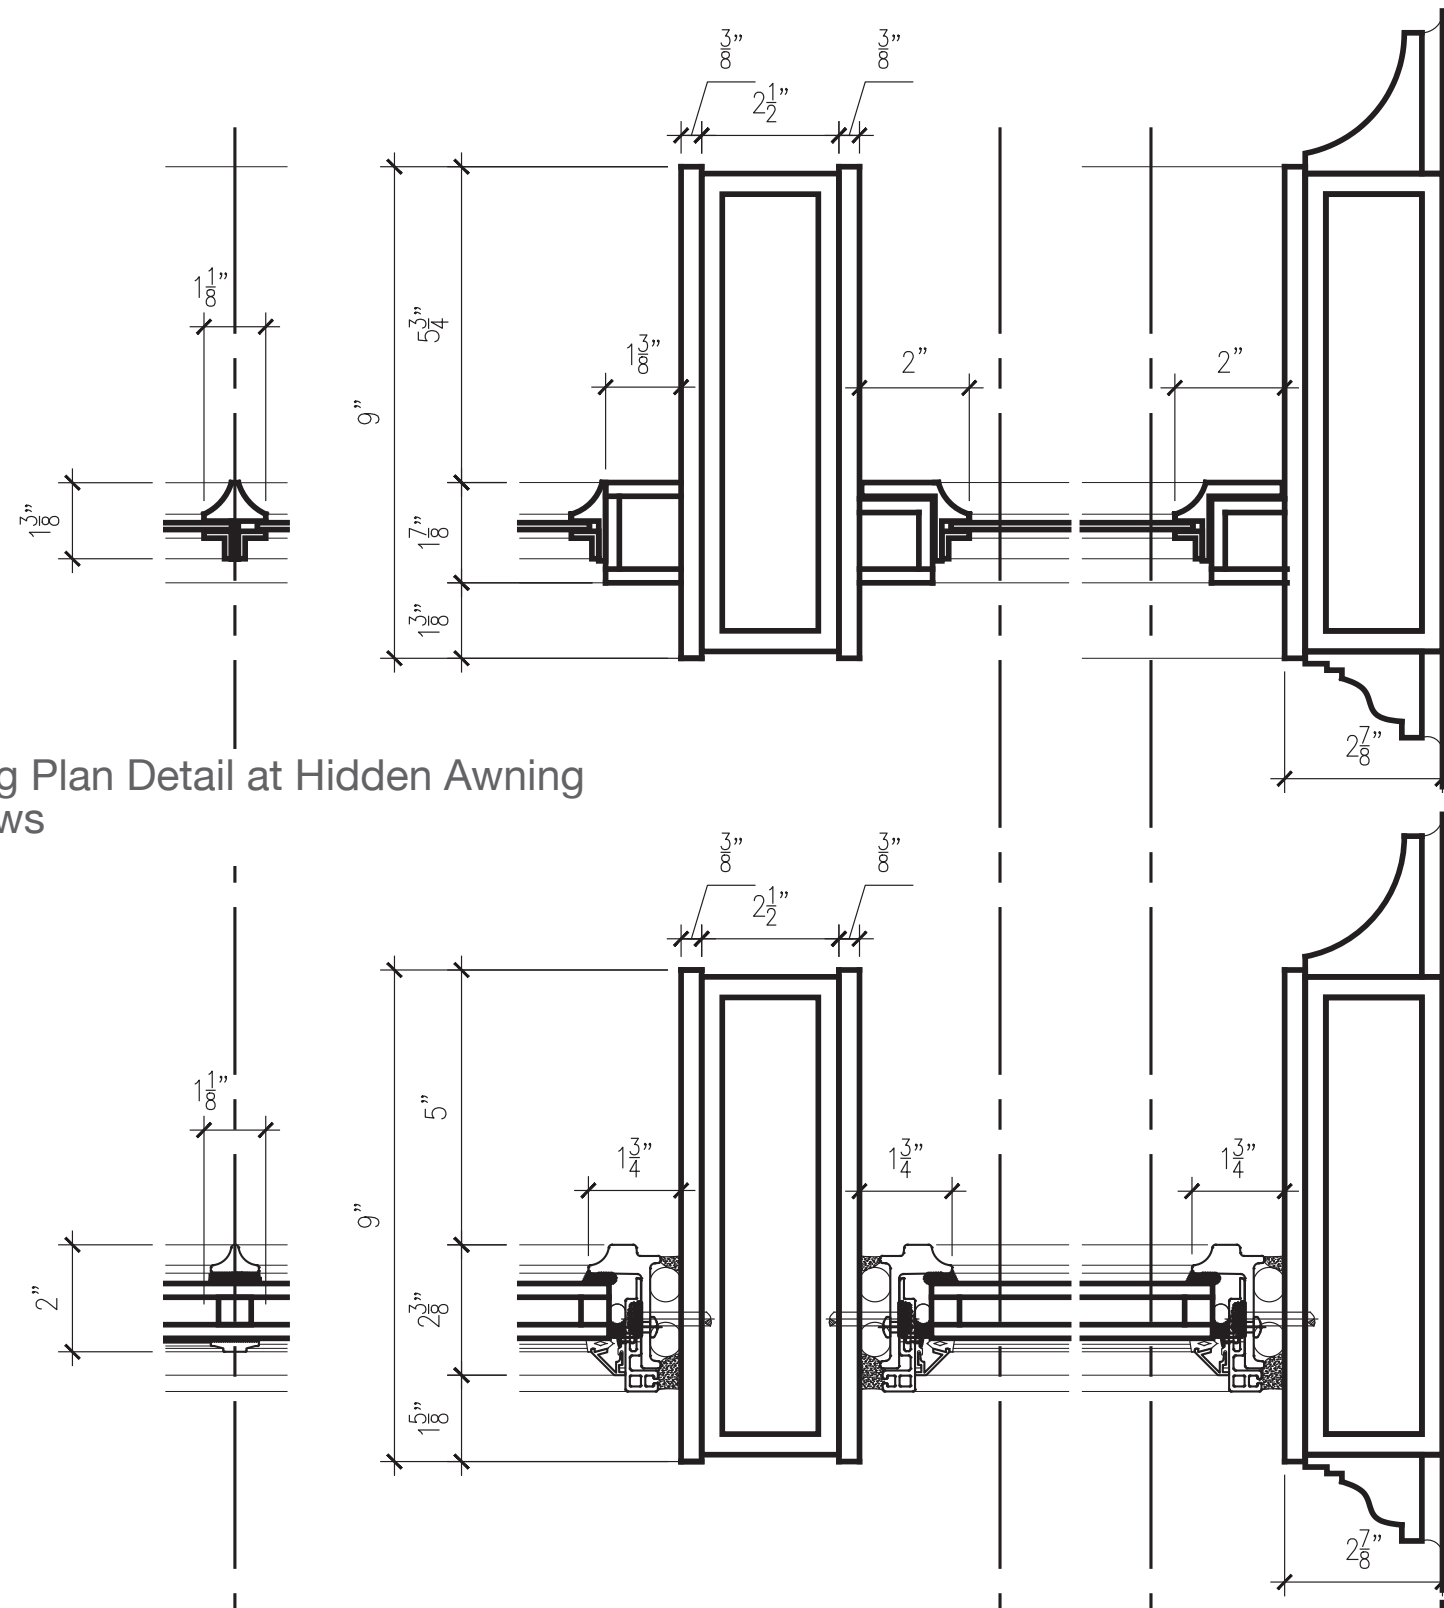
**Plan Detail Comparison**

Existing Plan Detail at Hidden Awning Windows

Proposed Plan Detail with Fixed Lites

- **Provided by Hopes Windows**
- **Maintains the delicate and diaphonous lines of the existing lites within the existing mullions and frame.**
- **Increases thermal performance**
- **Eliminates points of air and water leakage**

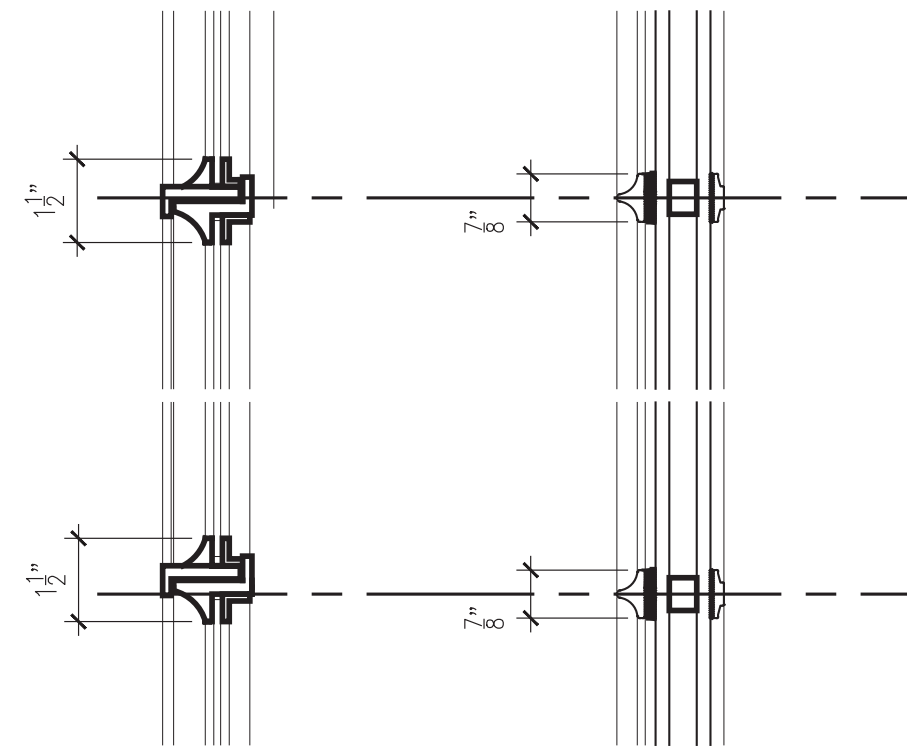
**Section Detail Comparison**

Existing Section Detail with Concealed Awning Windows

Proposed Section Detail with fixed lites

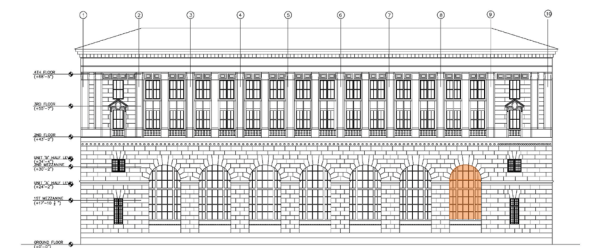
Window 7 Existing Conditions

- Angle frame glazing stop is missing. Ill fitting glass and substandard caulking installed.
- Angle frame glazing stop is damaged: bowed, bent or broken. Rust jacking may be one of the causes
- Glass is cracked, or glass has been replaced very poorly (bad fit, sloppy caulking)
- Severe issue, see note
- General indication of rust and peeling paint

Lower side plates of vertical mullions to be removed; Rust to be scraped and ground smooth. Rust inhibitor to be applied before reattaching side plates. Typical for all.

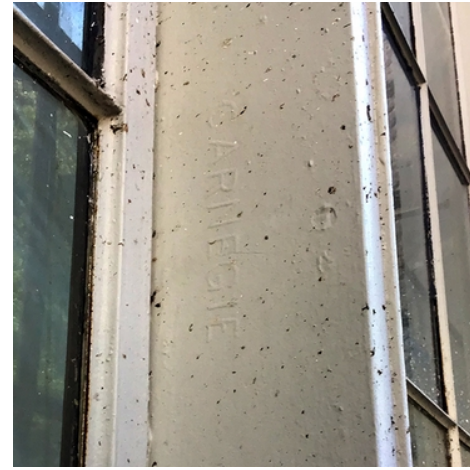
The monumental arched windows are steel, stamped with the Carnegie Steel mark. Surfaces examined were noted to be largely crisp, and clean of substantial paint accumulation, indicating either paint loss due to weathering, or due to previous paint removal efforts.

Isolated areas of corrosion damage were also noted, especially in areas of poor water drainage.

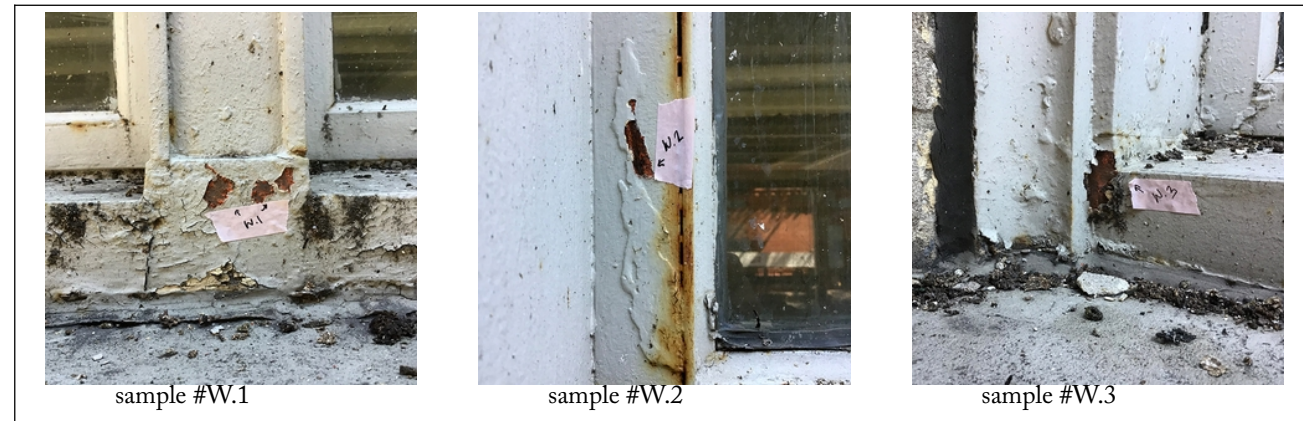
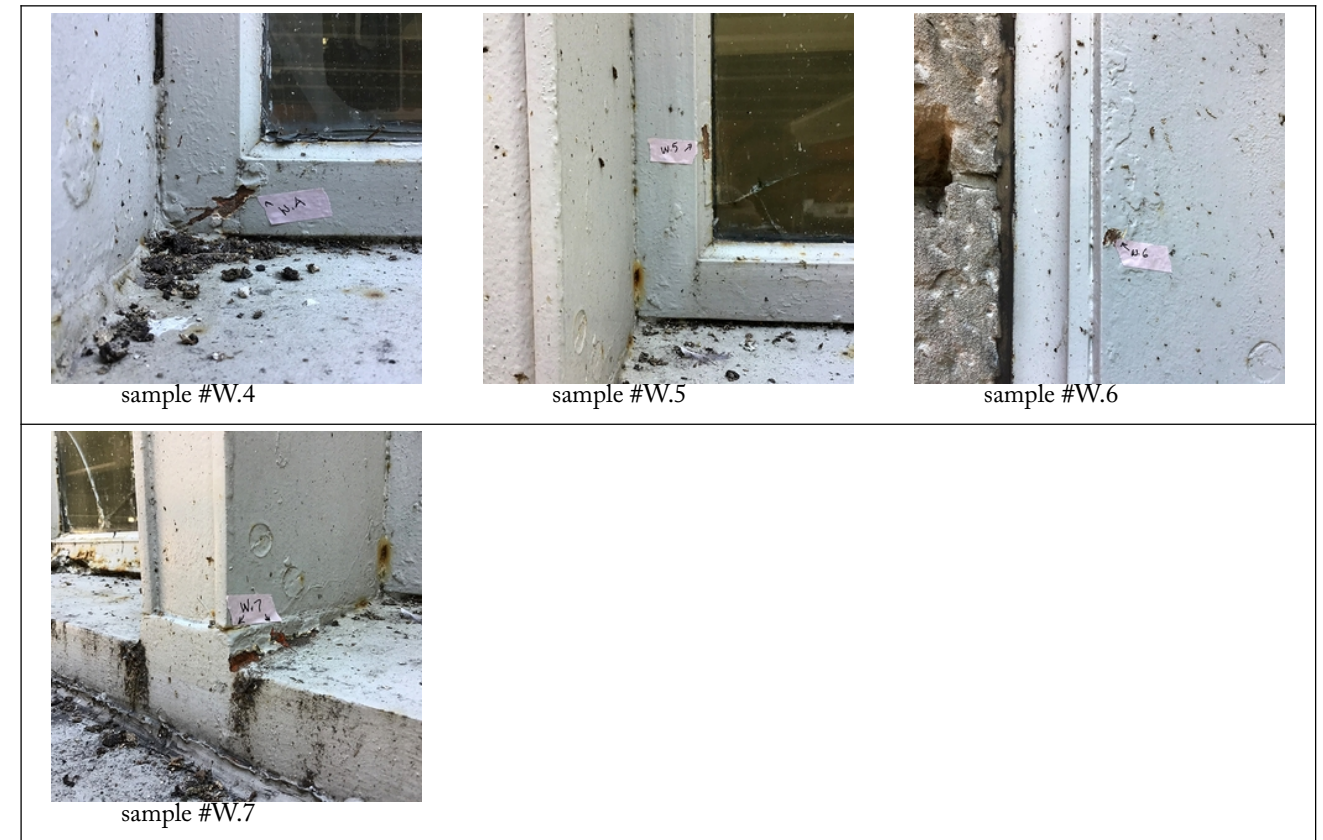
### Paint Sample Locations

Site investigation allowed for up-close examination of two of the windows, as accessed from the sill of the building's water-table, which allowed for examination of the lowest-most sections of each of these windows. Seven total paint samples were extracted from accessible elements using a precision knife blade. All existing layers are included in each extracted sample, and while the steel substrate was not included in the paint samples, surfaces were scraped sufficiently to ensure that scale, corrosion, foundry coatings, or the artefact of the steel surface are included as a complete sample.
