The Flatiron Building

PRESENTATION TO LANDMARK PRESERVATION COMMISSION

MAY 21, 2024

1. WINDOW REPLACEMENT
2. STOREFRONT MASTER PLAN MODIFICATION
3. ROOFTOP MECHANICAL AND BUIKHEAD PLAN
4. APPENDIX

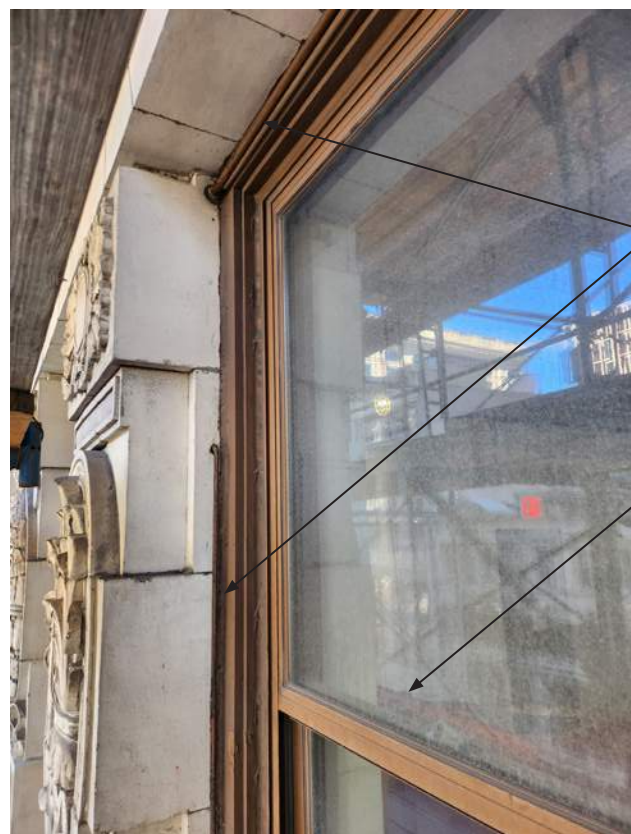
① HEAD DETAIL - EXISTING 2004 DOUBLE HUNG WINDOW

EXISTING WINDOW TRIM TO REMAIN. REFURBISH EXISTING WINDOW TRIM

REPLACE ALUMINIUM DOUBLE HUNG WD. TO NEW ALUMINIUM CASEMENT WINDOW

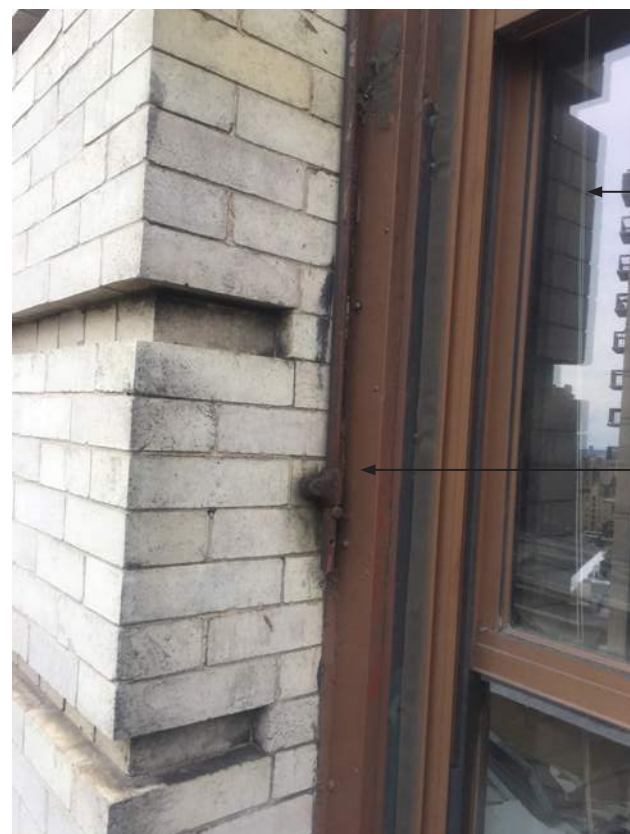
② JAMB DETAIL - EXISTING 2004 DOUBLE HUNG WINDOW

REPLACE ALUMINIUM DOUBLE HUNG WD. TO NEW ALUMINIUM CASEMENT WINDOW

EXISTING WINDOW TRIM TO REMAIN. REFURBISH EXISTING WINDOW TRIM

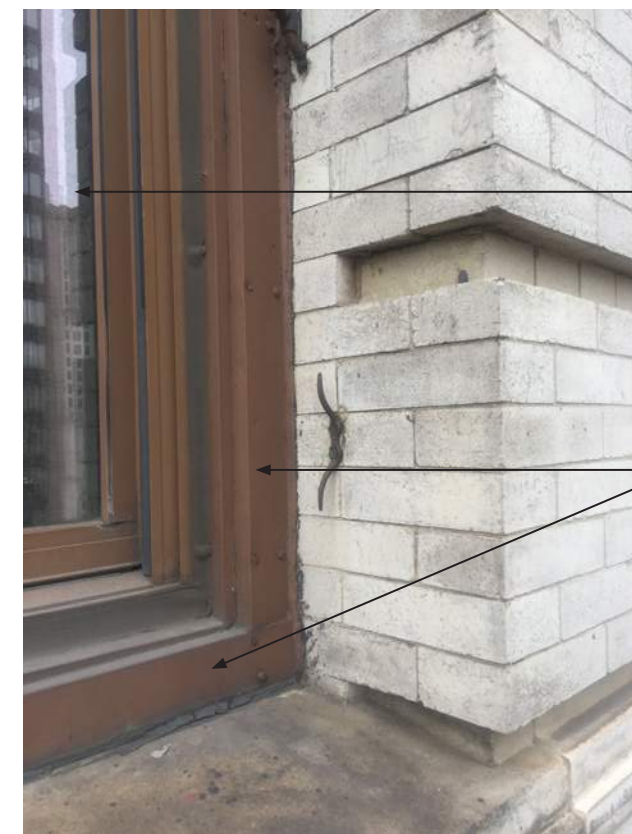
③ SILL DETAIL - EXISTING 2004 DOUBLE HUNG WINDOW

REPLACE ALUMINIUM DOUBLE HUNG WD. TO NEW ALUMINIUM CASEMENT WINDOW

EXISTING WINDOW TRIM TO REMAIN. REFURBISH EXISTING WINDOW TRIM

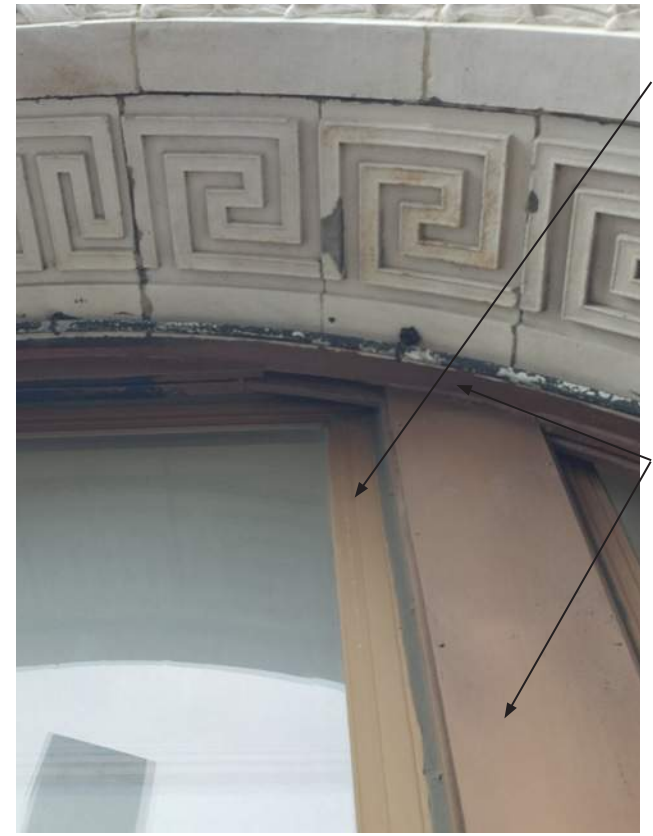
① HEAD DETAIL - EXISTING 2004 DOUBLE HUNG WINDOW

REPLACE ALUMINIUM DOUBLE HUNG WINDOW TO NEW ALUMINUM WINDOW

EXISTING WINDOW TRIM TO REMAIN. REFURBISH EXISTING WINDOW TRIM

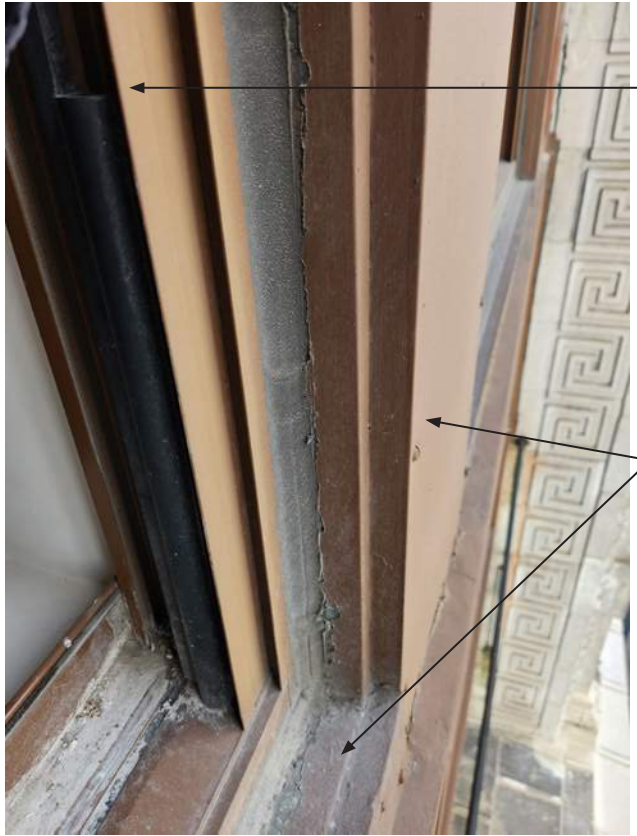
② JAMB DETAIL - EXISTING 2004 DOUBLE HUNG WINDOW

REPLACE ALUMINIUM DOUBLE HUNG WINDOW TO NEW ALUMINUM WINDOW

EXISTING WINDOW TRIM TO REMAIN. REFURBISH EXISTING WINDOW TRIM

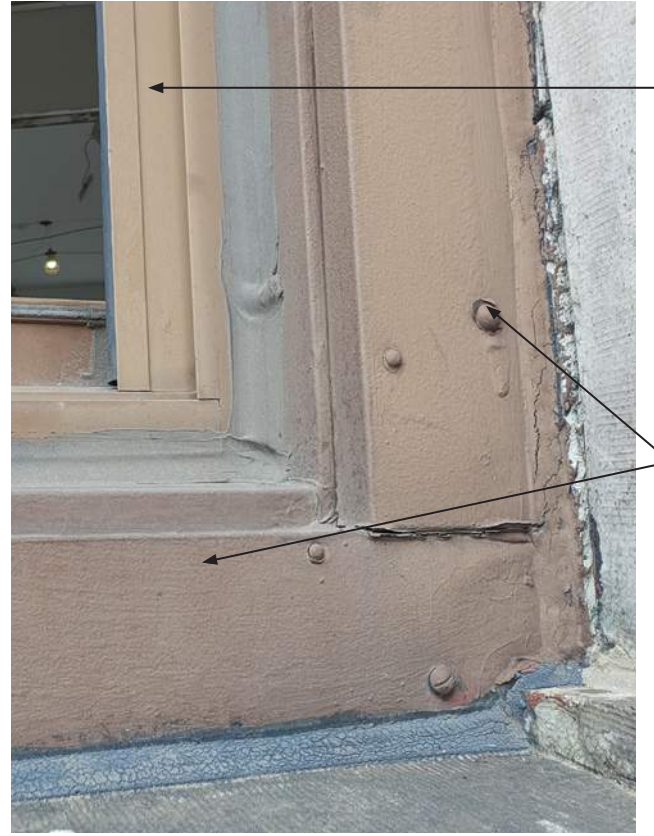
③ SILL DETAIL - EXISTING 2004 DOUBLE HUNG WINDOW

REPLACE ALUMINIUM DOUBLE HUNG WINDOW TO NEW ALUMINUM WINDOW

EXISTING WINDOW TRIM TO REMAIN. REFURBISH EXISTING WINDOW TRIM

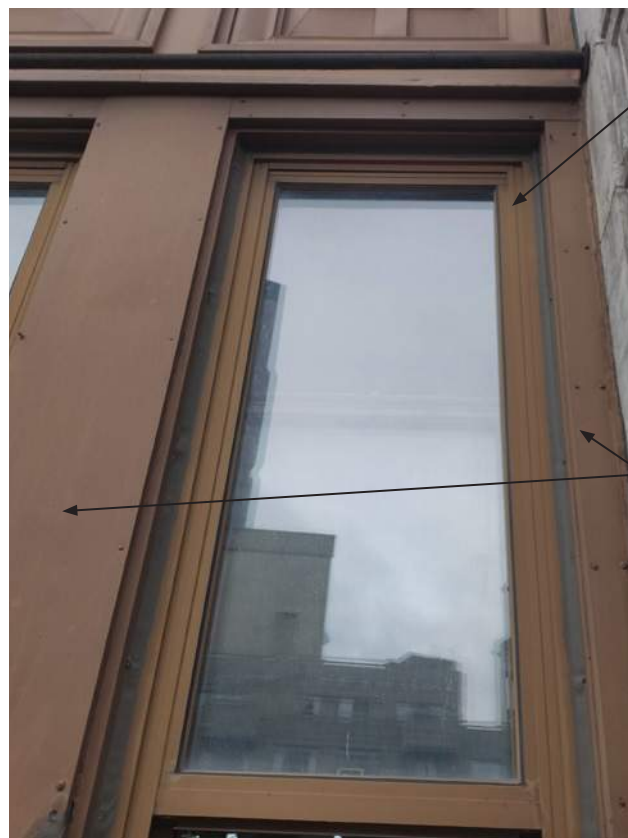
① HEAD DETAIL - EXISTING 2004 DOUBLE HUNG WINDOW

REPLACE ALUMINIUM DOUBLE HUNG WINDOW TO NEW ALUMINUM WINDOW

EXISTING WINDOW TRIM TO REMAIN. REFURBISH EXISTING WINDOW TRIM

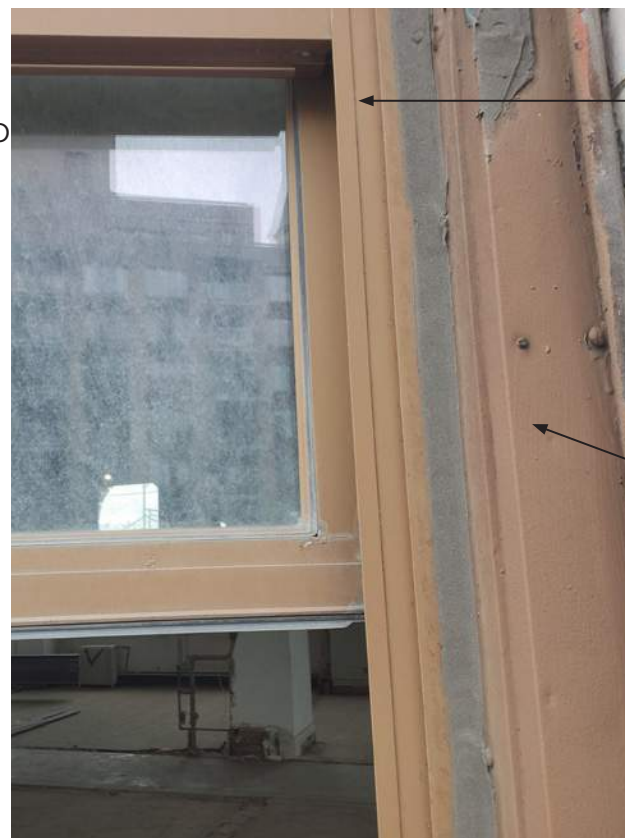
② JAMB DETAIL - EXISTING 2004 DOUBLE HUNG WINDOW

REPLACE ALUMINIUM DOUBLE HUNG WINDOW TO NEW ALUMINUM WINDOW

EXISTING WINDOW TRIM TO REMAIN. REFURBISH EXISTING WINDOW TRIM

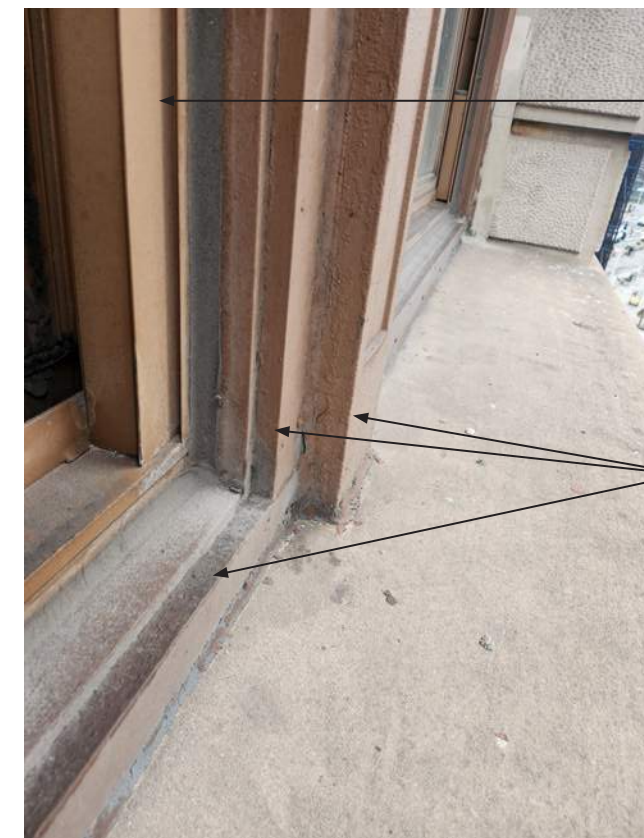
③ SILL DETAIL - EXISTING 2004 DOUBLE HUNG WINDOW

REPLACE ALUMINIUM DOUBLE HUNG WINDOW TO NEW ALUMINUM WINDOW

EXISTING WINDOW TRIM TO REMAIN. REFURBISH EXISTING WINDOW TRIM

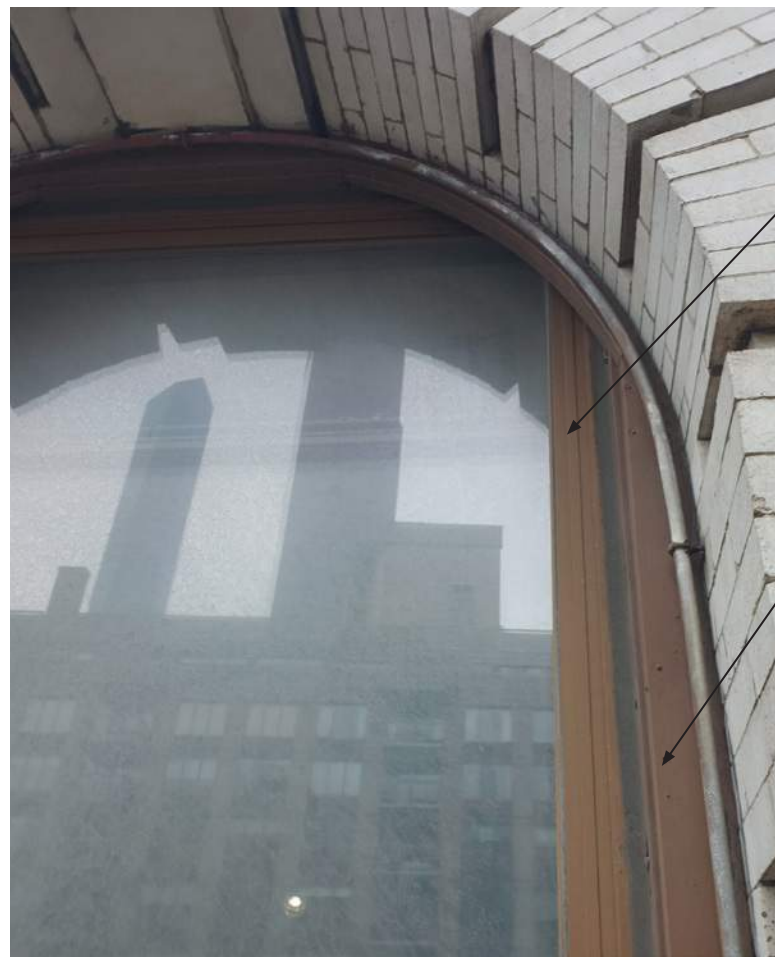
① HEAD DETAIL - EXISTING 2004 DOUBLE HUNG WINDOW

REPLACE ALUMINIUM DOUBLE HUNG WINDOW TO NEW ALUMINUM WINDOW

EXISTING WINDOW TRIM TO REMAIN. REFURBISH EXISTING WINDOW TRIM

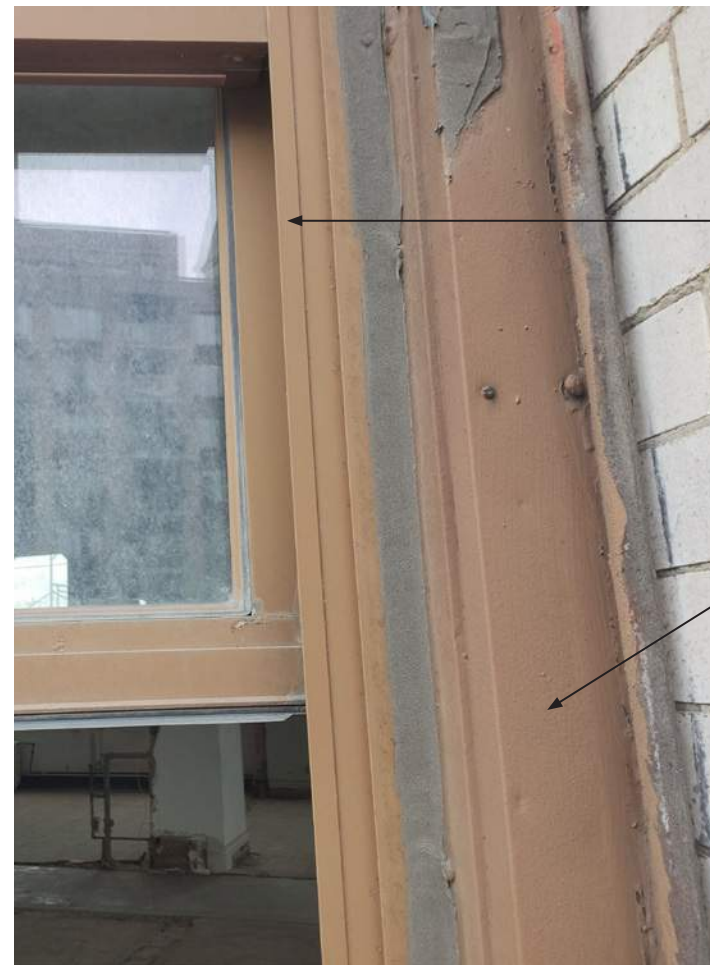
② JAMB DETAIL - EXISTING 2004 DOUBLE HUNG WINDOW

REPLACE ALUMINIUM DOUBLE HUNG WINDOW TO NEW ALUMINUM WINDOW

EXISTING WINDOW TRIM TO REMAIN. REFURBISH EXISTING WINDOW TRIM

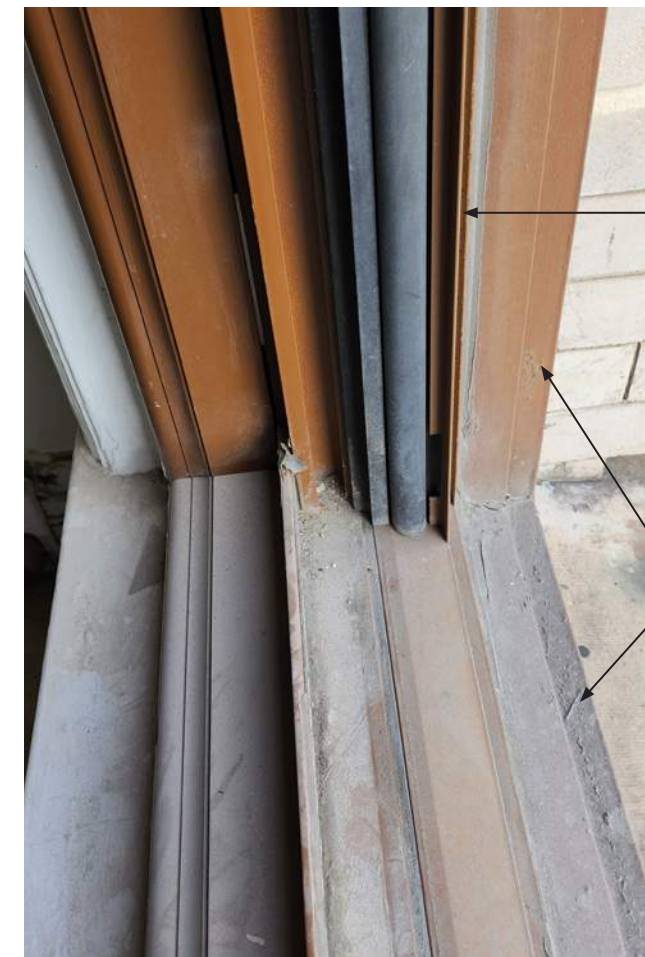
③ SILL DETAIL - EXISTING 2004 DOUBLE HUNG WINDOW

REPLACE ALUMINIUM DOUBLE HUNG WINDOW TO NEW ALUMINUM WINDOW

EXISTING WINDOW TRIM TO REMAIN. REFURBISH EXISTING WINDOW TRIM

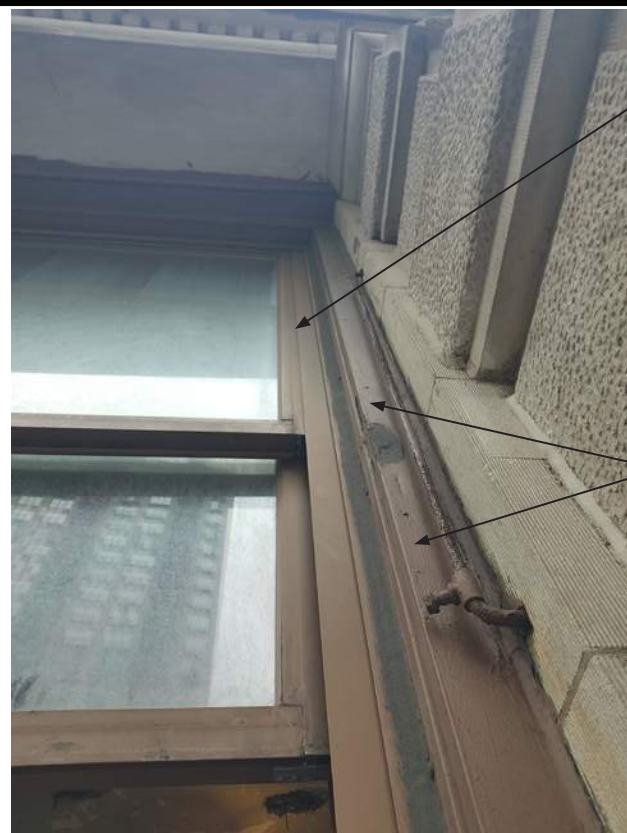
① HEAD DETAIL - EXISTING 2004 DOUBLE HUNG WINDOW

REPLACE ALUMINIUM DOUBLE HUNG WINDOW TO NEW ALUMINUM WINDOW

EXISTING WINDOW TRIM TO REMAIN. REFURBISH EXISTING WINDOW TRIM

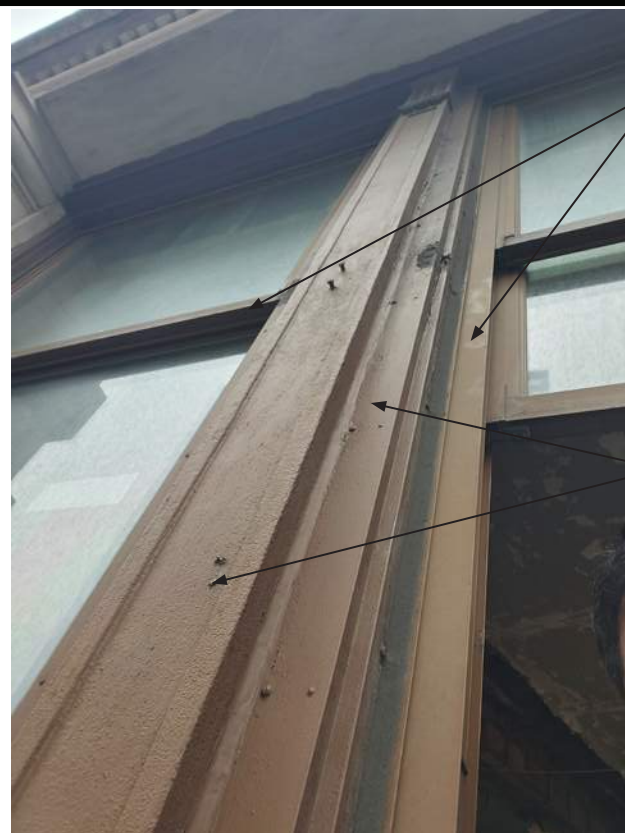
② JAMB DETAIL - EXISTING 2004 DOUBLE HUNG WINDOW

REPLACE ALUMINIUM DOUBLE HUNG WINDOW TO NEW ALUMINUM WINDOW

EXISTING WINDOW TRIM TO REMAIN. REFURBISH EXISTING WINDOW TRIM

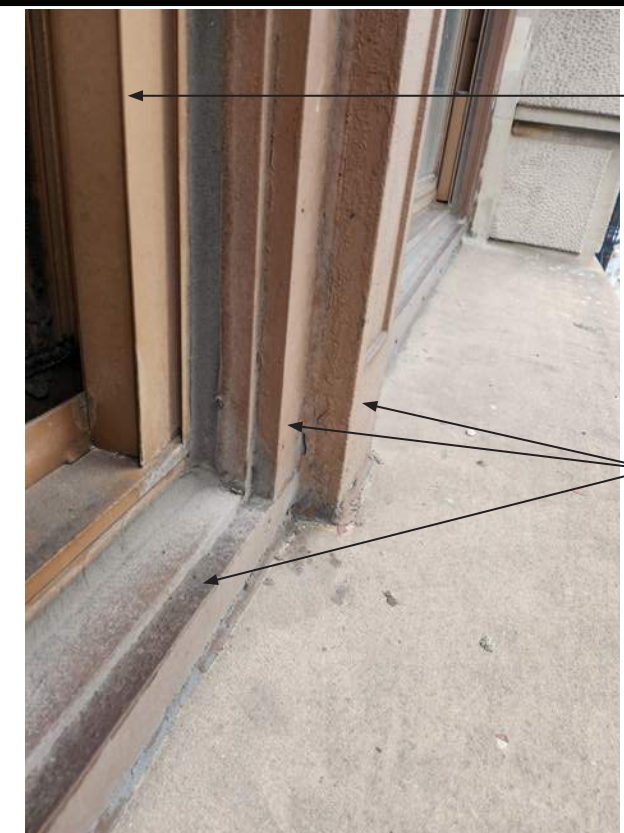
REPLACE ALUMINIUM DOUBLE HUNG WINDOW TO NEW ALUMINUM WINDOW

EXISTING WINDOW TRIM TO REMAIN. REFURBISH EXISTING WINDOW TRIM

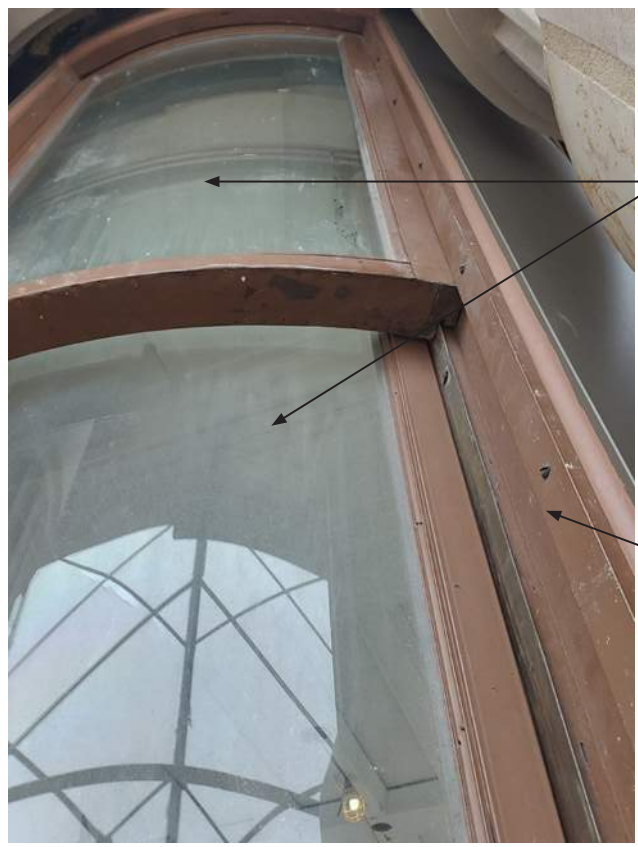
WINDOW TYPE "D" ELEVATIONS

③ SILL DETAIL - EXISTING 2004 DOUBLE HUNG WINDOW

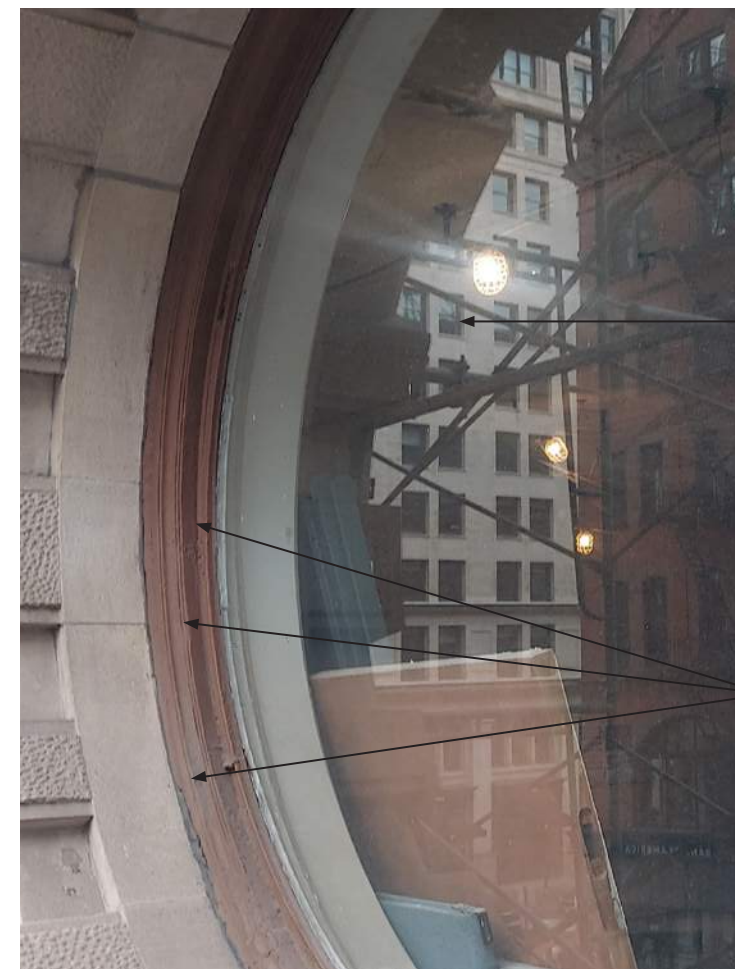
EXISTING WOOD DOUBLE HUNG WINDOW TO REMAIN. REFURBISH EXISTING WOOD WINDOW

EXISTING WINDOW TRIM TO REMAIN. REFURBISH EXISTING WINDOW TRIM

REPLACE NEW CLEAR INSULATED GLASS UNIT

EXISTING FIXED WOOD CIRCLE WINDOW TO REMAIN. REFURBISH EXISTING WOOD WINDOW TRIM

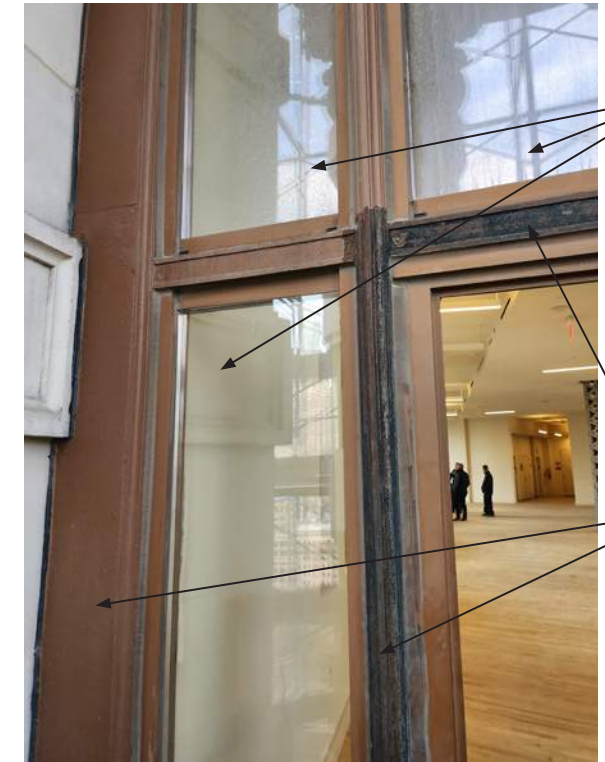
TYPE F - EXISTING STOREFRONT (WINDOW GLAZING INFILL REPLACED IN 2004.)

SINGLE PANE GLAZING REPLACED IN 2004 WITH INSULATED GLASS UNIT

EXISTING WOOD STOREFRONT TRIMS TO REMAIN. REFURBISH EXISTING WOOD FRAMES.

WINDOWS TO BE REFURBISHED

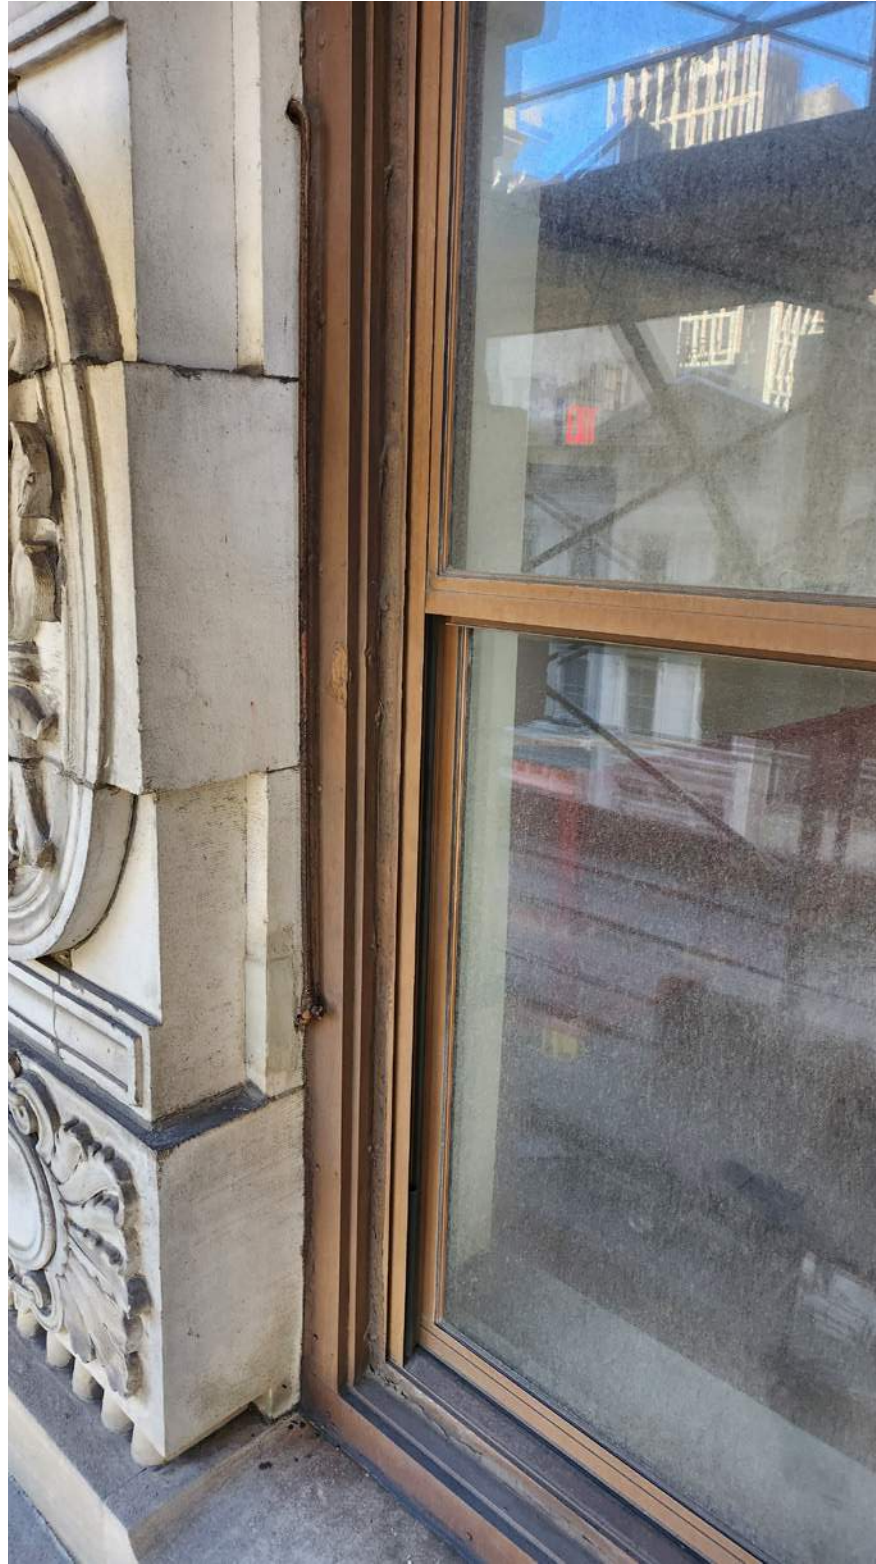
(A) TYPICAL WINDOW PHOTO - 2004 DOUBLE HUNG ALUMINIUM WINDOW REPLACEMENT

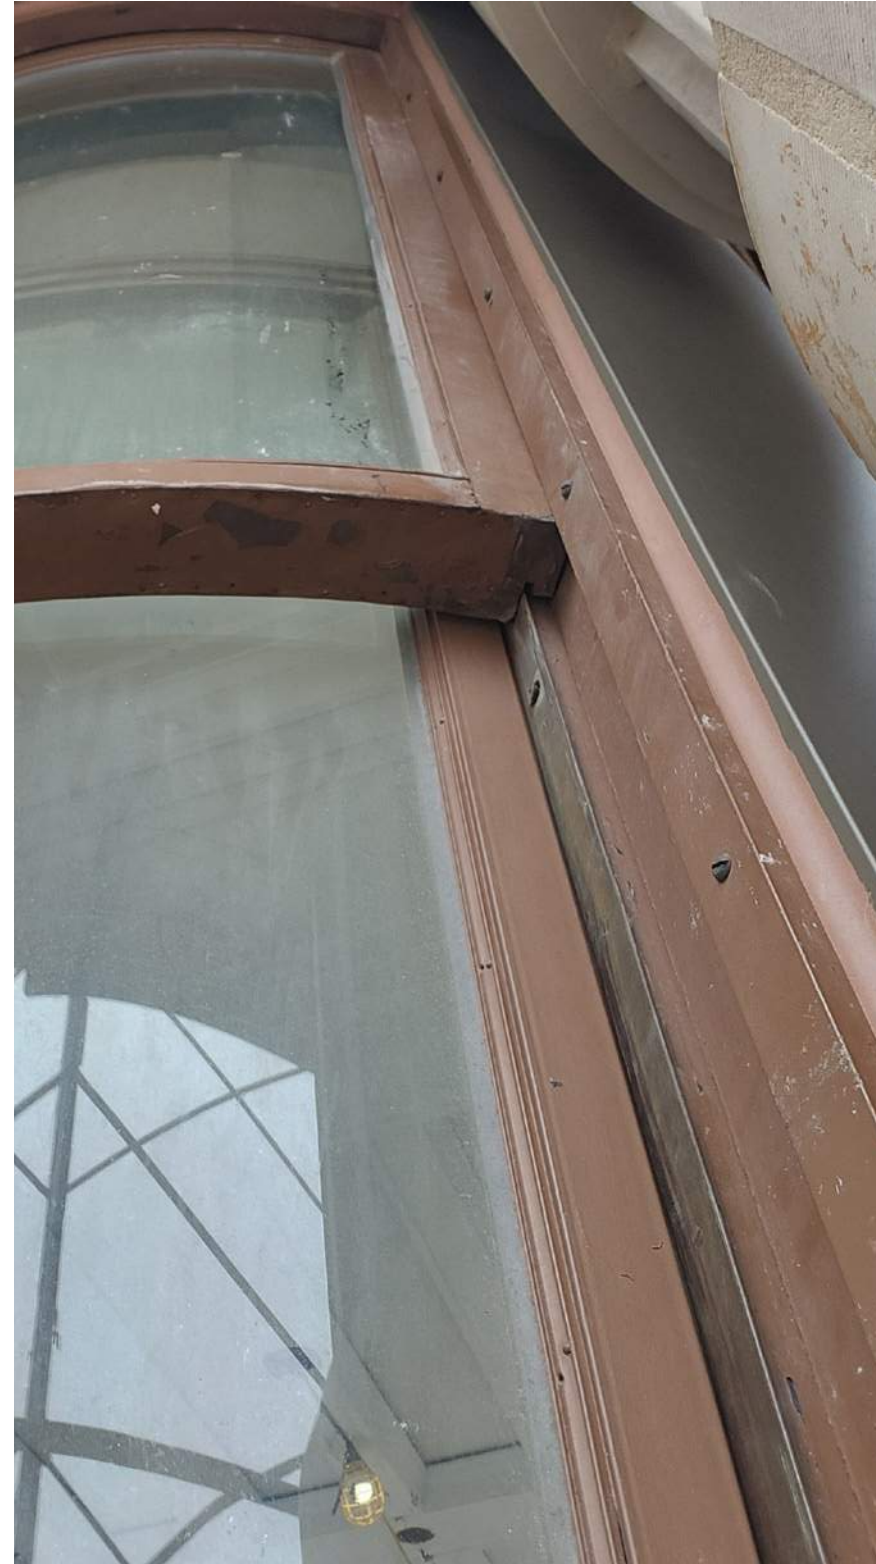
(B) TYPICAL WINDOW PHOTO - 1902 ORIGINAL DOUBLE HUNG WINDOW

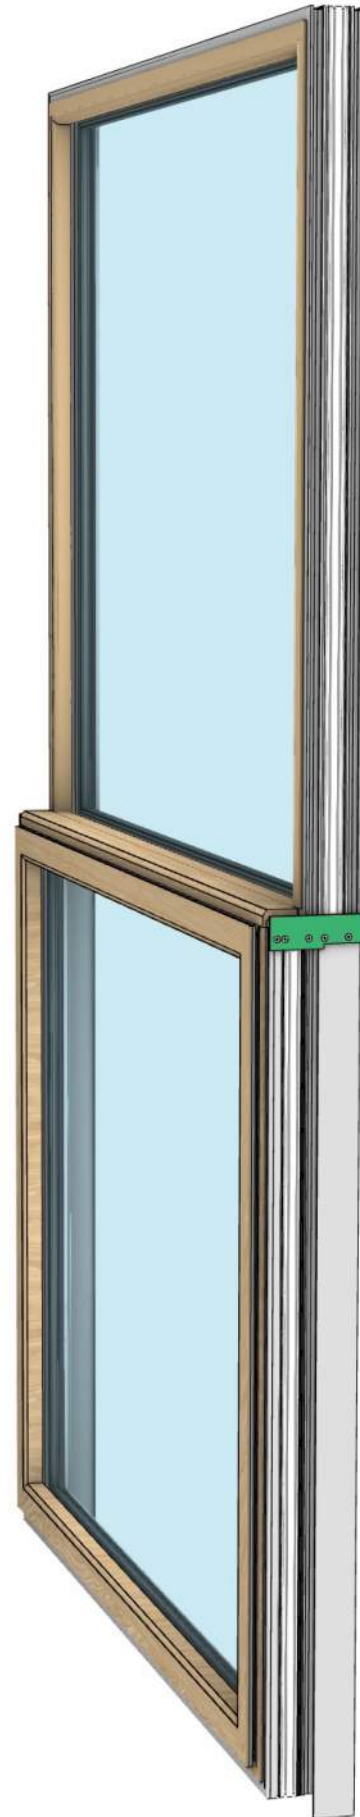
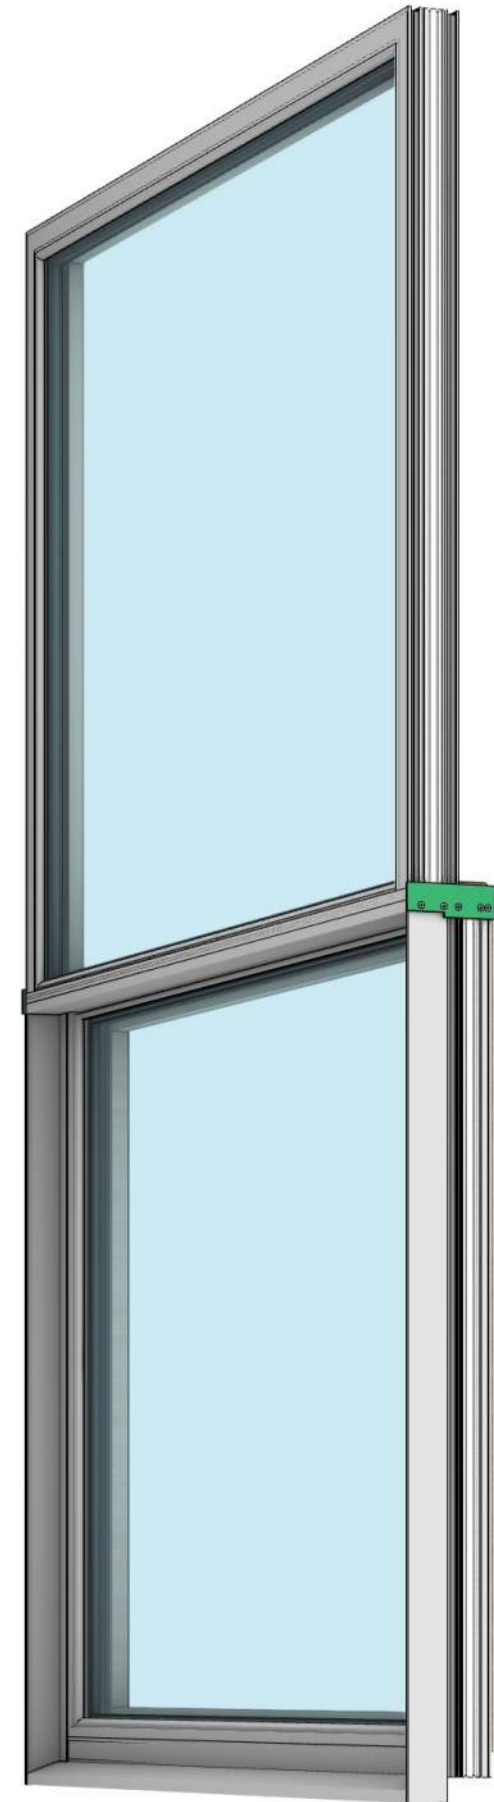
REPLACEMENT WINDOW -- 3D MODEL

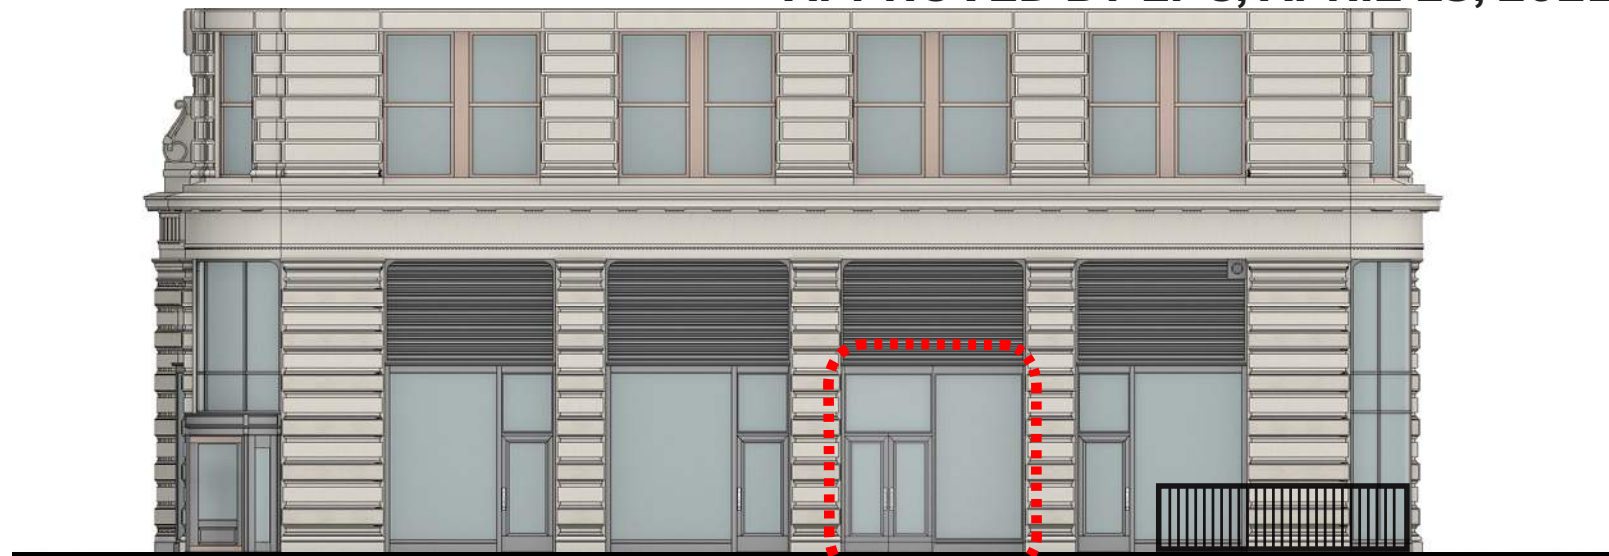
NEW SERVICE AND EGRESS DOORS

PROPOSED

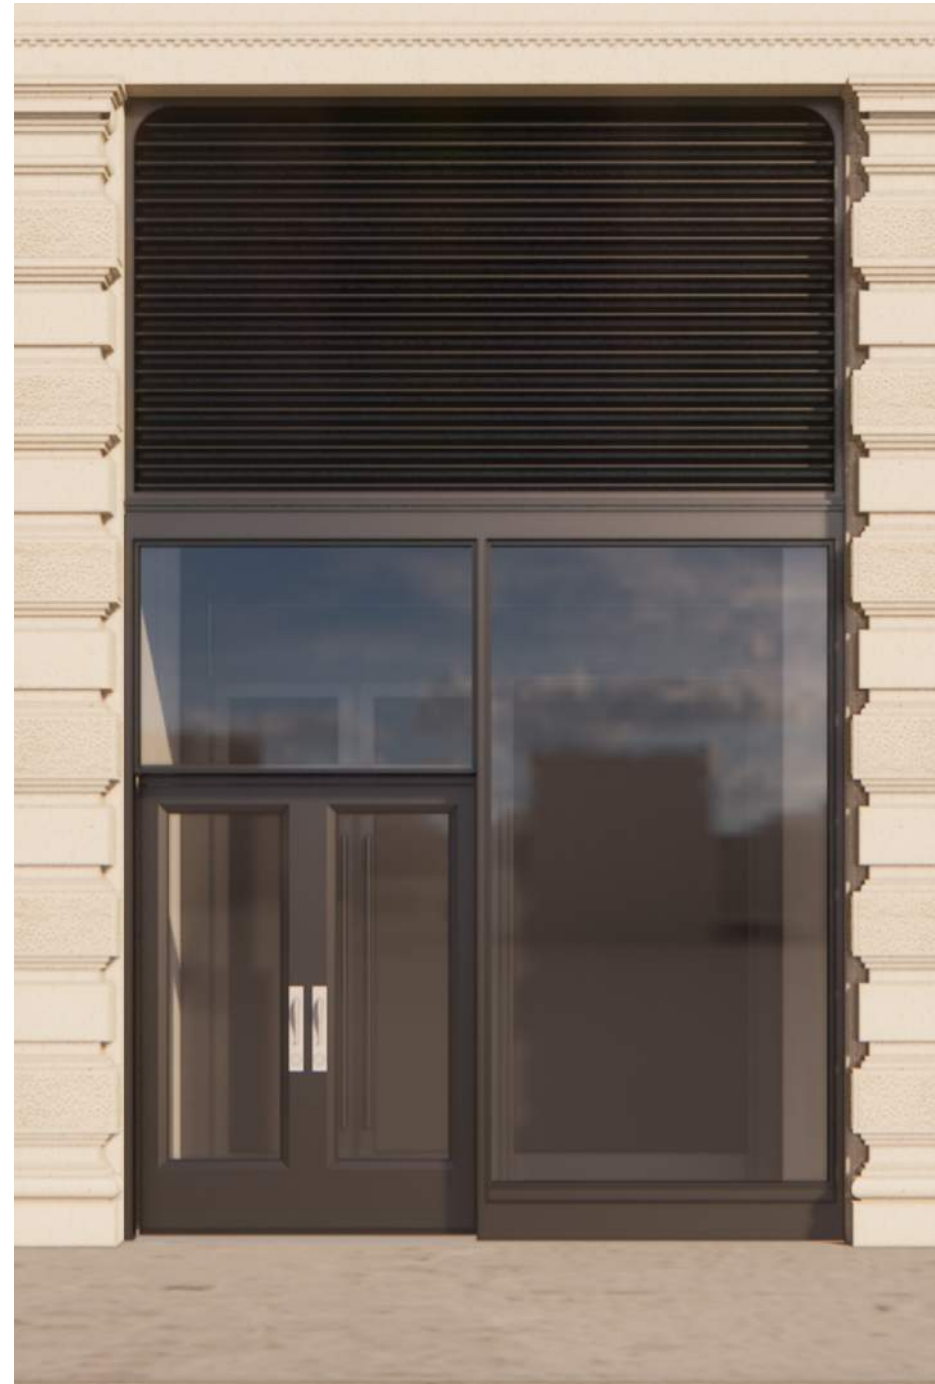
**PROPOSED NEW SERVICE
AND EGRESS DOORS**

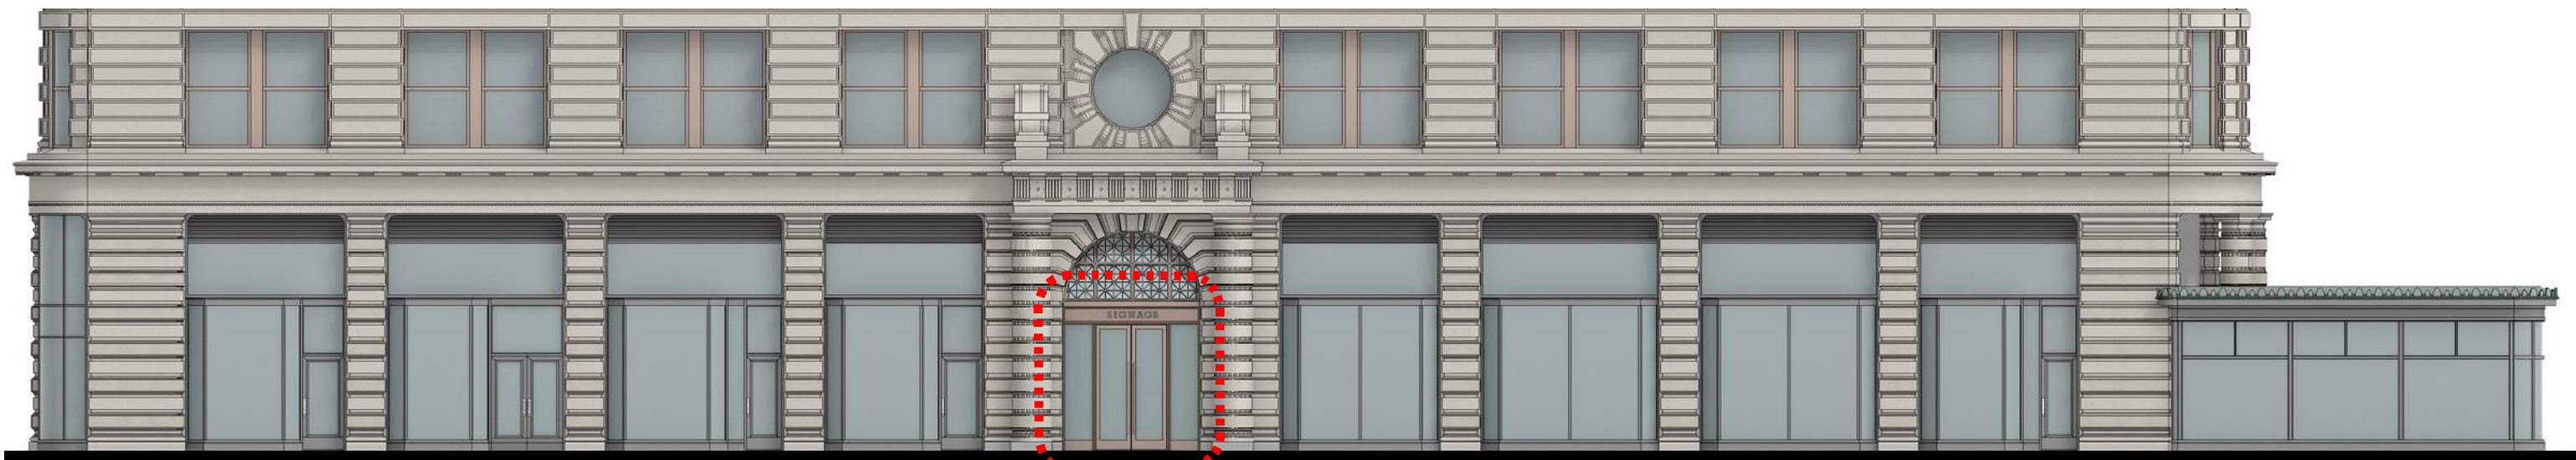
PROPOSED RETAIL ENTRY
