The Flatiron Building

PRESENTATION TO LANDMARK PRESERVATION COMMISSION

MAY 21, 2024

1. WINDOW REPLACEMENT
2. STOREFRONT MASTER PLAN MODIFICATION
3. ROOFTOP MECHANICAL AND BUIKHEAD PLAN
4. APPENDIX

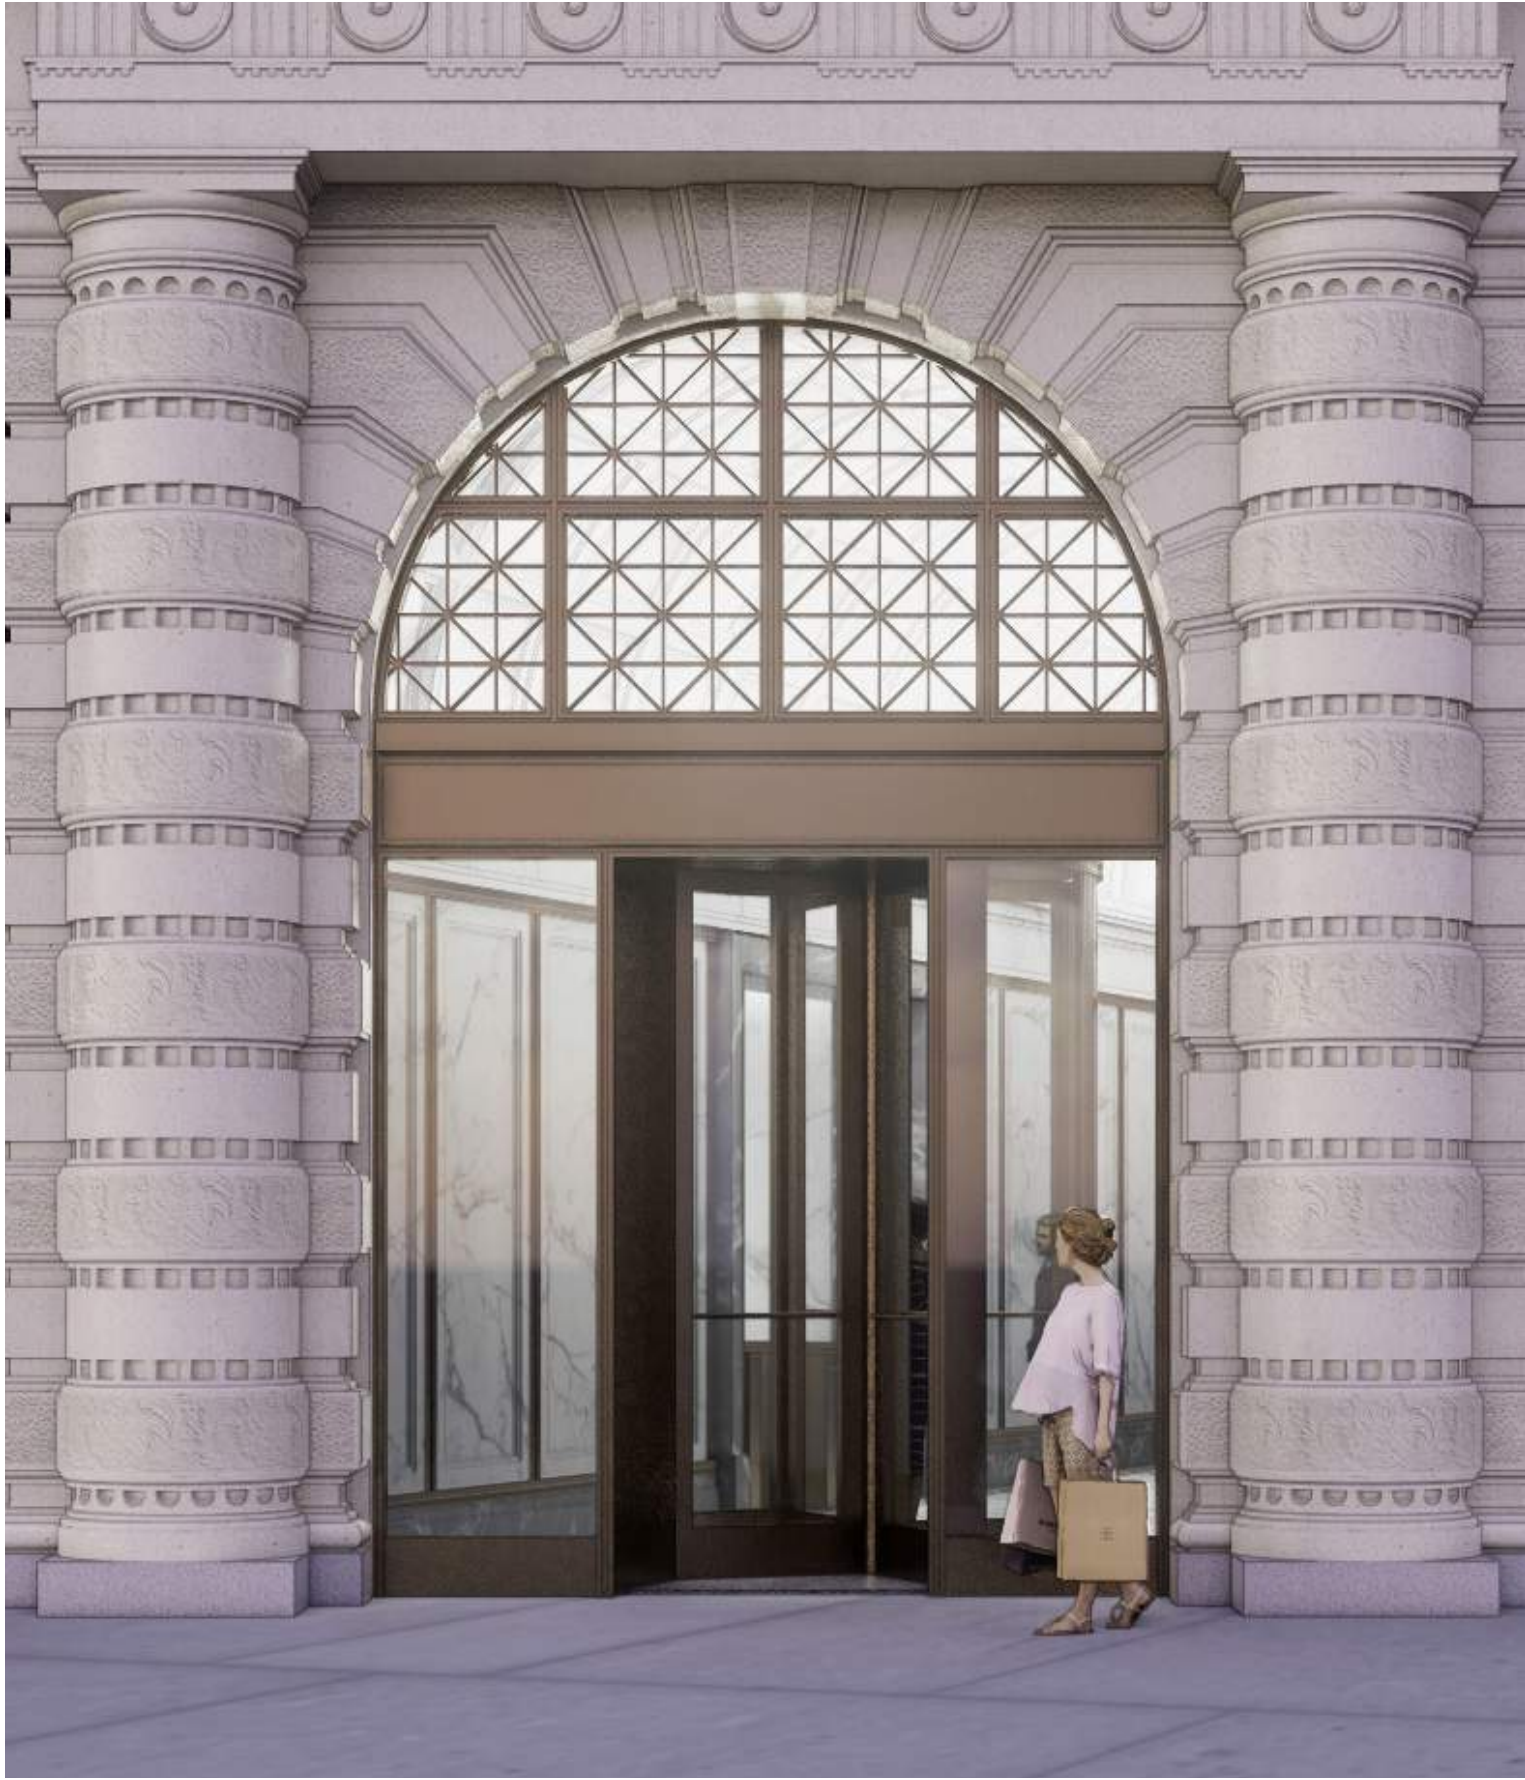
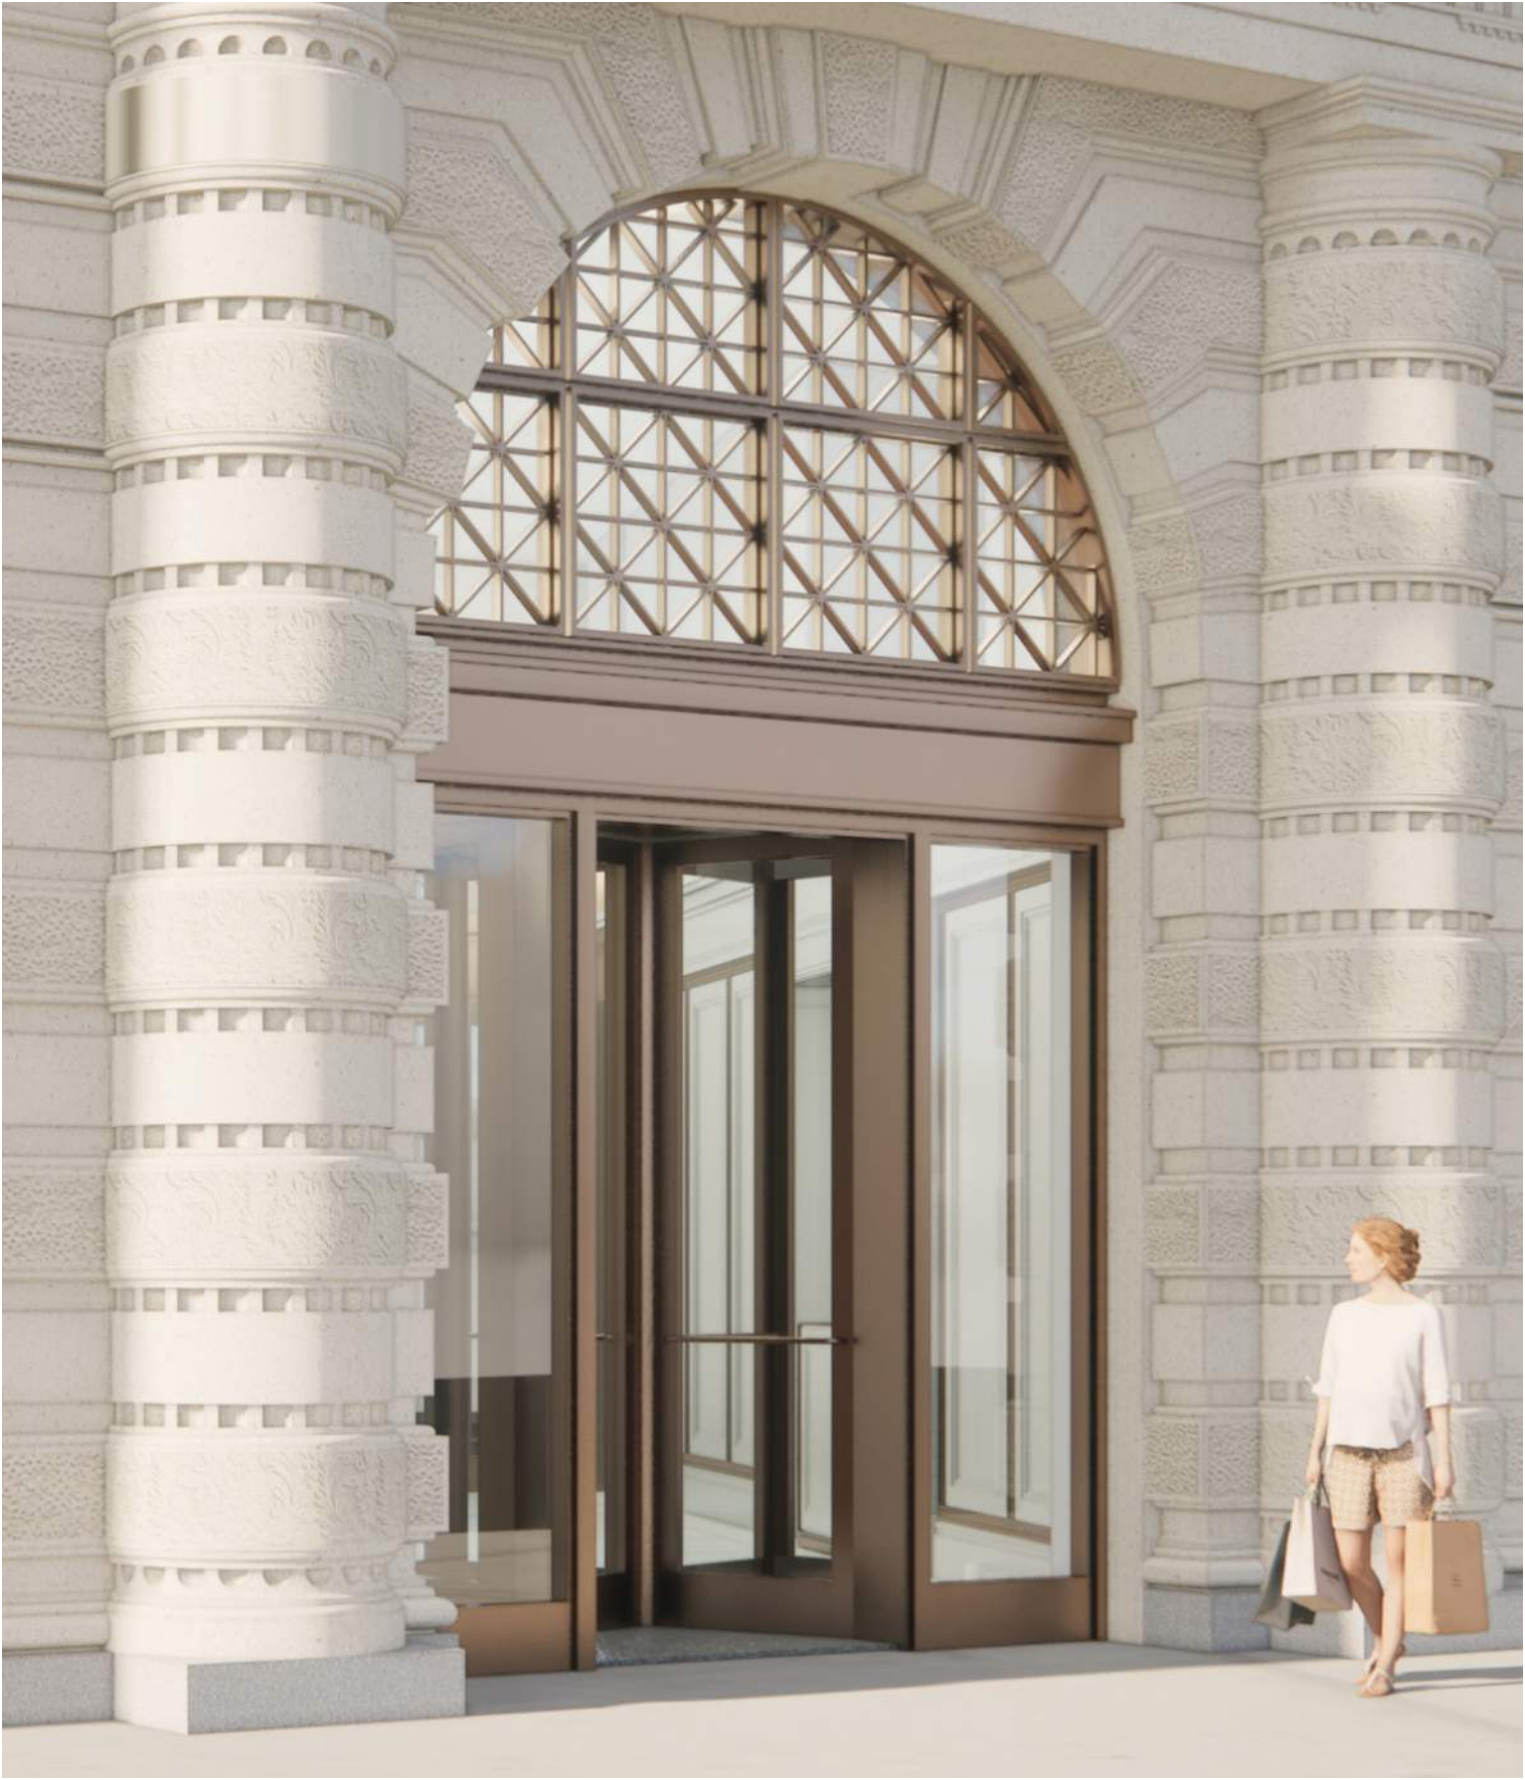
BROADWAY STOREFRONTS

APPROVED BY LPC APRIL 13TH, 2021 WITH REVISED TRANSOM GRILL DETAILS, APPROVED BY STAFF MAY 6TH, 2021

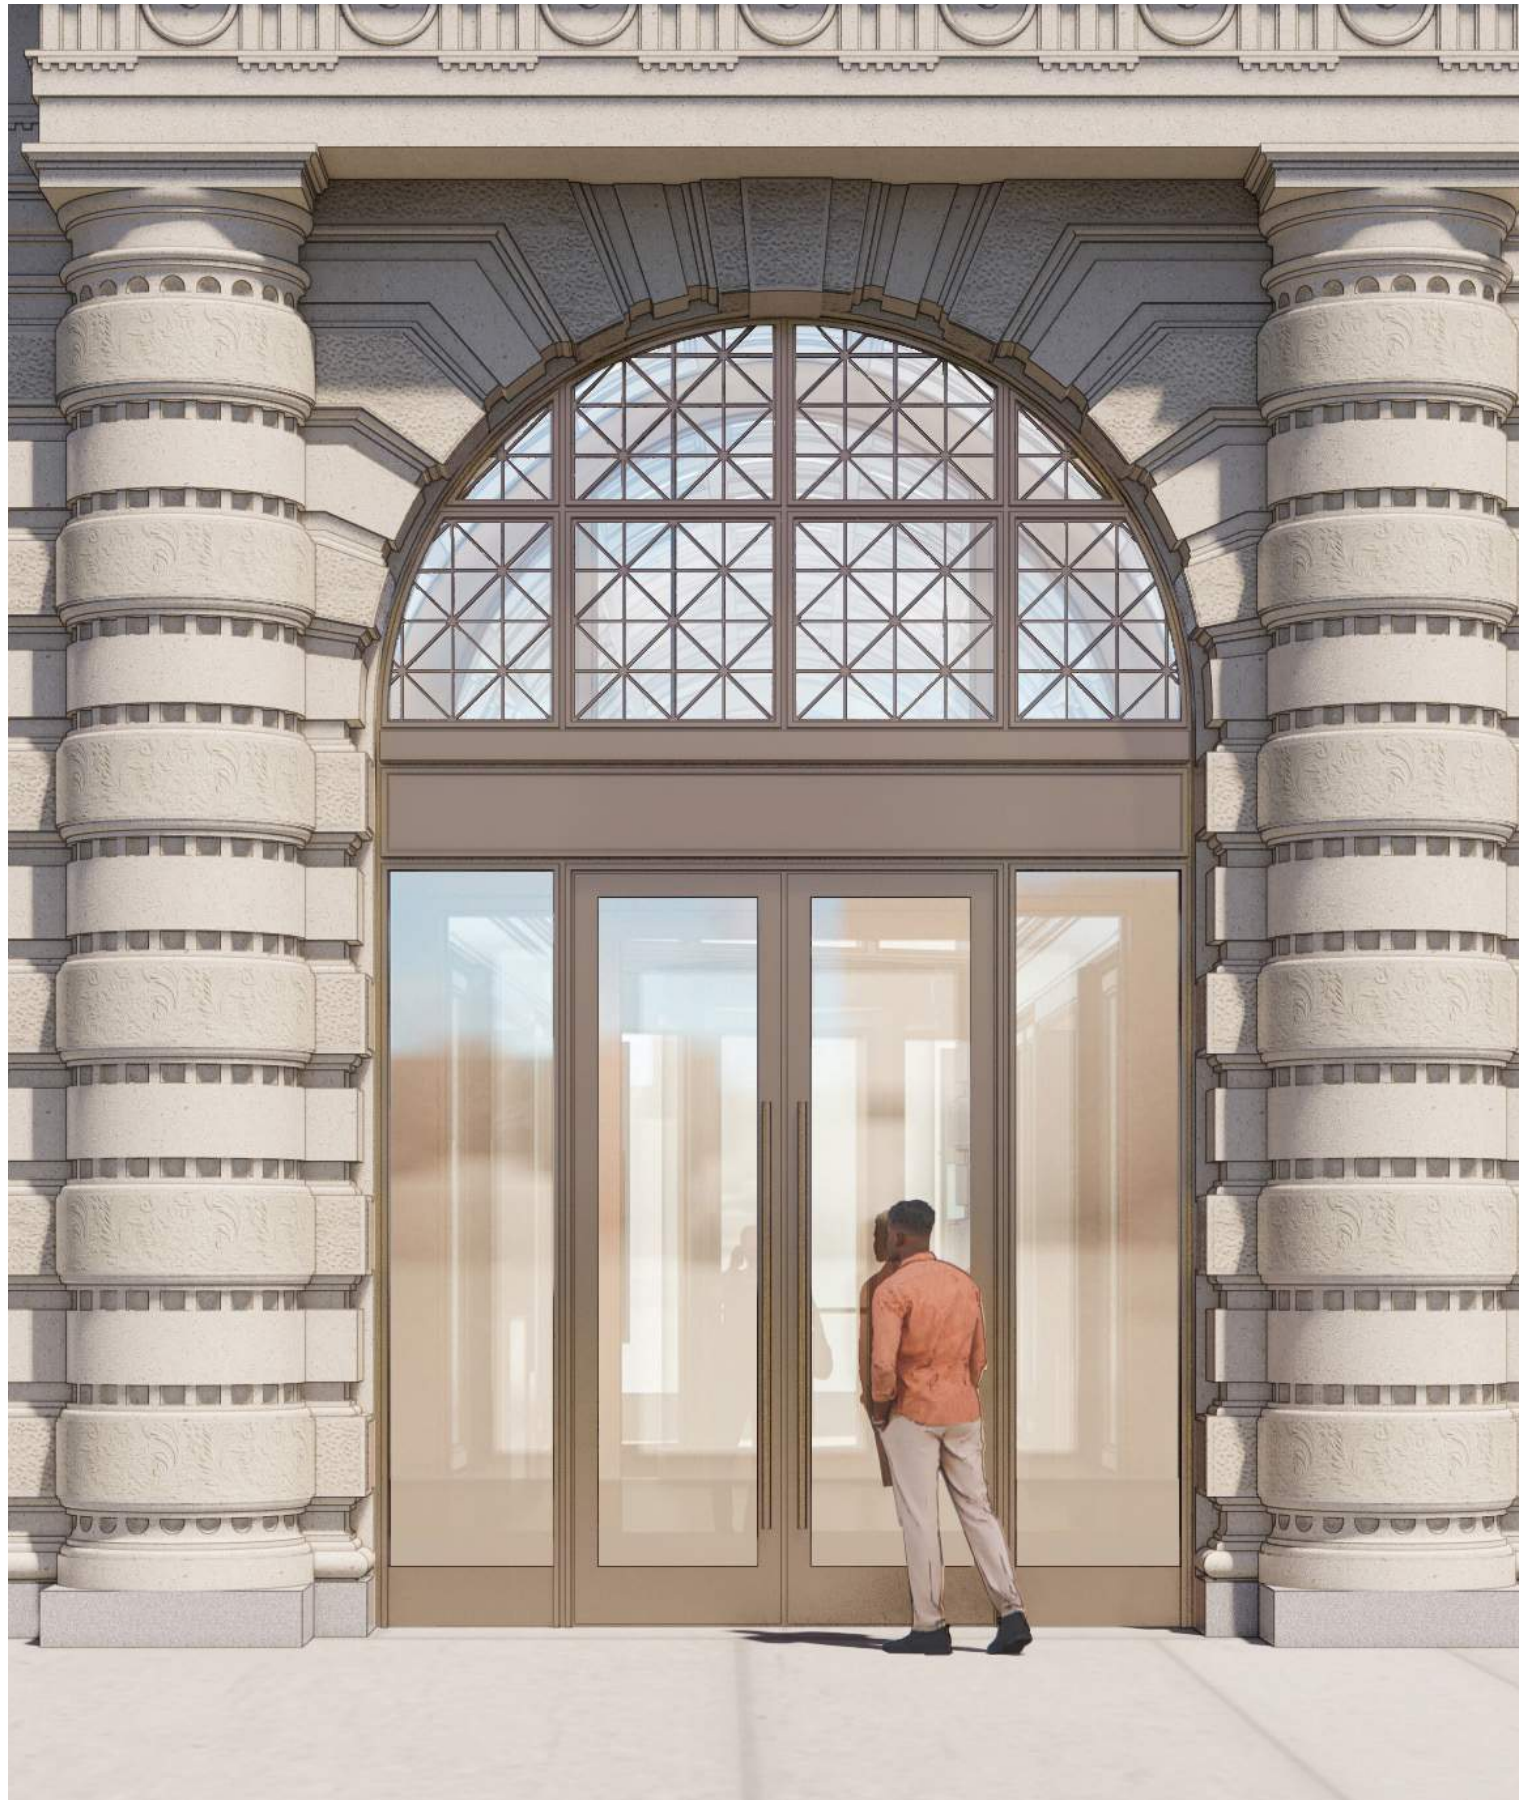
BROADWAY ENTRY

**APPROVED BY LPC APRIL 13TH, 2021 WITH REVISED TRANSOM GRILL DETAILS, APPROVED BY STAFF MAY 6TH, 2021
5TH AVENUE & PROPOSED BROADWAY ENTRY**

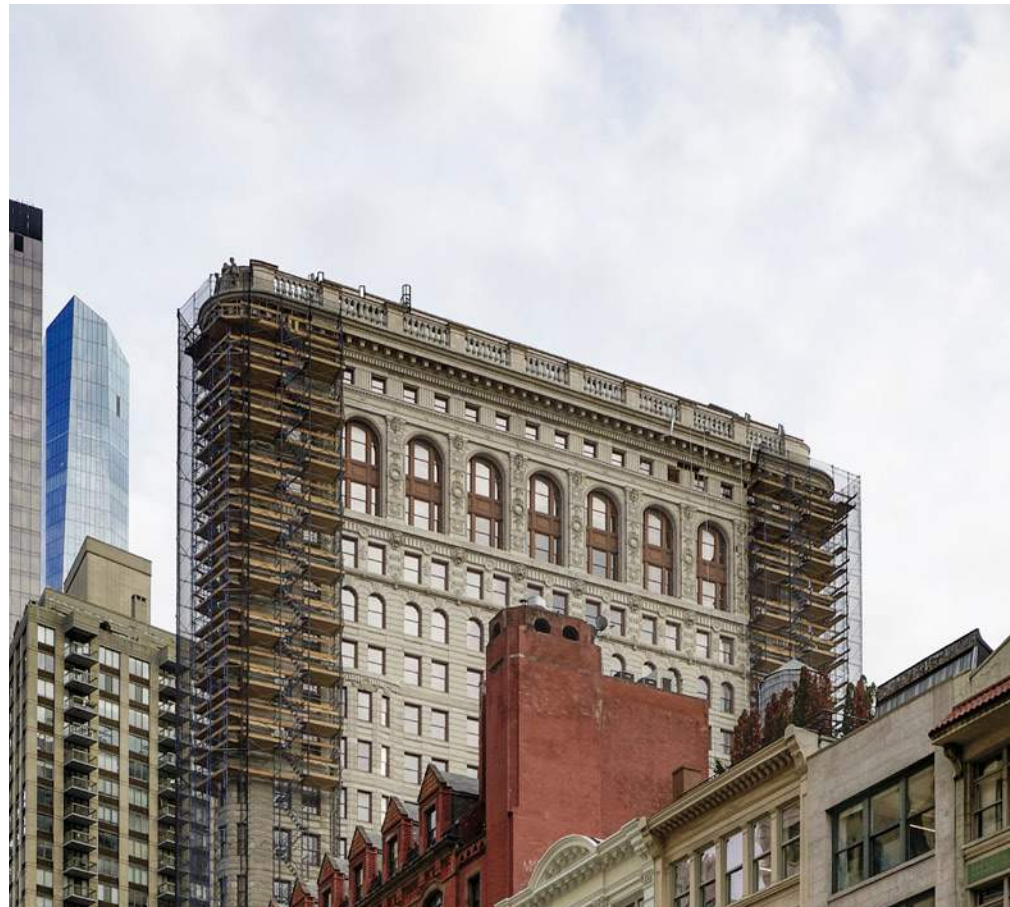
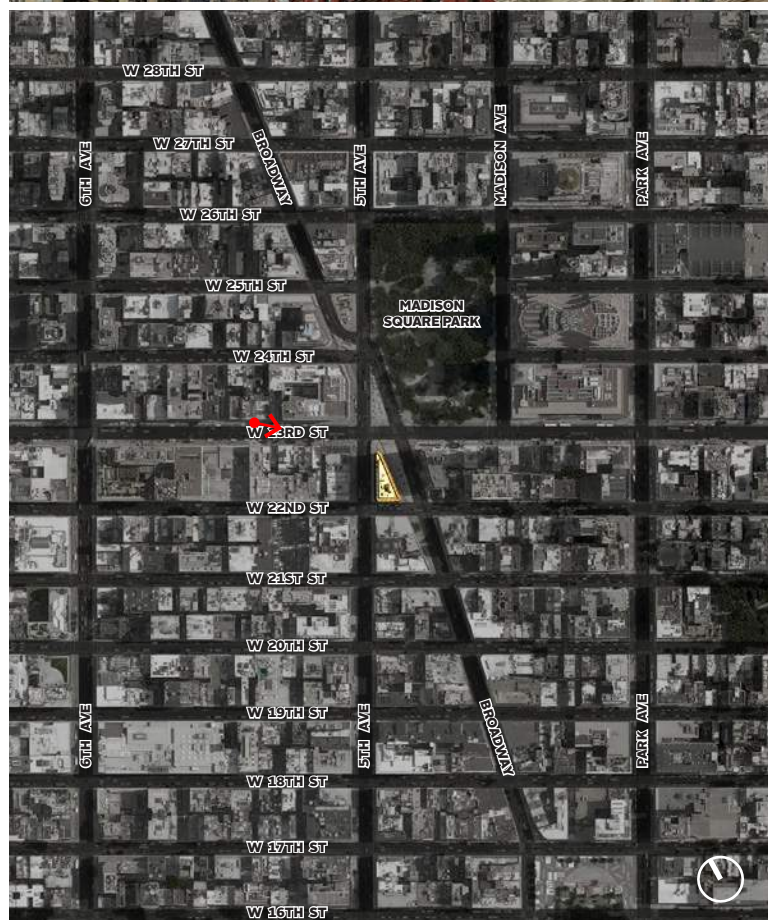
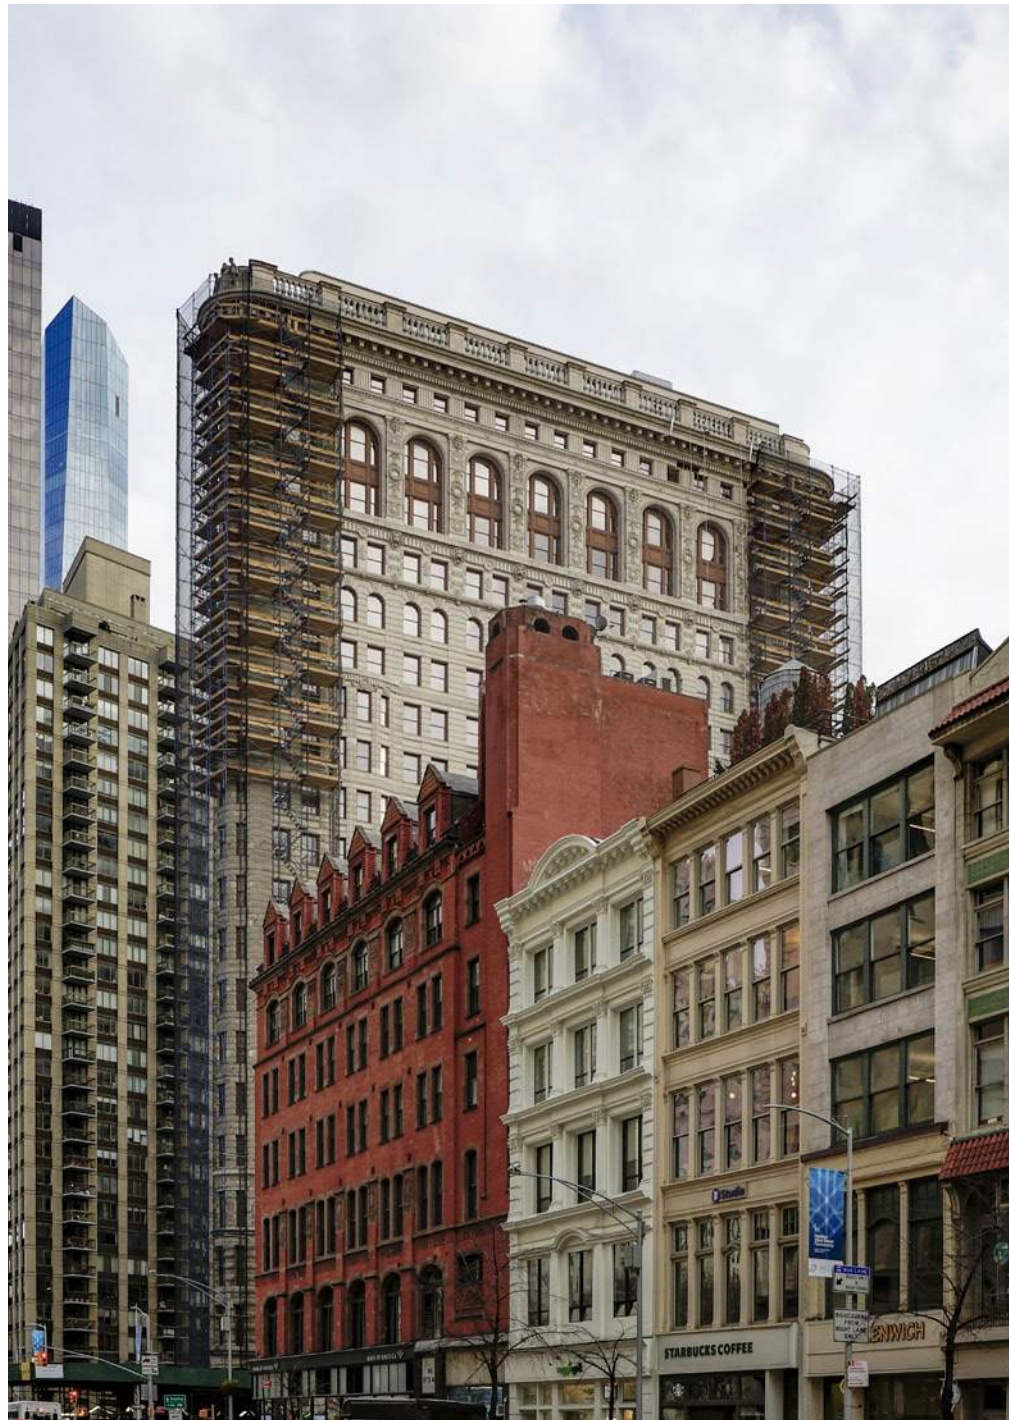
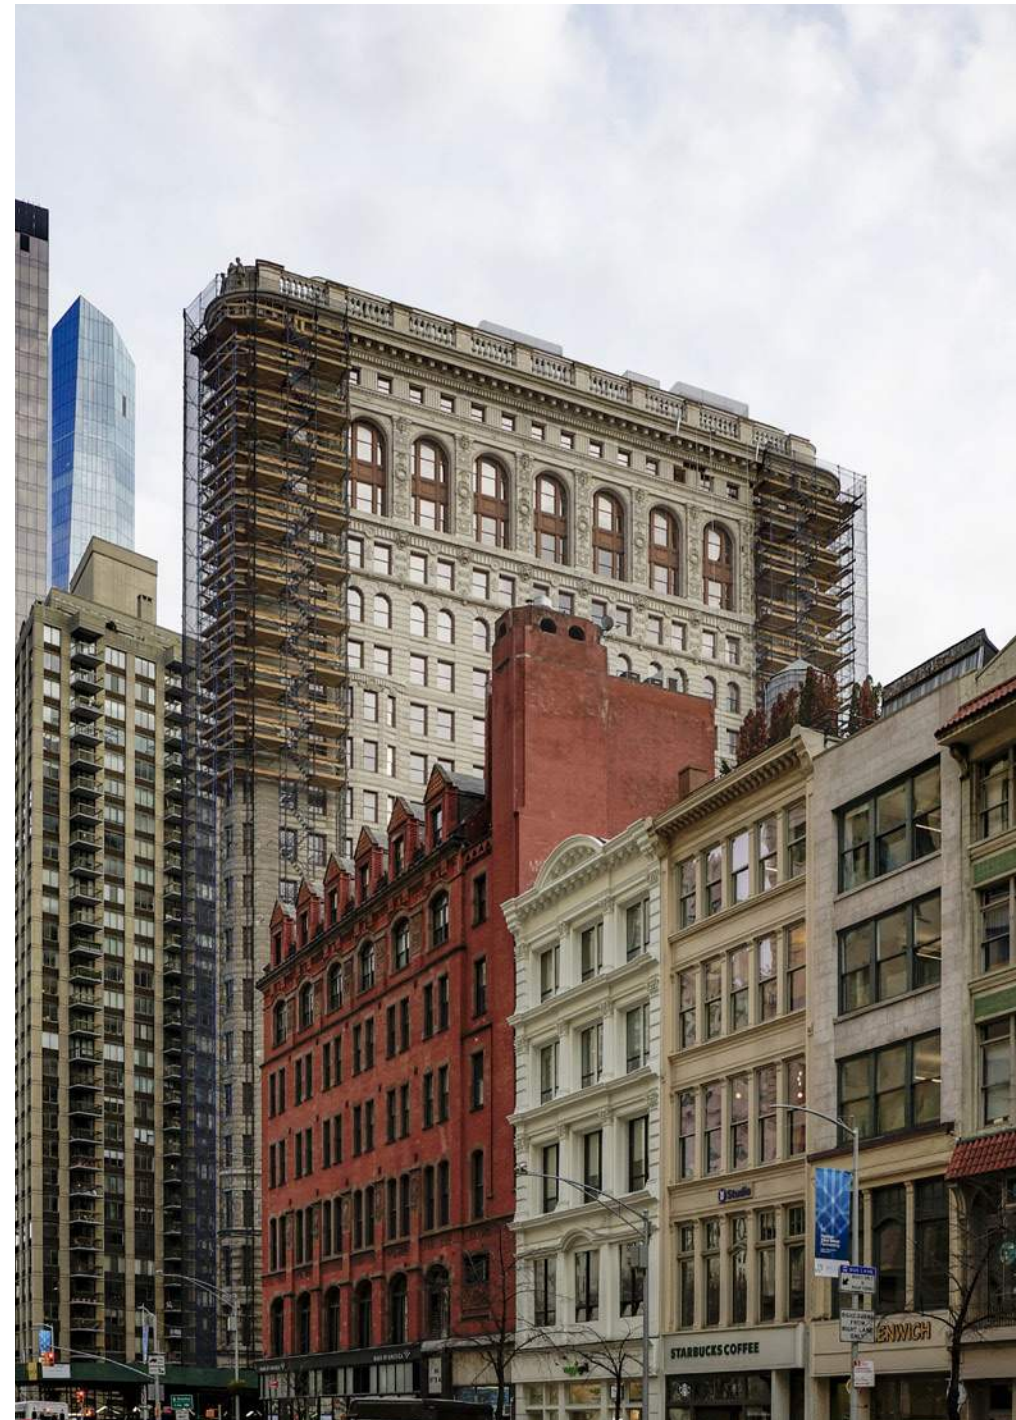
VIEW 8 (W 23RD ST, LOOKING EAST)

EXISTING CONDITION

APPROVED BY LPC, APRIL 13TH, 2021

PROPOSED

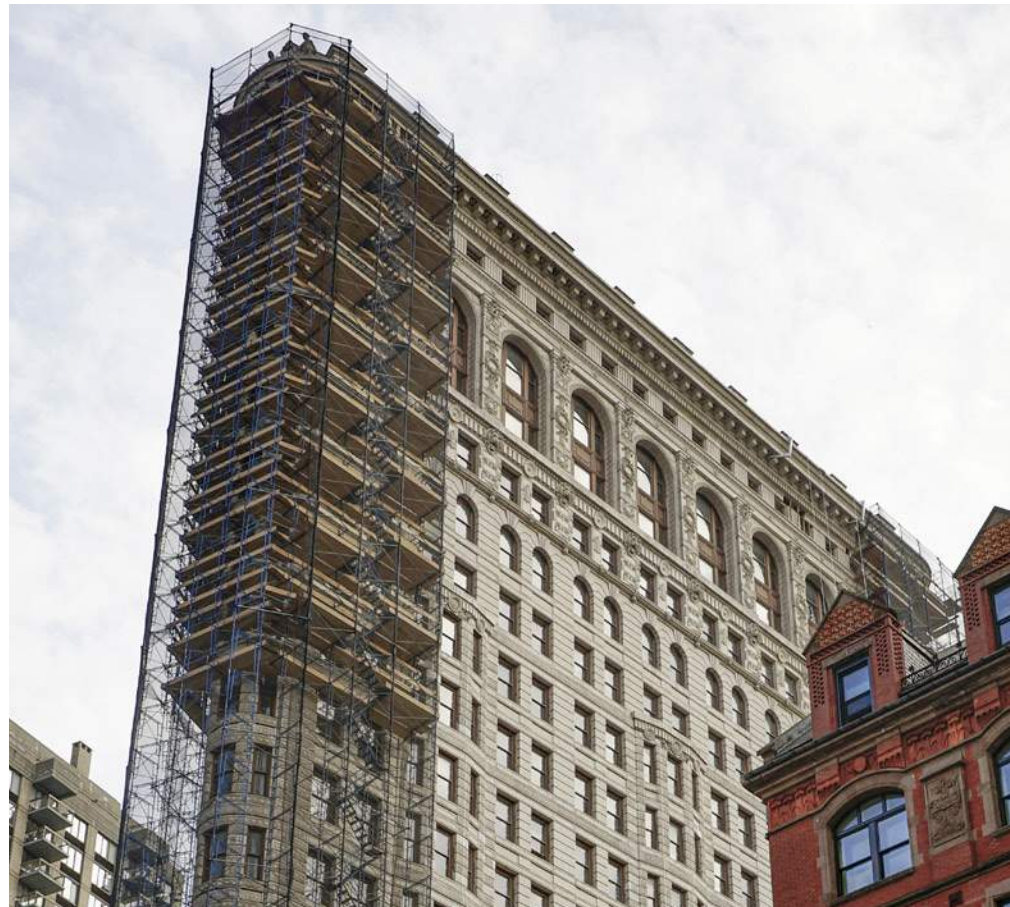
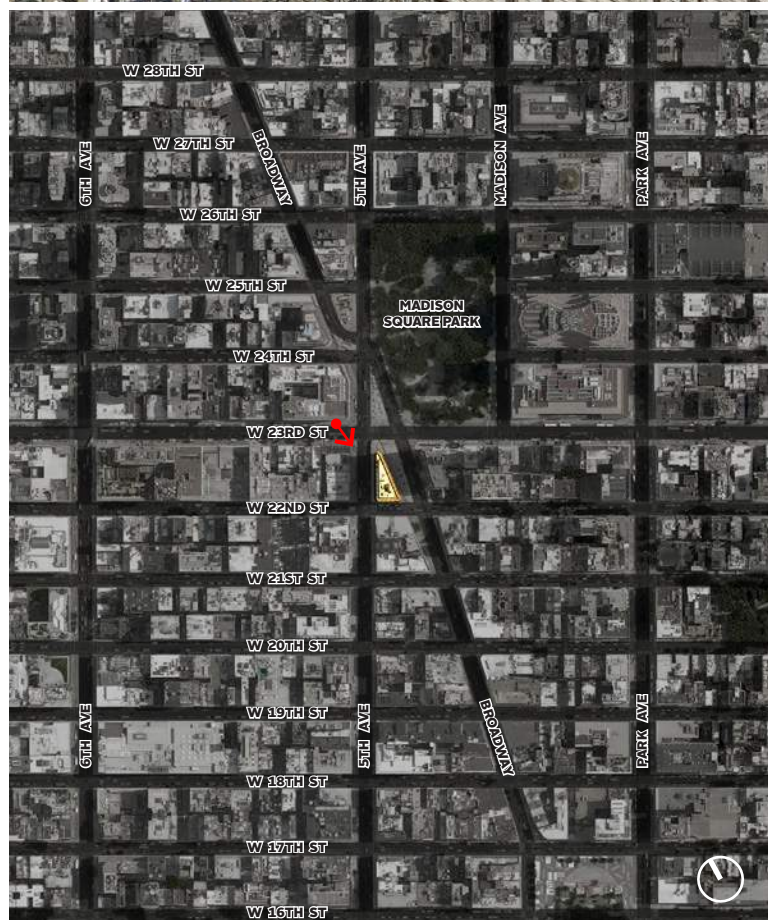
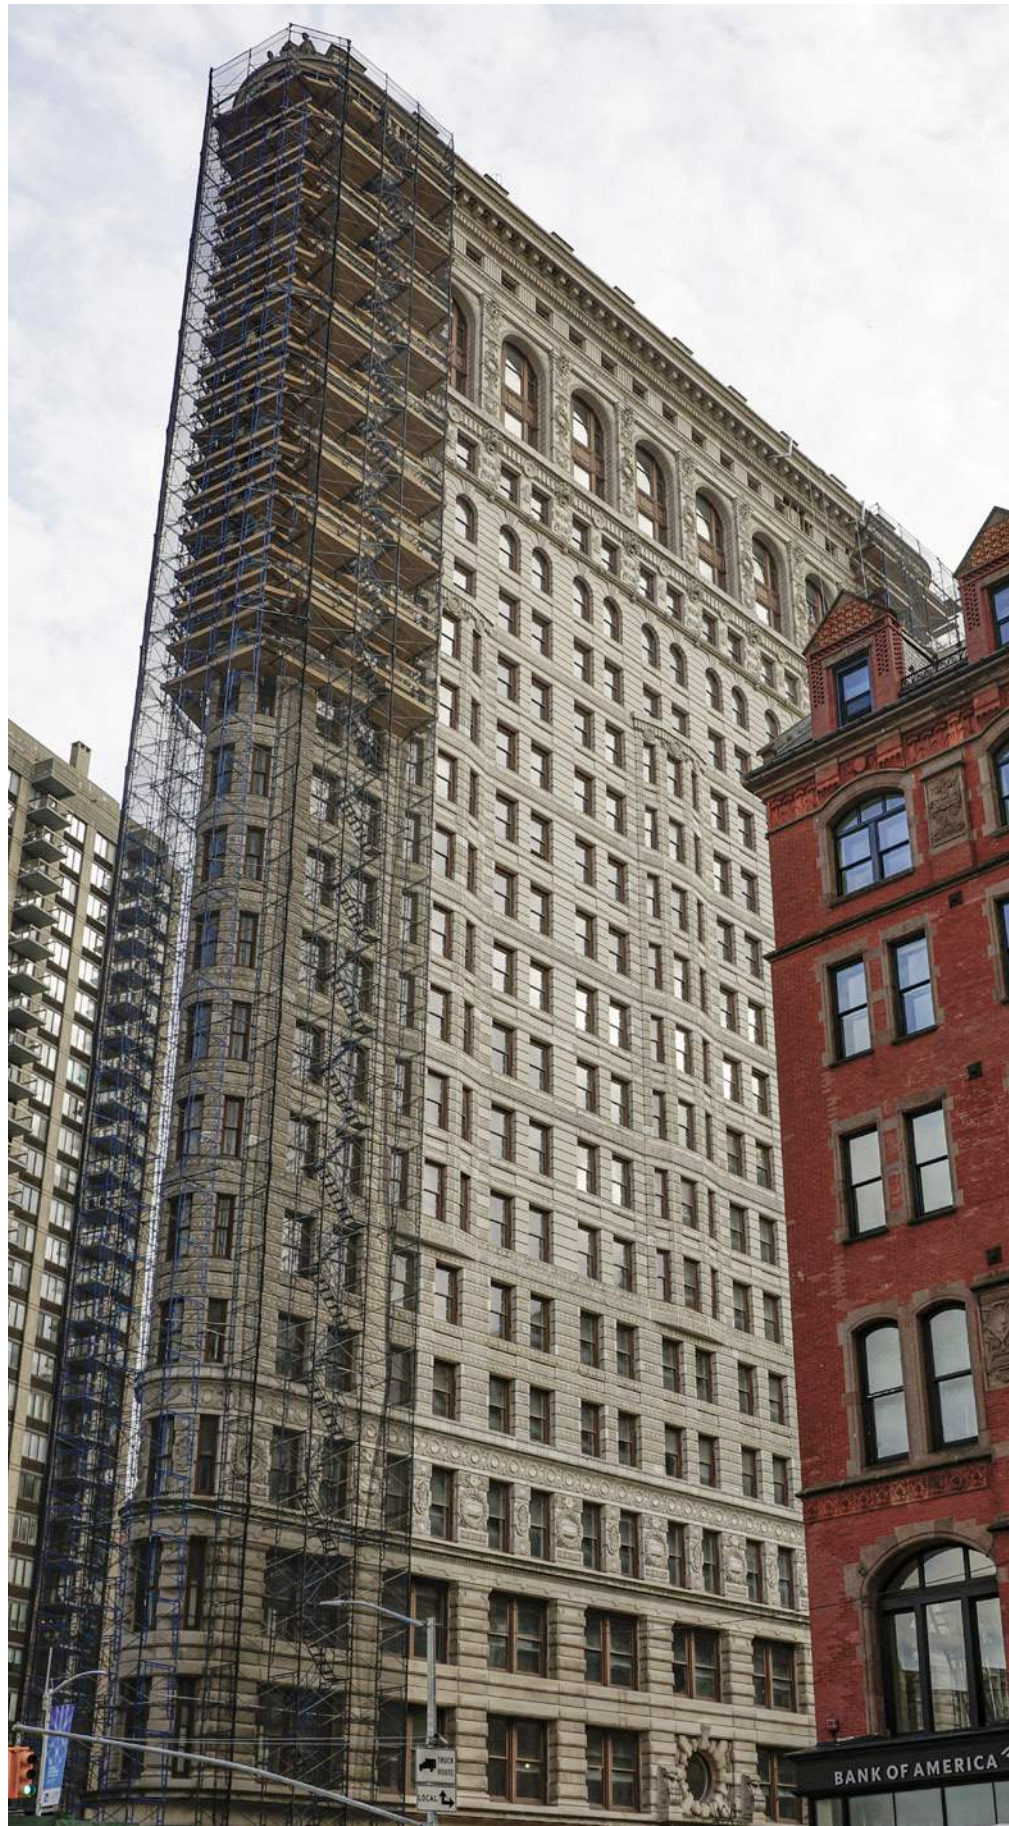
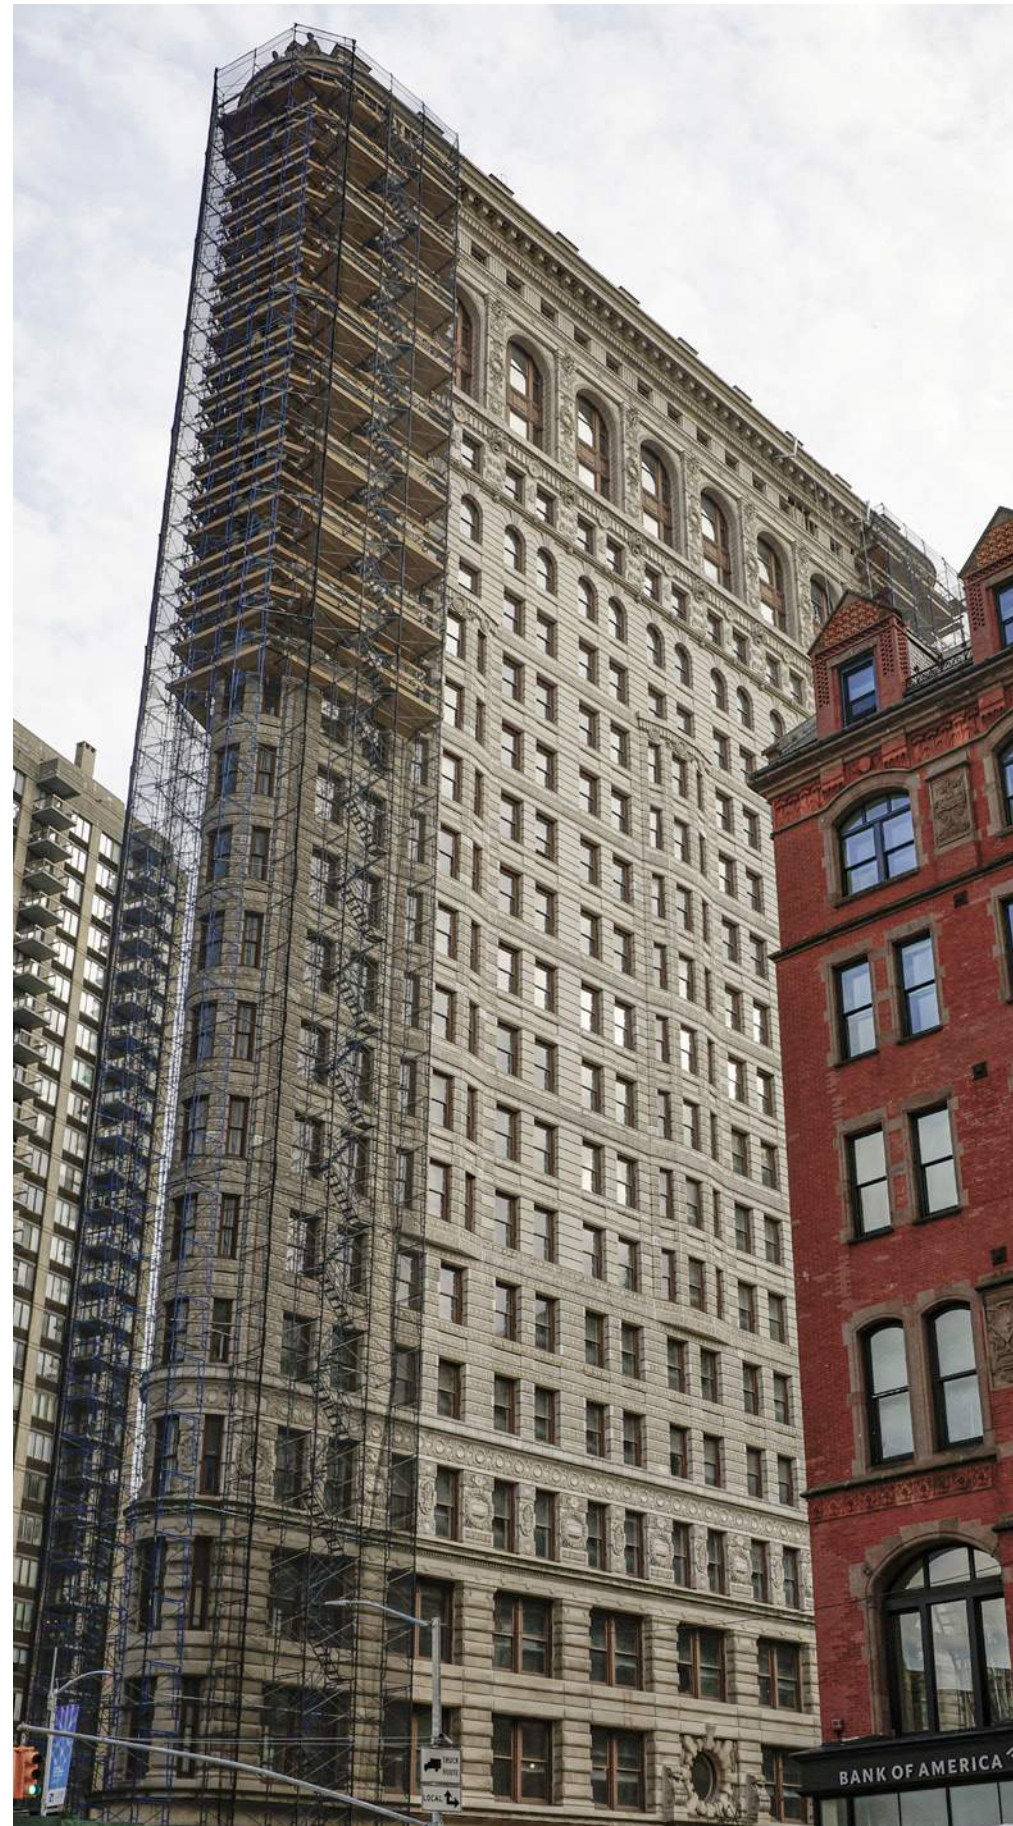
VIEW 9 (W 23RD ST, LOOKING EAST)

EXISTING CONDITION

APPROVED BY LPC, APRIL 13TH, 2021

PROPOSED

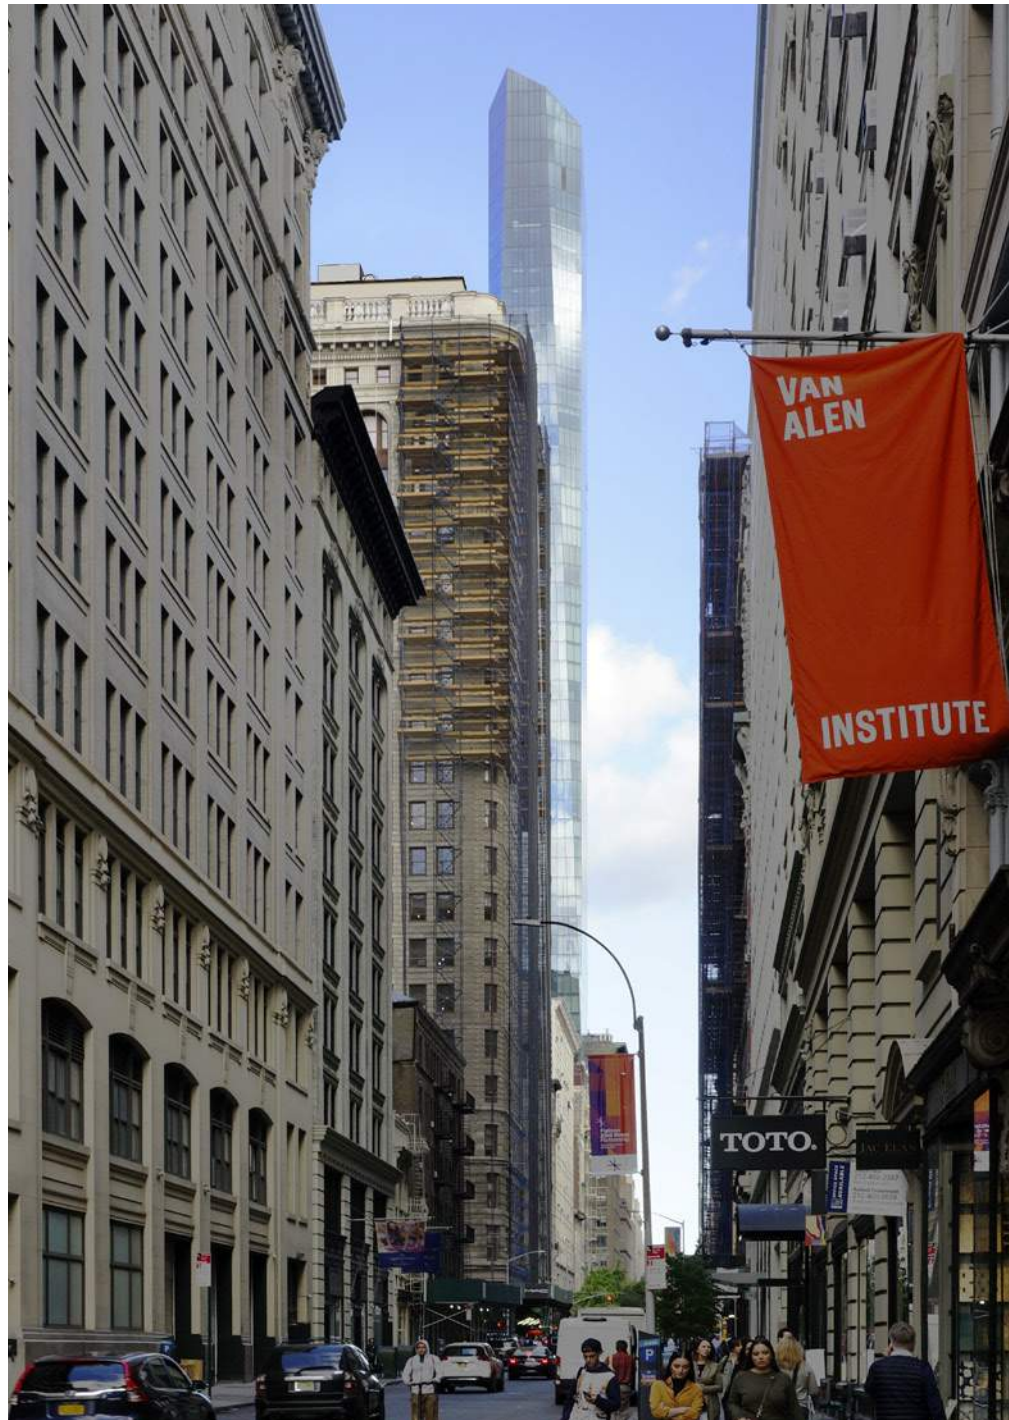
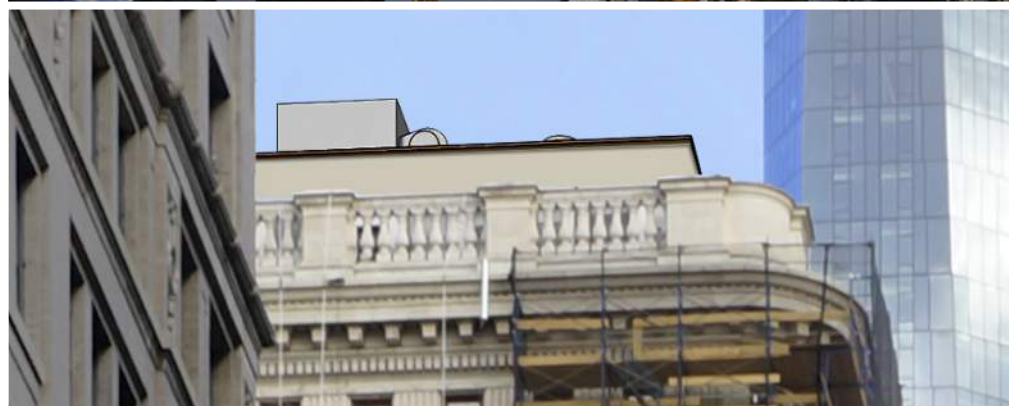
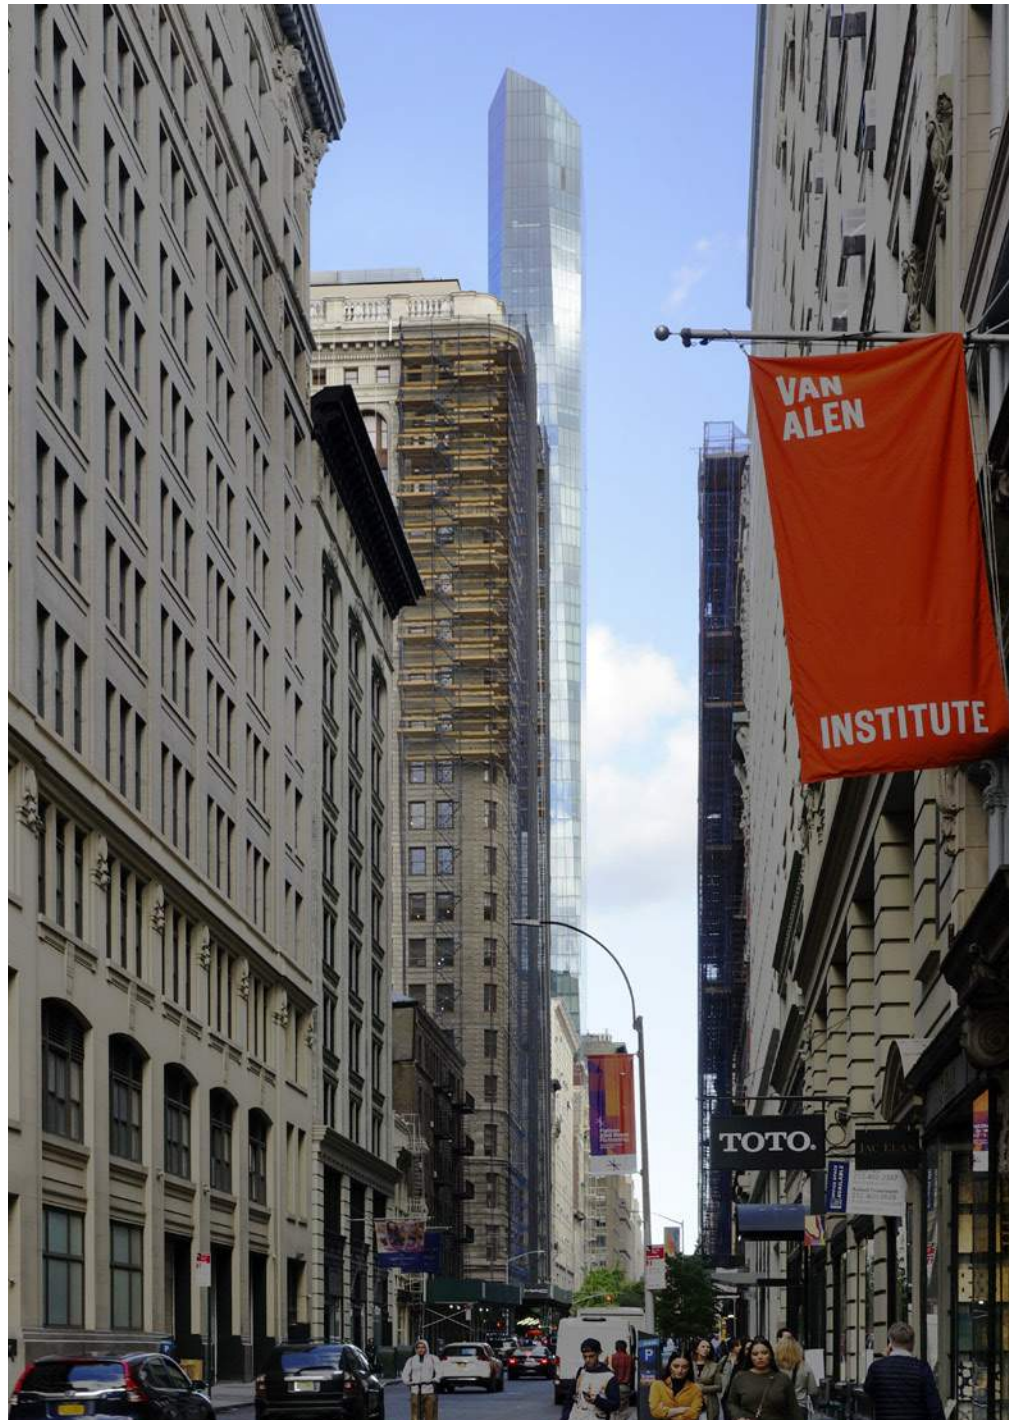
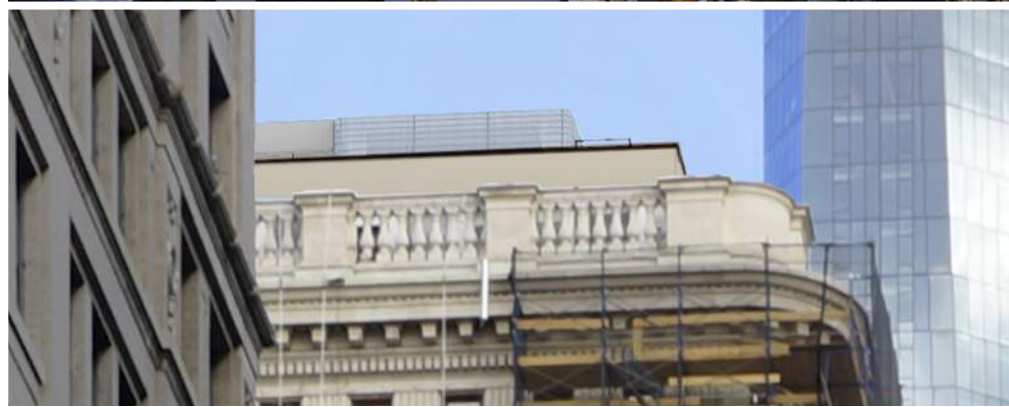
VIEW 10 (W 22ND ST, LOOKING EAST)

EXISTING CONDITION

PROPOSED

APPROVED BY LPC, APRIL 13TH, 2021
