The Flatiron Building

PRESENTATION TO LANDMARK PRESERVATION COMMISSION

MAY 21, 2024

1. WINDOW REPLACEMENT
2. STOREFRONT MASTER PLAN MODIFICATION
3. ROOFTOP MECHANICAL AND BUIKHEAD PLAN
4. APPENDIX

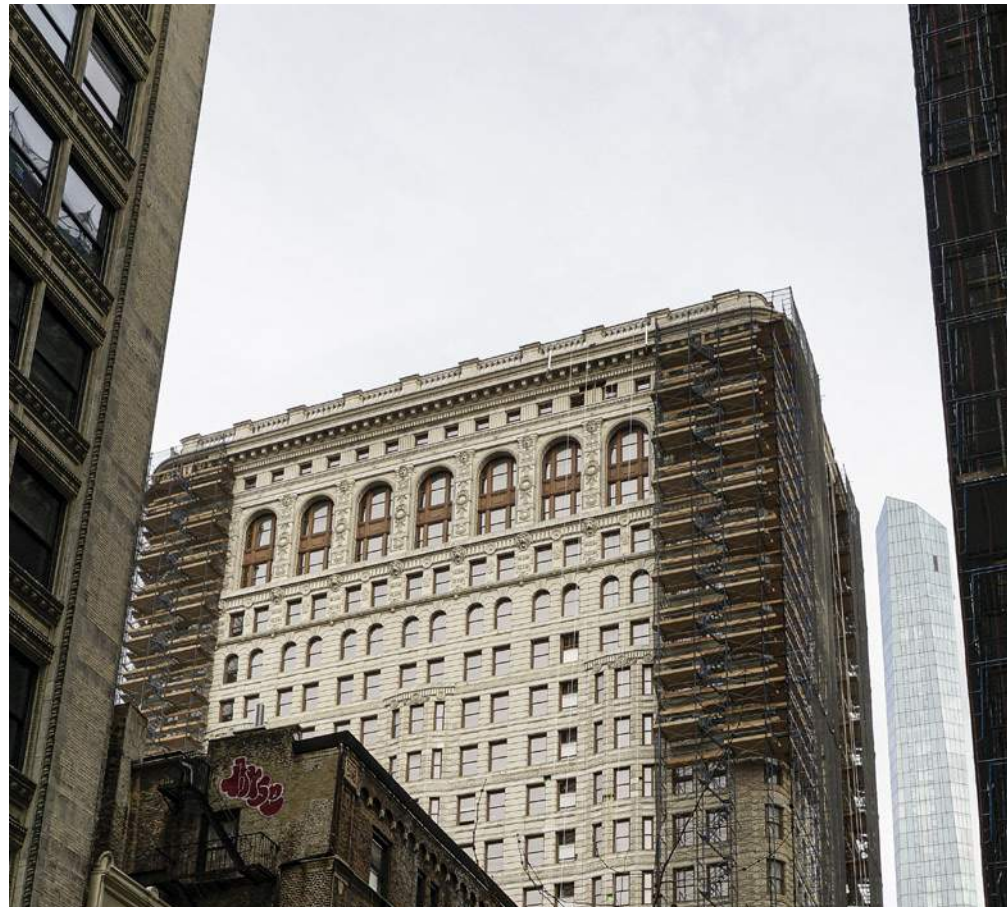
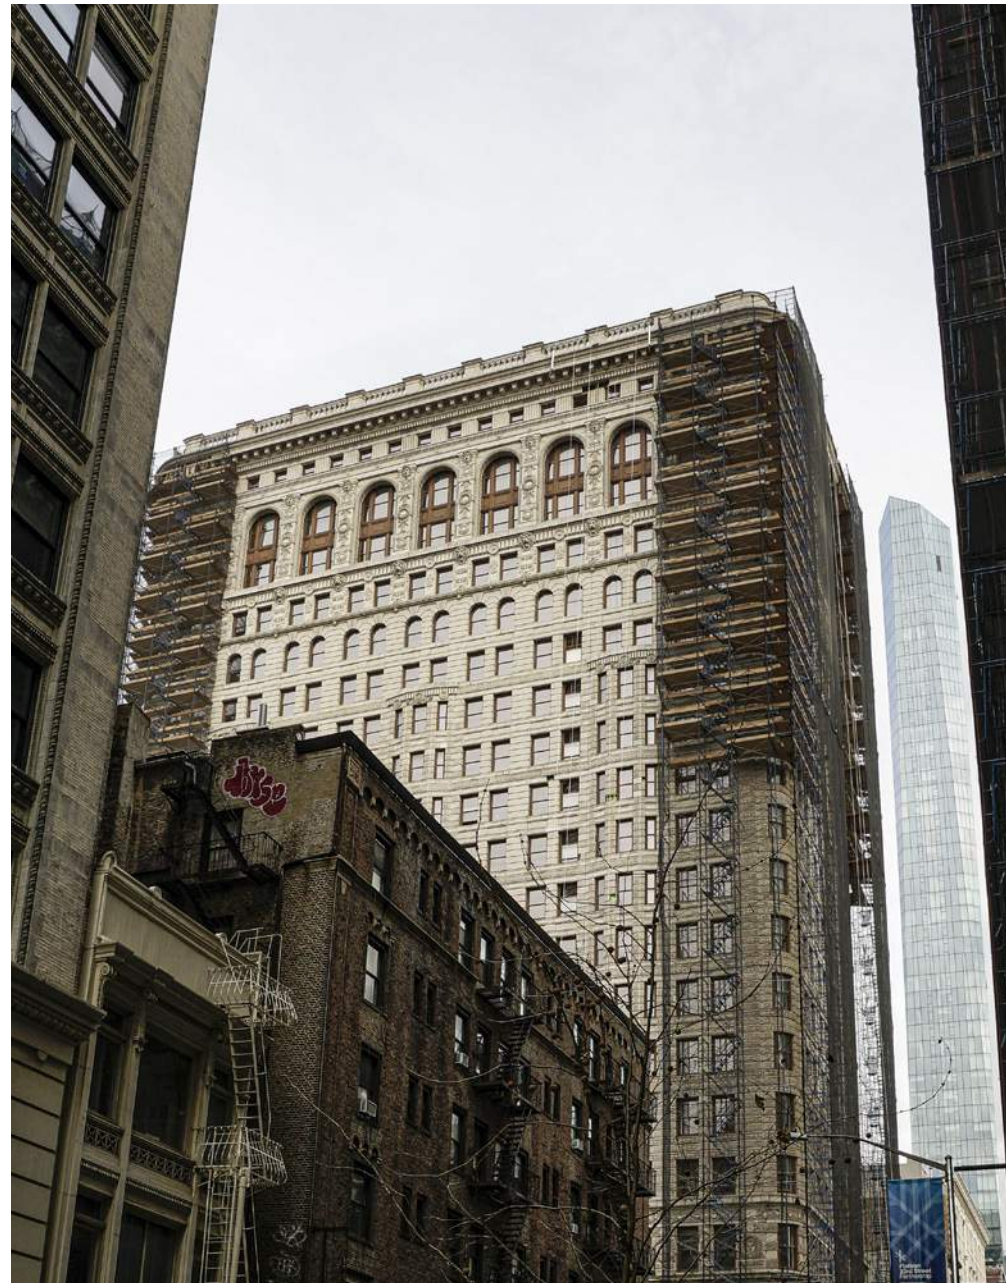
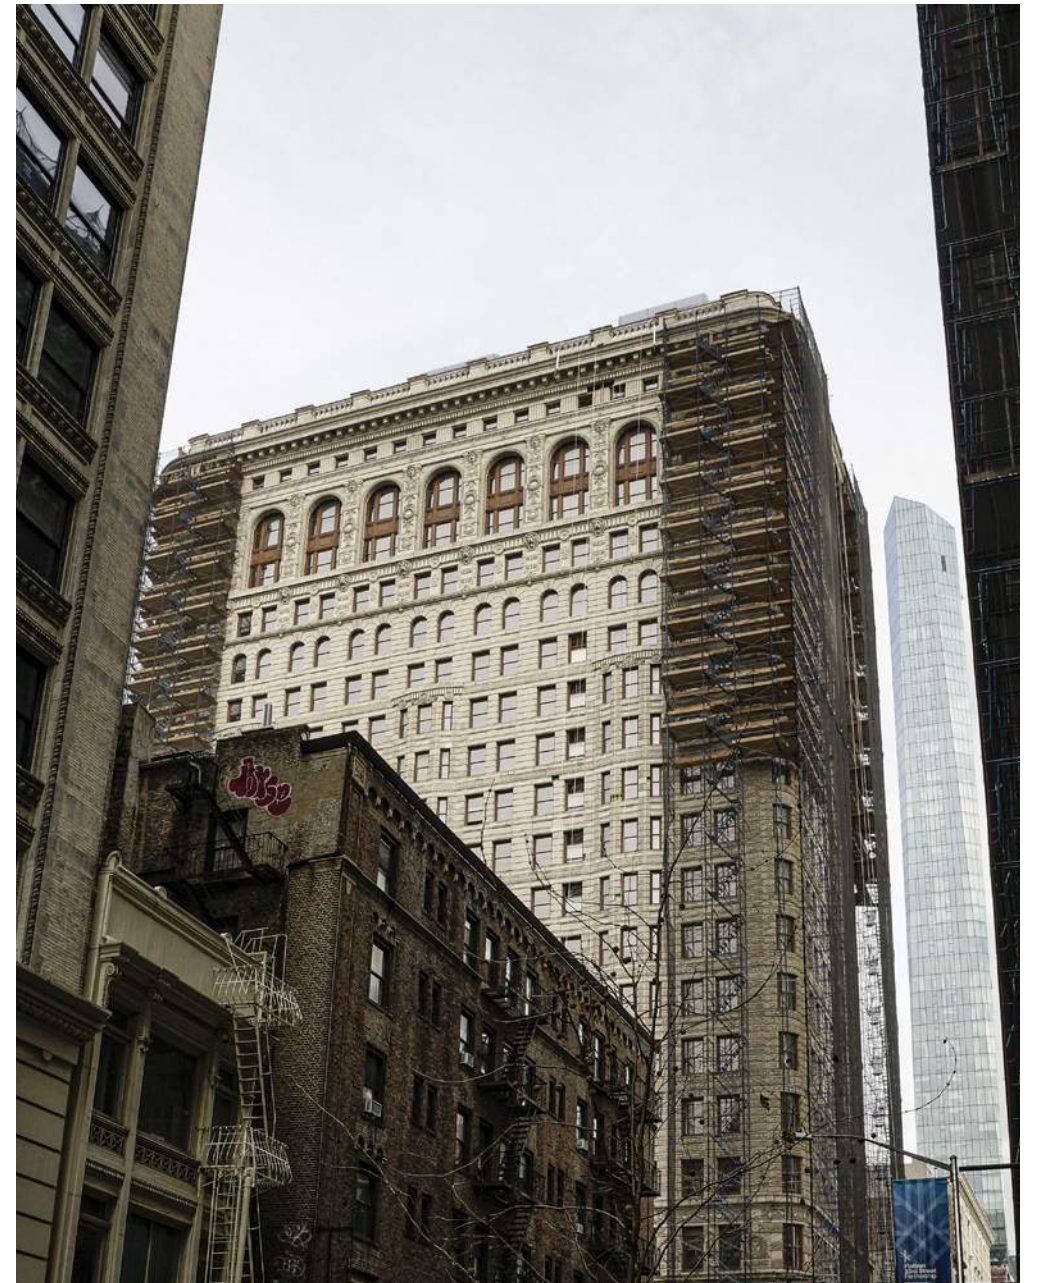
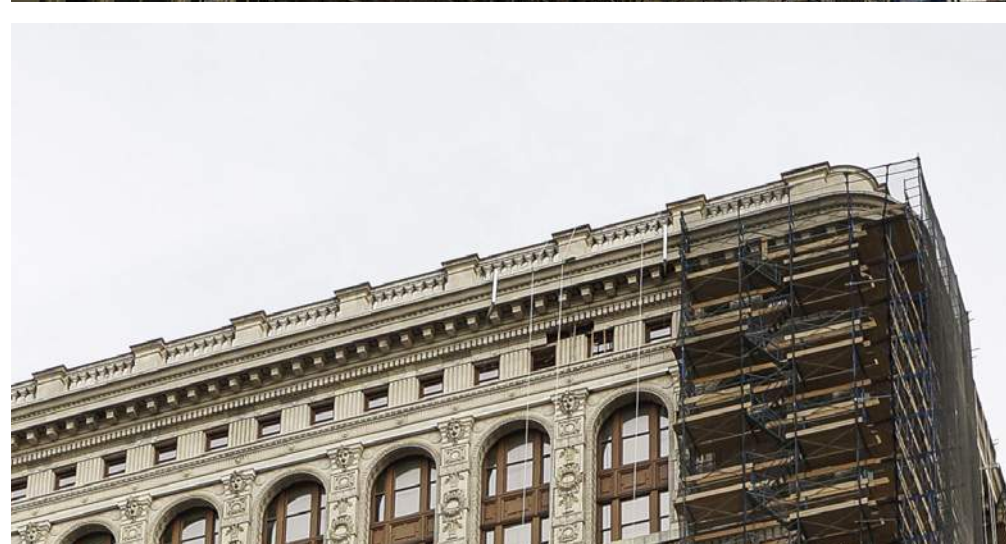
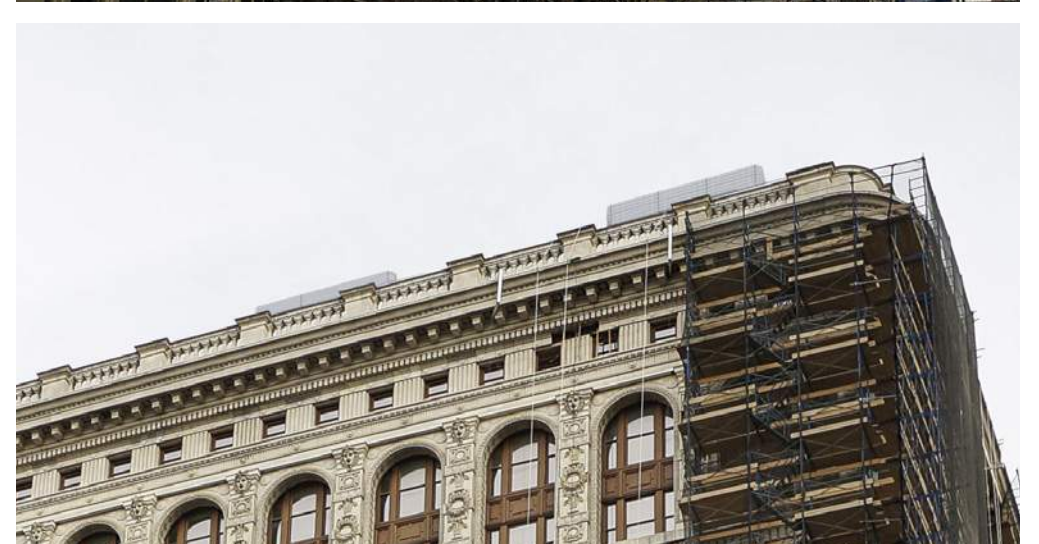
VIEW 11 (W 22ND ST, LOOKING EAST)

EXISTING CONDITION

APPROVED BY LPC, APRIL 13TH, 2021

PROPOSED

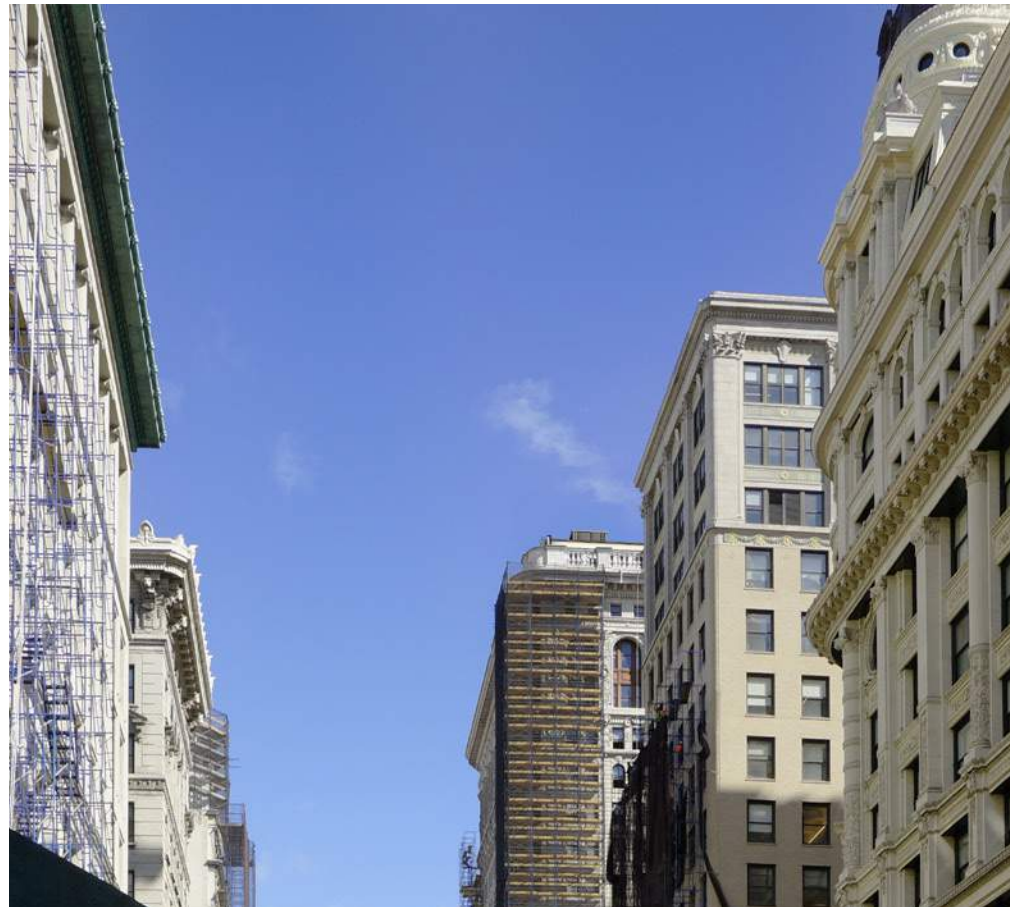
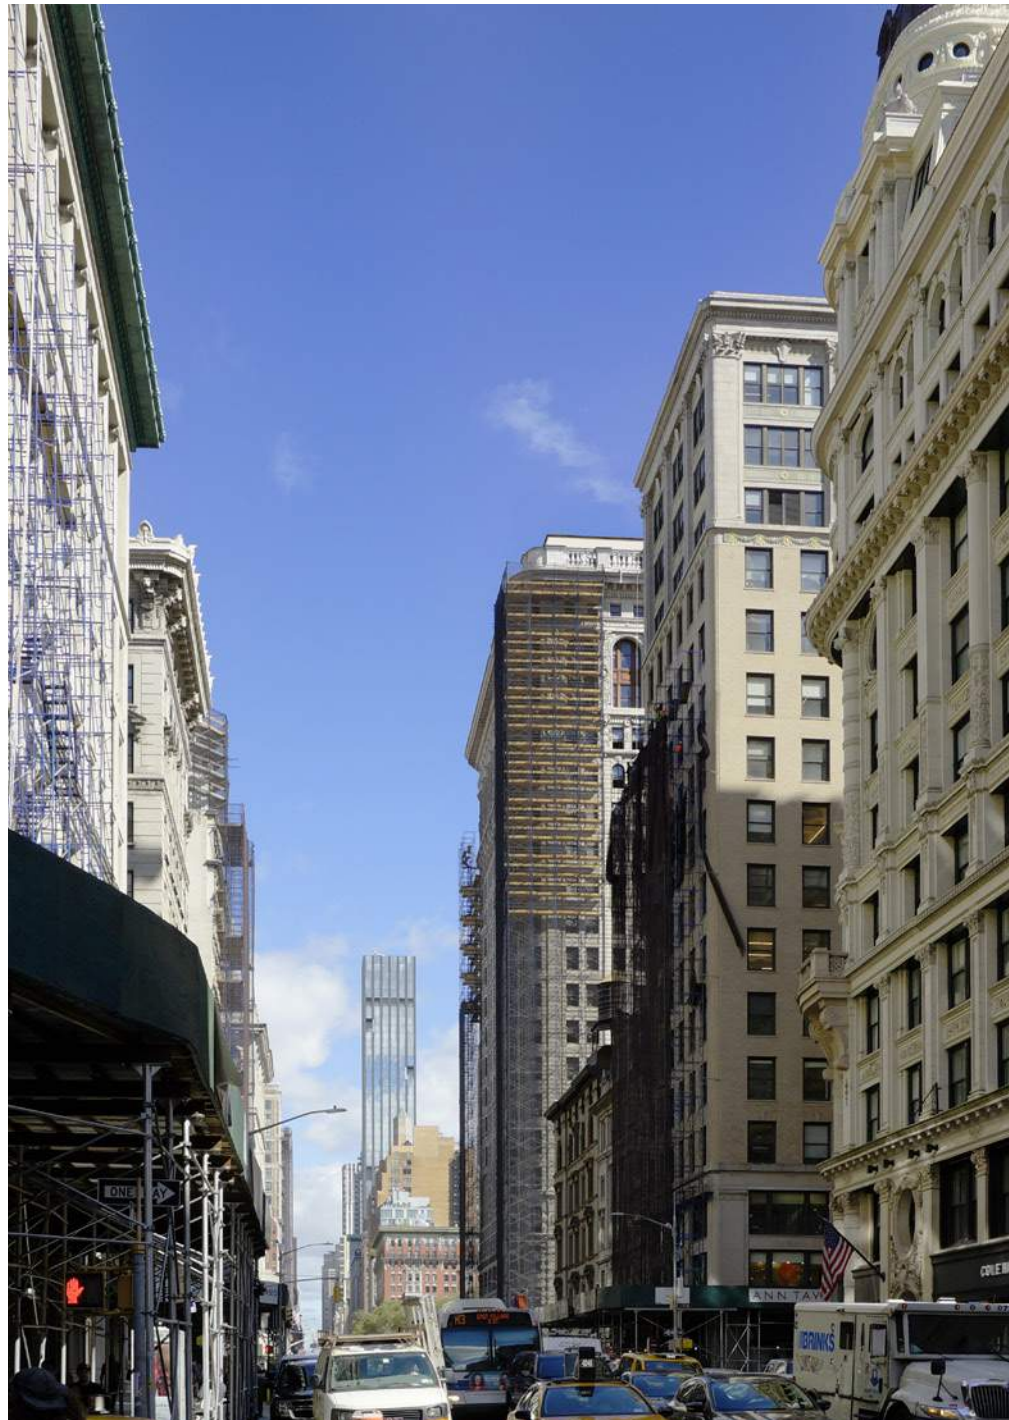
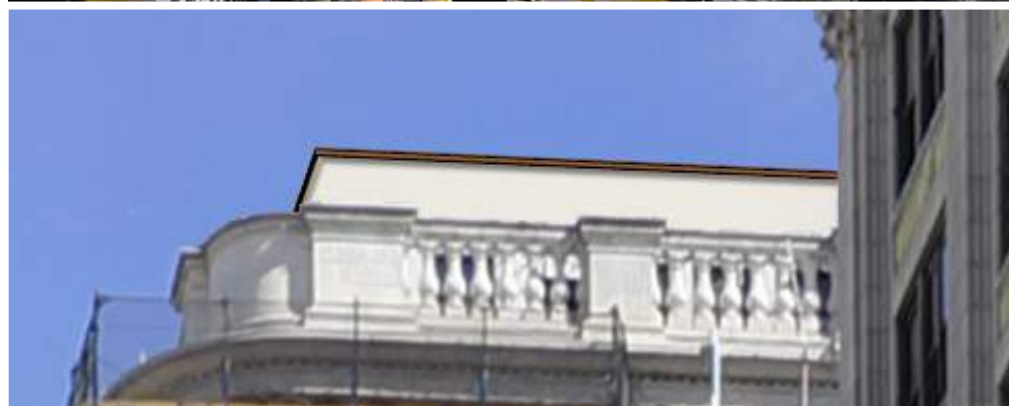
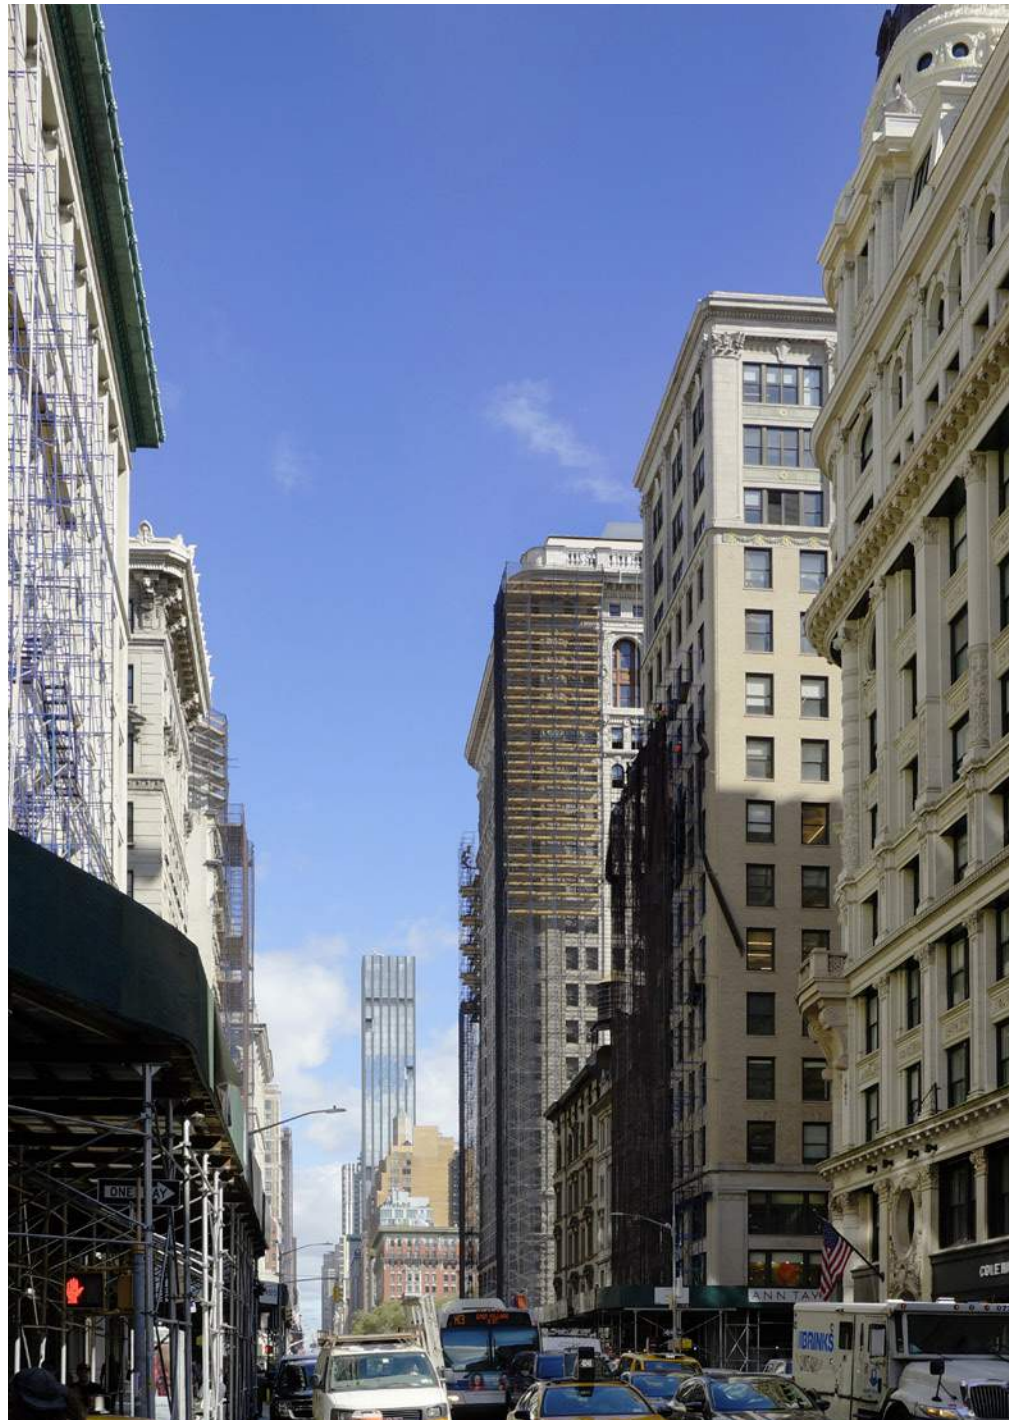
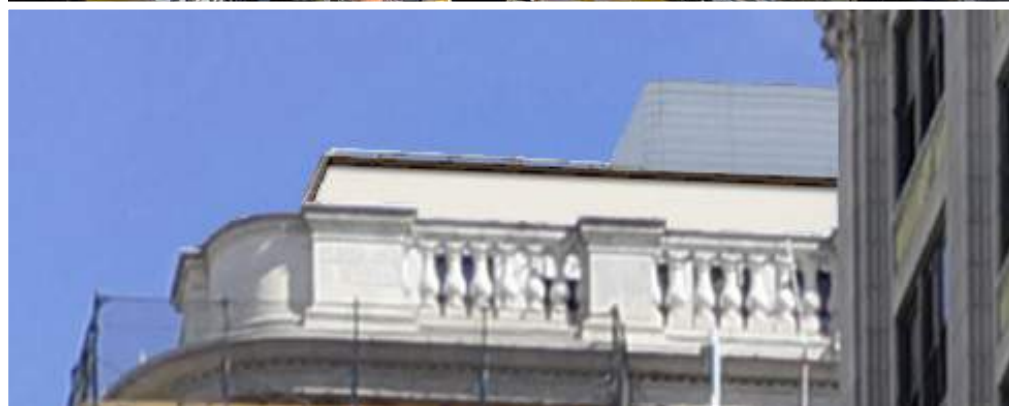
VIEW 12 (W 20TH ST & 5TH AVE INTERSECTION, LOOKING NORTH)

EXISTING CONDITION

APPROVED BY LPC, APRIL 13TH, 2021

PROPOSED

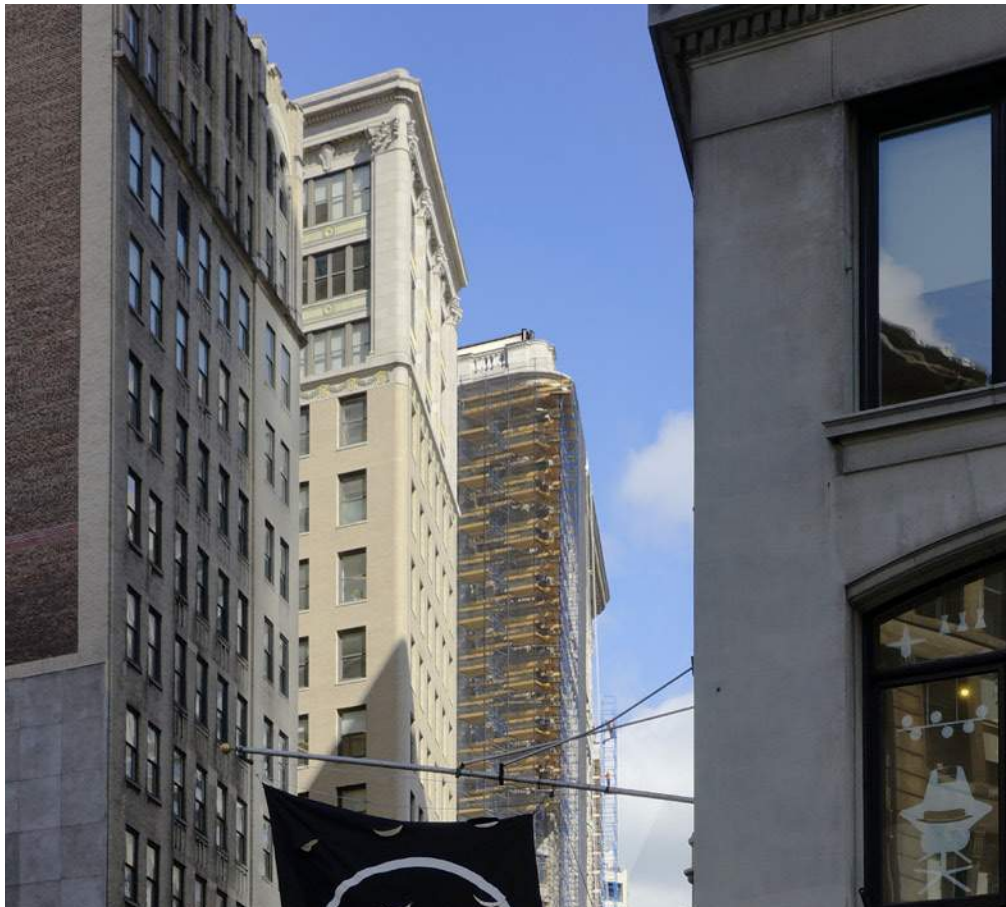
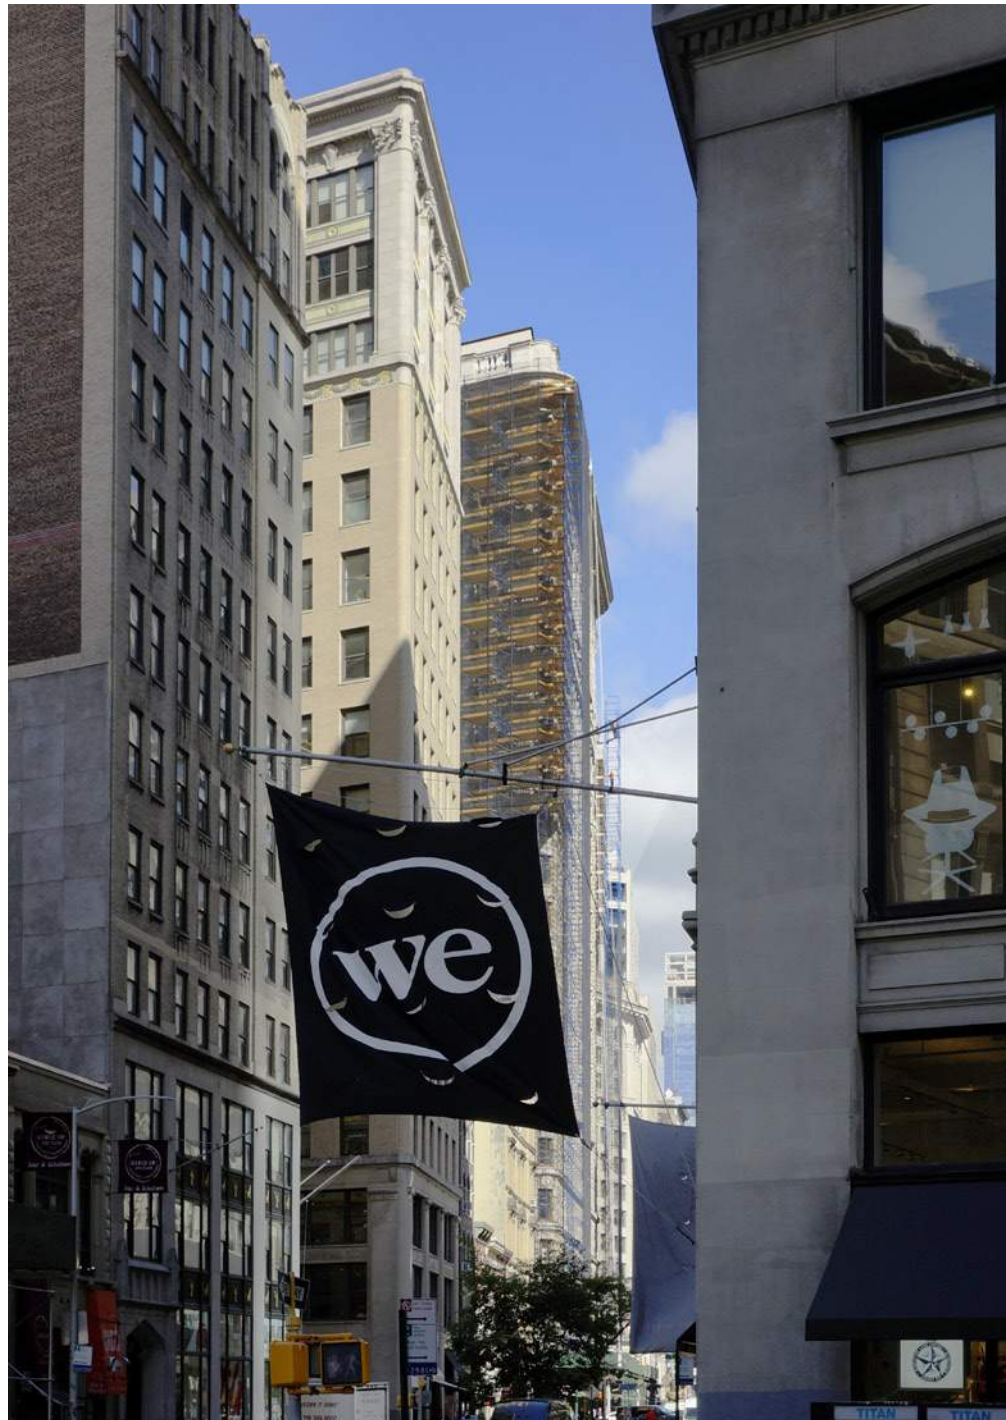
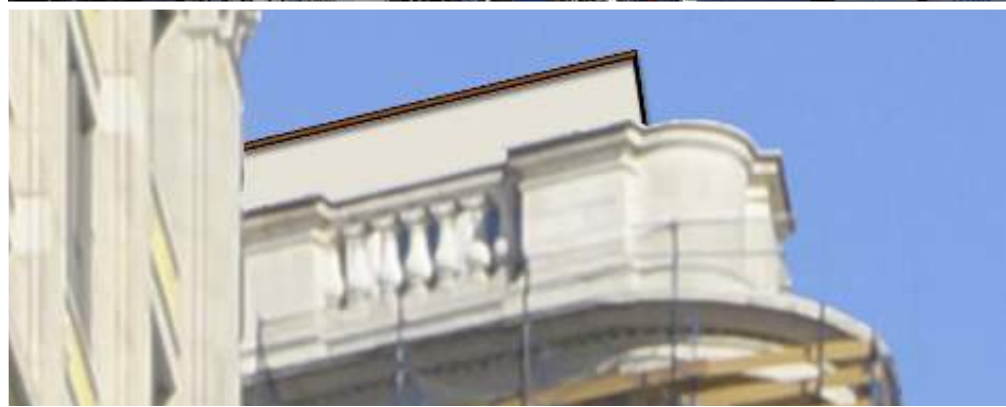
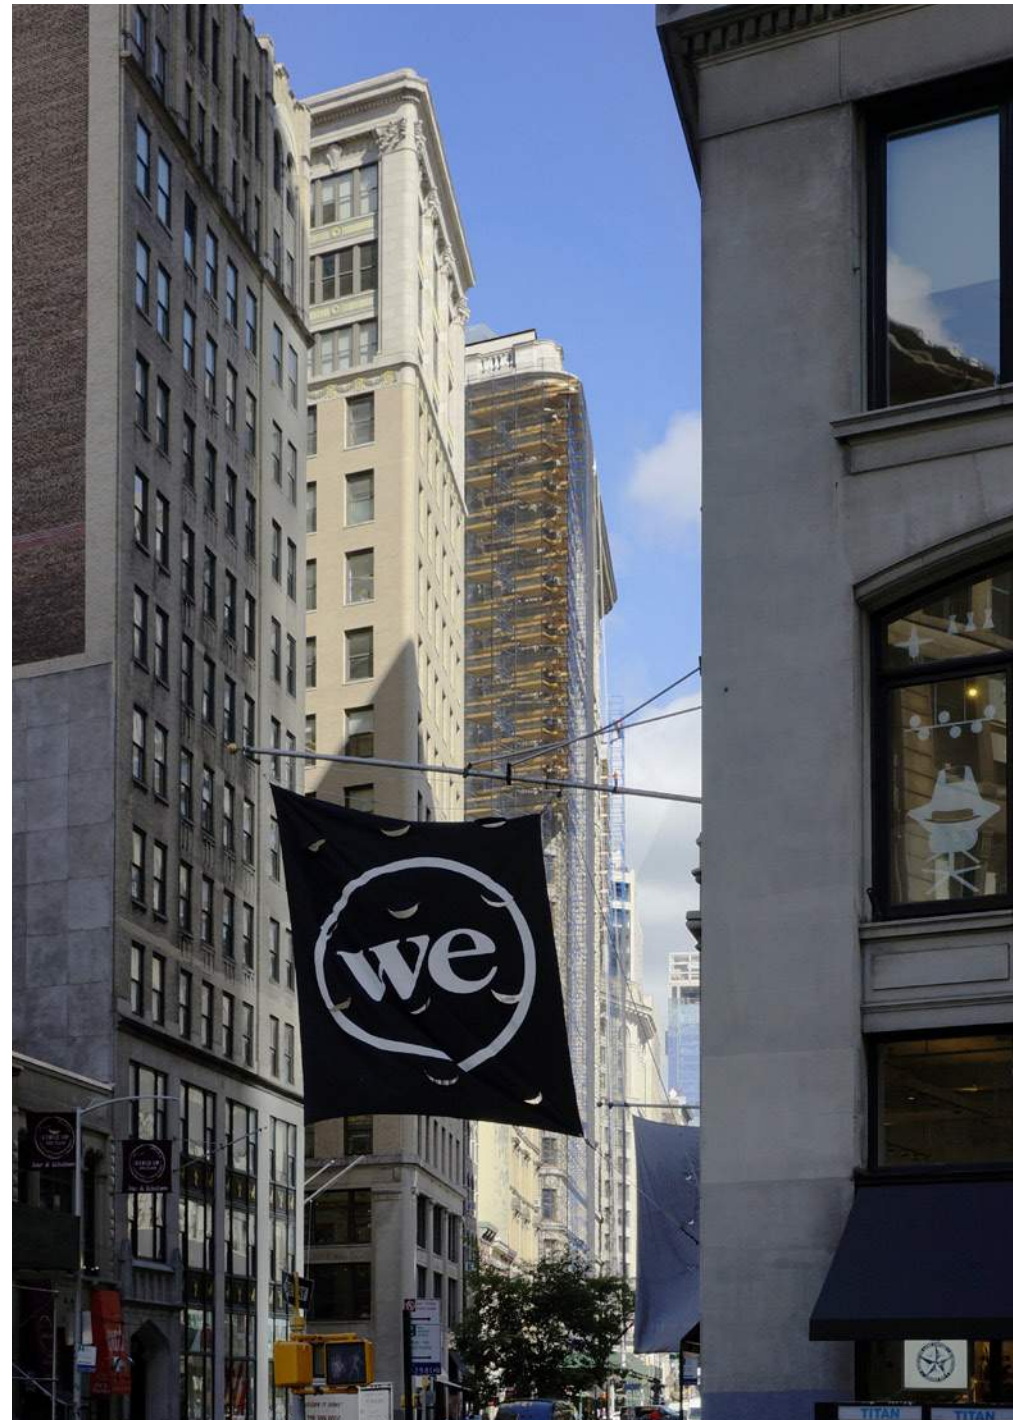
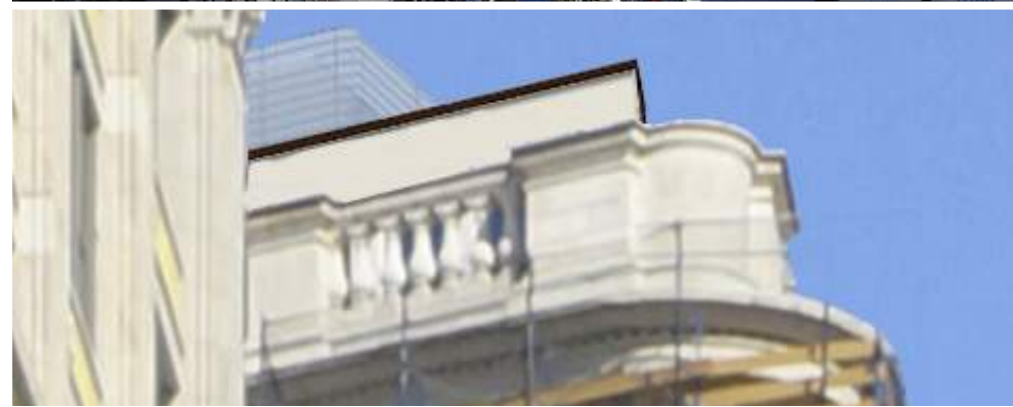
VIEW 13 (E 20TH ST & BROADWAY INTERSECTION, LOOKING NORTH)

EXISTING CONDITION

APPROVED BY LPC, APRIL 13TH, 2021

PROPOSED

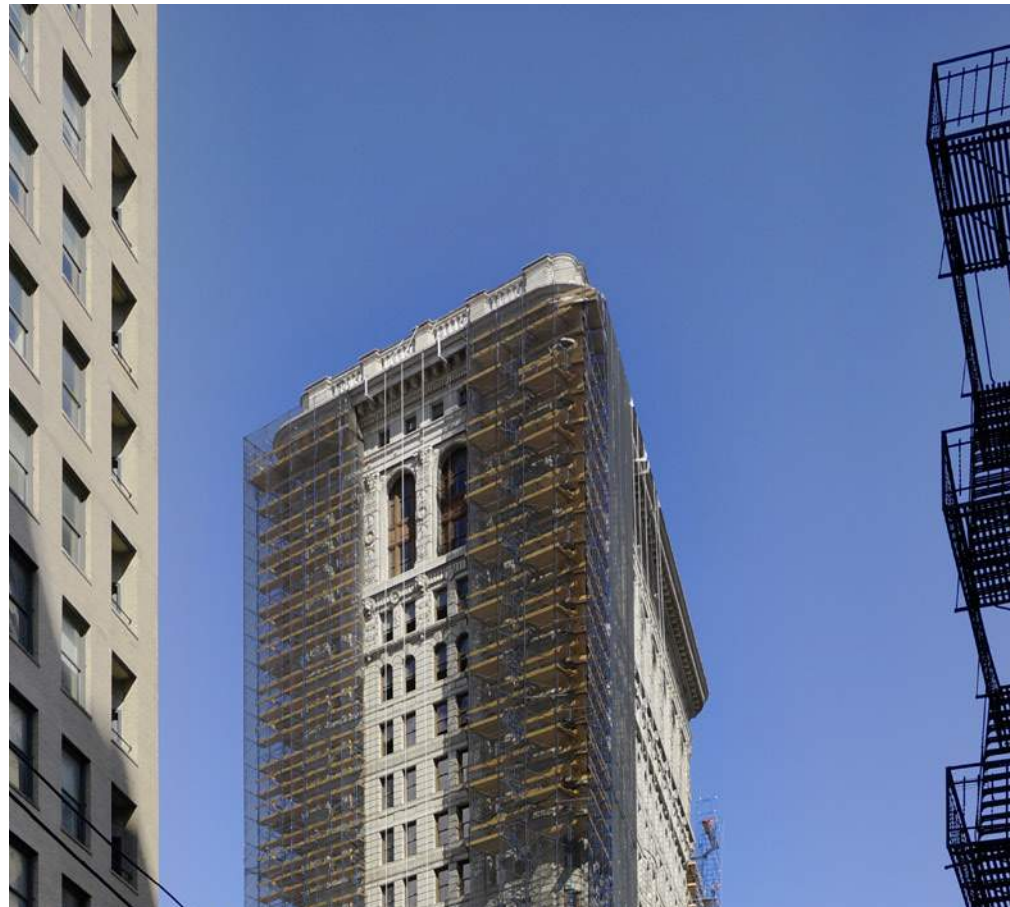
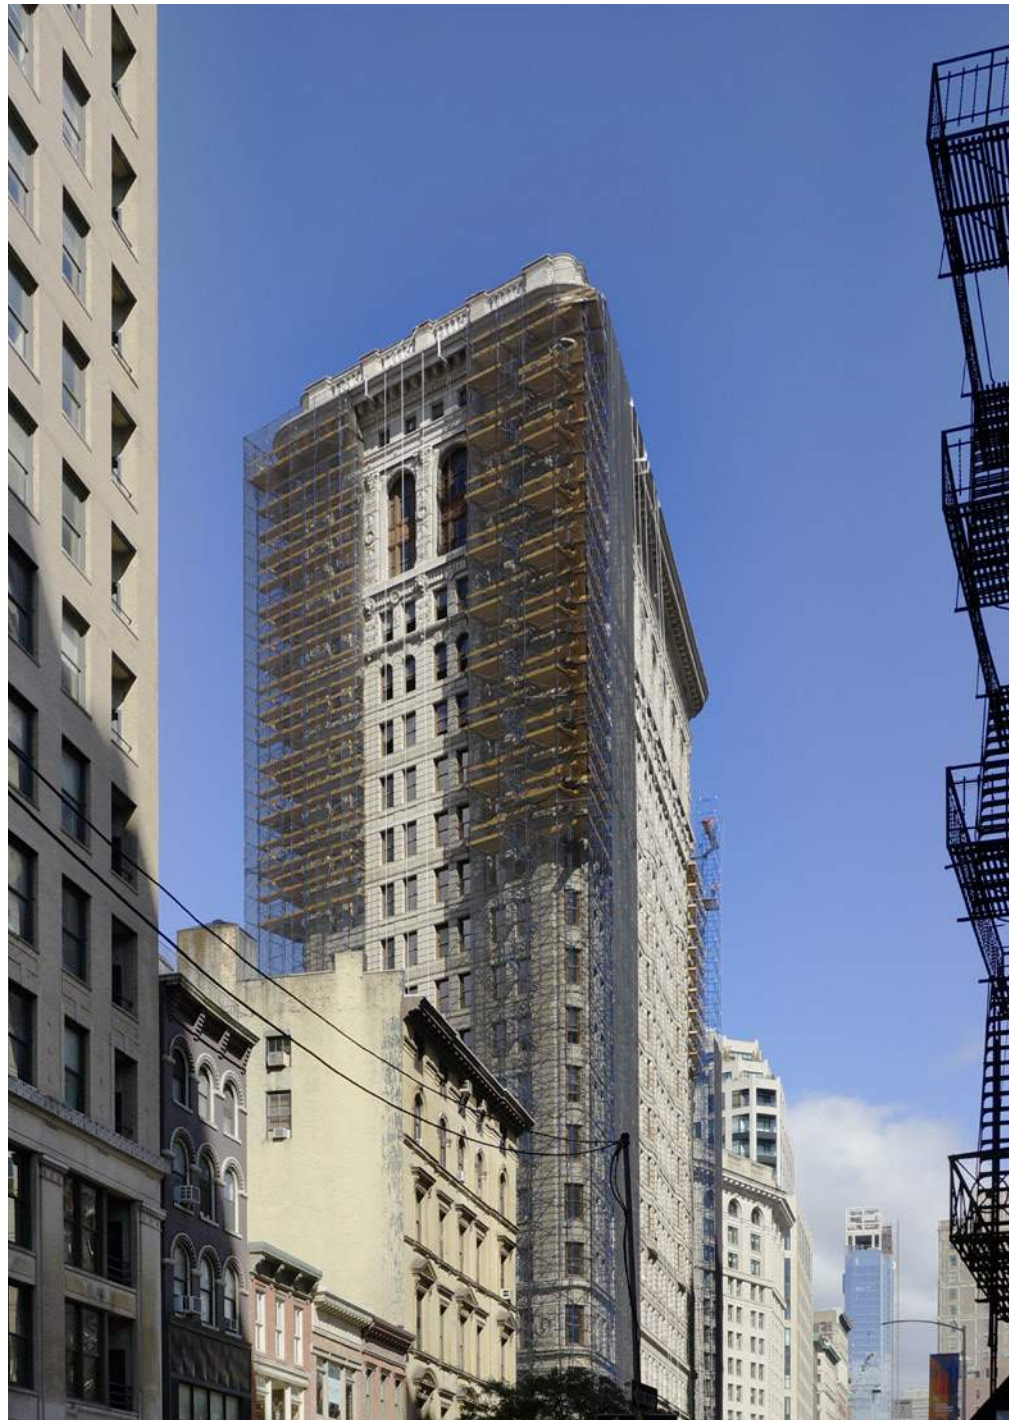
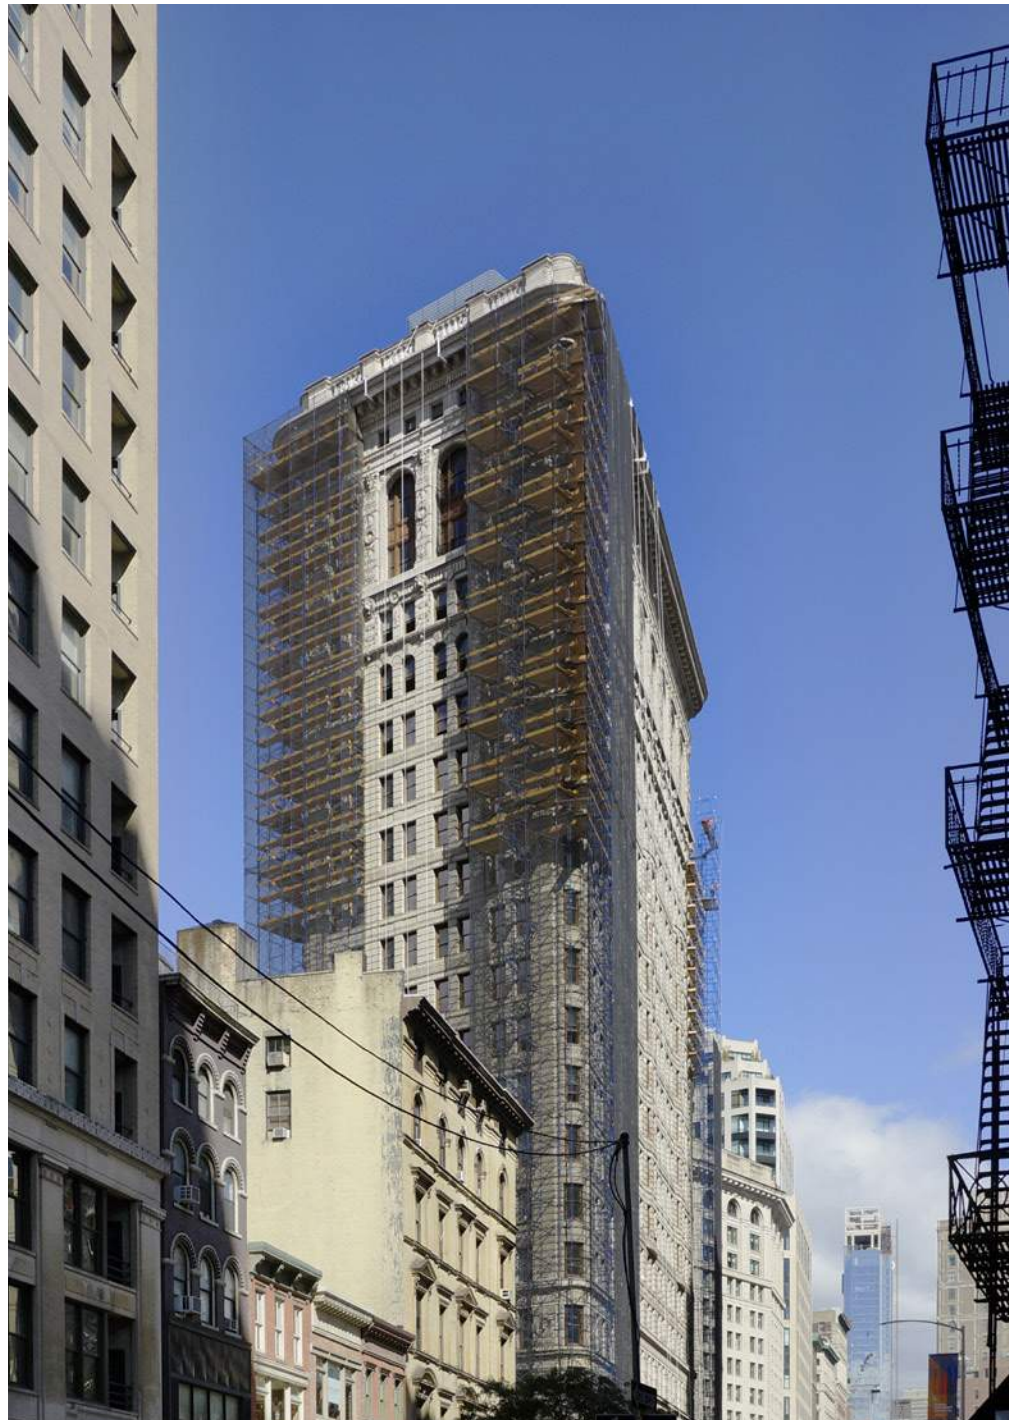
VIEW 14 (E 21ST ST & BROADWAY INTERSECTION, LOOKING NORTH)

EXISTING CONDITION

APPROVED BY LPC, APRIL 13TH, 2021

PROPOSED

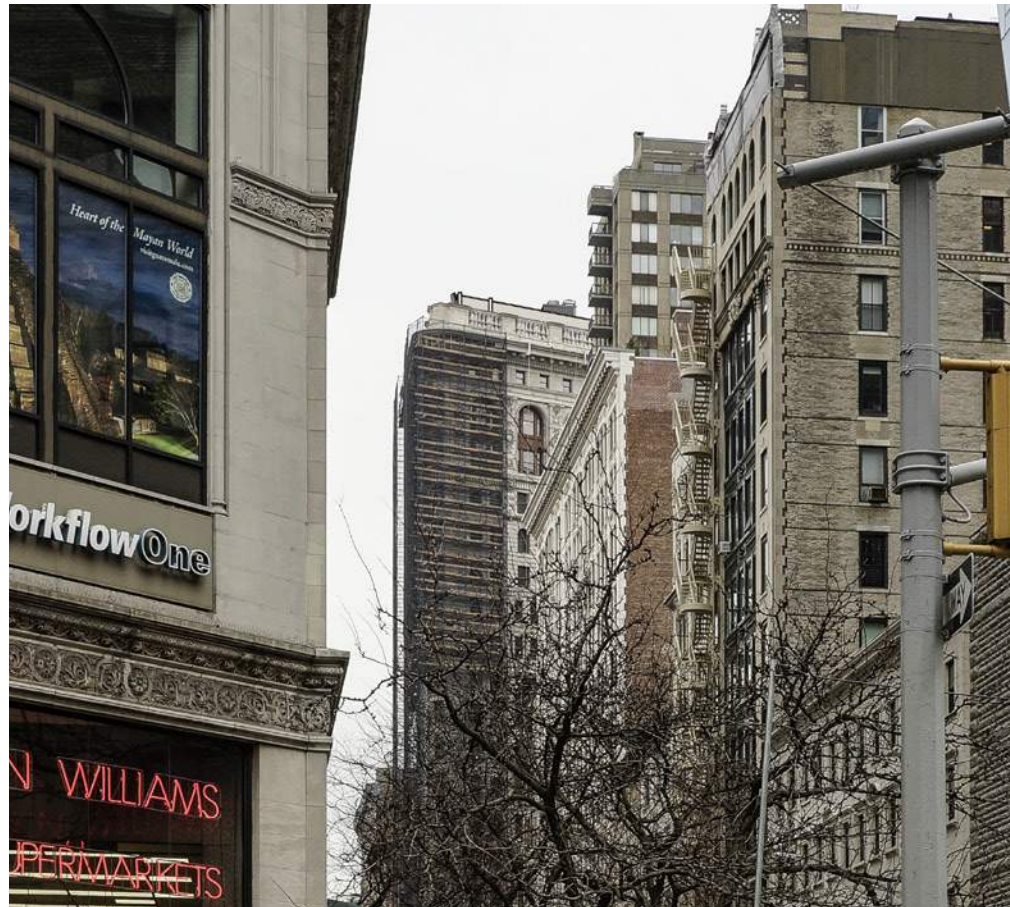
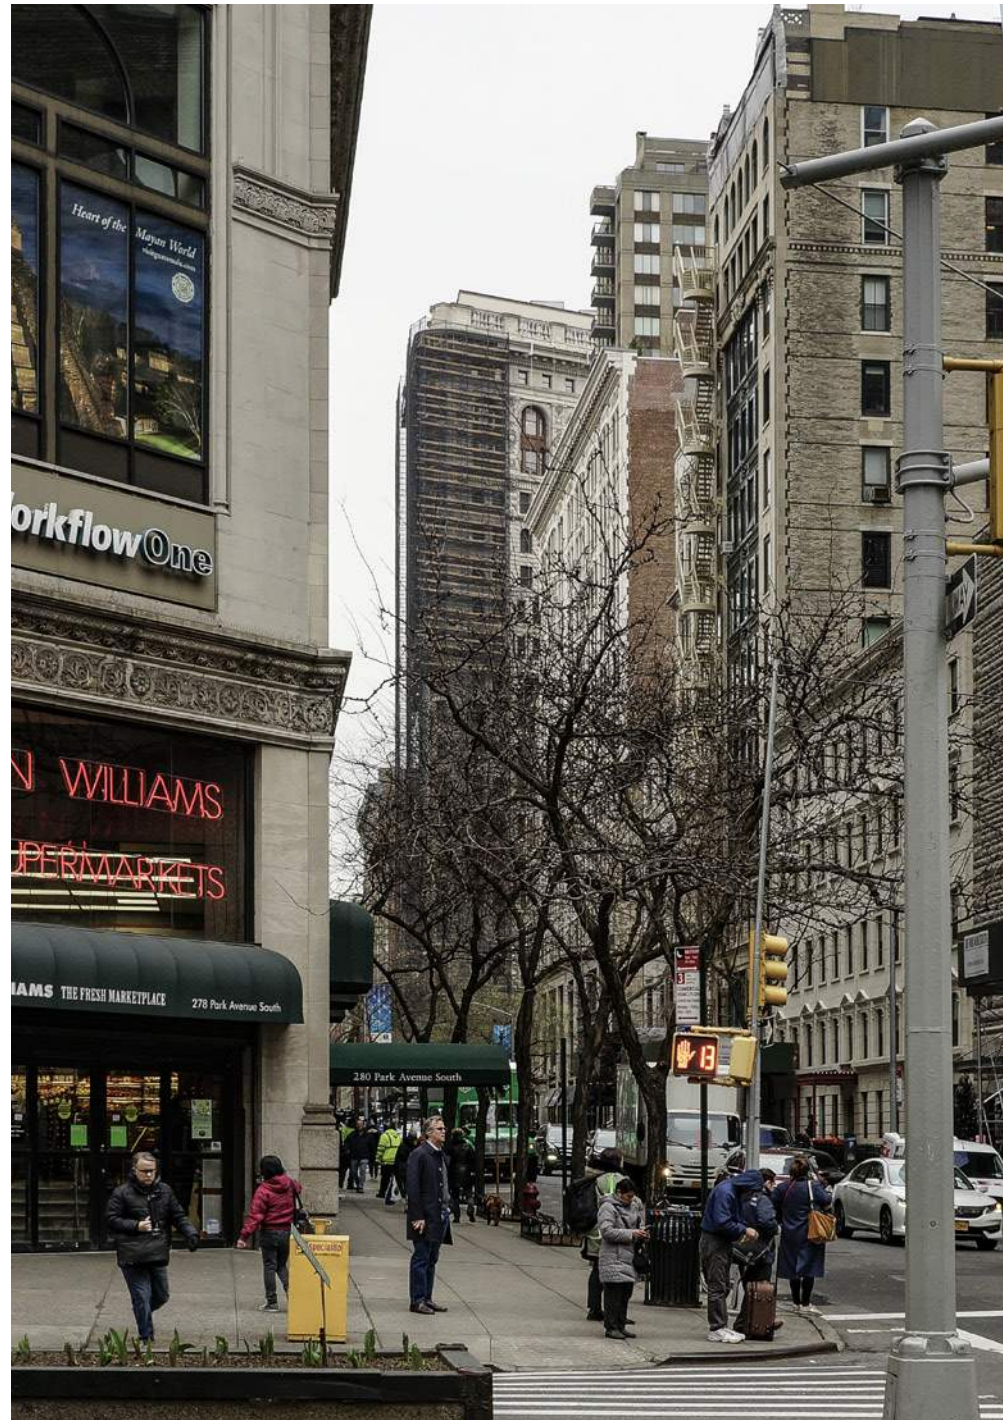
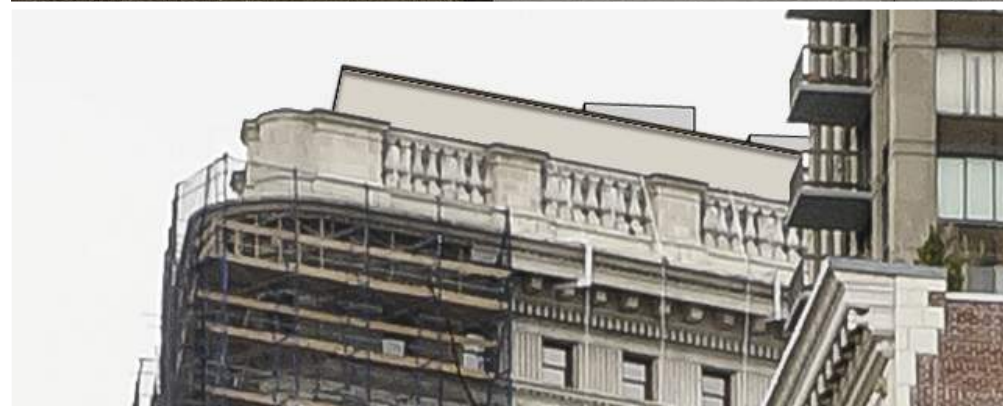
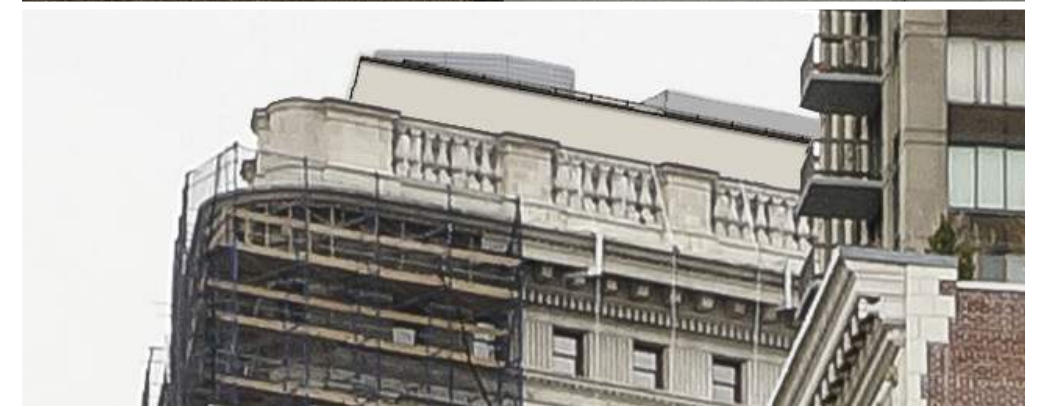
VIEW 15 (E 22ND ST, LOOKING WEST)

EXISTING CONDITION

APPROVED BY LPC, APRIL 13TH, 2021

PROPOSED
