The Flatiron Building

PRESENTATION TO LANDMARK PRESERVATION COMMISSION

MAY 21, 2024

1. WINDOW REPLACEMENT
2. STOREFRONT MASTER PLAN MODIFICATION
3. ROOFTOP MECHANICAL AND BUIKHEAD PLAN
4. APPENDIX

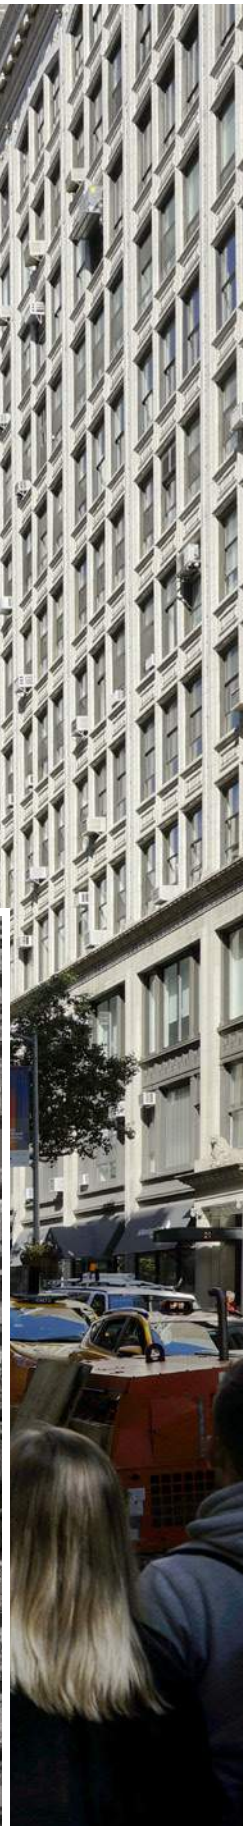
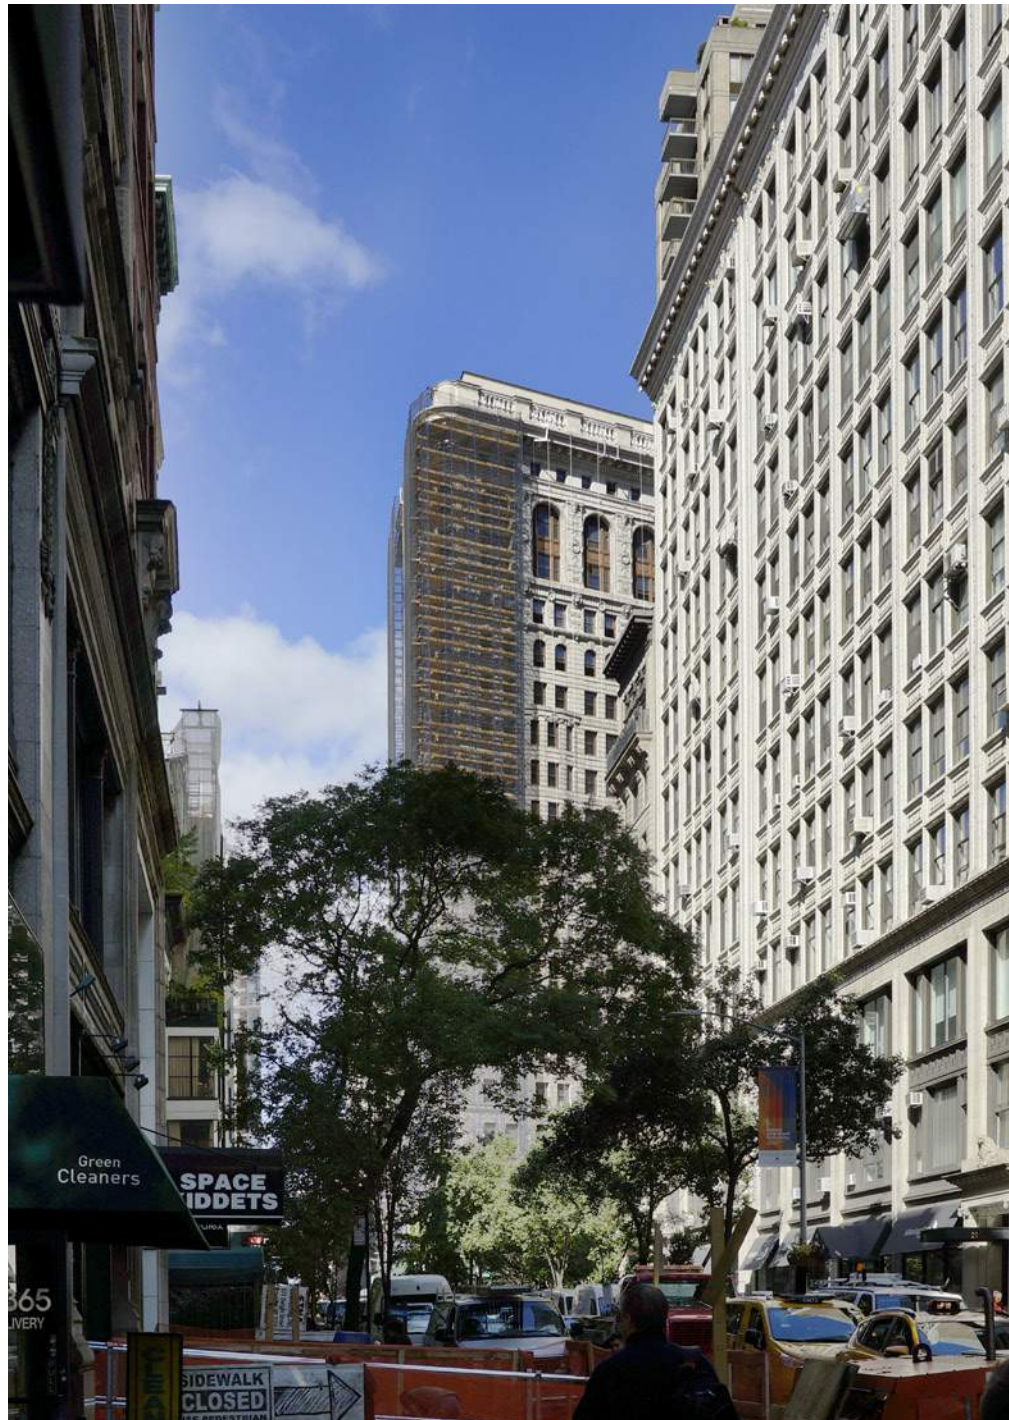
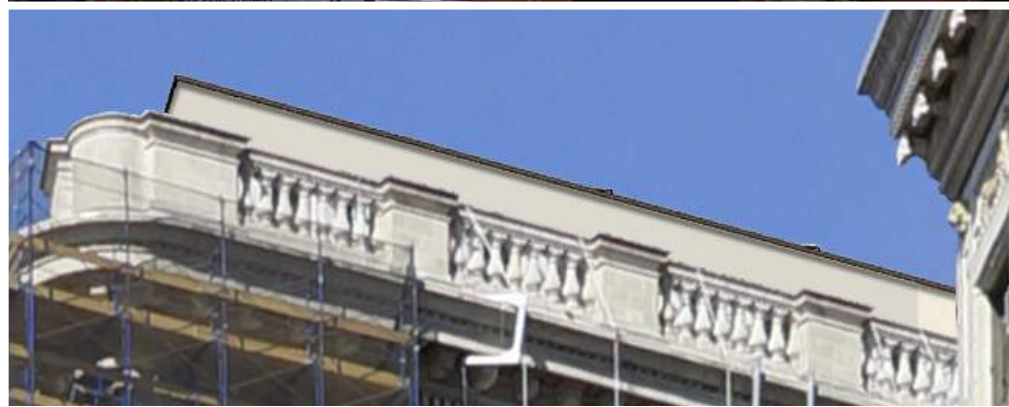
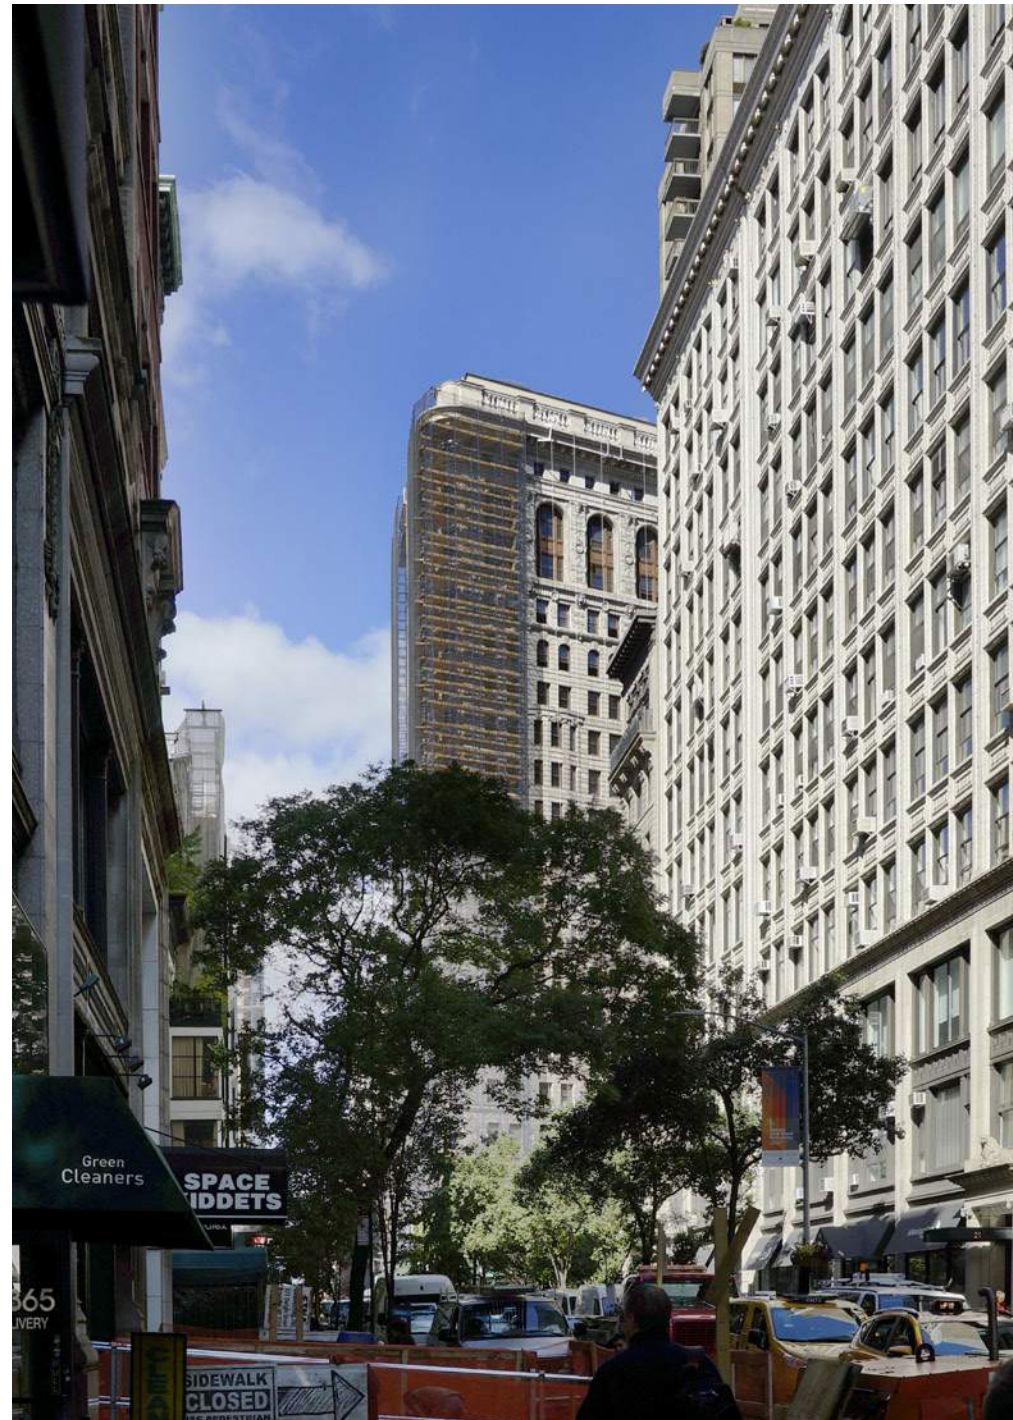
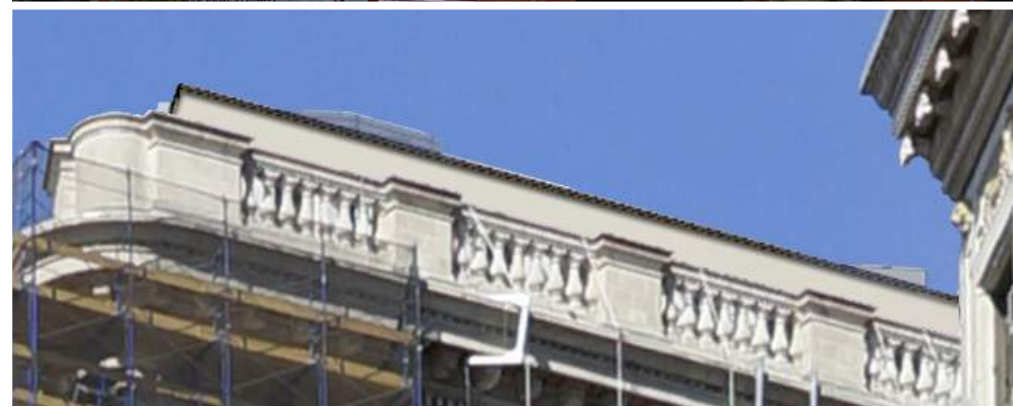
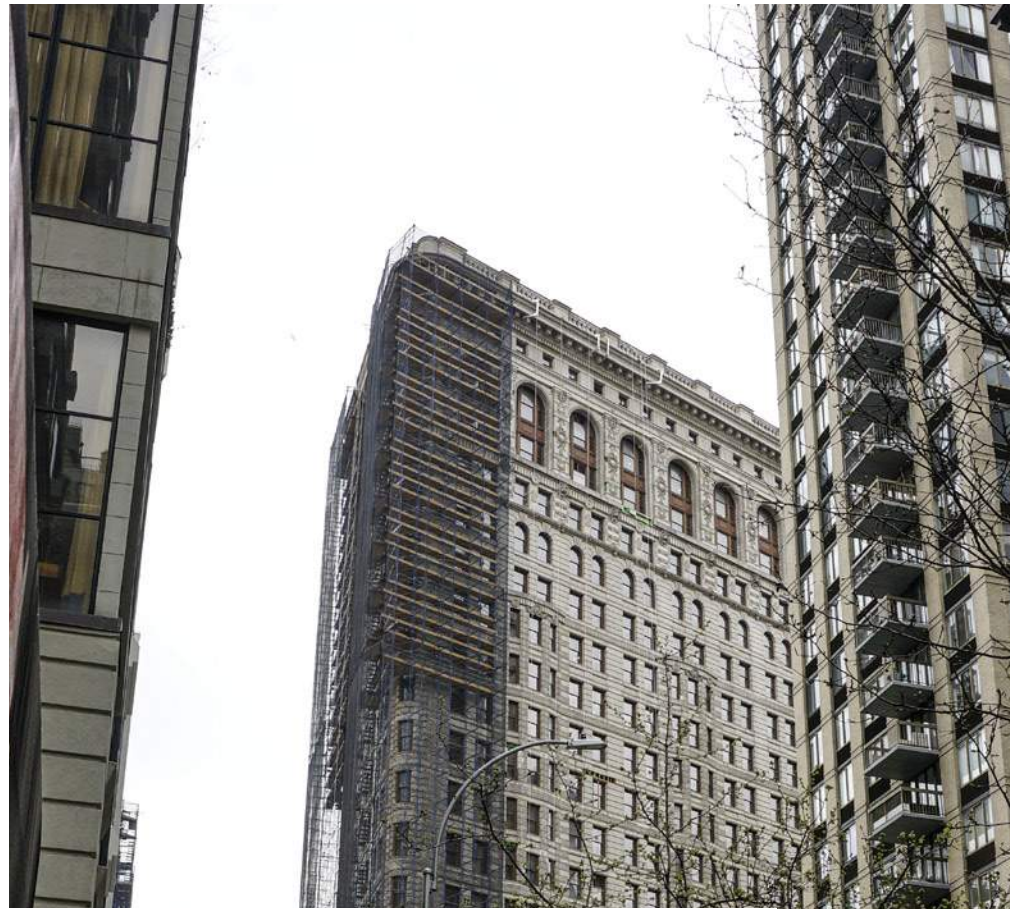
VIEW 16 (E 22ND ST, LOOKING WEST)

EXISTING CONDITION

APPROVED BY LPC, APRIL 13TH, 2021

PROPOSED

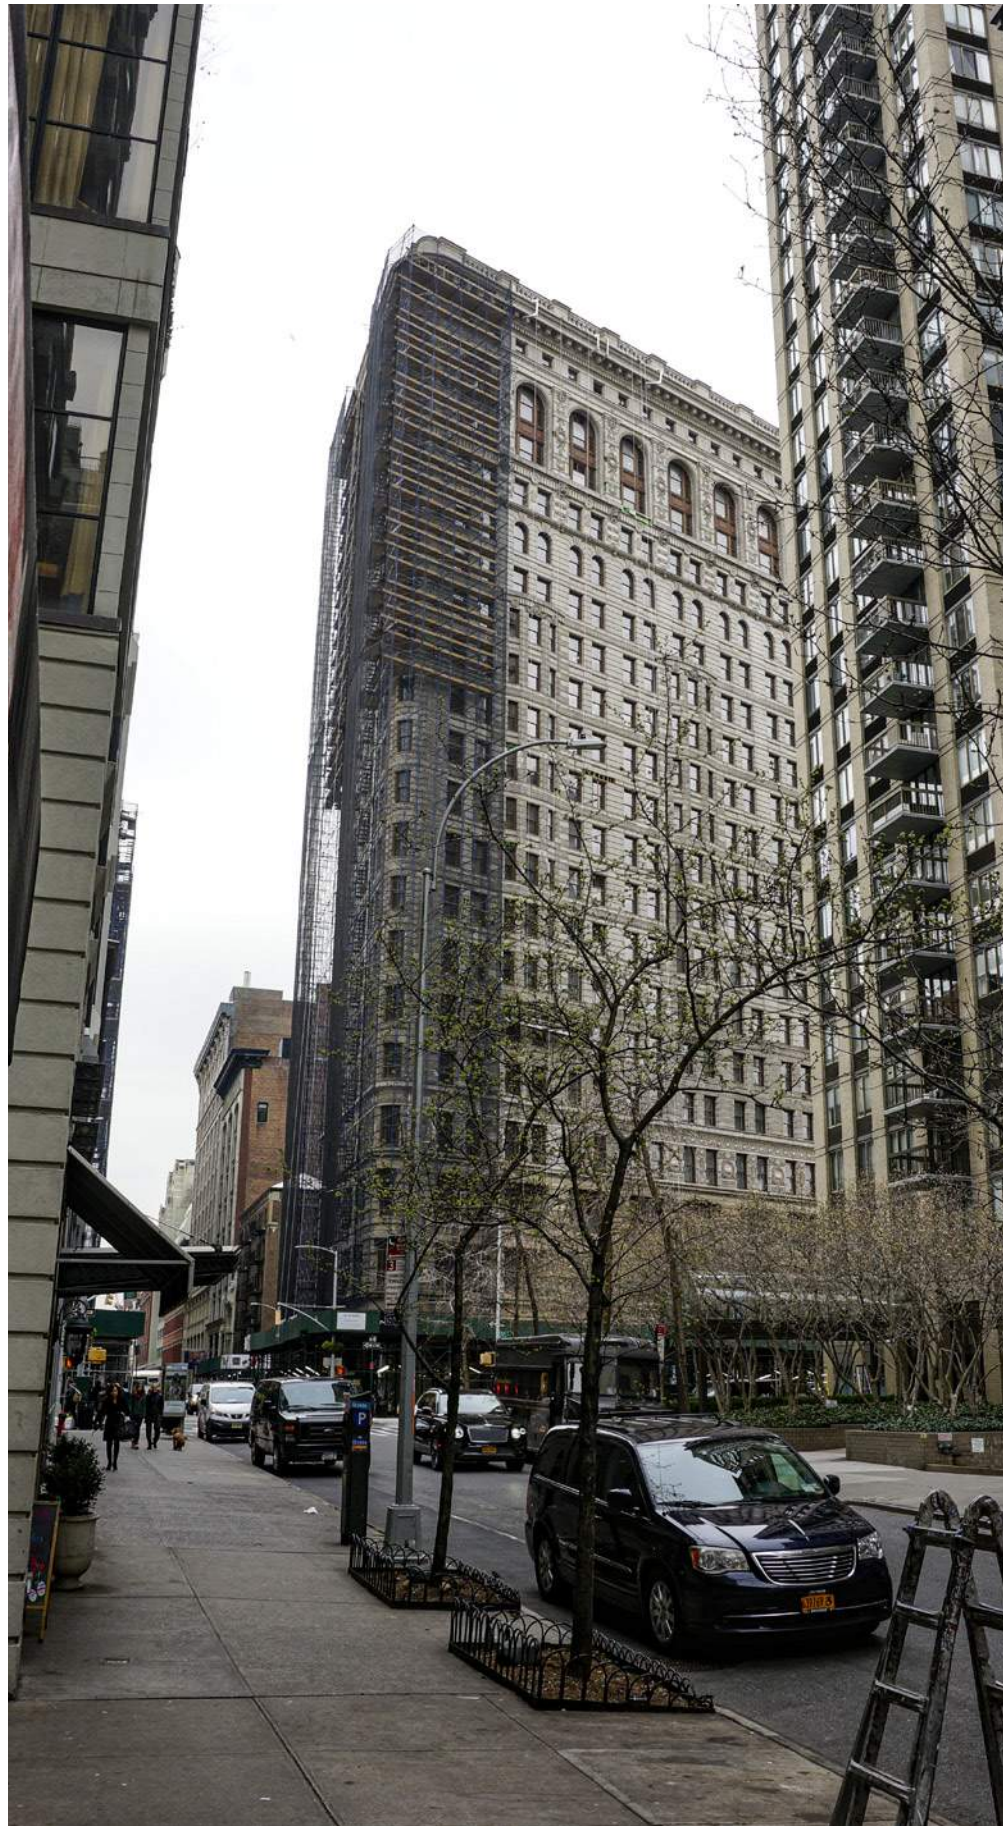
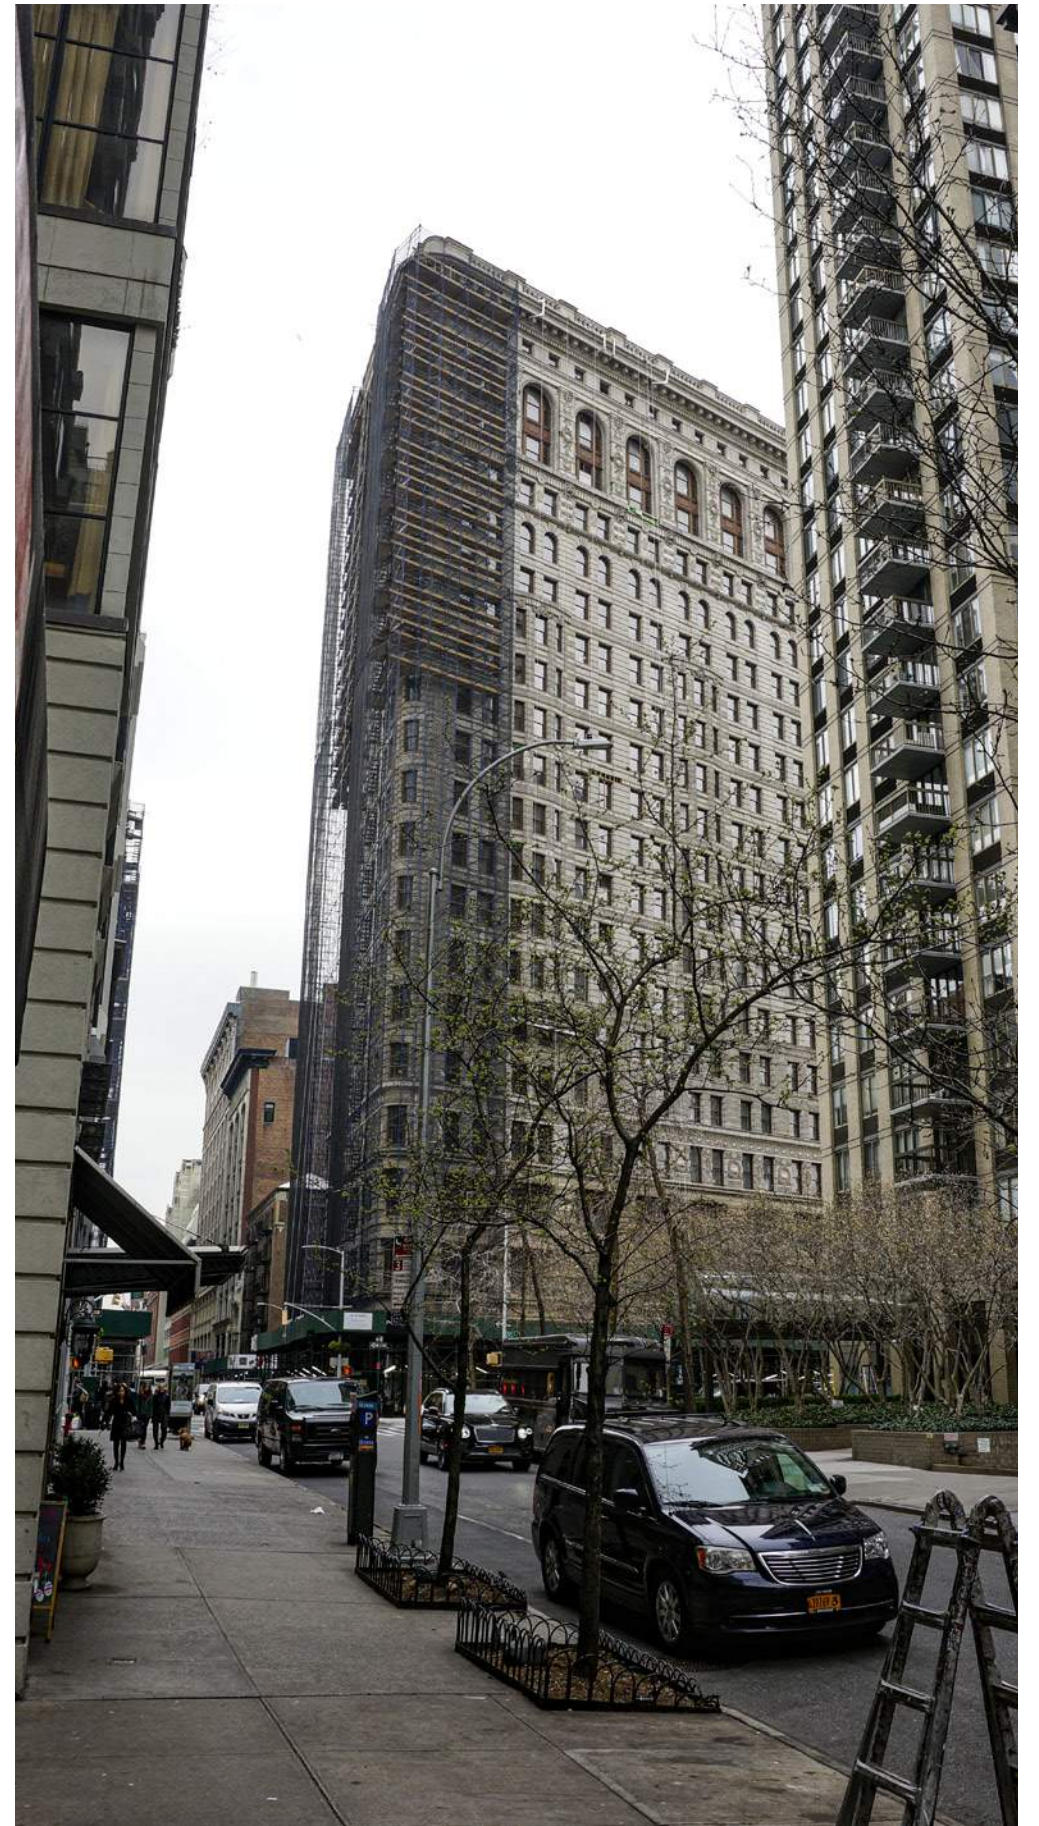
VIEW 17 (E 22ND ST, LOOKING WEST)

EXISTING CONDITION

APPROVED BY LPC, APRIL 13TH, 2021

PROPOSED

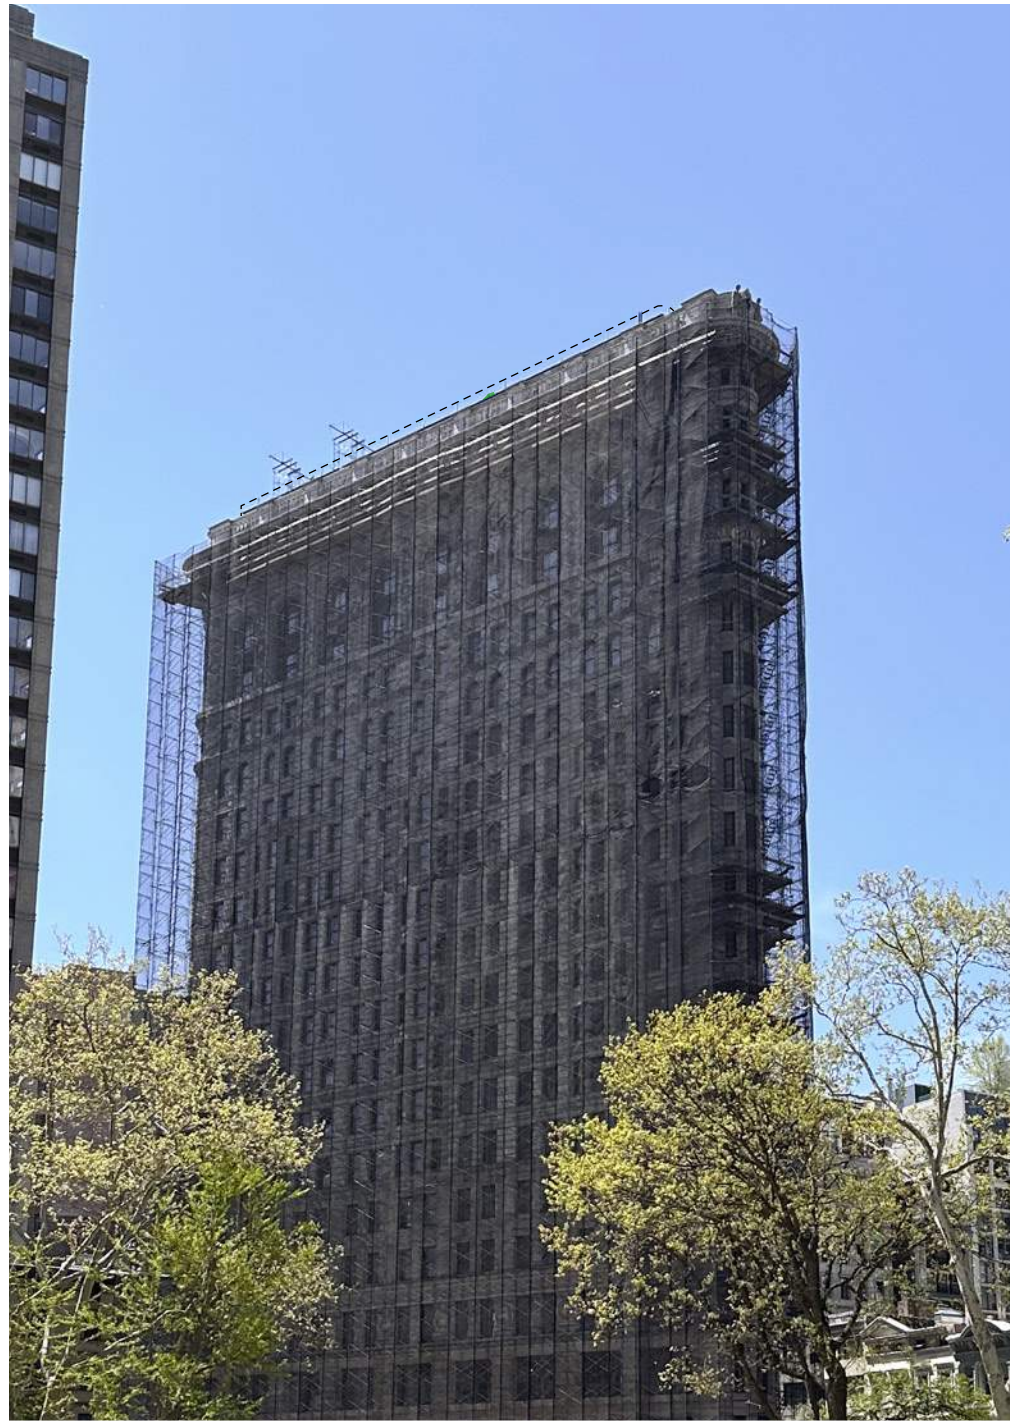
VIEW 1

2024 ROOFTOP MOCKUP

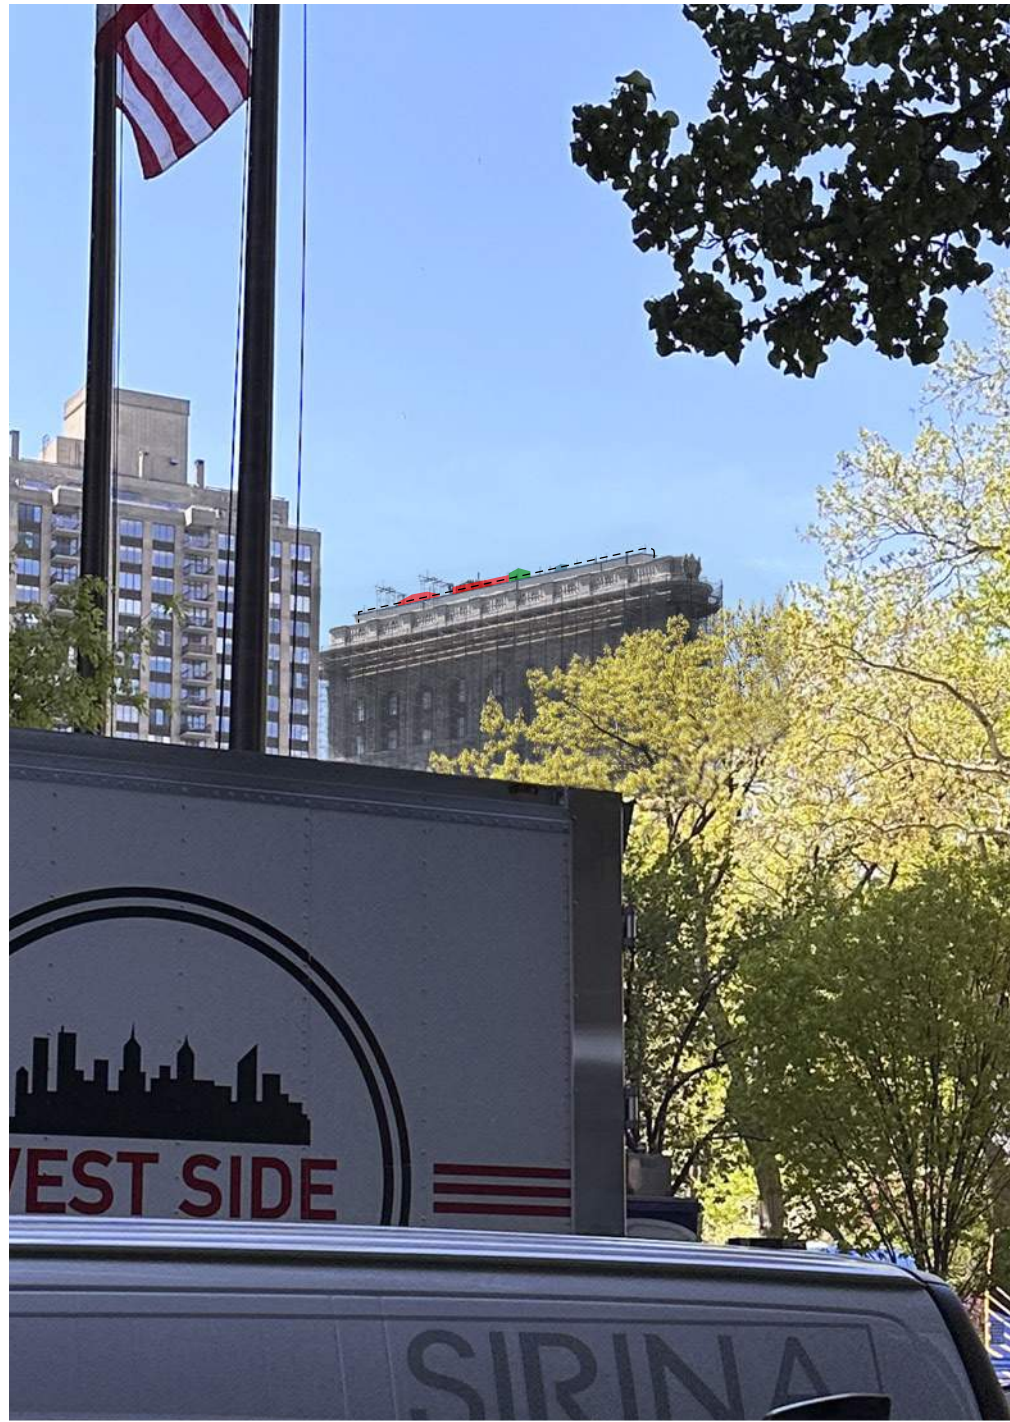
VIEW 4

2024 ROOFTOP MOCKUP

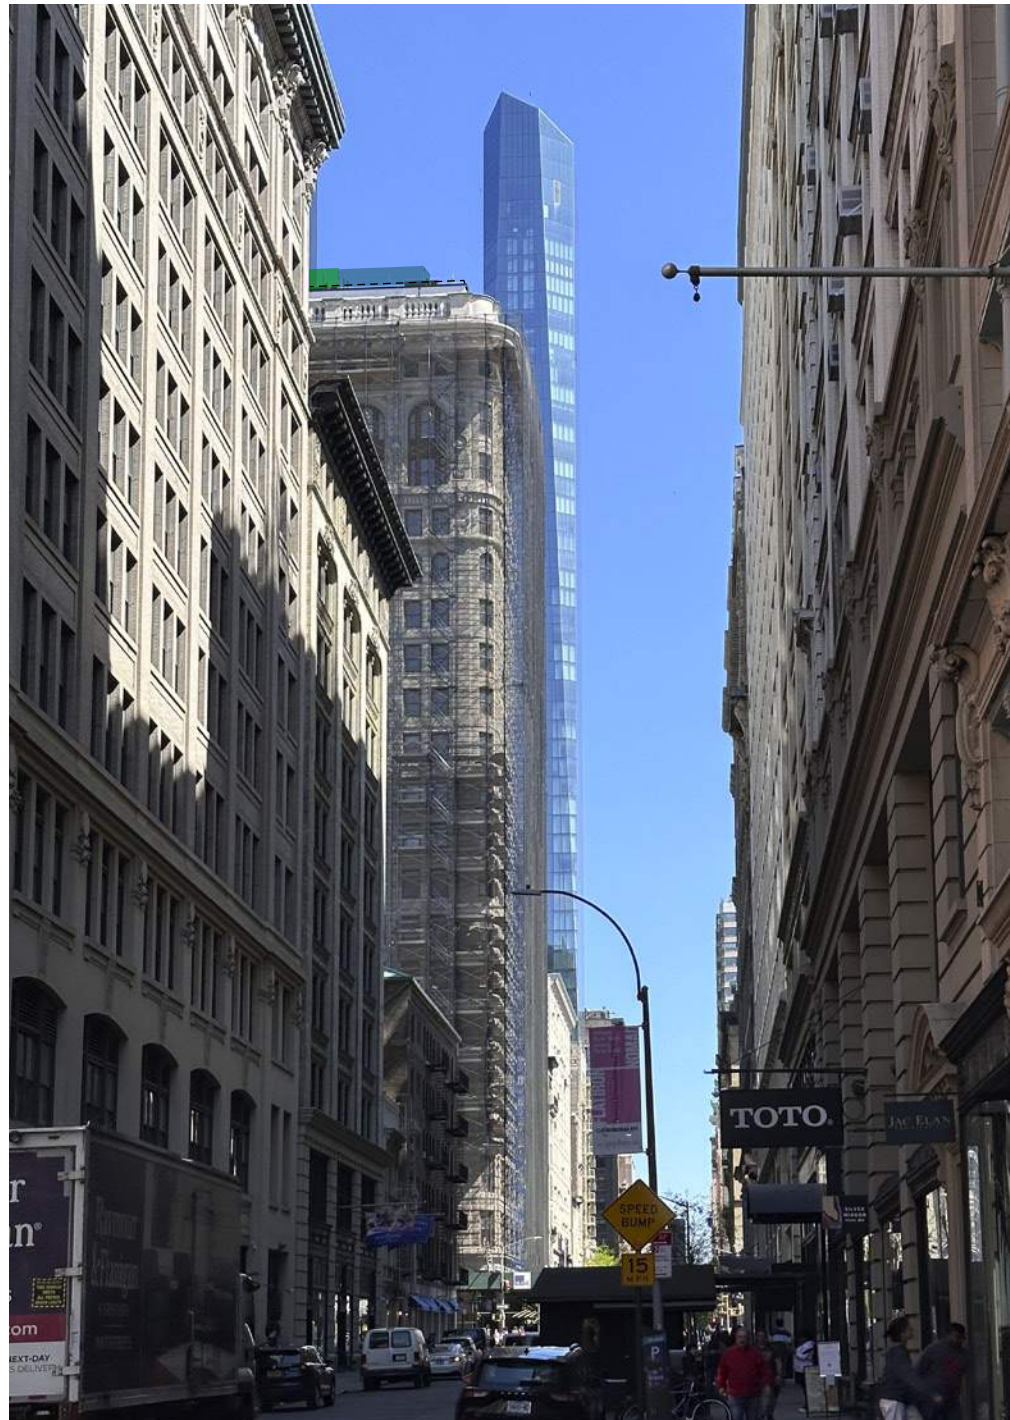
VIEW 10

2024 ROOFTOP MOCKUP

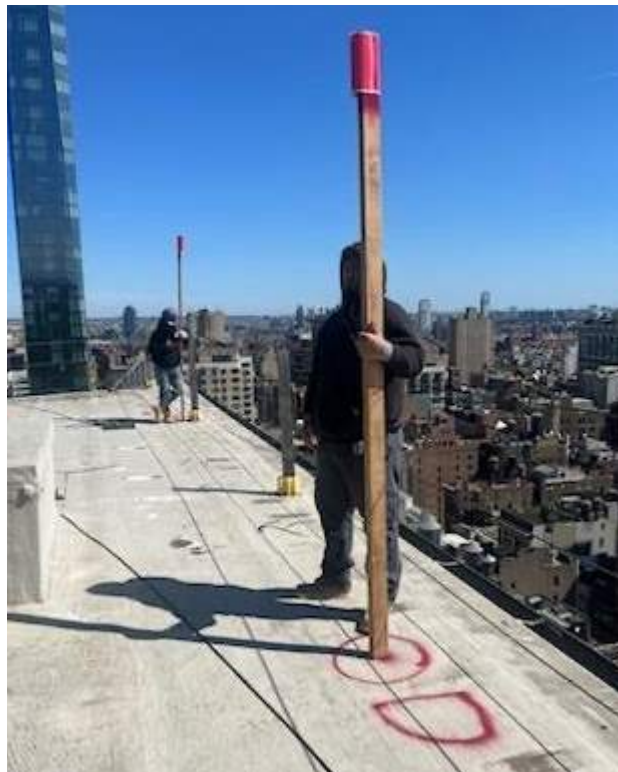
SITE PHOTO

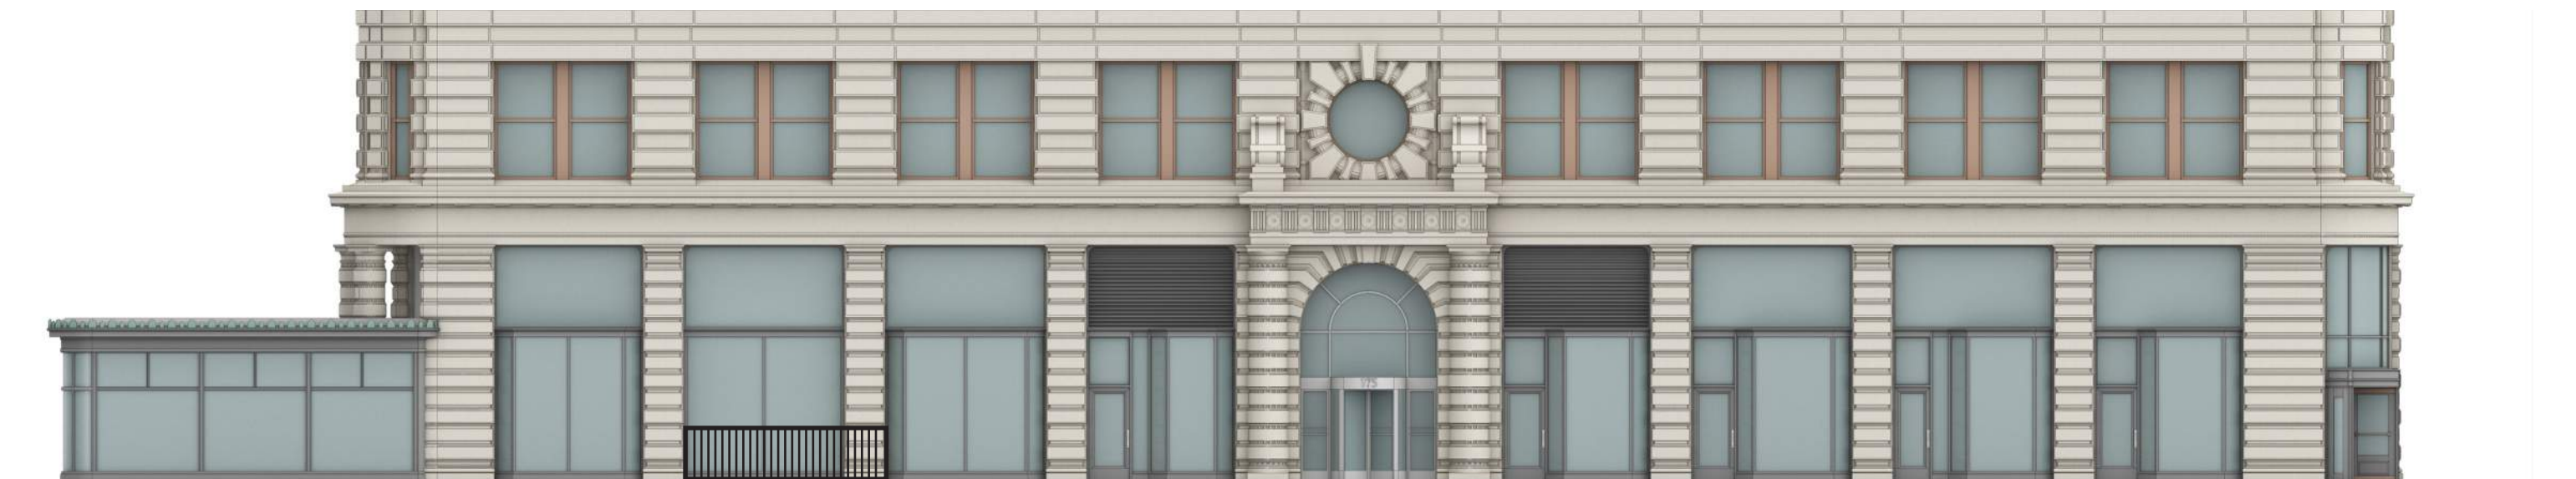
STOREFRONT ELEVATION ON 5TH AVENUE - EXISTING AND PROPOSED

EXISTING CONDITION

AUTOMATIC DOORS

01 # 02 # 03 # 04 # 05 # 06 # 07 # 08 # 09 # 10

PROPOSED

PLAN

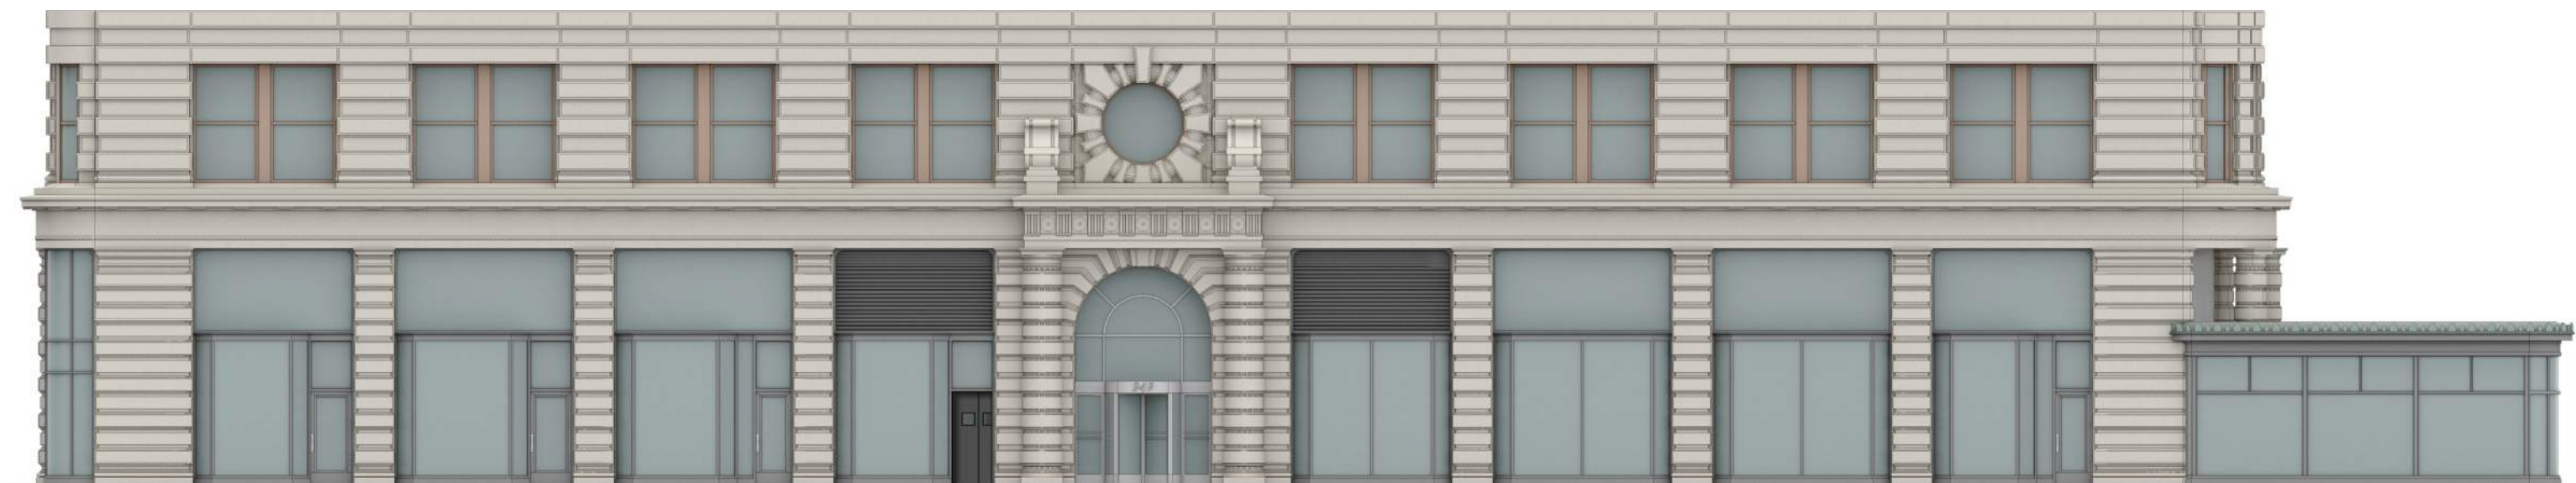
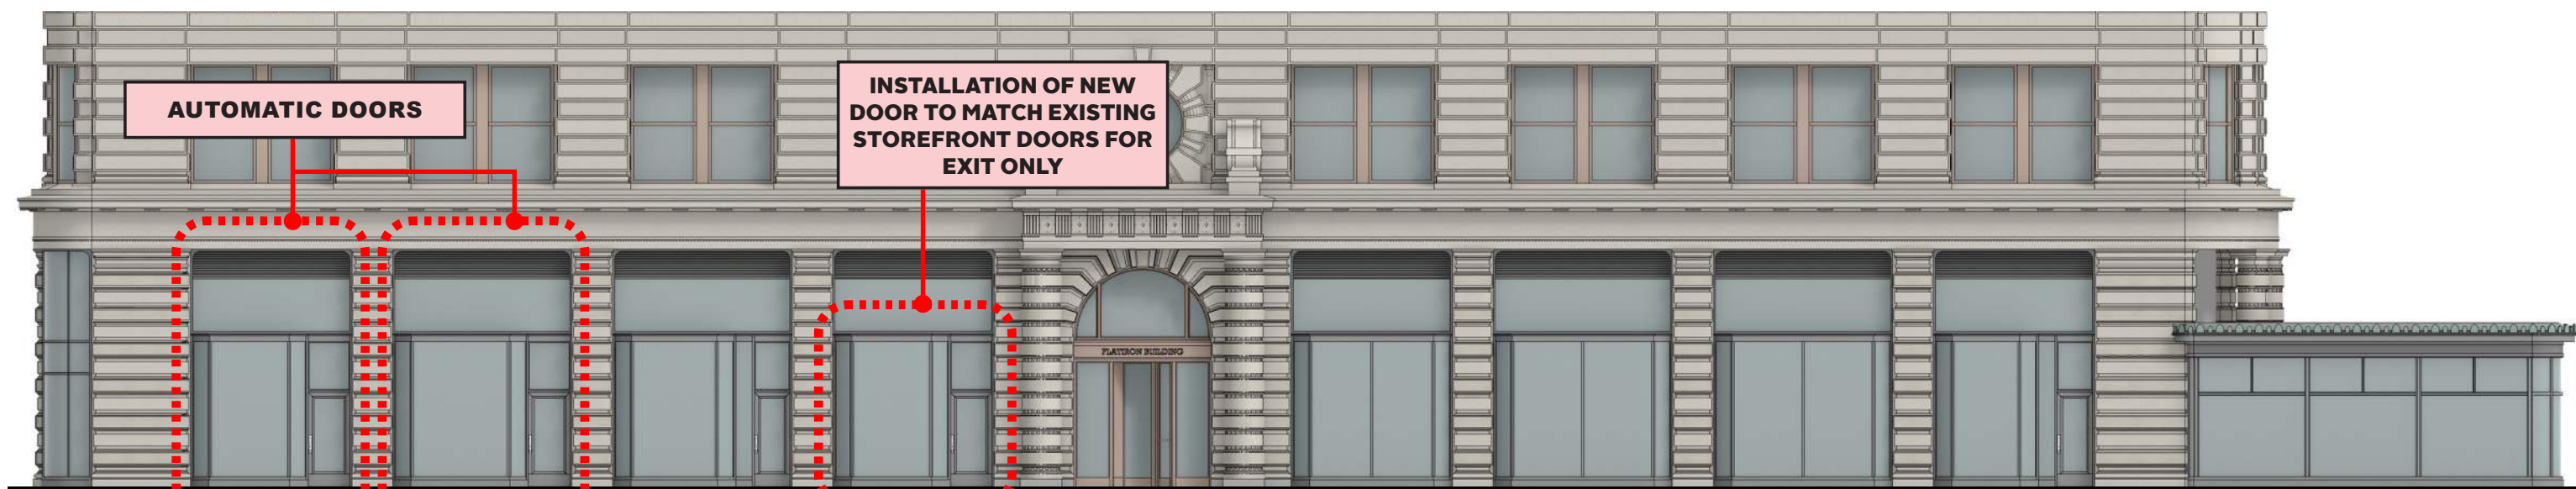
STOREFRONT ELEVATION ON BROADWAY - EXISTING AND PROPOSED

EXISTING CONDITION

15 # 16 # 17 # 18 # 19 # 20 # 21 # 22 # 23 PROPOSED

PLAN

13'-6 5/16" 15'-0 5/8" 15'-0 5/8" 13'-6 5/16" 13'-6 5/16" 15'-0 5/8" 15'-0 5/8" 13'-6 5/16"

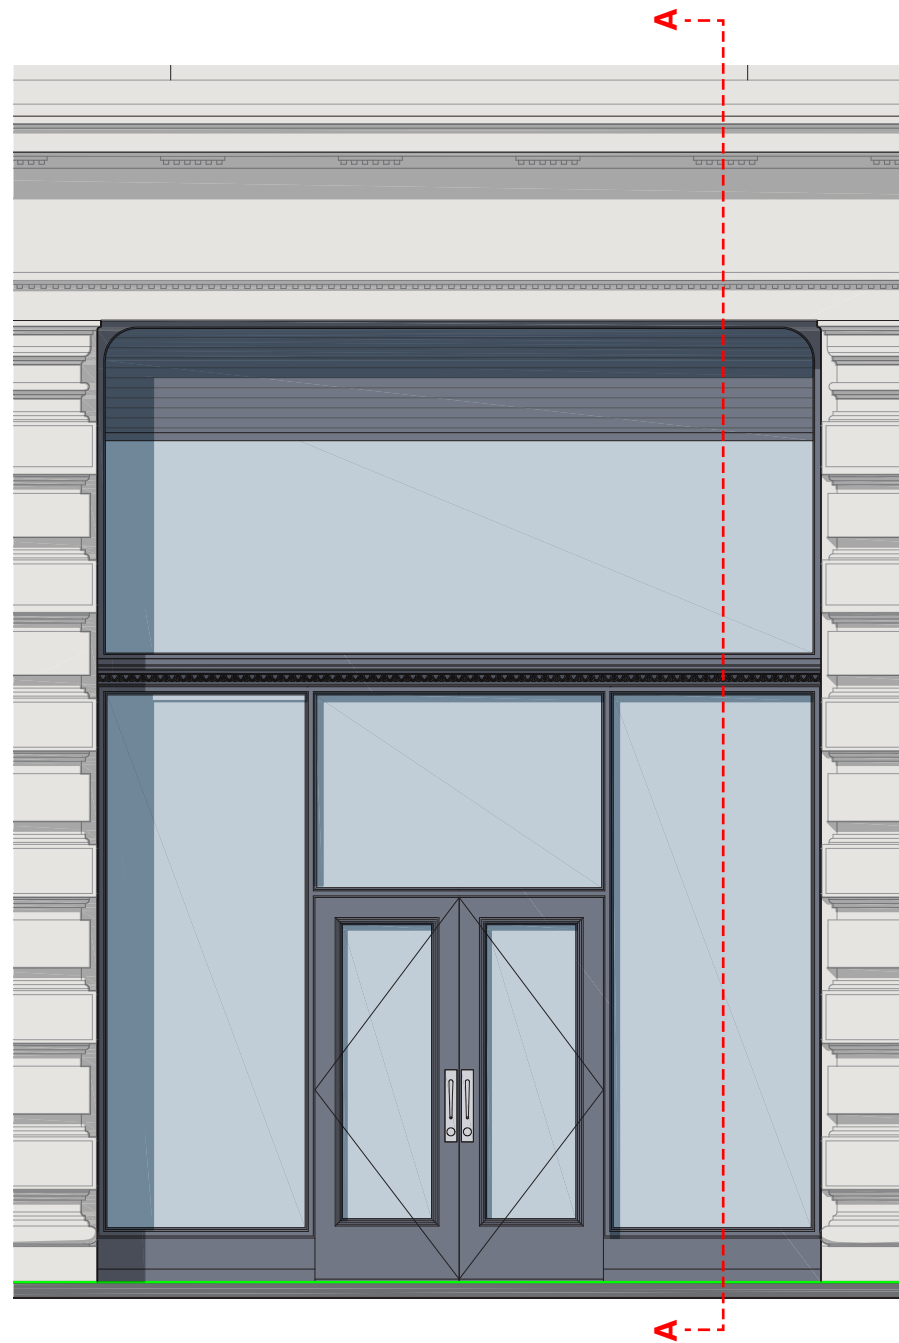
REVISED STOREFRONT DOUBLE DOOR

PLAN AND ELEVATION

- STOREFRONT MULLIONS TO MATCH ORIGINAL STOREFRONT DESIGN IN KIND AND TO BE APPROVED BY LPC.

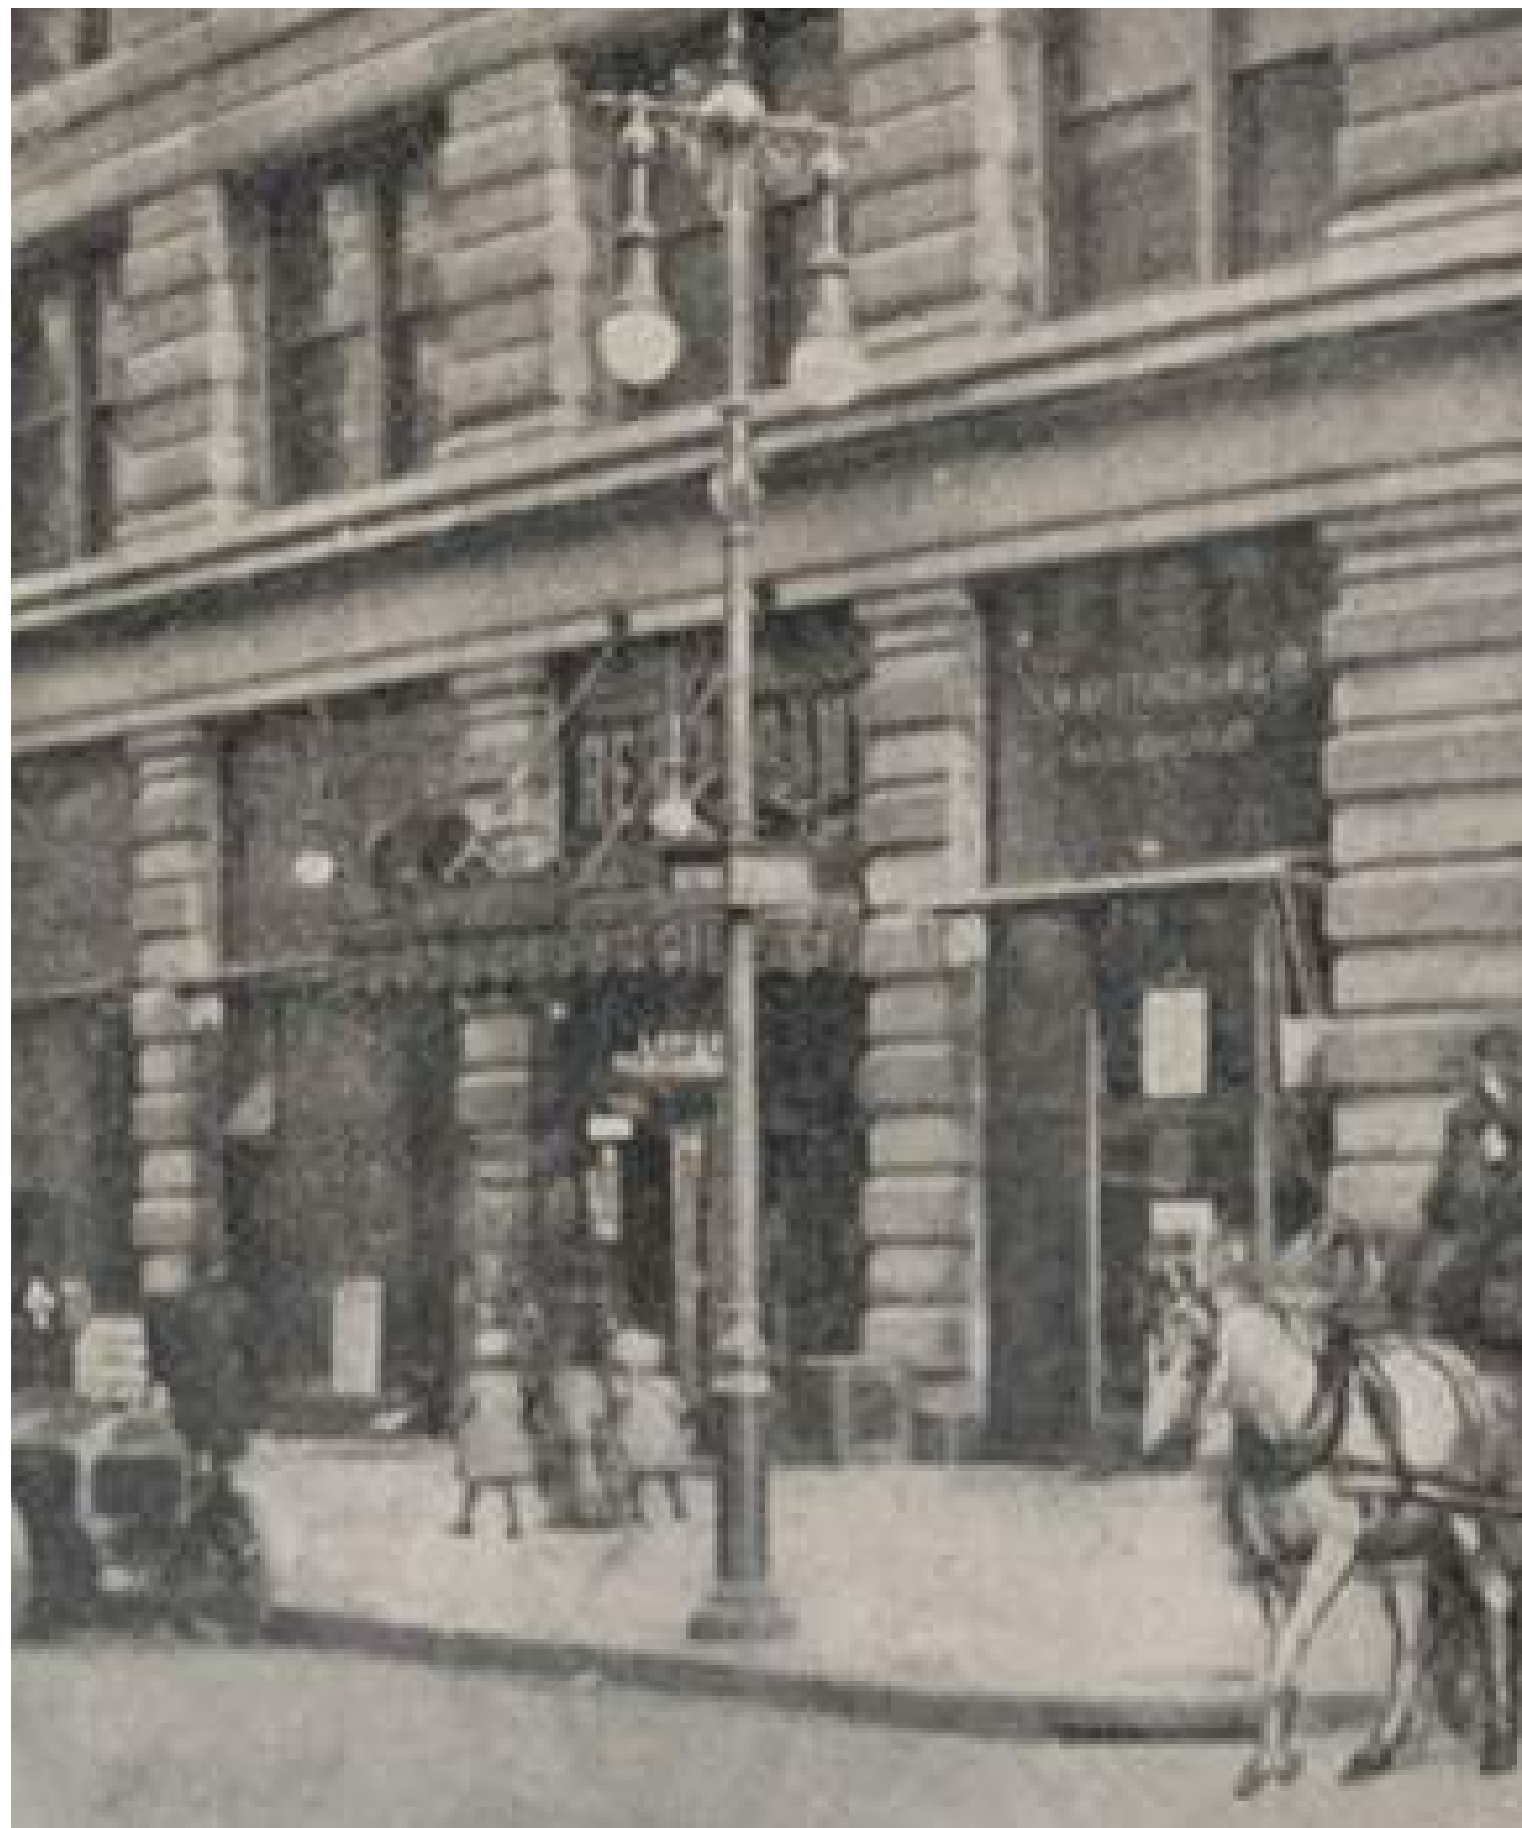
ENTRY TO CELLAR RESTAURANT ON 5TH AVENUE (1911)
