The Flatiron Building

PRESENTATION TO LANDMARK PRESERVATION COMMISSION

MAY 21, 2024

1. WINDOW REPLACEMENT
2. STOREFRONT MASTER PLAN MODIFICATION
3. ROOFTOP MECHANICAL AND BUIKHEAD PLAN
4. APPENDIX

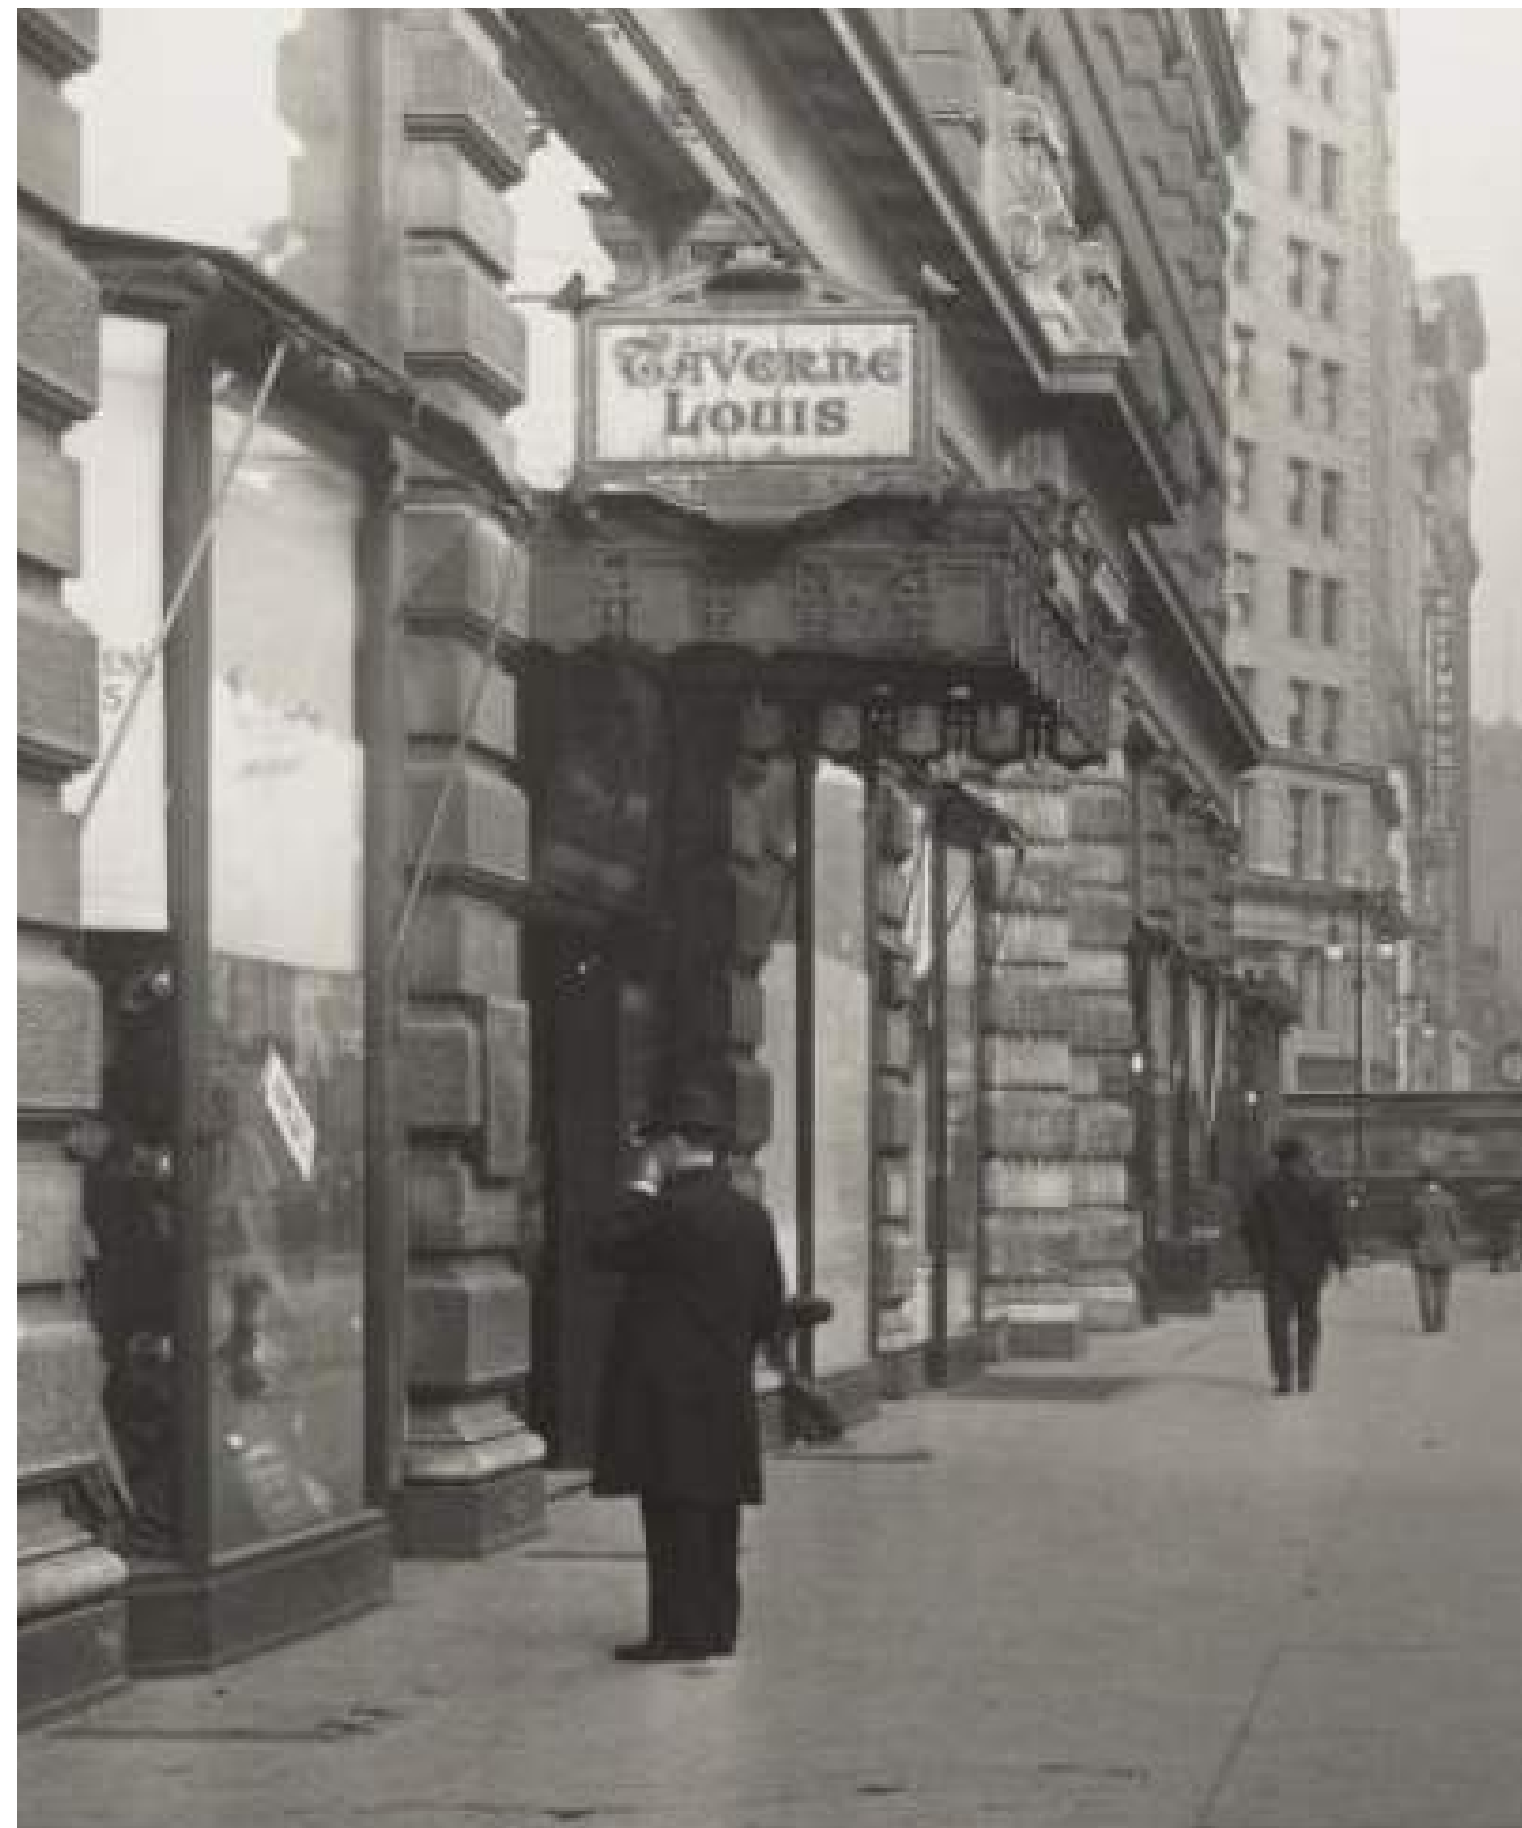
ENTRY TO CELLAR RESTAURANT ON BROADWAY (1913)

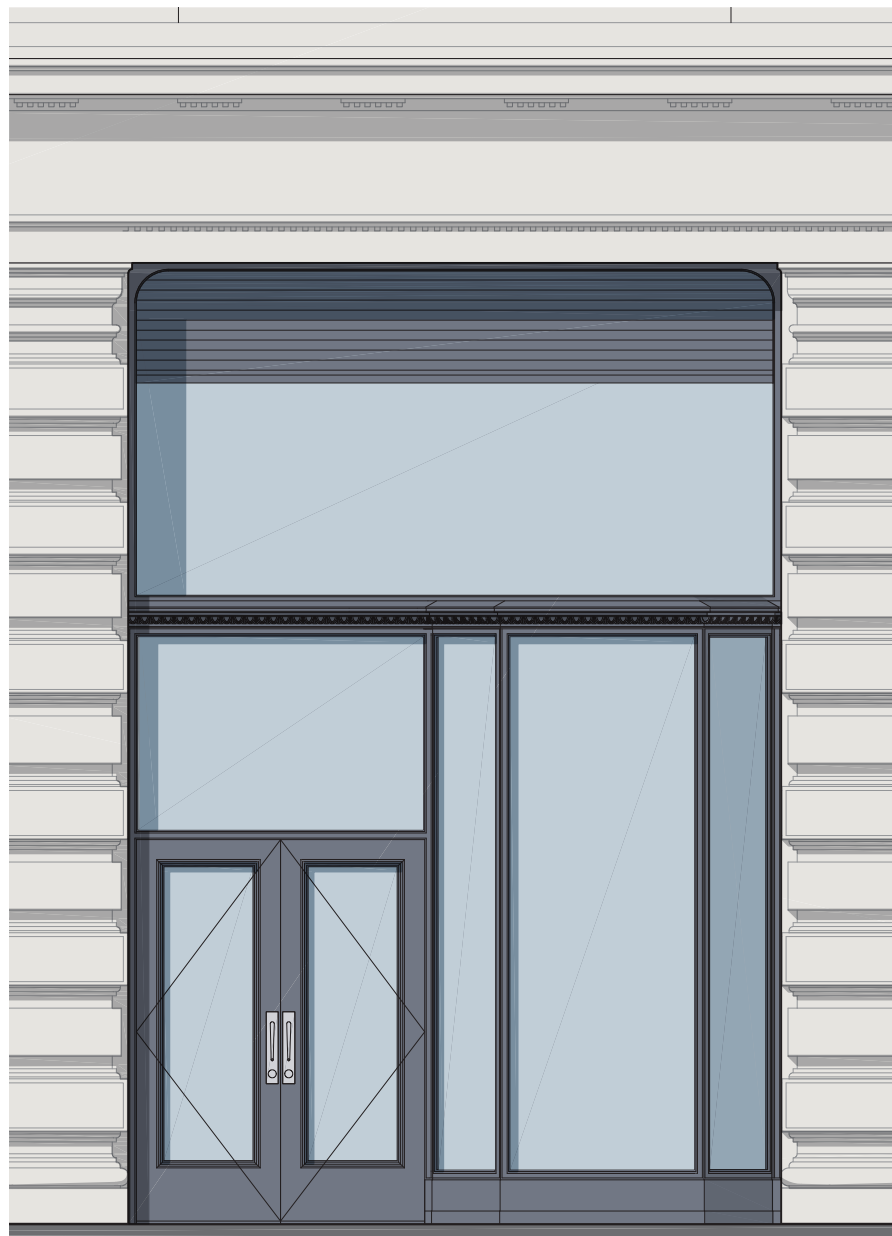
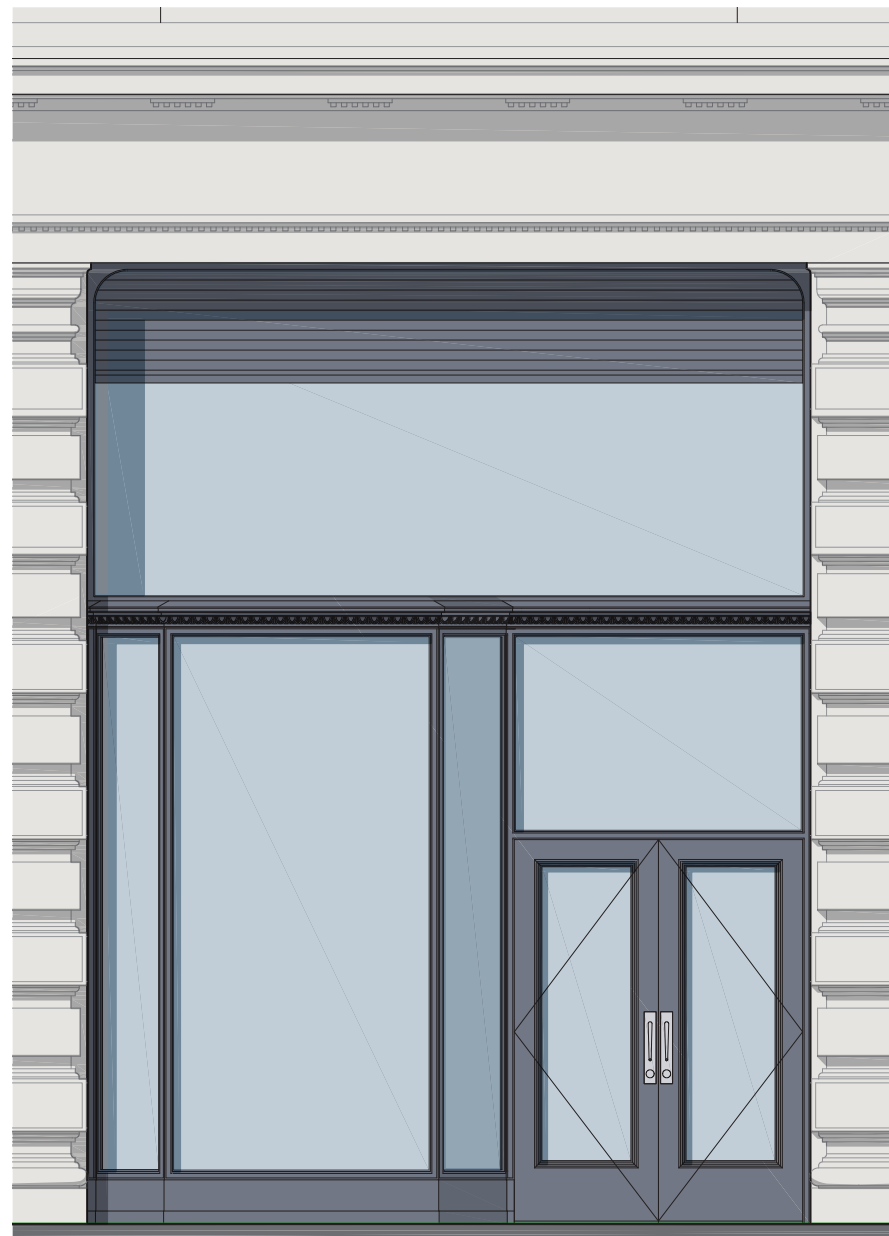
EXHIBIT A

- DOUBLE DOORS TO BE LIMITED TO BAYS #17 ON BROADWAY AND #08 ON 5TH AVENUE
- LOCATION OF DOUBLE DOORS TO BE LIMITED TO THE HIGHLIGHTED STOREFRONT BAYS NOTED IN THE PLAN ABOVE

**DOUBLE DOOR WITH BAY WINDOW
BAY #08 ON 5TH AVENUE**

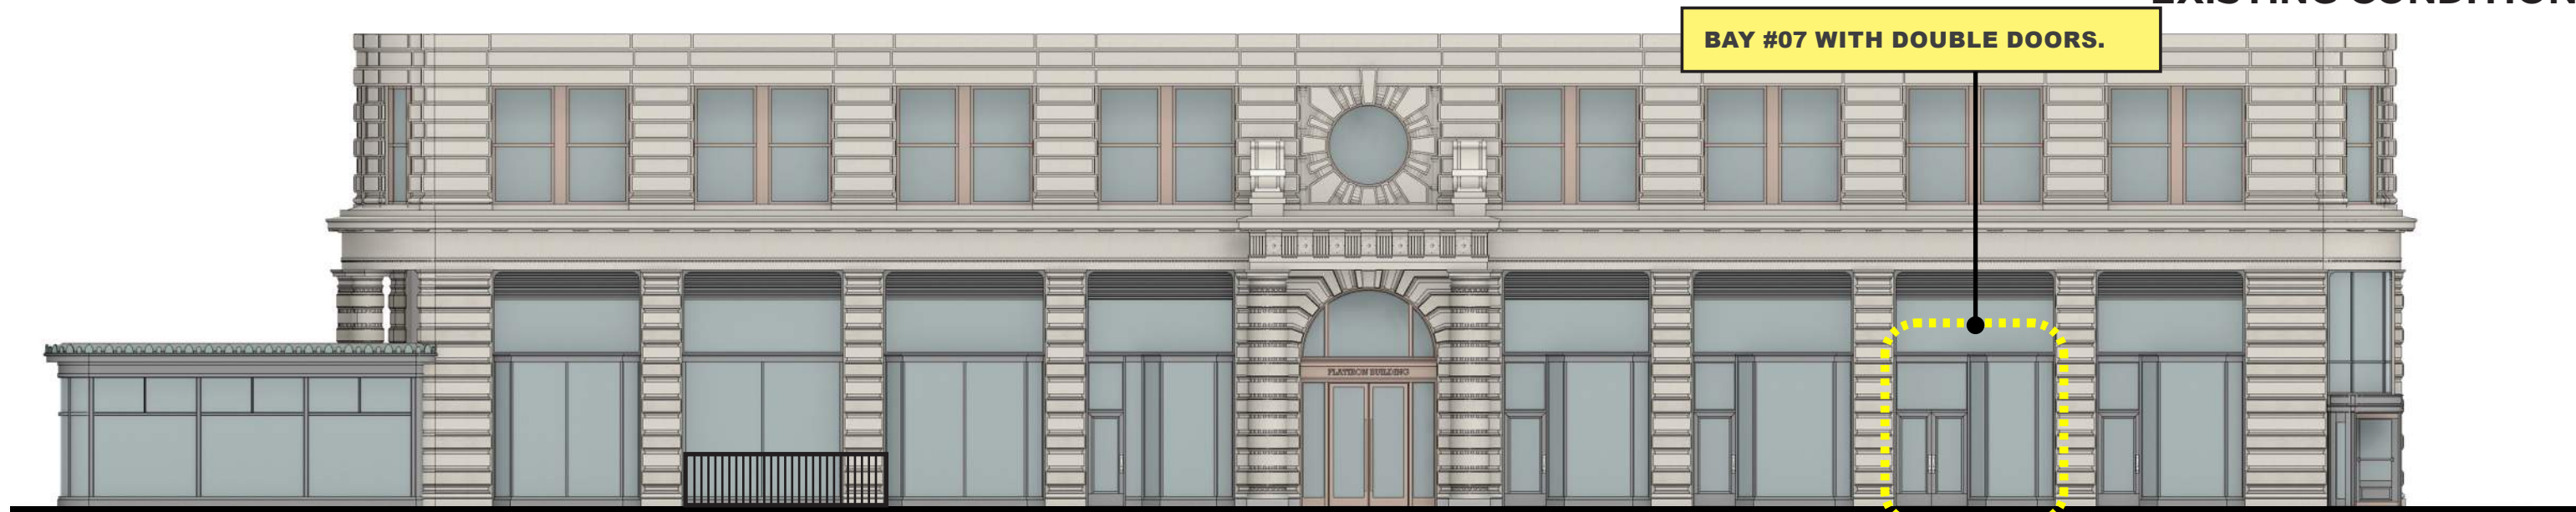
STOREFRONT ELEVATION ON 5TH AVENUE - EXISTING AND PROPOSED

EXISTING CONDITION

BAY #07 WITH DOUBLE DOORS.

- # 01
- # 02
- # 03
- # 04
- # 05
- # 06
- # 07
- # 08
- # 09
- # 10

PROPOSED

PLAN

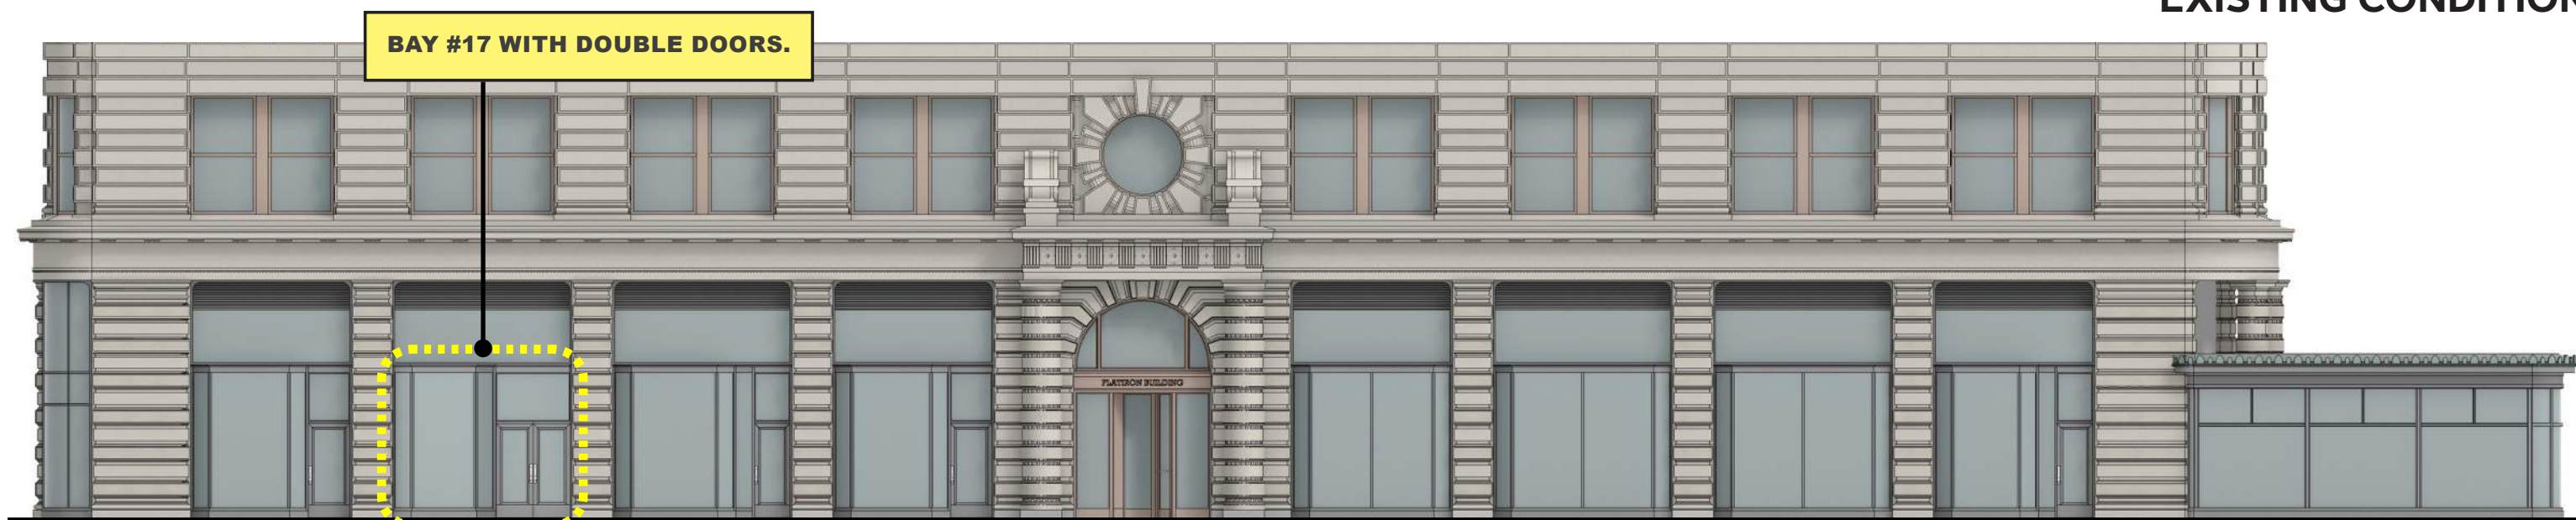
STOREFRONT ELEVATION ON BROADWAY - EXISTING AND PROPOSED

EXISTING CONDITION

15 # 16 # 17 # 18 # 19 # 20 # 21 # 22 # 23

PROPOSED

13' - 6 5/16" 15' - 0 5/8" 15' - 0 5/8" 13' - 6 5/16" 13' - 6 5/16" 15' - 0 5/8" 15' - 0 5/8" 13' - 6 5/16"

PLAN

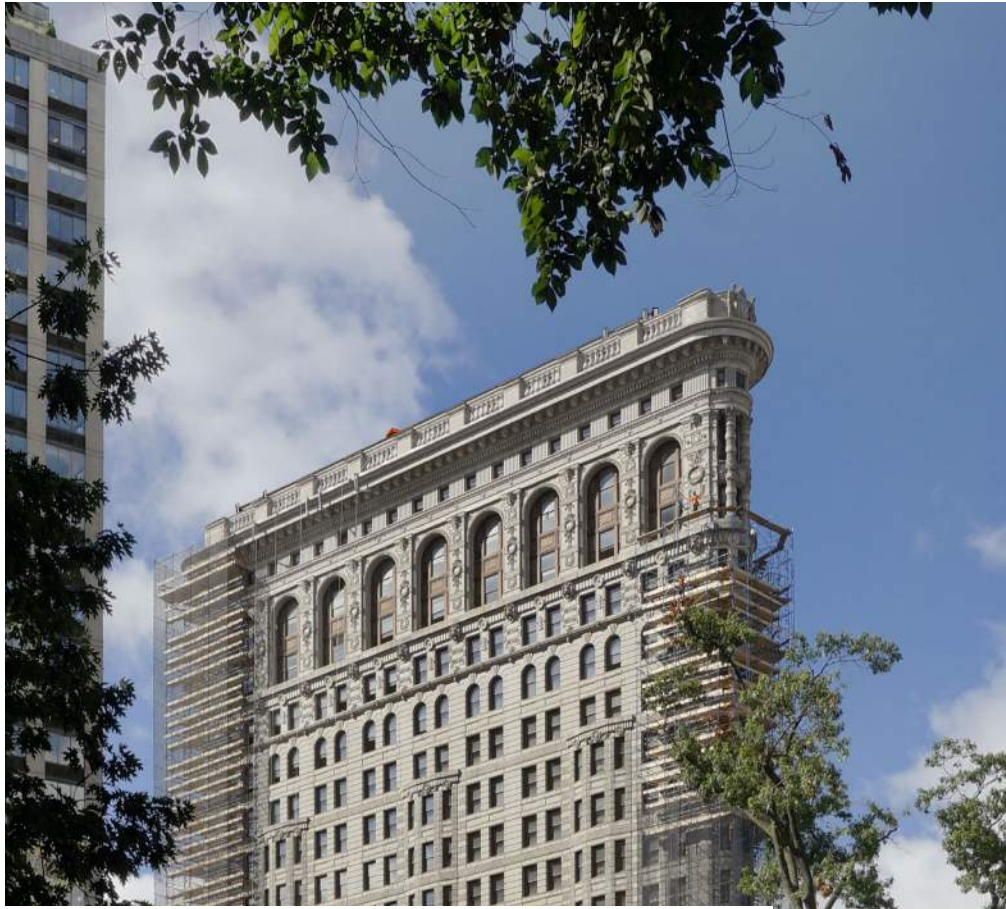
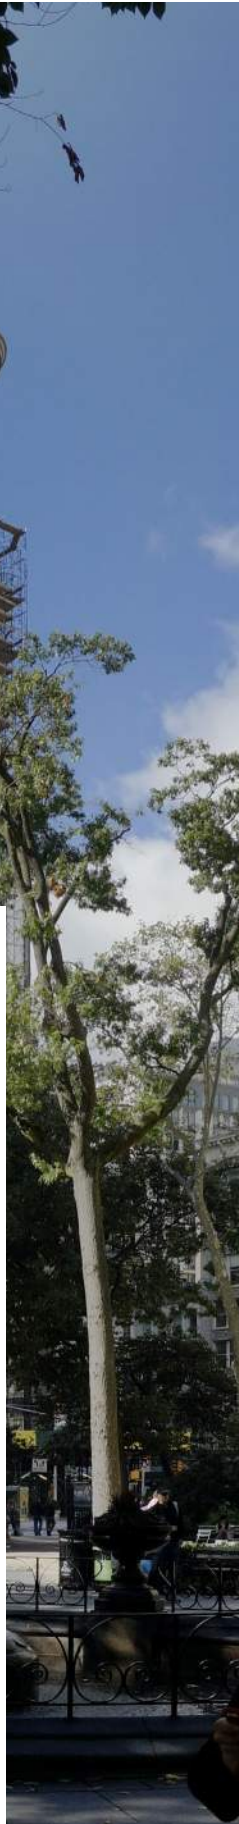
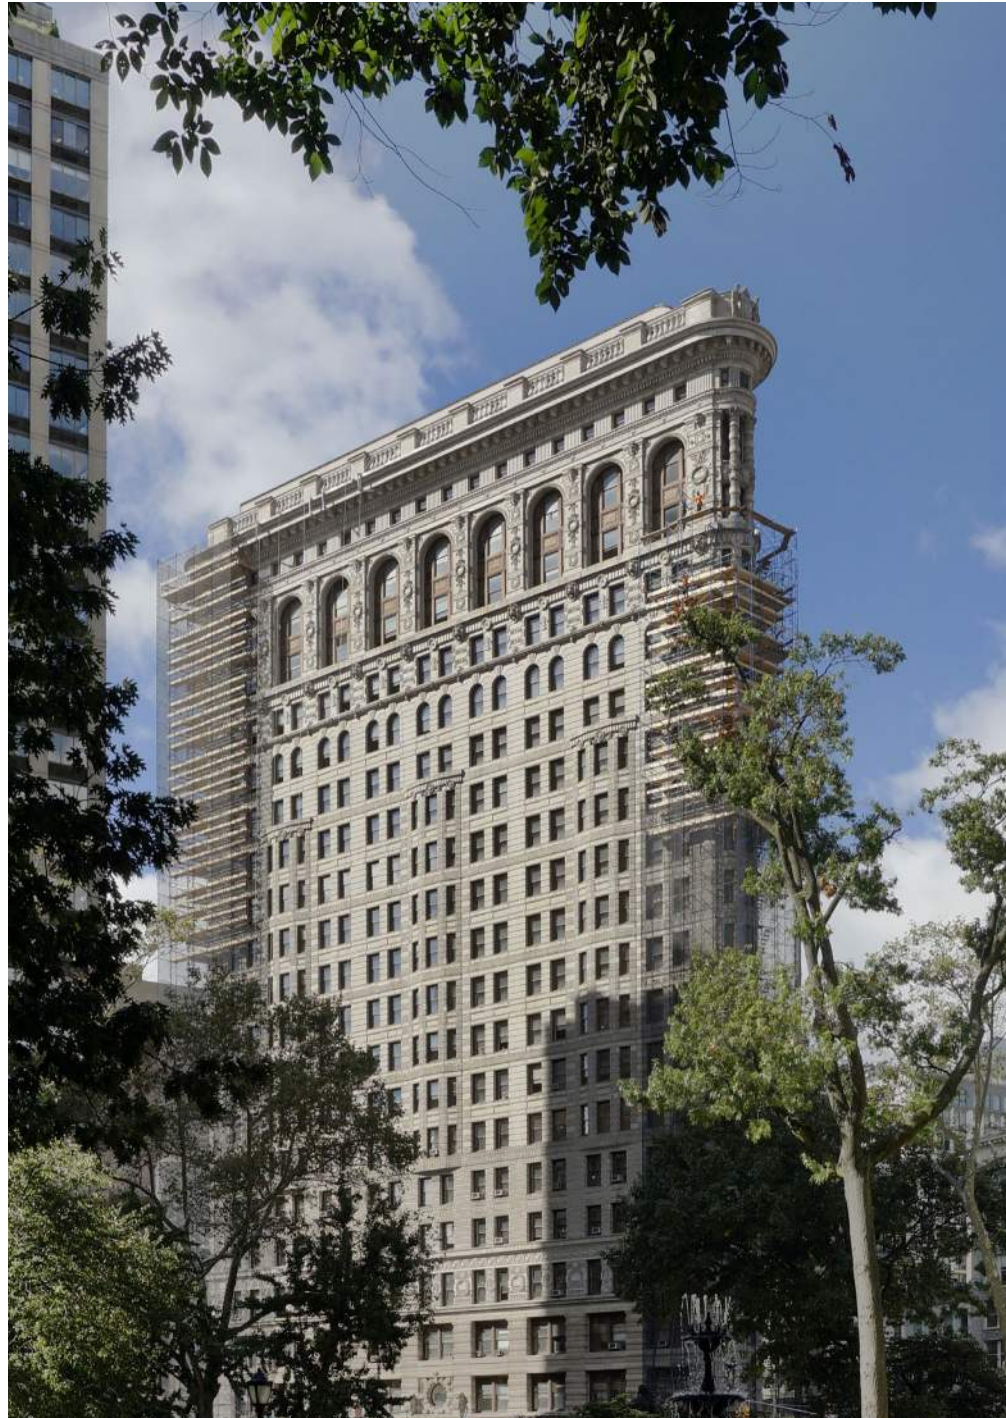
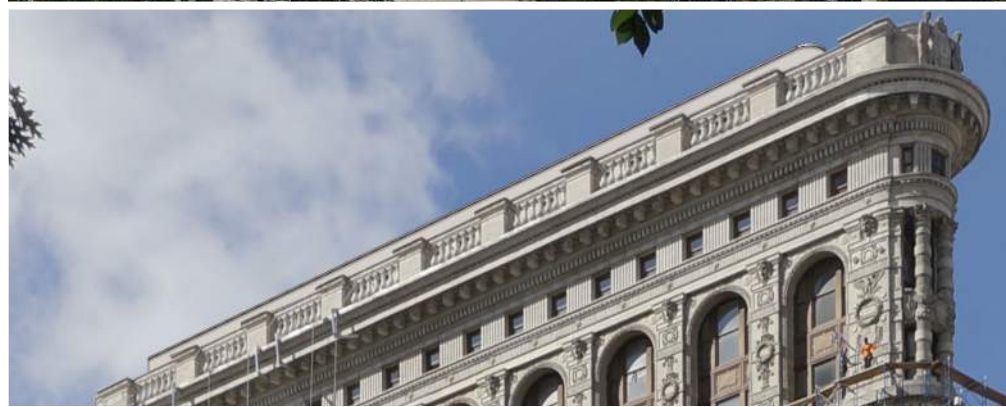
VIEW 1 (ON MADISON SQUARE PARK, LOOKING SOUTH-WEST)

EXISTING CONDITION

PROPOSED

MOCK-UP

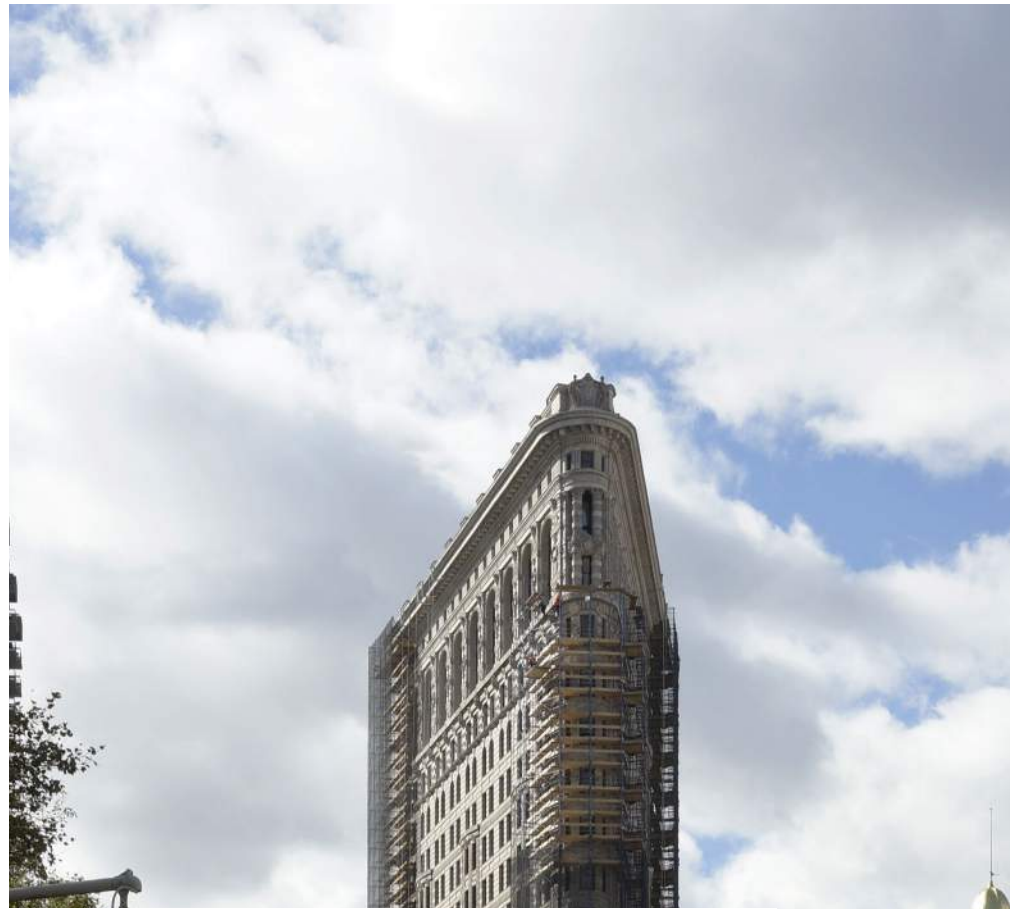
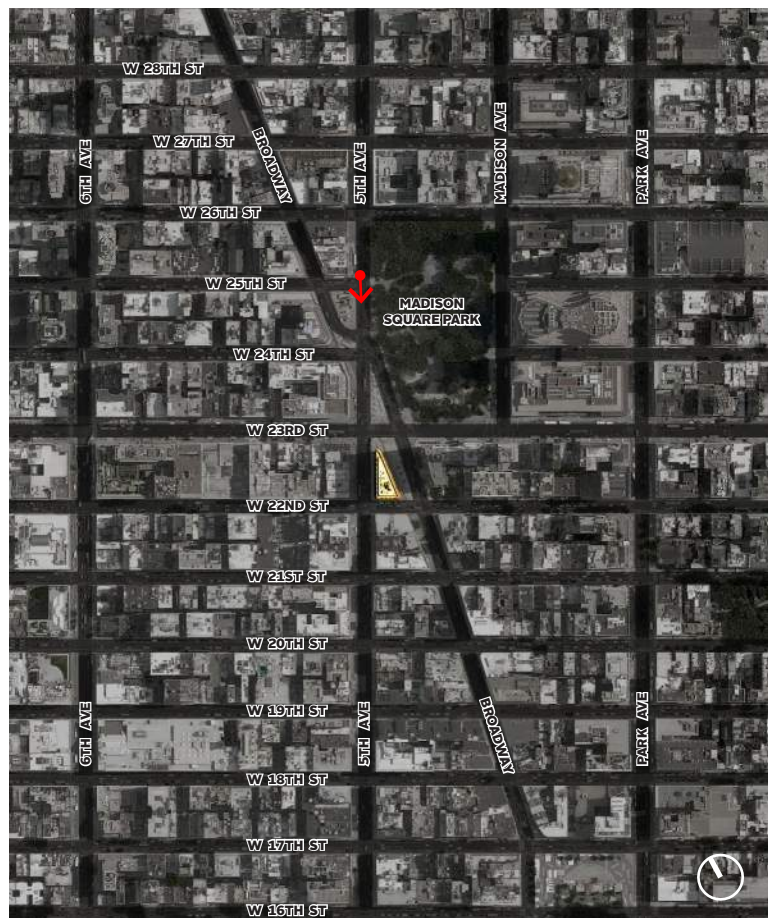
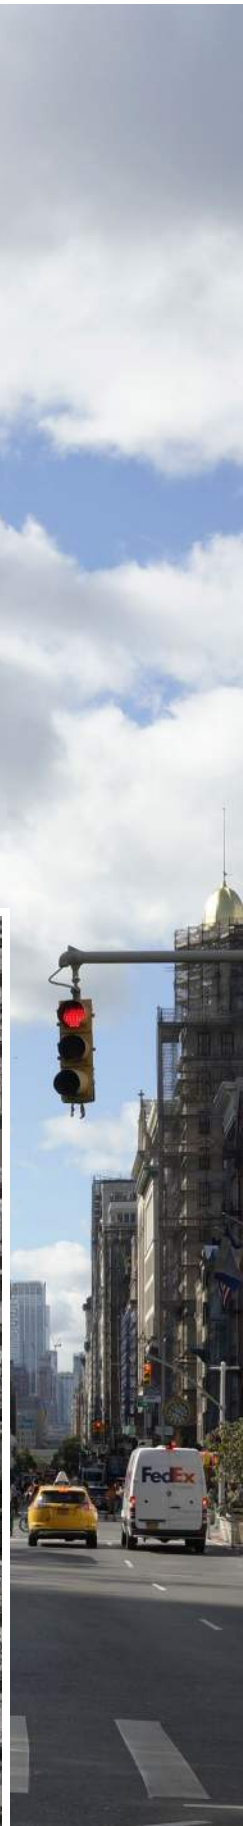
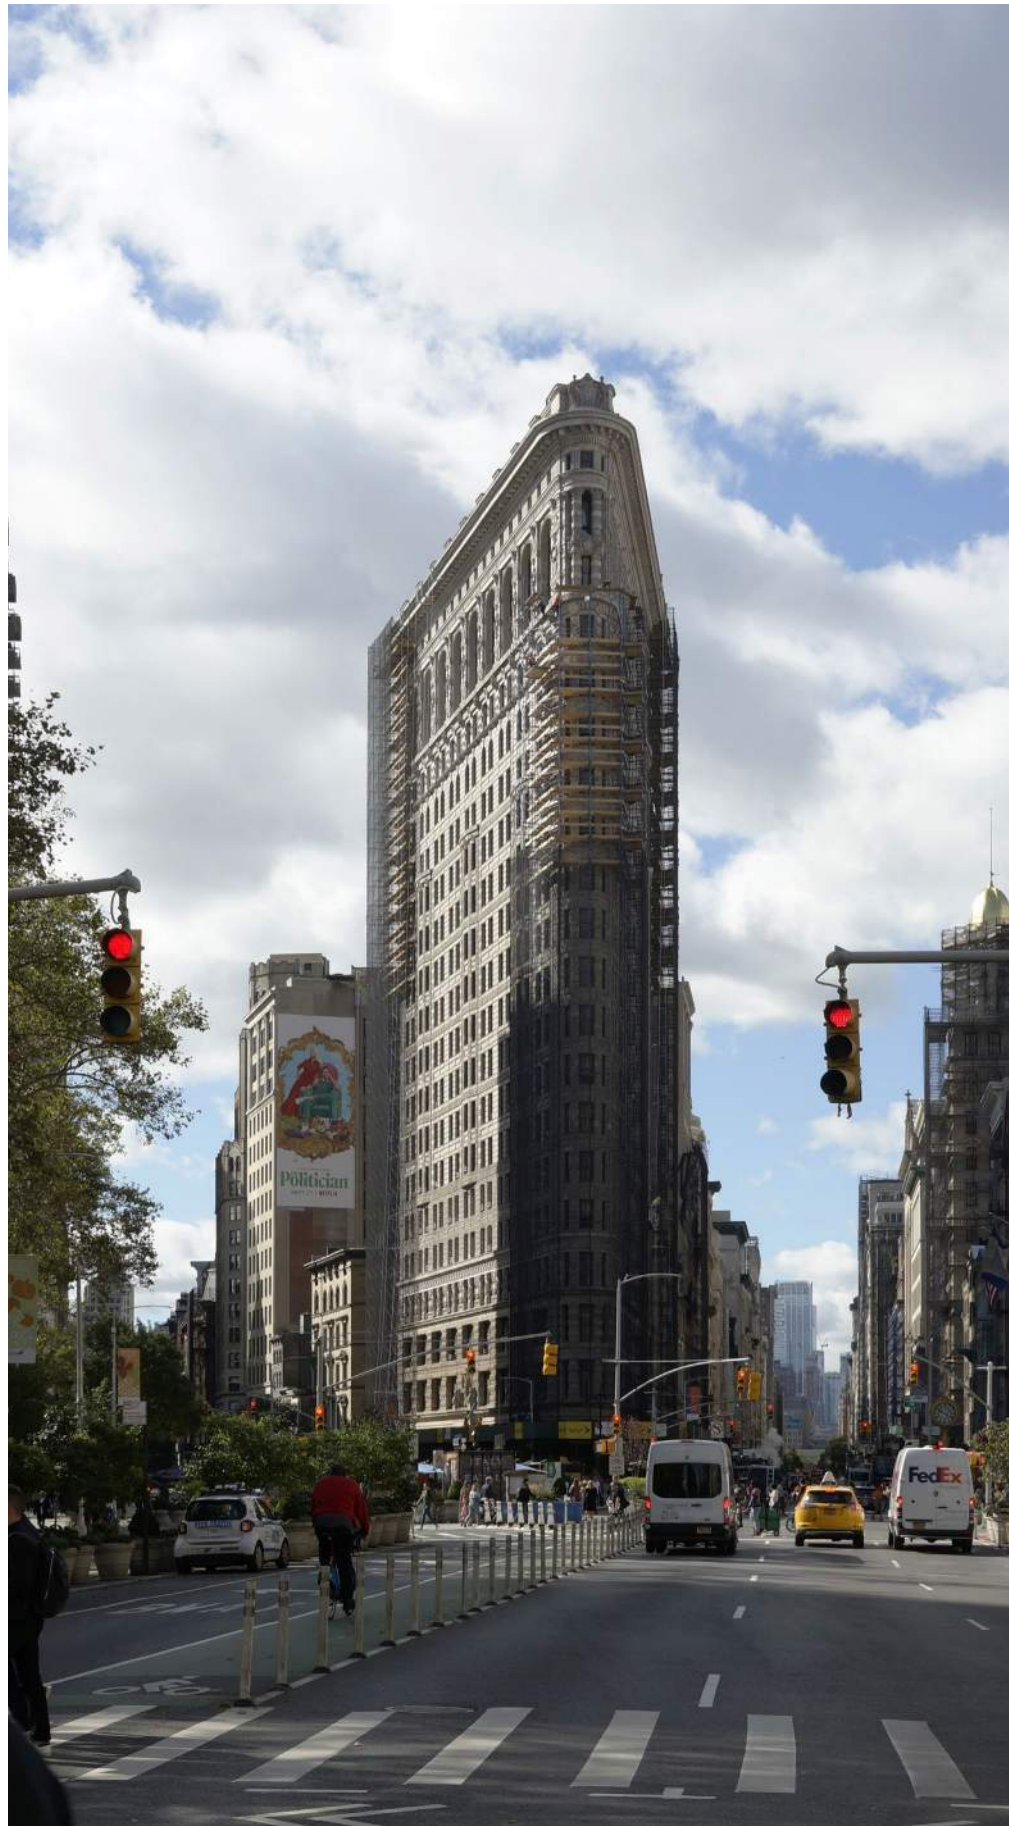
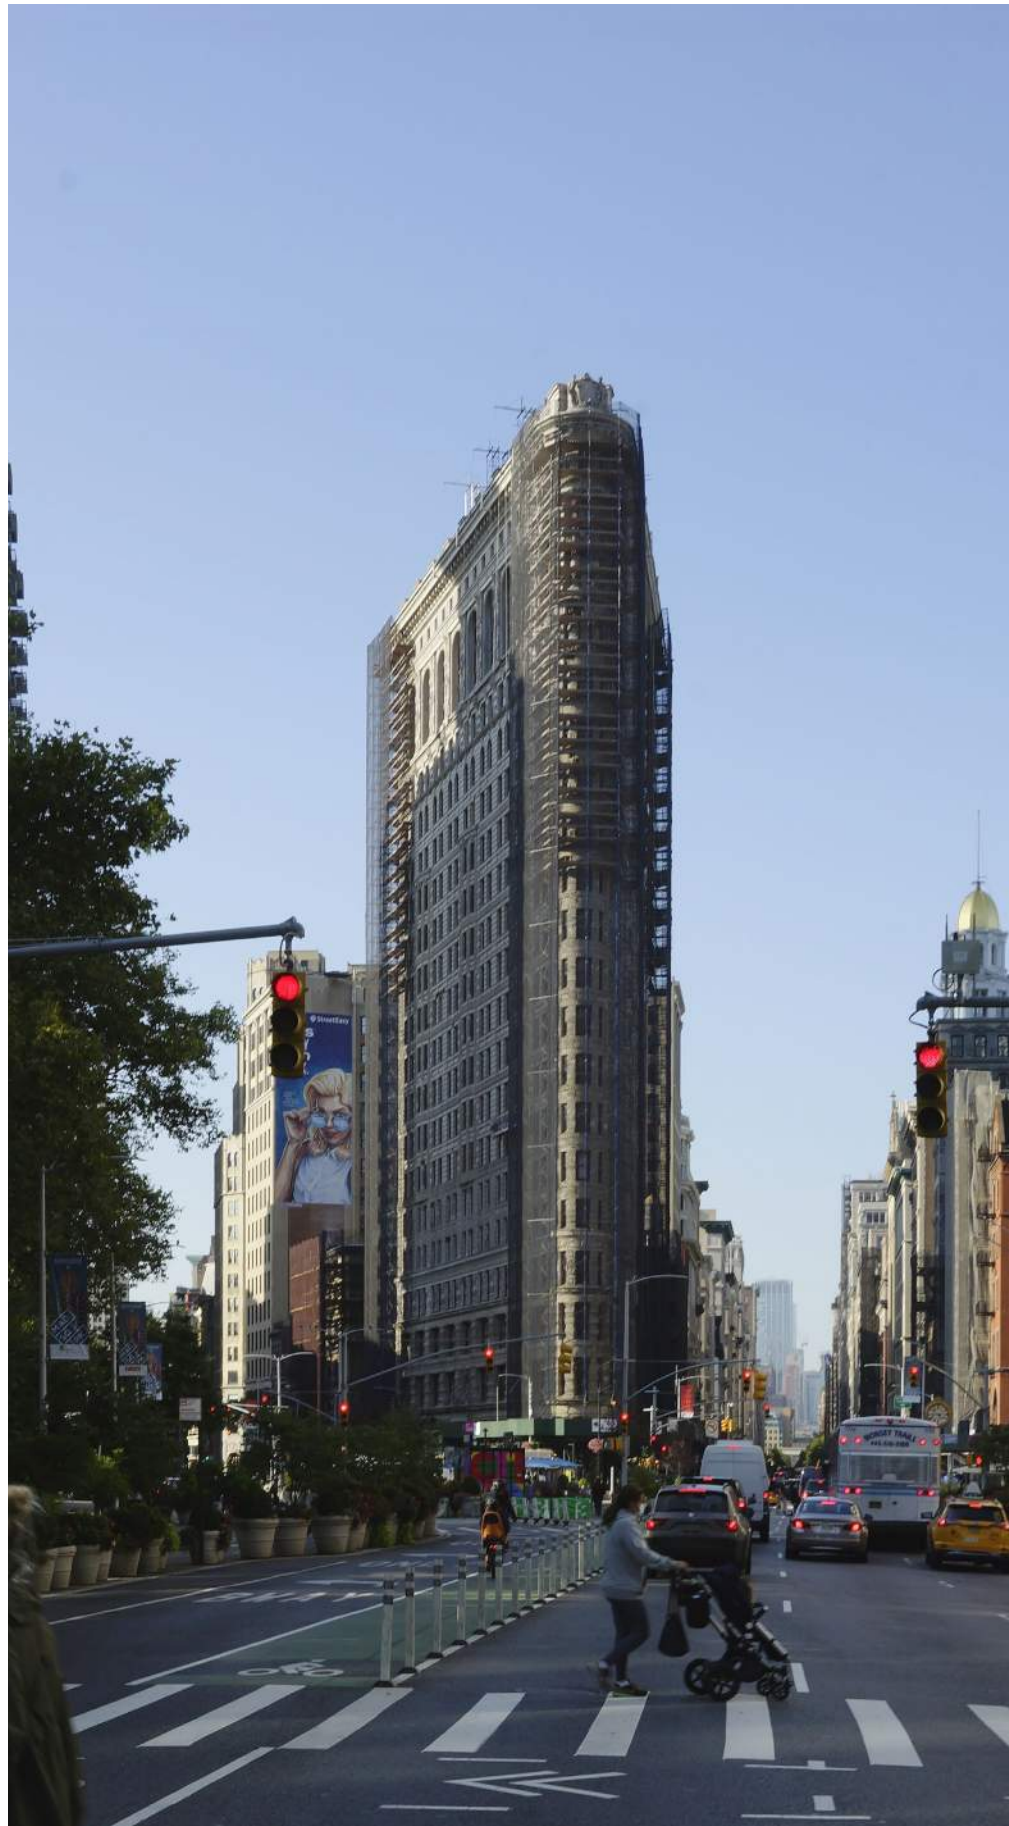
VIEW 3 (AT W 25TH ST & 5TH AVE INTERSECTION, LOOKING SOUTH)

EXISTING CONDITION

PROPOSED

MOCK-UP

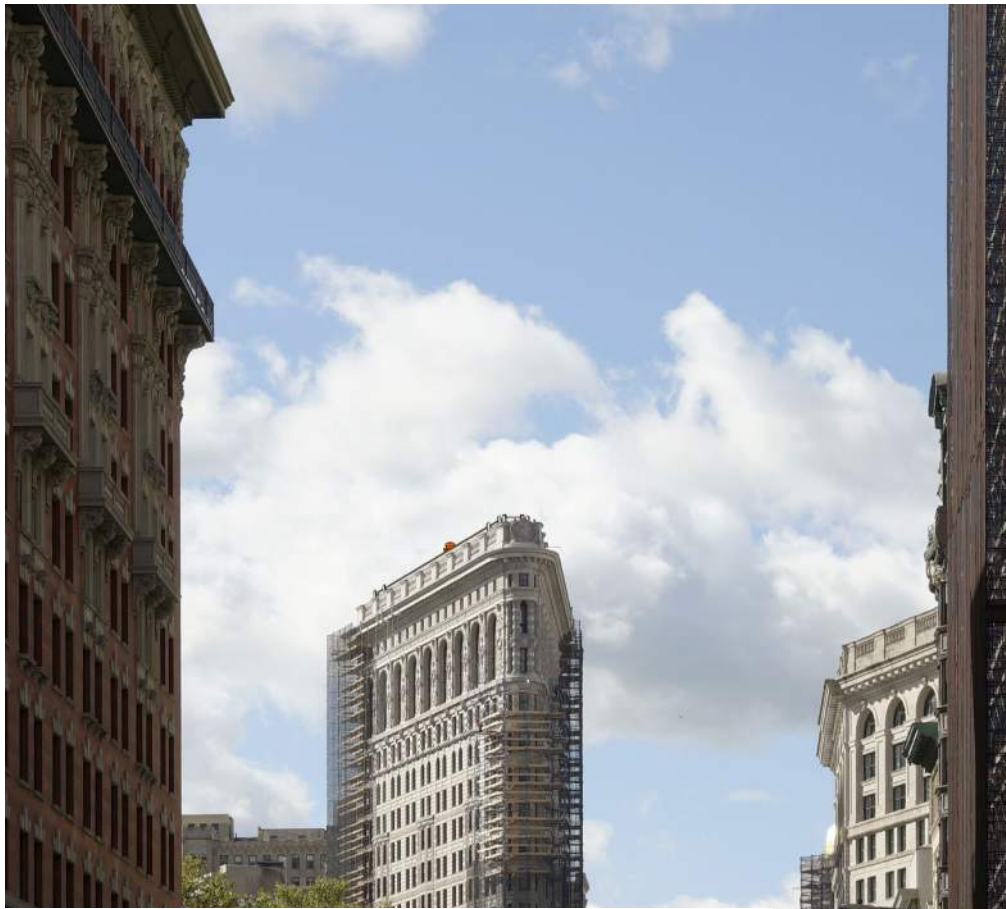
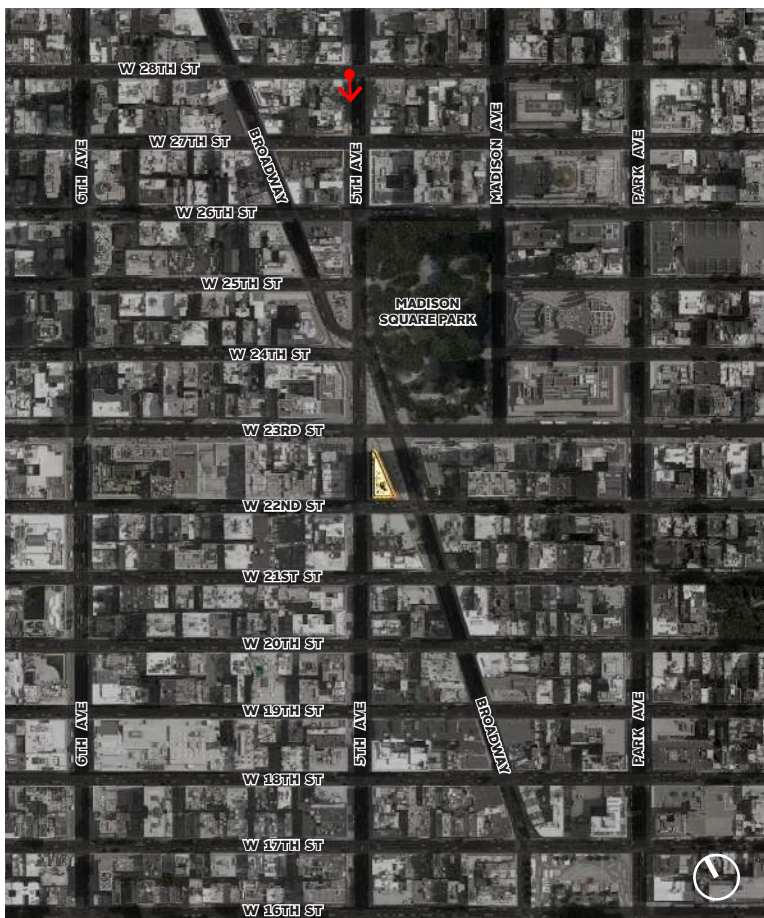
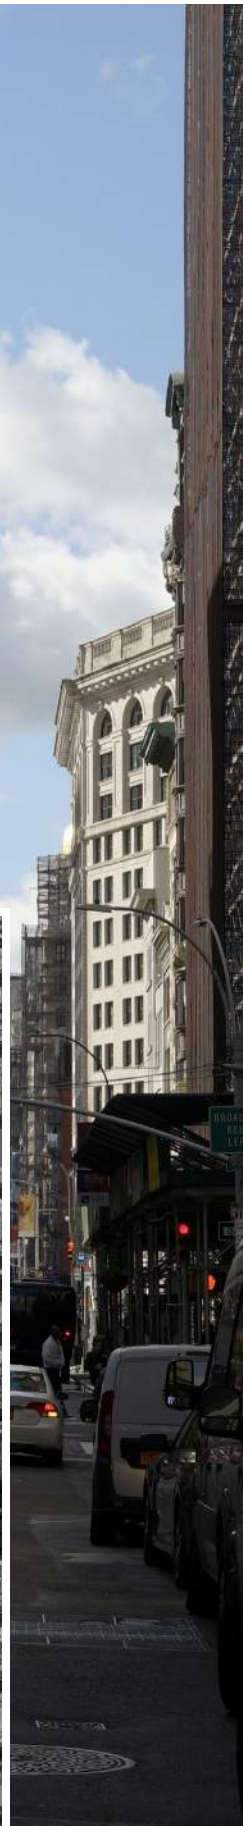
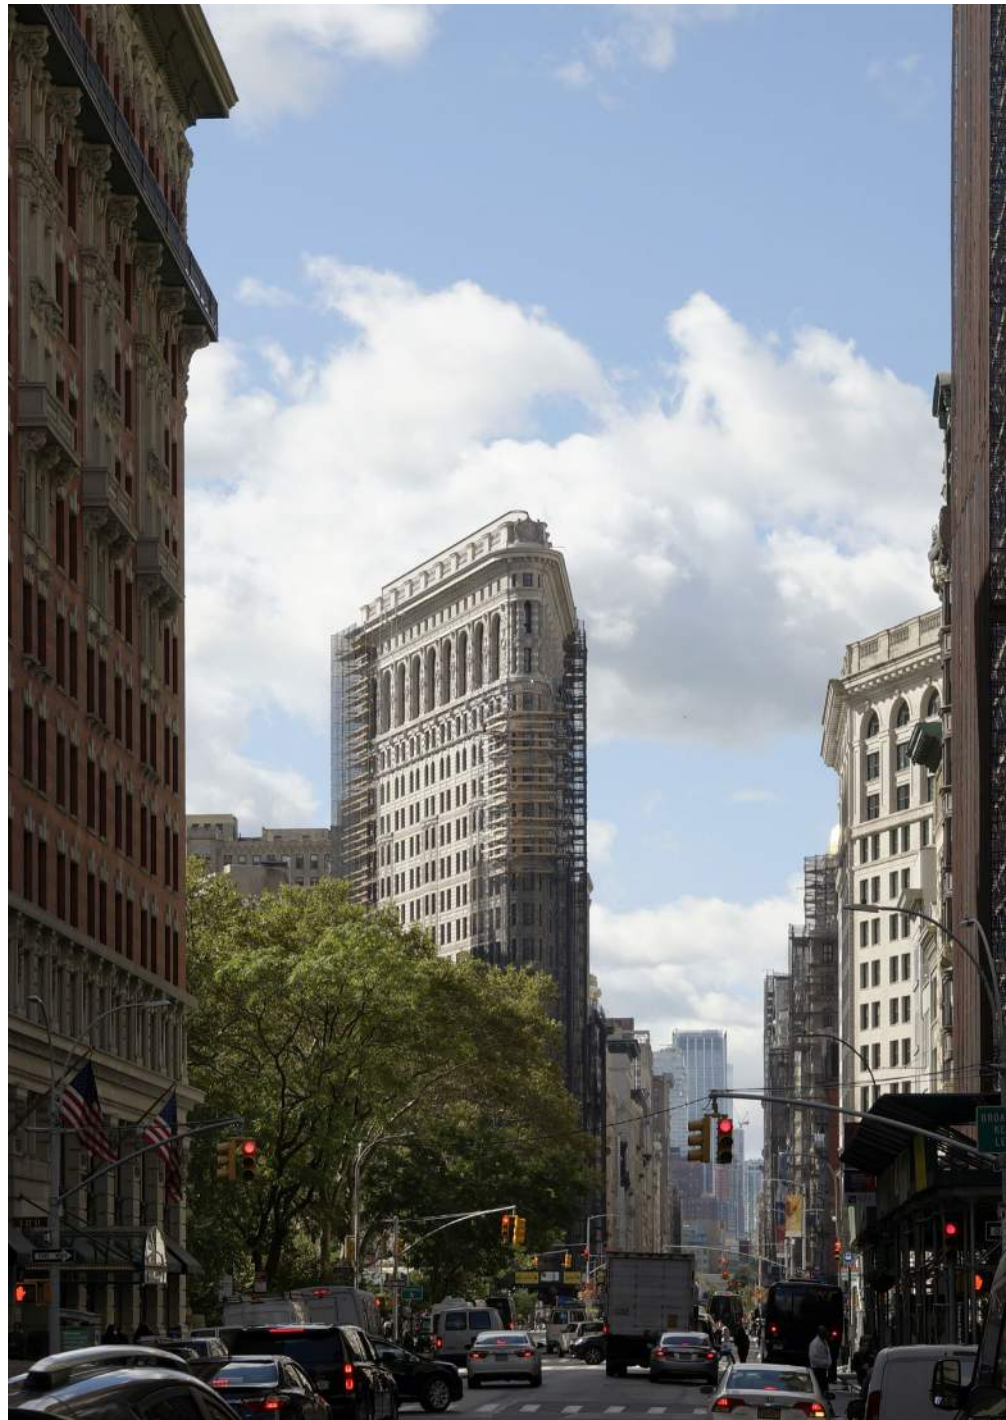
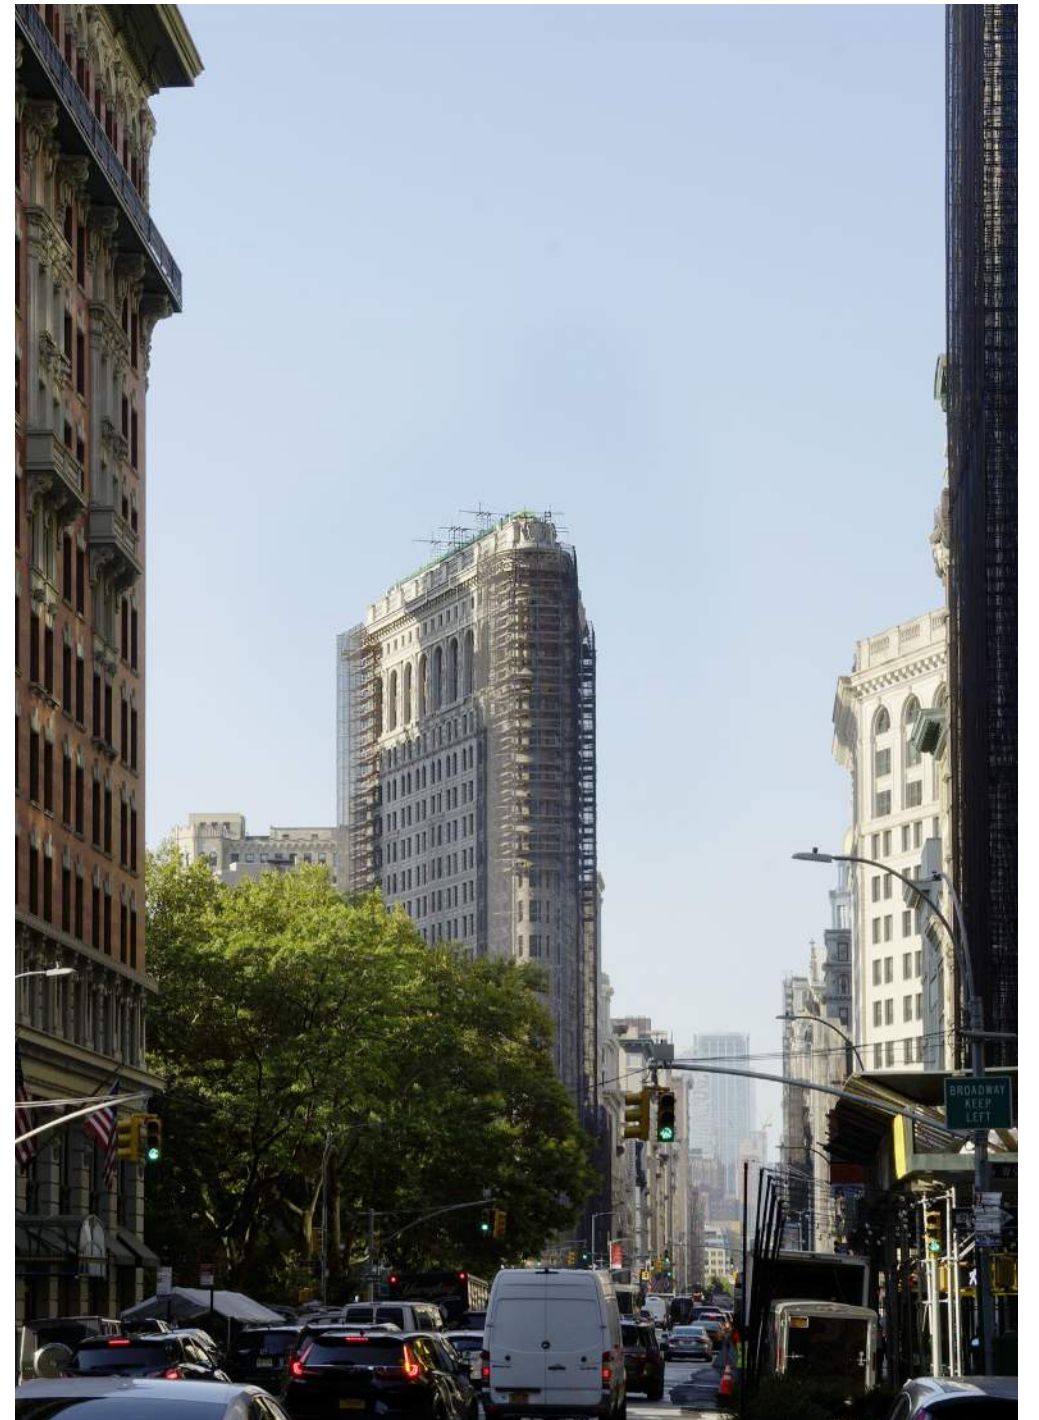
VIEW 4 (AT W 28TH ST & 5TH AVE INTERSECTION, LOOKING SOUTH)

EXISTING CONDITION

PROPOSED

MOCK-UP
