The Flatiron Building

PRESENTATION TO LANDMARK PRESERVATION COMMISSION

MAY 21, 2024

1. WINDOW REPLACEMENT
2. STOREFRONT MASTER PLAN MODIFICATION
3. ROOFTOP MECHANICAL AND BUIKHEAD PLAN
4. APPENDIX

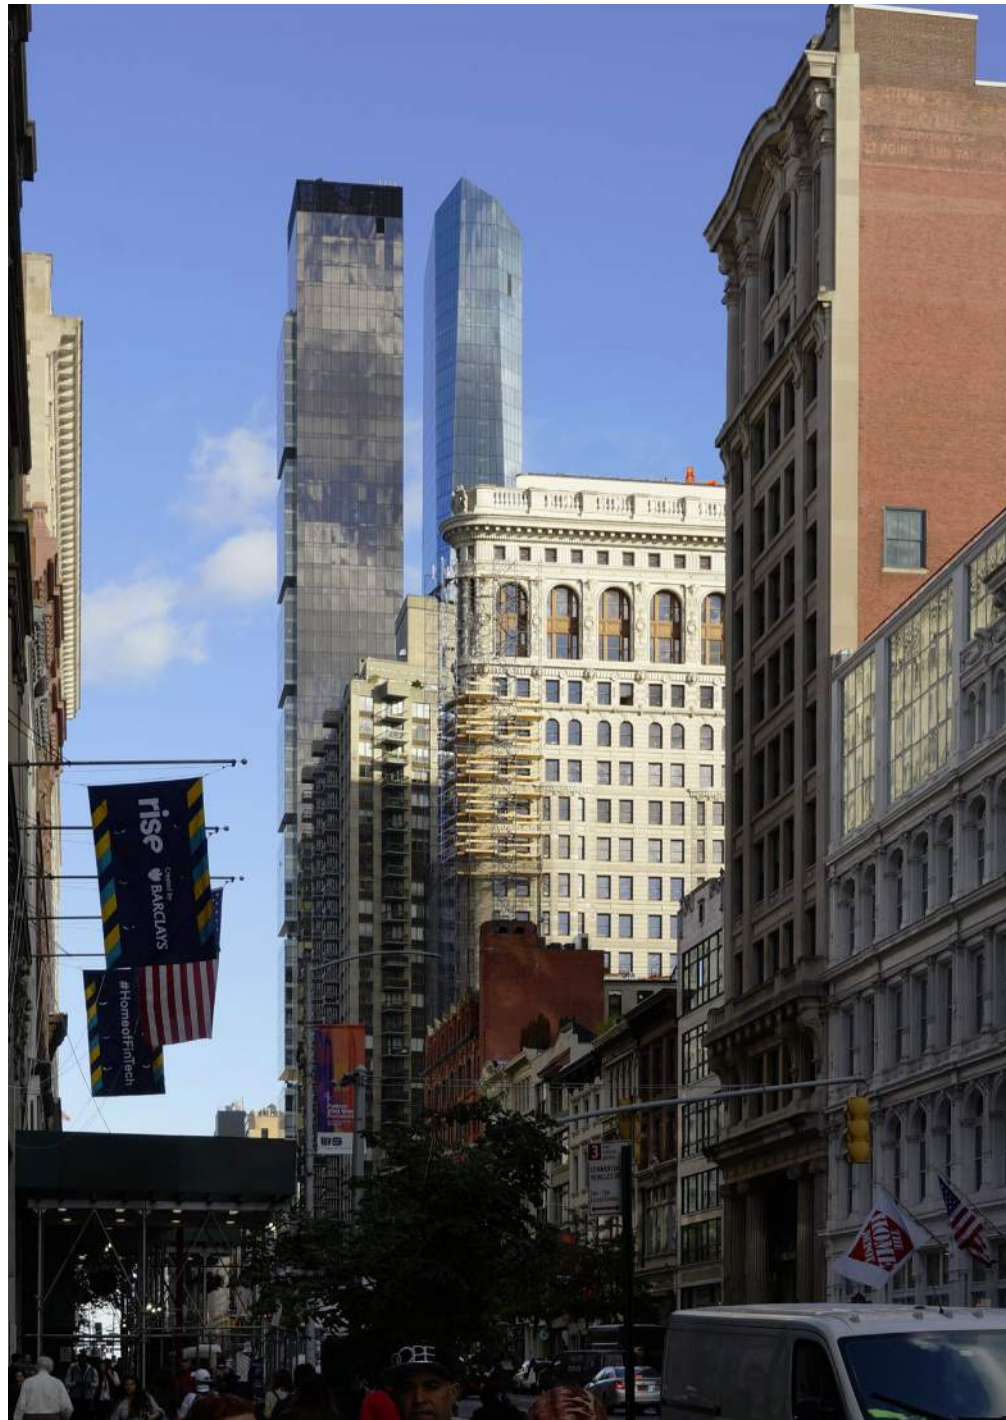
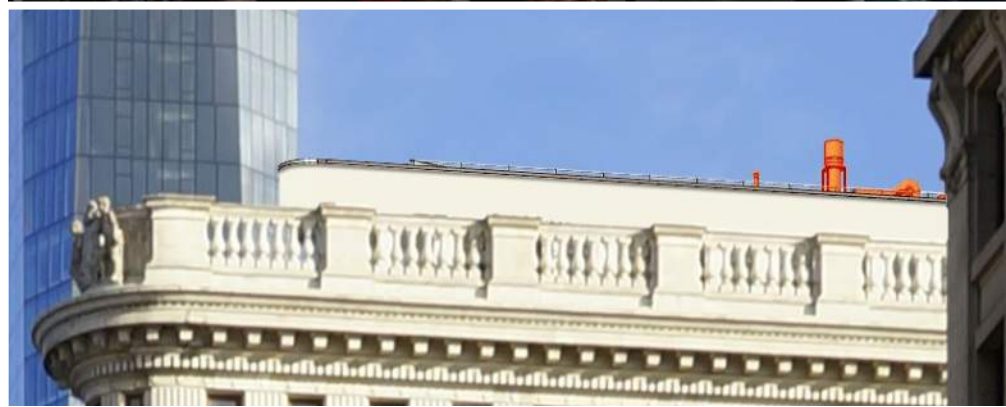
PROPOSED

VIEW 6 (ON W 23RD ST, LOOKING EAST)

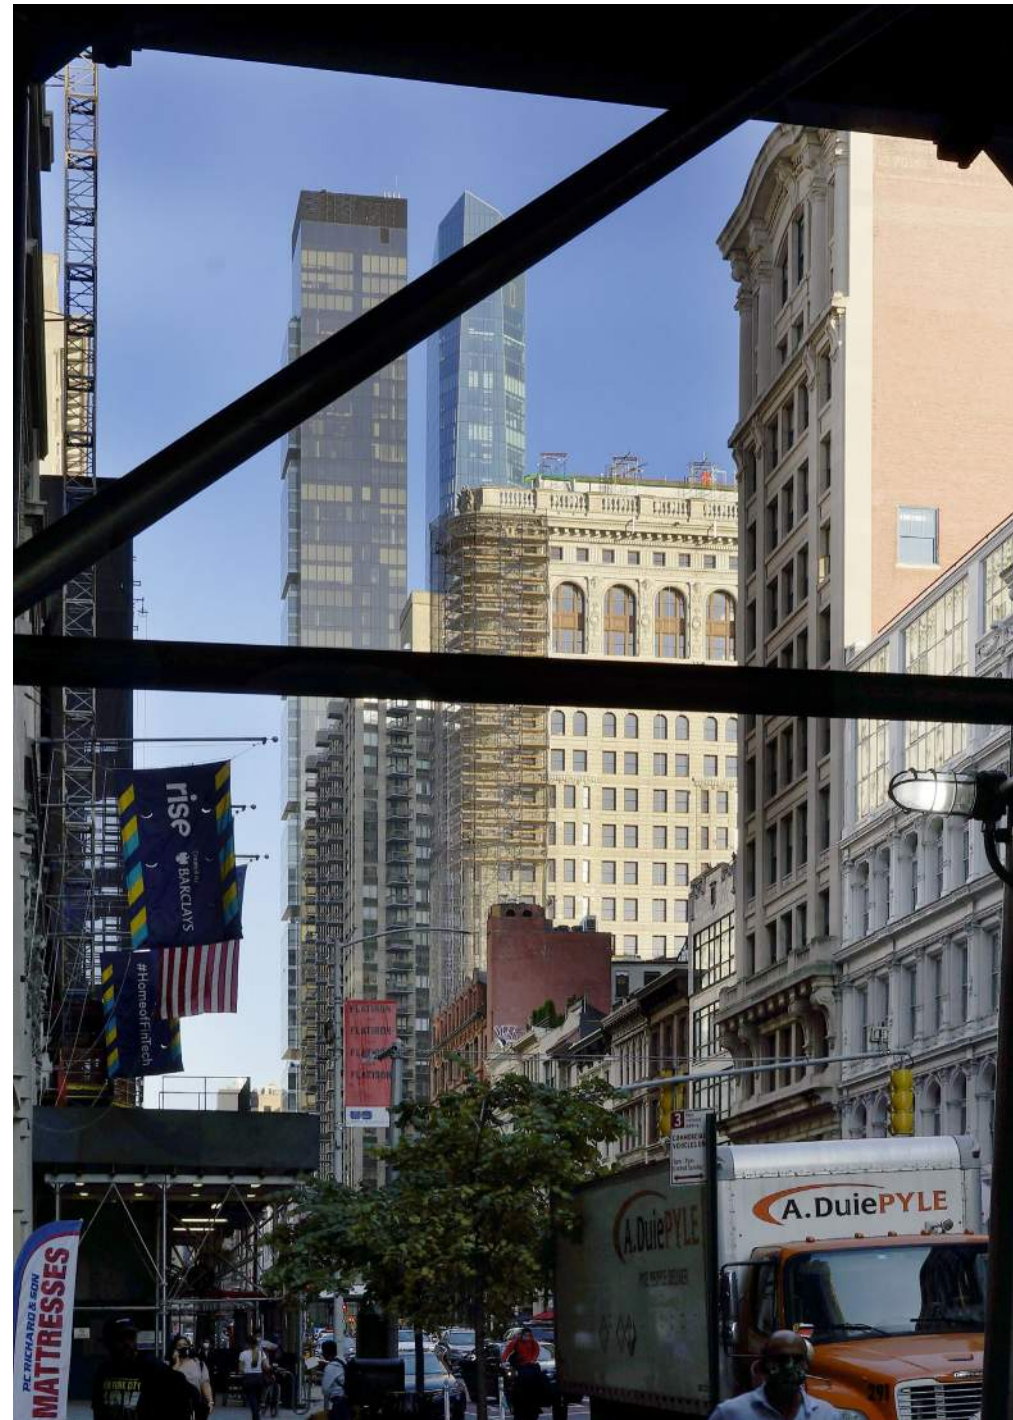
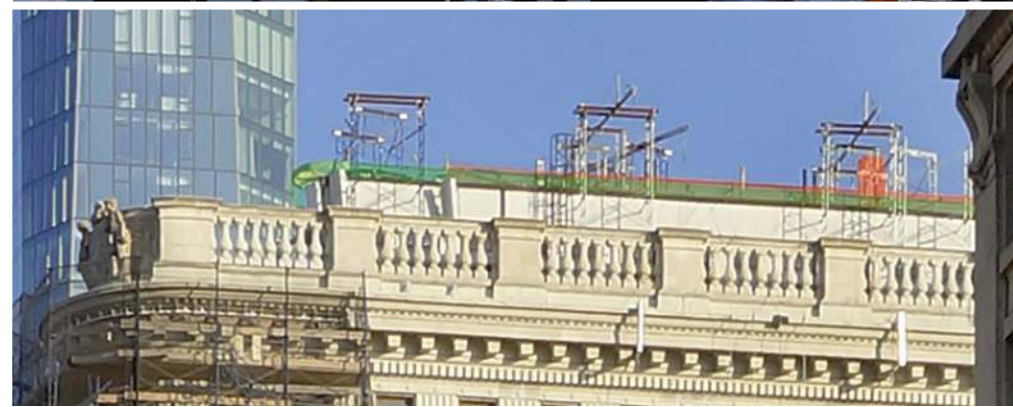
MOCK-UP

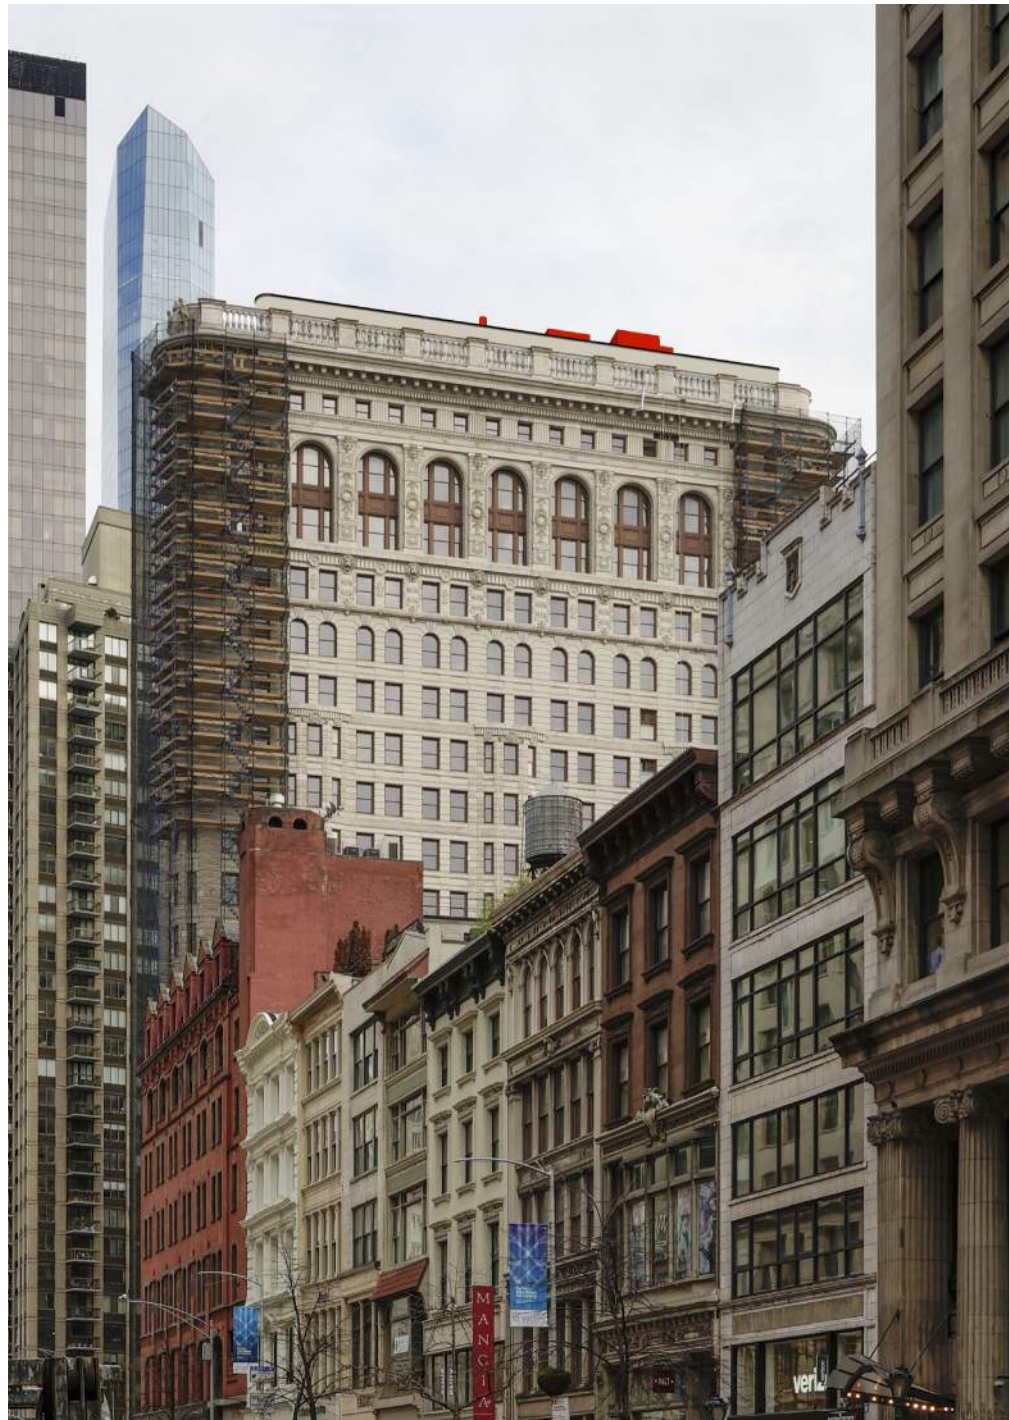
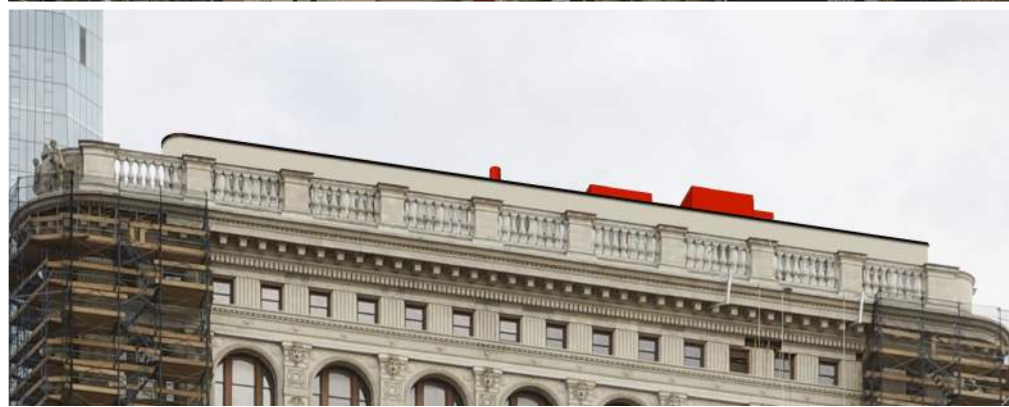
PROPOSED

VIEW 7 (ON W 23RD ST, LOOKING EAST)

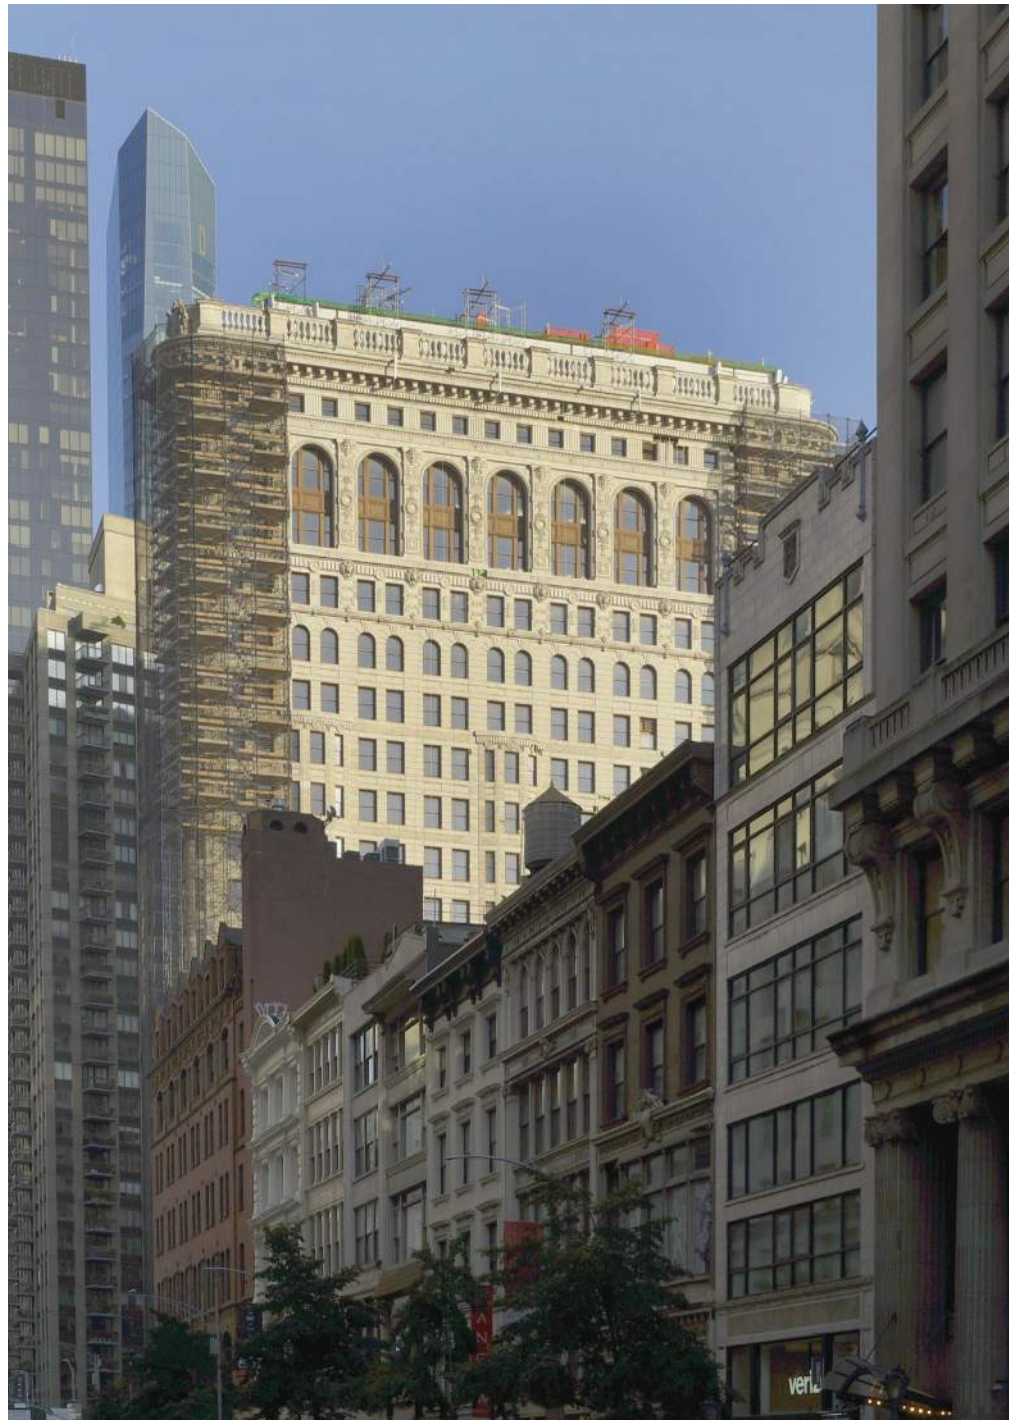
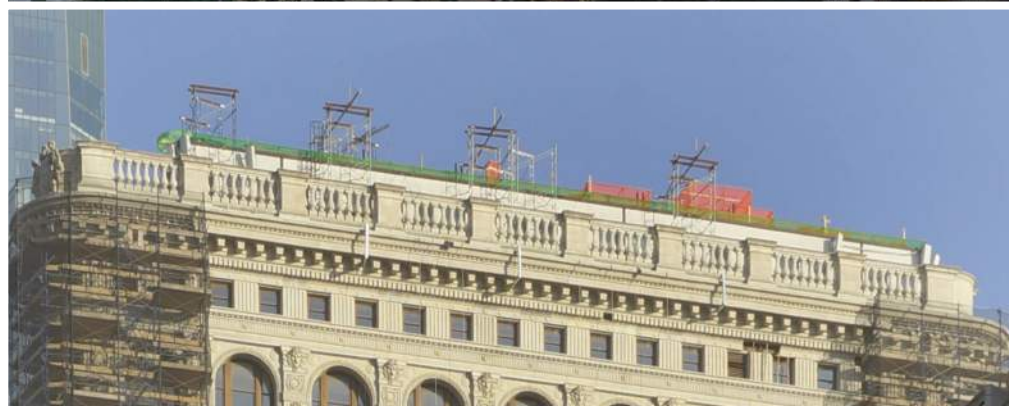
MOCK-UP

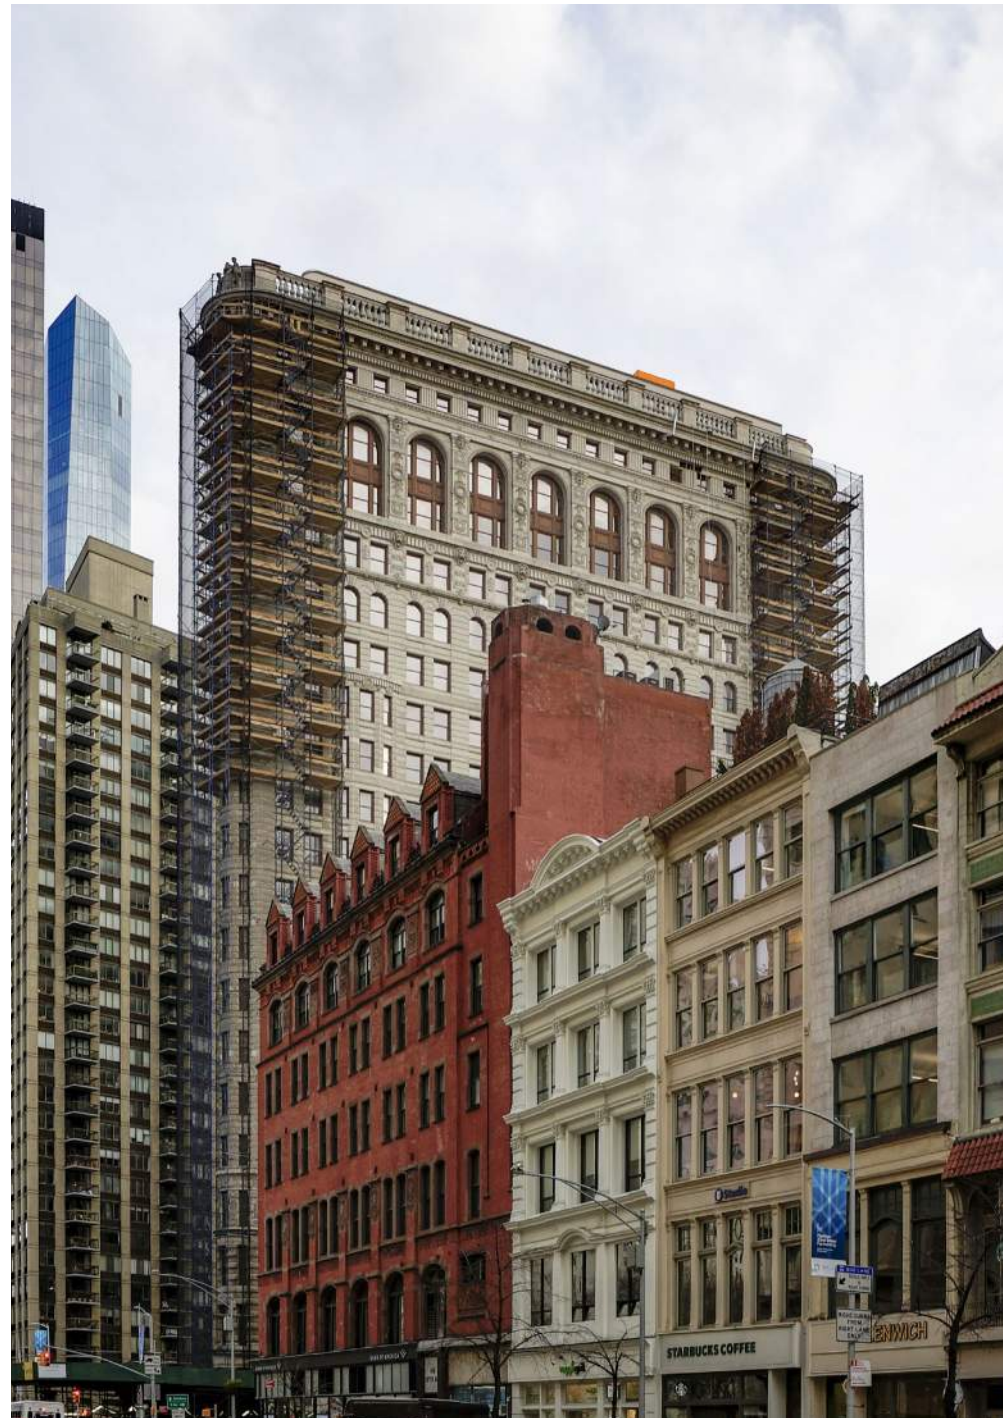
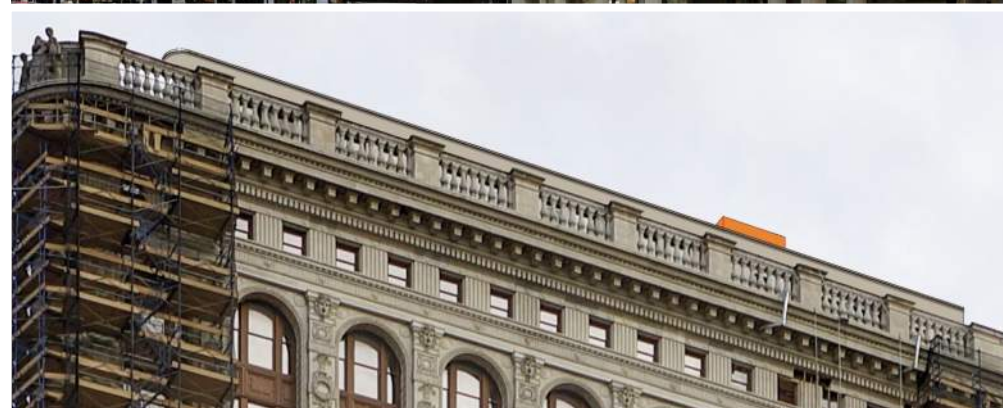
PROPOSED

VIEW 8 (ON W 23RD ST, LOOKING EAST)

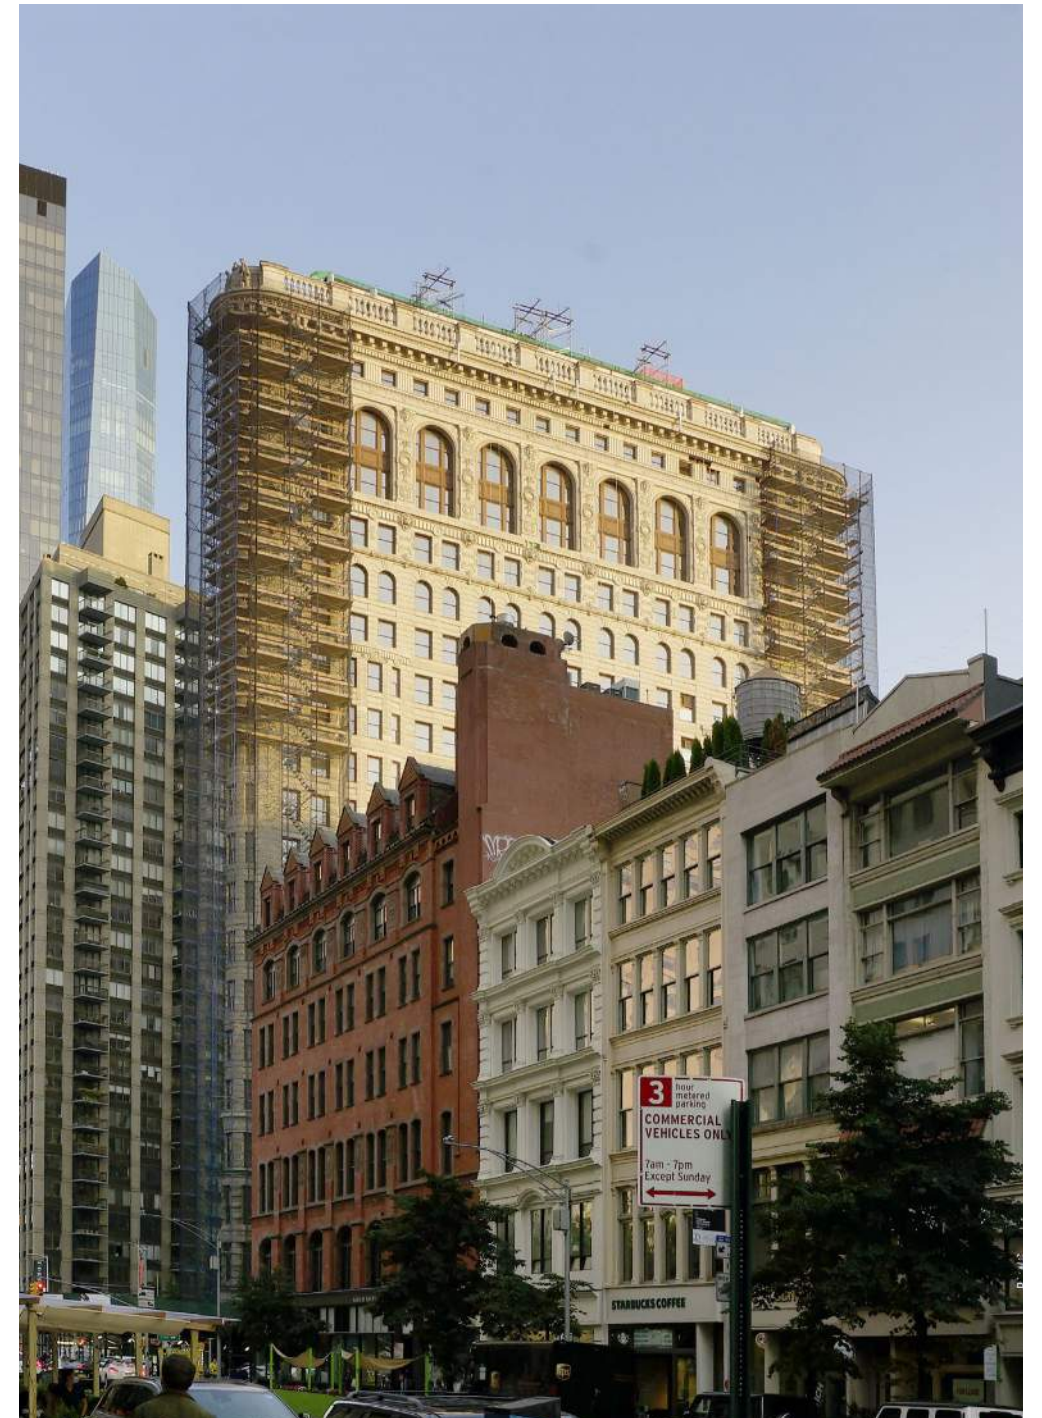
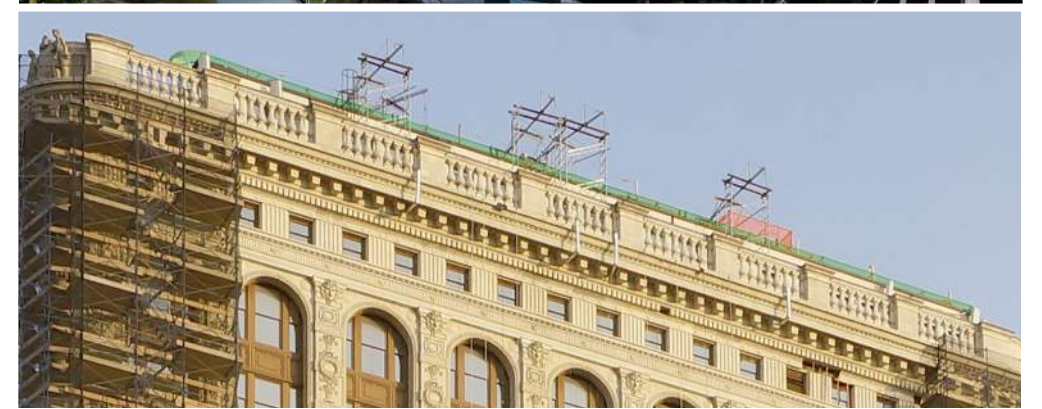
MOCK-UP

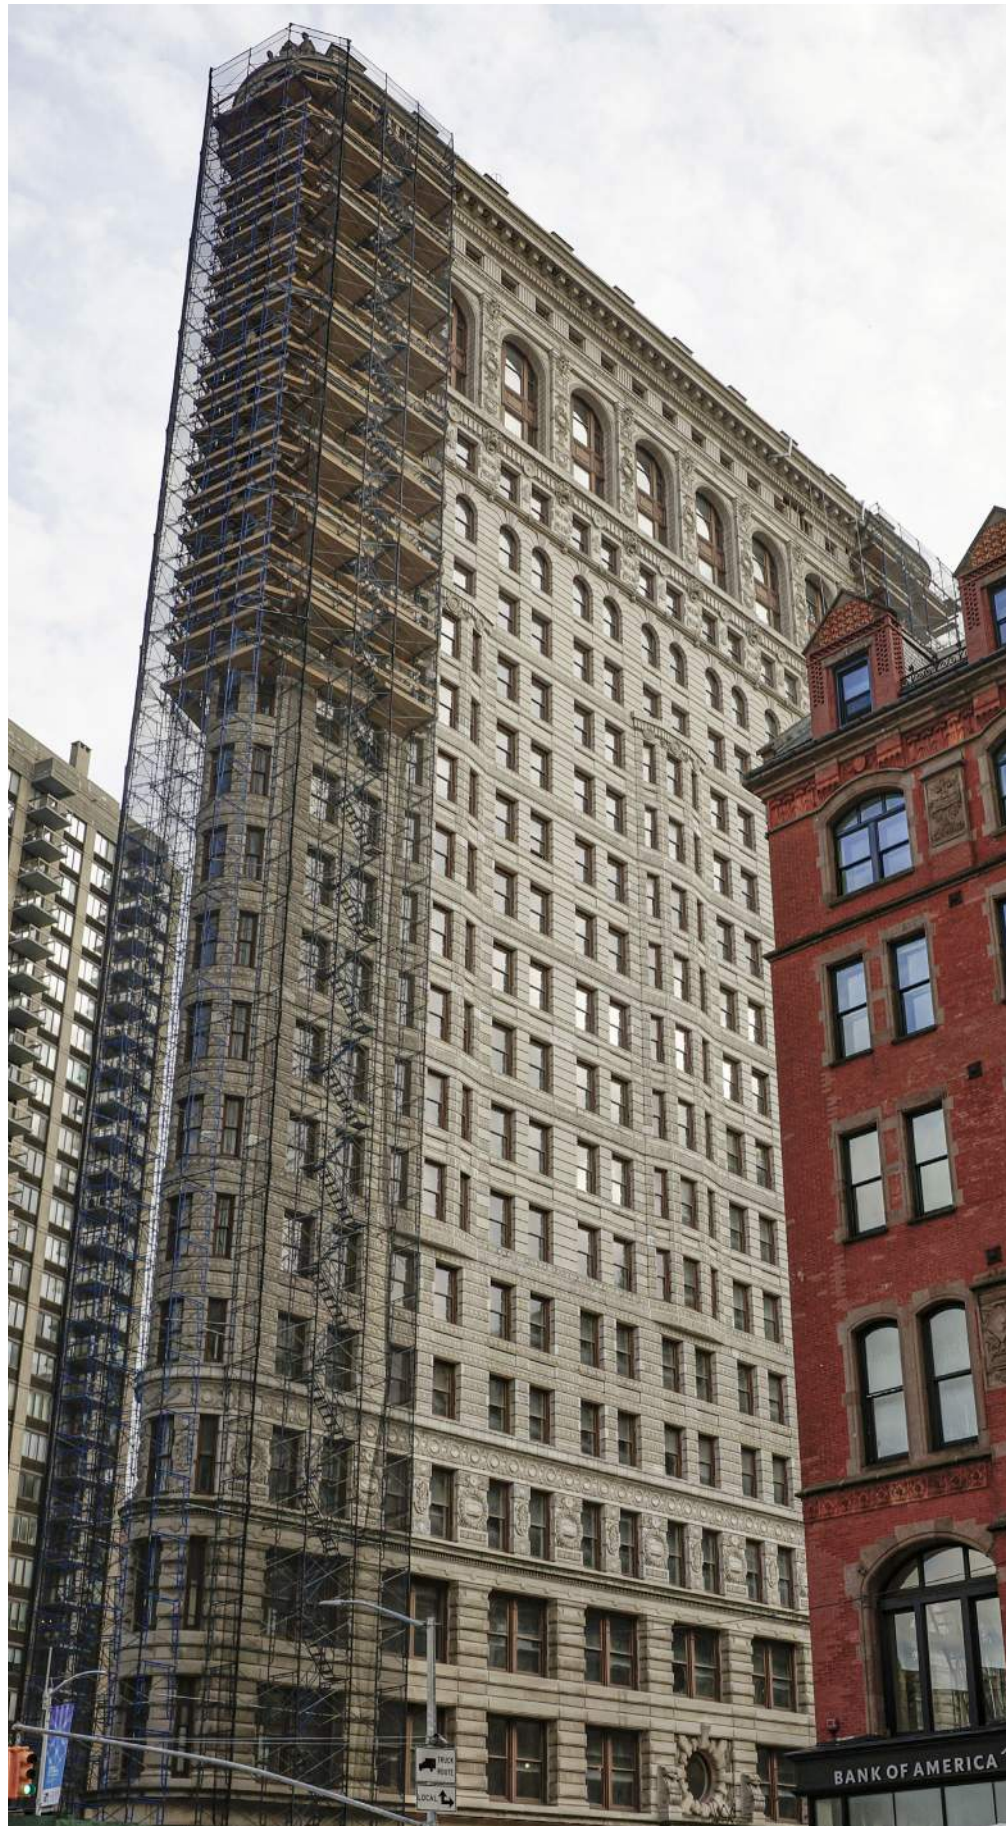
PROPOSED
VIEW 9 (ON W 23RD ST, LOOKING EAST)

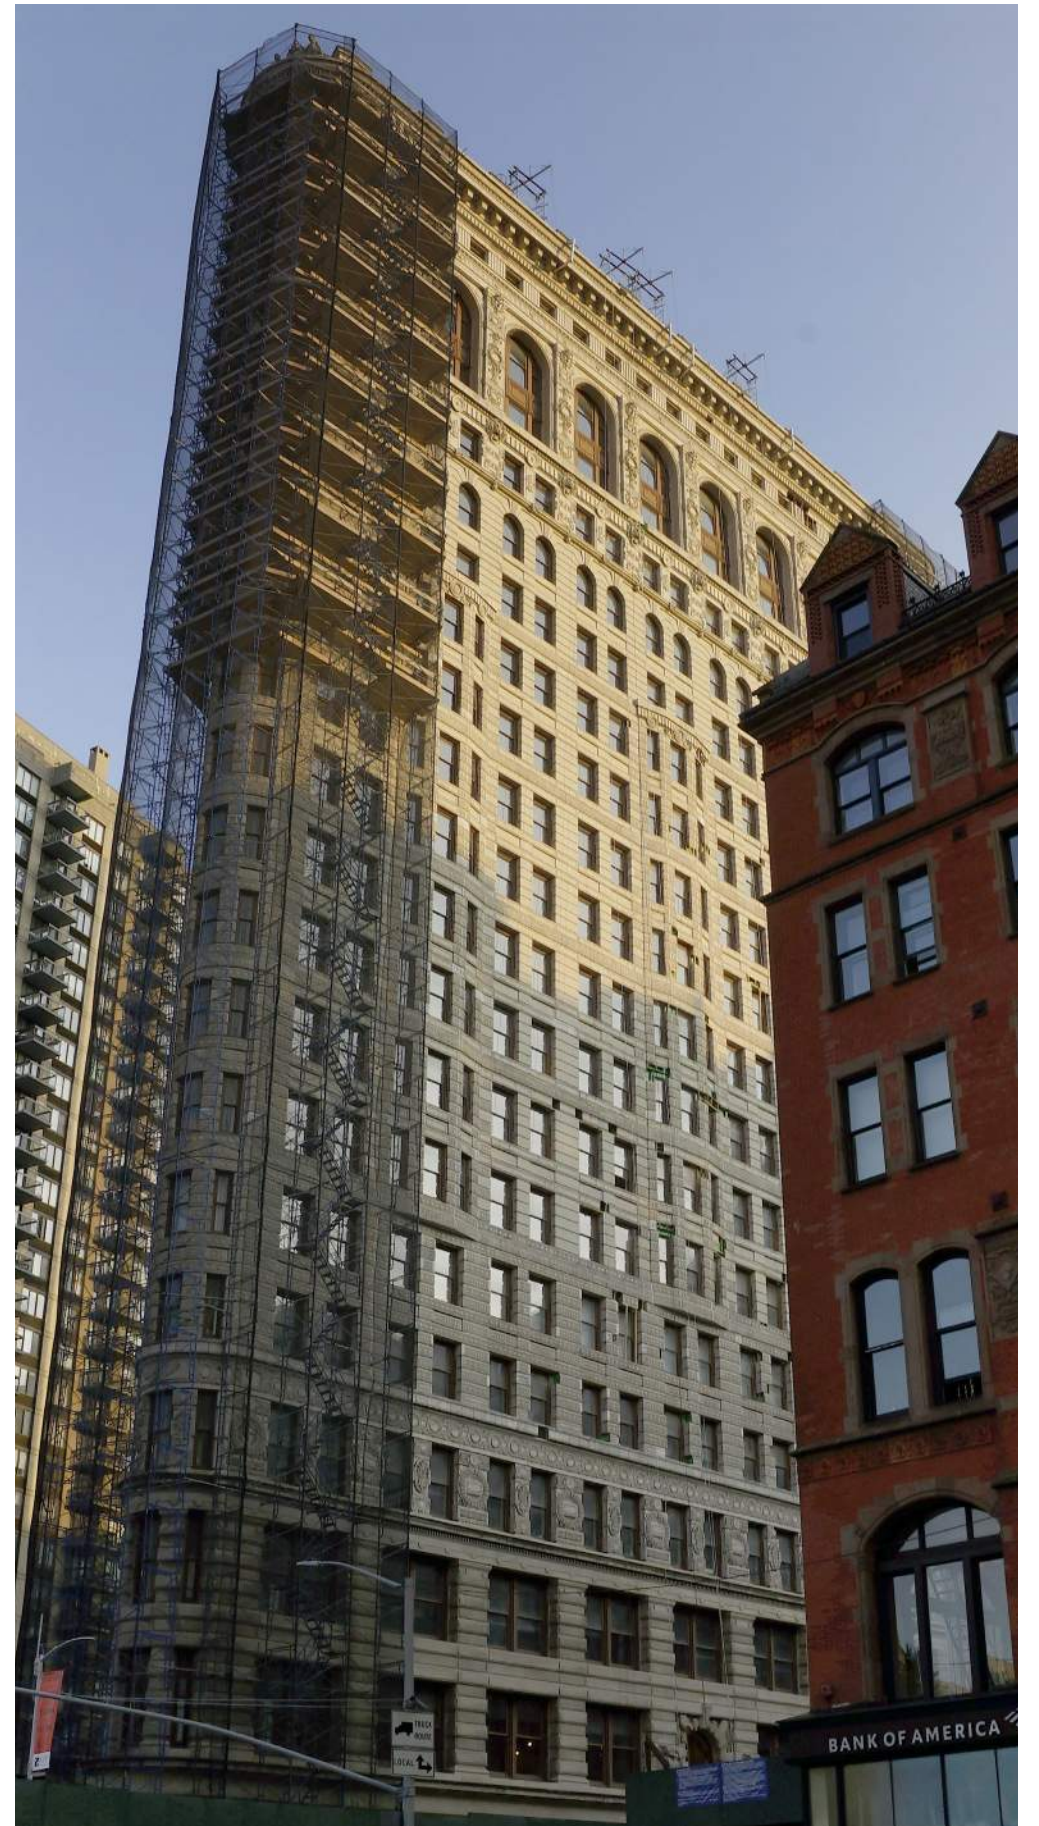
MOCK-UP

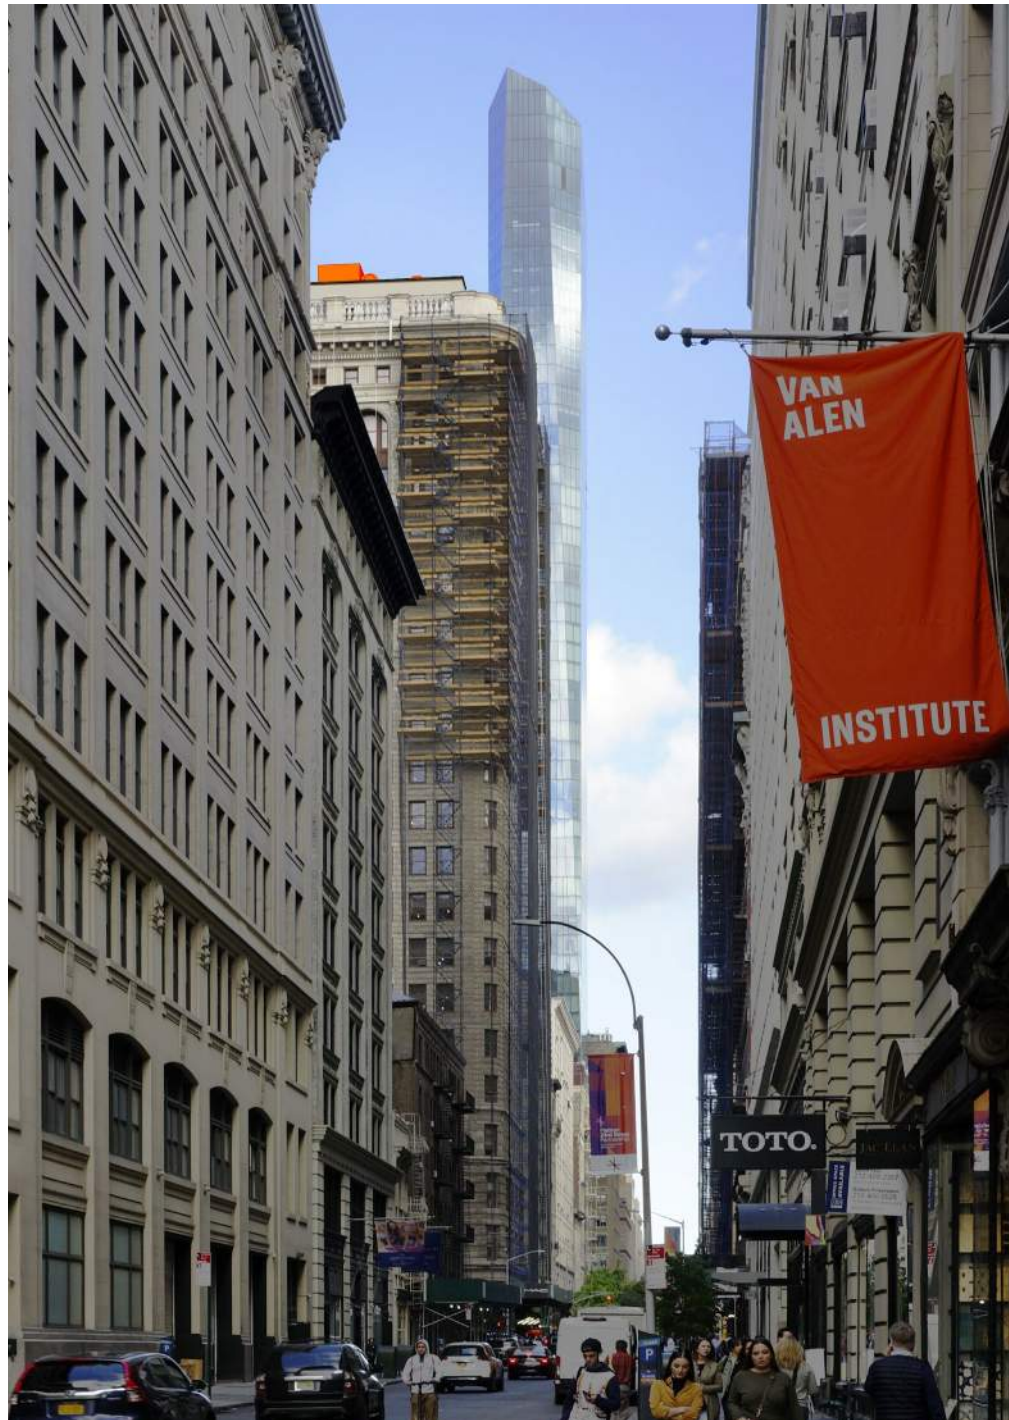
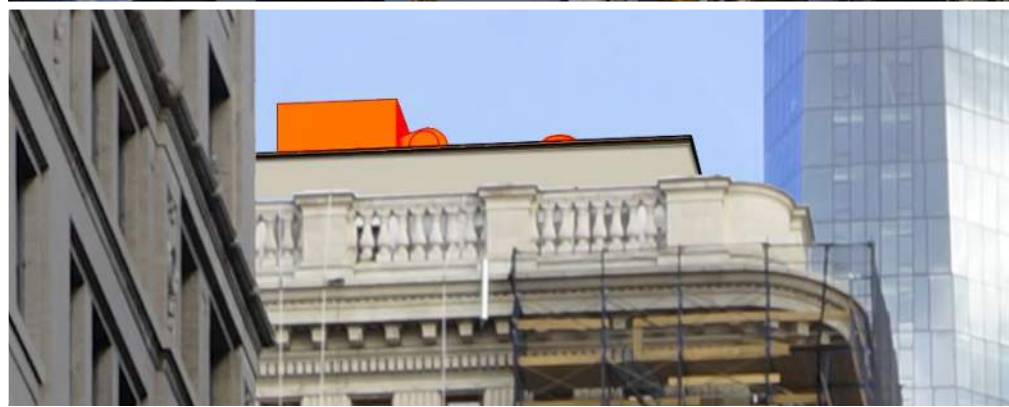
PROPOSED

VIEW 10 (ON W 22ND ST, LOOKING EAST)

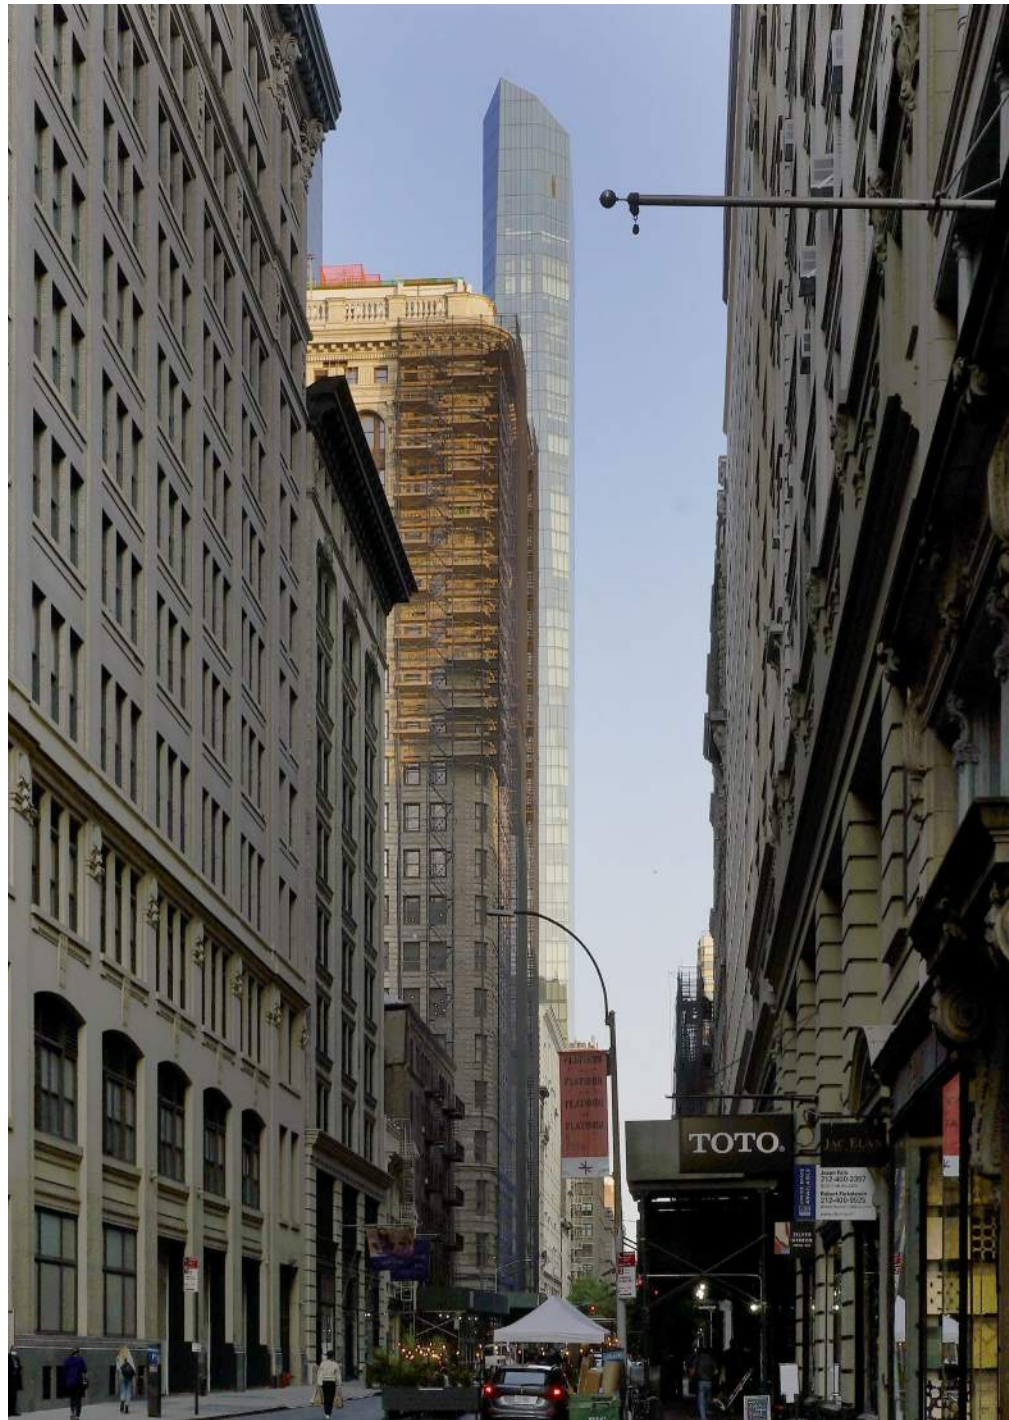
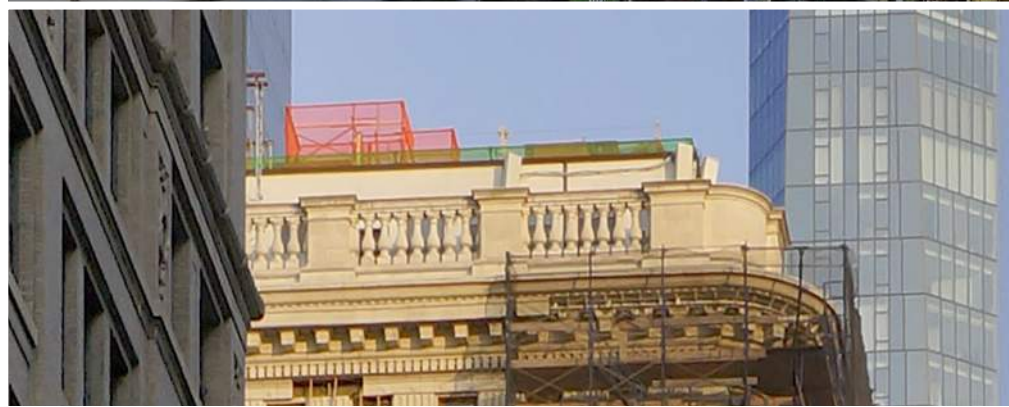
MOCK-UP

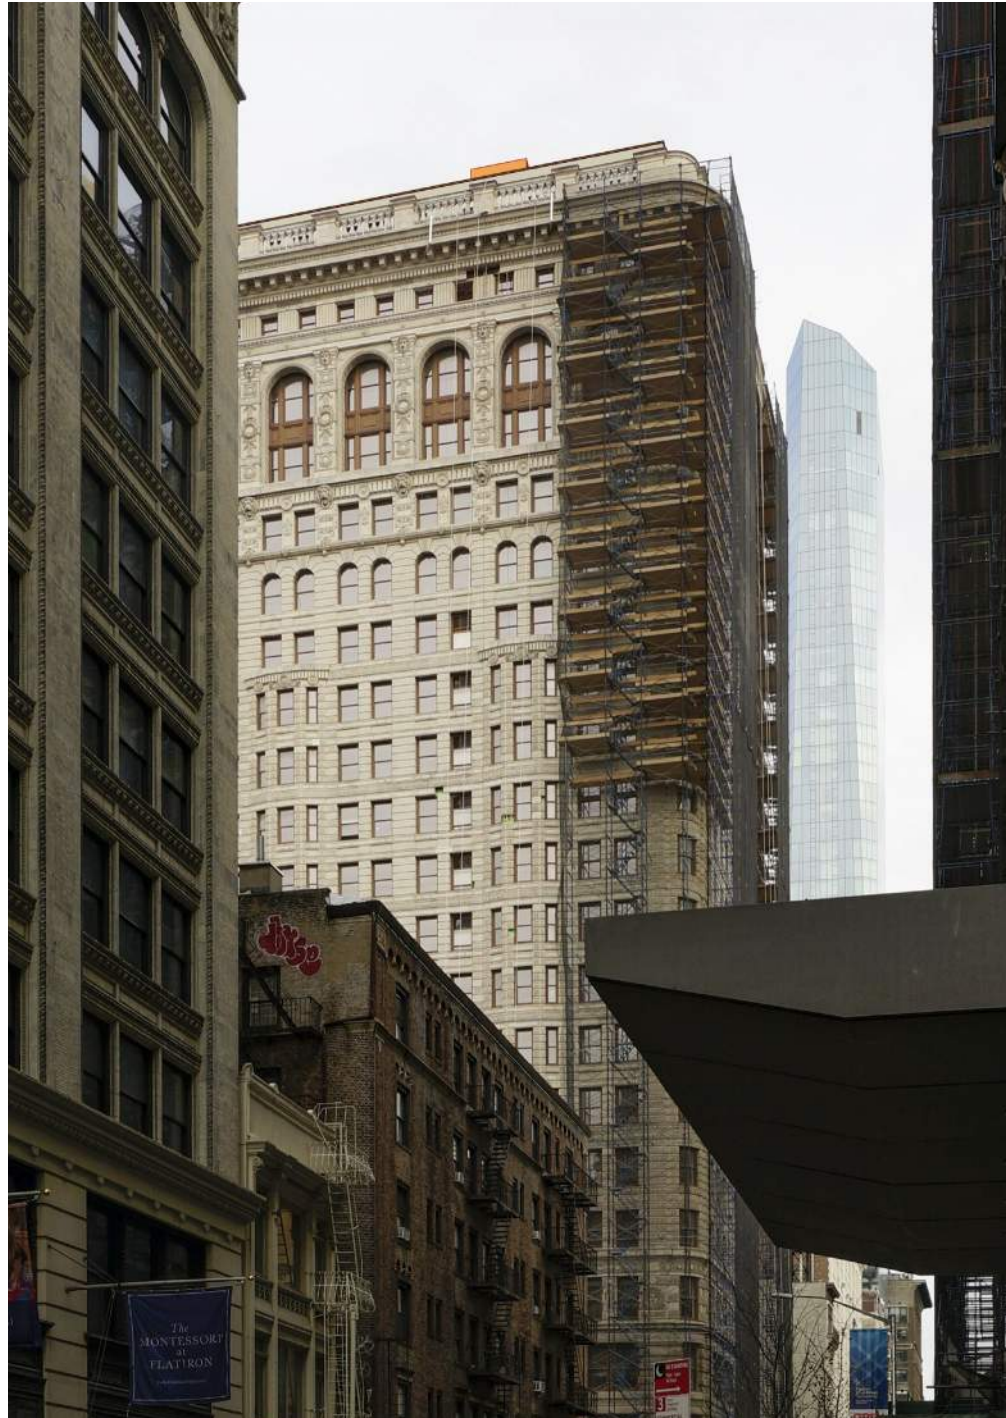
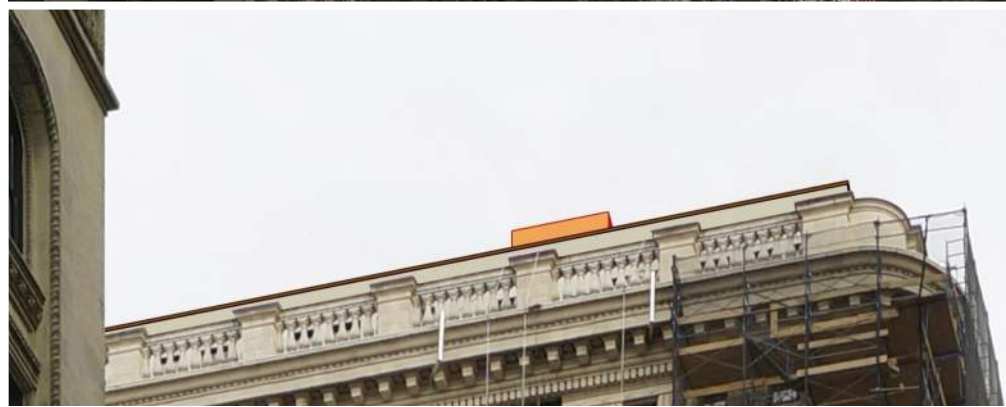
PROPOSED

VIEW 11 (ON W 22ND ST, LOOKING EAST)

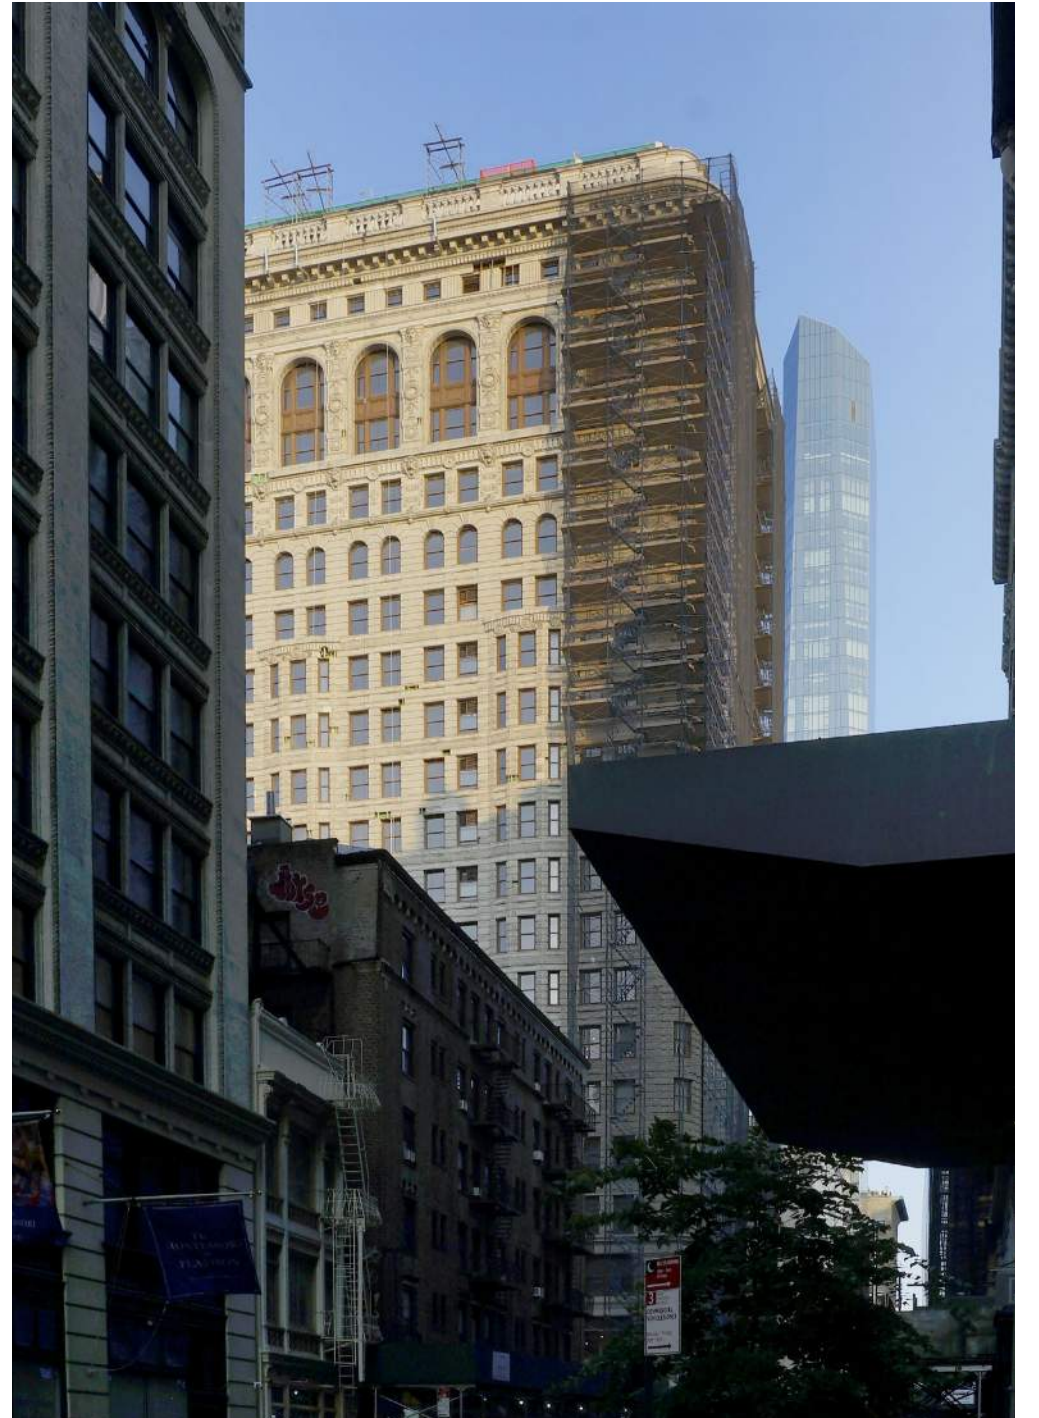
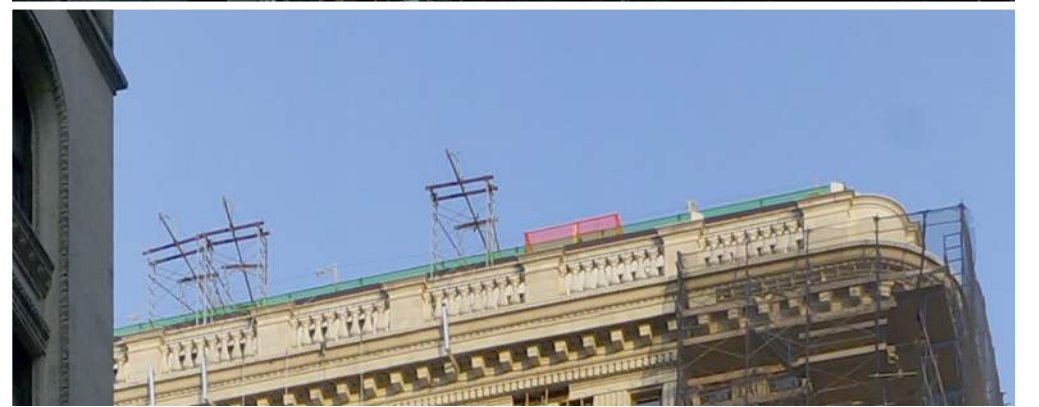
MOCK-UP
