The Flatiron Building

PRESENTATION TO LANDMARK PRESERVATION COMMISSION

MAY 21, 2024

1. WINDOW REPLACEMENT
2. STOREFRONT MASTER PLAN MODIFICATION
3. ROOFTOP MECHANICAL AND BUIKHEAD PLAN
4. APPENDIX

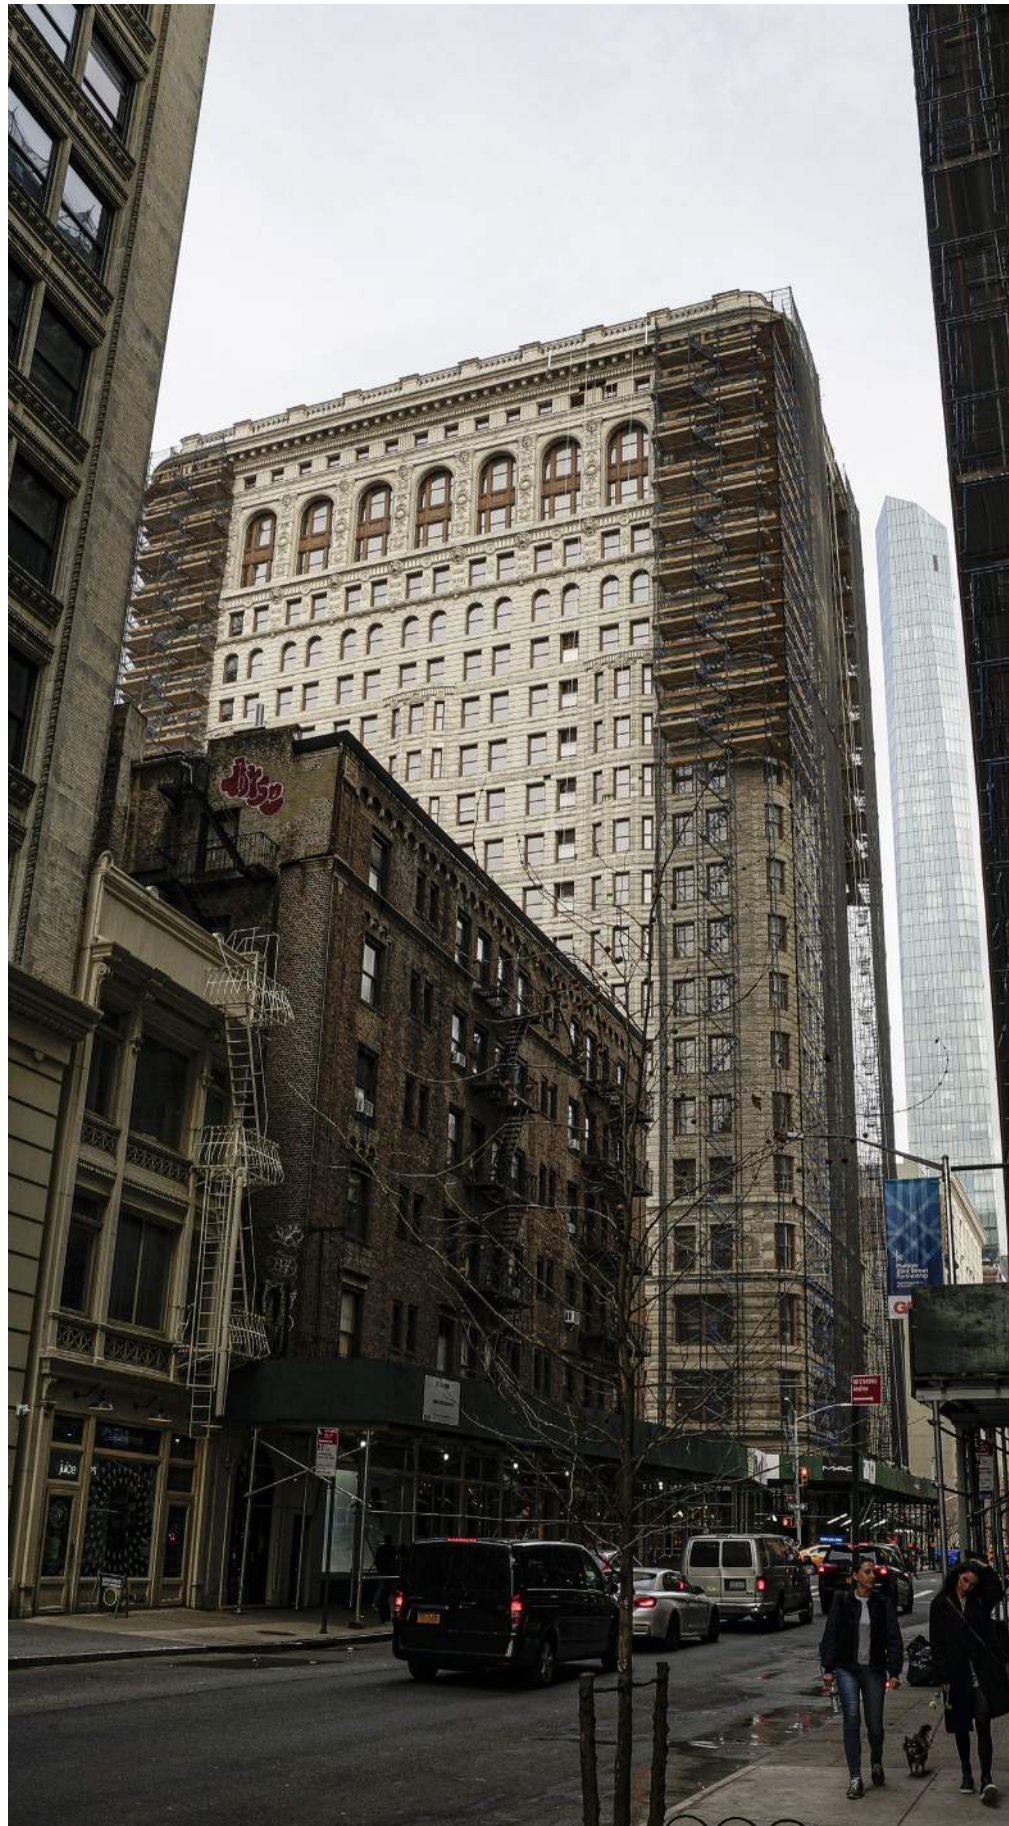
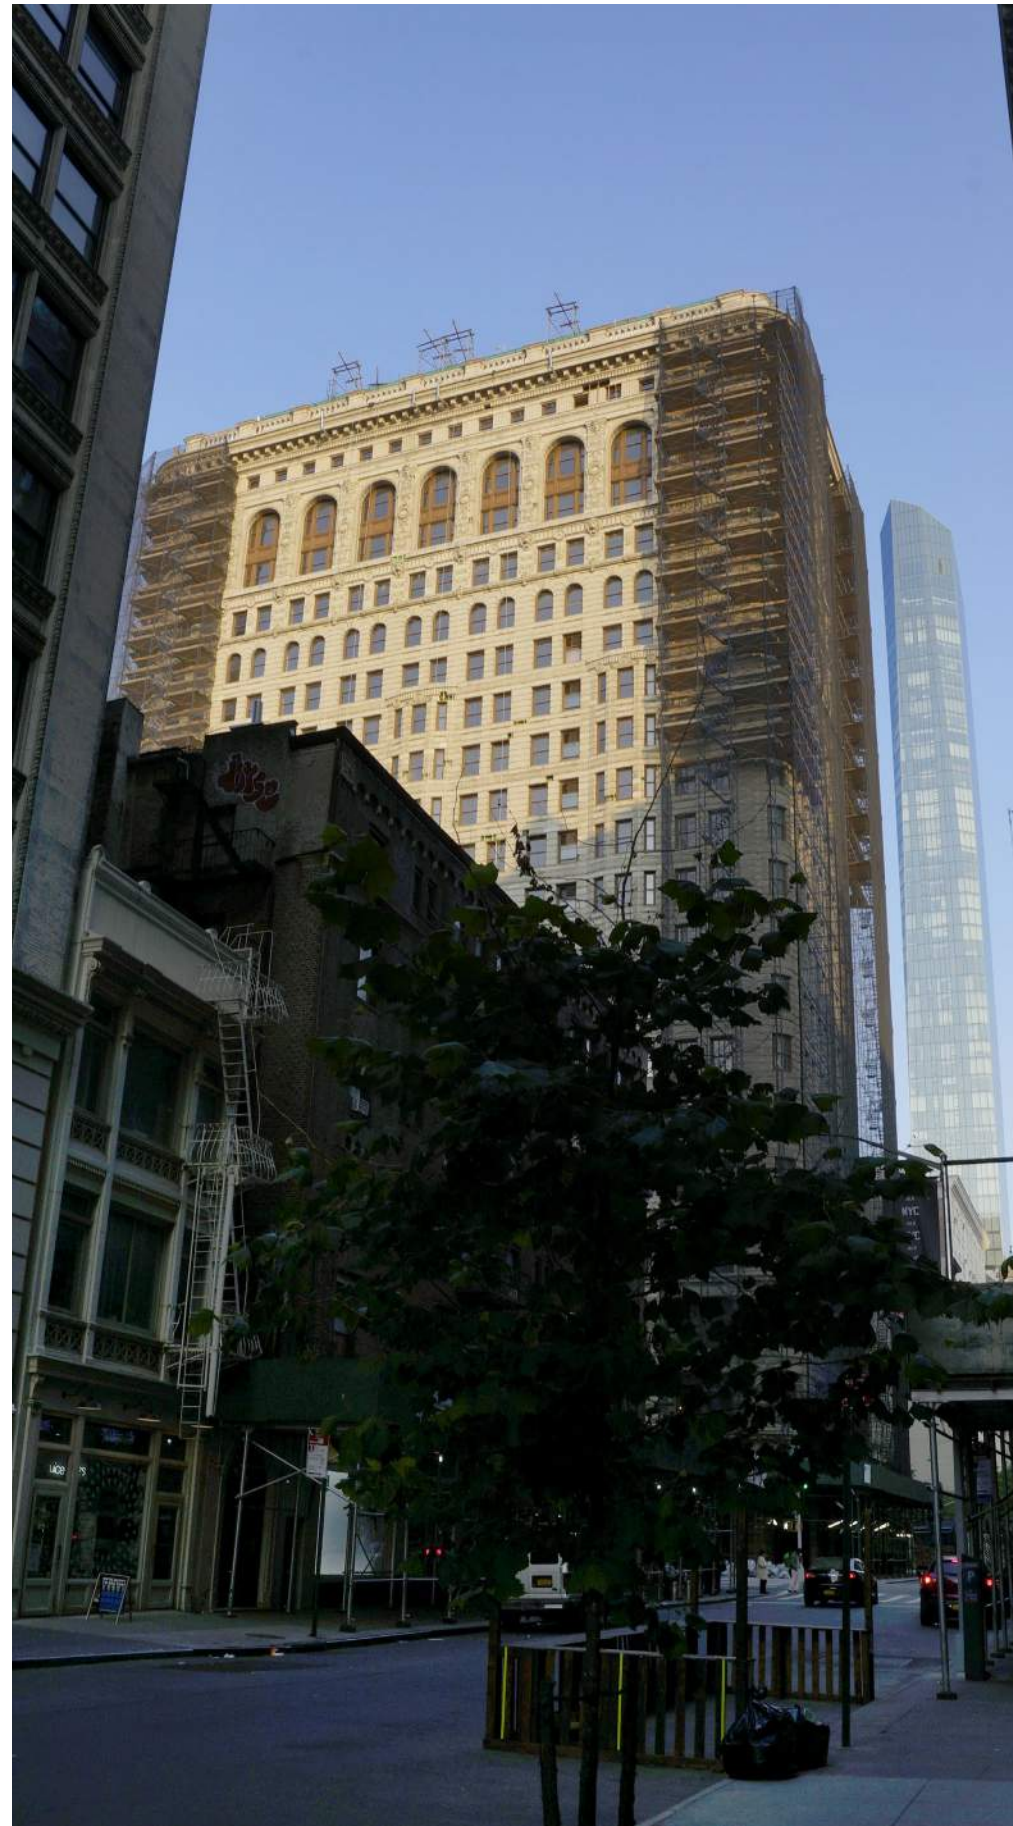
VIEW 12 (ON W 22ND ST, LOOKING EAST)

EXISTING CONDITION

PROPOSED

MOCK-UP

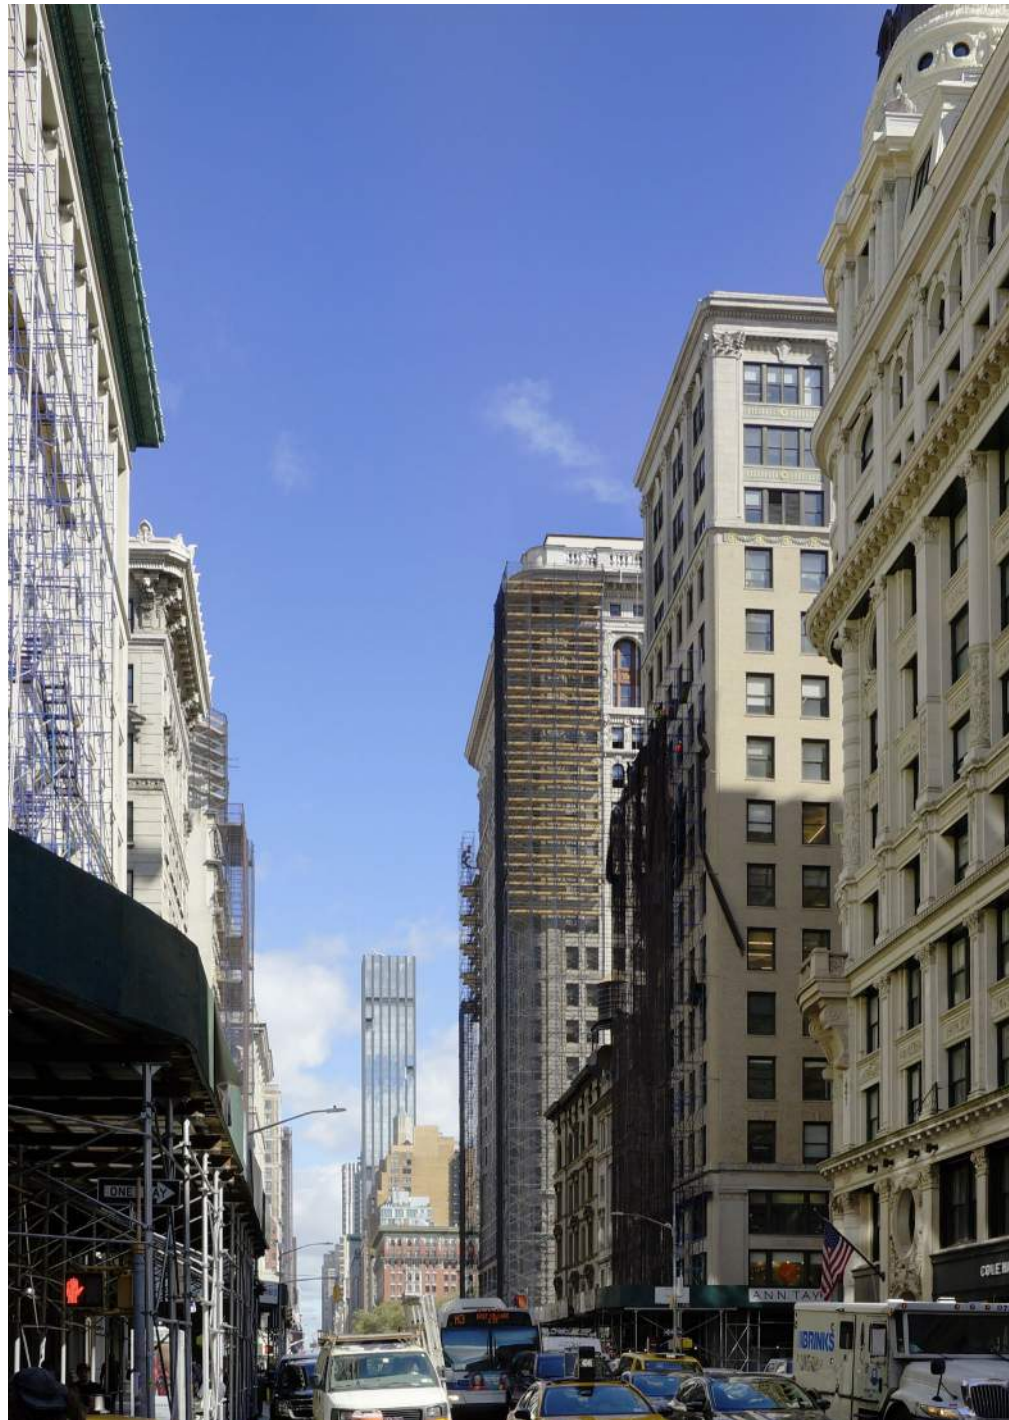
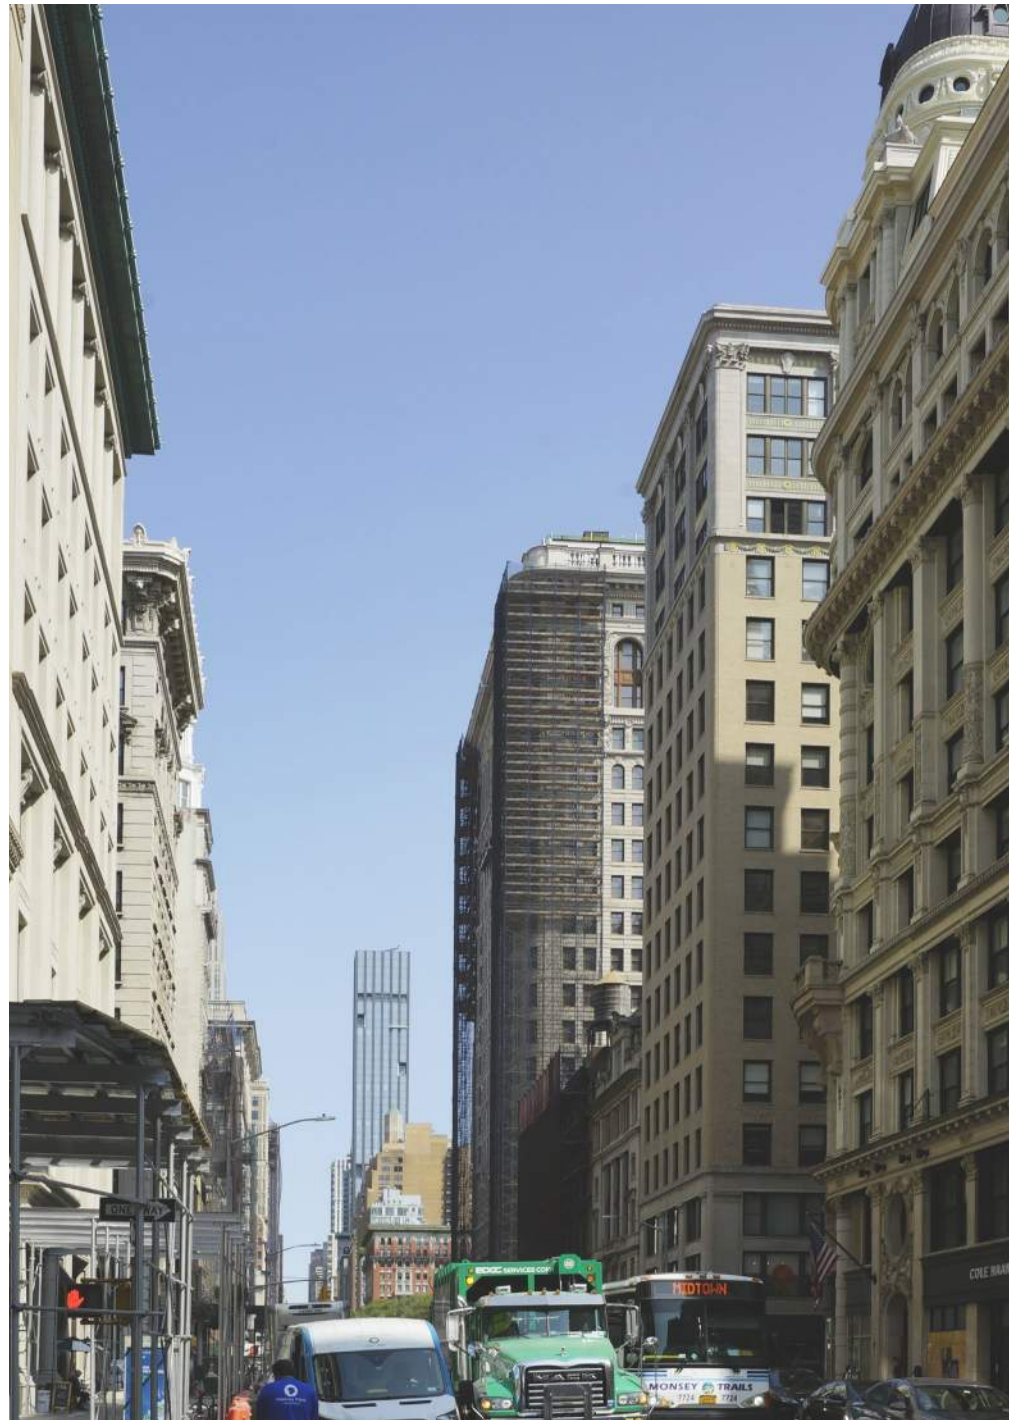
VIEW 13 (AT W 20TH ST & 5TH AVE INTERSECTION, LOOKING NORTH)

EXISTING CONDITION

PROPOSED

MOCK-UP

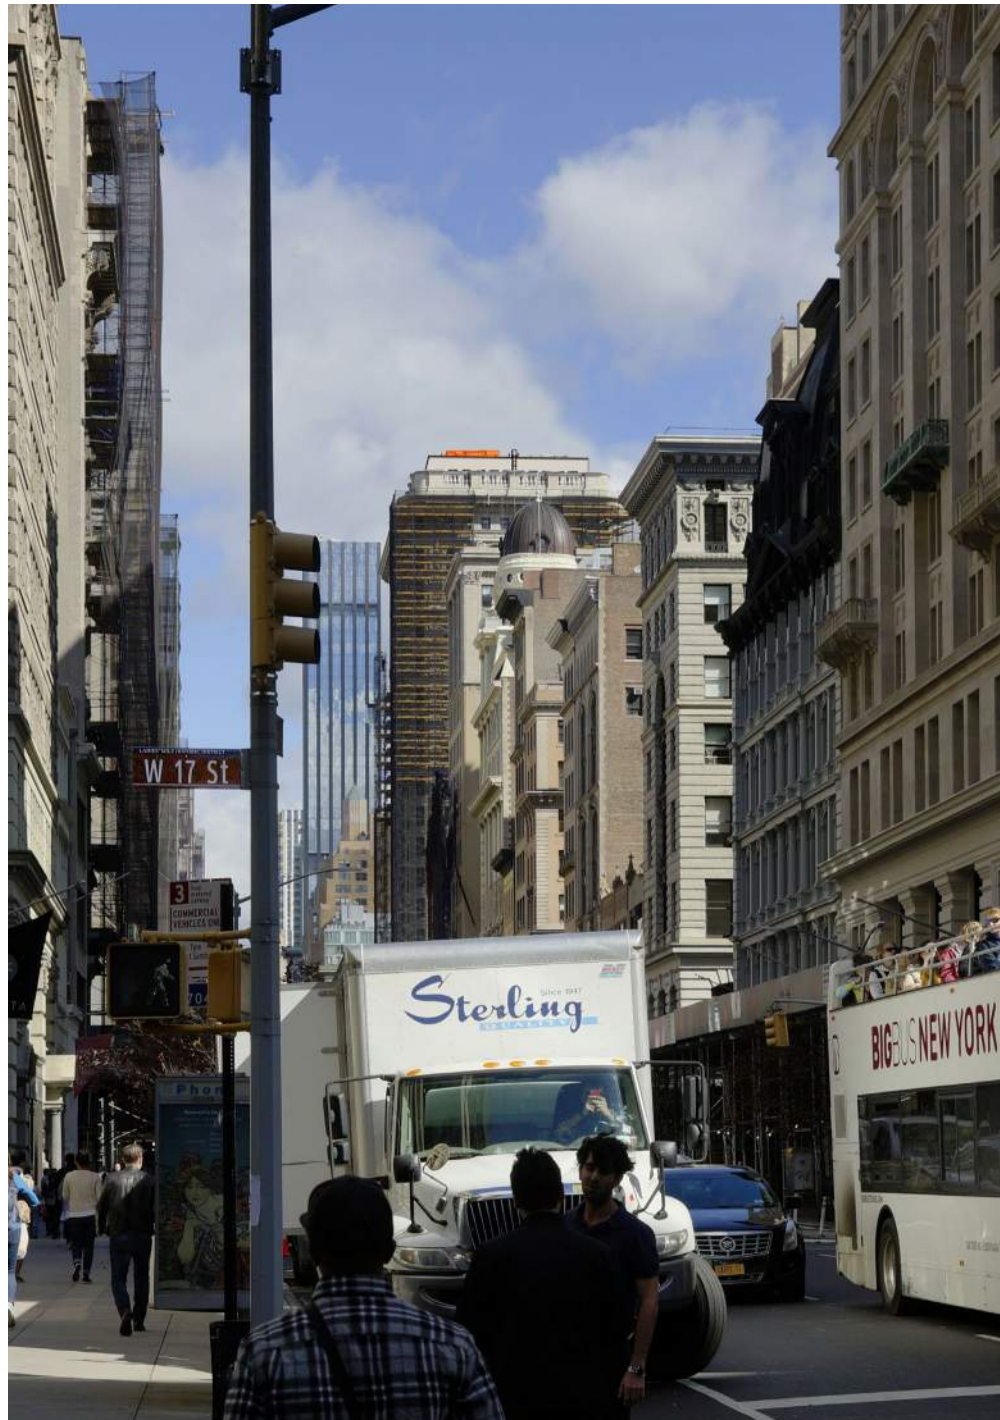
VIEW 14 (AT W 17TH ST & 5TH AVE INTERSECTION, LOOKING NORTH)

EXISTING CONDITION

PROPOSED

MOCK-UP

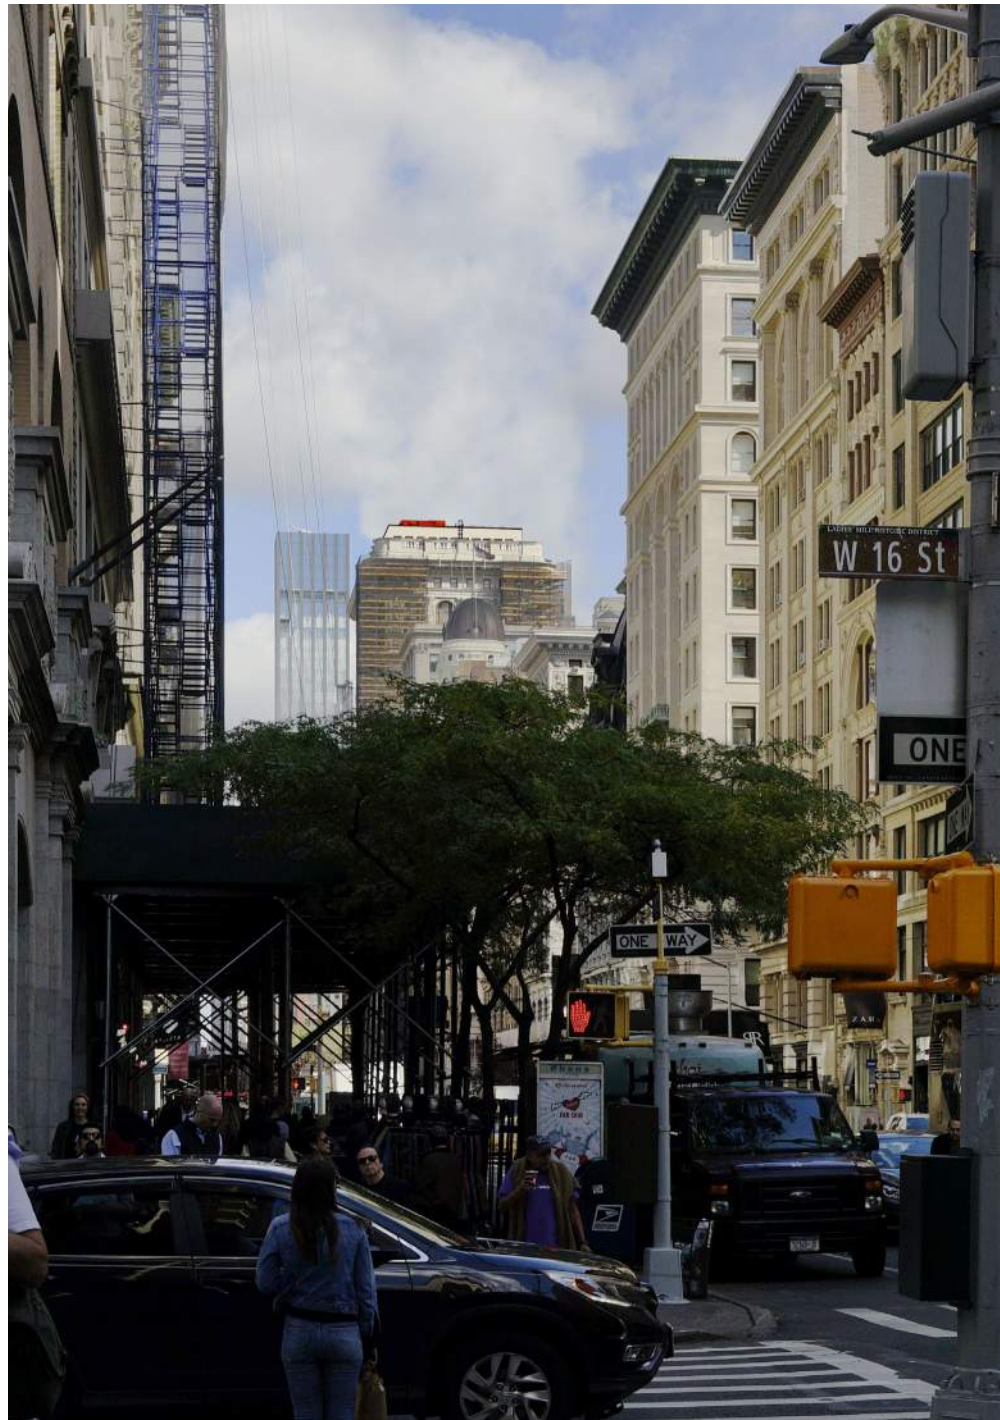
VIEW 15 (AT W 16TH ST & 5TH AVE INTERSECTION, LOOKING NORTH)

EXISTING CONDITION

PROPOSED

MOCK-UP

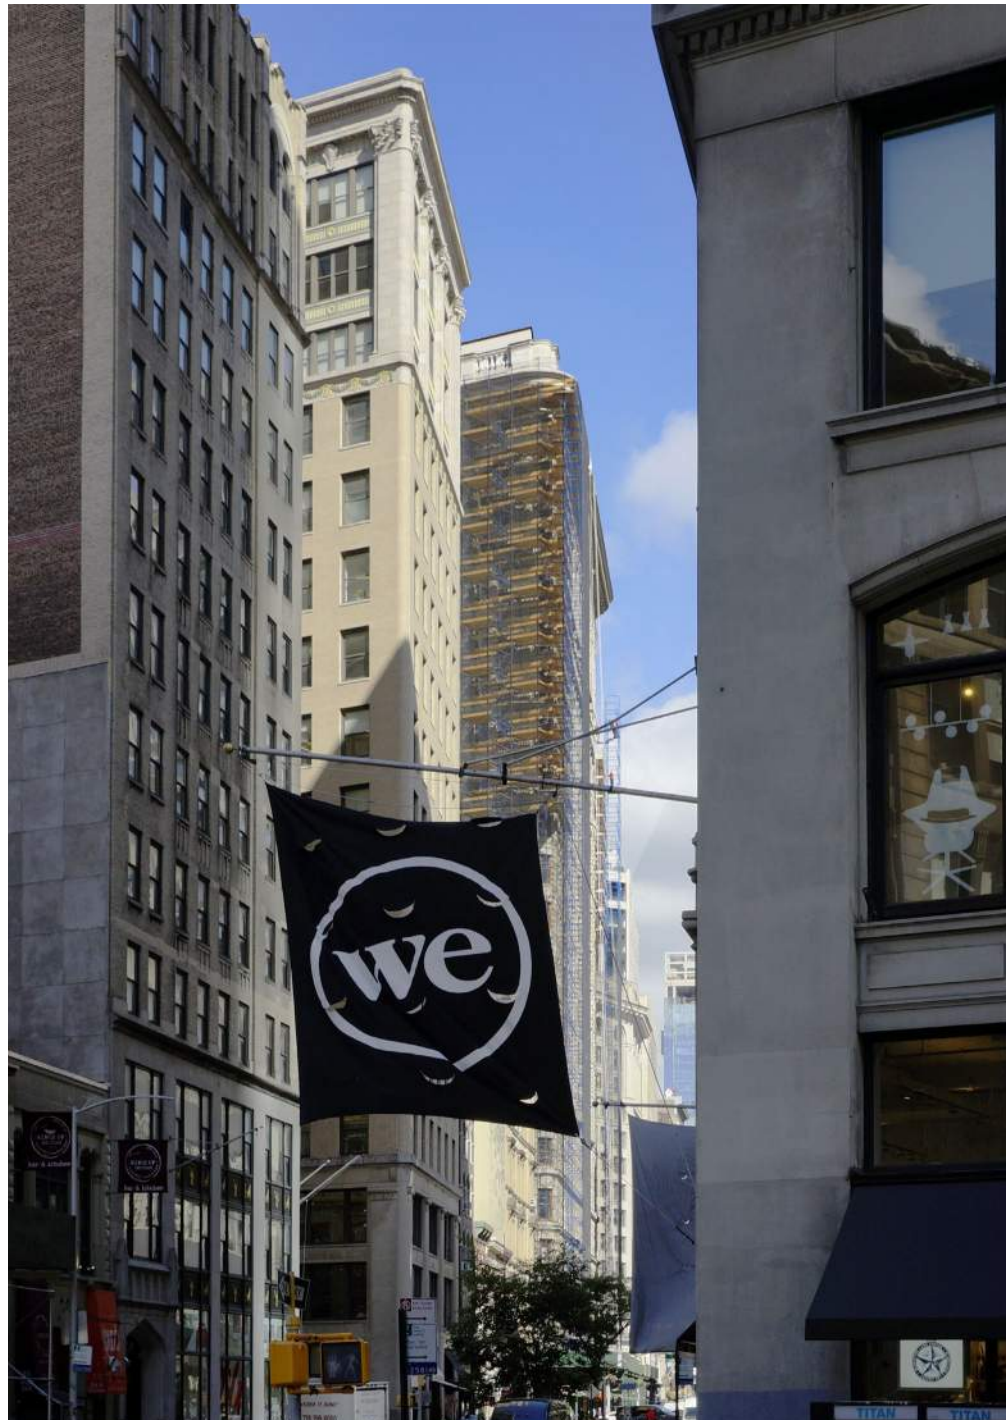
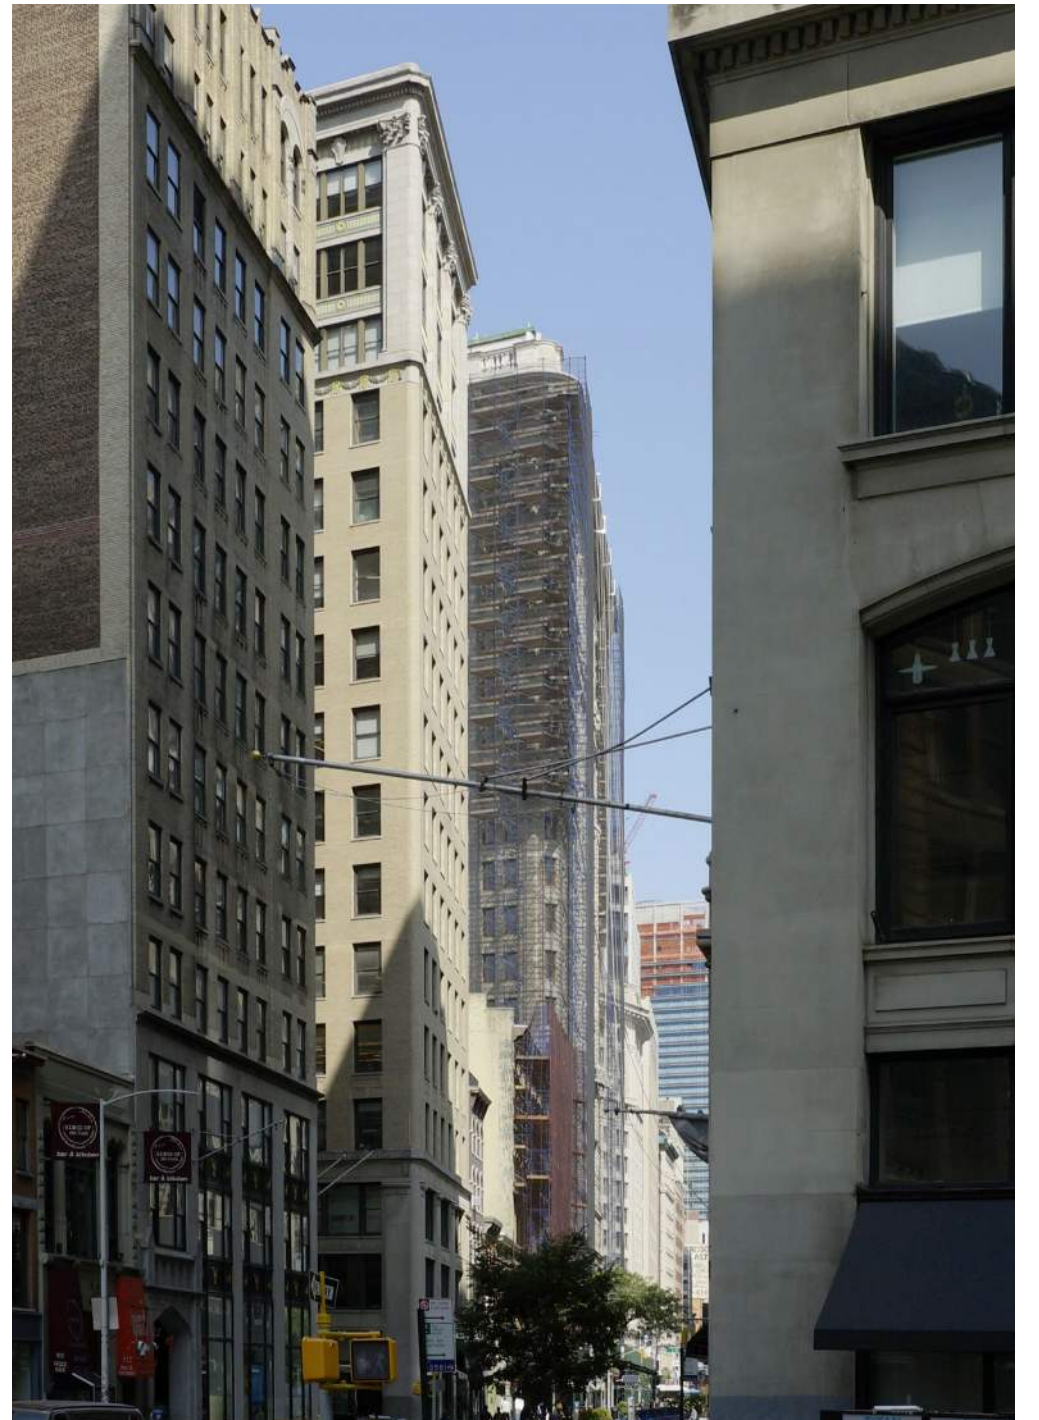
VIEW 16 (AT E 20TH ST & BROADWAY INTERSECTION, LOOKING NORTH)

EXISTING CONDITION

PROPOSED

MOCK-UP

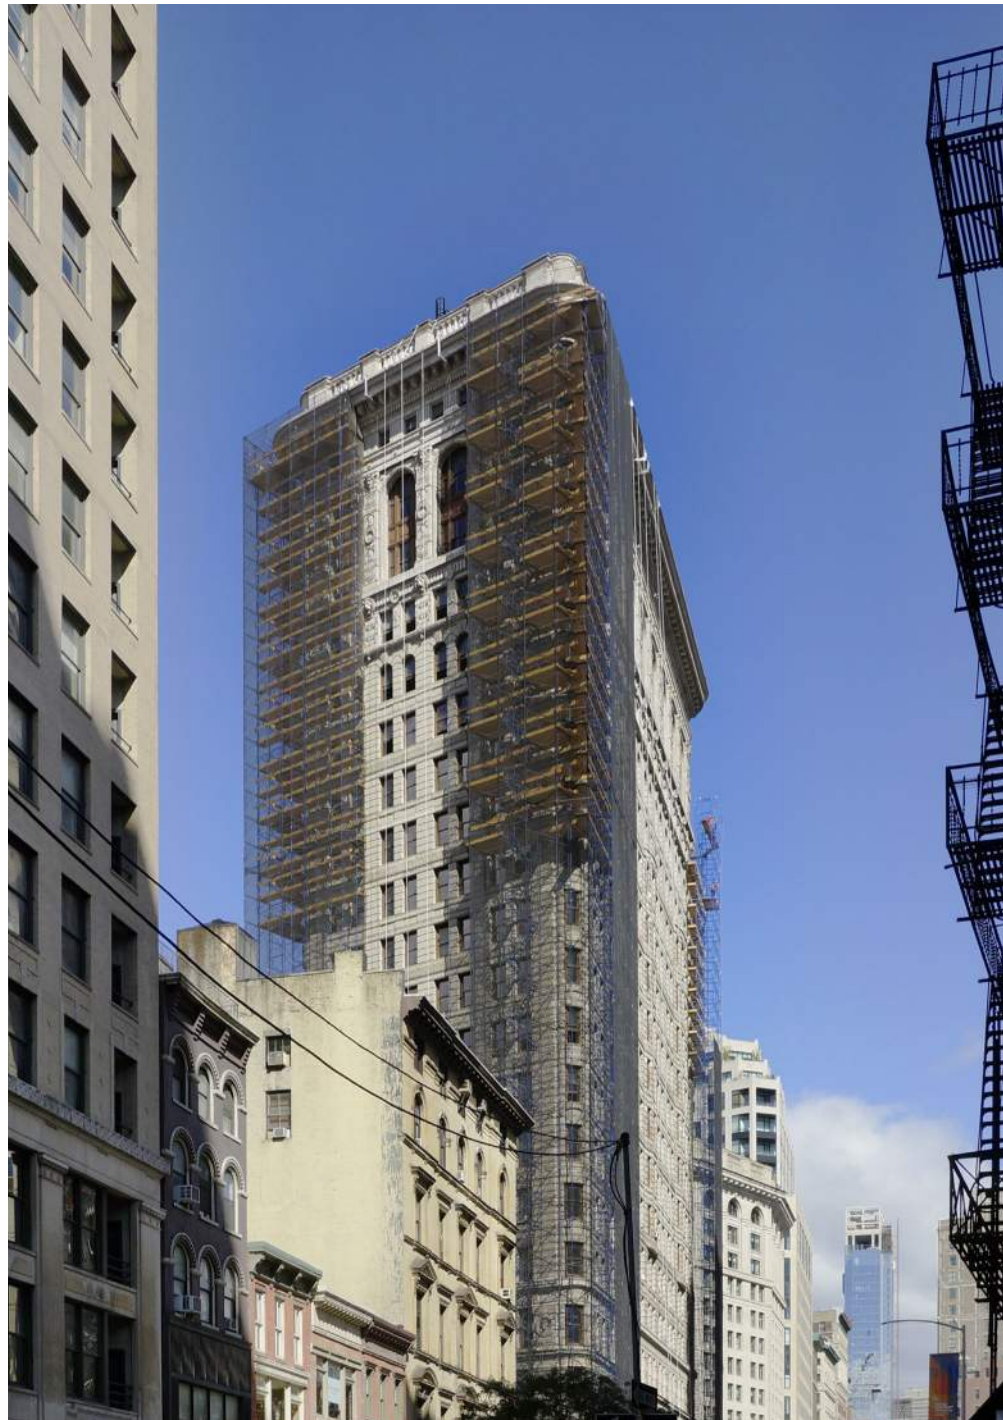
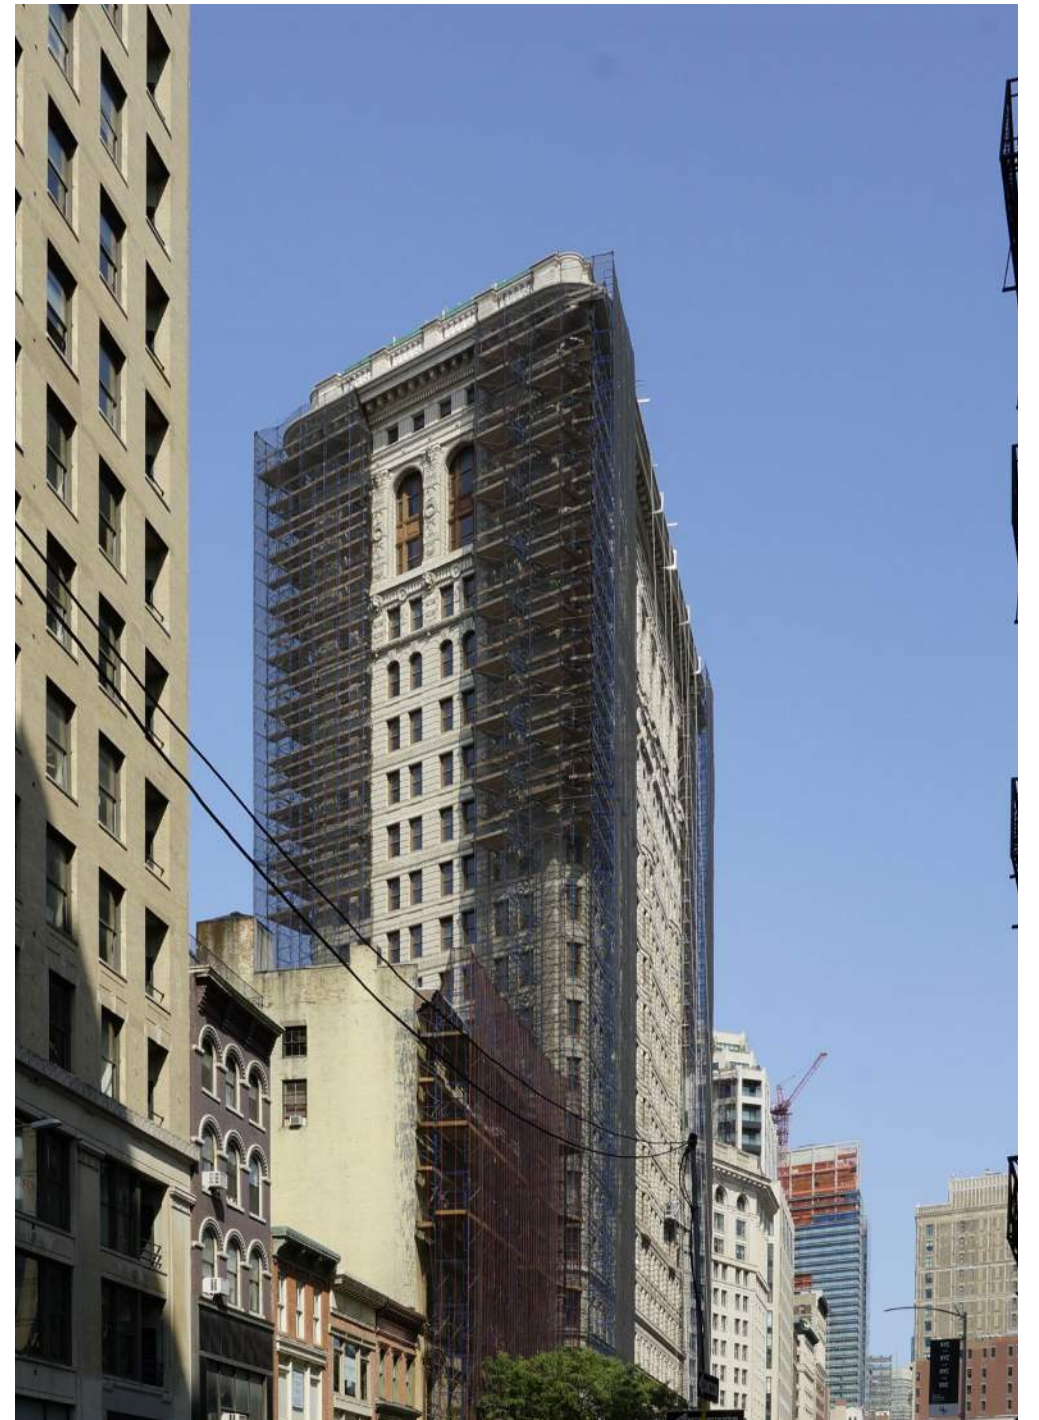
VIEW 17 (AT E 21ST ST & BROADWAY INTERSECTION, LOOKING NORTH)

EXISTING CONDITION

PROPOSED

MOCK-UP

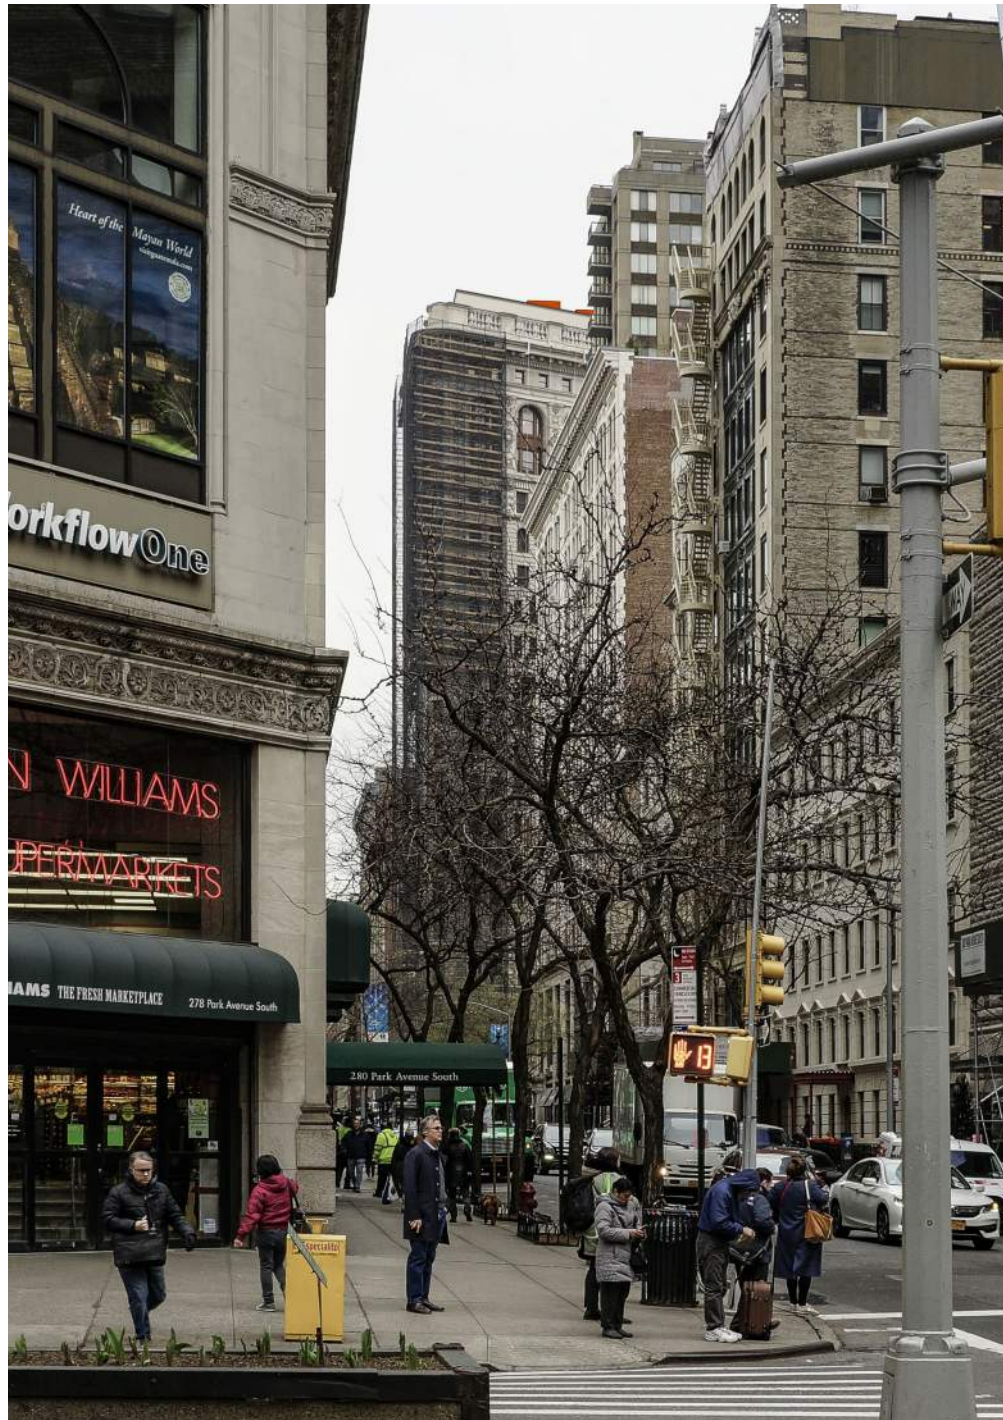
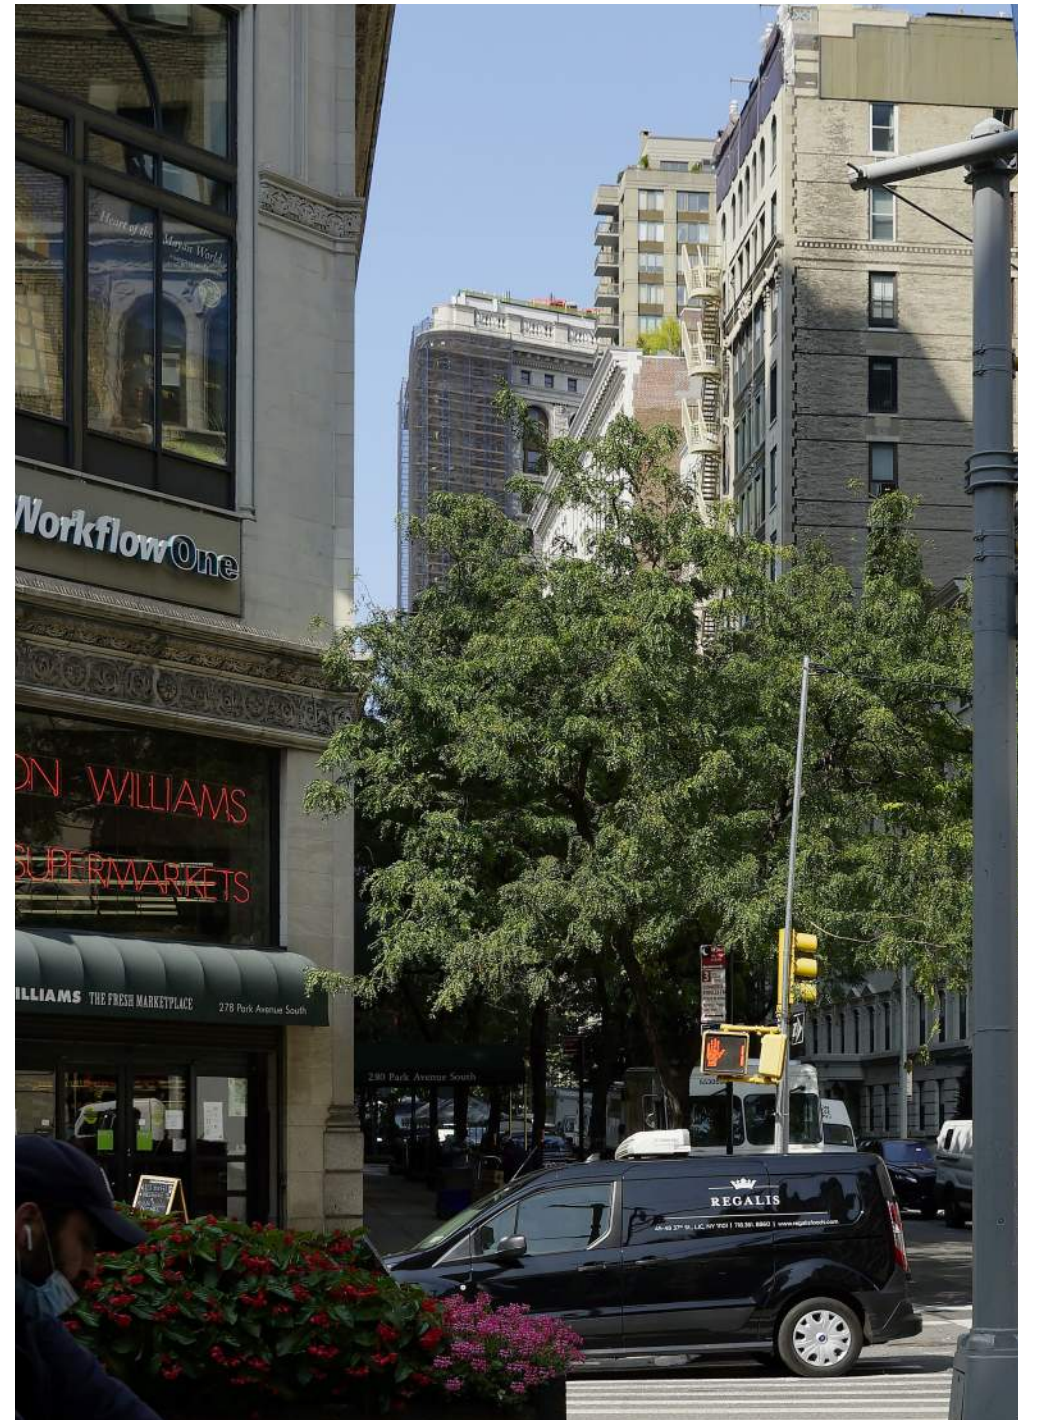
VIEW 18 (ON E 22ND ST, LOOKING WEST)

EXISTING CONDITION

PROPOSED

MOCK-UP

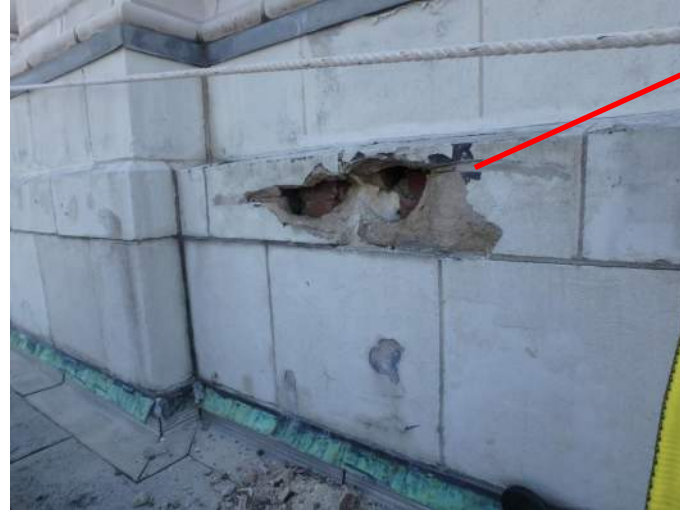
PHOTO # 1:
West Elevation
Main Roof
Close-up photo of main roof
spalled terracotta.

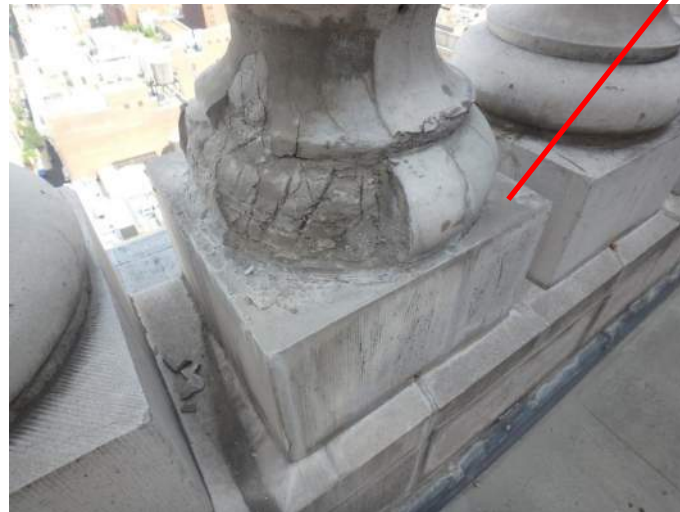
PHOTO # 2:
West Elevation
Main Roof
Close-up photo of spalled
precast balustrade at perimeter
of main roof.
Photos by CANY

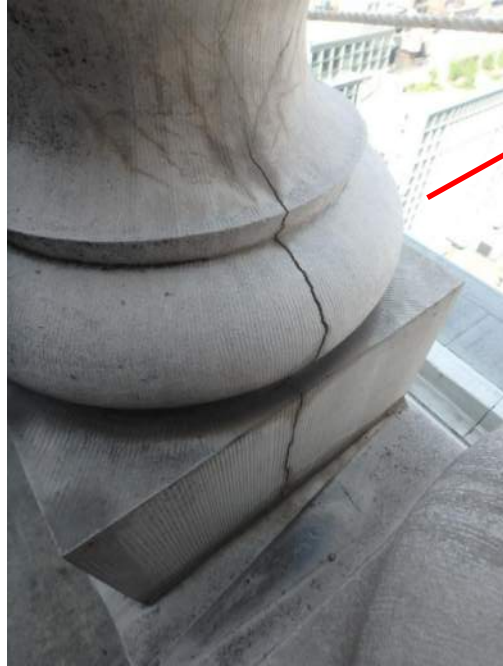
PHOTO # 5:

East Elevation
21st Floor, at cornice

Overview photo of typical failing
crack repair at cornice, new
cracks are beginning to open
again.

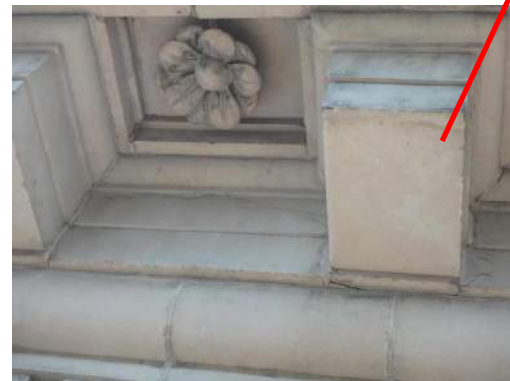
PHOTO # 8:

East Elevation
21st Floor

Close-up photo of typical
cracks/ deteriorated joint
around modillions at the
underside of cornice.

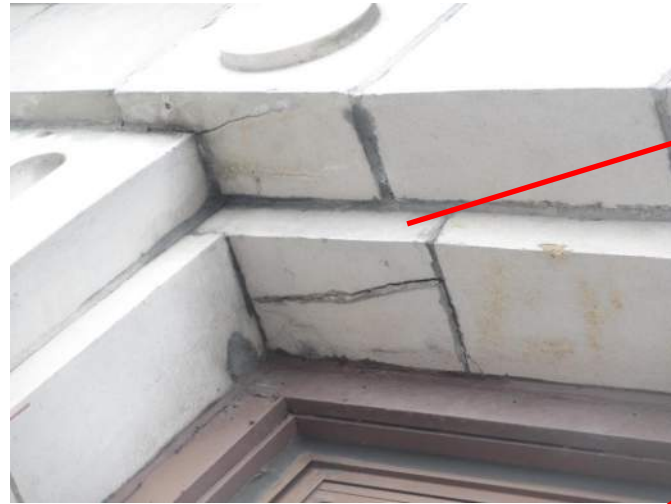
South Elevation
20th Floor

Close-up photo of typical failed previous terracotta patch repair and new cracks at window lintel.

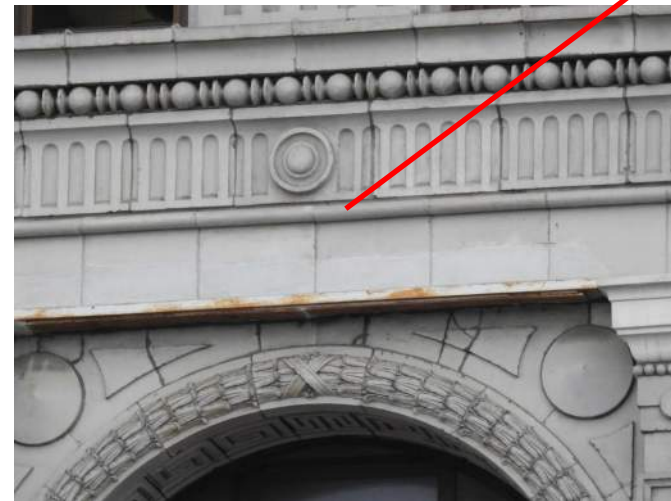
PHOTO # 24:

South Elevation
19th floor

Close-up of typical rusted/corroded remedial lintel on the South Elevation.

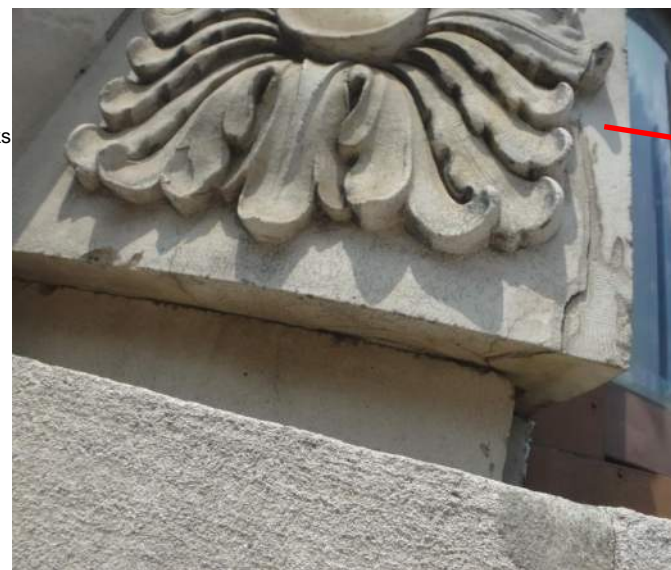
PHOTO # 19:

South Elevation
4th Floor

Close-up photo of typical cracks at limestone window jamb.

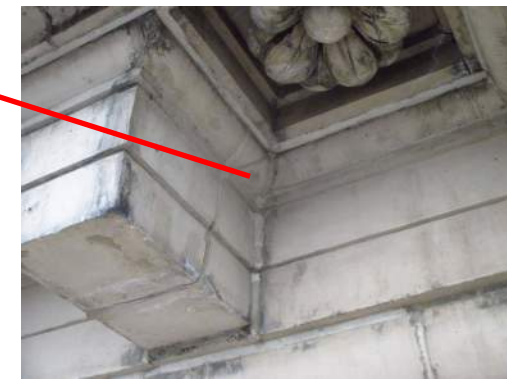
South Elevation
21st Floor

Close-up photo of typical deteriorated joint around modillions at the underside of cornice.

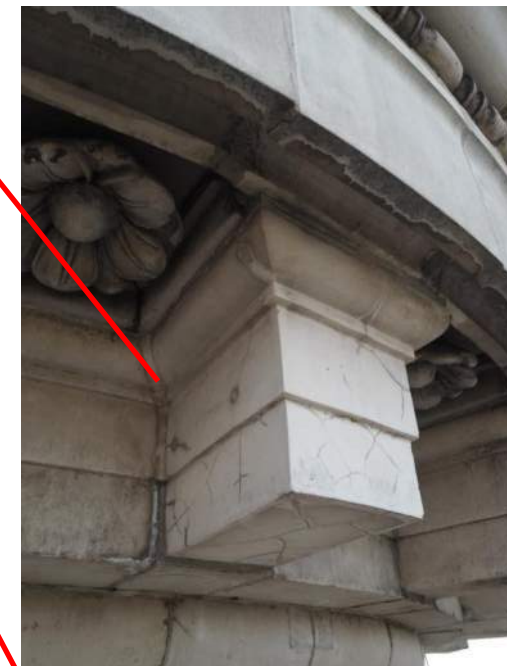
PHOTO # 7:

North Elevation
21st Floor

Close-up photo of typical cracked modillion at the underside of cornice.

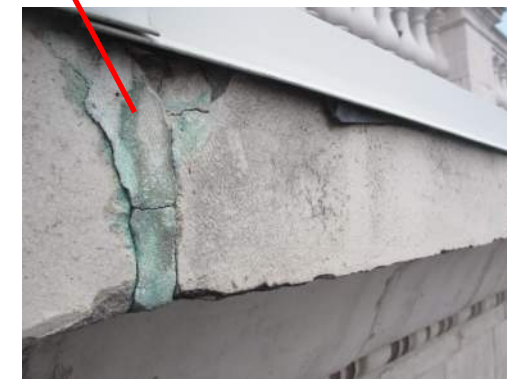
PHOTO # 4:

South Elevation
21st Floor, at cornice

Overview photo of typical cracking at cornice, new cracks are forming.

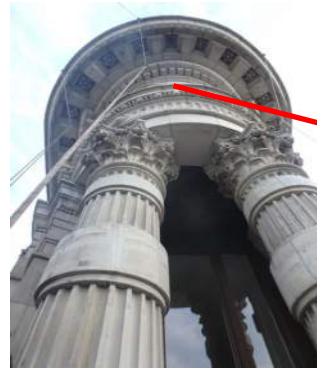
North Elevation
19th Floor

Overview photo of typical failed previous terracotta patch repair and new cracks at columns.

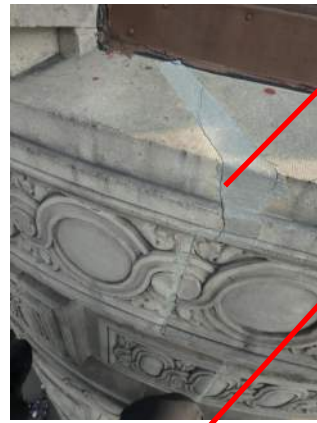
PHOTO # 21:

North Elevation
14th floor

Close-up of typical cracked/failed patch repair at terra cotta sill.

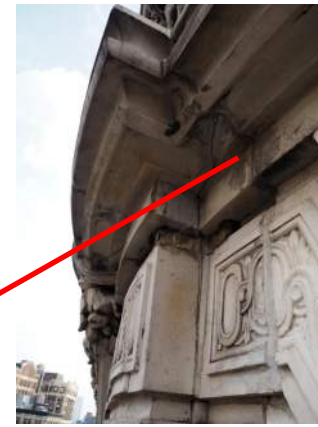
North Elevation
17th Floor

Close-up photo of typical failed previous terracotta patch repair and new cracks at water table.

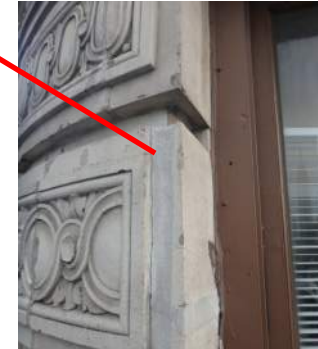
North Elevation
14th Floor

Close-up photo of typical failed previous terracotta patch repair.

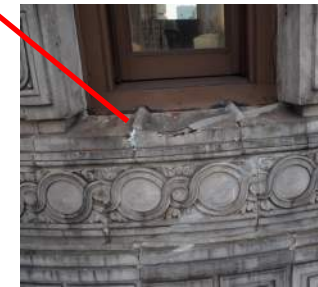
PHOTO # 17:

North Elevation
11th Floor

Overview photo of spalling and failed previous terracotta patch repair and deteriorated mortar joints at window sill.

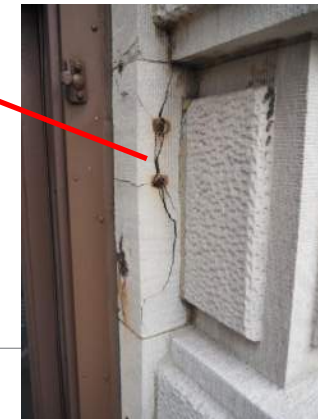
PHOTO # 18:

North Elevation
3rd Floor

Close-up photo of typical cracks at limestone window jamb.
