Daylighting and Street Safety: An Analysis

**VISION
ZERO**  
Building a
Safer City

NEW YORK CITY

January 2025

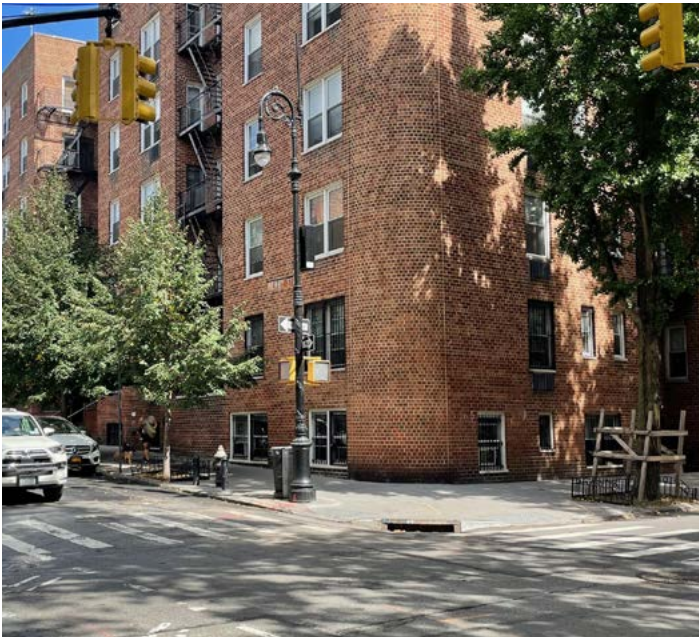
Hydrant zones
Restricted parking adjacent to crosswalks via fire hydrants and bus stops

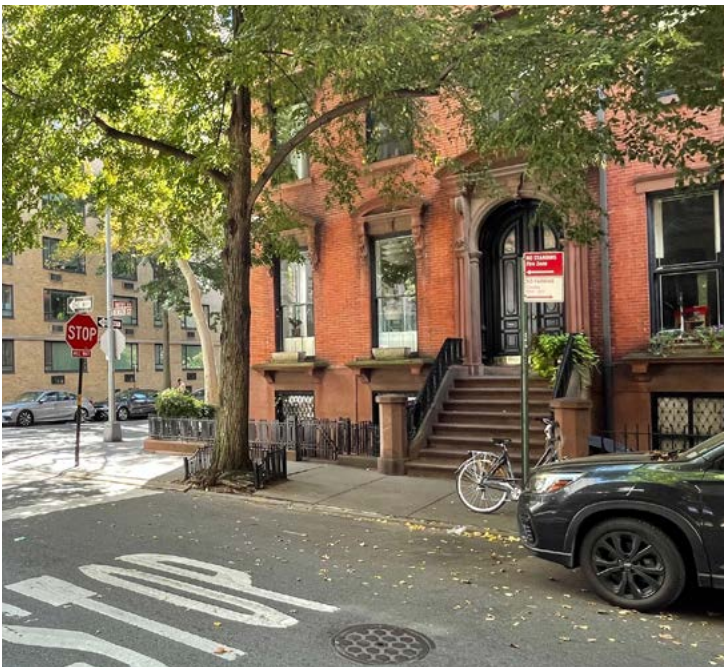
Sign-only daylighting
Restricting parking adjacent to crosswalks using signage only

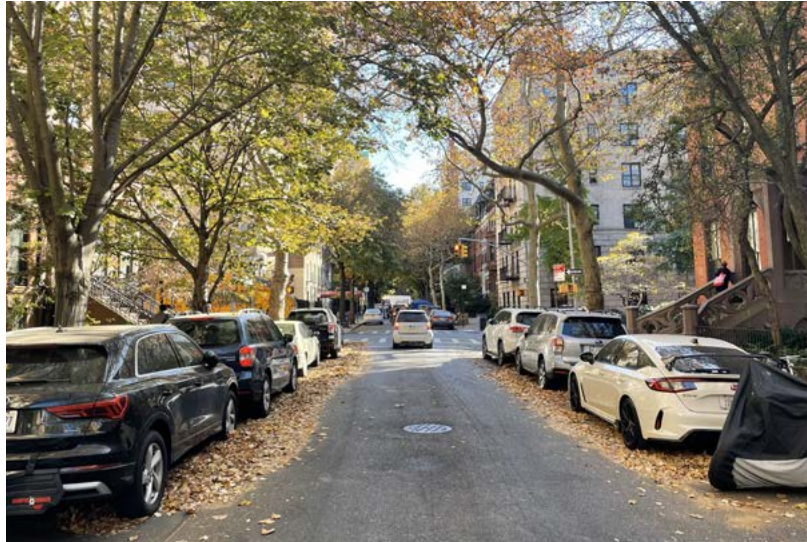
Example of a “tight” feeling street, where visibility and vehicle movement is restricted

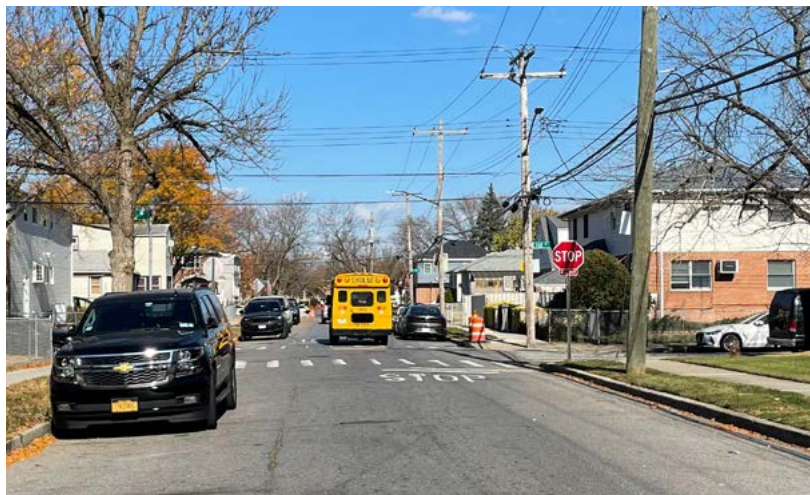
Example of an “open” feeling street, with expanded visibility and more unrestricted vehicle movements

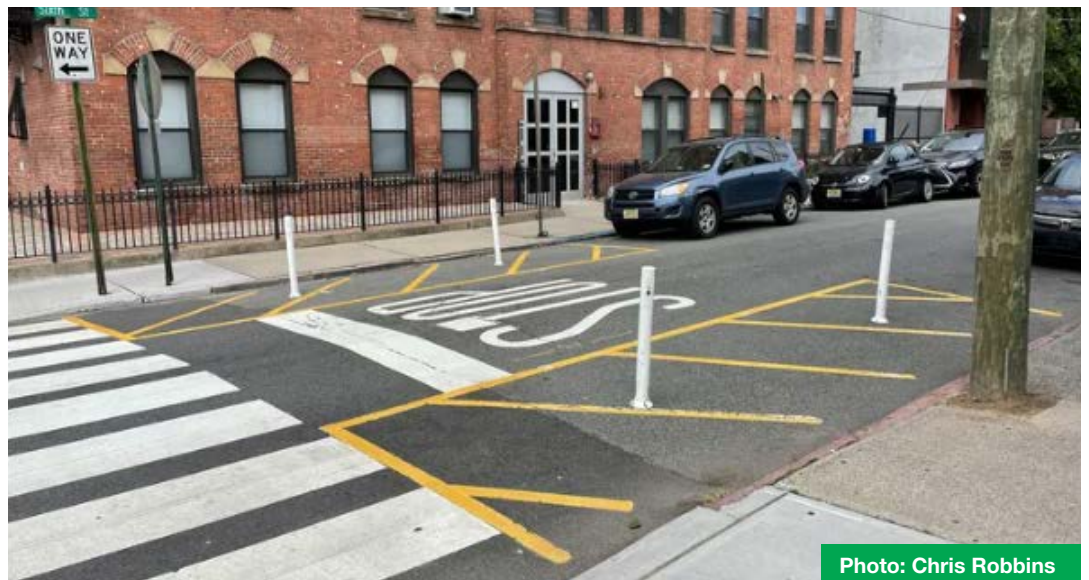
EXTENDED PARKING ZONE DIAGRAM

- The city is small – 1.3 square miles – and there are no limited access highways and a few major arterials.
- The size of the daylighted area fluctuates by time of day – 15 feet in the nighttime, 25 feet during the day.
- “Hoboken Daylighting” includes hardening via plastic delineators based on community input and pedestrian crash data (starting in the 2010s).
- The city has not published a before-after analysis of the specific effects of daylighting on safety.
