Re: NYSDEC Permit 2-6106-00002/00022 Ren 4 (Permit)
Southwest Brooklyn Marine Transfer Station (MTS)
New York City Department of Sanitation (DSNY)
2023 Bulkhead Inspection Report

Re: Southwest Brooklyn Marine Transfer Station
2023 Bulkhead Fender System Inspection

SOUTHWEST BROOKLYN MARINE TRANSFER STATION
DECEMBER 2023

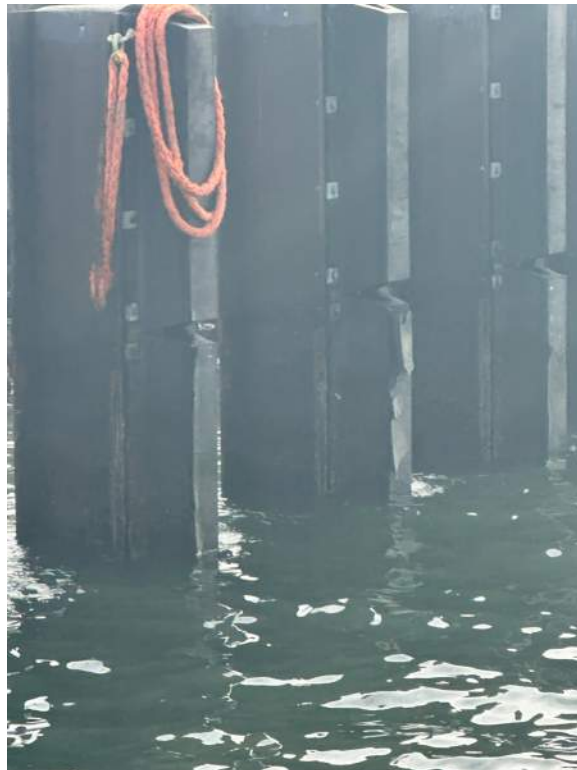
Photo 3. Loose Bolt
